Rhode Island and Connecticut Coastal Nonstructural Assessment

February 2017

**USACE National Nonstructural Flood Proofing Committee
in support of the USACE-New England District**

Enclosure A Nonstructural Assessment Structure Inventory Attribute Sheets

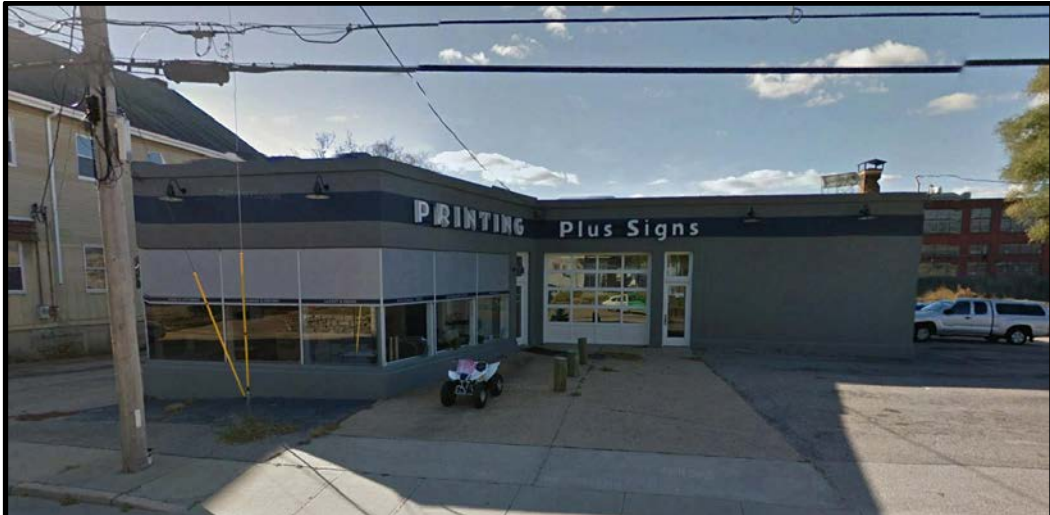
Structure Location:	179 Main Street, Westerly, RI
Occupancy / Built:	commercial / 1948
Structure Condition (visual):	good
1 st Floor Area (sq ft):	4390
Exterior Wall Construction	CMU
Foundation Wall:	CMU
Slab/Crawlspace/Basement:	slab
# Entrances / # 1 st Floor Windows	2 pedestrian 1 vehicle / numerous
Garage:	none
Exterior Mechanical/Electrical/Fuel:	electric, oil, no AC
# Fireplace	0
Landscaping and Shrubs:	0

Recommended Nonstructural Technique: Dry Flood Proof to 2% flood elevation

The exterior structure walls could resist flooding to possibly over 3-foot of depth. It is recommended that a water resistant sealant be applied to the walls to a height of four feet. The pedestrian entrances and vehicle entrances should be retrofitted with certified flood barriers and the structure windows should be retrofitted to either reduce the amount of glass and replace with similar exterior wall material or consider aquarium level of performance glass as a replacement.

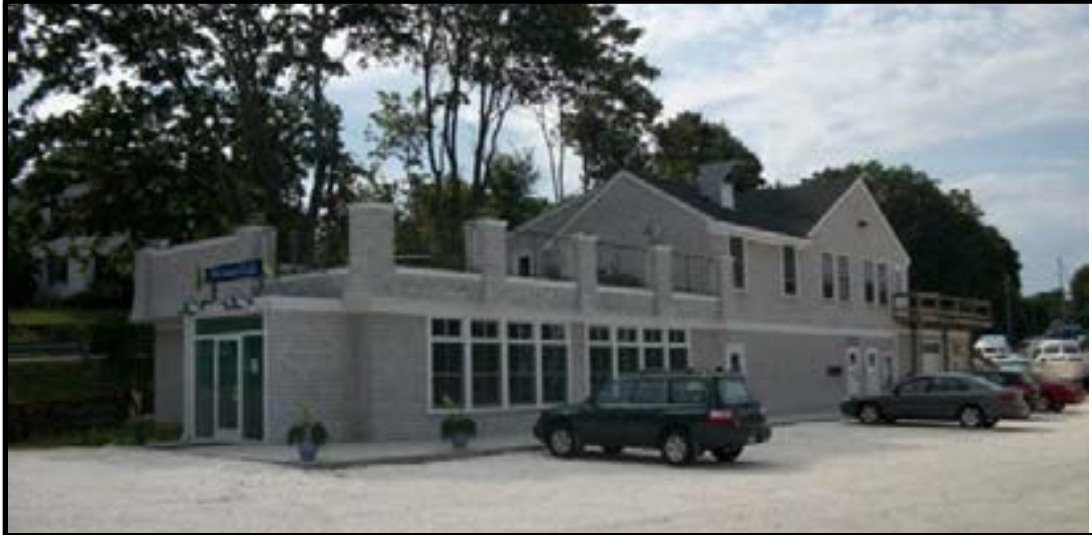
Structure Location:	19 Margin Street, Westerly, RI
Occupancy / Built:	commercial / 1930
Structure Condition (visual):	good
1 st Floor Area (sq ft):	3448
Exterior Wall Construction	wood shingle
Foundation Wall:	NA
Slab/Crawlspace/Basement:	slab
# Entrances / # 1 st Floor Windows	5 / multiple
Garage:	none
Exterior Mechanical/Electrical/Fuel:	AC, electric, gas
# Fireplace	0
Landscaping and Shrubs:	yes

The structure is extremely large and would thus be difficult to elevate above the 1% annual chance exceedance flood elevation. The construction appears to be wood frame, slab on grade. Dry flood proofing could be considered to a height of approximately 3- to 4-feet which could provide protection up to the 1% flood elevation. For permanent dry flood proofing the owner should consider retrofitting all entrances with certified flood barriers and removing the exterior siding to all incorporation of flood resistant material, after which the original siding could be replaced. For temporary measures, the owner could consider attaching a water impenetrable sheeting to the exterior of the structure, approximately 4-feet in height, all of the way around the exterior of the structure. The sheeting should be extended 4- to 5- feet away from the structure and weighted with sandbags to prevent flood waters from seeping under the sheeting. The temporary measure would require the removal of all vegetation within 5-feet from the exterior of the structure.

Recommended Nonstructural Technique: Dry Flood Proof to approximately 1% flood elevation

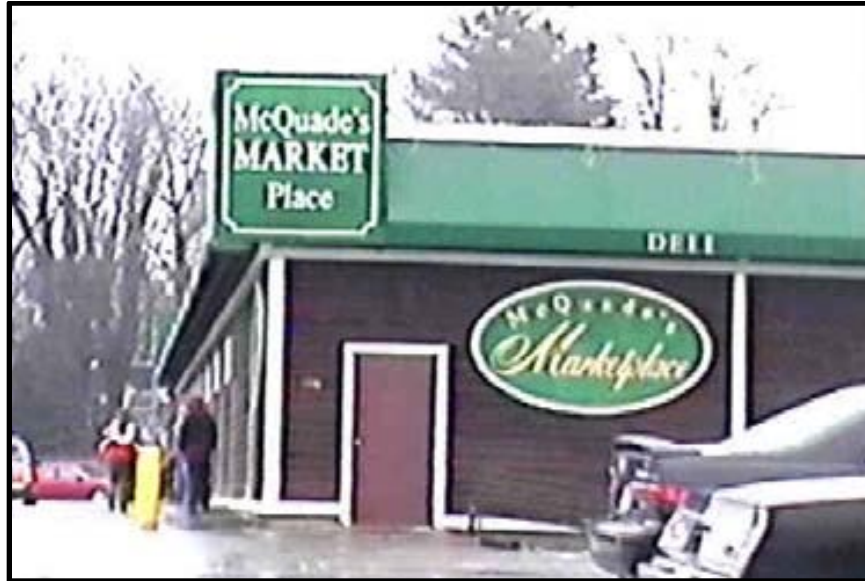
Structure Location:	106 Main St, Westerly, RI
Occupancy / Built:	commercial / 1985
Structure Condition (visual):	good
1 st Floor Area (sq ft):	27,636
Exterior Wall Construction:	CMU
Foundation Wall:	CMU
Slab/Crawlspace/Basement:	Slab
# Entrances / # 1 st Floor Windows:	NA / NA
Garage:	NA
Exterior Mechanical/Electrical/Fuel:	electric, gas
# Fireplace	0
Landscaping and Shrubs:	0

Recommended Nonstructural Technique: Dry Flood Proof to the 1% flood elevation

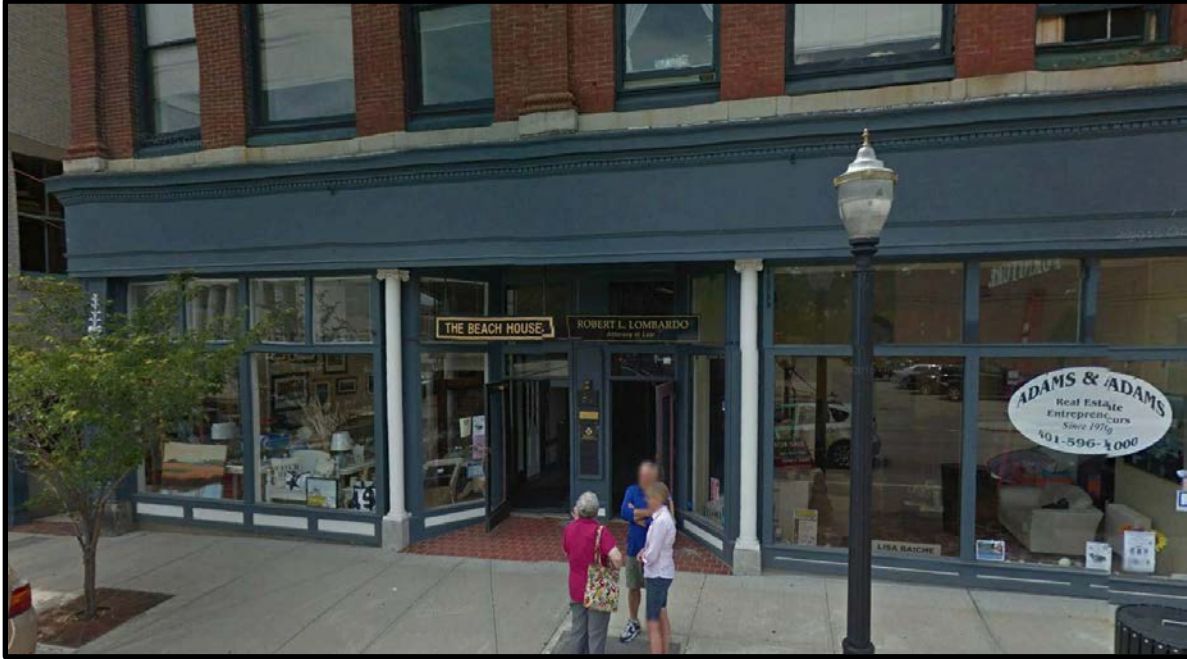
Structure Location:	12 High St, Westerly, RI
Occupancy / Built:	commercial / 1910
Structure Condition (visual):	good
1 st Floor Area (sq ft):	9,576
Exterior Wall Construction:	brick/masonry
Foundation Wall:	brick/masonry
Slab/Crawlspace/Basement:	basement
# Entrances / # 1 st Floor Windows:	multiple / multiple
Garage:	none
Exterior Mechanical/Electrical/Fuel:	AC, electric, oil
# Fireplace	0
Landscaping and Shrubs:	0

Recommended Nonstructural Technique: Requires additional investigation. See assessment notes

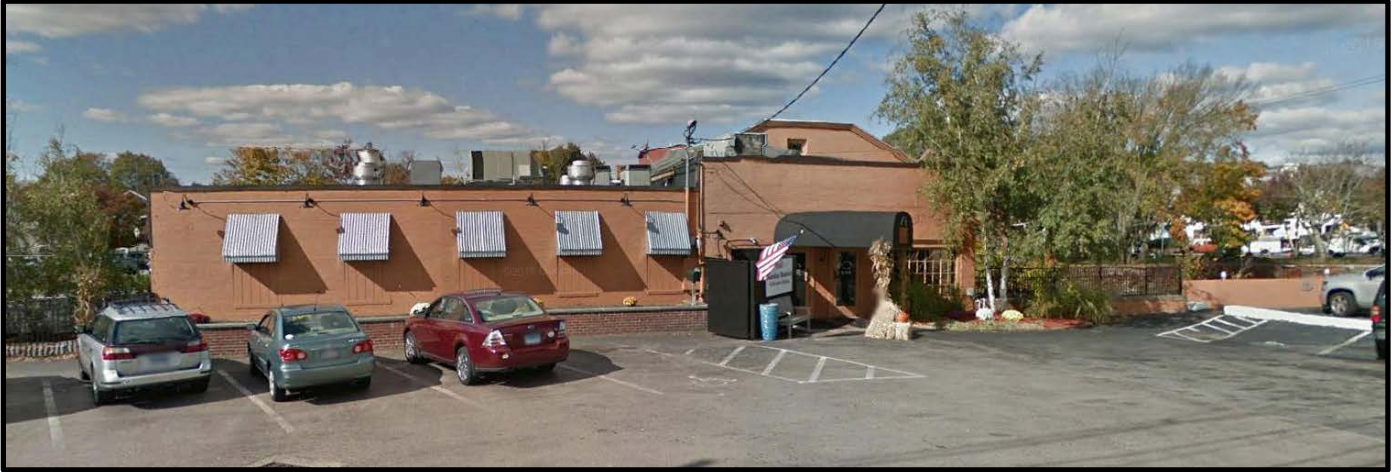
Structure Location:	37 Main St, Westerly, RI
Occupancy / Built:	commercial / 1900
Structure Condition (visual):	good
1 st Floor Area (sq ft):	4,026
Exterior Wall Construction:	CMU / concrete
Foundation Wall:	CMU
Slab/Crawlspace/Basement:	slab
# Entrances / # 1 st Floor Windows:	2 / multiple
Garage:	none
Exterior Mechanical/Electrical/Fuel:	AC, electric, gas
# Fireplace	0
Landscaping and Shrubs:	yes

Recommended Nonstructural Technique: Dry Flood Proof to the 2% flood elevation

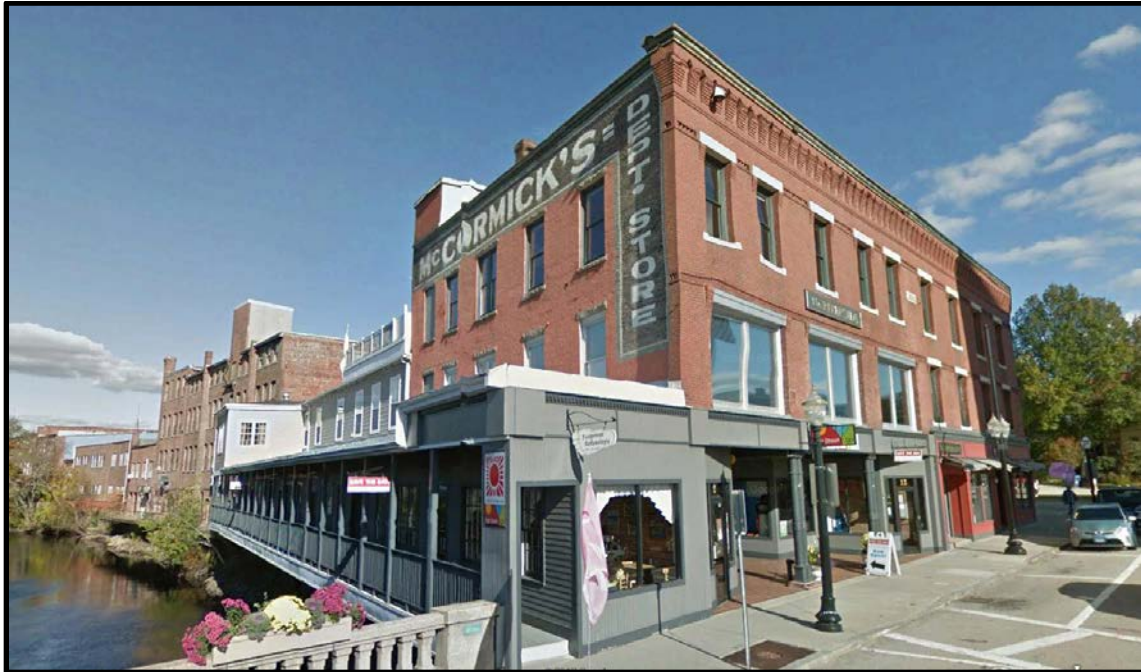
Structure Location:	2 Broad St, Westerly, RI
Occupancy / Built:	commercial / 1882
Structure Condition (visual):	good
1 st Floor Area (sq ft):	6,661
Exterior Wall Construction:	brick / masonry / clapboard
Foundation Wall:	brick / masonry
Slab/Crawlspace/Basement:	basement
# Entrances / # 1 st Floor Windows:	multiple / multiple
Garage:	none
Exterior Mechanical/Electrical/Fuel:	AC, electric, gas
# Fireplace	0
Landscaping and Shrubs:	0

Recommended Nonstructural Technique Requires additional investigation. See assessment notes

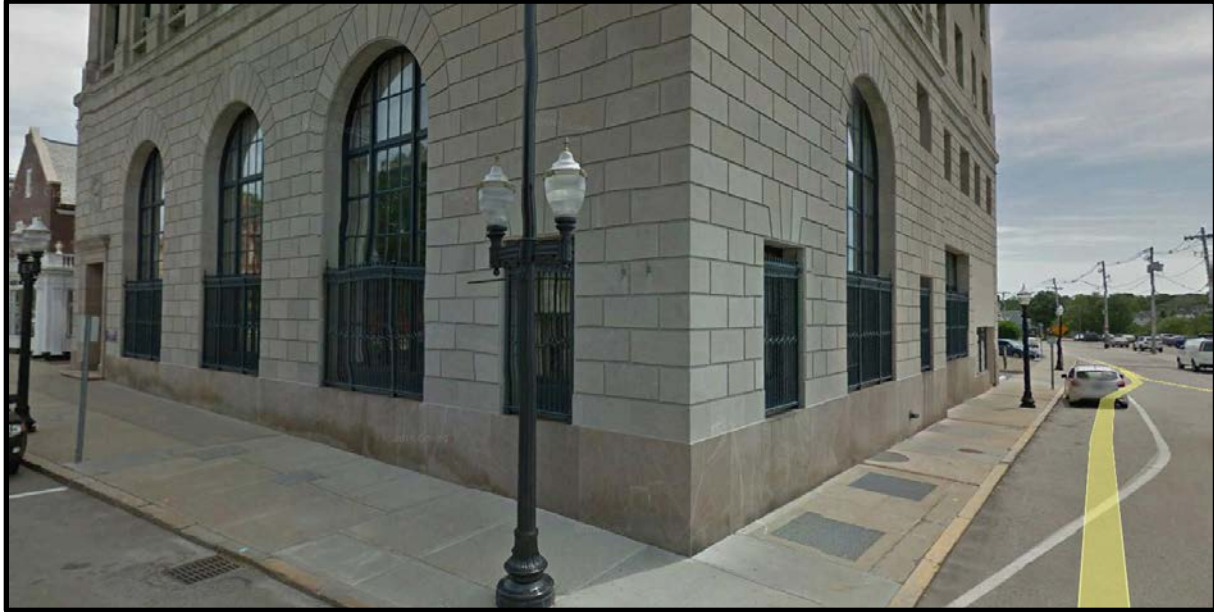
Structure Location:	23 Broad St, Westerly, RI
Occupancy / Built:	commercial / 1900
Structure Condition (visual):	good
1 st Floor Area (sq ft):	9,597
Exterior Wall Construction:	stone / masonry
Foundation Wall:	stone / masonry
Slab/Crawlspace/Basement:	basement
# Entrances / # 1 st Floor Windows:	3 / 14
Garage:	none
Exterior Mechanical/Electrical/Fuel:	AC, electric, oil
# Fireplace	0
Landscaping and Shrubs:	0

Recommended Nonstructural Technique: Dry Flood Proof to the 0.2 % flood elevation

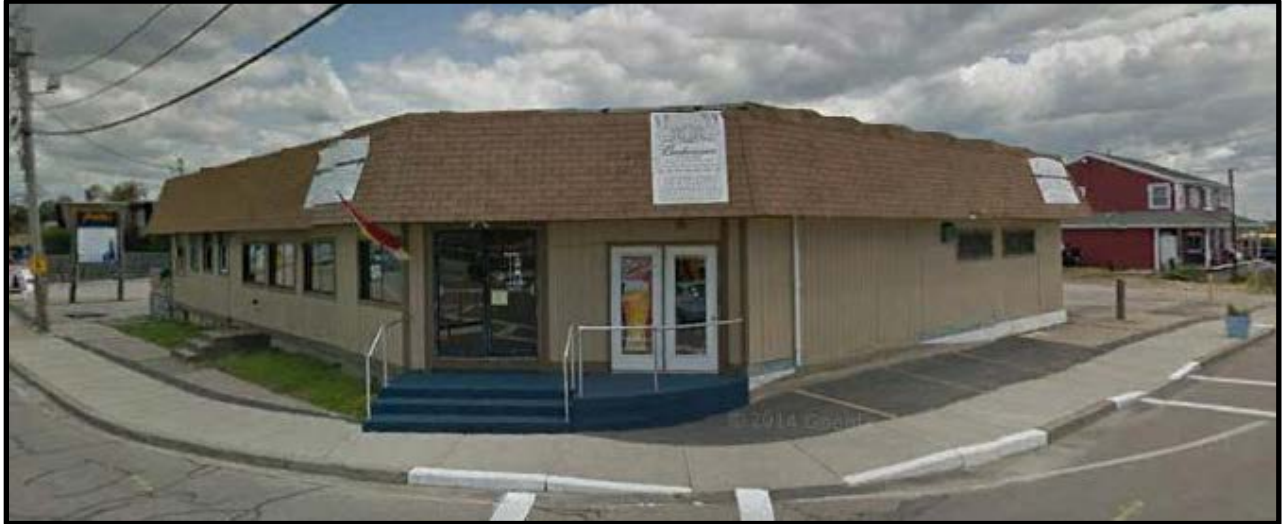
Structure Location:	148 Atlantic Ave, Westerly, RI
Occupancy / Built:	commercial / 1920's
Structure Condition (visual):	good
1 st Floor Area (sq ft):	NA
Exterior Wall Construction:	wood / vinyl
Foundation Wall:	CMU
Slab/Crawlspace/Basement:	half basement/crawlspace
# Entrances / # 1 st Floor Windows:	3-double / multiple
Garage:	none
Exterior Mechanical/Electrical/Fuel:	AC, electric
# Fireplace	0
Landscaping and Shrubs:	0

Recommended Nonstructural Technique: Dry Flood Proof to between 2% and 1% flood elevation

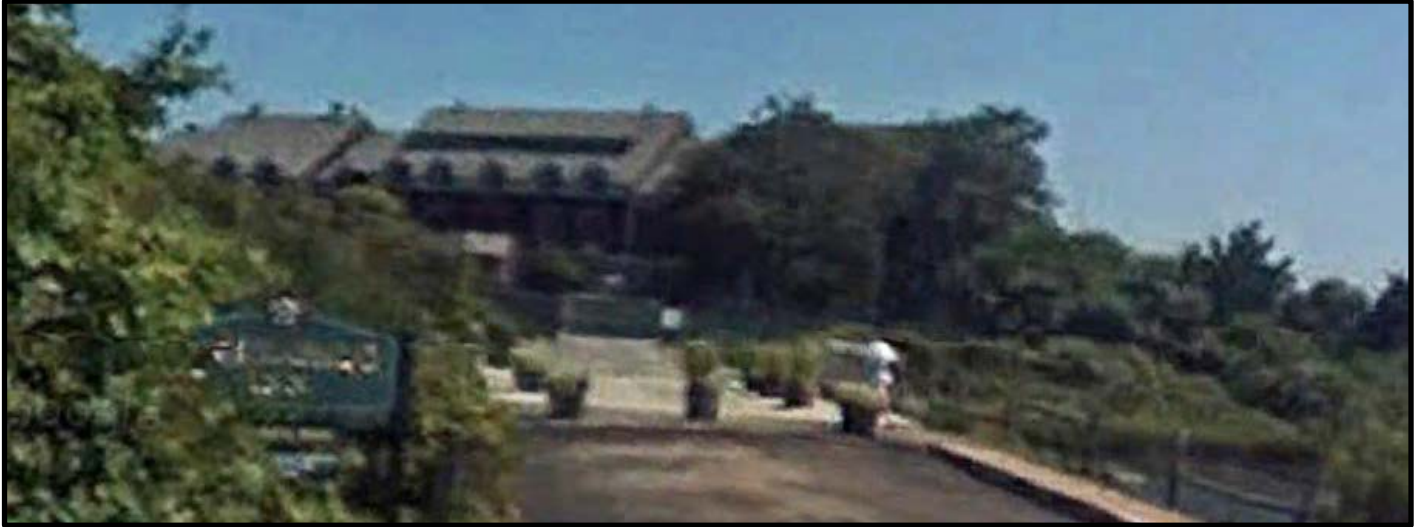
Structure Location:	25 Spray Road, Westerly, RI
Occupancy / Built:	commercial / NA
Structure Condition (visual):	good
1 st Floor Area (sq ft):	NA
Exterior Wall Construction:	wood
Foundation Wall:	concrete, CMU
Slab/Crawlspace/Basement:	NA
# Entrances / # 1 st Floor Windows:	multiple / multiple
Garage:	none
Exterior Mechanical/Electrical/Fuel:	NA
# Fireplace	NA
Landscaping and Shrubs:	yes

Recommended Nonstructural Technique: Dry Flood Proof, Elevate, or Earthen Berm to the 0.2% flood depth

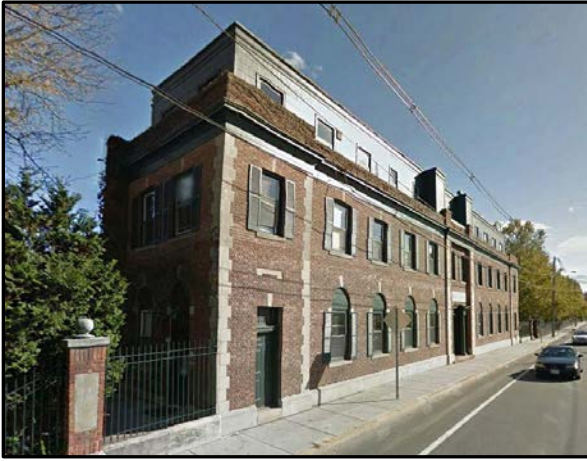
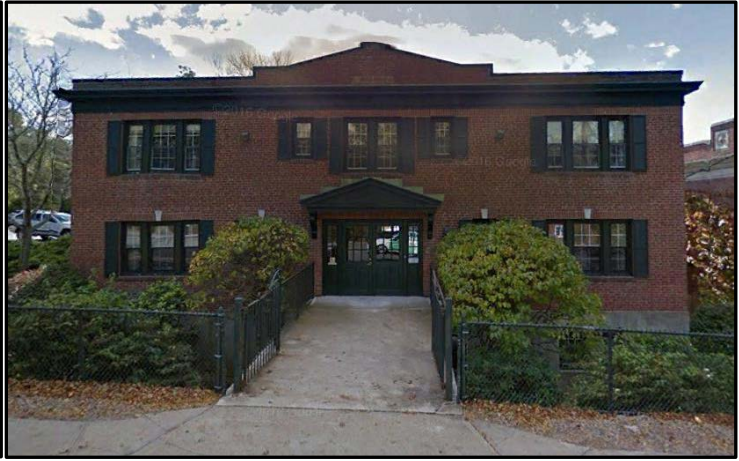
Structure Location:	26 Beach Drive, Westerly, RI
Occupancy / Built:	industrial / NA
Structure Condition (visual):	good
1 st Floor Area (sq ft):	NA
Exterior Wall Construction:	concrete, brick
Foundation Wall:	concrete, masonry
Slab/Crawlspace/Basement:	NA
# Entrances / # 1 st Floor Windows:	multiple / multiple
Garage:	none
Exterior Mechanical/Electrical/Fuel:	NA
# Fireplace	NA
Landscaping and Shrubs:	yes

Recommended Nonstructural Technique: Dry Flood Proof individual structures

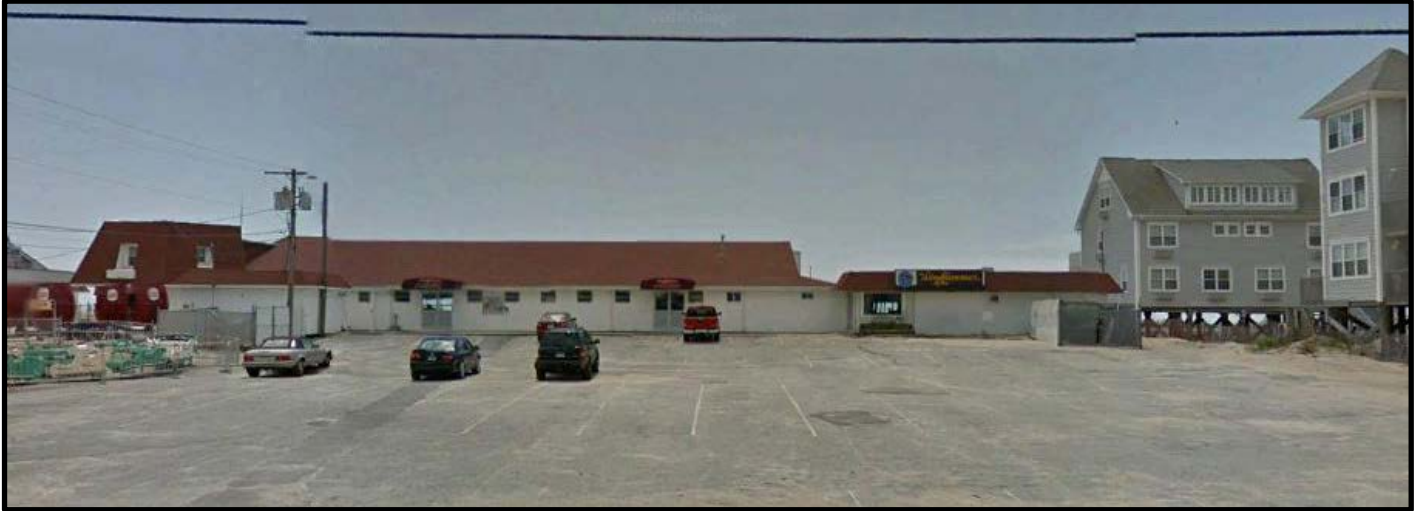
Structure Location:	321 Atlantic Avenue, Westerly, RI
Occupancy / Built:	commercial / NA
Structure Condition (visual):	good
1 st Floor Area (sq ft):	NA
Exterior Wall Construction:	CMU
Foundation Wall:	CMU
Slab/Crawlspace/Basement:	slab
# Entrances / # 1 st Floor Windows:	multiple / multiple
Garage:	none
Exterior Mechanical/Electrical/Fuel:	yes
# Fireplace	0
Landscaping and Shrubs:	0

Recommended Nonstructural Technique: Relocate and Elevate

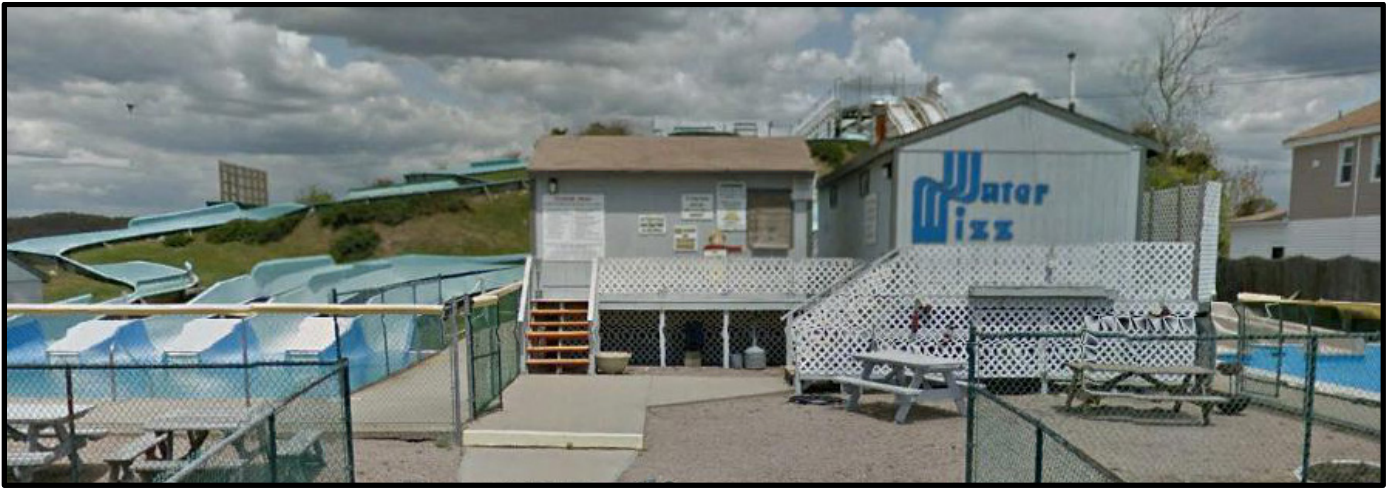
Structure Location:	328 Atlantic Avenue, Westerly, RI
Occupancy / Built:	commercial / NA
Structure Condition (visual):	good
1 st Floor Area (sq ft):	NA
Exterior Wall Construction:	wood
Foundation Wall:	post/piers
Slab/Crawlspace/Basement:	none
# Entrances / # 1 st Floor Windows:	multiple / multiple
Garage:	none
Exterior Mechanical/Electrical/Fuel:	yes
# Fireplace	0
Landscaping and Shrubs:	0

Recommended Nonstructural Technique: Elevate or Dry Flood Proof

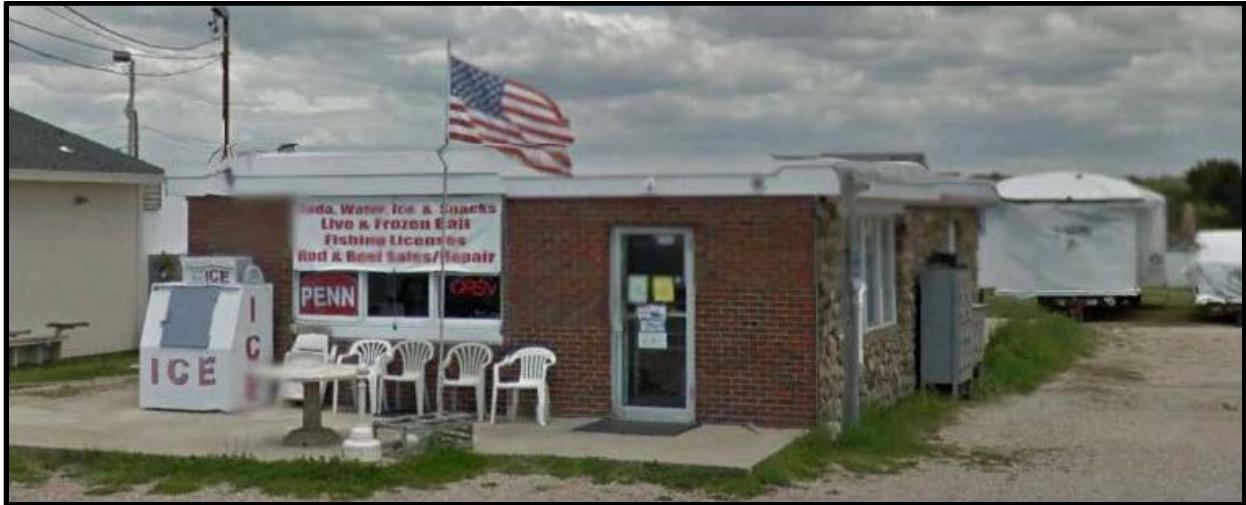
Structure Location:	664 Atlantic Avenue, Westerly, RI
Occupancy / Built:	commercial / NA
Structure Condition (visual):	good
1 st Floor Area (sq ft):	NA
Exterior Wall Construction:	masonry, stone
Foundation Wall:	masonry, stone
Slab/Crawlspace/Basement:	slab
# Entrances / # 1 st Floor Windows:	1 / multiple
Garage:	none
Exterior Mechanical/Electrical/Fuel:	electric, others NA
# Fireplace	0
Landscaping and Shrubs:	0

Recommended Nonstructural Technique: Dry Flood Proof or Relocate

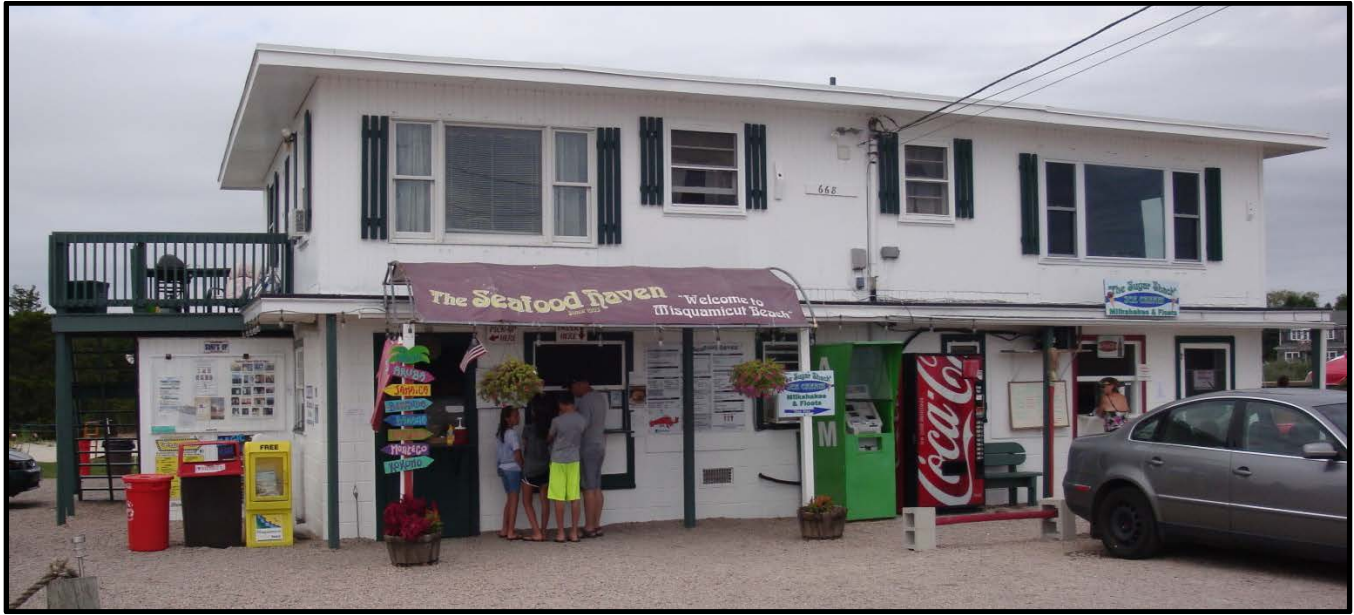
Structure Location:	668 Atlantic Ave, Westerly, RI
Occupancy / Built:	commercial / NA
Structure Condition (visual):	good
1 st Floor Area (sq ft):	NA
Exterior Wall Construction:	CMU
Foundation Wall:	CMU
Slab/Crawspace/Basement:	none
# Entrances / # 1 st Floor Windows:	3 / multiple
Garage:	none
Exterior Mechanical/Electrical/Fuel:	electric, propane
# Fireplace	0
Landscaping and Shrubs:	0

Recommended Nonstructural Technique: Dry Flood Proof 3.5 feet within the 4% flood elevation of 4.9 feet

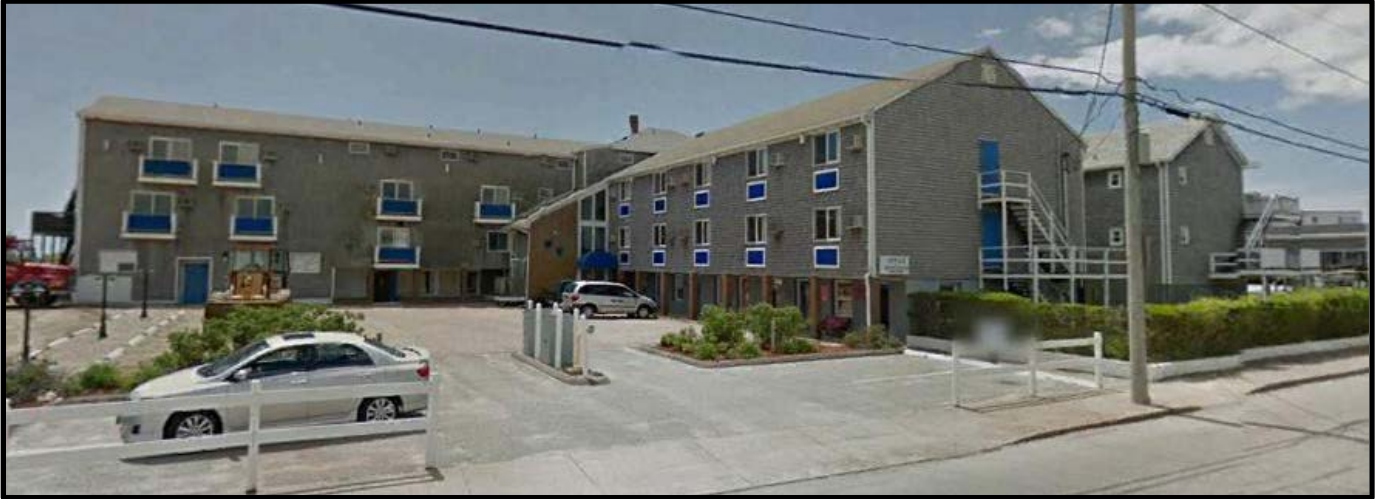
Structure Location:	69 Atlantic Avenue, Westerly, RI
Occupancy / Built:	commercial / NA
Structure Condition (visual):	good
1 st Floor Area (sq ft):	NA
Exterior Wall Construction:	wood shingle, concrete
Foundation Wall:	concrete
Slab/Crawlspace/Basement:	slab
# Entrances / # 1 st Floor Windows:	multiple / multiple
Garage:	none
Exterior Mechanical/Electrical/Fuel:	NA
# Fireplace	0
Landscaping and Shrubs:	0

Recommended Nonstructural Technique: Conversion to Wet Flood Proofing up to 0.2% flood depth

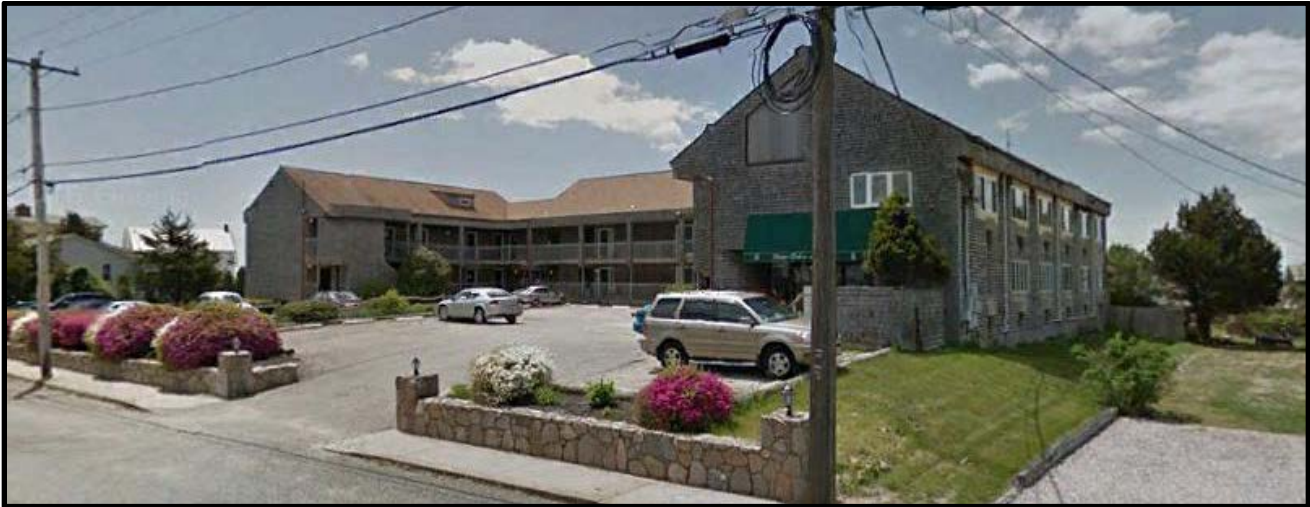
Structure Location:	8 Crandall Avenue, Westerly, RI
Occupancy / Built:	commercial / NA
Structure Condition (visual):	good
1 st Floor Area (sq ft):	NA
Exterior Wall Construction:	wood shingle, concrete
Foundation Wall:	concrete
Slab/Crawlspace/Basement:	slab
# Entrances / # 1 st Floor Windows:	multiple / multiple
Garage:	none
Exterior Mechanical/Electrical/Fuel:	AC, electric
# Fireplace	0
Landscaping and Shrubs:	yes

Recommended Nonstructural Technique: Dry Flood Proof between the 1% and 0.2% flood depth

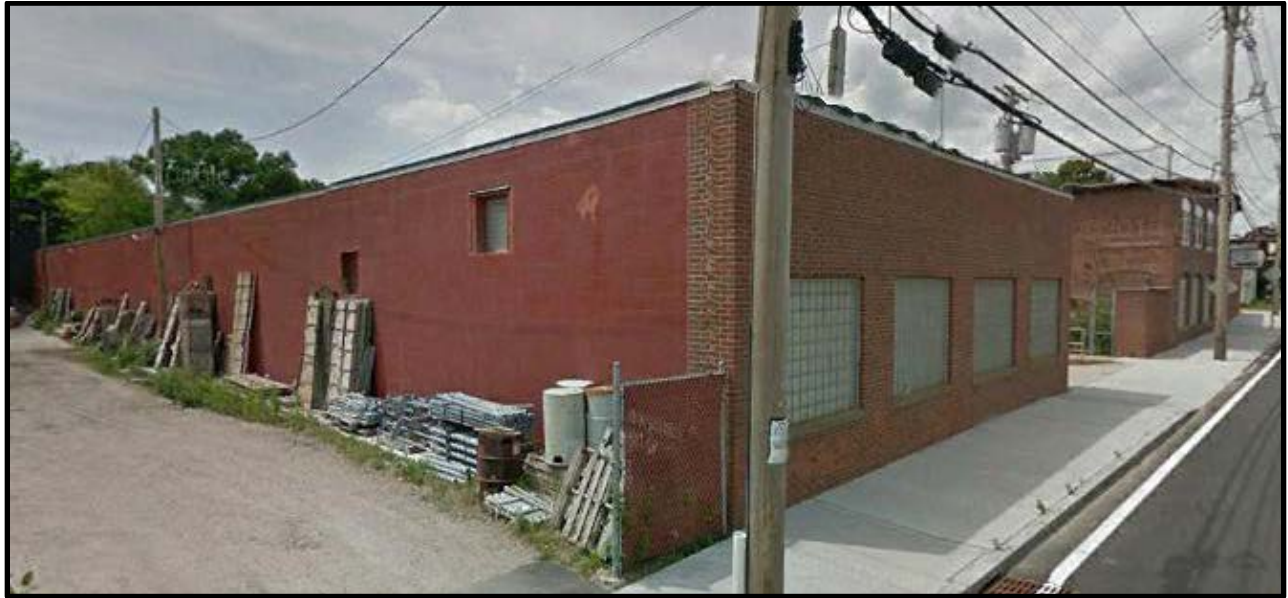
Structure Location:	34 Canal Street, Pawcatuck, CT
Occupancy / Built:	Industrial / 1900
Structure Condition (visual):	good
1 st Floor Area (sq ft):	63,778
Exterior Wall Construction:	brick / CMU
Foundation Wall:	concrete / CMU
Slab/Crawlspace/Basement:	slab
# Entrances / # 1 st Floor Windows:	multiple / multiple
Garage:	none
Exterior Mechanical/Electrical/Fuel:	electric, gas
# Fireplace	0
Landscaping and Shrubs:	0

Recommended Nonstructural Technique: Dry Flood Proof to the 0.2% flood elevation

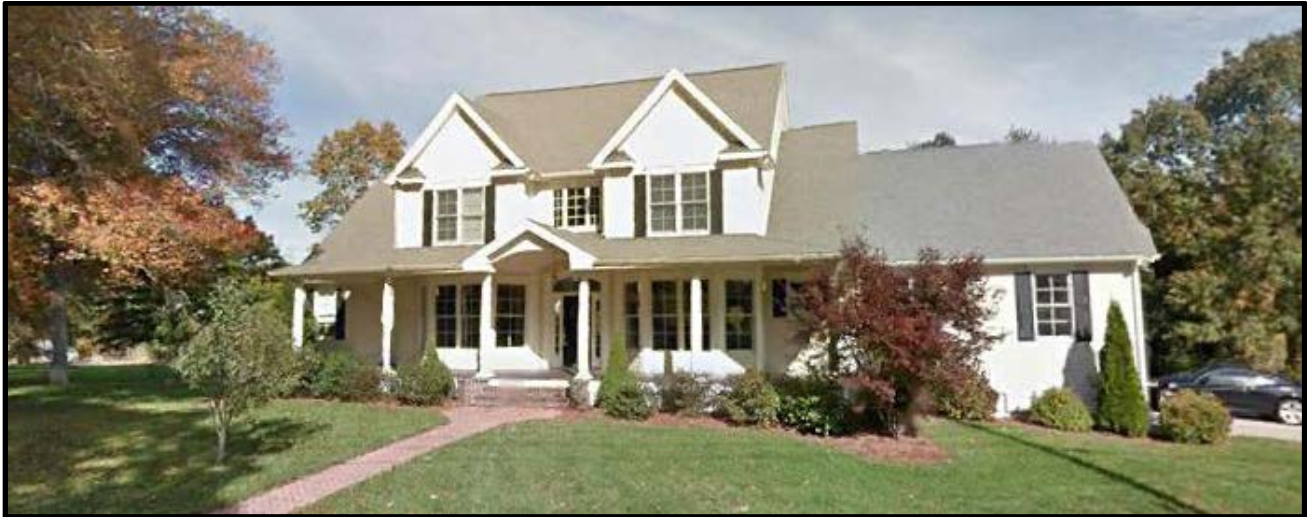
Structure Location:	5 Saratoga Ave, Westerly, RI
Occupancy / Built:	residential / 2002
Structure Condition (visual):	good
1 st Floor Area (sq ft):	2,095
Exterior Wall Construction:	wood, clapboard
Foundation Wall:	CMU
Slab/Crawlspace/Basement:	basement
# Entrances / # 1 st Floor Windows:	3 / multiple
Garage:	attached
Exterior Mechanical/Electrical/Fuel:	AC, electric, oil
# Fireplace	1
Landscaping and Shrubs:	yes

Recommended Nonstructural Technique: Temporary Dry Flood Proof to the 0.2% flood elevation or Elevate

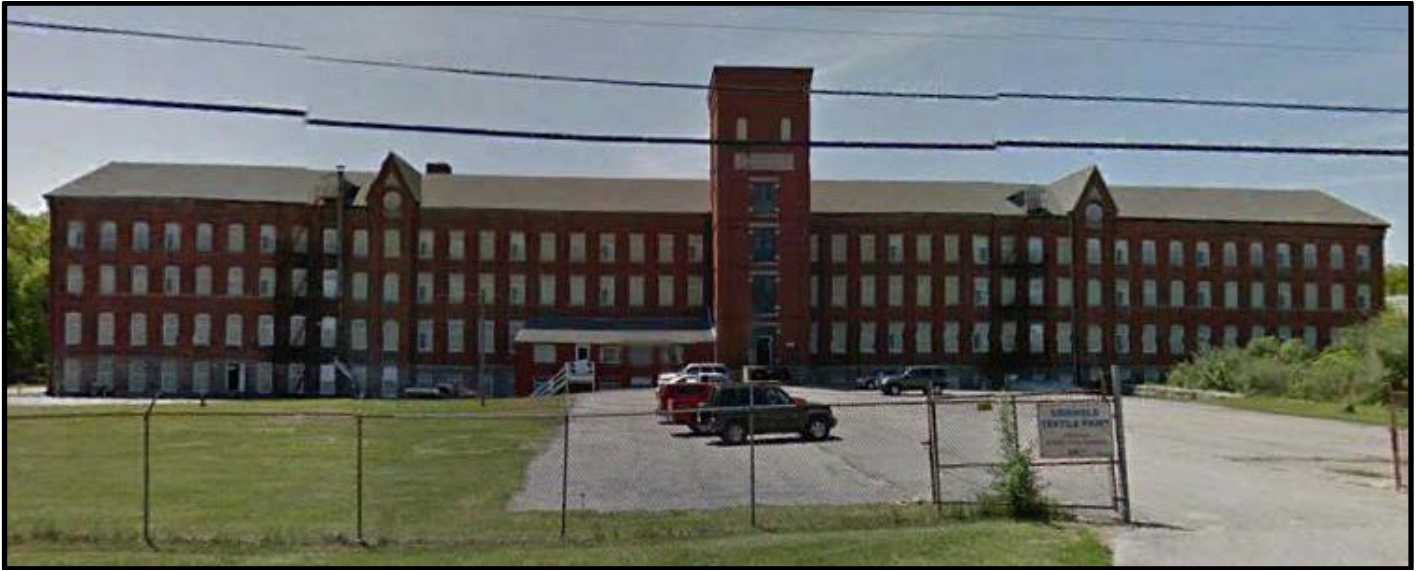
Structure Location:	84 White Rock Road, Westerly, RI
Occupancy / Built:	Industrial / 1849
Structure Condition (visual):	good
1 st Floor Area (sq ft):	36,395
Exterior Wall Construction:	brick / masonry
Foundation Wall:	brick / masonry
Slab/Crawspace/Basement:	basement
# Entrances / # 1 st Floor Windows:	multiple / multiple
Garage:	none
Exterior Mechanical/Electrical/Fuel:	electric, steam, oil
# Fireplace	0
Landscaping and Shrubs:	0

Recommended Nonstructural Technique: Earthen Berm or Dry Flood Proof to the 0.2% flood elevation

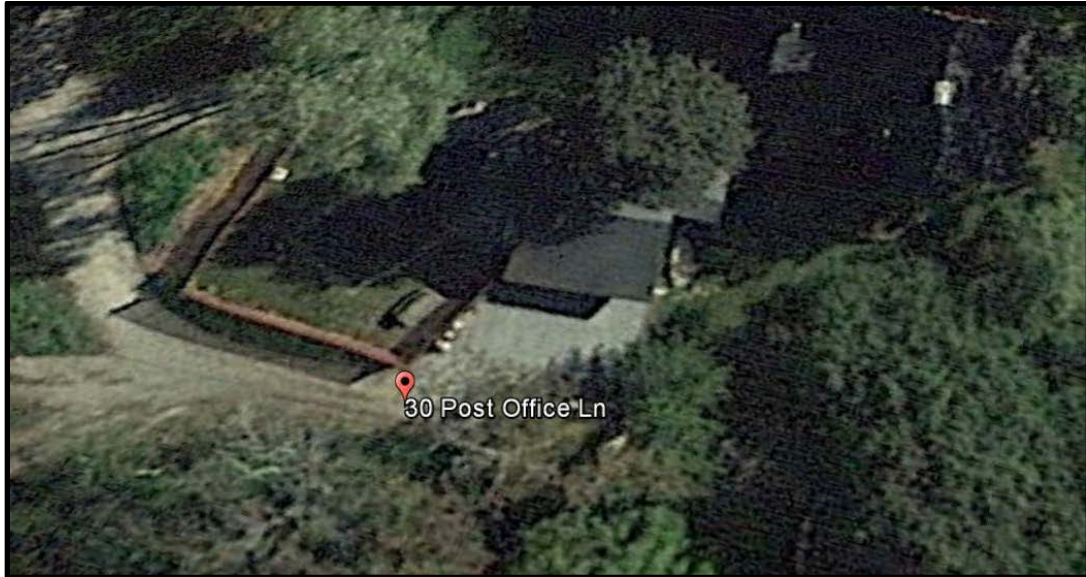
Structure Location:	30 Post Office Lane, Westerly, RI
Occupancy / Built:	residential / 1952
Structure Condition (visual):	below average
1 st Floor Area (sq ft):	950
Exterior Wall Construction:	wood, wood shingle
Foundation Wall:	CMU
Slab/Crawlspace/Basement:	basement
# Entrances / # 1 st Floor Windows:	2 / multiple
Garage:	attached
Exterior Mechanical/Electrical/Fuel:	electric, oil
# Fireplace	0
Landscaping and Shrubs:	yes

Recommended Nonstructural Technique: Elevate to the 0.2% flood elevation

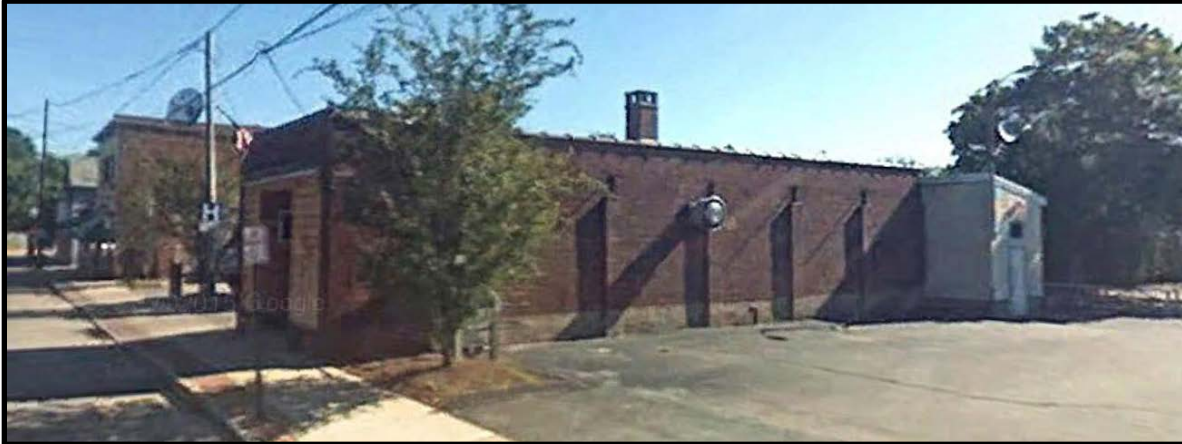
Structure Location:	16 Mechanic St, Stonington, CT
Occupancy / Built:	commercial / 1909
Structure Condition (visual):	below average
1 st Floor Area (sq ft):	2,200
Exterior Wall Construction:	brick / masonry / wood
Foundation Wall:	brick / masonry
Slab/Crawlspace/Basement:	crawlspace
# Entrances / # 1 st Floor Windows:	2 / multiple
Garage:	none
Exterior Mechanical/Electrical/Fuel:	AC, electric, oil
# Fireplace	0
Landscaping and Shrubs:	0

Recommended Nonstructural Technique: Already has flood protection to the 1% flood event

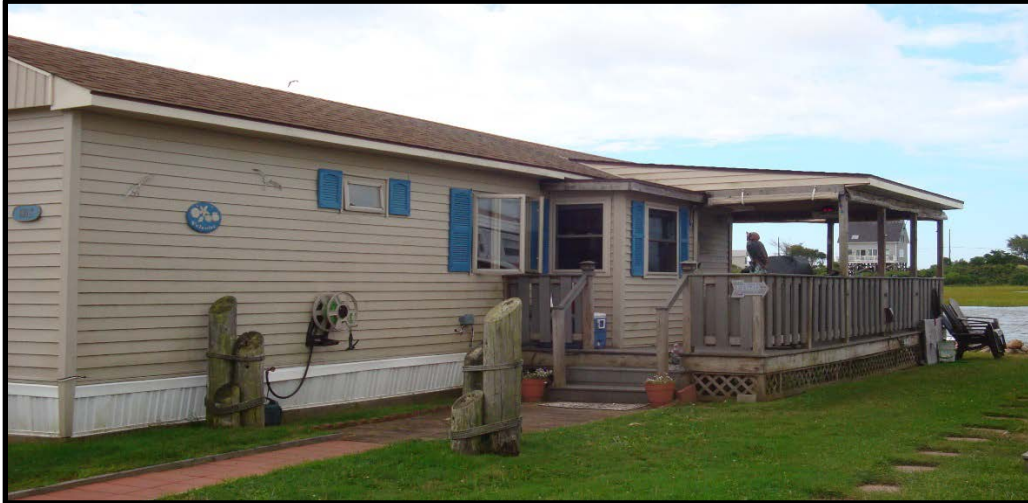
Structure Location:	Modular or Trailer Homes in AE Zone
Occupancy / Built:	residential / NA
Structure Condition (visual):	good
1 st Floor Area (sq ft):	NA
Exterior Wall Construction:	wood, vinyl
Foundation Wall:	piers or columns
Slab/Crawlspace/Basement:	none
# Entrances / # 1 st Floor Windows:	1 / multiple
Garage:	none
Exterior Mechanical/Electrical/Fuel:	varies
# Fireplace	0
Landscaping and Shrubs:	yes

Recommended Nonstructural Technique: Elevate to above the 1% flood depth (maximum 12 feet)
