MAINE DEPARTMENT OF TRANSPORTATION

**2006 CONSTRUCTION
MONITORING REPORT:**

South Bog Stream, Rangeley Plantation

**Compensation for Phillips & Madrid Route 4 Highway Improvement Projects
(MDOT PIN 9205.00 & 10019.00)**

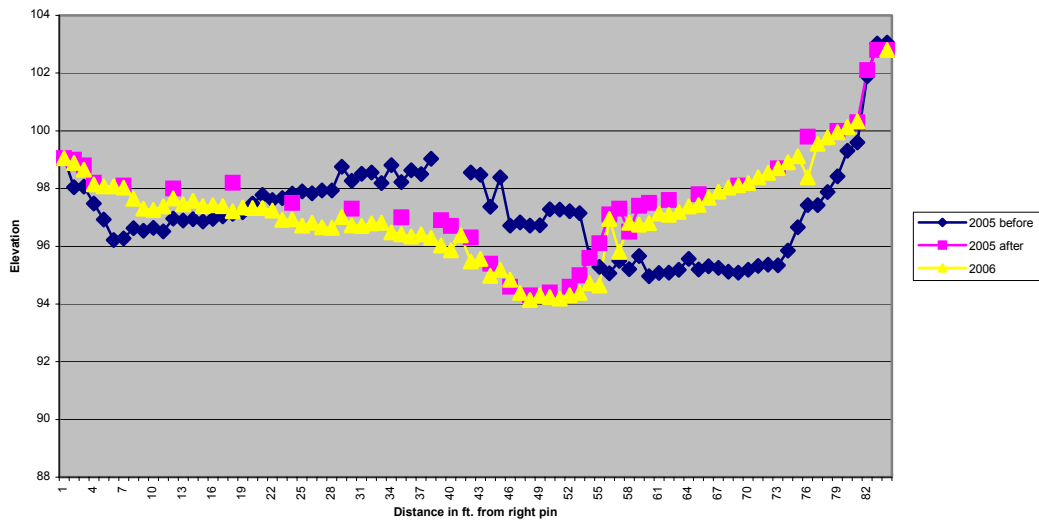
Figure 6. Transect 3, Station 207 (riffle), project area.

Data for physical measurements collected both pre- and post-construction are presented in Tables 3 to 5 and Figures 3 to 8. Data for biological sampling are presented in Tables 6 and 7. Figures 6 and 7 graphically demonstrate the changes in cross sectional profile within the treatment area as the streambed was reconfigured to concentrate the flow into one channel (by eliminating the side channel), and to reestablish a more suitable width to depth ratio. Longitudinal profiles document the increase in the number of pools within the section (Table 3; Figure 3). The pools are relatively shallow, but are numerous and mimic the step pool morphology of a natural B type stream. The frequency of measurements used to determine the longitudinal profile was not adequate to capture each riffle-pool sequence, and will be measured more intensively beginning in 2007.

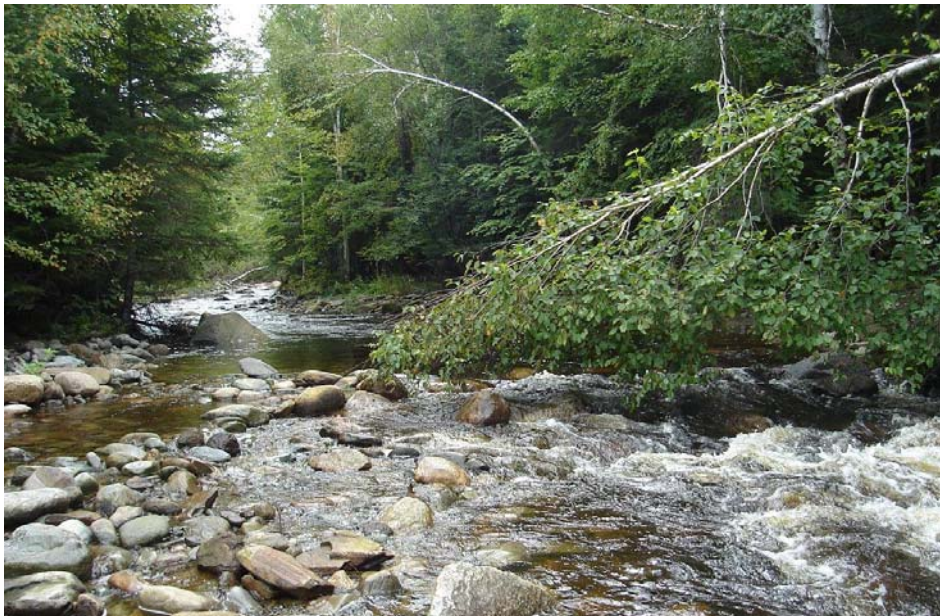
Transect 3 (Station 207, Project Area) looking upstream, August 2006, post-construction. Pool in left-center has been deepened, and flow has been concentrated to right of photo.

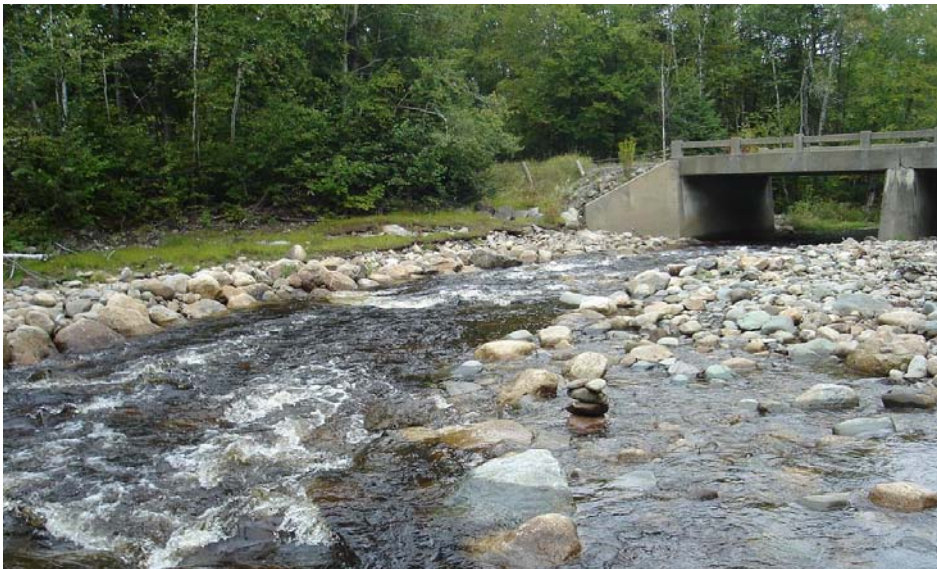
Transect 3 (Station 207, Project Area) looking downstream toward South Shore Drive Bridge, August 2006, post-construction. Flow concentrated in newly-created step-pool channel to left of photo. Flow is spilling onto flood plain due to high flows.

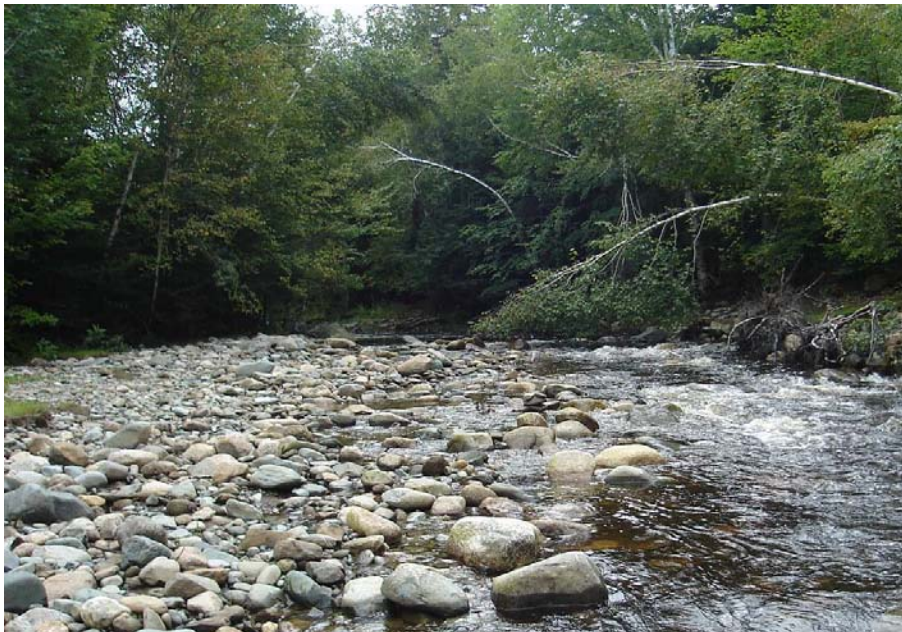
Transect 4 (Station 270, Project Area) looking upstream, August 2006, post-construction. Flow is concentrated in new channel at right of photo. Recently deepened pool is at top of photo.

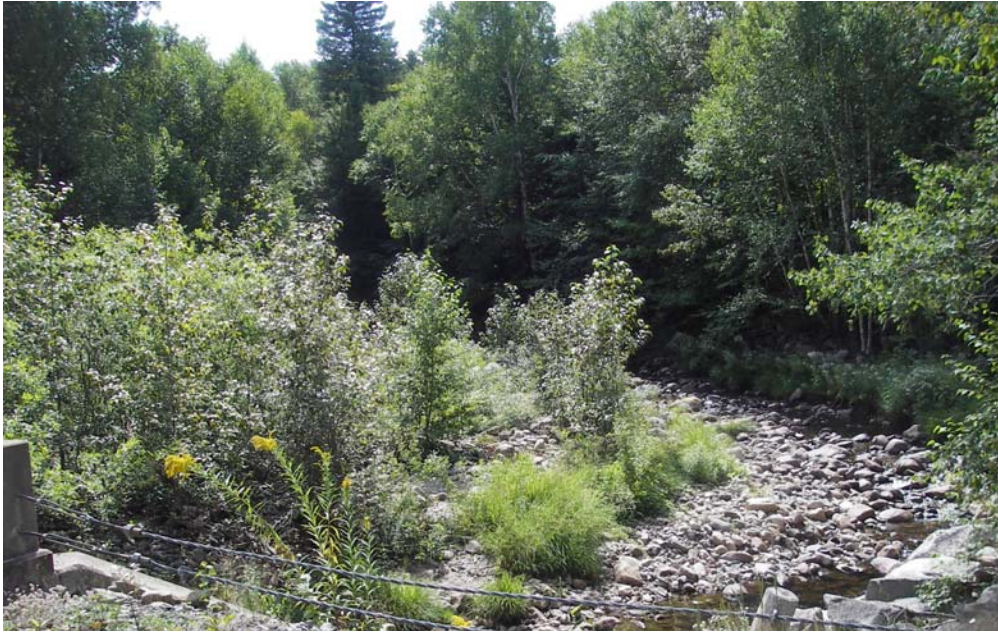
Upstream view from South Shore Drive Bridge prior to restoration, July 2005.⁴

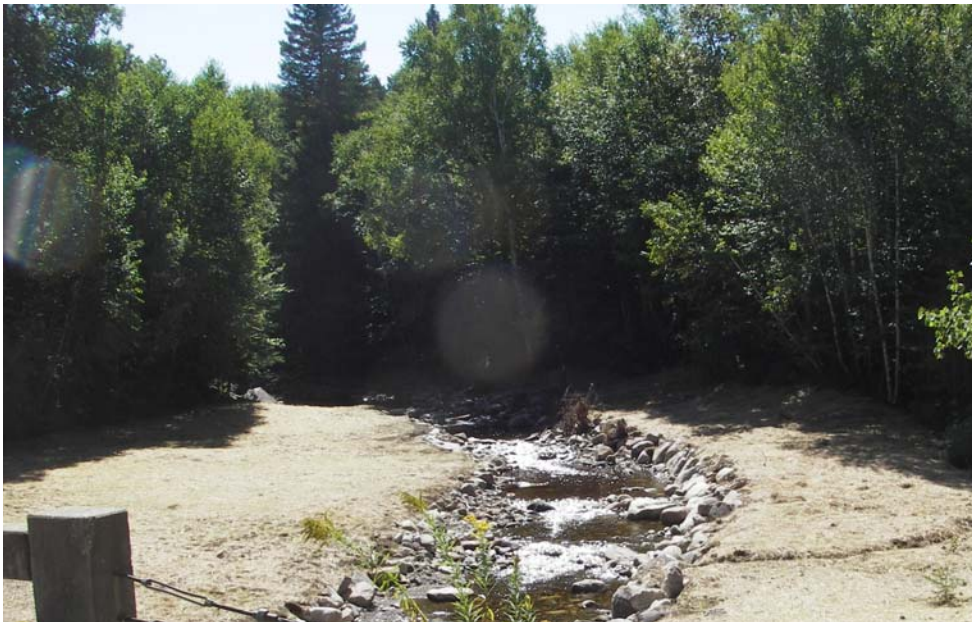
Upstream view from South Shore Drive Bridge, immediately post-restoration, August 2005. Step-pool formation is evident in photograph.

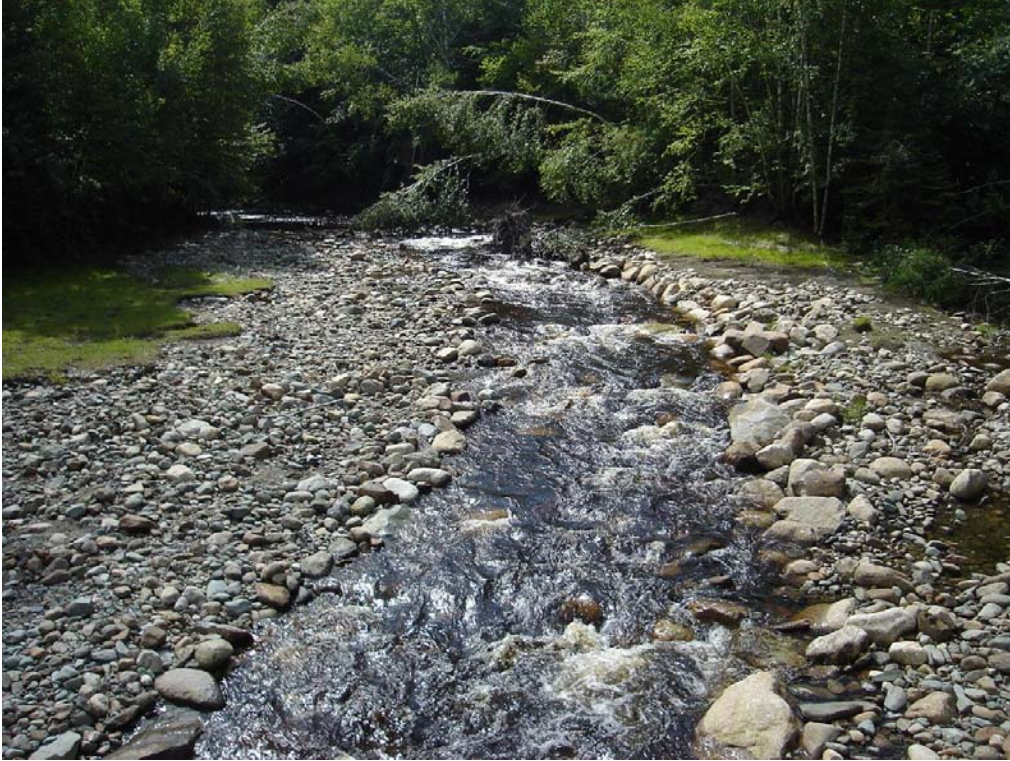
The year 2005 was the wettest on record in Franklin County, and multiple high post-construction flows (during a normally dry period of the year) resulted in erosion of an estimated 25-33% of the topsoil placed on disturbed areas of the site before protective seeding germinated. The lost topsoil will not be replaced. Other than the loss of topsoil, however, the project withstood the high flows and its structural integrity was not compromised. Flows were also above average in 2006, but there was no further loss of topsoil or damage to the project.

Upstream view from South Shore Drive Bridge post-restoration, August 2006. Step-pool formation is still evident but much of riparian loam has been washed away by high flows.
