**Annual Wetland Monitoring Report #2
for Vermont Transco's
Zelazny Wetland Mitigation/Restoration
Project**

November 7, 2007

ACOE permit # NAE-2004-856 - Issued on December 21, 2005 for the construction of a new 345kV electrical transmission line from West Rutland to New Haven Vermont.

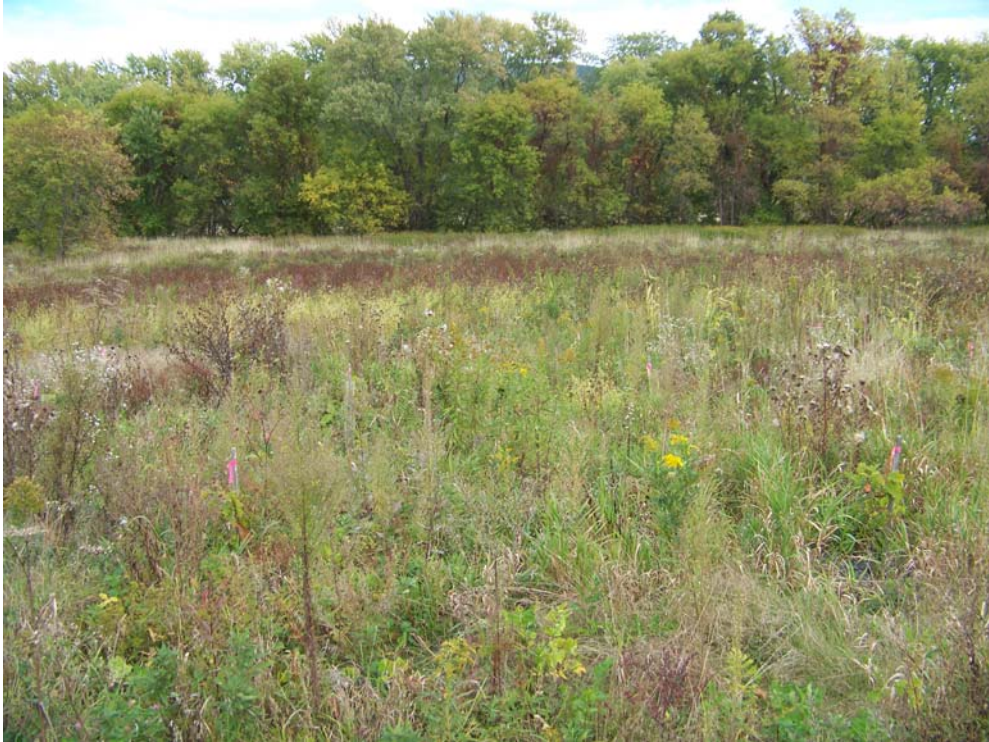
1) A view looking east of Planting Section 1 from Photograph Station 1. Note the plantings in the foreground are indicated with flagging. Otter Creek is located in the background. – 10/3/07

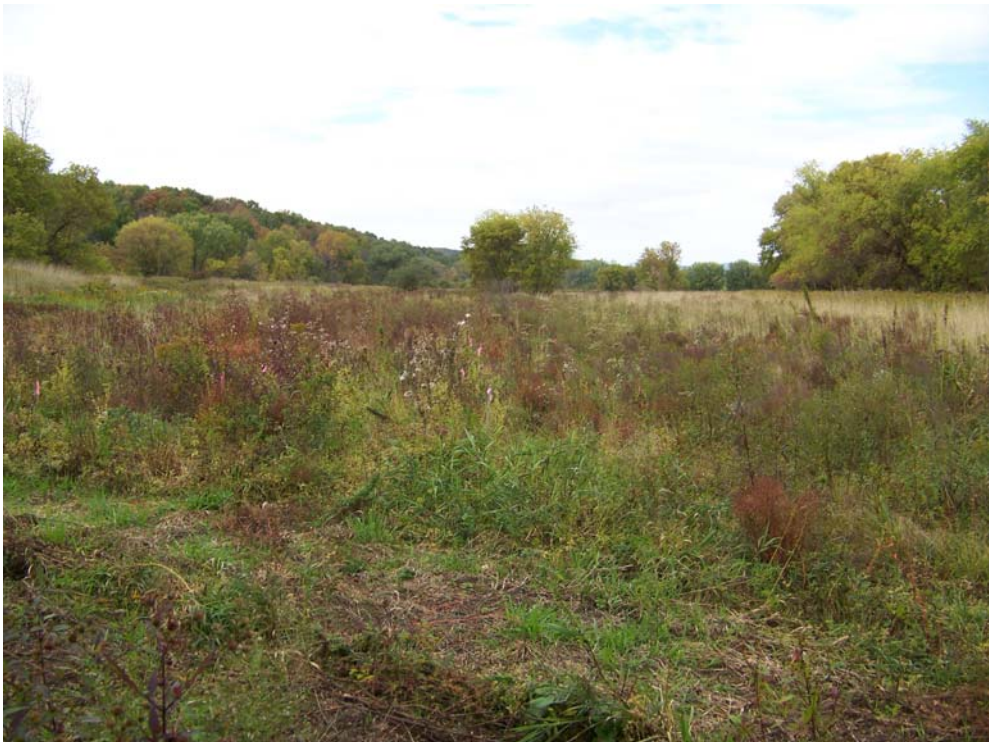
2) A view looking north of Planting Section 1 from Photograph Station 2. – 10/3/07

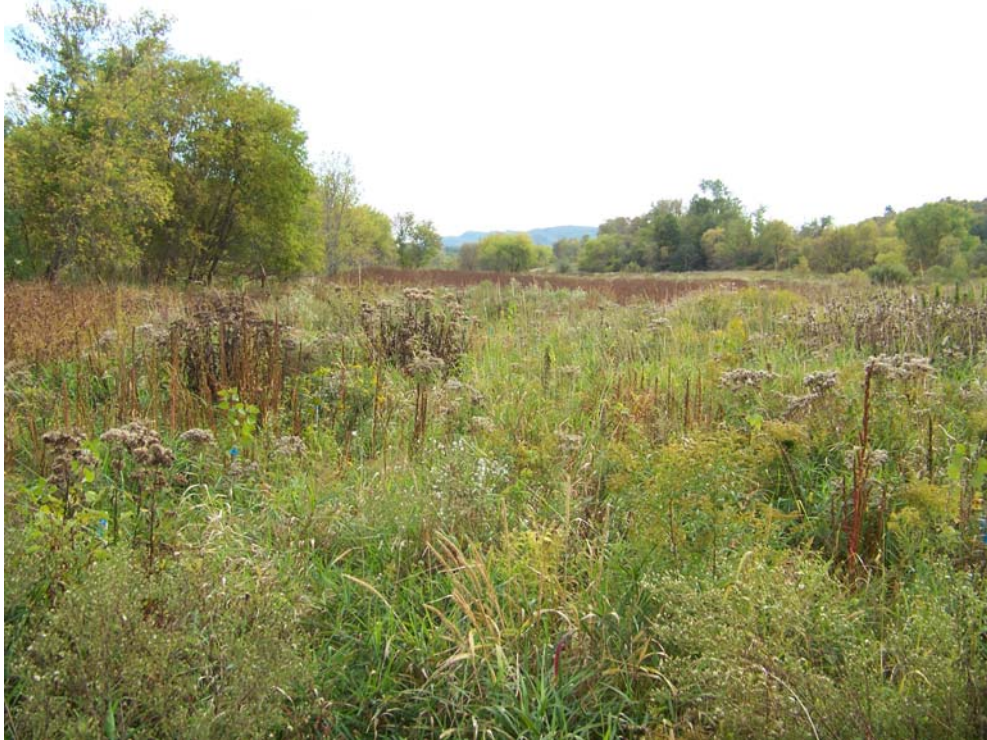
3) A view looking south of Planting Section 1 from Photograph Station 3. – 10/3/07

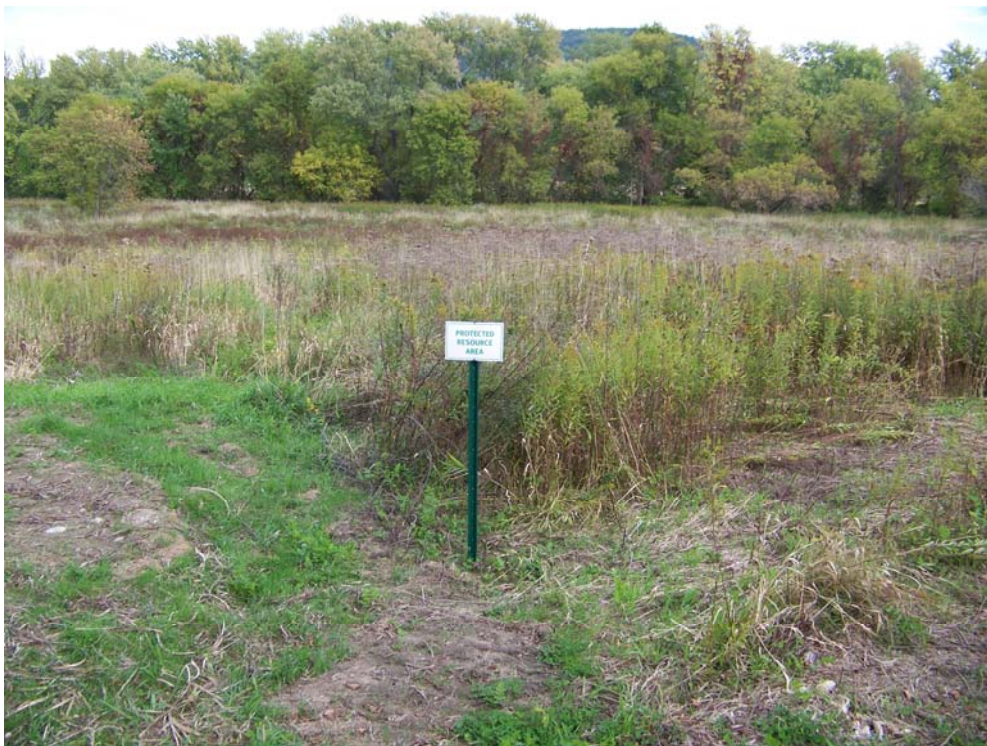
4) A view of planting Section 1 and the entrance to the site. Note the *Protective Resource Area* signage, deployed around the site perimeter. – 10/3/07
