Monitoring Survey of the Morris Cove Borrow Pit
September-October 2011

Disposal Area Monitoring System DAMOS

Contribution 190
October 2012

**US Army Corps
of Engineers**®
New England District

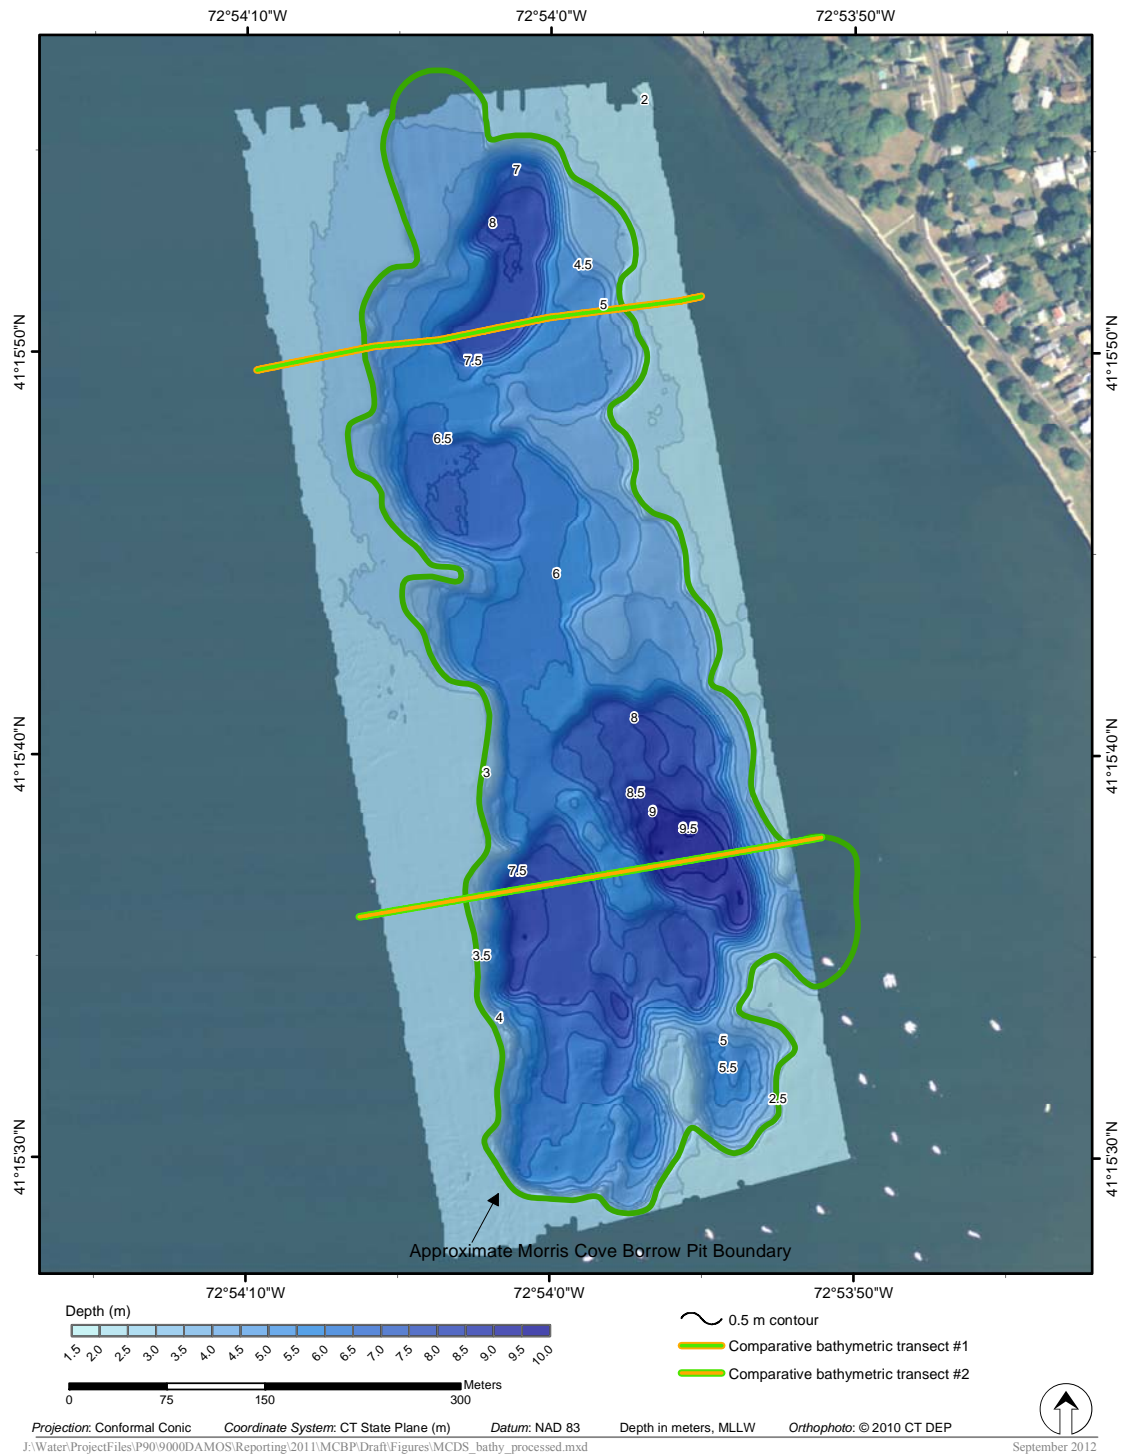
Figure 3-1. Bathymetric contour map of MCBP, September 2011 (0.5 m contour intervals) over a hillshaded relief layer

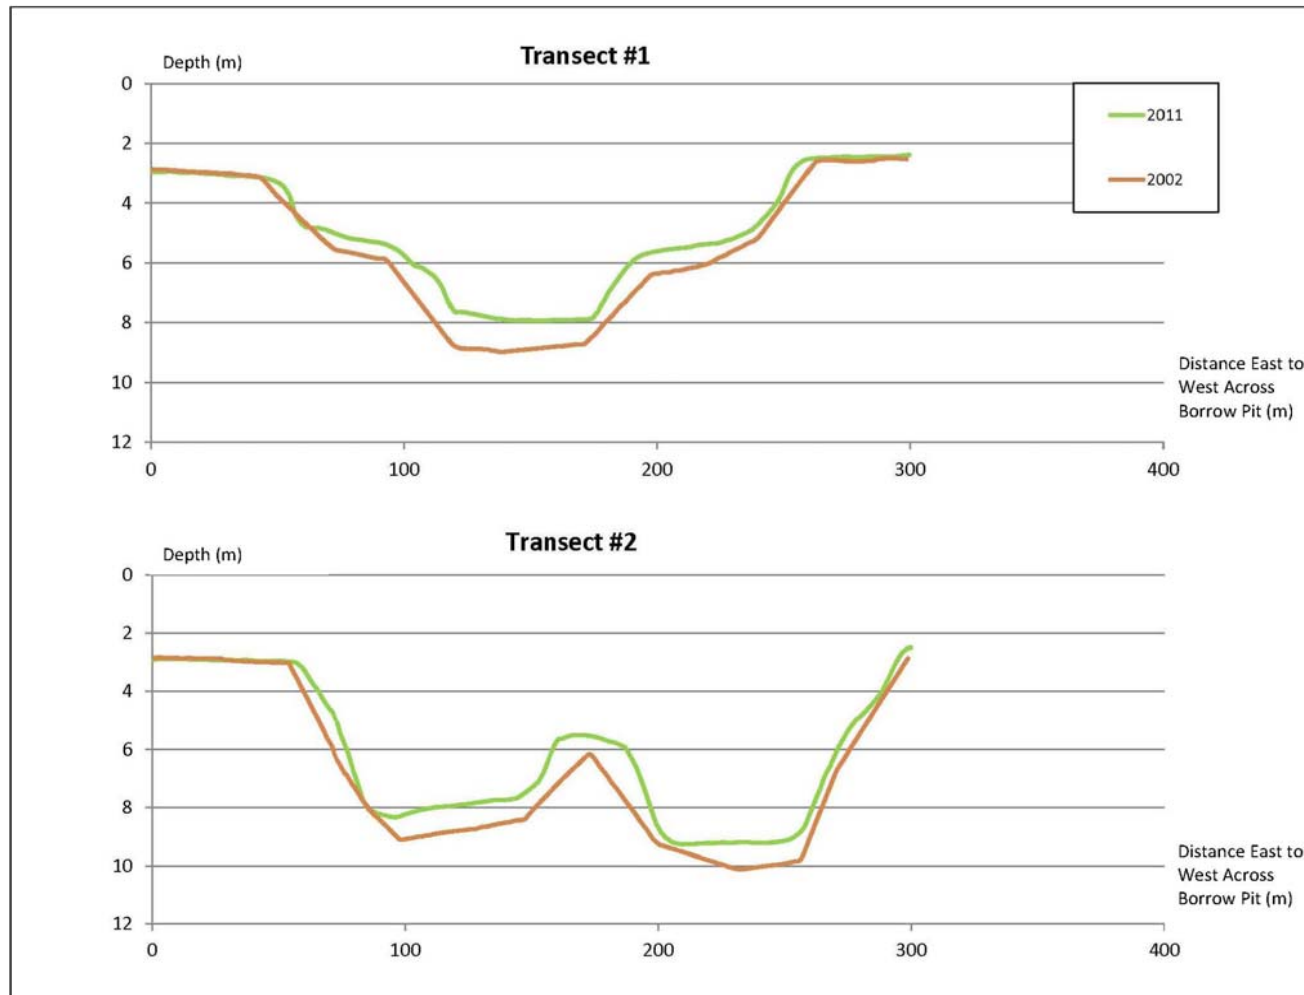
Figure 3-2. Depth difference profile map of MCBP survey area, May 2002 vs. September 2011. 2002 results have been corrected by a -0.25 m offset.

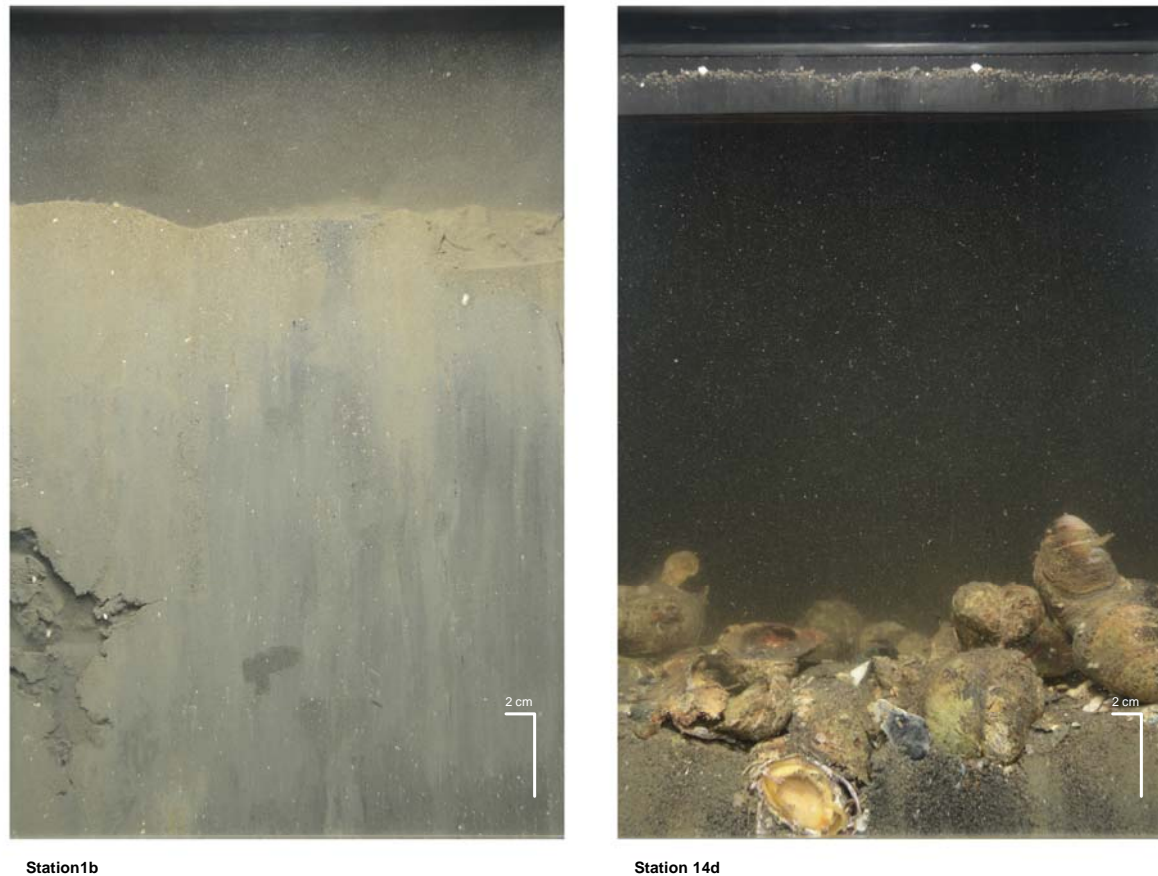
Figure 3-8. Comparison of sediment physical characteristics west of the borrow pit (Station 1) and east of the borrow pit (Station 14). Station 1b (left) had a layer of very fine sand over silt/clay and a surface largely formed by biological activities (tubes, burrows) with deep prism penetration (16.3 cm). Station 14d (right) had a layer of fine sand over medium sand, shallow prism penetration (2.3 cm) and a surface largely formed by the presence of live shells and fragments (*Crepidula* sp.).

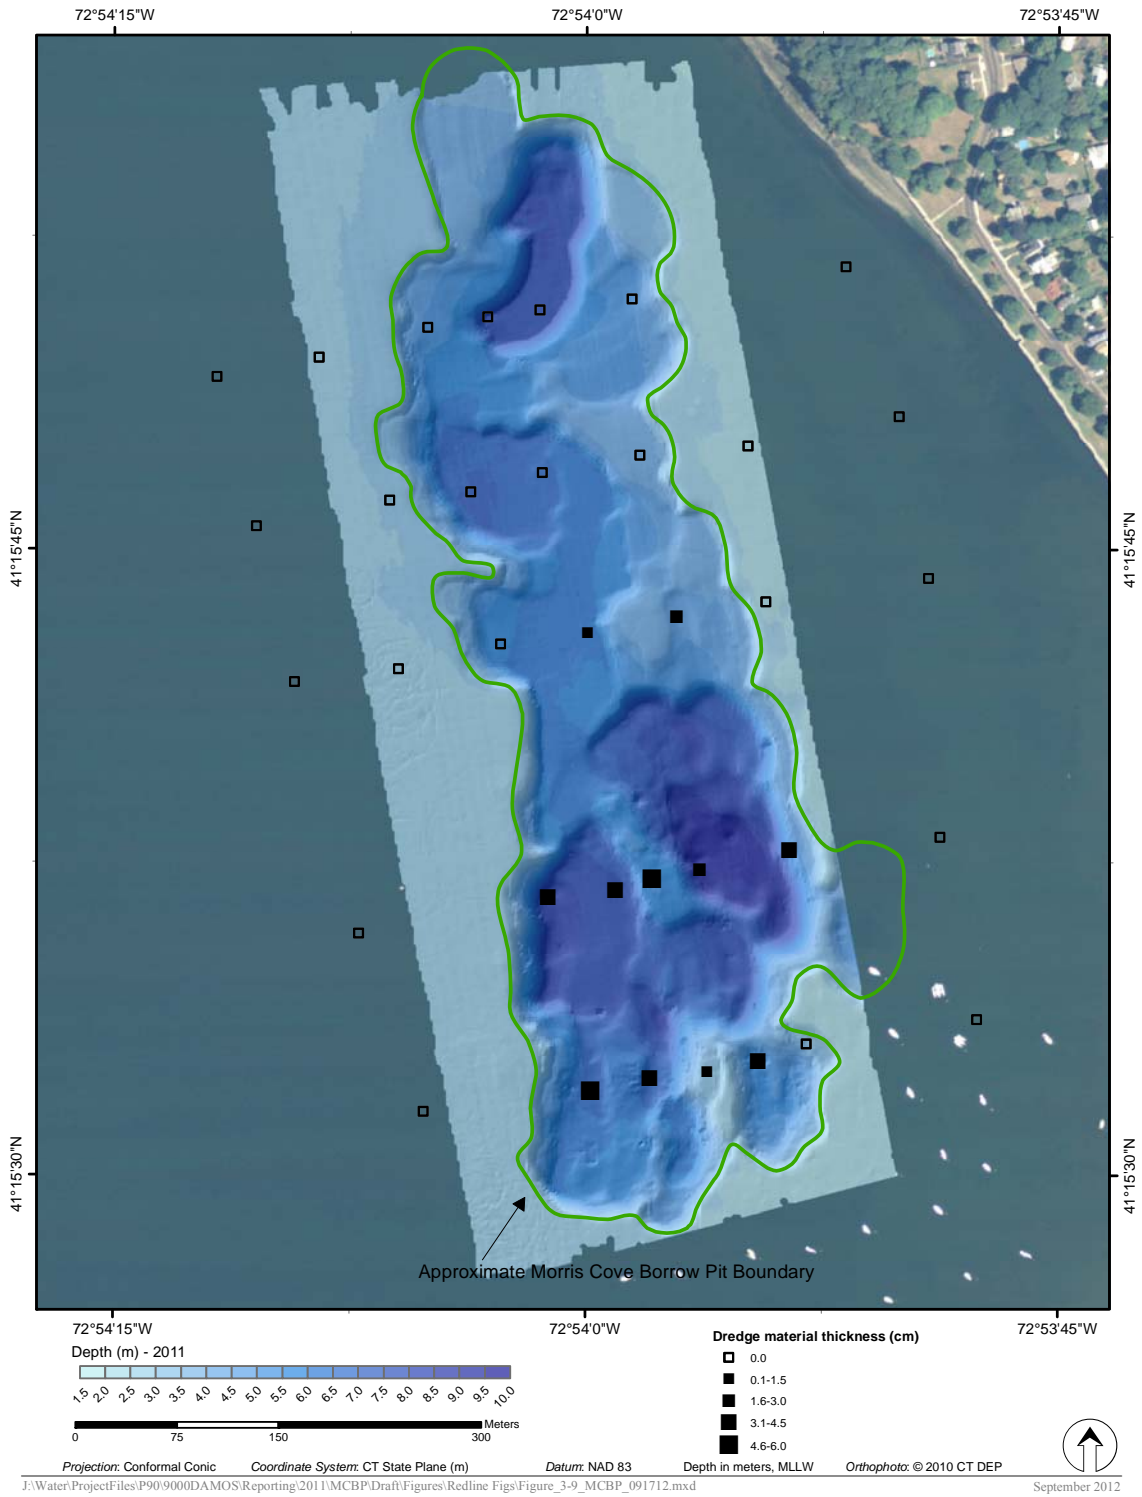
Dredged material was identified in the sediment-profile images collected from 11 of the 20 stations located within the borrow pit, exceeding the penetration depth of the camera prism in at least one replicate at seven of those stations (Figure 3-9). The dredged material observed within the borrow pit was found primarily at stations located within the southern or central portion of the borrow pit (near the pilot study buoy location). Generally, the physical composition of the dredged material did not appear dissimilar from the sediments in other portions of the borrow pit (unconsolidated silt/clay).

Figure 3-9. Thickness of dredged material identified in SPI images

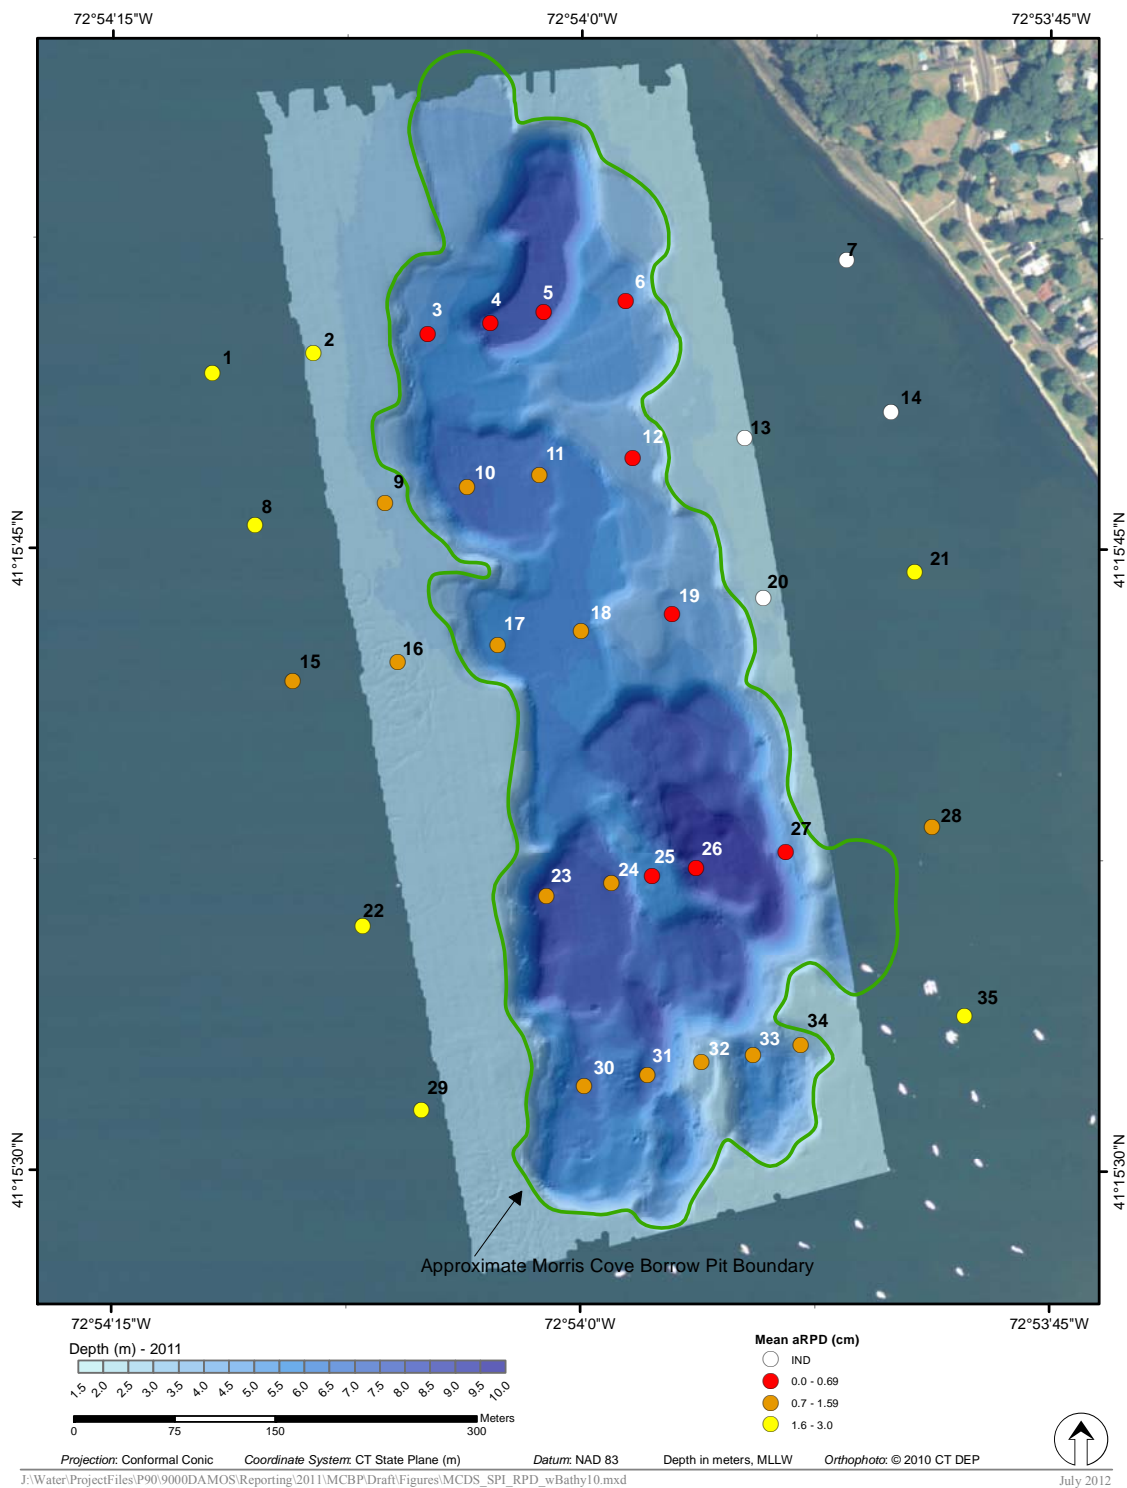
The SPI data indicated poor biological conditions and a stressed community within the borrow pit. The mean aRPD depth (0.8 cm; Figure 3-10, Table 3-1) was less than half that of stations outside the borrow pit, and 15 stations had mean aRPD depths less than 1 cm, indicating limited oxygen penetration into the sediment (Figure 3-19, Figure 3-20).

Figure 3-10. Map of mean replicate aRPD depths (cm) at MCBP

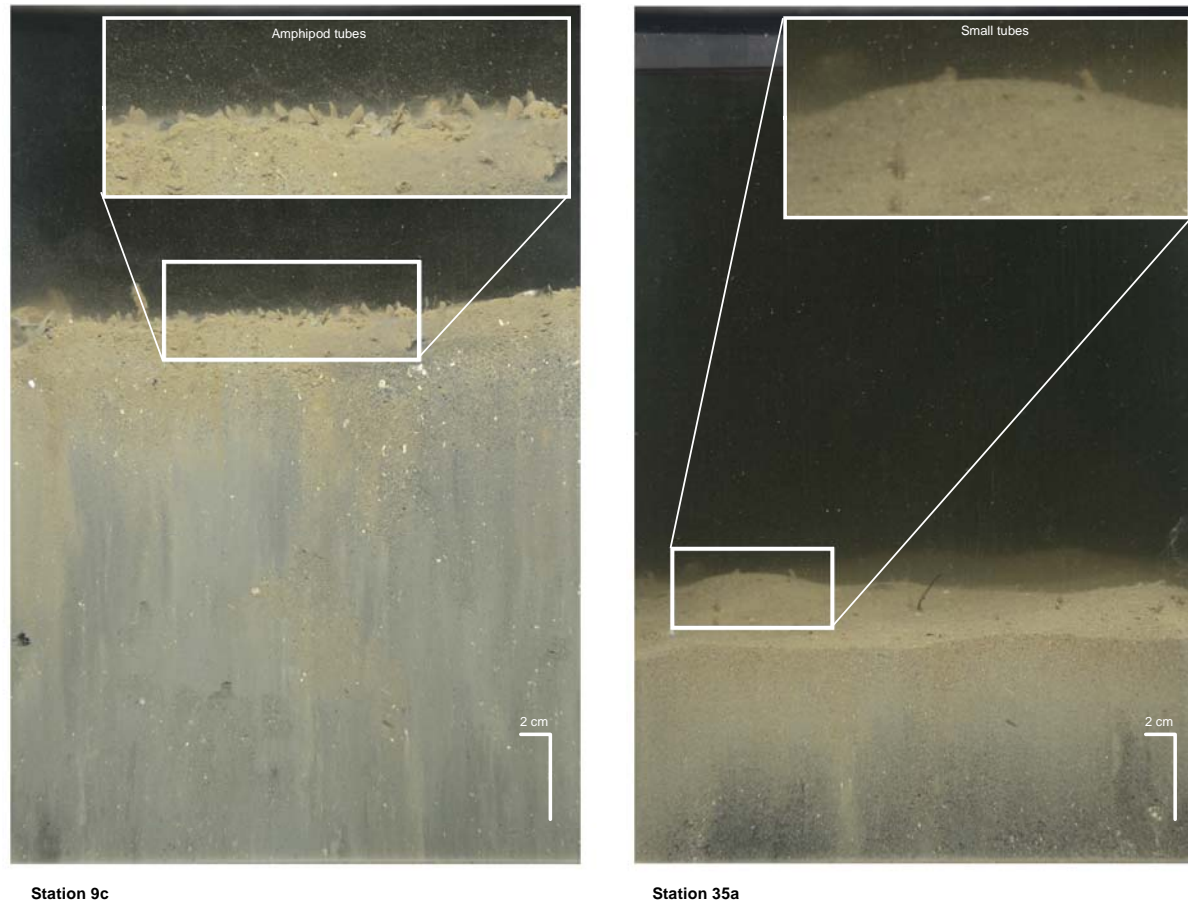
Evidence of Stage 2 succession was present at one station (Station 21), and Stage 3 infauna was observed at the two southern stations (Stations 28 and 35) on the eastern side of the borrow pit (Figures 3-11, 3-12). There were no subsurface feeding voids visible in any of the eastern stations. Successional stage was indeterminate in all replicates at four stations located in the east (Stations 7, 13, 14, and 20; Figure 3-13). All of the western stations had evidence of Stage 3 succession in at least one replicate (Figure 3-12). All of the western stations also had an average of one feeding void present at each station, with the exception of Station 8 (Figure 3-13, Table 3-1). Methane was present in only one replicate from Stations 8 and 29, located west of the borrow pit (Figure 3-14). Evidence of *Beggiatoa* was not identified in any replicate images outside of the borrow pit (Figure 3-15).

Figure 3-11. Comparison of biological characteristics west of the borrow pit (Station 9) and east of the borrow pit (Station 35). Station 9d had a Stage 2 (amphipod tubes) over Stage 3 (large burrows, feeding voids) successional classification and a shallow aRPD (0.9 cm). Station 35a had a Stage 1 (small tubes) over Stage 3 (large burrows) successional classification and a deep aRPD (2.3 cm).

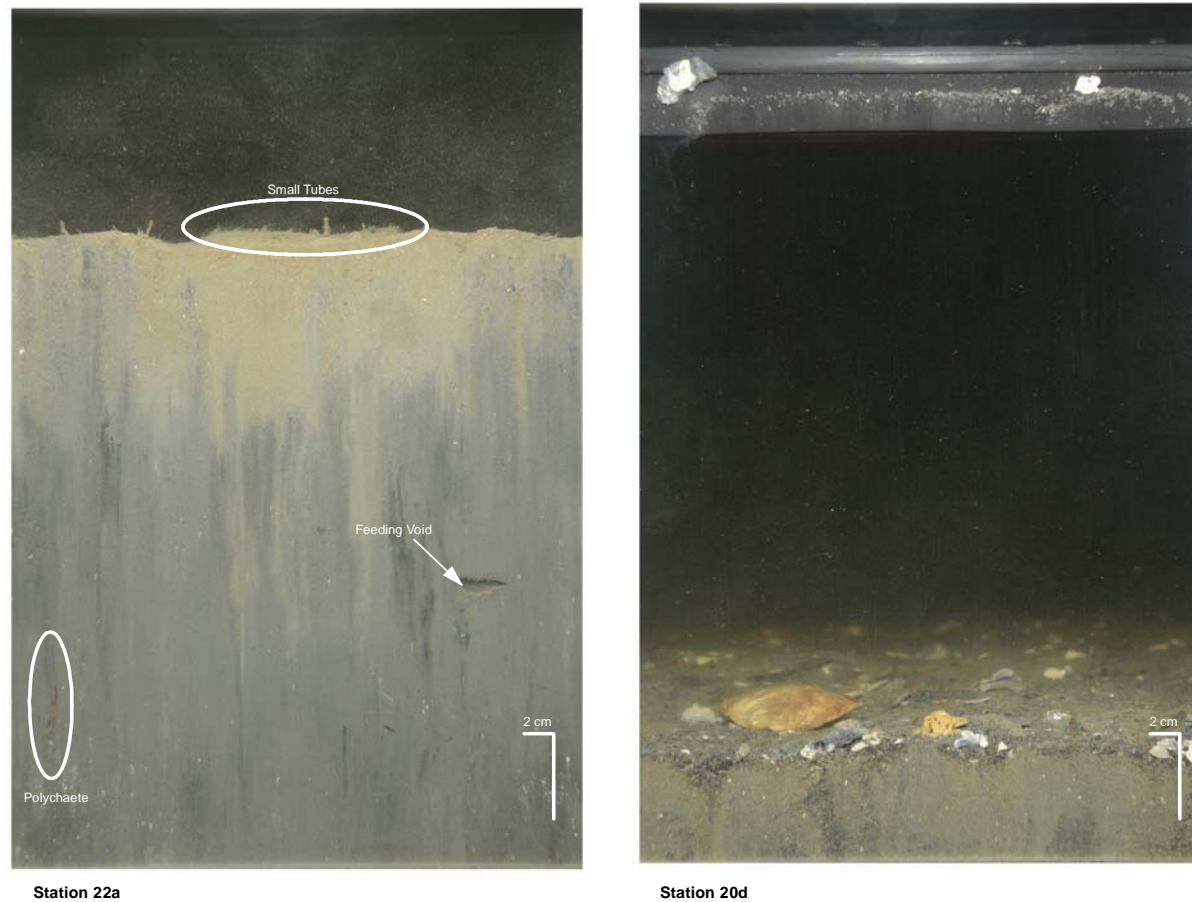
Figure 3-13. Comparison of biological characteristics west of the borrow pit (Station 22) and east of the borrow pit (Station 20). Station 22a had a Stage 1 (very small tubes) over Stage 3 (large polychaete and feeding voids) successional classification and a deep aRPD (2.3 cm). Station 20d had an indeterminate successional stage and aRPD due to coarse sediment and limited prism penetration.

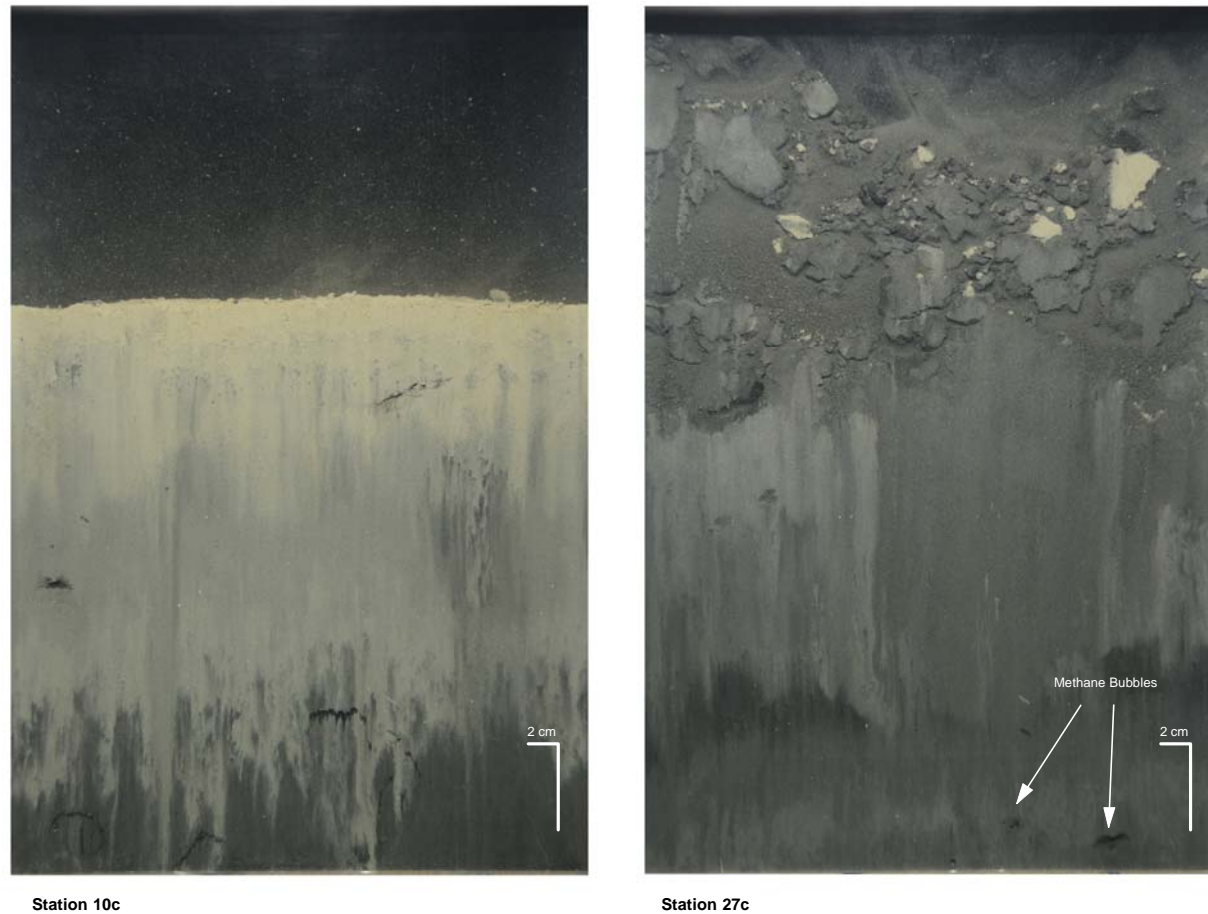
Figure 3-16. Comparison of physical characteristics of stations within MCBP (Stations 10 and 27). Station 10c (left) had low biological boundary roughness (0.4 cm) in partially consolidated silt. Station 27c (right) had high physical boundary roughness (3.5 cm) due to disturbance of the loose unconsolidated sediment surface by the camera.

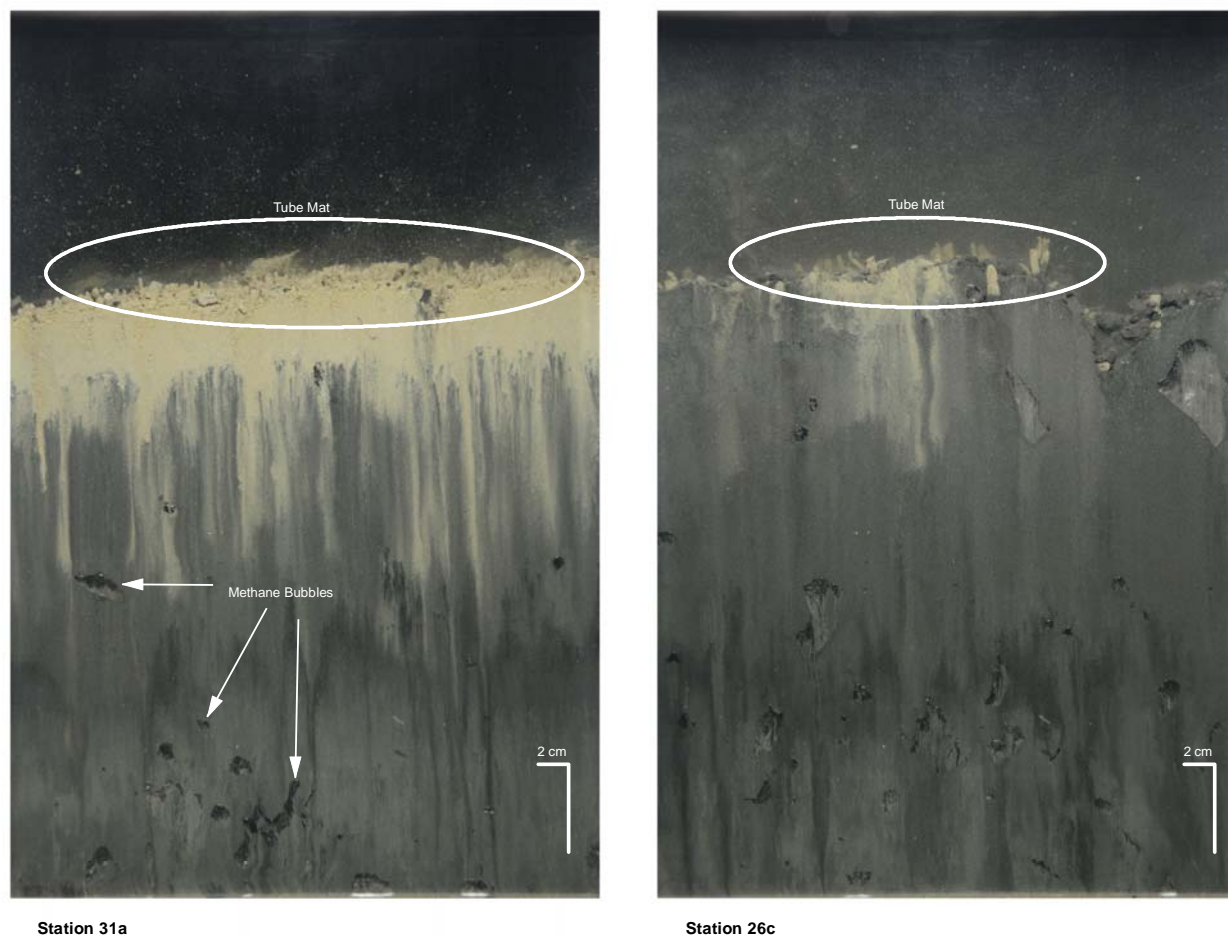
Figure 3-17. Comparison of physical characteristics of stations within MCBP (Stations 31 and 26). Station 31a had distinctive layering of oxidized and reduced sediments with methane bubbles and moderate biological roughness from a tube mat (1.0 cm). Station 26c also had distinctive layering of reduced sediments and a high physical boundary roughness from the collapse of loose sediments around a tube mat (1.7 cm).

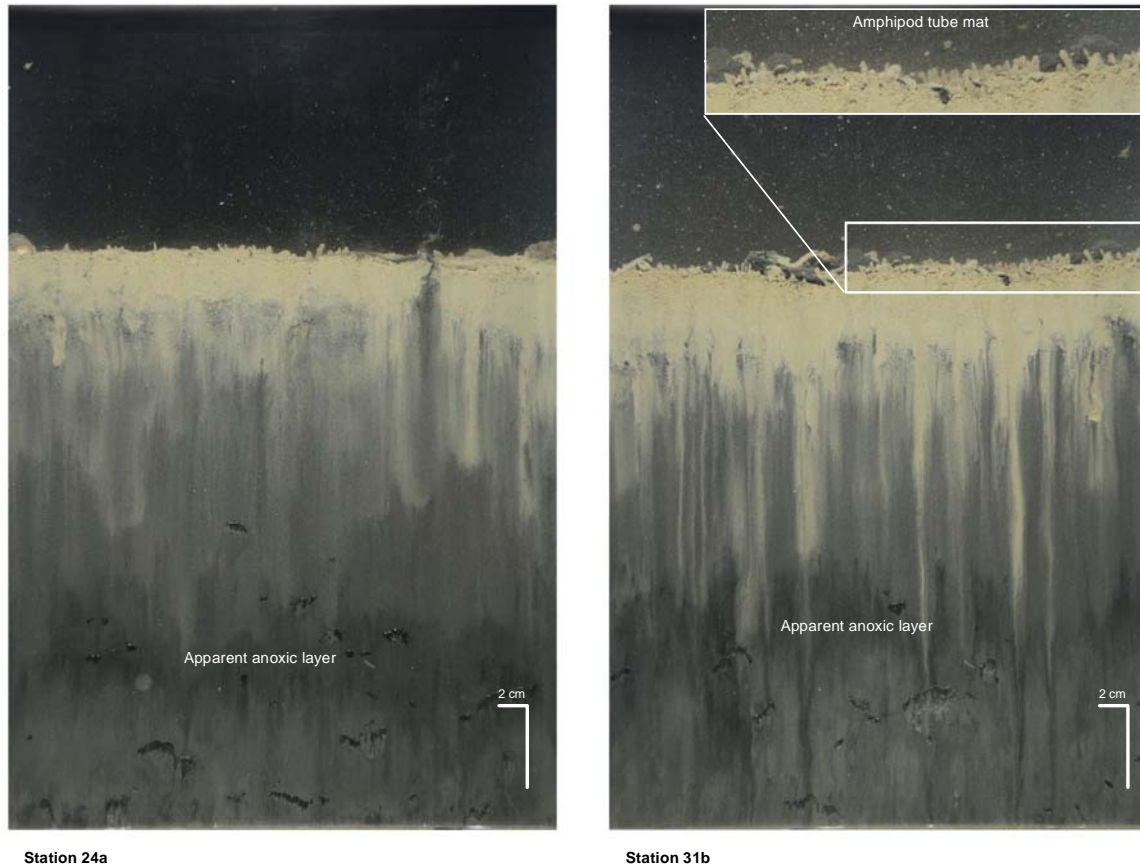
Figure 3-18. Comparison of SPI stations displaying dredged material and anoxic layer (Stations 24 and 31). Station 24a (left) displayed an anoxic layer approximately 9.0 cm below the sediment-water interface overlying apparent dredged material from 2000. Station 31b (right) displayed a similar anoxic layer over dredged material and an amphipod tube mat visible at the surface. This anoxic layer indicates a potential pit-wide anoxic event.

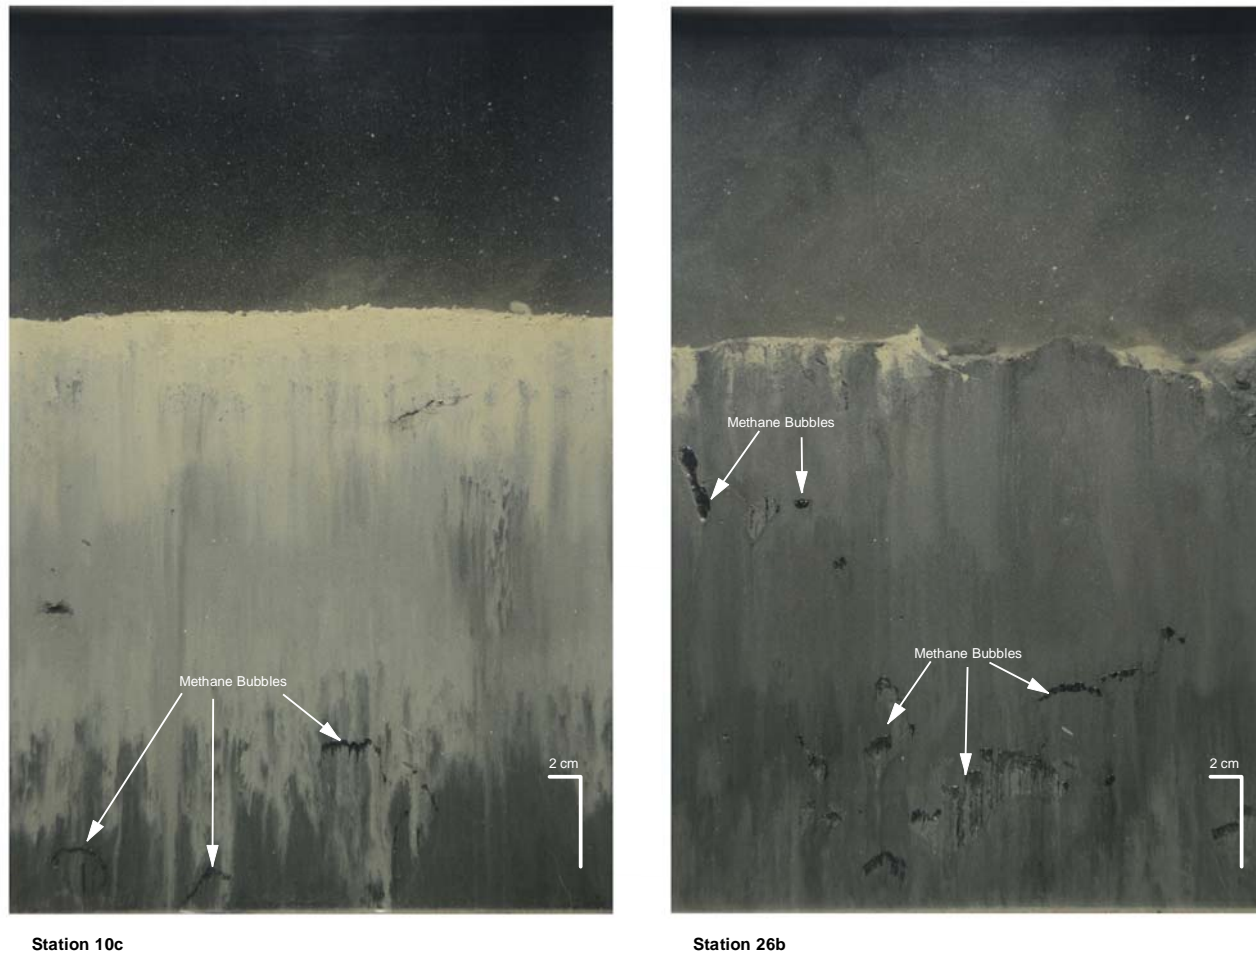
Figure 3-19. Comparison of biological condition of stations within MCBP (Stations 10 and 26). Evidence of Stage 2 -> 3 succession at Station 10c (left) with a relatively shallow aRPD (0.8 cm) and very little methane. Evidence of Stage 1 succession at Station 26b (right) with very shallow aRPD (0.1 cm) and numerous methane bubbles.

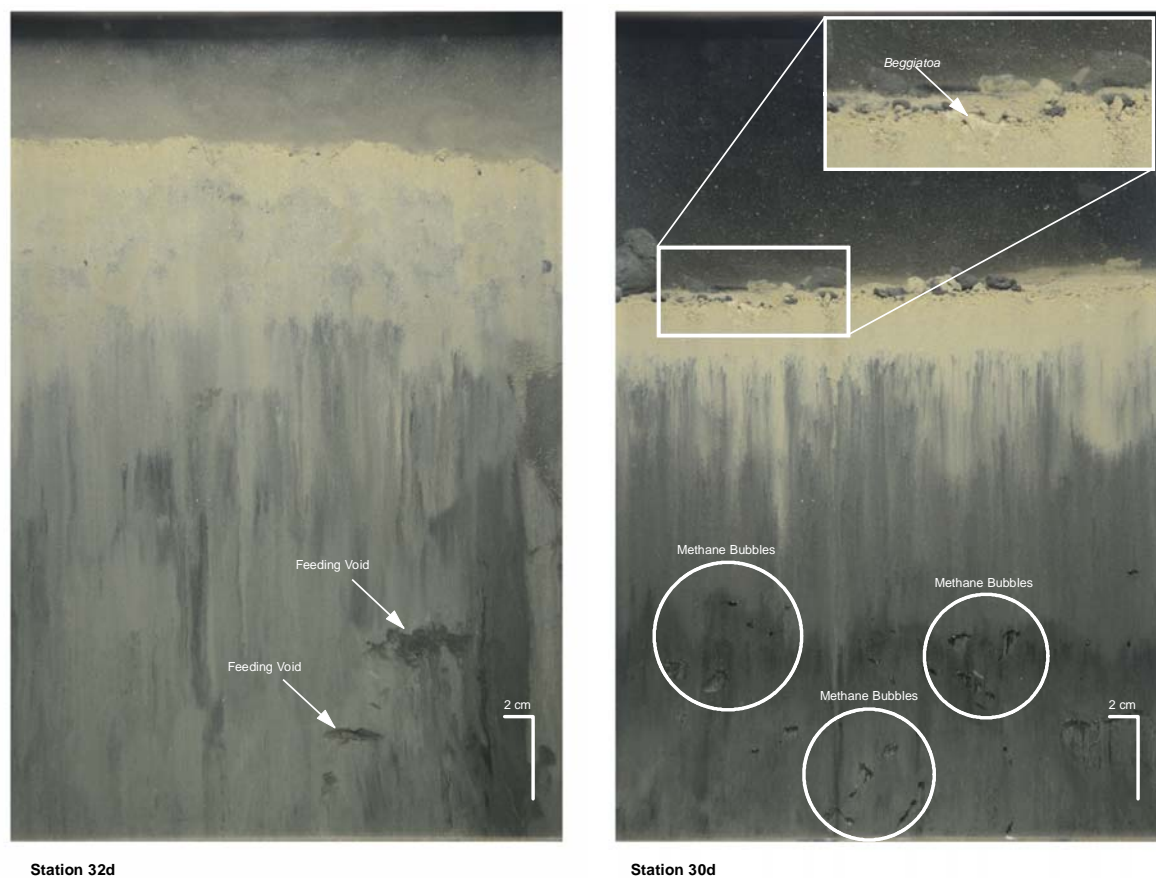
Figure 3-21. Comparison of biological condition of stations within MCBP (Stations 32 and 30). Station 32d (left) displayed evidence of Stage 2 -> 3 succession with deep feeding voids, a relatively deep aRPD (1.1 cm), and no methane bubbles. Station 30d (right) displayed evidence of Stage 1 -> 2 succession, a relatively deep aRPD (1.3 cm), abundant methane bubbles, distinctive layering of reduced sediments, and a bloom of *Beggiatoa* sp. at the sediment-water interface.

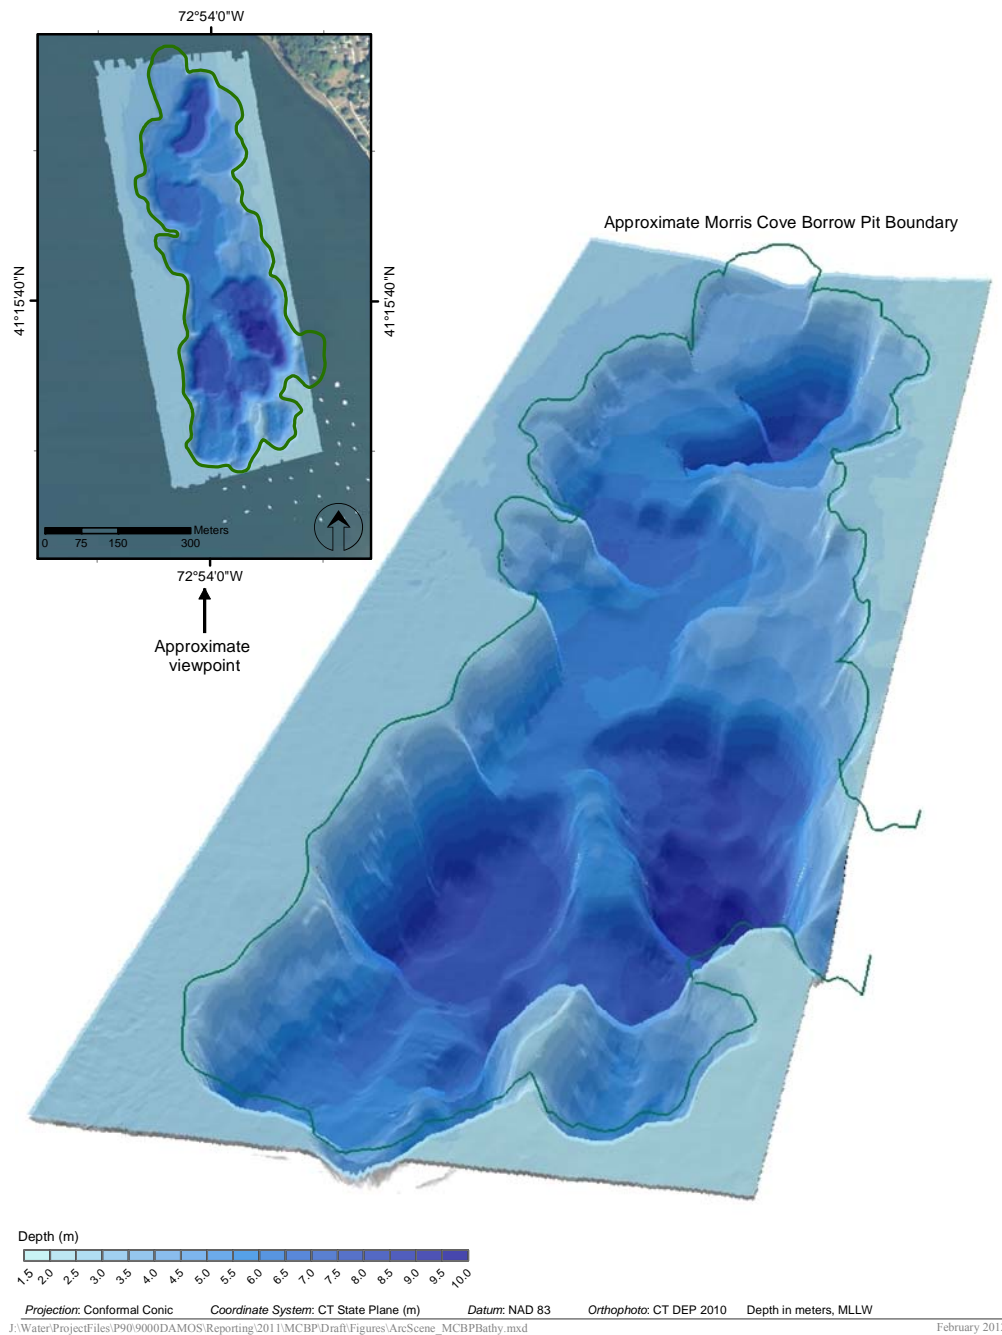
The borrow pit appears to be a stable environment; significant changes to the major physical features within the pit (steep walls, isolated deep depressions) were not observed (Figure 4-1). Based on the measured thickness of fine-grained material observed in the sediment-profile images (SPI) overlaying the previously placed dredged material, it is estimated that the borrow pit receives approximately 0.5–0.8 cm of new material per year. There was not any evidence of coarse-grained sediments at the surface within the borrow pit, indicating the absence of erosional processes in the immediate area (Figure 4-2). Considering the functional history of the borrow pit (source of sand and gravel), the presence of soft, fine-grained material within the depths of the borrow pit

Figure 4-1. Three-dimensional representation of MCBP based on multibeam bathymetry used to calculate volumetric capacity. Actual side slopes ranged from approximately 1:5 on the eastern side of the borrow pit to 1:17 on the western side. The appearance of steep borrow pit walls are accentuated by the image aspect.

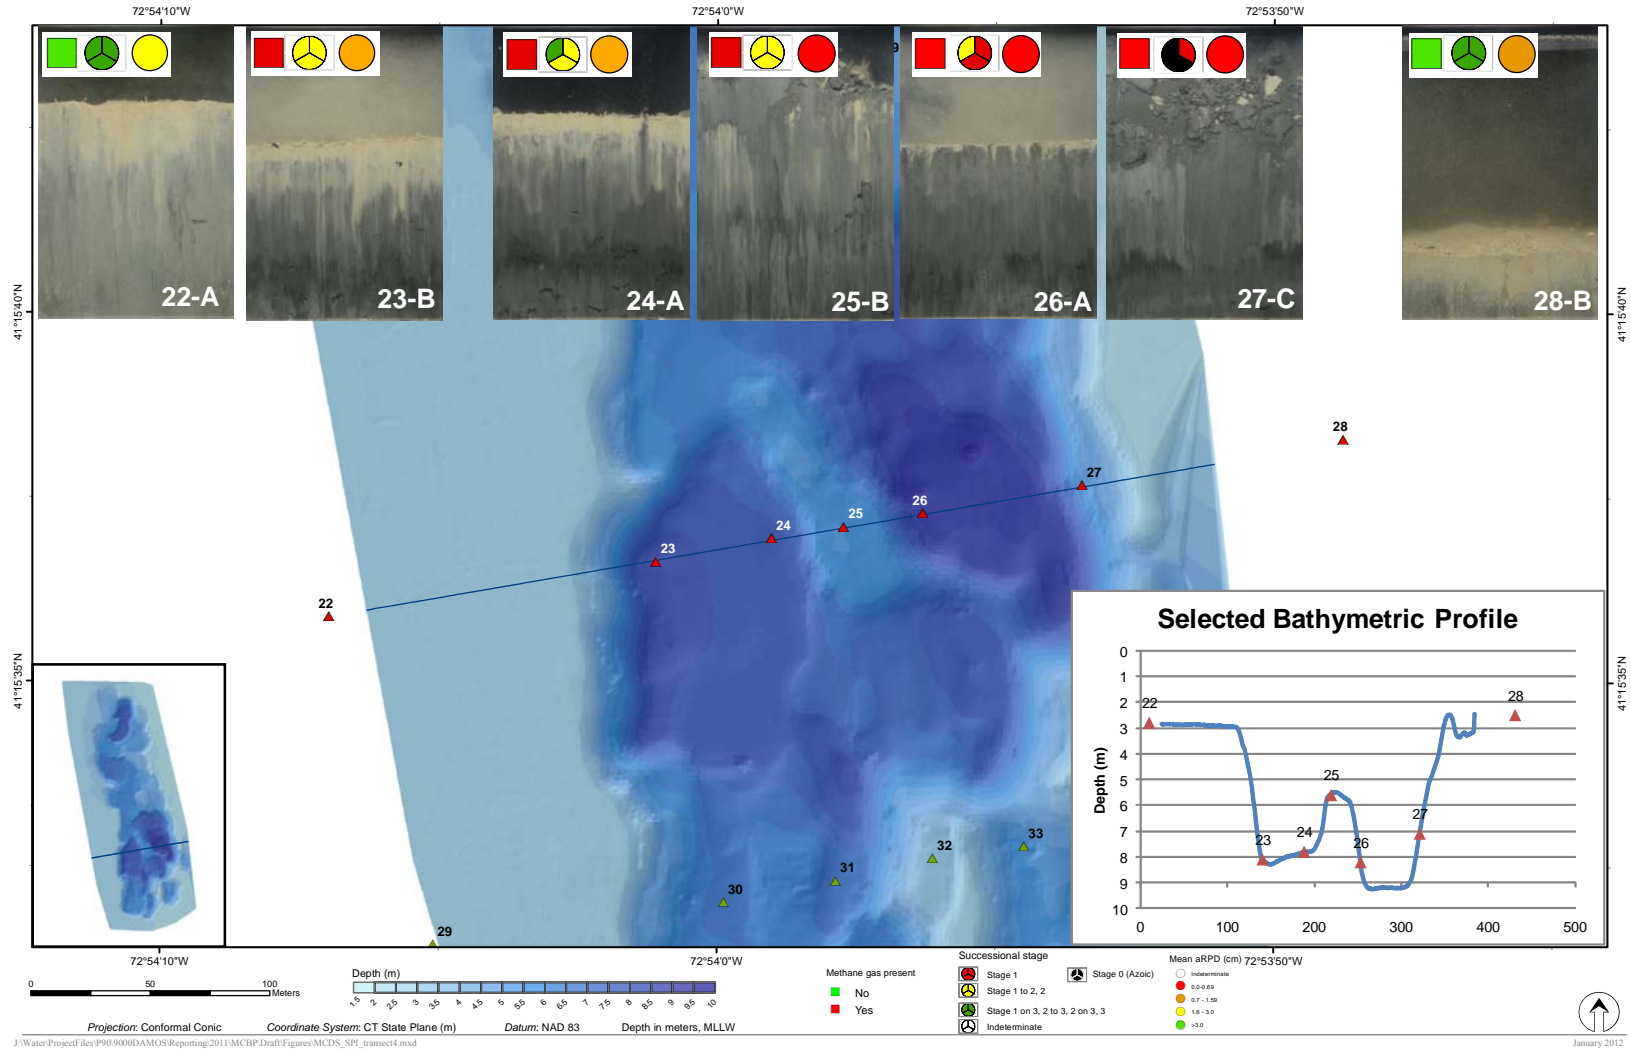
The organic sediments and depleted dissolved oxygen environment that exists within the borrow pit do not provide productive habitat for the local biological community (Figure 4-5). If the conditions were more favorable in the area in and around the borrow pit, there would be an opportunity to support other marine species such as

Figure 4-5. Sediment-profile image transect #4 across the two deepest depressions in the southern MCBP
Monitoring Survey at the Morris Cove Borrow Pit September-October 2011

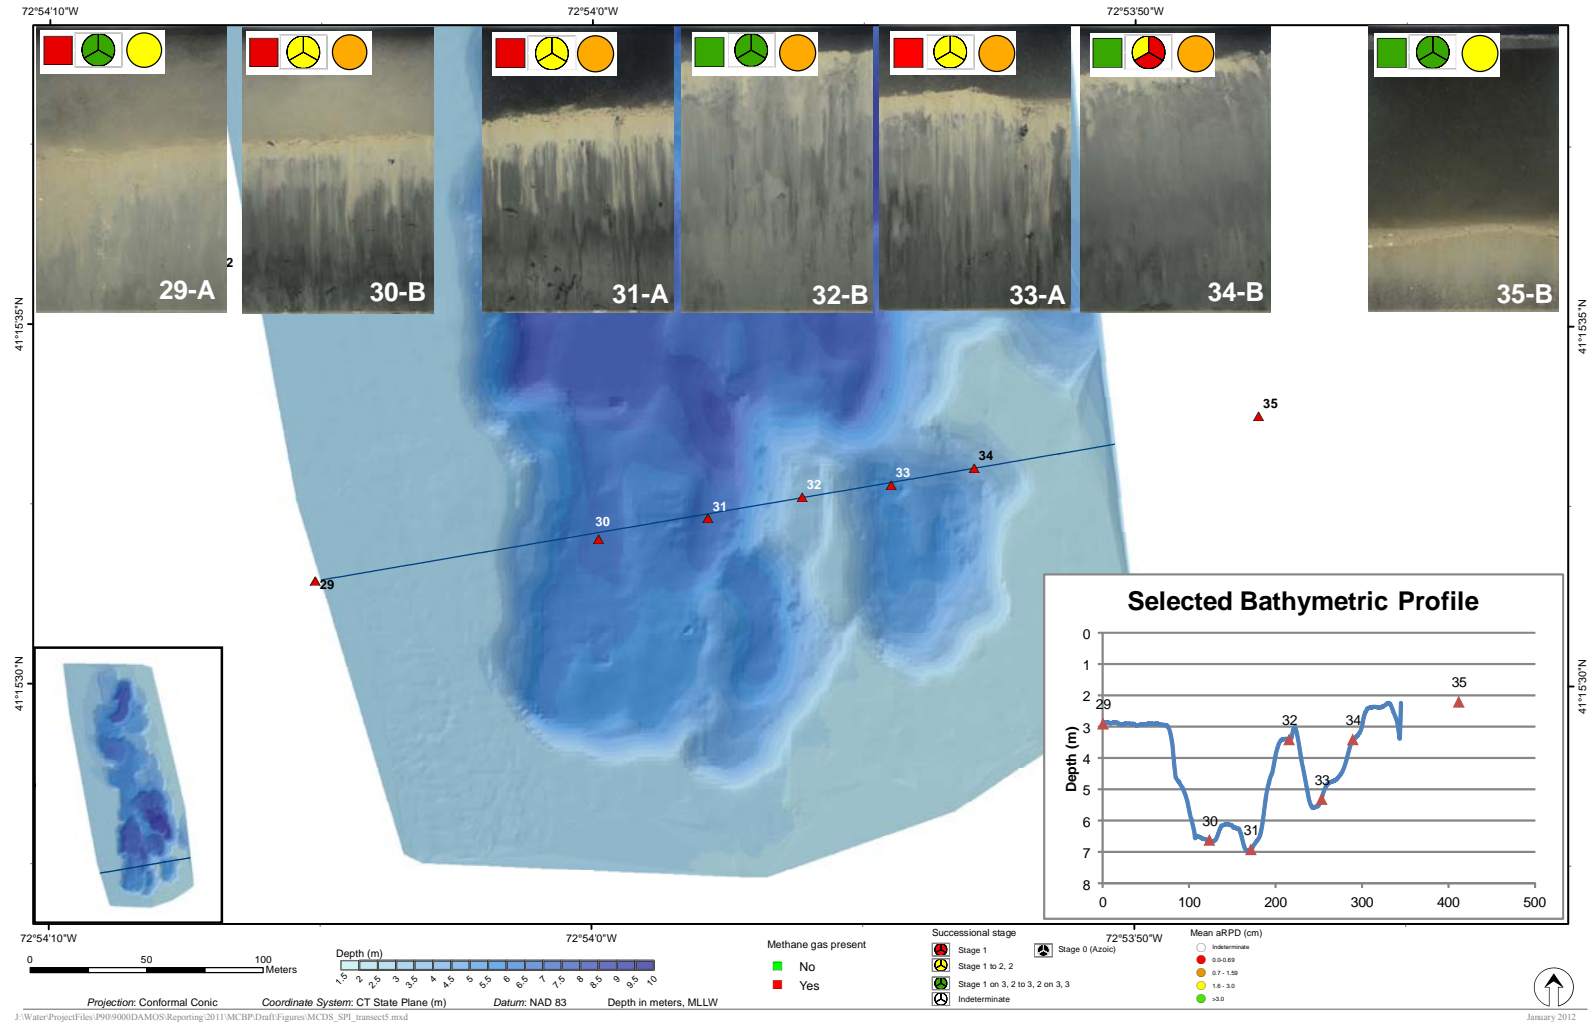
Within Long Island Sound, New Haven Harbor has been identified as an estuary where winter flounder are known to spawn. Morris Cove in particular has been identified as spawning habitat (SAIC 1996) for this commercially and recreationally important species. Winter flounder prefer shallow water for spawning (Schultz et al 2007), and prefer a flat, hard, and clean bottom protected from waves and currents (Castonguay and Visel 1988), making Morris Cove valuable potential nursery habitat. The low current velocities observed in the WHG study also suggest that the cove would have a current regime supportive of winter flounder eggs and juveniles (Schultz et al 2007). However, the deeper depths, fine organic sediment substrate, and degraded dissolved oxygen environment within the borrow pit are not suitable as flounder habitat (Figure 4-6).

Figure 4-6. Sediment-profile image transect #5 across the southern margin of MCBP
