## Letter Report

Subject: USACOE General Permit #NAE 2008-3065  
Fall 2013 Wetland Inspection Report  
0 Brook Street, Holliston, MA

Re: Wetland Replication Areas  
0 Brook Street  
Holliston, MA  
Wetland Mitigation  
DEP #185-0712; NHESP File No. 08-25195

0 Brook Street, Holliston, MA  
September 26, 2013

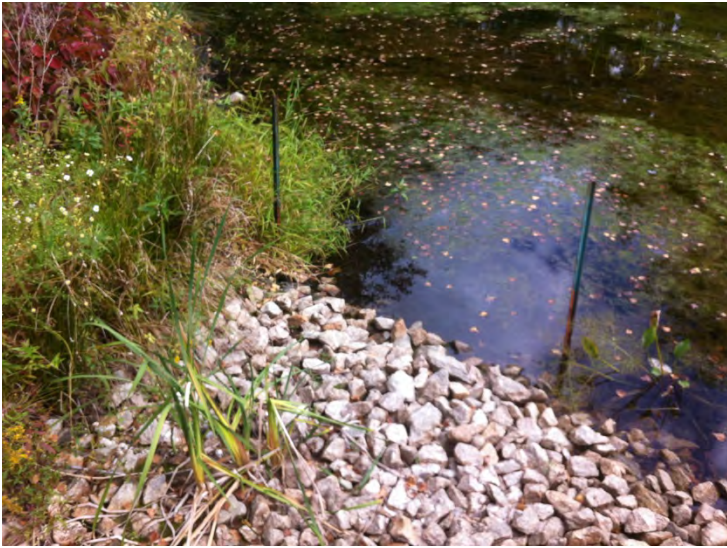
View of culvert #1 inlet to the vernal pool

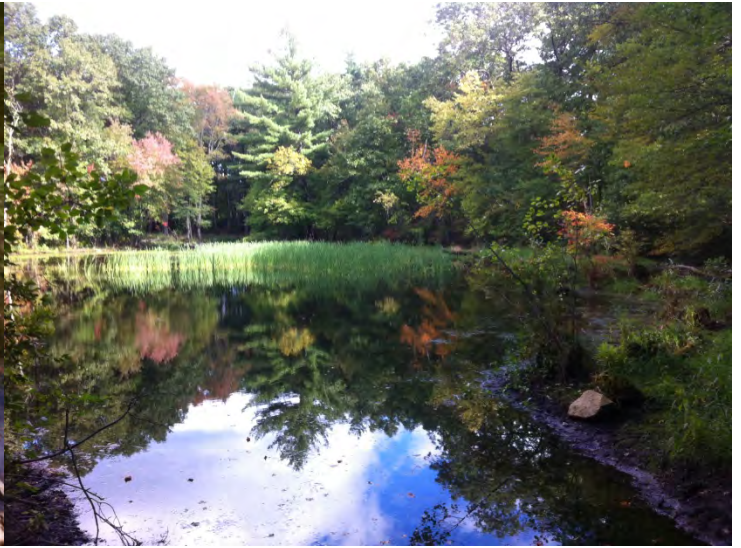
View north from the outlet of the vernal pool

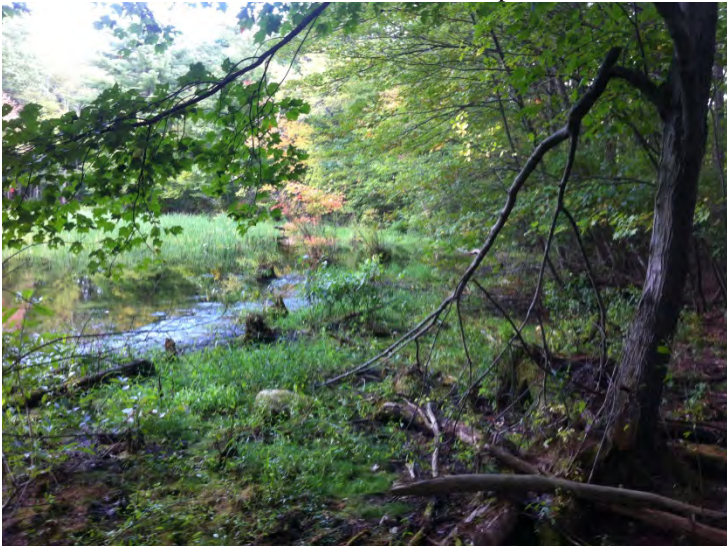
View northeast from the outlet of the vernal pool

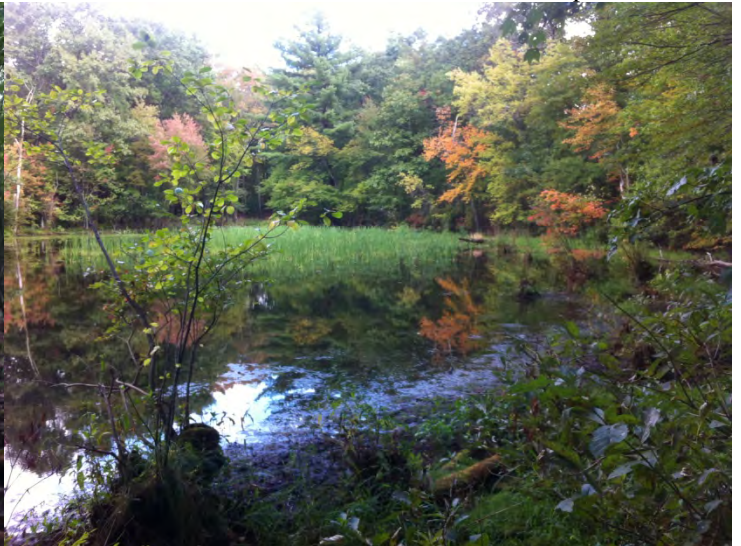
View north of the vernal pool

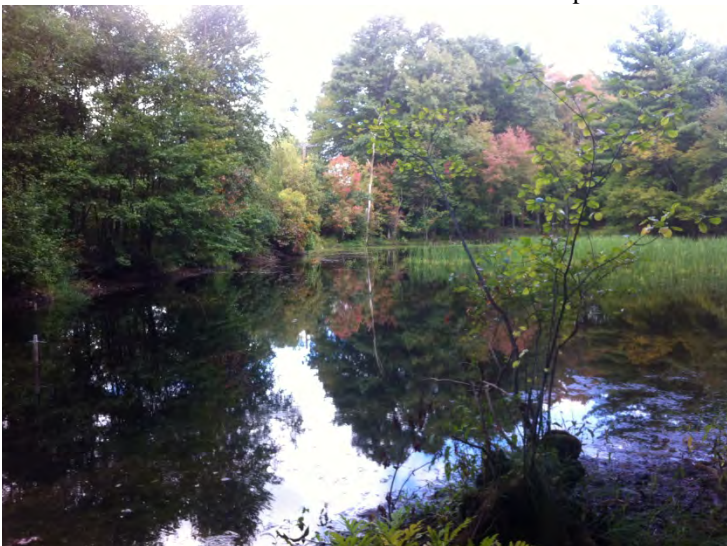
View northwest of the vernal pool

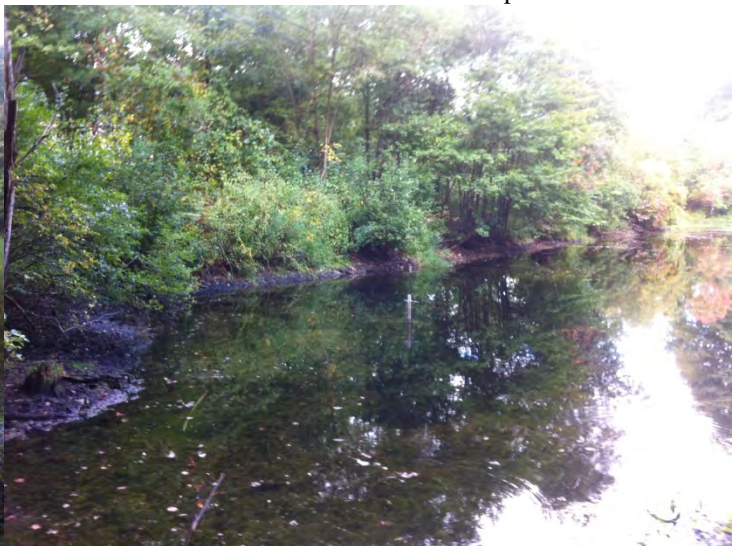
View west from the outlet of the vernal pool

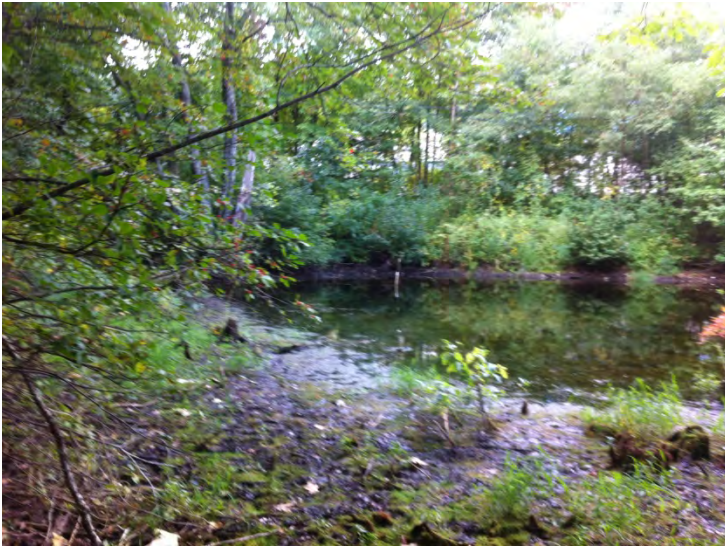
View west of the vernal pool

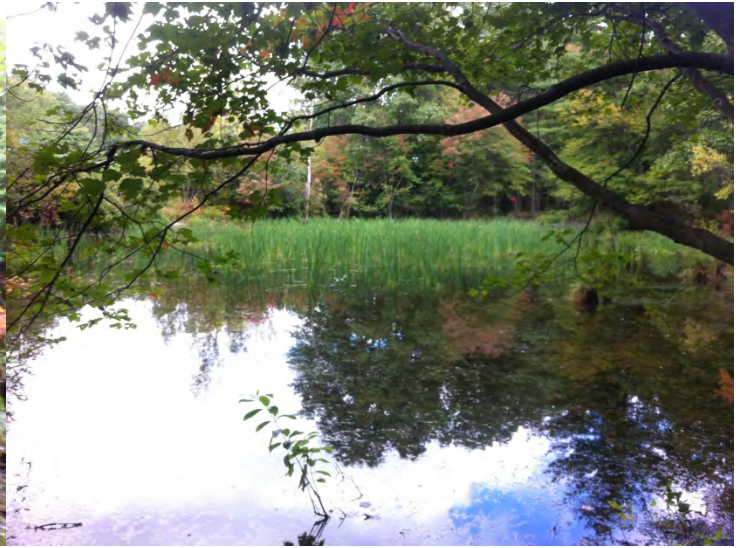
View north of the vernal pool

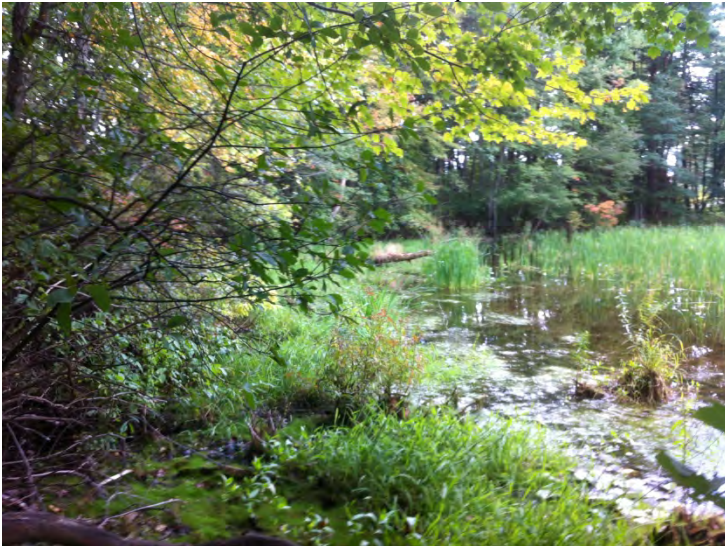
View south of the vernal pool

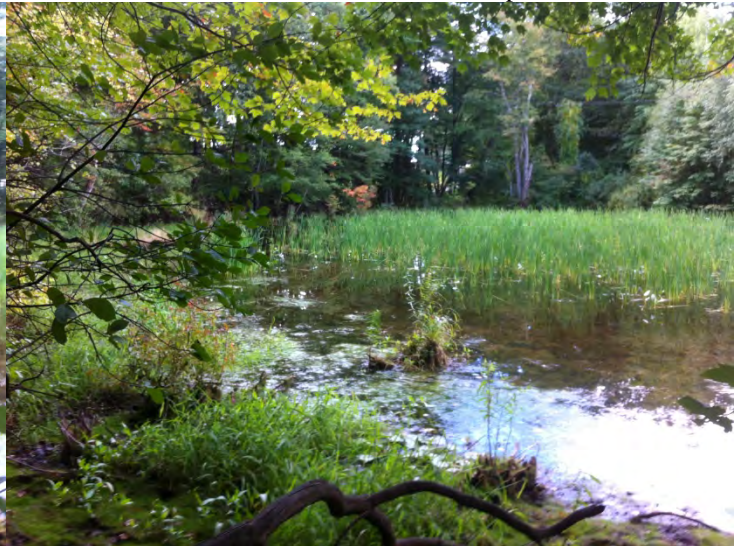
View south of the vernal pool

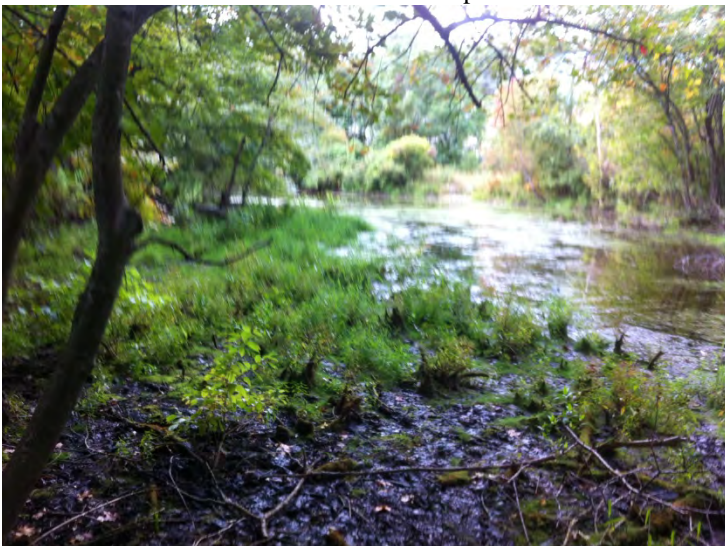
View southwest of the vernal pool

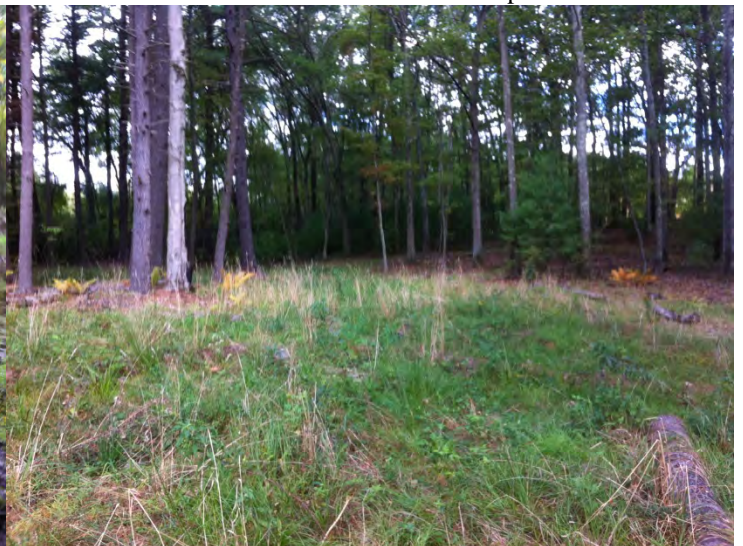
View northwest of the restored buffer zone

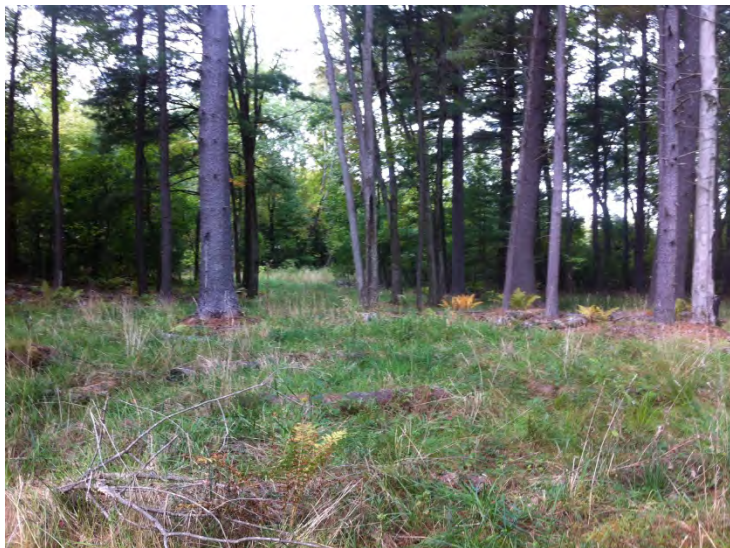
View west of the restored buffer zone

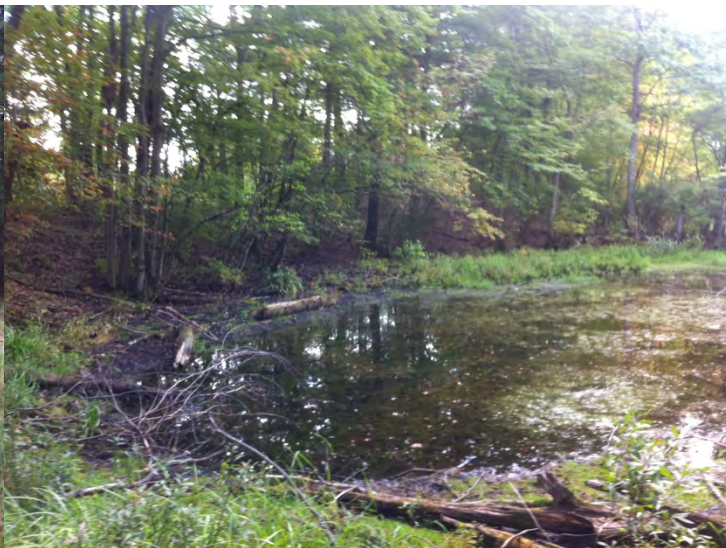
View east from the northern end of the vernal pool

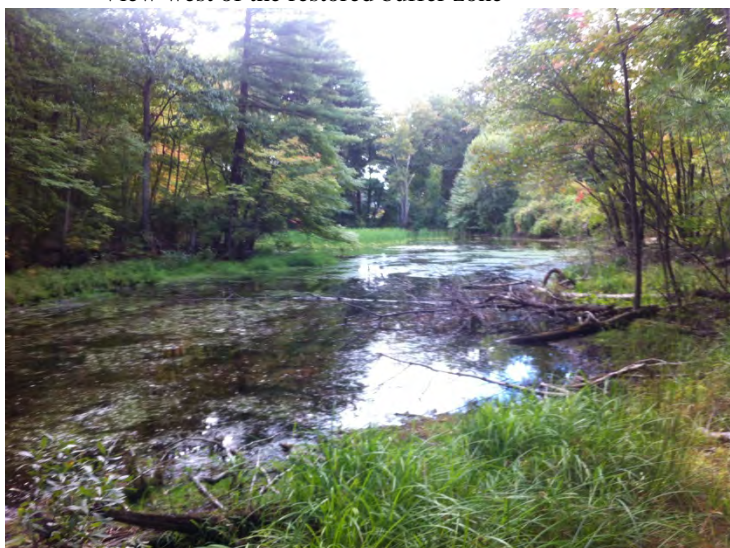
View south of the vernal pool

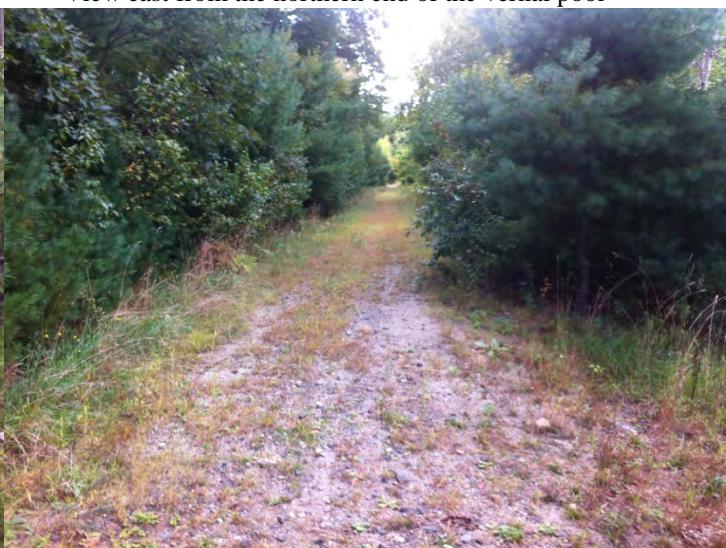
View north of the rail trail

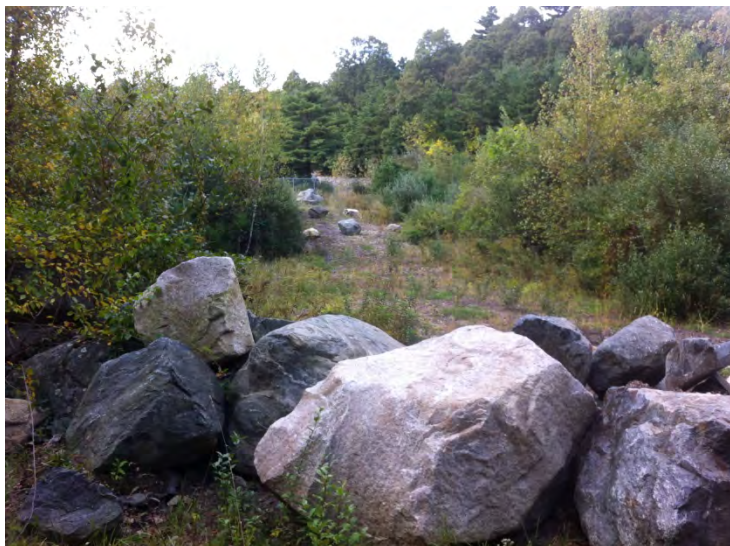
View west of the access way

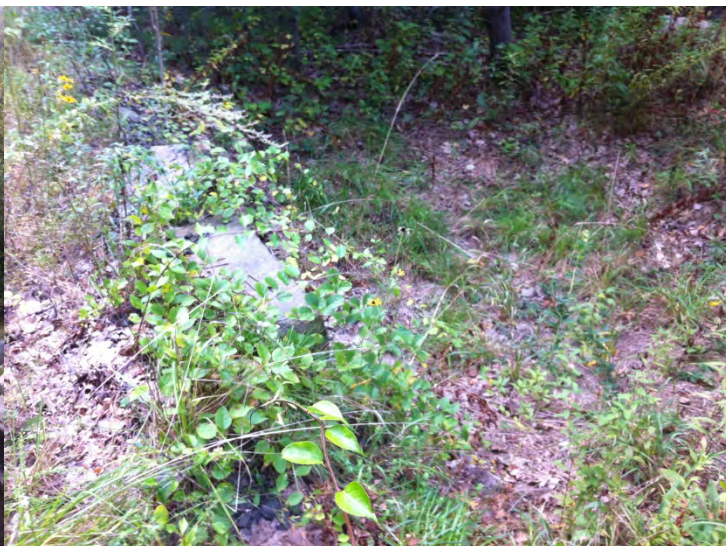
View of culvert #3 just south of the access way.

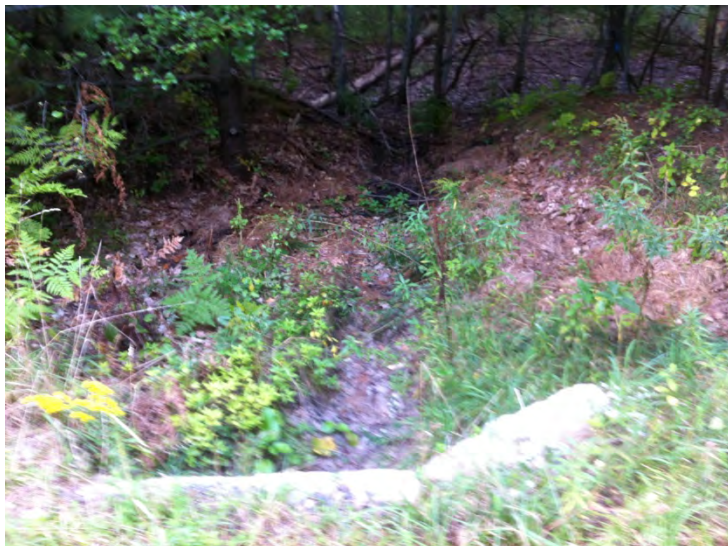
View east of culvert #3

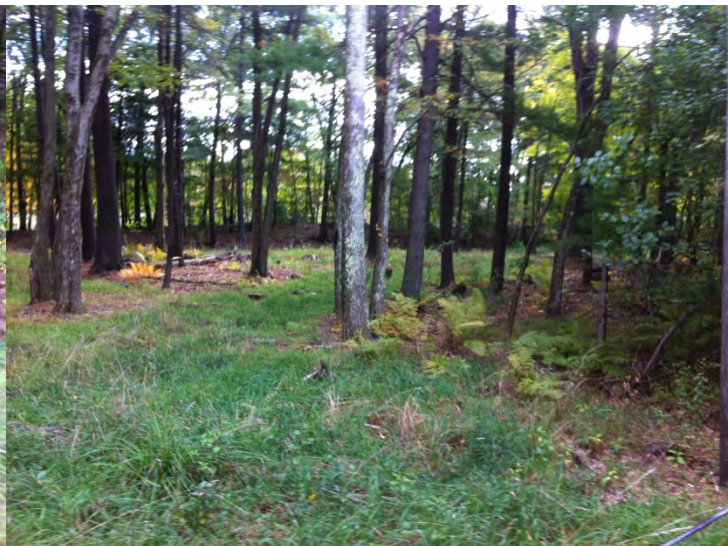
View east of the restored buffer zone

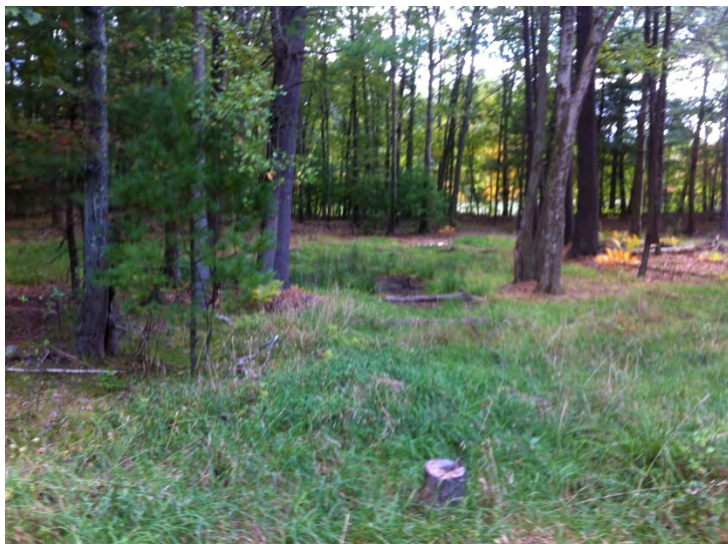
View east of the restored buffer zone

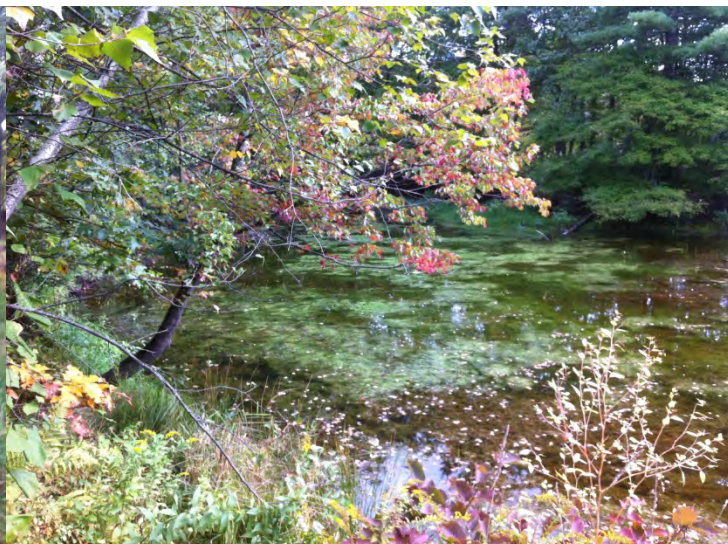
View northeast from culvert #1

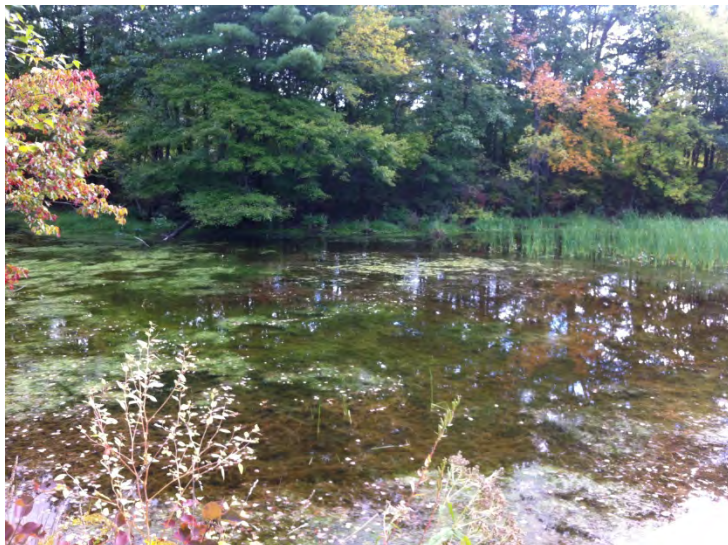
View east from culvert #1

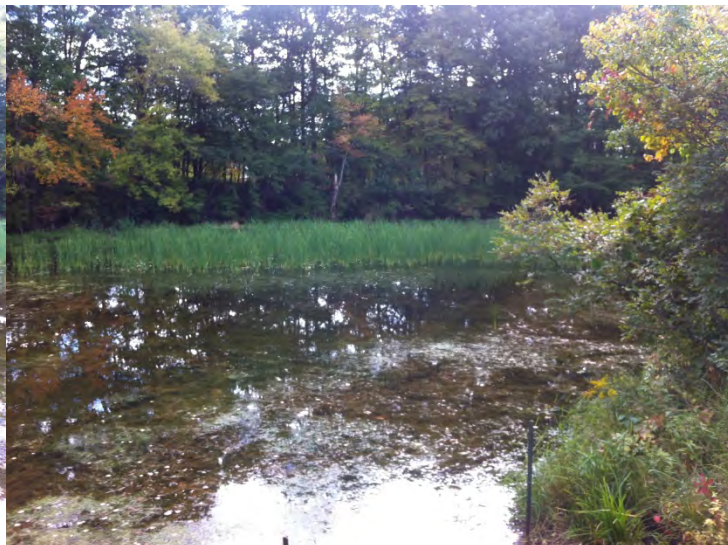
View southeast from culvert #1

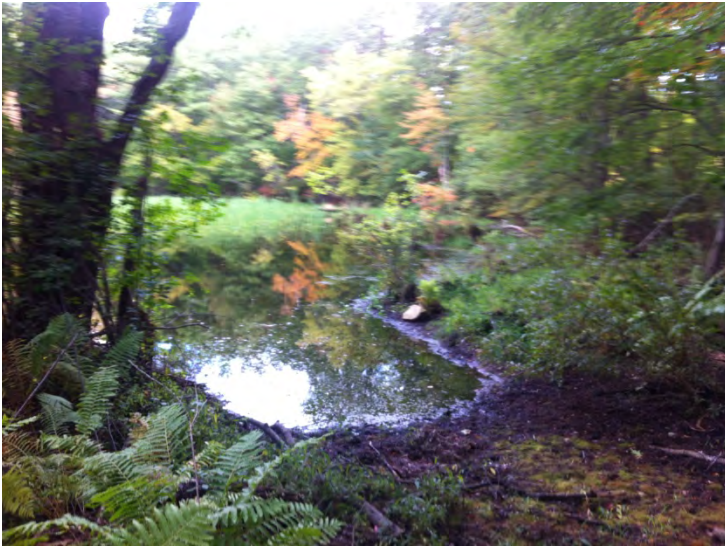
View north from the vernal pool outlet

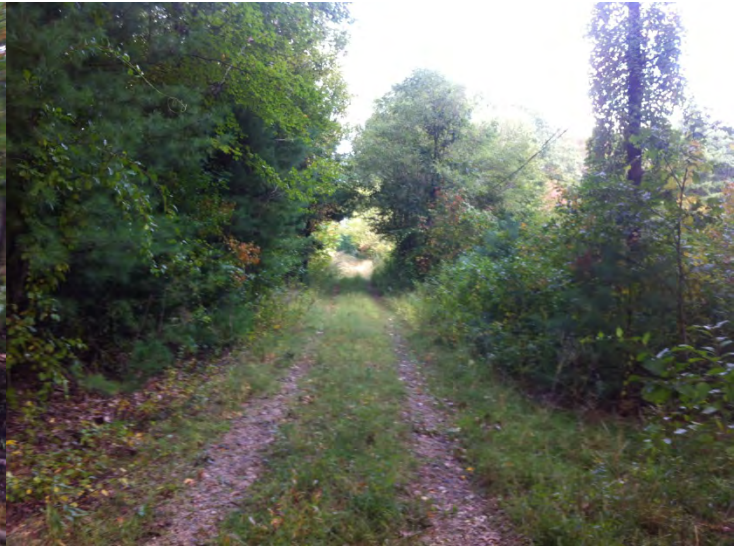
View north of the rail trail from culvert #2

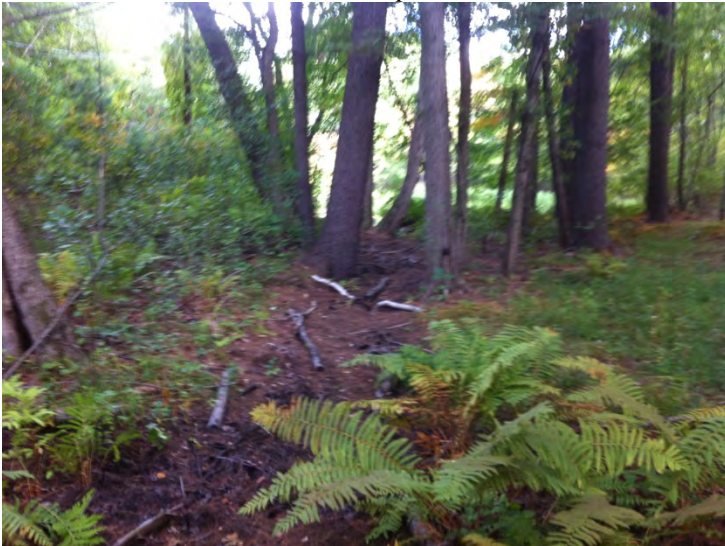
View north of the intermittent stream

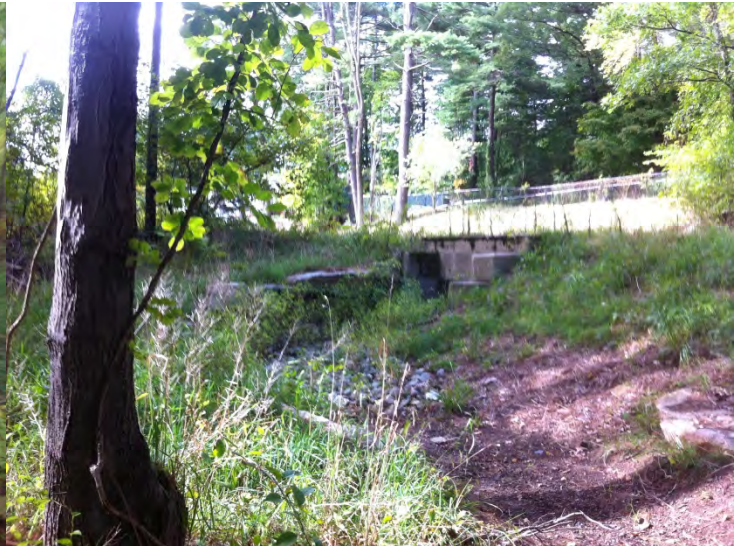
View south to culvert #2

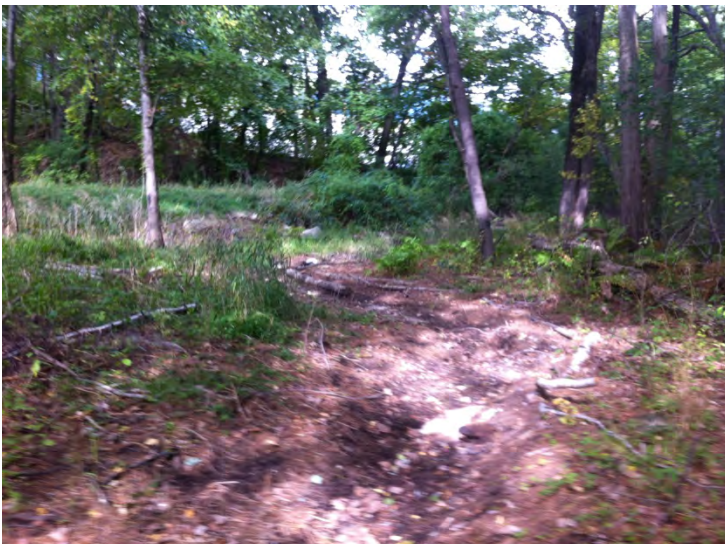
View west of the intermittent stream

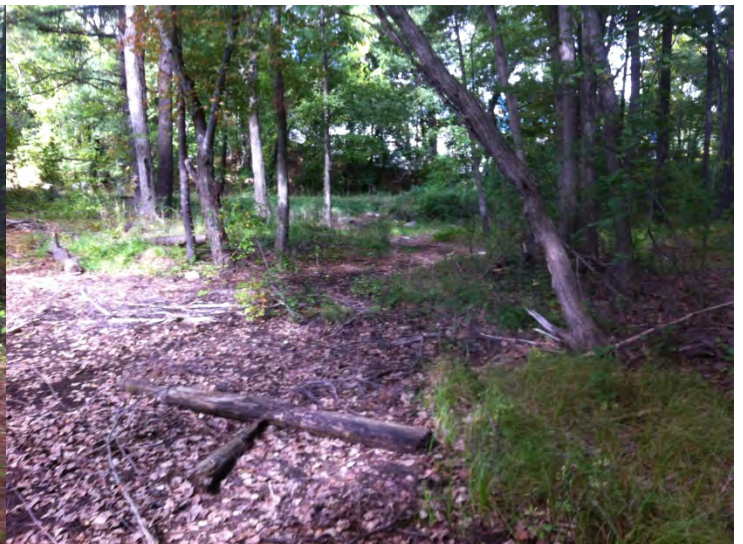
View west of the BVW and intermittent stream

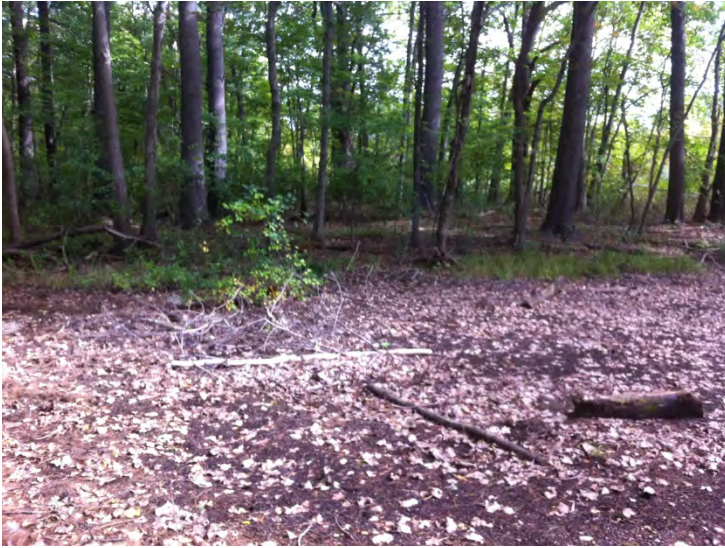
View north of the BVW

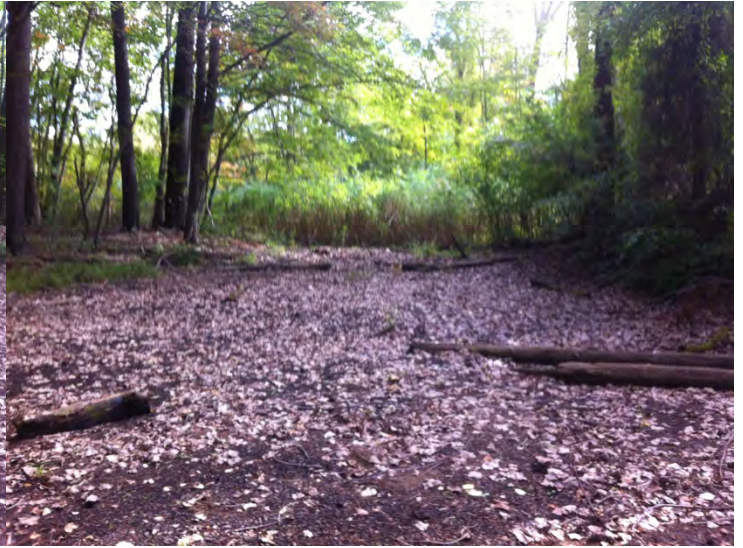
View east of the BVW

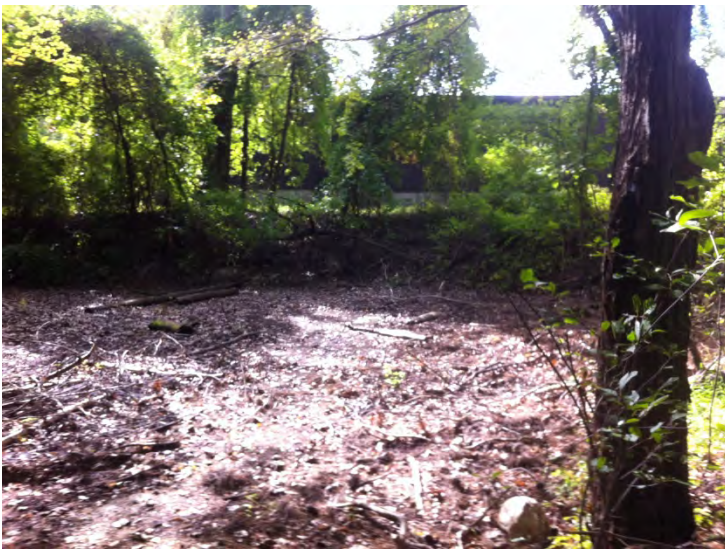
View south of the BVW

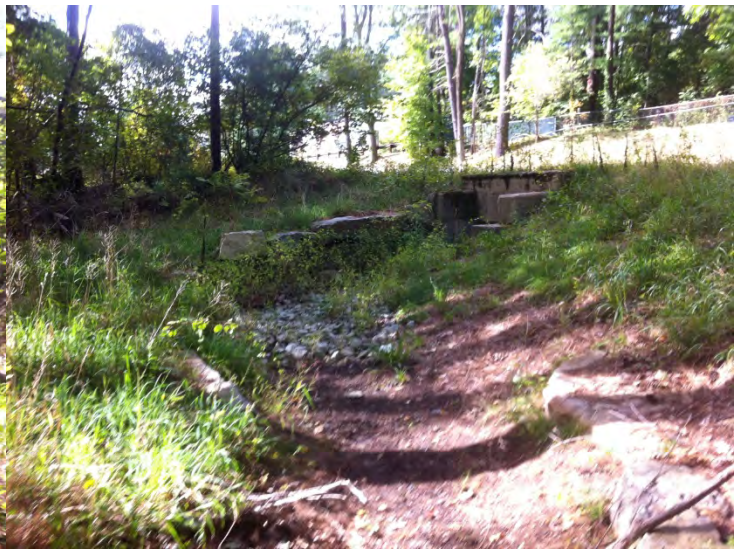
View south of culvert #2

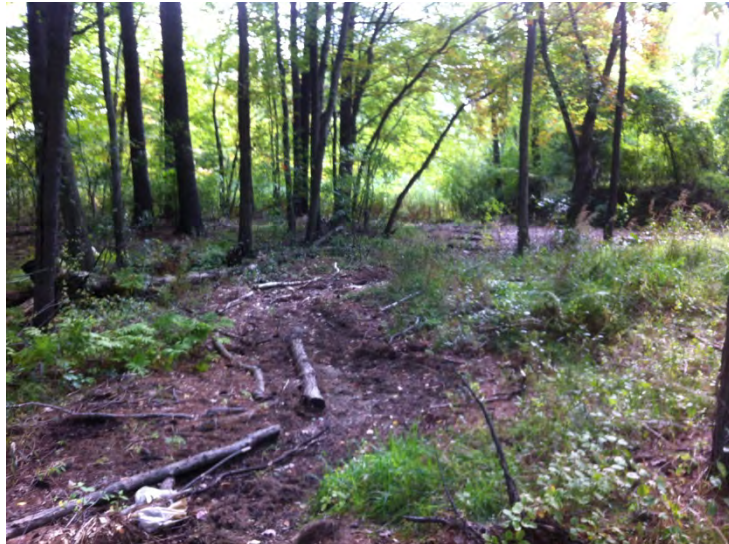
View east of the intermittent stream
