Letter Report

Subject: USACOE General Permit #NAE 2008-3065
Fall 2014 Wetland Inspection Report
0 Brook Street, Holliston, MA

Re: Wetland Replication Areas
0 Brook Street
Holliston, MA
Wetland Mitigation
DEP #185-0712; NHESP File No. 08-25195

Brook Street Holliston, MA
Vernal Pool / Wetland Restoration
Photographs Taken September 18, 2014

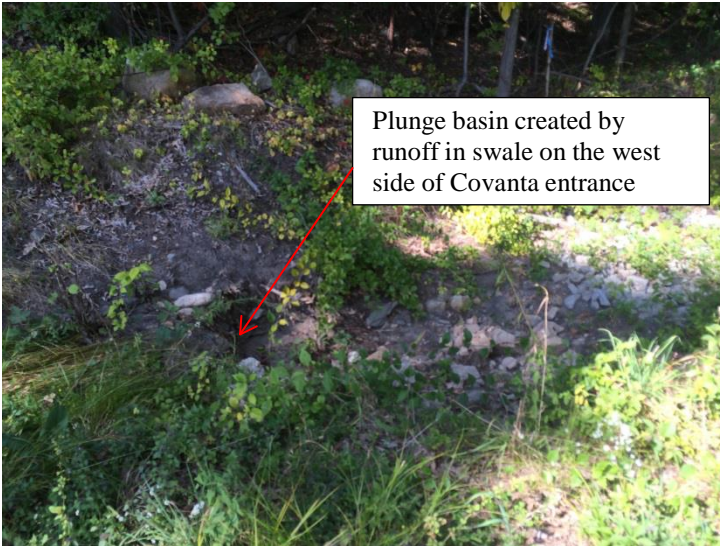
Plunge basin created by runoff in swale on the west side of Covanta entrance

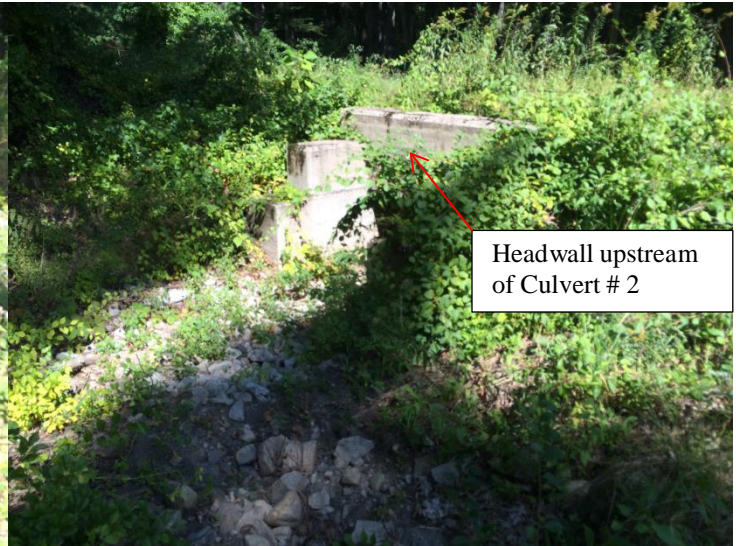
Headwall upstream of Culvert # 2

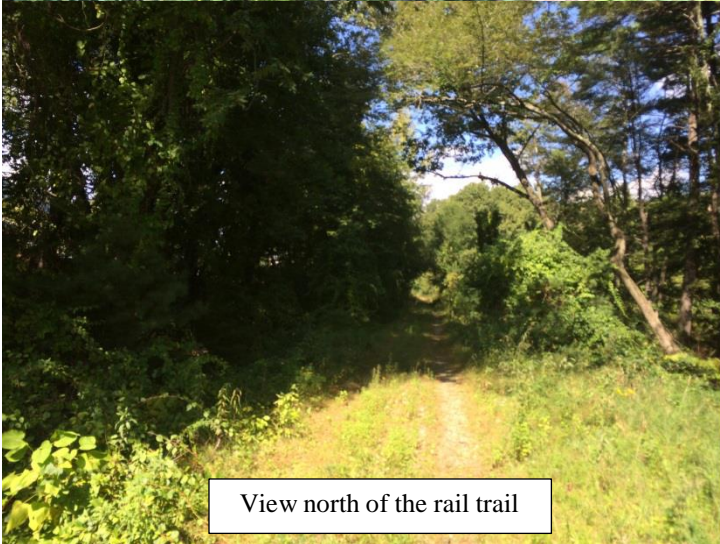
View north of the rail trail

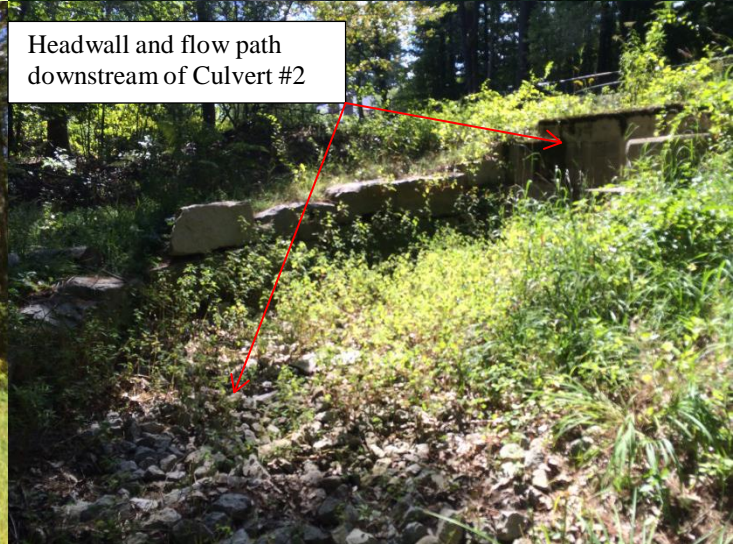
Headwall and flow path downstream of Culvert #2

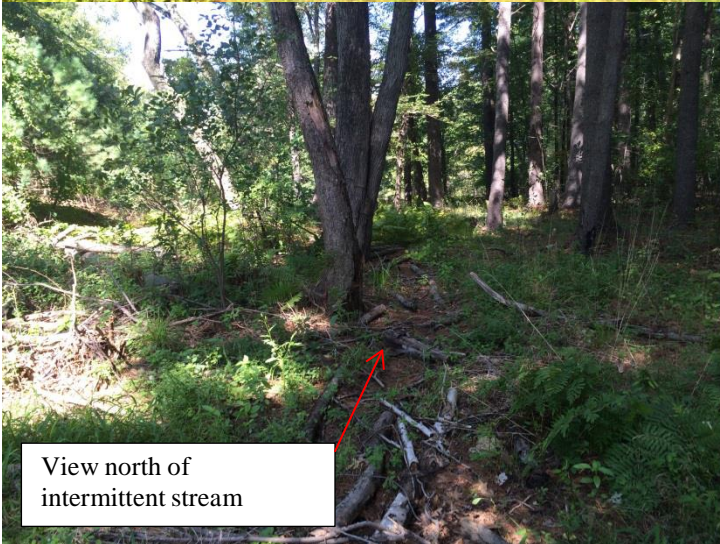
View north of intermittent stream

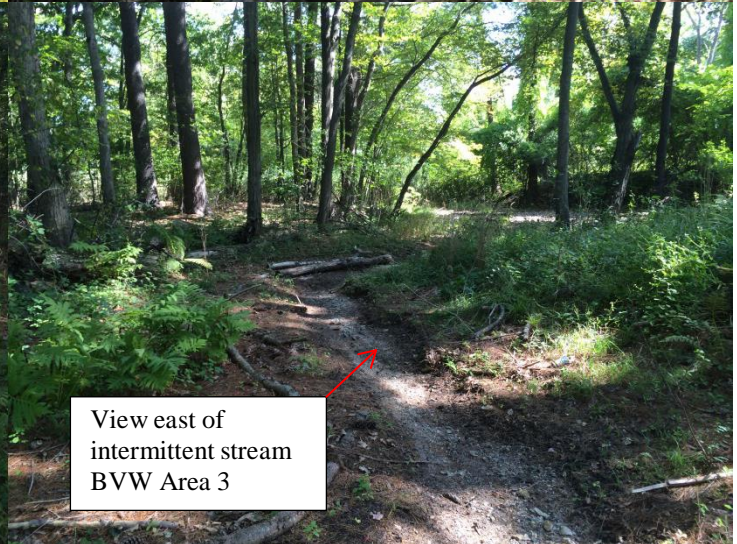
View east of intermittent stream BVW Area 3

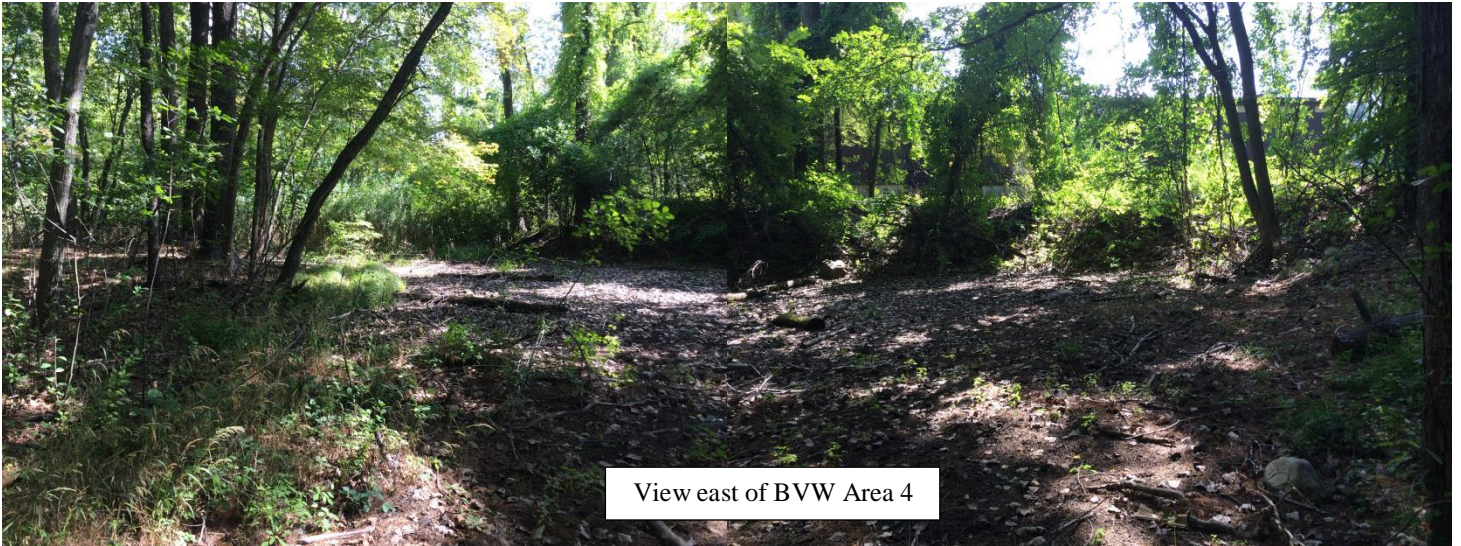
View east of BVW Area 4

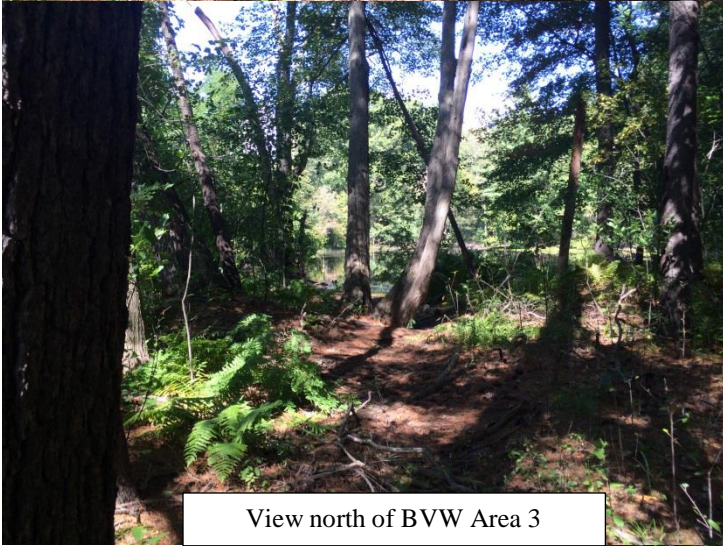
View north of BVW Area 3

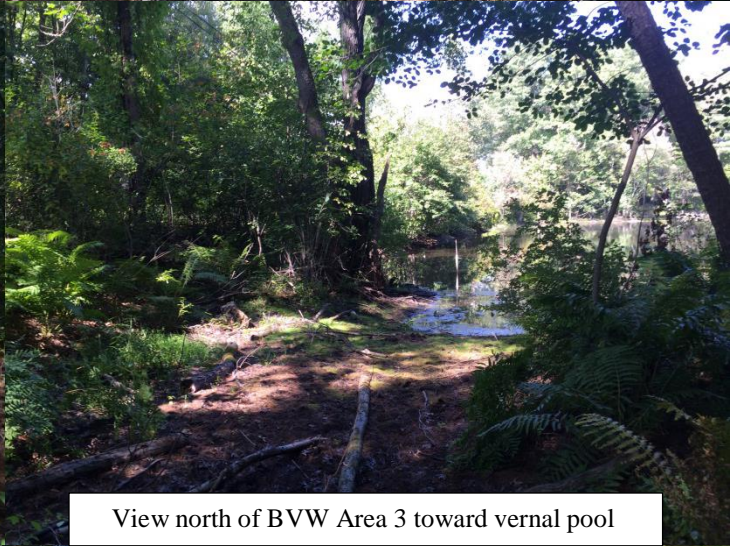
View north of BVW Area 3 toward vernal pool

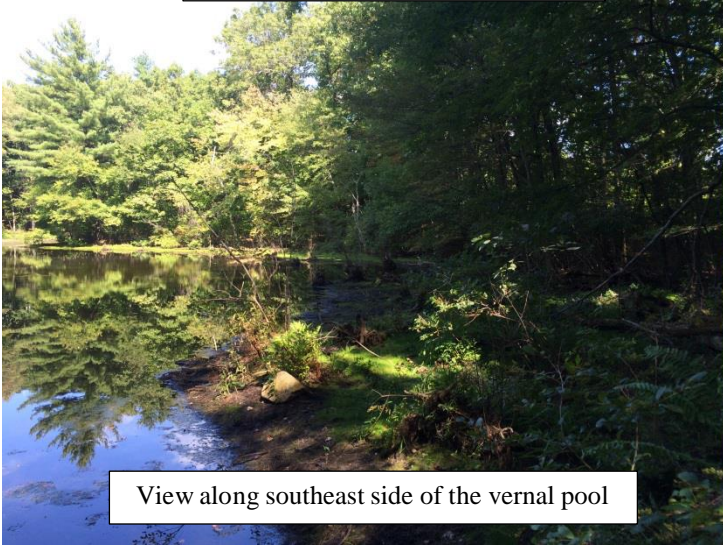
View along southeast side of the vernal pool

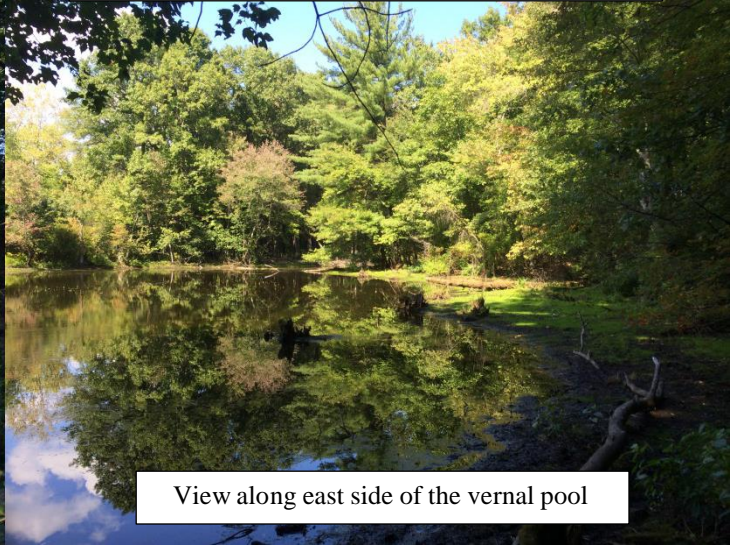
View along east side of the vernal pool

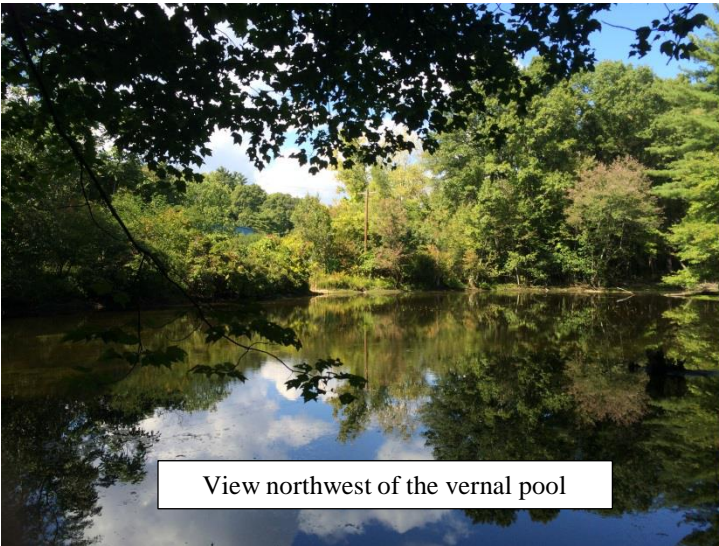
View northwest of the vernal pool

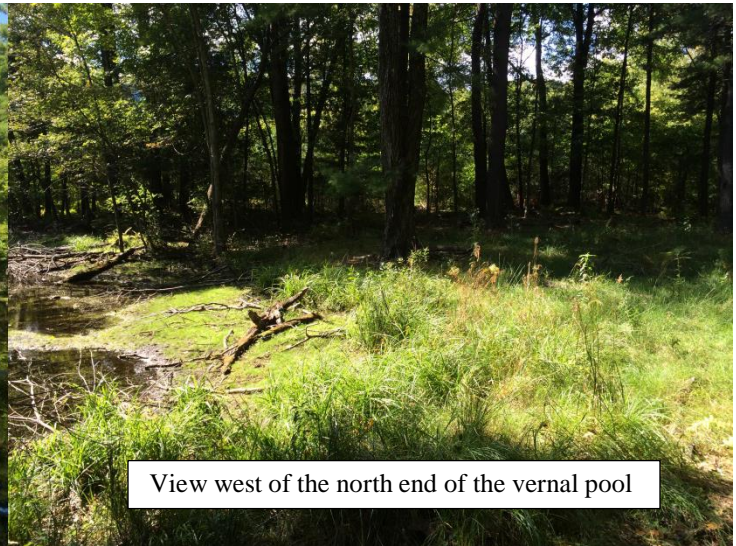
View west of the north end of the vernal pool

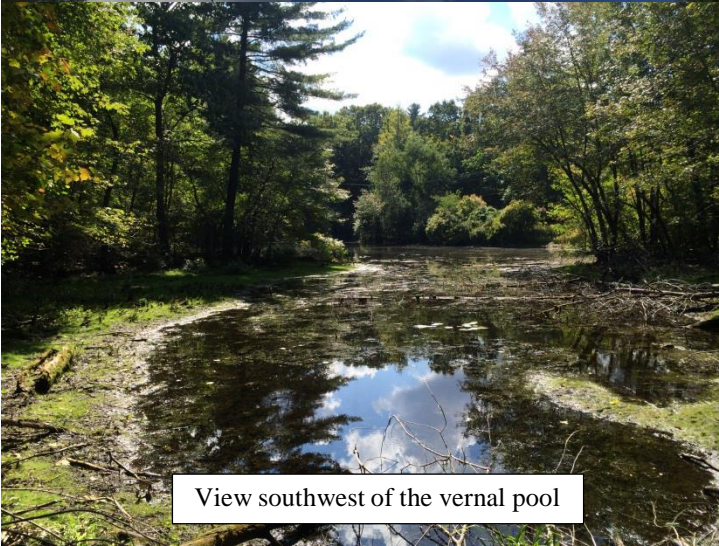
View southwest of the vernal pool

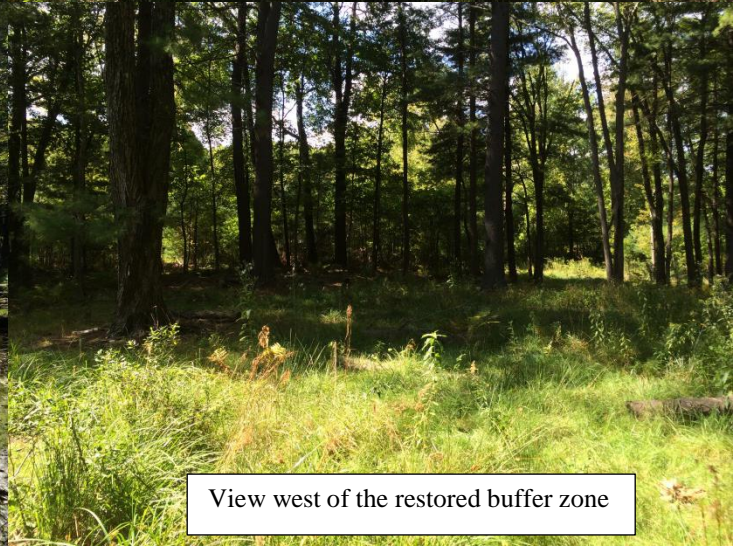
View west of the restored buffer zone

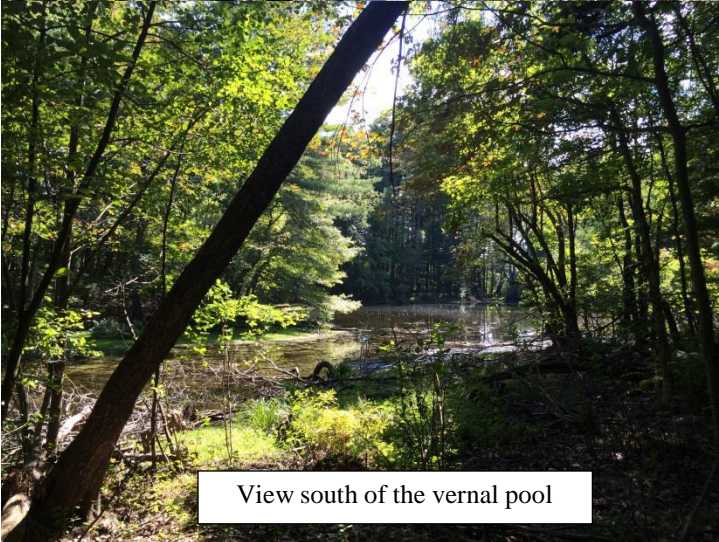
View south of the vernal pool

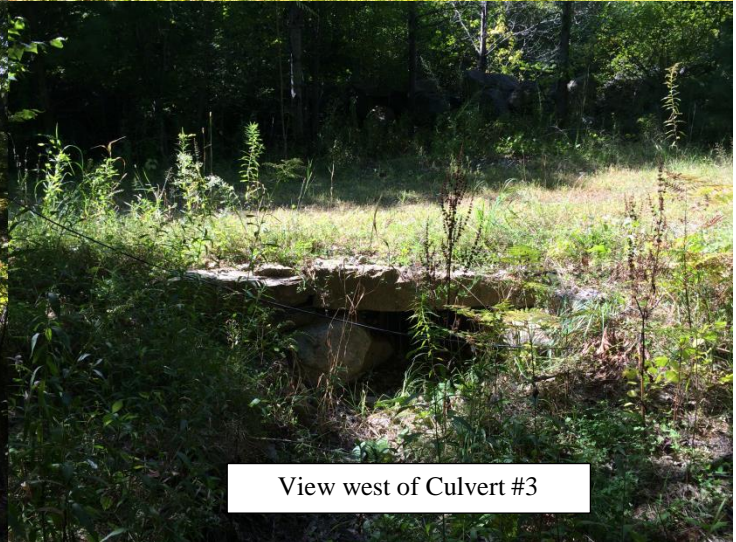
View west of Culvert #3

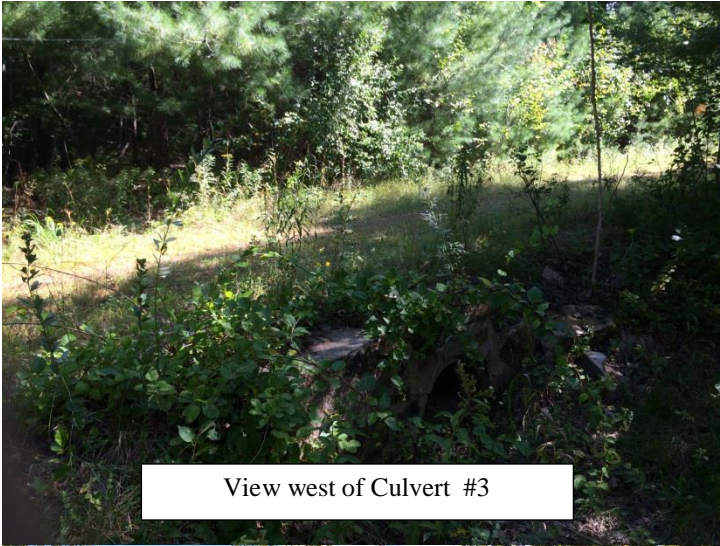
View west of Culvert #3

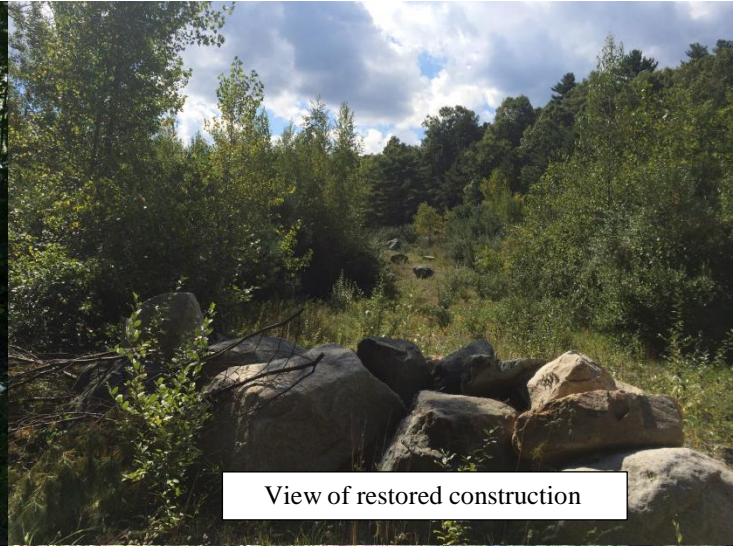
View of restored construction

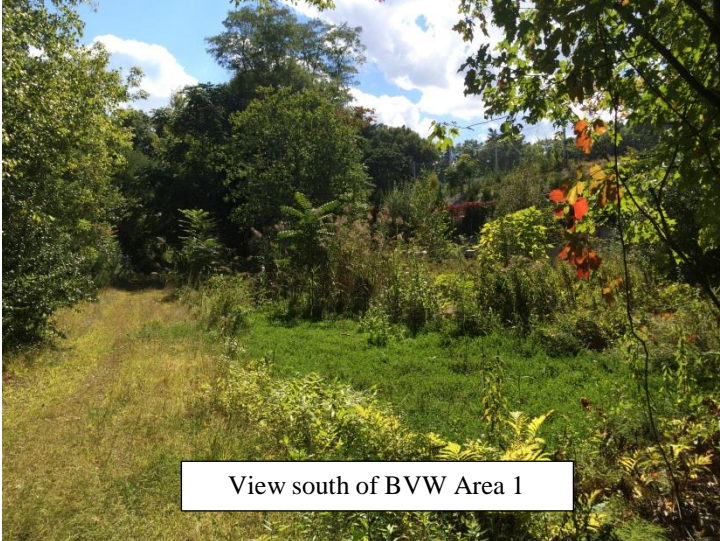
View south of BVW Area 1

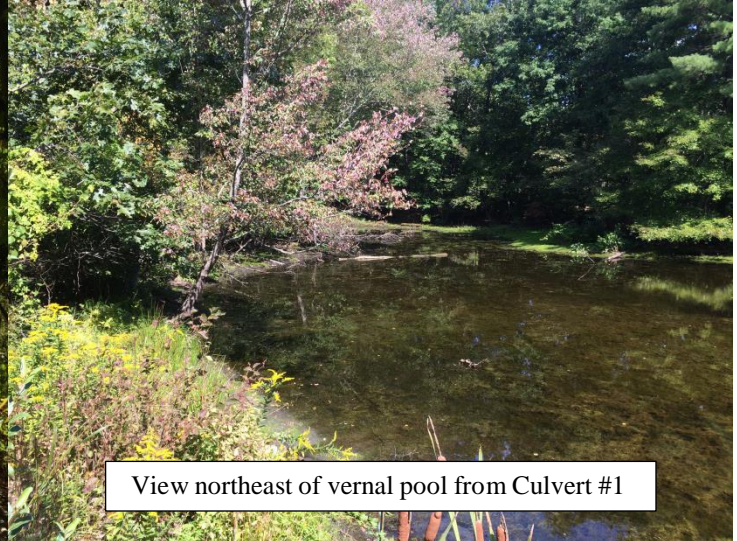
View northeast of vernal pool from Culvert #1

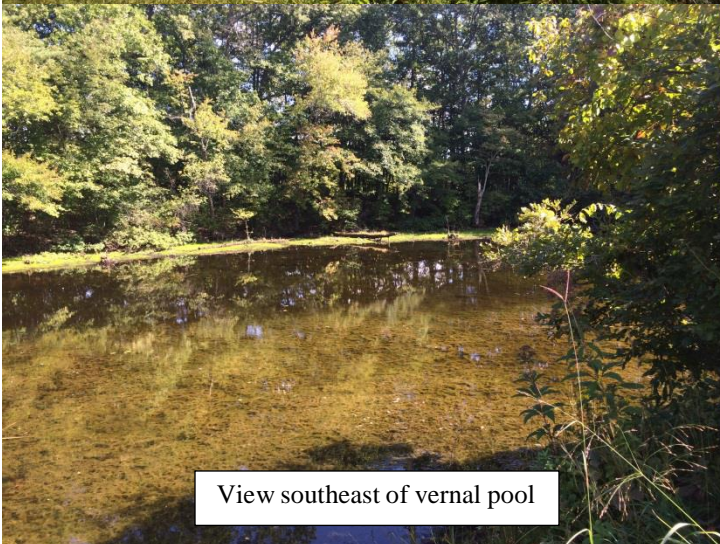
View southeast of vernal pool

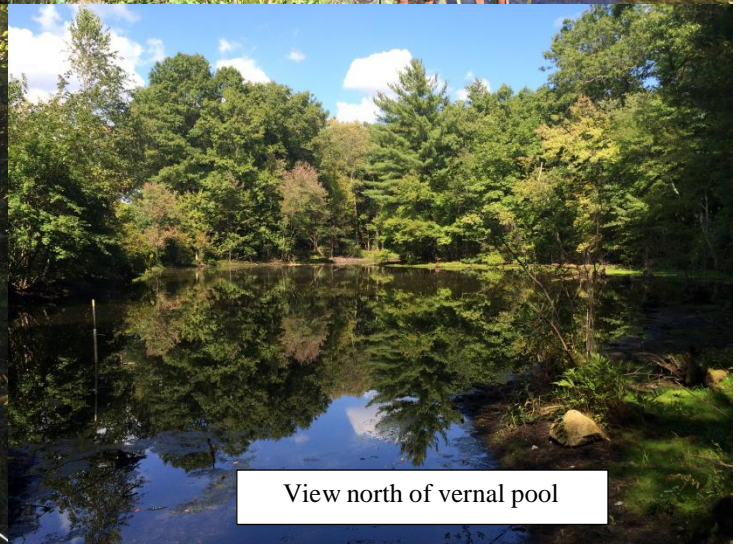
View north of vernal pool
