Figure 3 shows area of roof repair on Operating House #1, looking north.

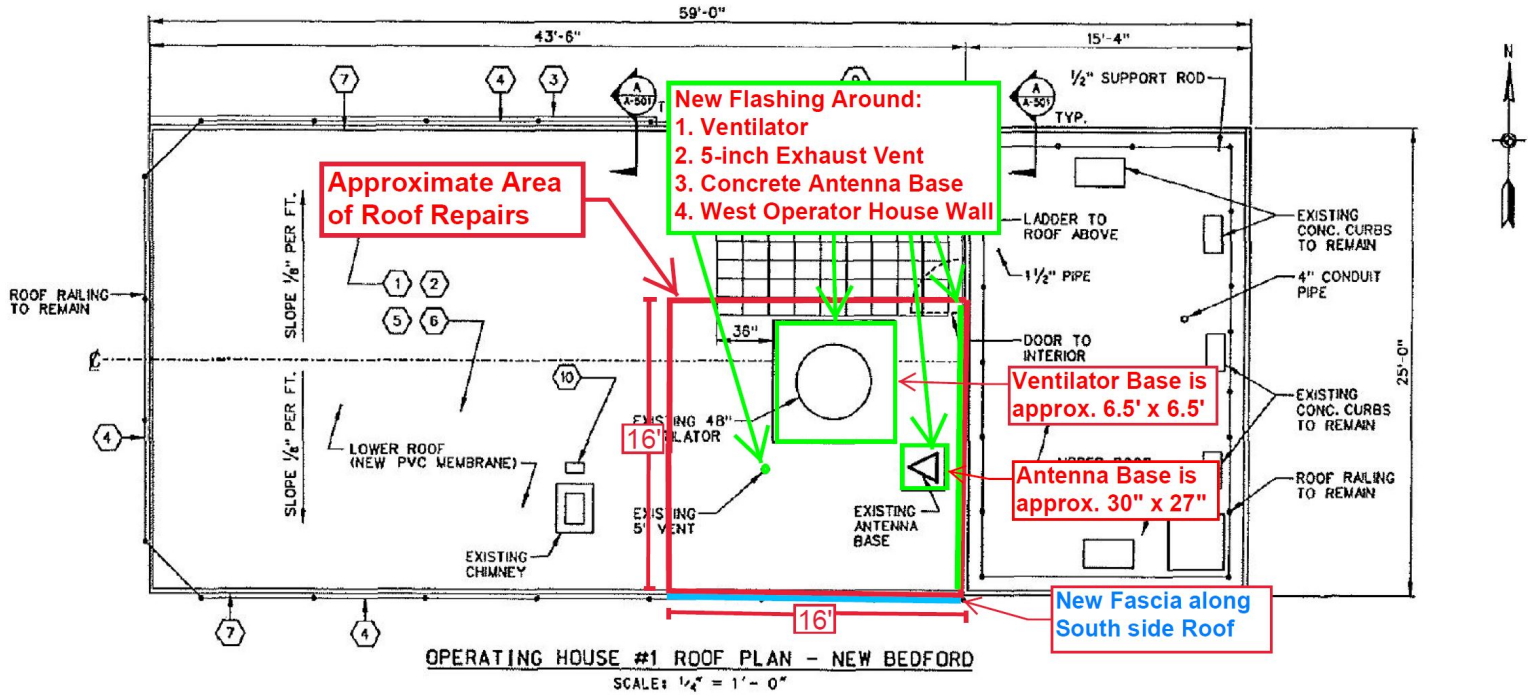
FIGURE 4

Figure 4 shows plan view of roof repair area.

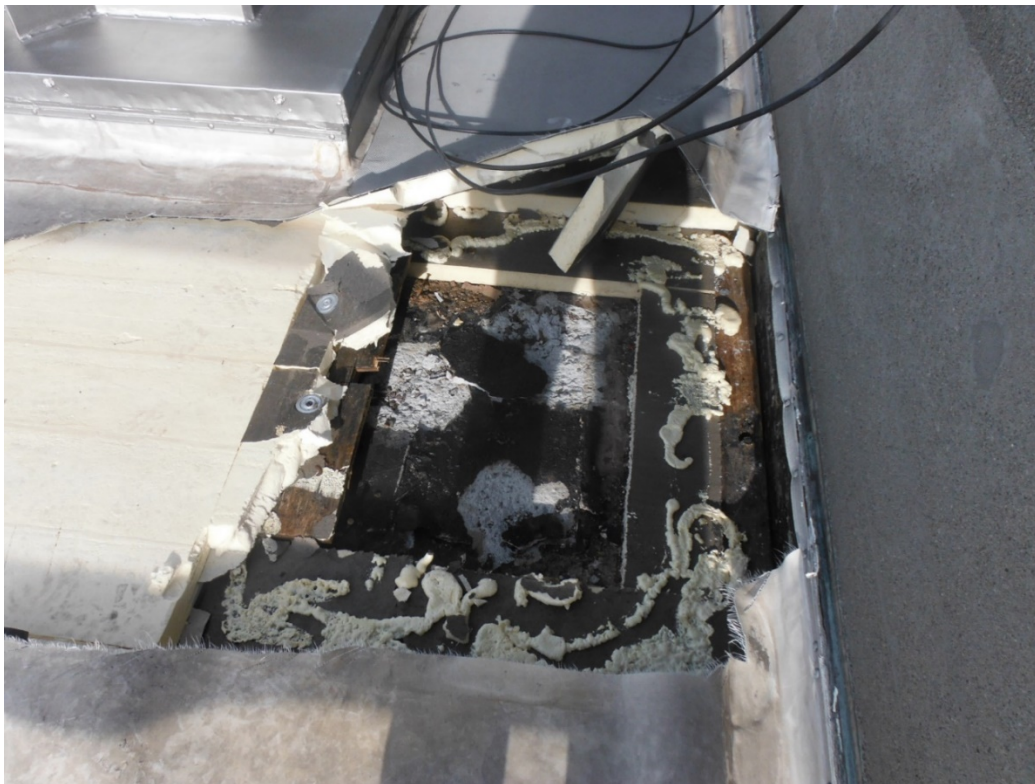
Photo 1: Shows damaged roof and insulation after a winter storm caused an antennae to fall.

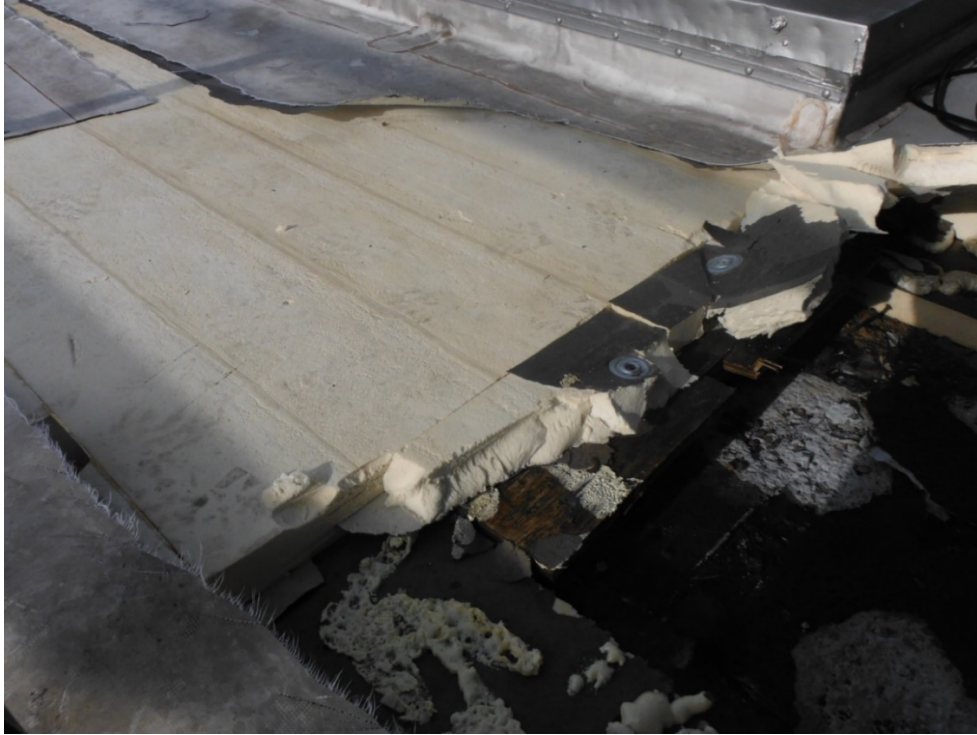
Photo 2: Shows damaged roof and insulation after a winter storm caused an antennae to fall.

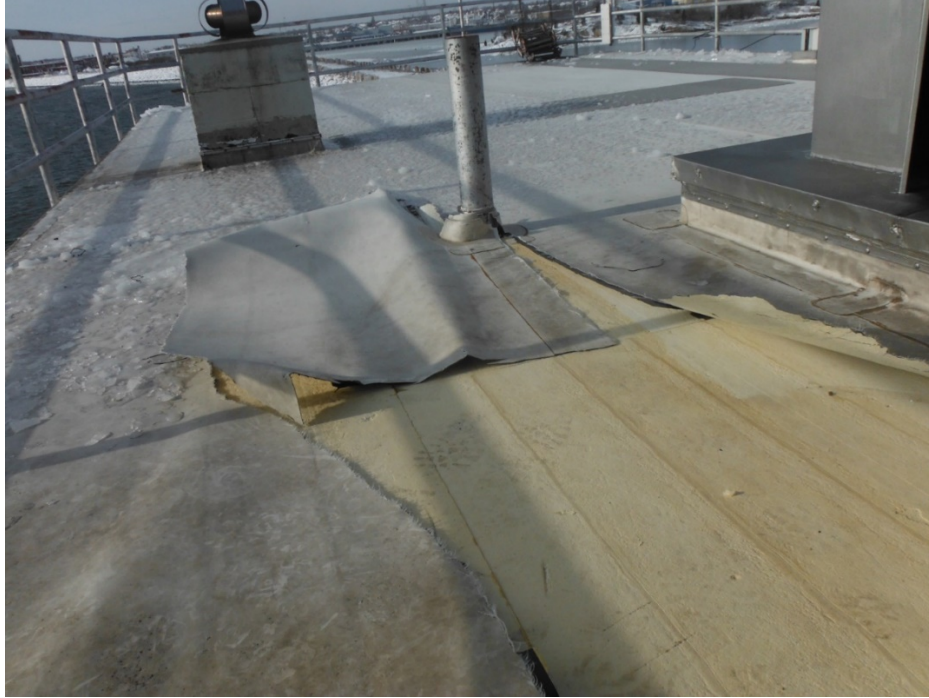
Photo 3: View of damaged PVC membrane adjacent to 5-inch exhaust vent and ventilator.

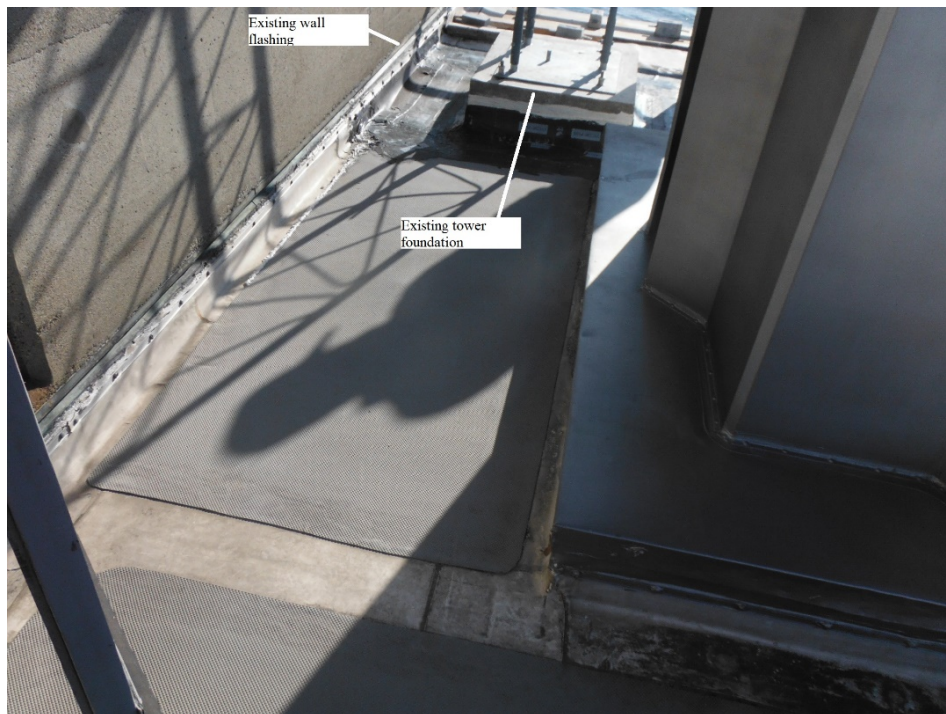
Photo 4: Shows temporary patch materials with existing PVC membrane, looking south.

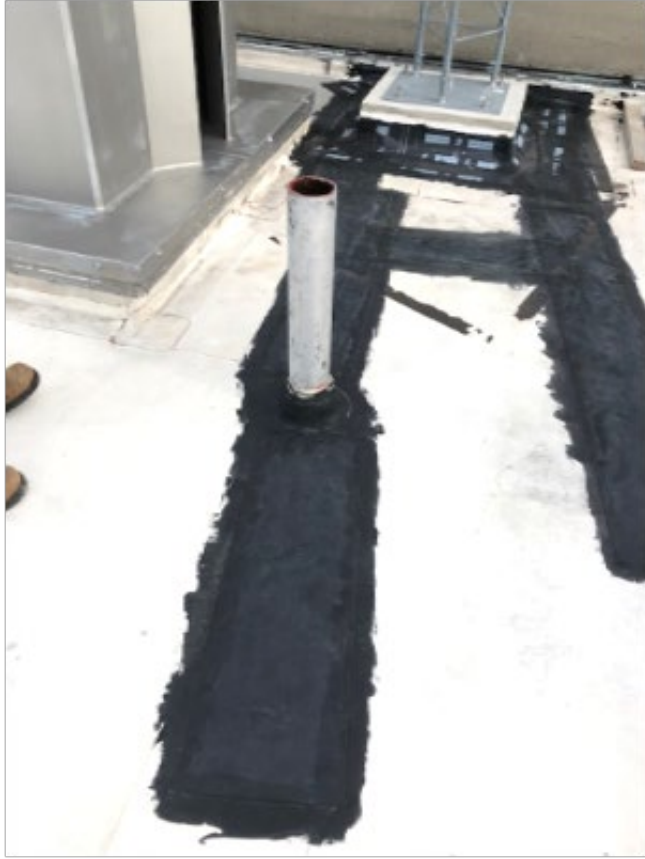
Photo 5: Shows temporary patch materials with existing PVC membrane, looking east.

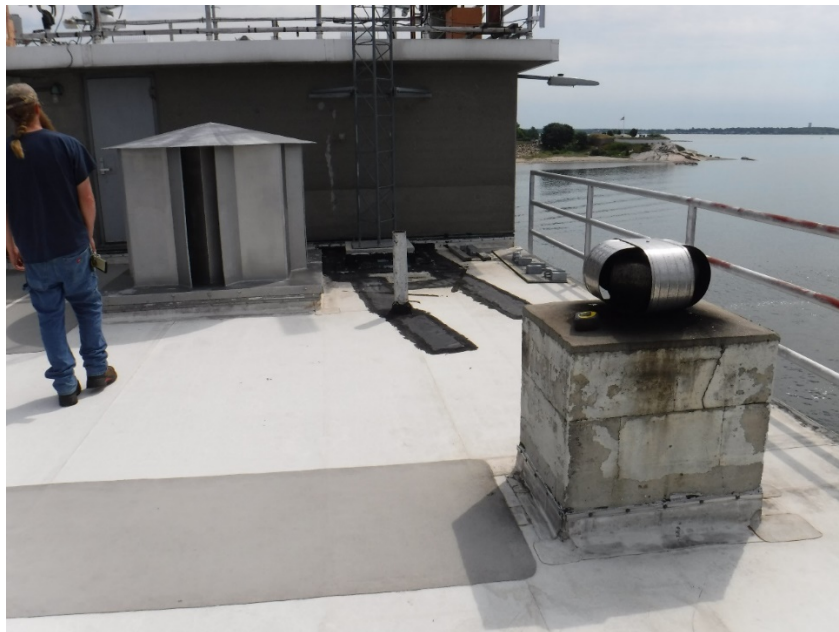
Photo 6: Shows temporary patch materials with existing PVC membrane, looking east.
