**GATE HOIST REPAIR  
U.S. ARMY CORPS OF ENGINEERS  
UNION VILLAGE DAM  
EAST THETFORD, VERMONT  
Statement of Work**

**Informational Photos**

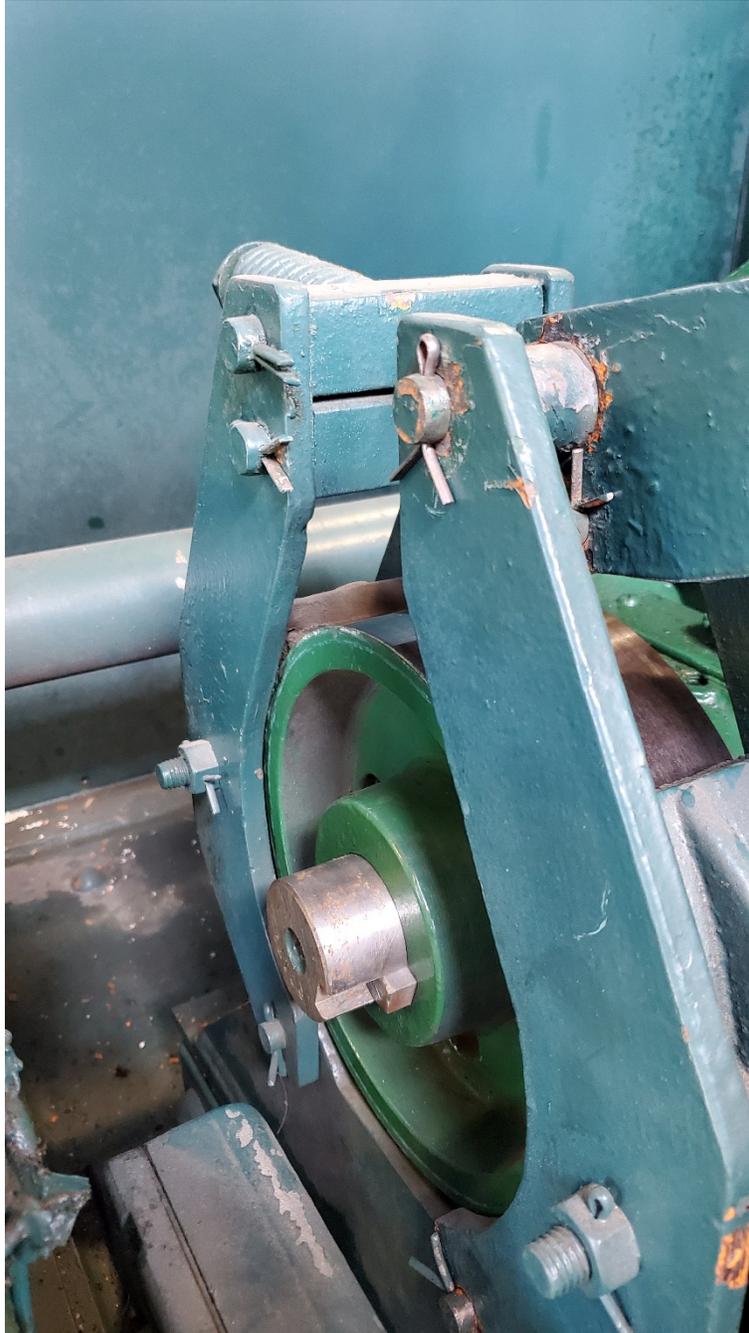
**Photo 8:** Side view of brake and rotor on gate hoist 1. Showing glazing on face of rotor and wear on the size of the rotor due to movement in the armature shaft
