U.S. Army Corps of Engineers
CONCORD, MASSACHUSETTS
www.nae.usace.army.mil

FRENCHBORO HARBOR
FRENCHBORO LONG ISLAND, MAINE
CONDITION SURVEY
6-FOOT CHANNEL
AND 10-FOOT ANCHORAGES

SHEET IDENTIFICATION
V-101
SHEET 1 OF 1

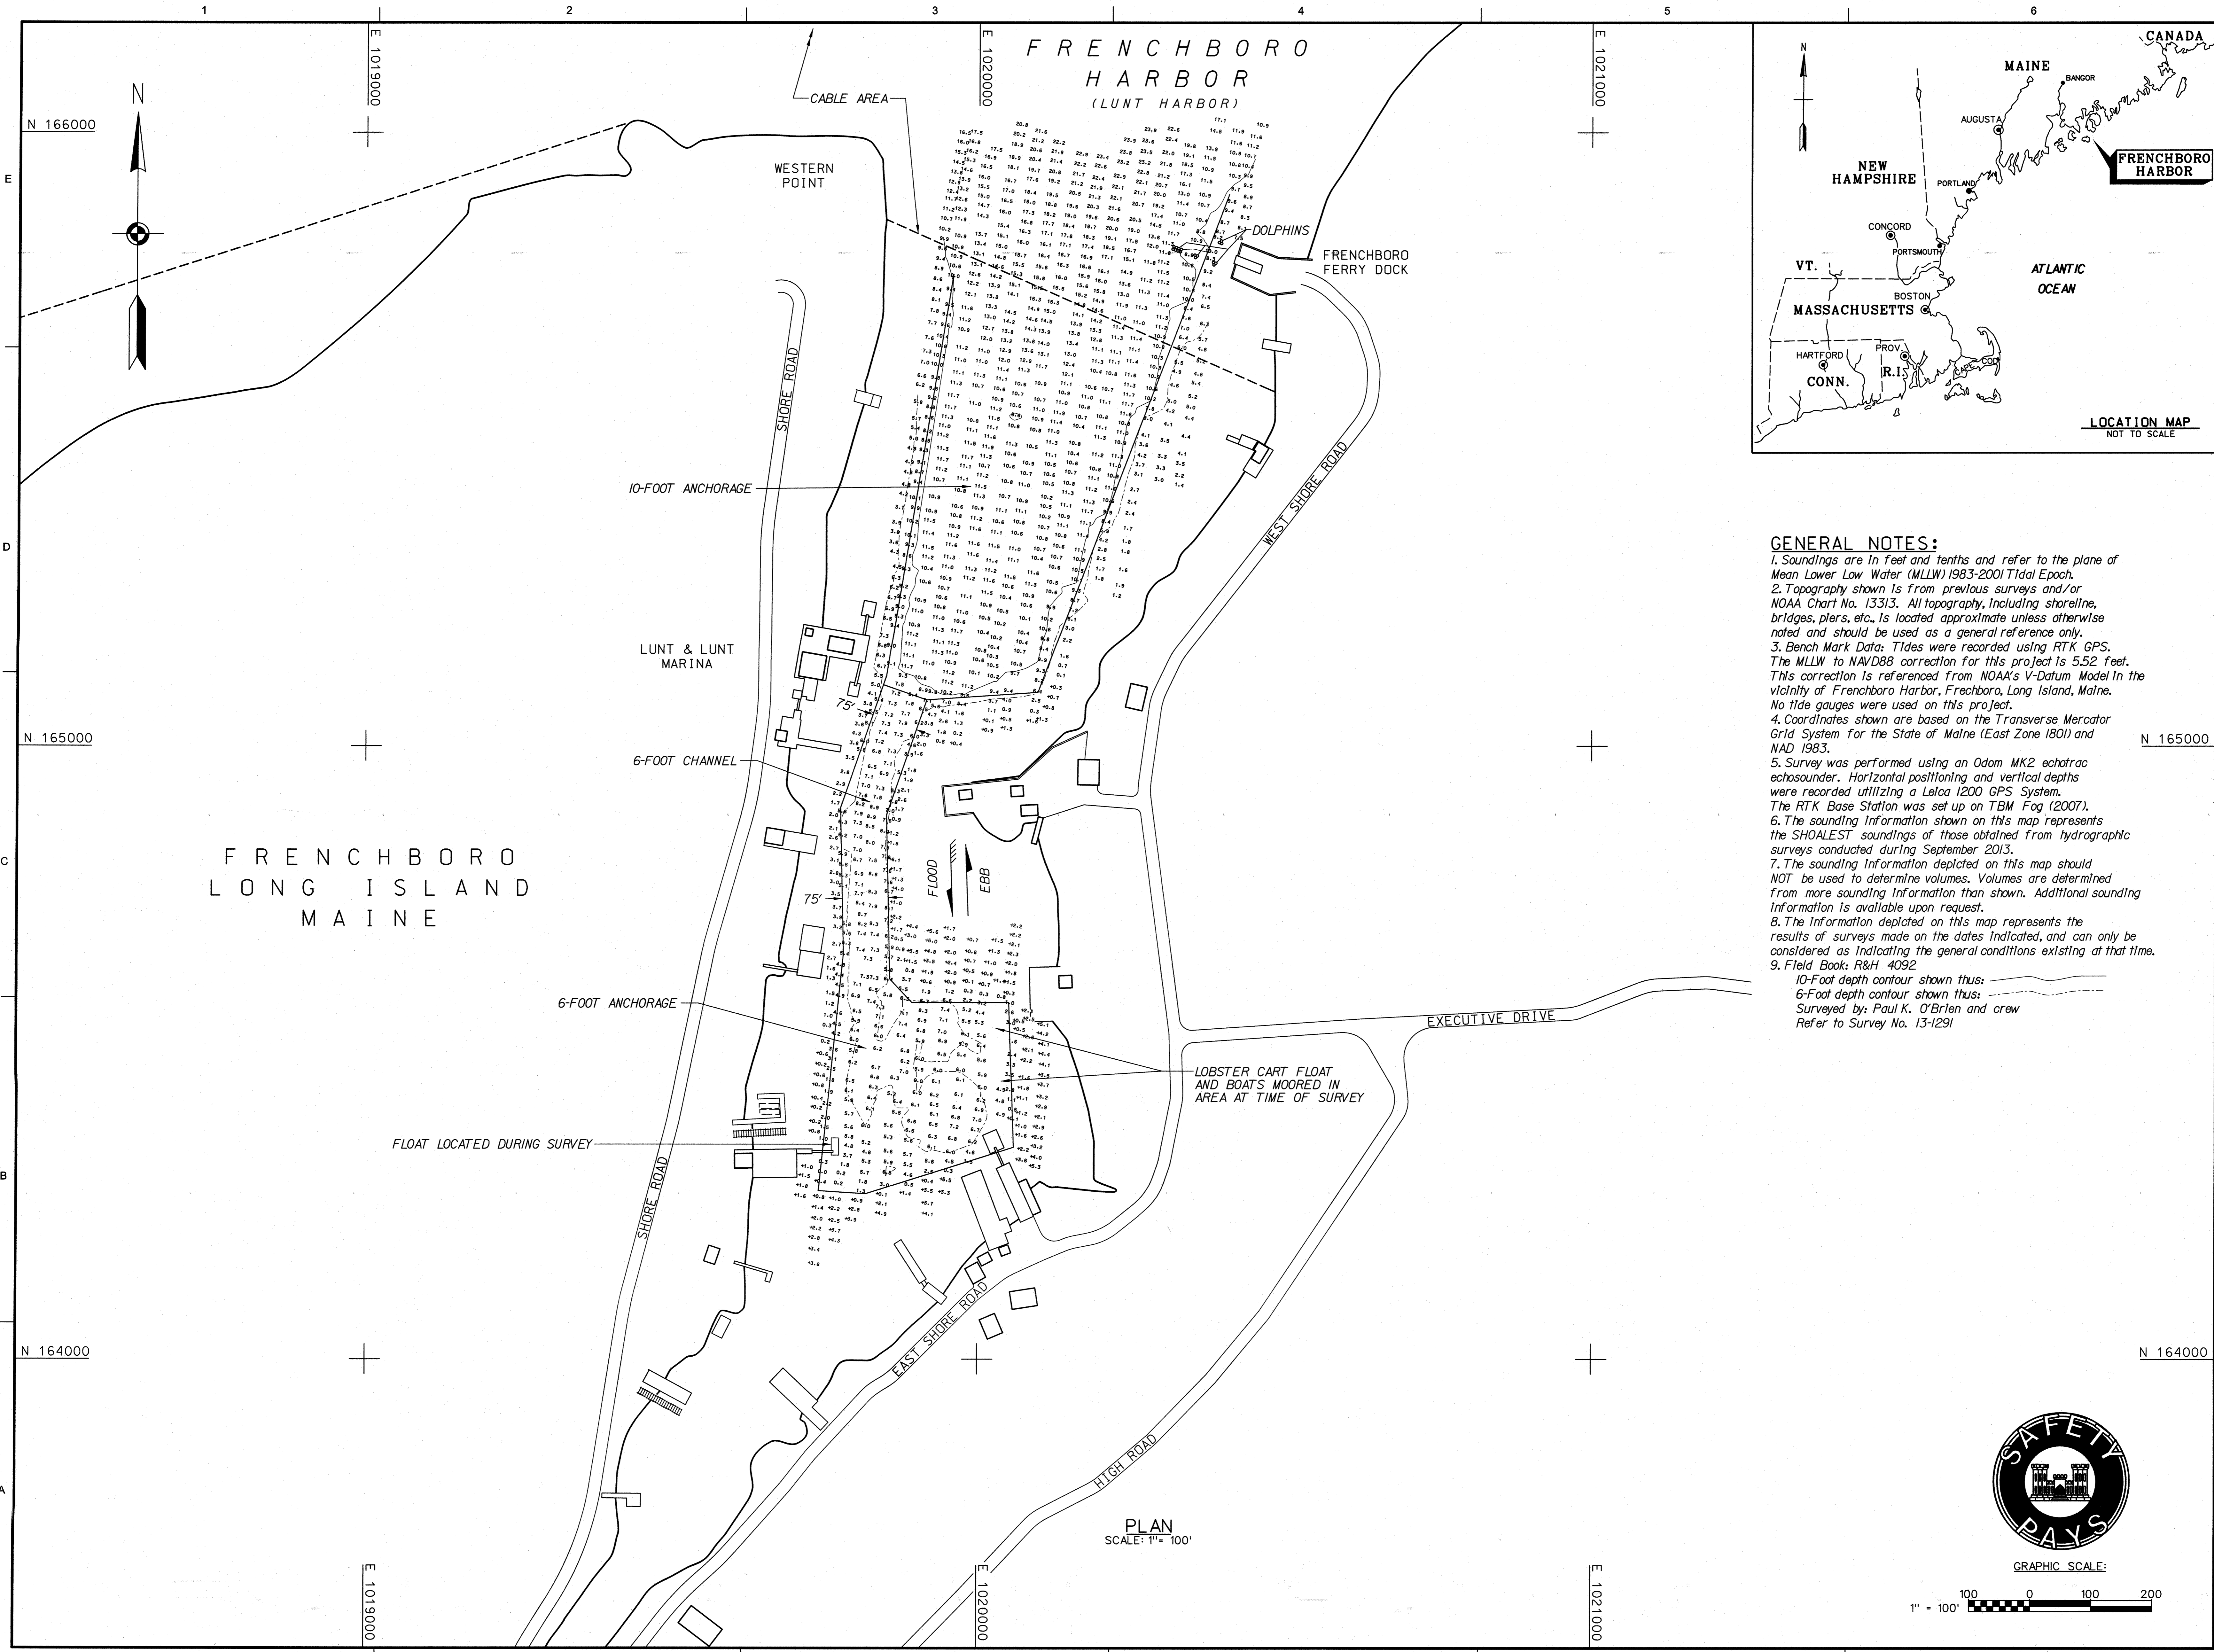
6. The sounding information shown on this map represents the SHOALEST soundings of those obtained from hydrographic surveys conducted during September 2013.
