**CAPE COD CANAL HIGHWAY BRIDGES
BOURNE AND SANDWICH, MASSACHUSETTS
MAJOR REHABILITATION EVALUATION REPORT**

**APPENDIX A
ENGINEERING RELIABILITY ANALYSIS**

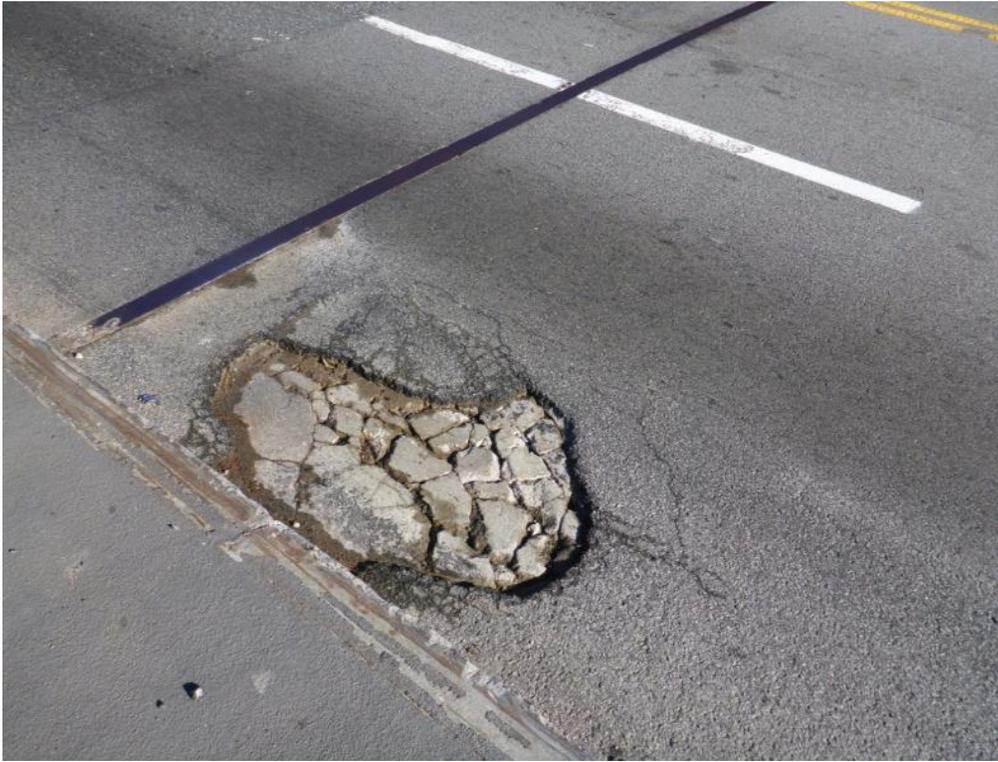
- ◆ ***Deteriorated area of deck over the abutments*** - There is a 2'-6" wide by 4'-4" long area of the top of deck in the right southbound lane adjacent to the northern deck joint of the north abutment with full depth spalling of the wearing surface which exposes a similar sized area of sound alligator cracked deck (see Photo 1). The underside of the deck and T-beam below this area exhibit heavy efflorescence and active water leaking during rain. There are four locations in the southbound lane over the south abutment which exhibit the beginning signs of similar conditions.

Photo 1 – Bourne Bridge, deteriorated deck of north abutment.

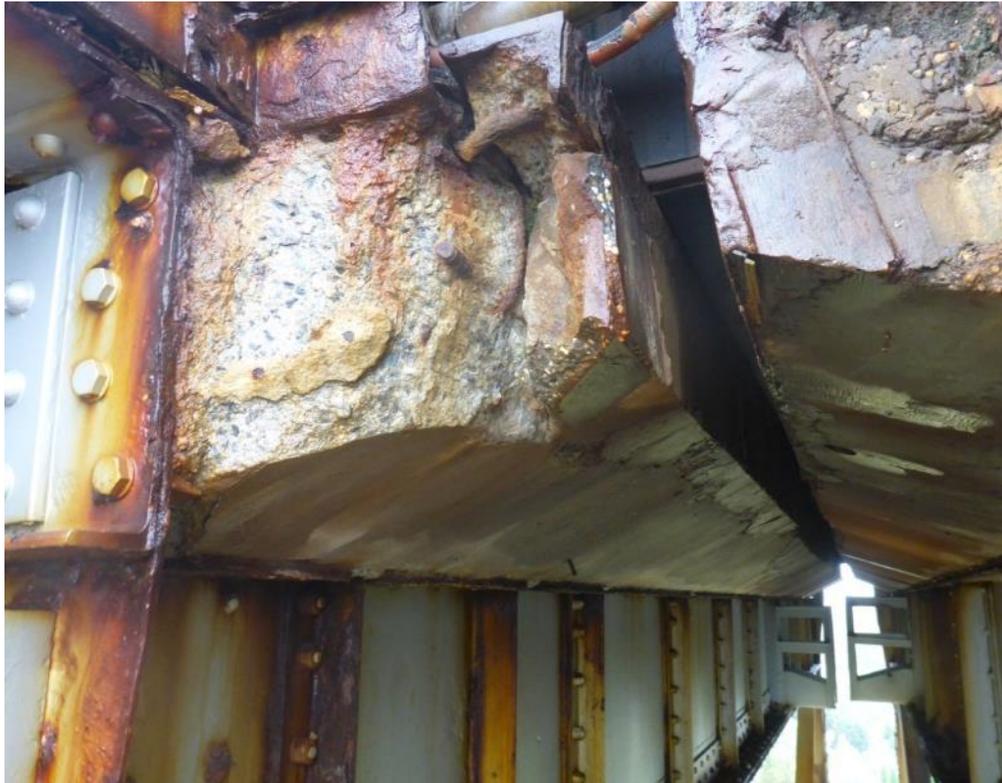
- ◆ ***Deteriorated deck joints*** – The pier 5 deck joint compression seal is dislodged throughout the width of the northbound lanes. The western 6'-0" of the Transflex deck joint at pier 3 (see Photo 2) is loose with up to 1 1/4" gaps at the anchor nuts and up to 1/2" of deflection and bouncing under live load. The modular deck joint at pier 4 exhibits misalignment between the south edge beam and the adjacent center beam in the right southbound lane with the seal between these two beams partially dislodged for a length of 6'-0". Lastly, the pier 6 deck joint compression seal is dislodged and missing across the full width of the roadway (see Photo 3).

Photo 2 – Bourne Bridge, underside of Pier 3 deck joint.

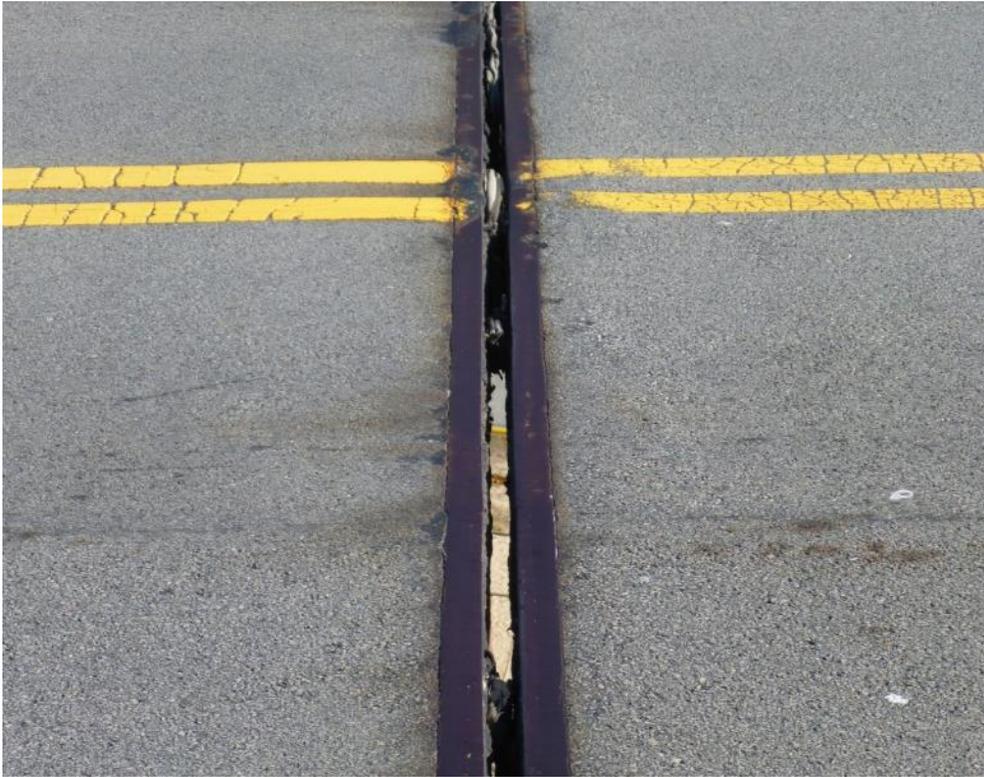
Photo 3 – Bourne Bridge, dislodged and missing compression seal @ Pier 6 deck joint.

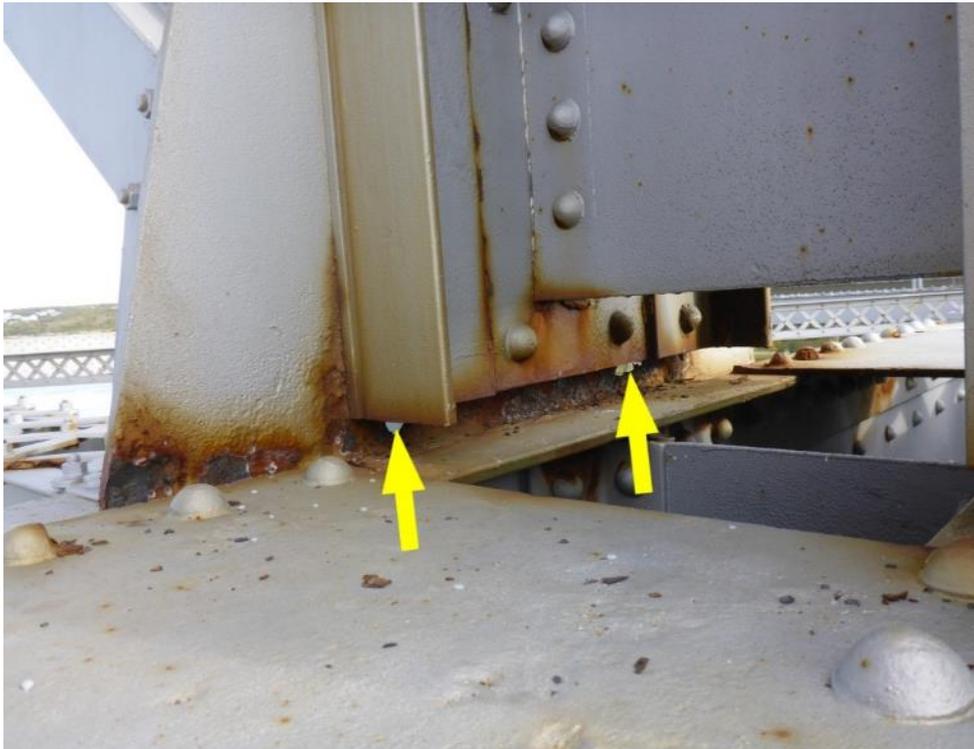
Photo 4 – Bourne Bridge, Span 2, west truss, east gusset plate at L7' with holes along the top of the lower chord member.

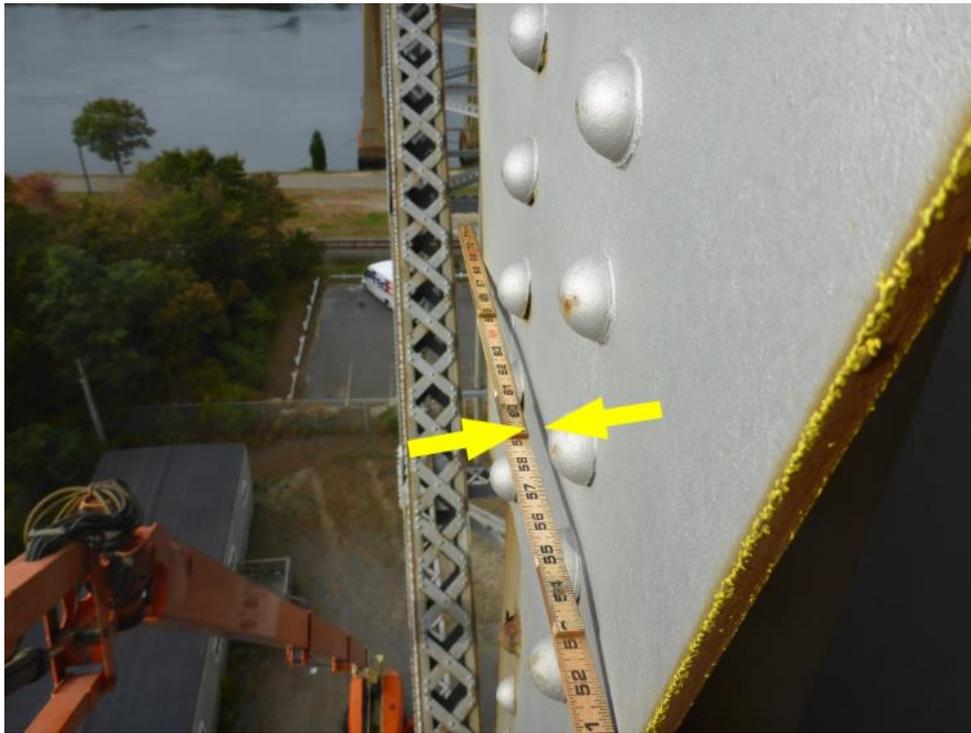
- Span 3: The exterior gusset plates at truss joints U0 and U2 exhibit pack rust with section loss along the edges of the truss vertical member with deformation of the gusset plate (see Photo 5). The exterior gusset plate at truss joint U1 exhibits heavy section loss along the top edge of the vertical member. The exterior gusset plate at truss joint U6 exhibits heavy section loss along the interface with the sidewalk channel.
- Span 5: The gusset plates at truss joint L7 exhibit heavy section loss along the top of the lower chord member and surrounding the vertical member.
- Span 4: The gusset plates at truss joint L5 exhibit heavy section loss along the full height of both gusset plates along both edges of the truss vertical member.
- Span 6: The gusset plates at truss joint L7 exhibit heavy section loss along the top of the lower chord member.

Photo 5 – Bourne Bridge, Span 3, west truss, west gusset plate at U0 with thick pack rust along both edges deforming the gusset plate.

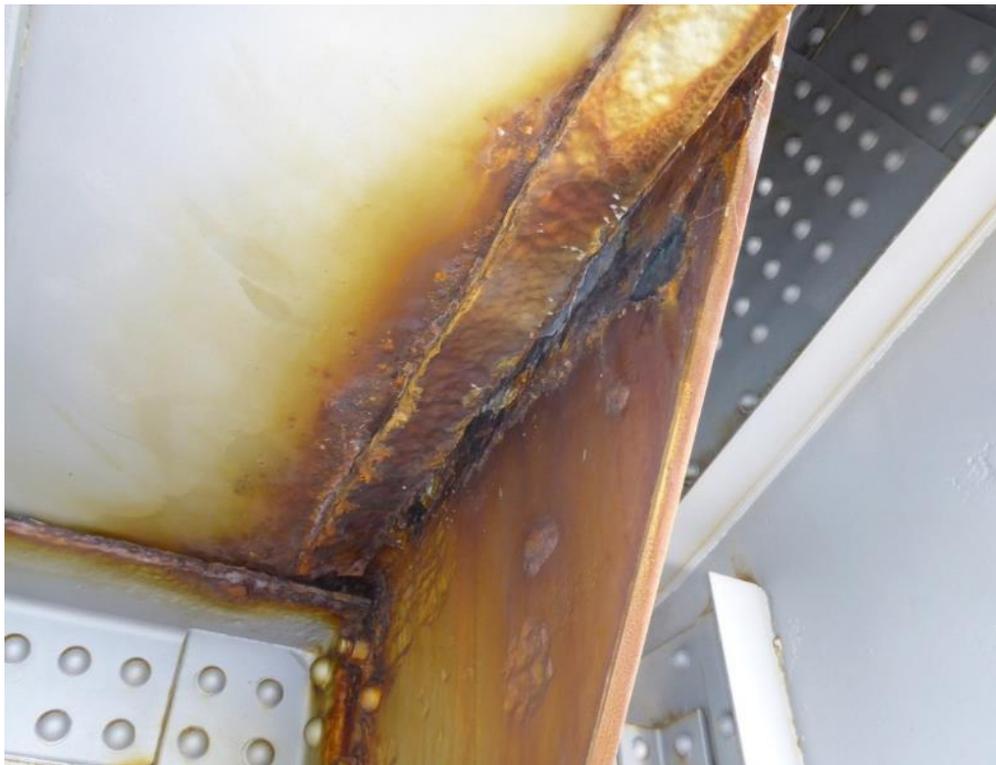
- Span 3: The exterior gusset plate at truss joint U0 exhibits pack rust with section loss along the edges of the truss vertical member with deformation of the gusset plate. The exterior gusset plate at truss joint U6 exhibits heavy section loss along the interface with the sidewalk channel (see Photo 6).

Photo 6 – Bourne Bridge, Span 2, east truss, west gusset plate at U6': section loss with active corrosion along the interface with the sidewalk curb channel.

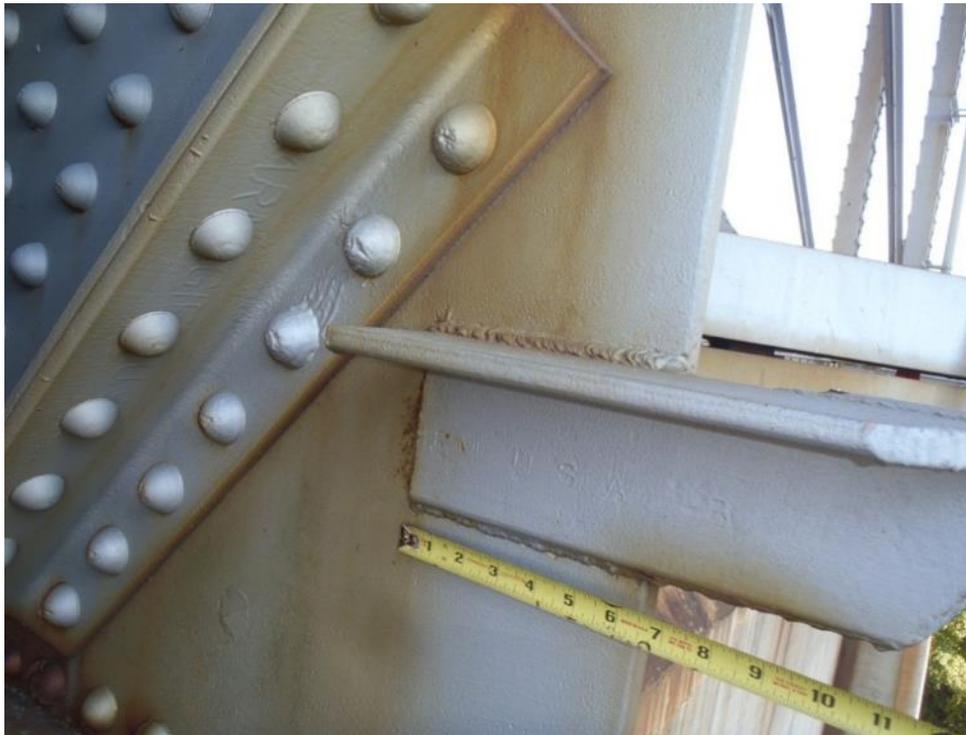
Photo 7 – Bourne Bridge, Span 4, west truss joint L8: Angle welded to the interior face of the east gusset plate (considered a FSD).

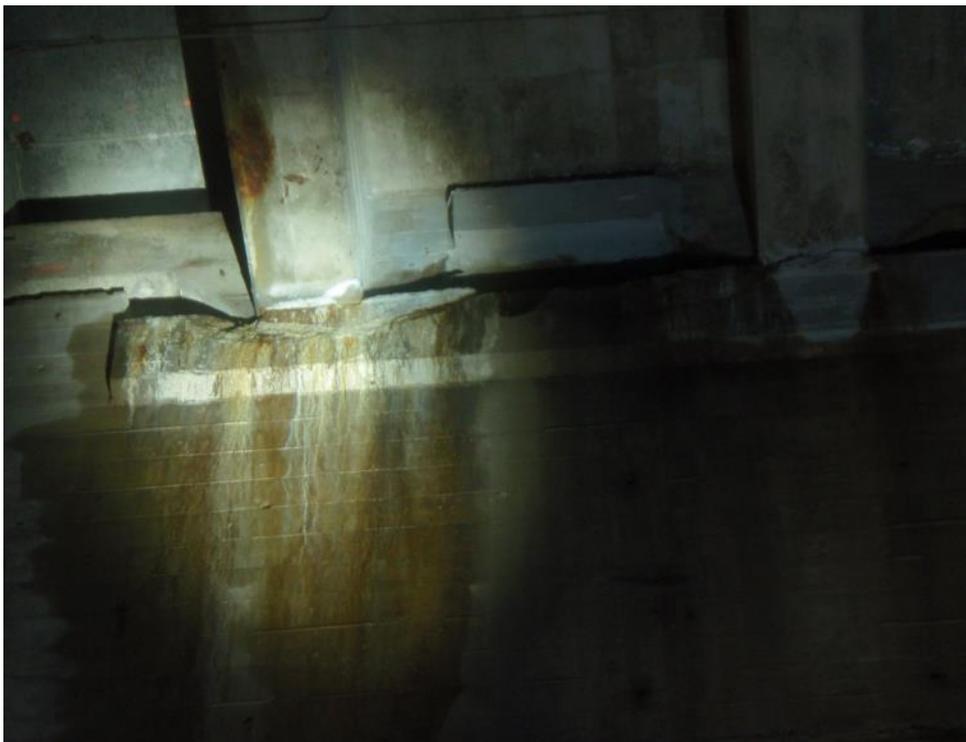
Photo 8 – Bourne Bridge, Beam BM1, chamber 2 of the south abutment: The bearing area is undermined resulting in a 33% reduction in bearing area.

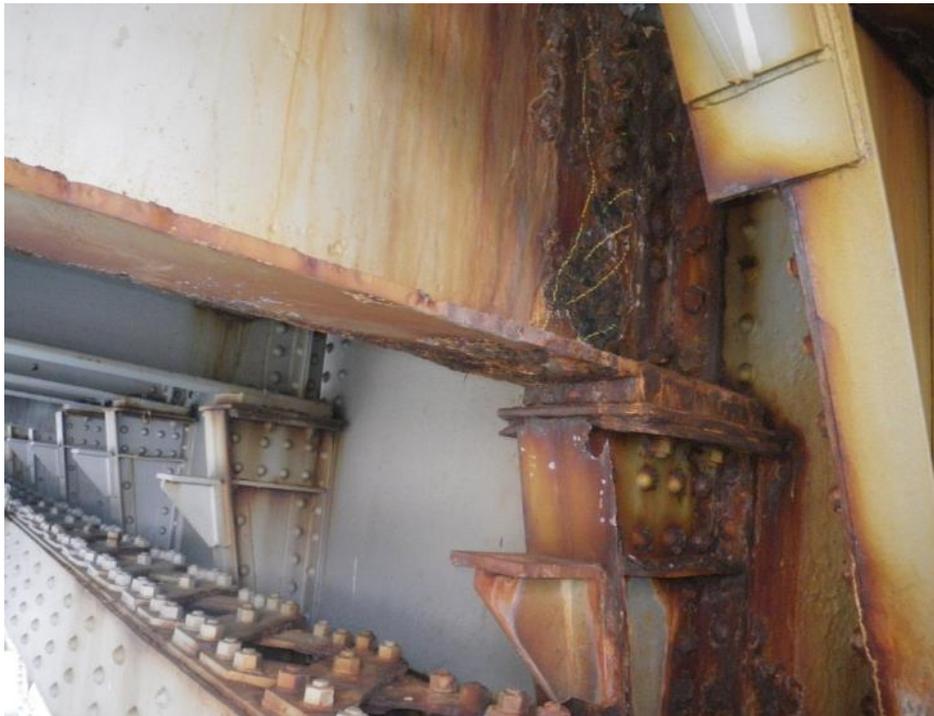
Photo 9 – Bourne Bridge, Span 1, north side of floorbeam FB10: Active corrosion with 1/16" loss by full height of the web.

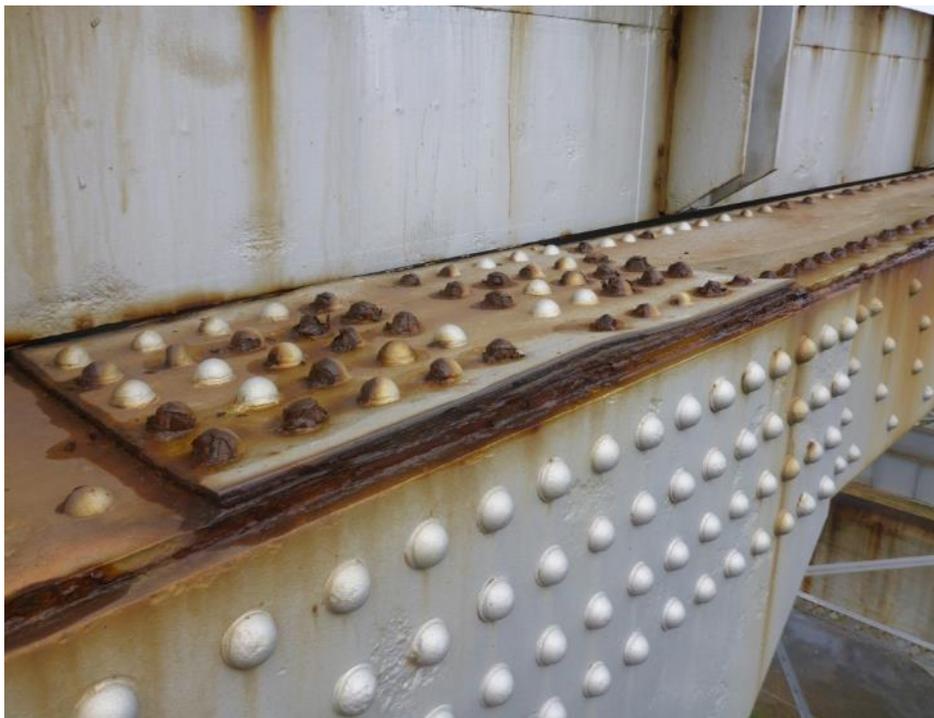
Photo 10 – Bourne Bridge, Span 5, east truss upper chord member U5U6 has up to 1" thick pack rust at the top splice plate with active corrosion on the rivet heads.

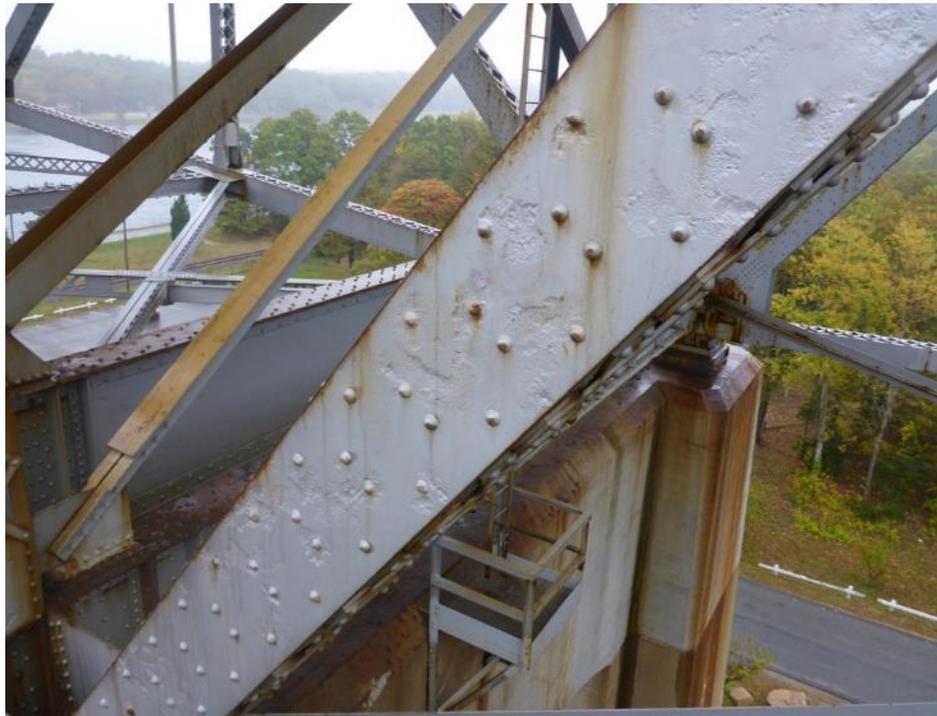
Photo 11 – Bourne Bridge, Span 5, west truss diagonal L8U7: Widespread 1/16" deep pitting.

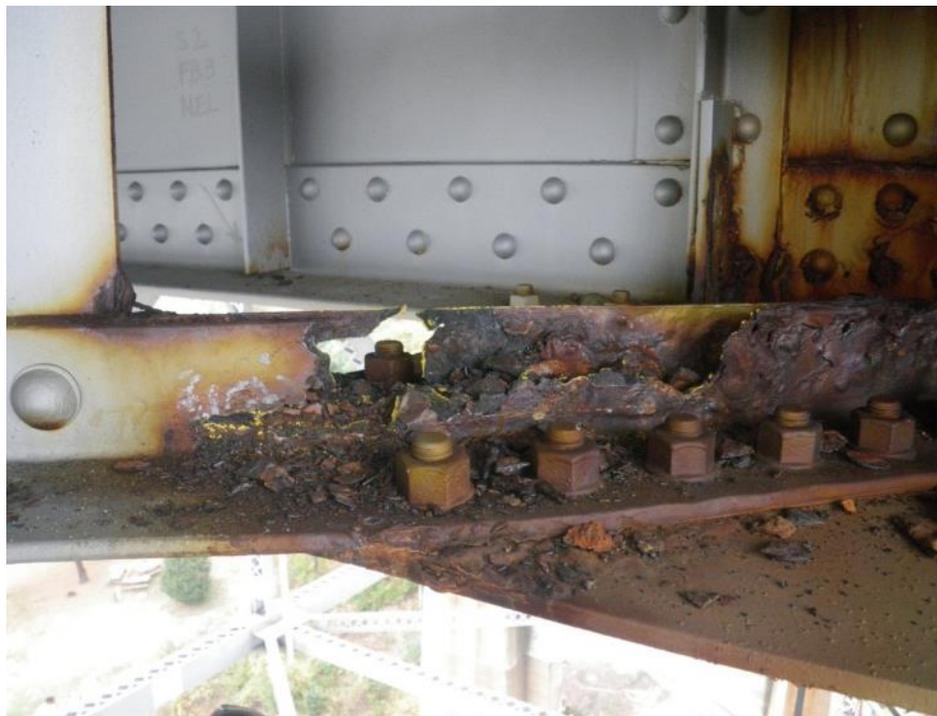
Photo 12 – Bourne Bridge, Span 2, upper lateral bracing at the connection to the east truss at U3': 100% loss by full height of both vertical legs of the bottom flange angles.

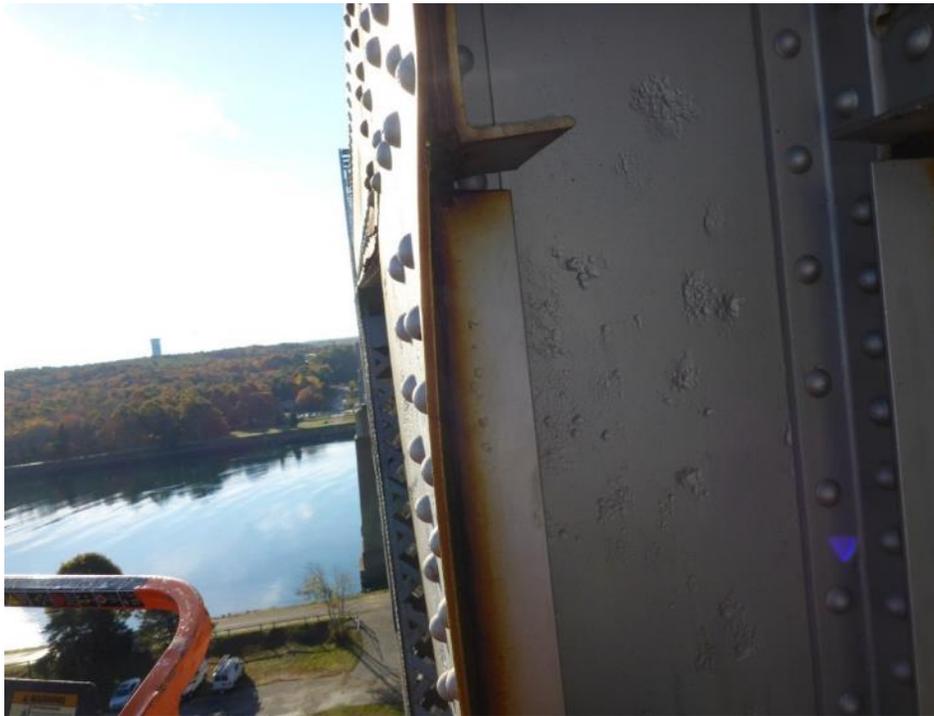
Photo 13 – Bourne Bridge, Span 2, east truss, east gusset plate at U0': 1/2" thick pack rust along both edges of the truss vertical member with deforming of the gusset plate.

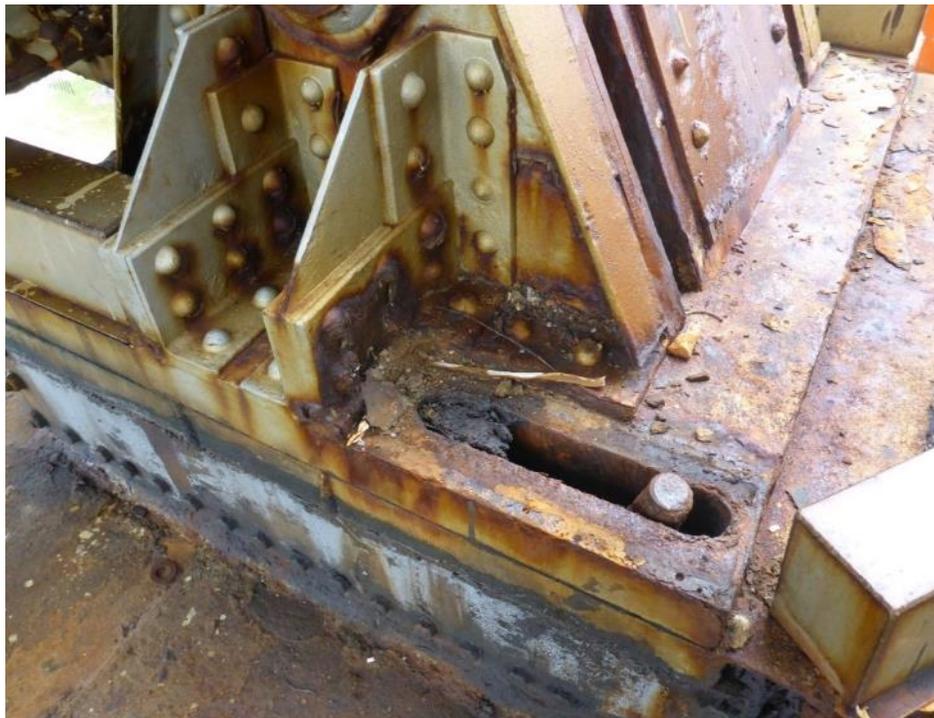
Photo 14 – Bourne Bridge, Span 3, east bearing at pier 3 has a detached covering and a broken anchor bolt.

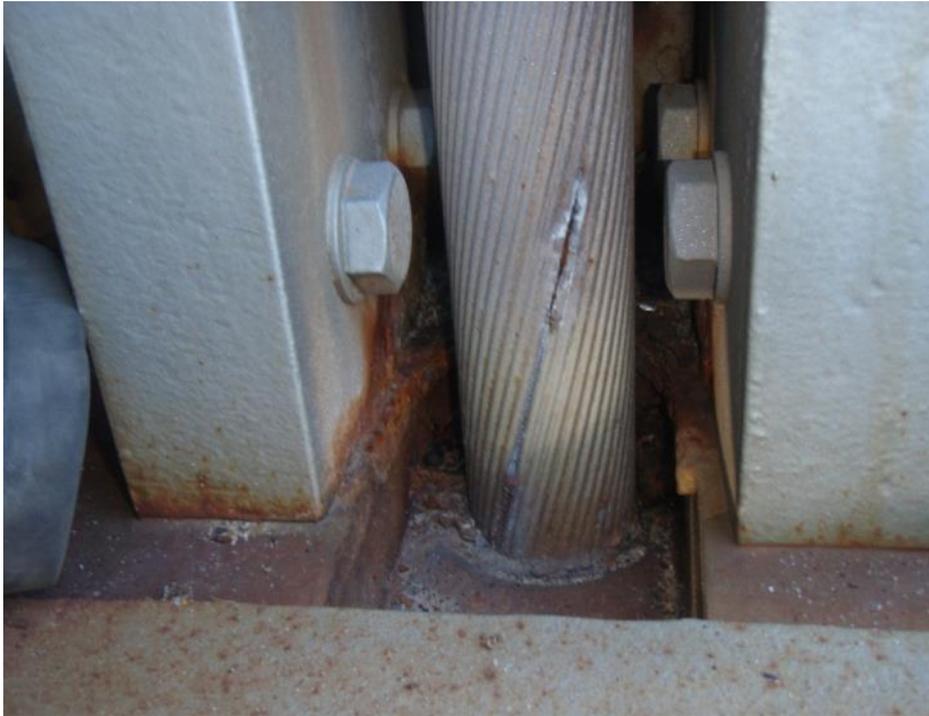
Photo 15 – Bourne Bridge, south suspender at east truss joint 14': A 1/16" wide gap by 6" long between two wires, indicative of stage IV corrosion.

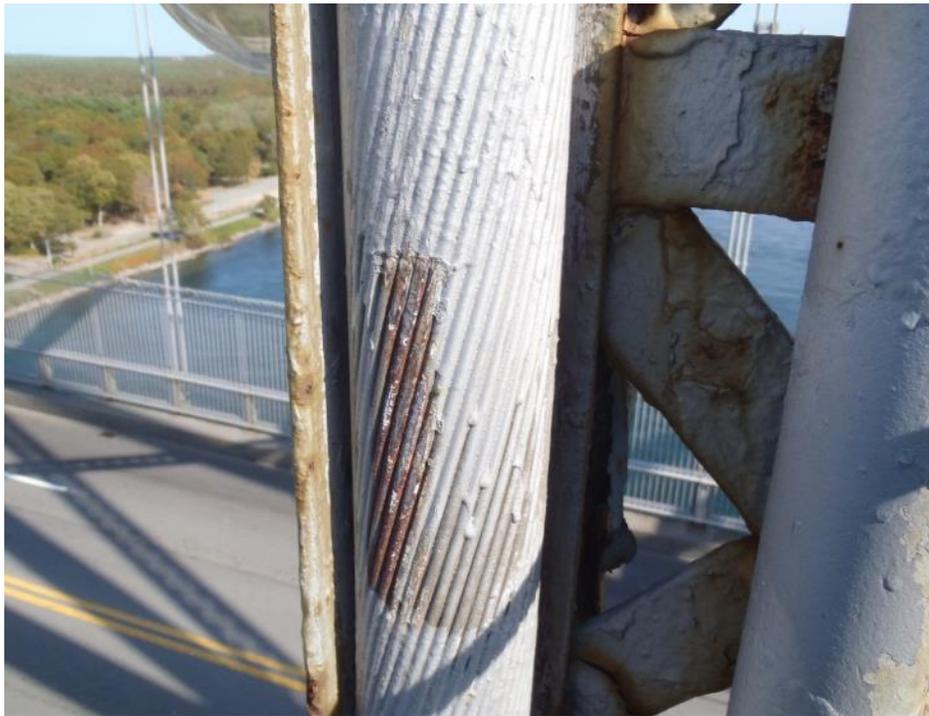
Photo 16 – Bourne Bridge, North suspender at west truss joint 13: Area of stage IV corrosion.

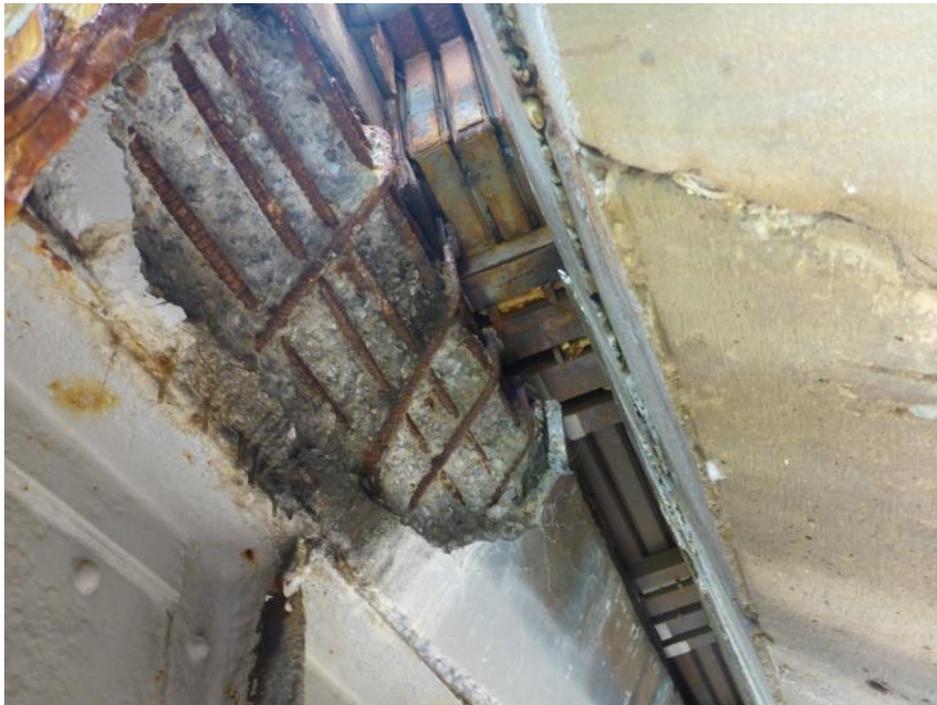
Photo 17 – Sagamore Bridge, deteriorated joint header at south abutment.
Repaired in 2018.

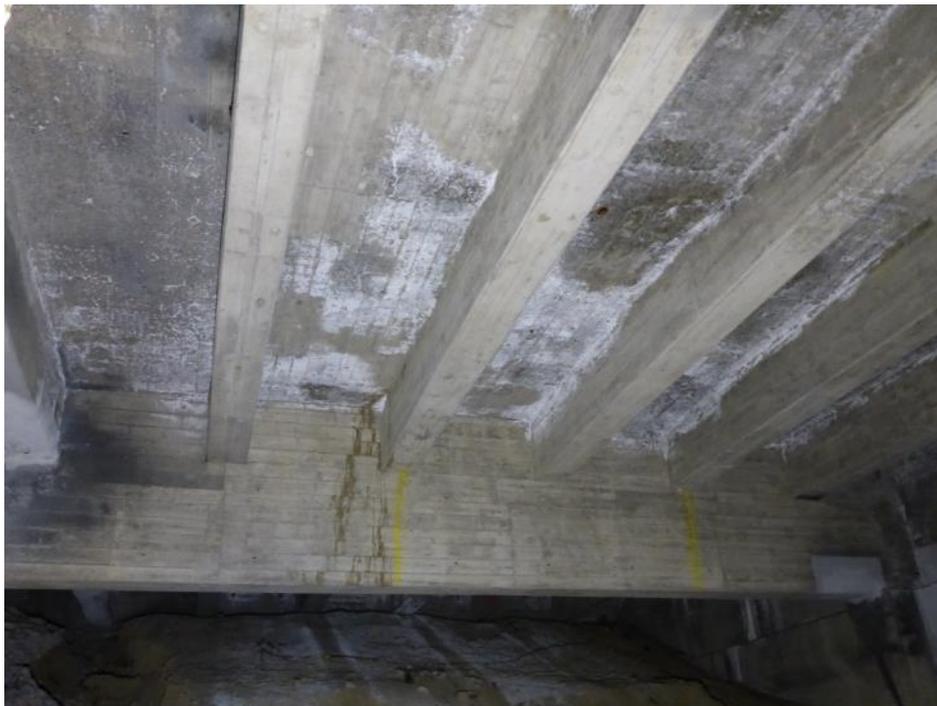
Photo 18 – Sagamore Bridge, efflorescence in the underside of the deck in chamber 1 of the south abutment.

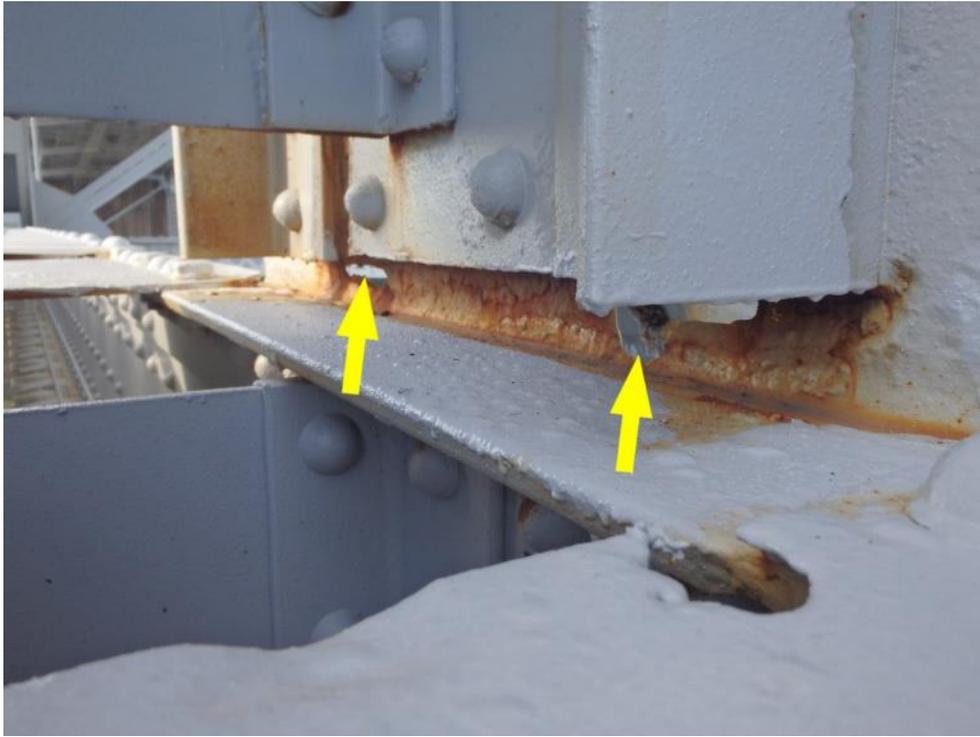
Photo 19 – Sagamore Bridge, advanced deterioration to the west gusset plate at truss joint L7 of the east truss in span 3.

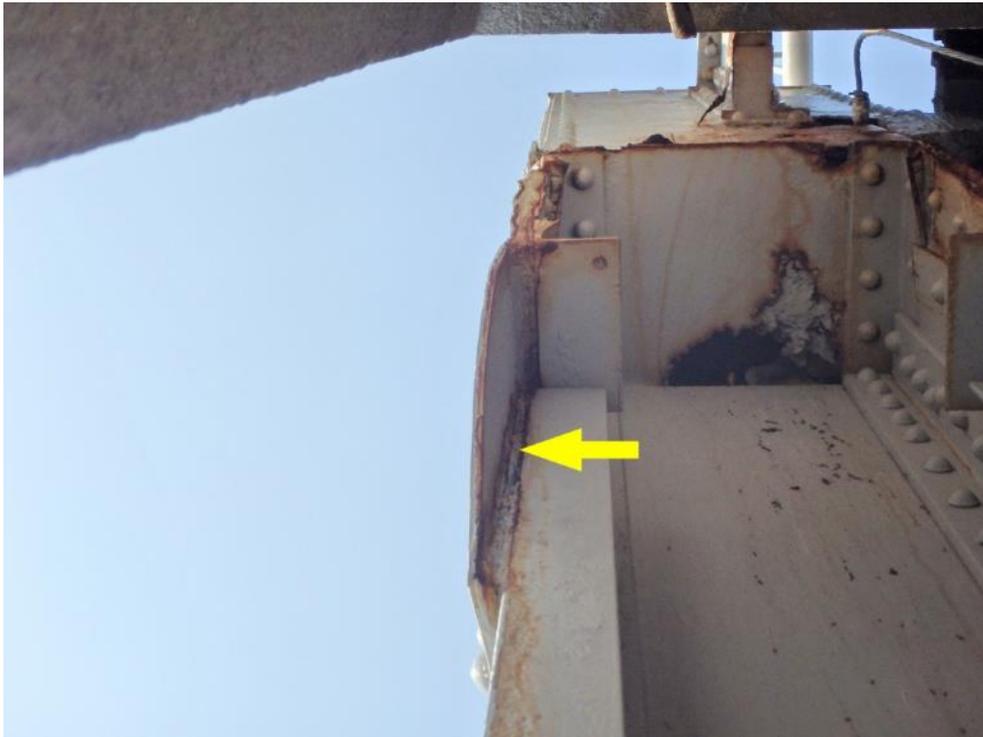
Photo 20 – Sagamore Bridge, pack rust along the north edge of truss vertical member deforming the gusset plate at truss joint U0' of the east truss.

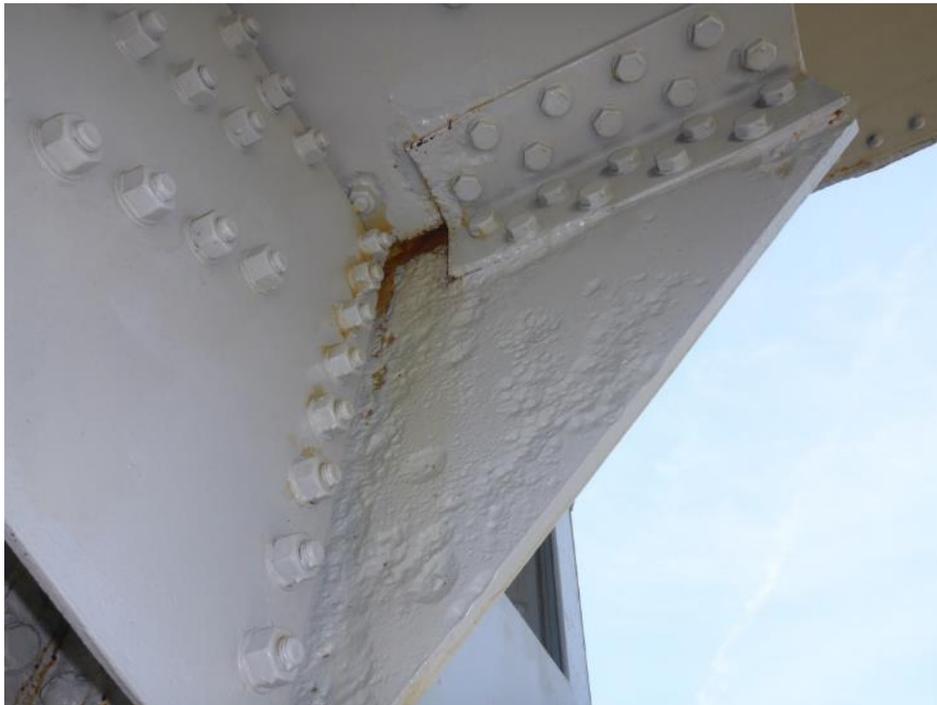
Photo 21 – Sagamore Bridge, heavy pitting on the interior face of the east gusset plate at truss joint U0 of the west truss.

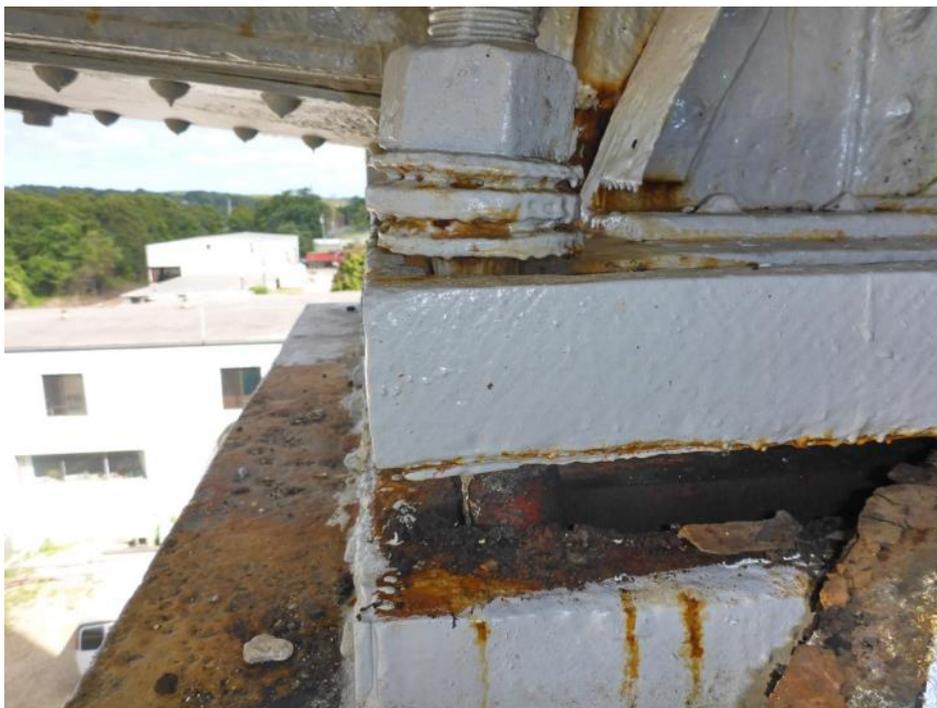
Photo 22 – Sagamore Bridge, bent anchor bolt at the south abutment out of plumb 1/4".

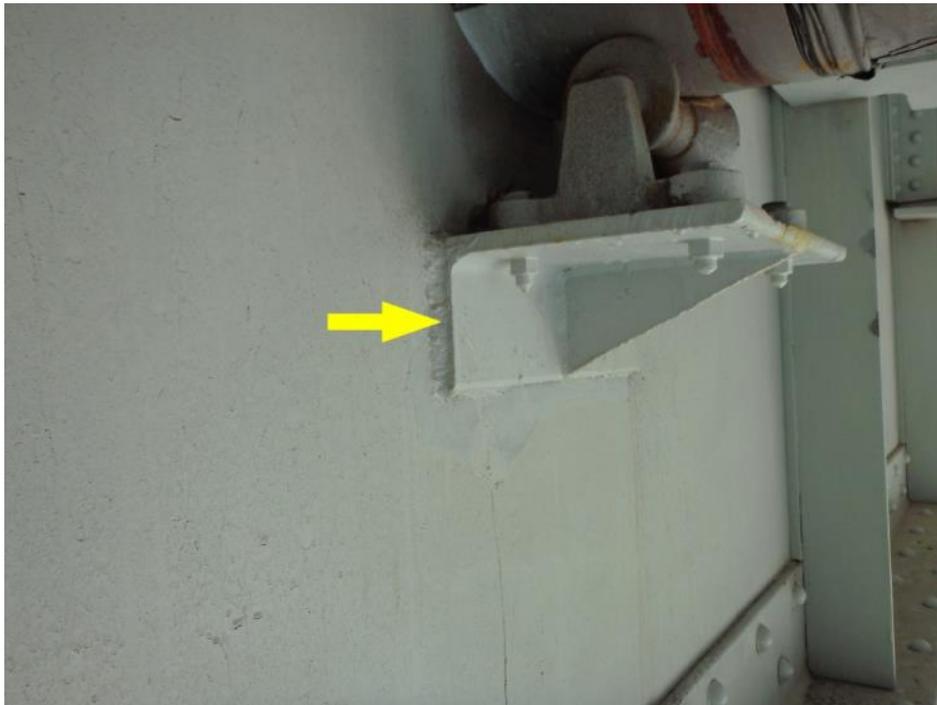
Photo 23 – Sagamore Bridge, fatigue sensitive detail utility bracket welded to the north face of the web of floorbeam FB5'.

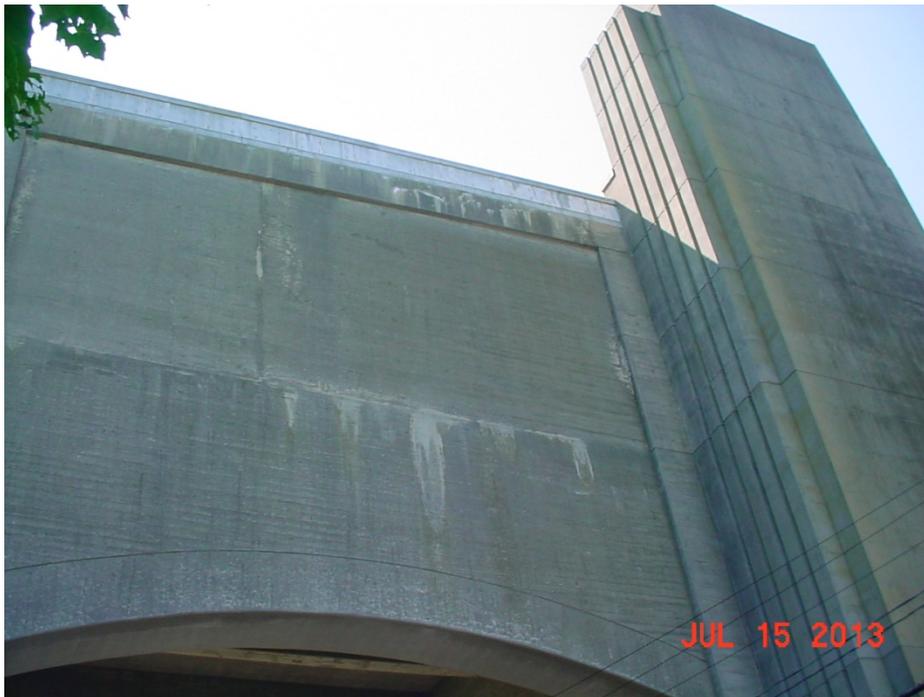
Photo 24 – Sagamore Bridge, South Abutment on East Face exhibits an area of delaminating concrete 4'x1' which may pose a future falling hazard.

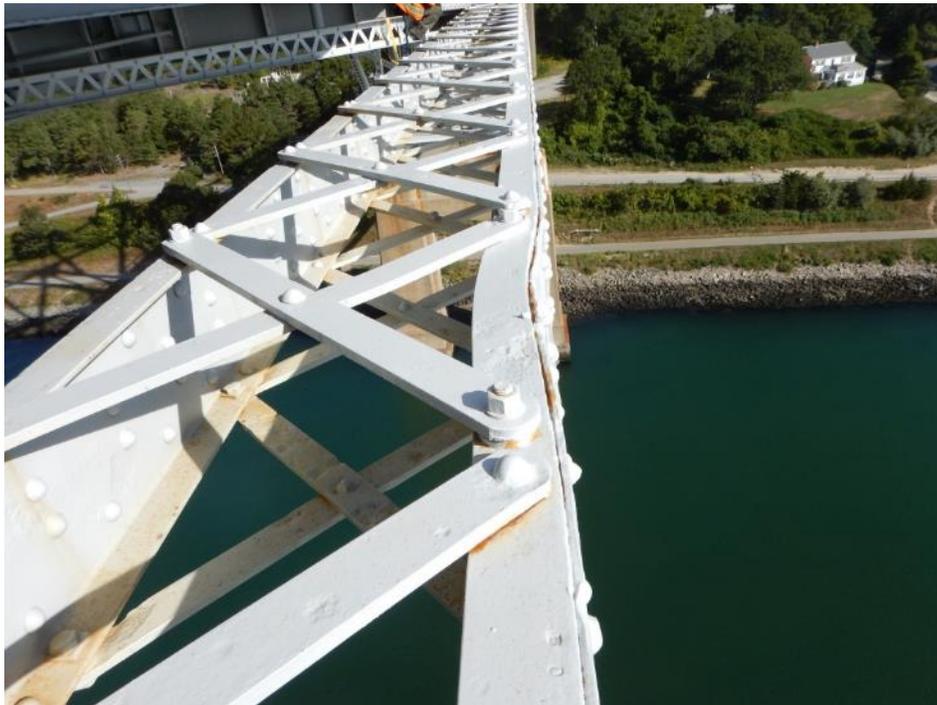
Photo 25 – Sagamore Bridge, impact damage to the east wind chord.

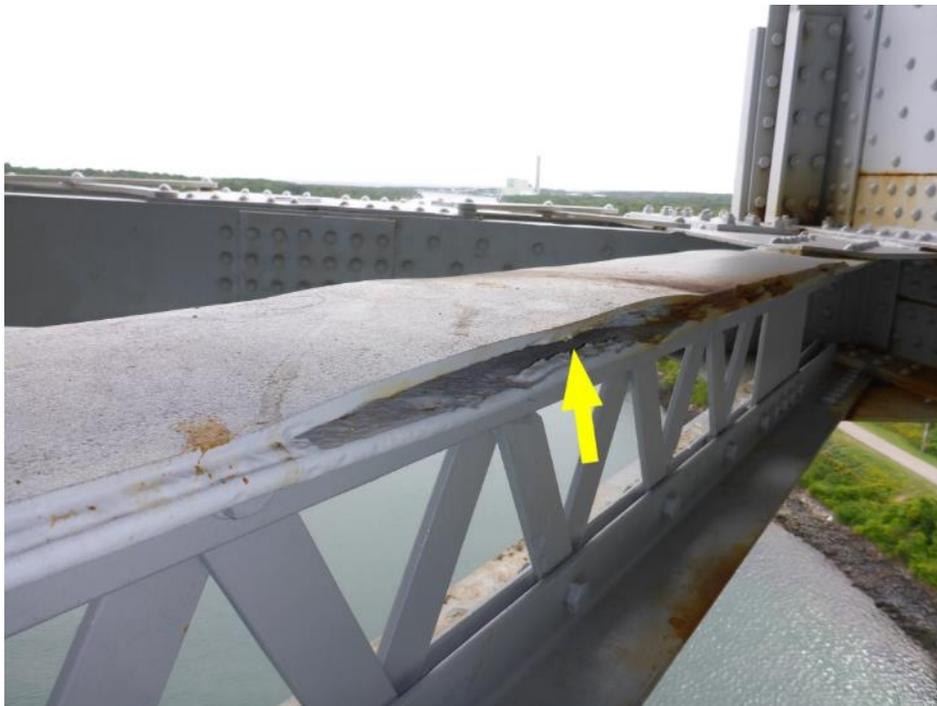
Photo 26 – Sagamore Bridge, fully cracked weld along the top flange cover plate repair.

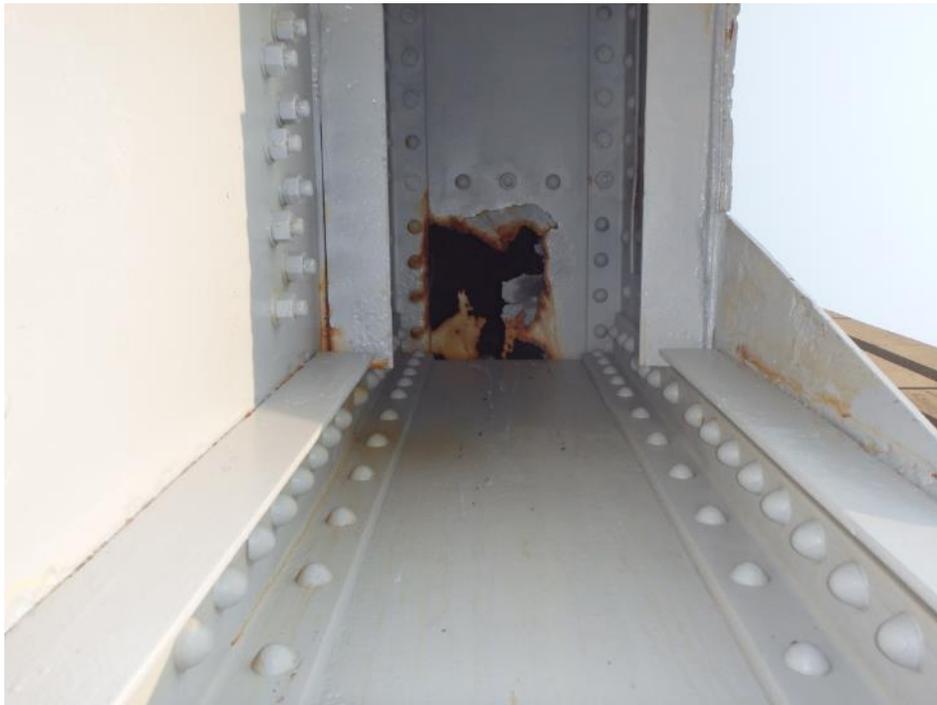
Photo 27 – Sagamore Bridge, corrosion hole in the internal longitudinal stiffener plate of east truss upper chord member U0'U1' in span 2.

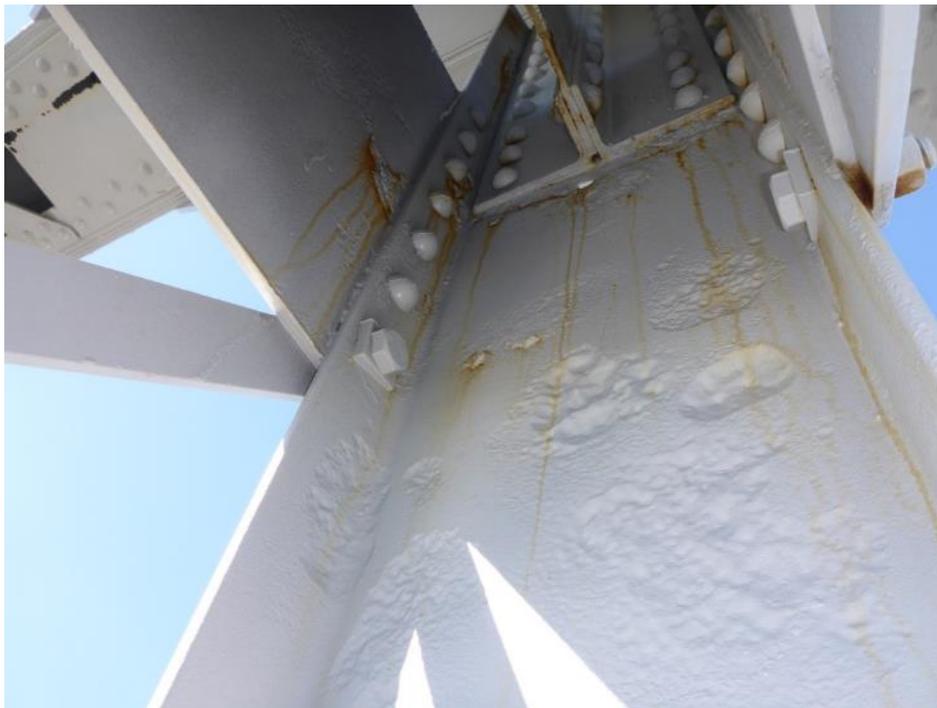
Photo 28 – Sagamore Bridge, area of pitting to the interior face of east truss vertical member in span 1.

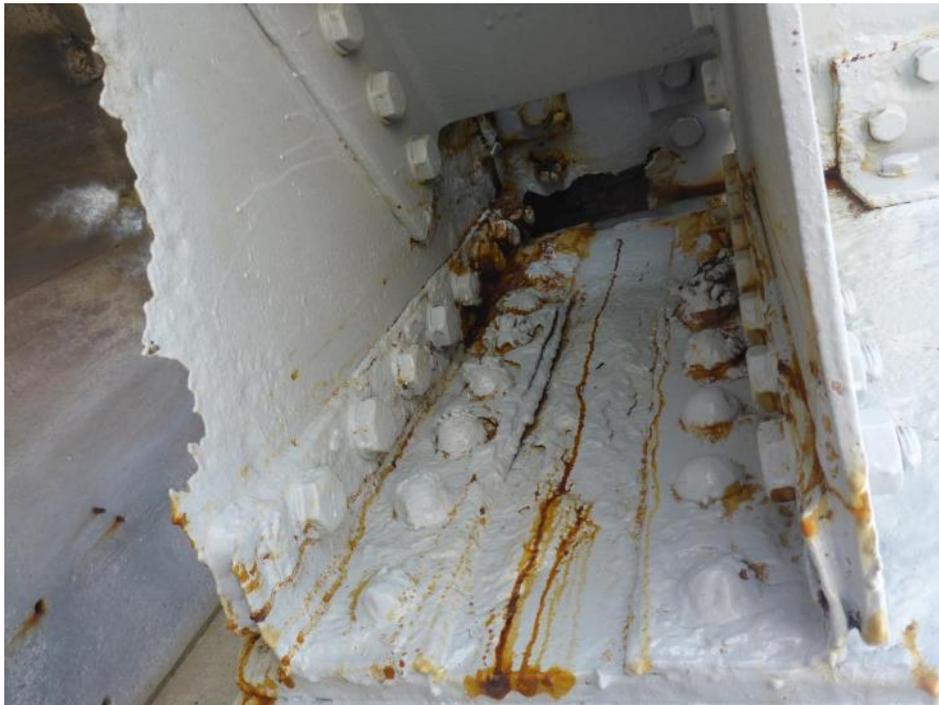
Photo 29 – Sagamore Bridge, interior view of the south connection plate of sway brace with advanced deterioration.

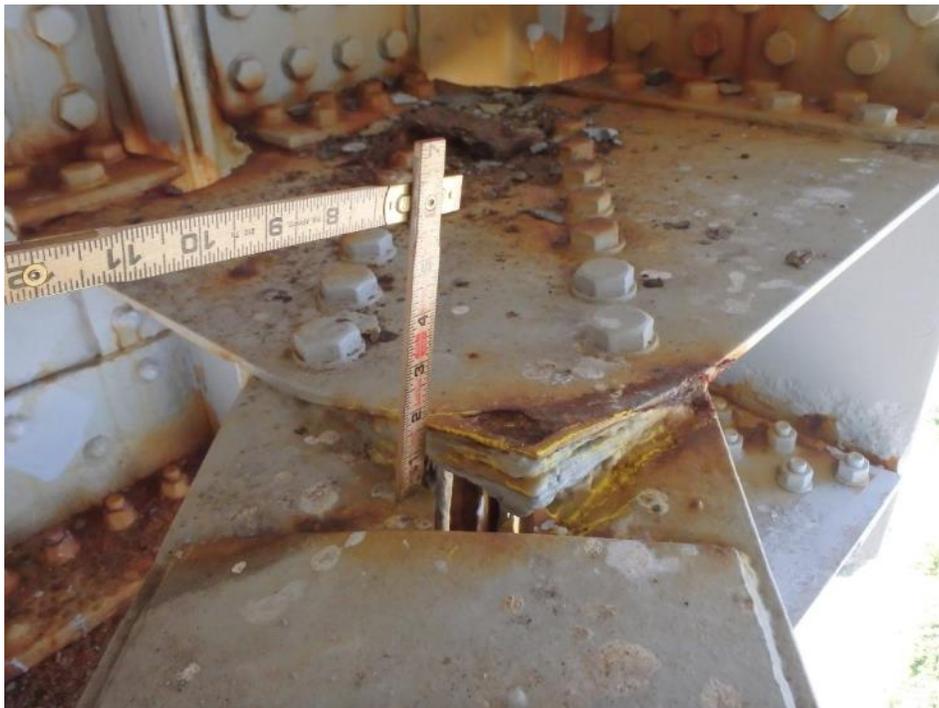
Photo 30 – Sagamore Bridge, pack rust between the upper connection plate and the upper lateral bracing between truss joints at U1 in span 3.

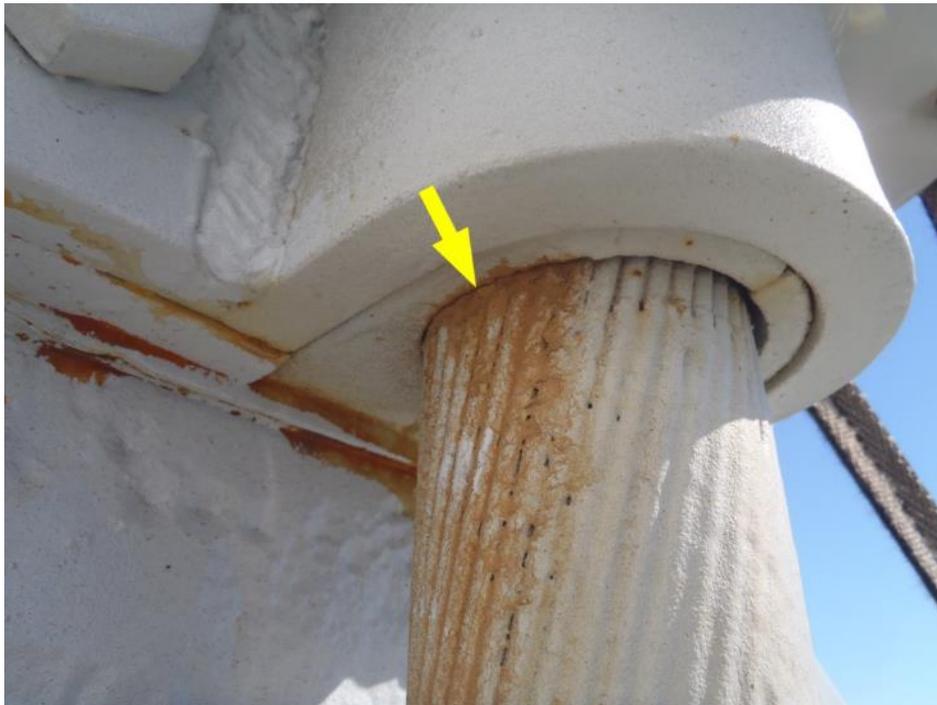
Photo 31 – Sagamore Bridge, misalignment with rubbing between the collar assembly and the south suspender cable at truss joint 15 of the east truss.
