**CAPE COD CANAL HIGHWAY BRIDGES
BOURNE AND SANDWICH, MASSACHUSETTS
MAJOR REHABILITATION EVALUATION REPORT**

**APPENDIX A
ENGINEERING RELIABILITY ANALYSIS**

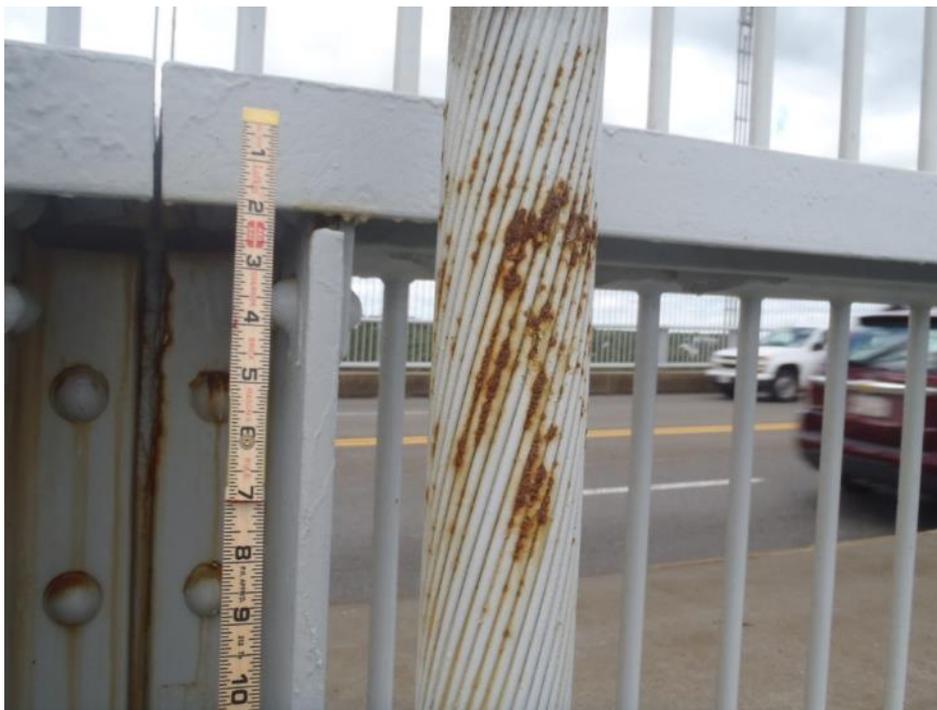
Photo 32 – Sagamore Bridge, area of stage III corrosion on the south suspender at east truss joint 12 between the top and bottom rails of the railing.
