## Daily Report

<b>Project:</b>	Durham Meadows Pipeline Installation
<b>Location:</b>	South Main Street, Middletown CT
<b>Project #:</b>	AECOM: 60445033
<b>Contractor:</b>	Ludlow Construction

<b>Date:</b>	September 10, 2019
<b>Day of Week:</b>	Tuesday
<b>Report No:</b>	3
<b>Page:</b>	1 of 8

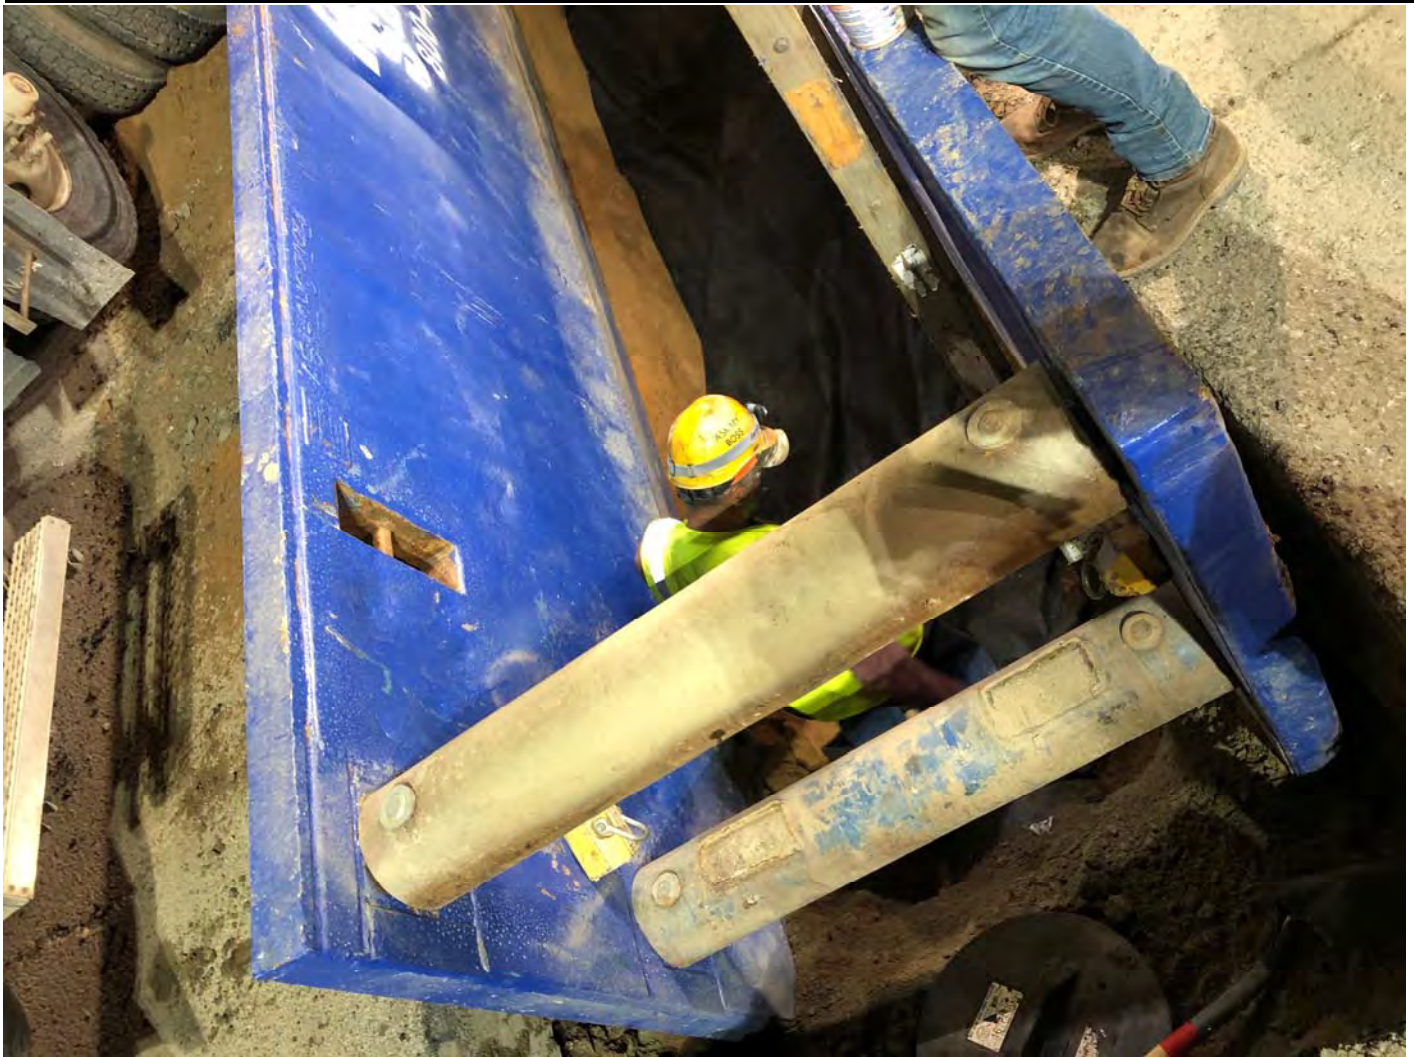
Figure 1 – Geotextile fabric placed below new pipe length

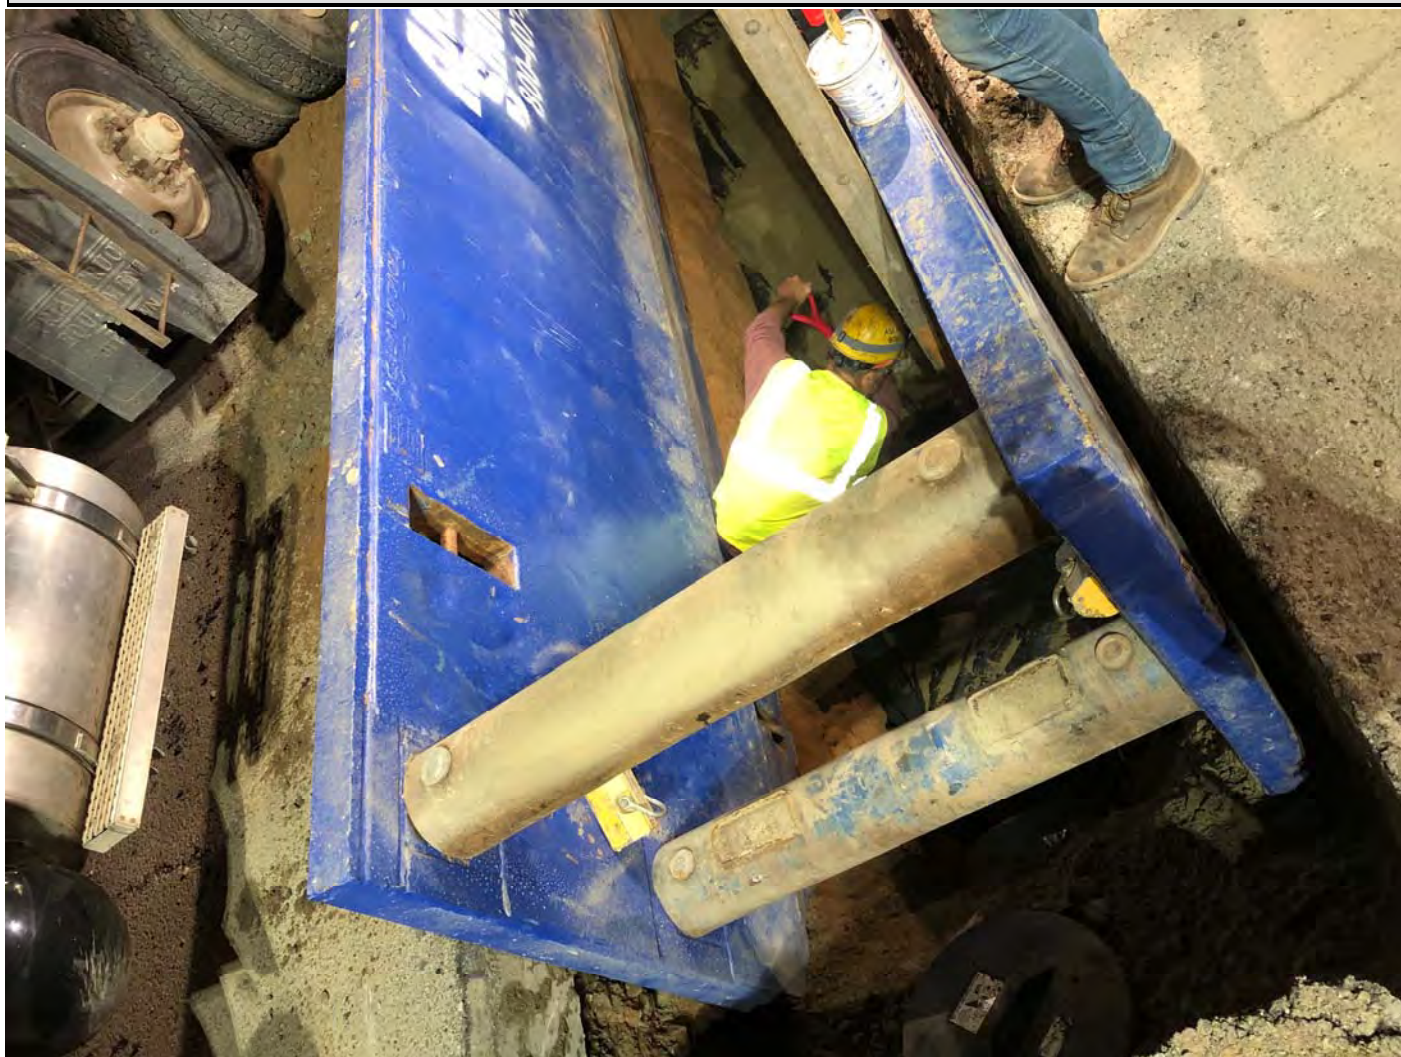
Figure 2 – Filter fabric filled with gravel being graded in preparation for pipe placement

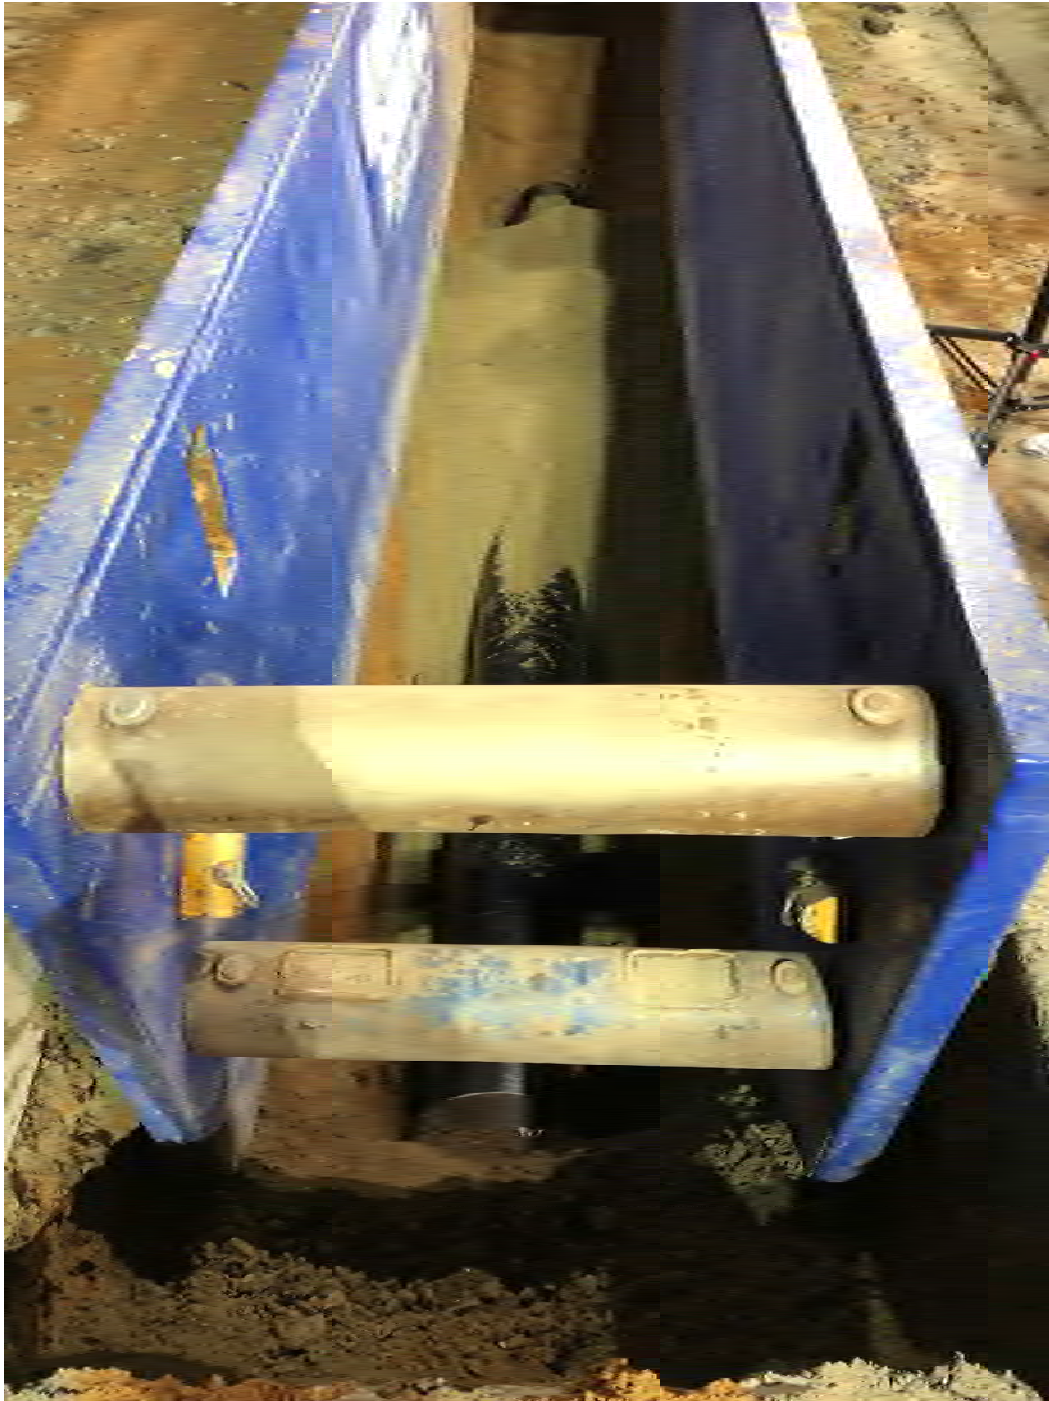
Figure 3 – Pipe Bedding being placed around newly installed pipe length, gravel wrapped in filter fabric underneath

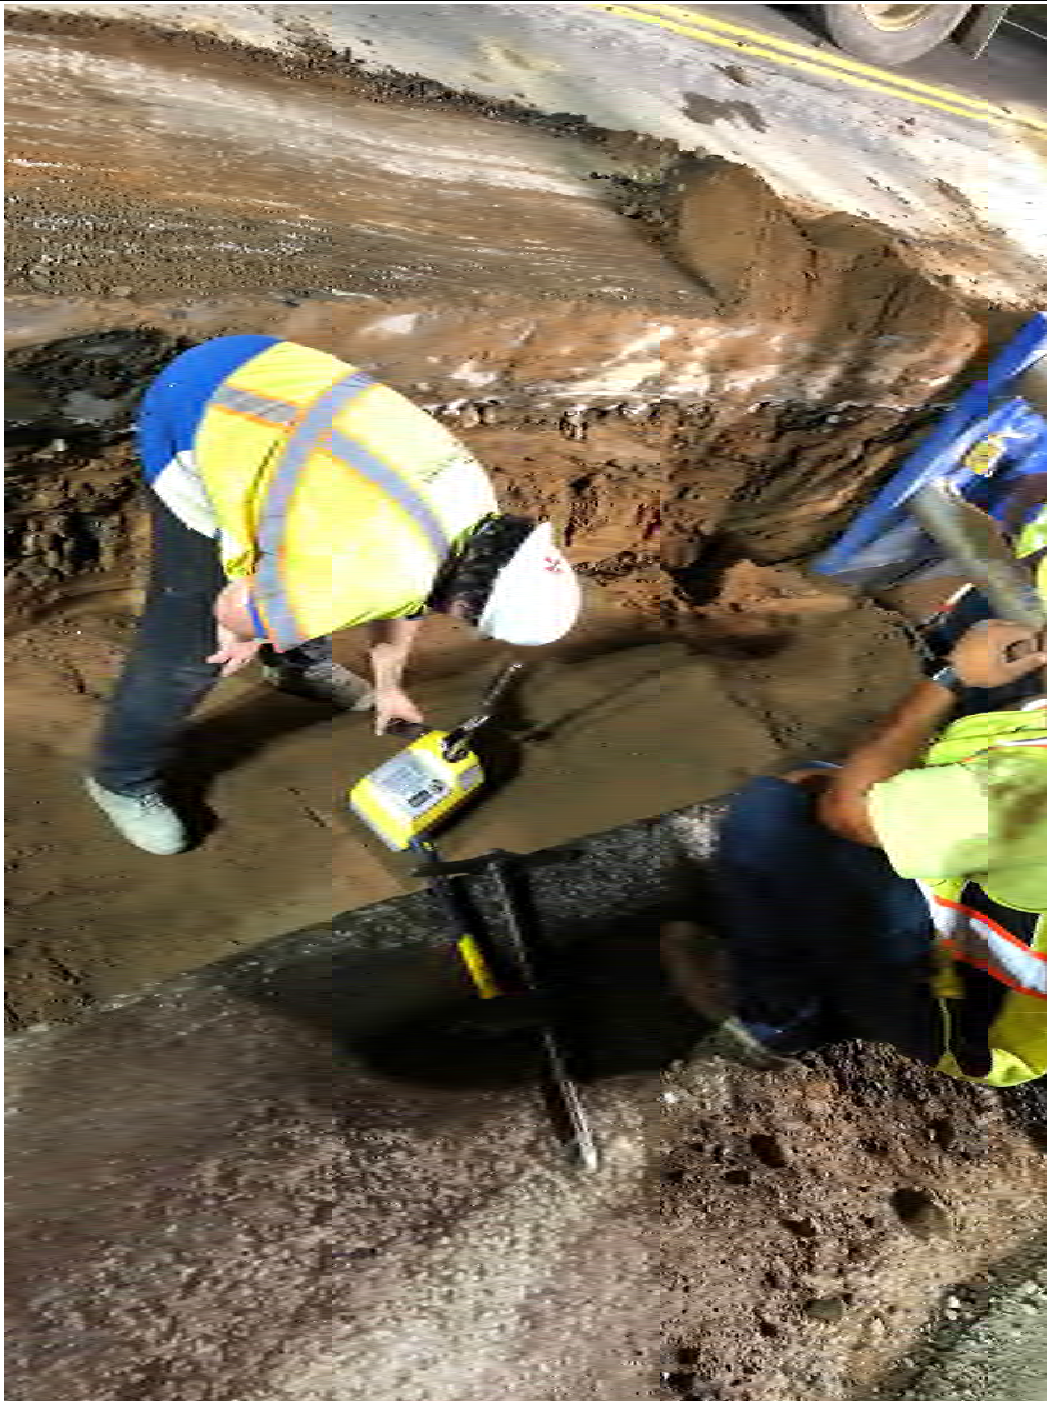
- Backfill did not pass compaction. test. Fine layer of sandy silty gravel is moist and hard to get to pass test
- Re-compacting area over new lines, passed compaction. test after re-compaction

Figure 4 – Compaction testing underway

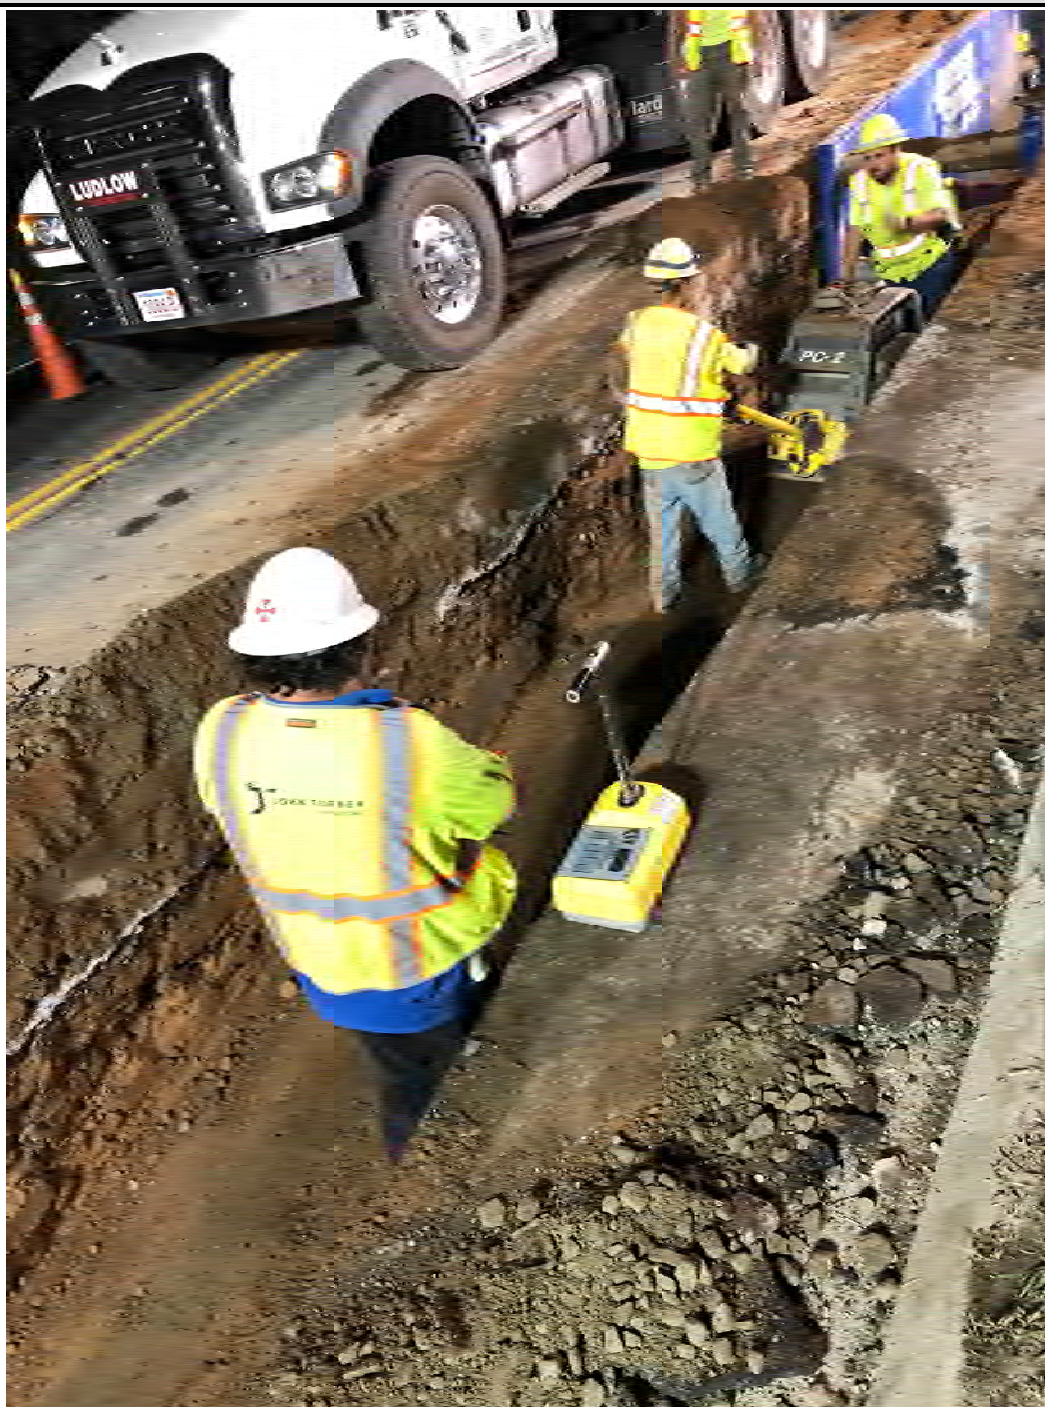
- Failed @ both 10” and 8”, high moisture creating issues, recompacting layer
- 10 minutes to recompact section
- 5 minutes for compaction test results at each later
- Work stops during re-compaction situations because excavator used to trench for new pipe is also used to fill trenches over new pipe

Figure 5 – Recompacting backfill after failed compaction test

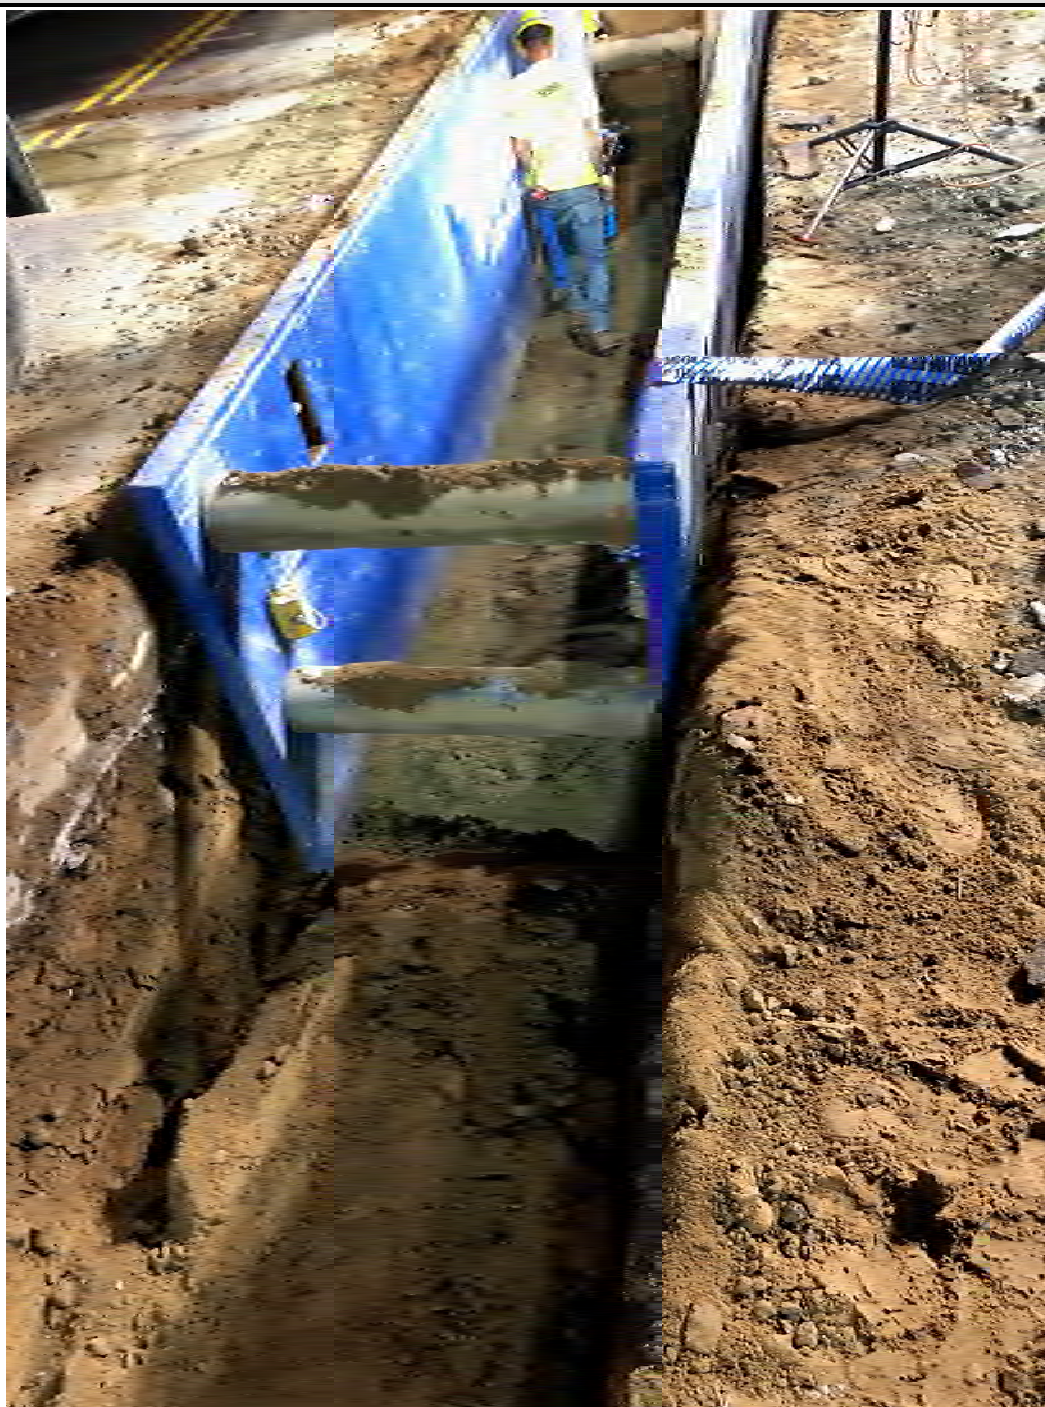
Figure 6 – Compacting first 12” backfill later above 3<sup>rd</sup> pipe length of the night
