## Daily Report

<b>Project:</b>	Durham Meadows Pipeline Installation
<b>Location:</b>	Talcott Ridge Drive, Middletown CT
<b>Project #:</b>	AECOM: 60445033
<b>Contractor:</b>	Ludlow Construction

**Date:** October 08, 2019  
**Day of Week:** Monday  
**Report No:** 10  
**Page:** 1 of 13

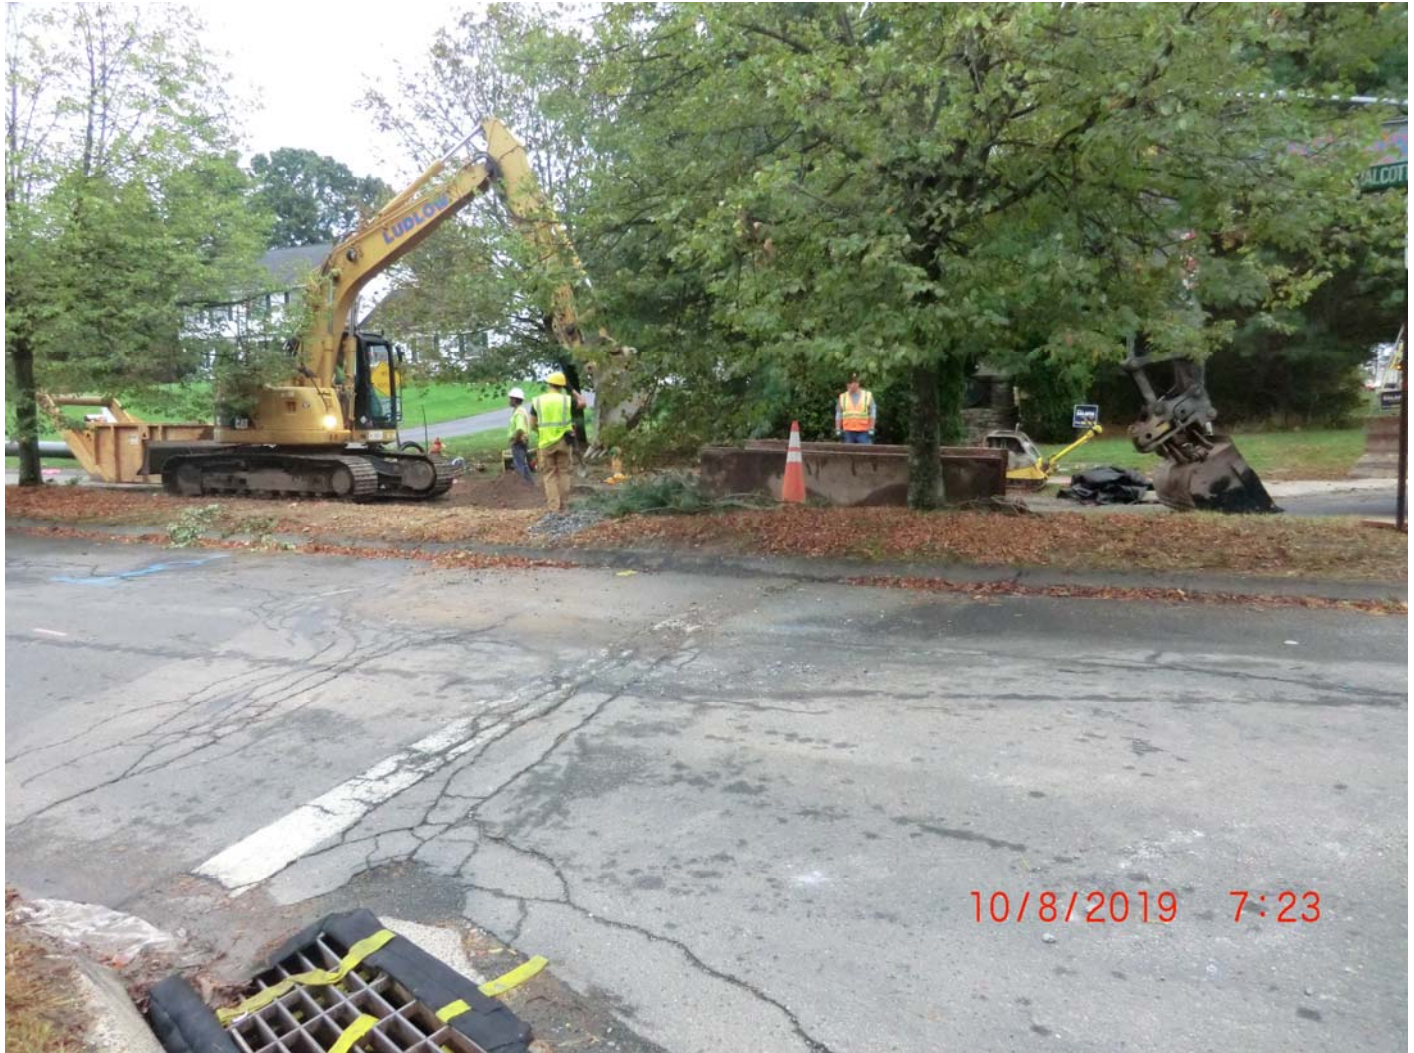
Figure 1 – Start of first run at 51+72. Note excavator to left digging and excavator to right backfilling (not currently active). Also note double catch basin to front left of picture – typical liner installed to catch sediment runoff. Picture taken facing south.

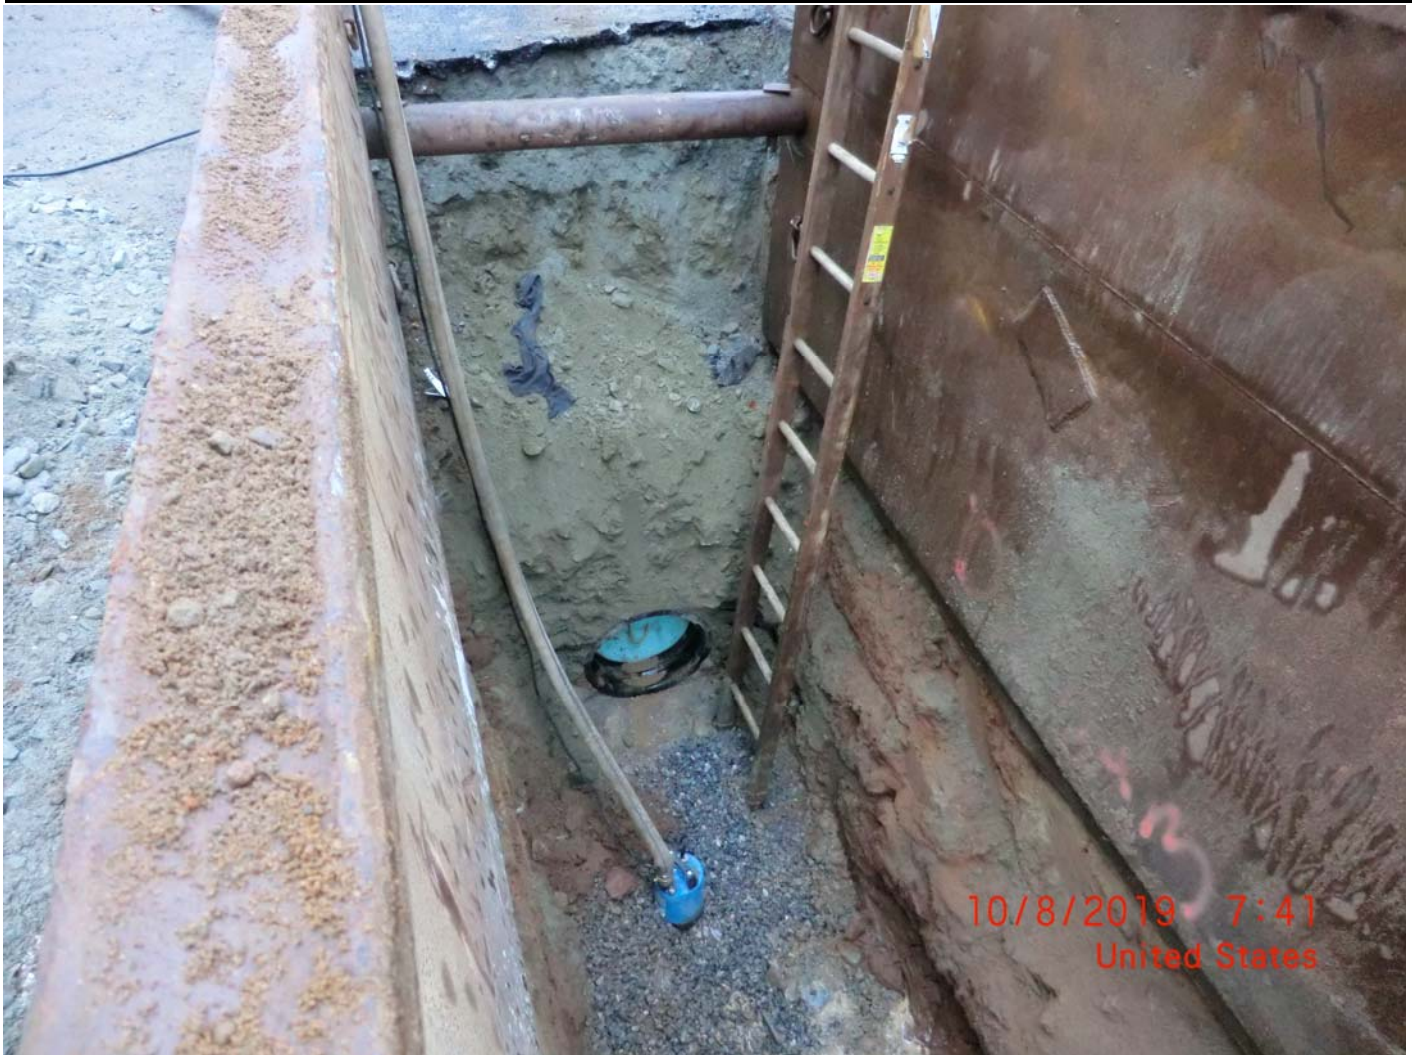
0840 – Un-corked pipe from previous days installation, released about 20 gallons of water that apparently seeped in overnight. Sump used to evacuate whatever water that did not drain into the gravel. First 18-foot section of pipe installed to 51+52.

**Figure 2 – Start of operations – Plugged pipe end from 10/7/19 at 51+72. When this plug was removed approximately 20 gallons water spilled out. Gate valve at other end of pipe (Tee-section with So. Main Street line) is closed at time of this picture. Picture taken facing west into road cut.**

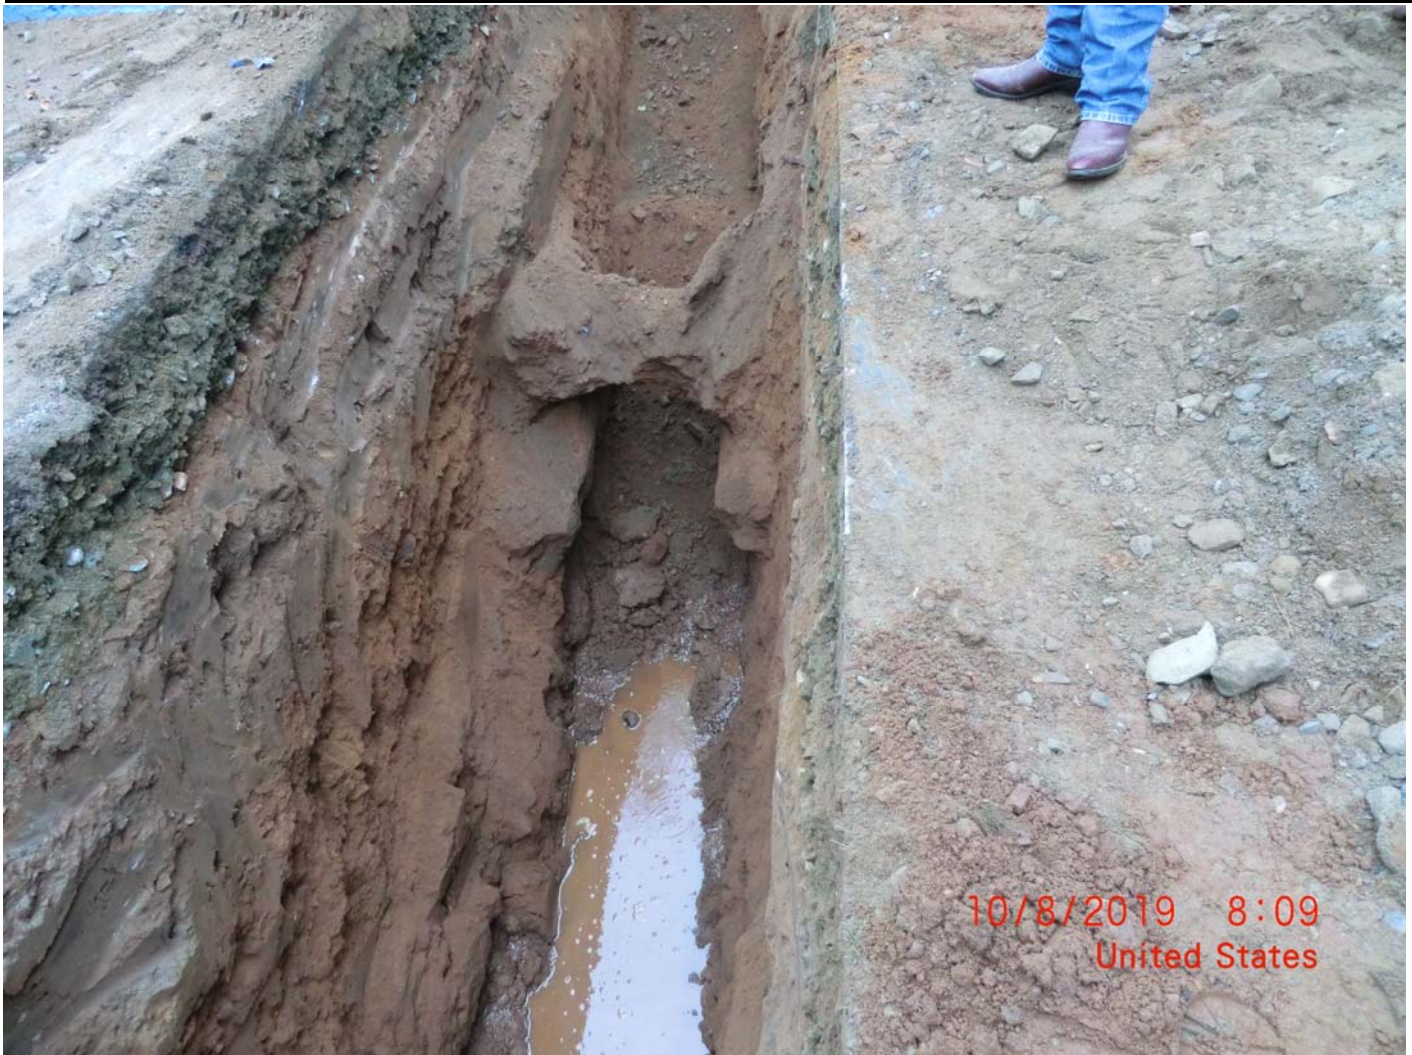
0750 – Most of first 18 feet dug. Located existing fire hydrant line at 4-5 feet below grade 8-inch line. Existing hydrant line located at 51+49.

Figure 3 – Existing fire hydrant line, 6-inch pipe located at approximately 51+49.

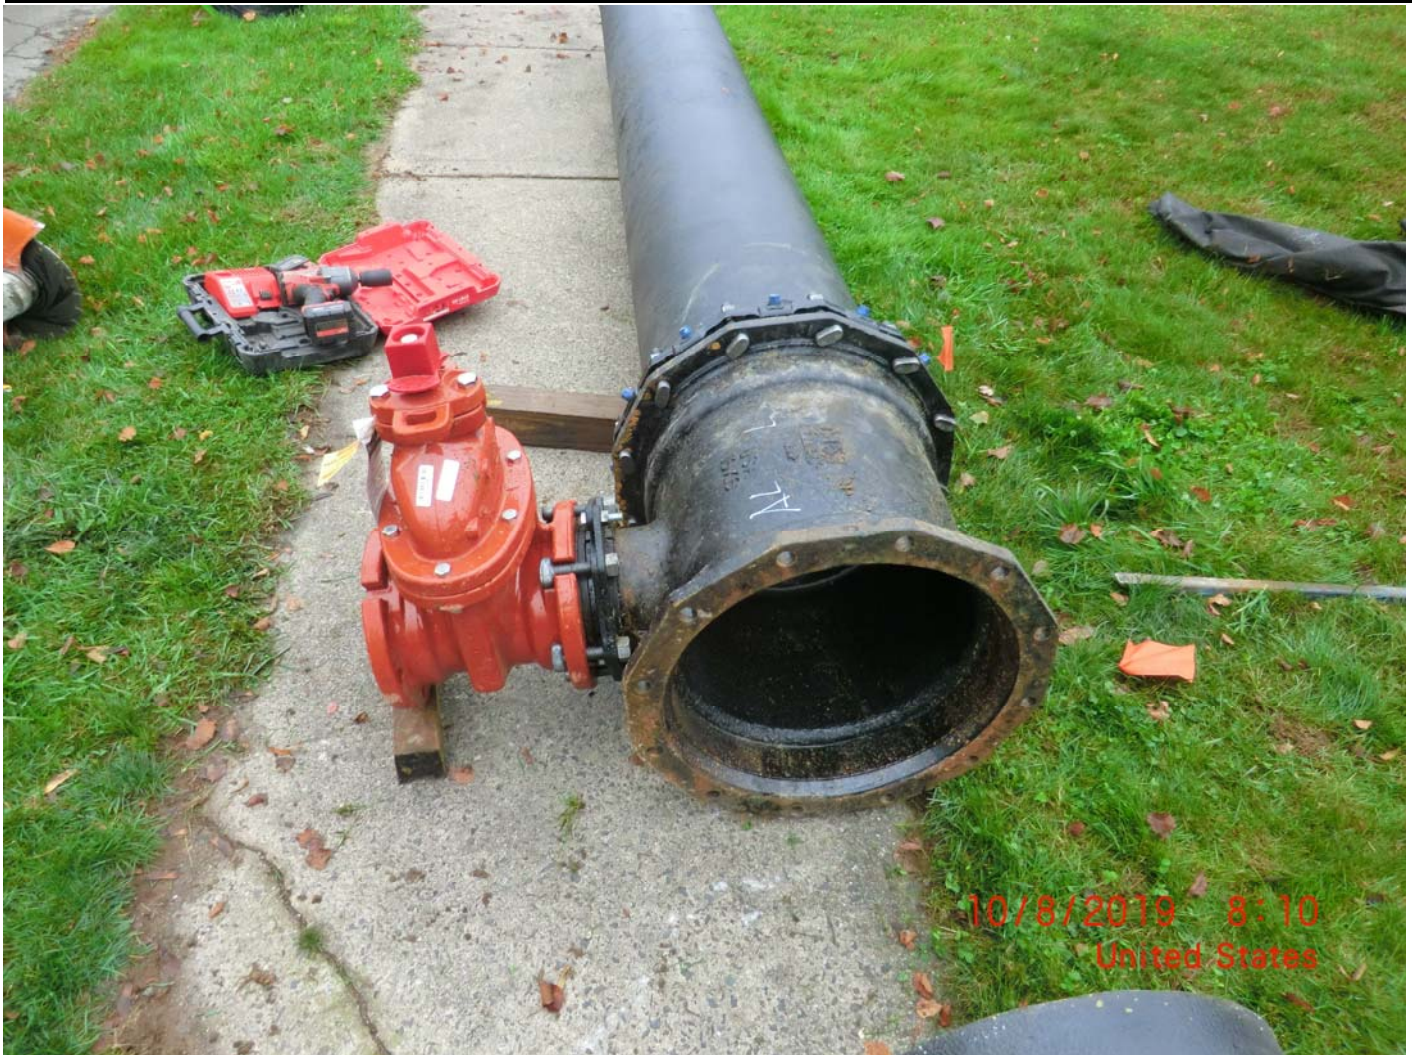
0830 – Fire hydrant Tee in cut into 18-foot section of 16” DI and Tee assembly attached to one cut end of pipe along with mega-lug restrainer. The second half of cut pipe to be installed in the ground to prevent bending at junction while lowering pipe into pit. First 18 foot run base prep (gravel and bedding) nearly completed.

Figure 4 – Fire Hydrant Tee assembly preparation. Pipe cut at approximately 14 feet to insert Tee. Remaining 6 feet at bottom right of picture.

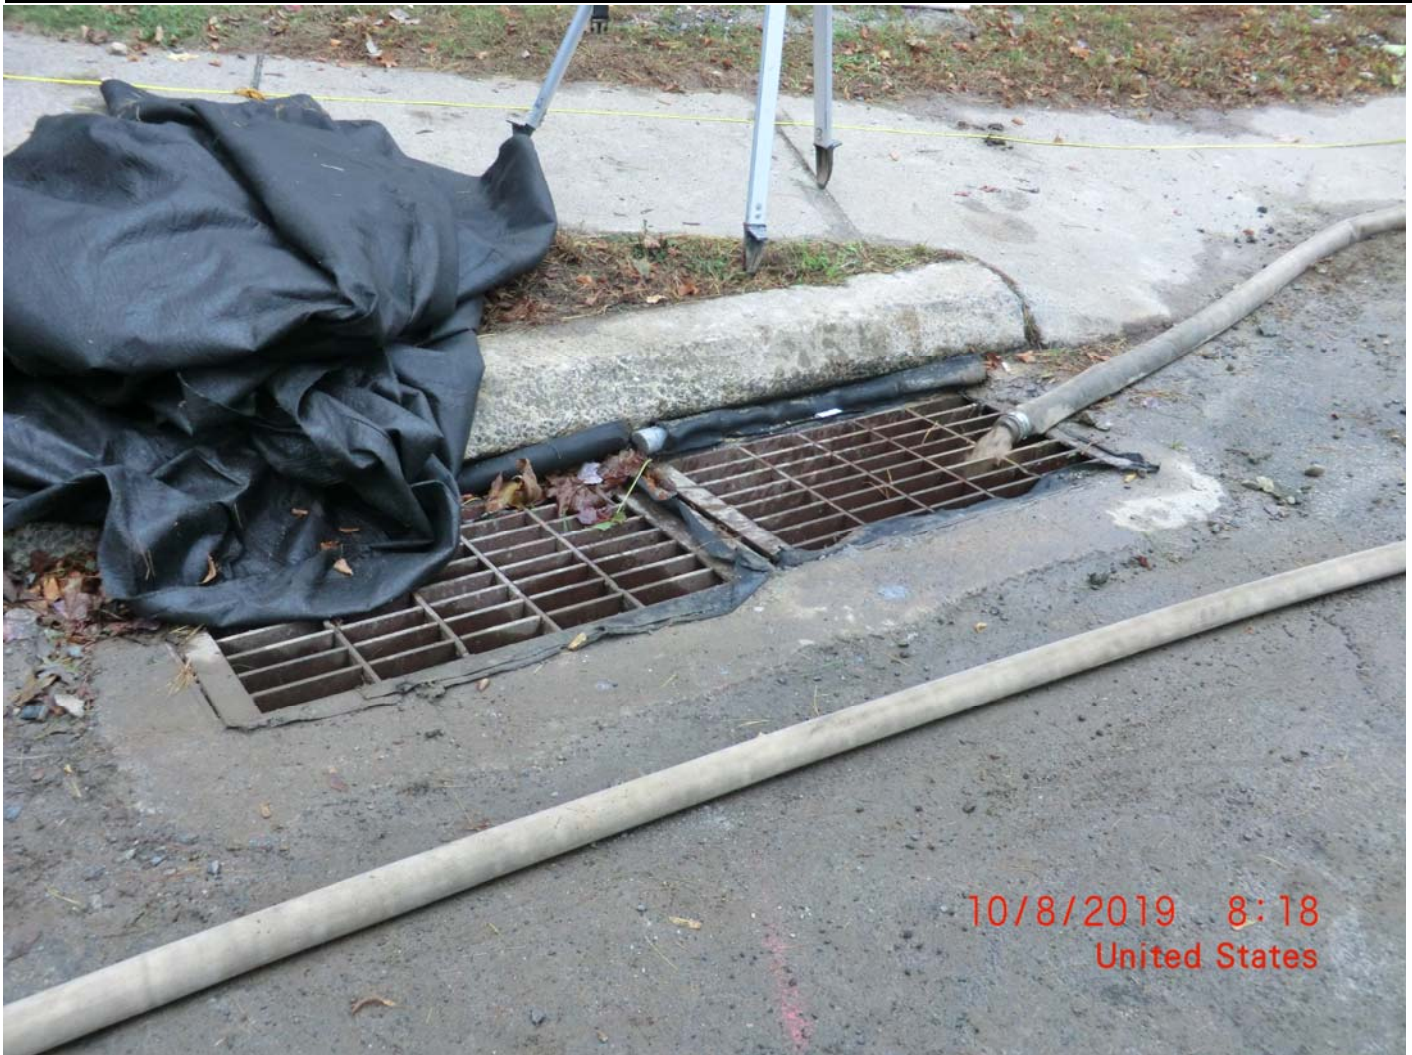
Figure 5 – Sump discharge to double catch basin (south side of Talcott Ridge Dr. at South Main St.). Note that catch basins have been lined.

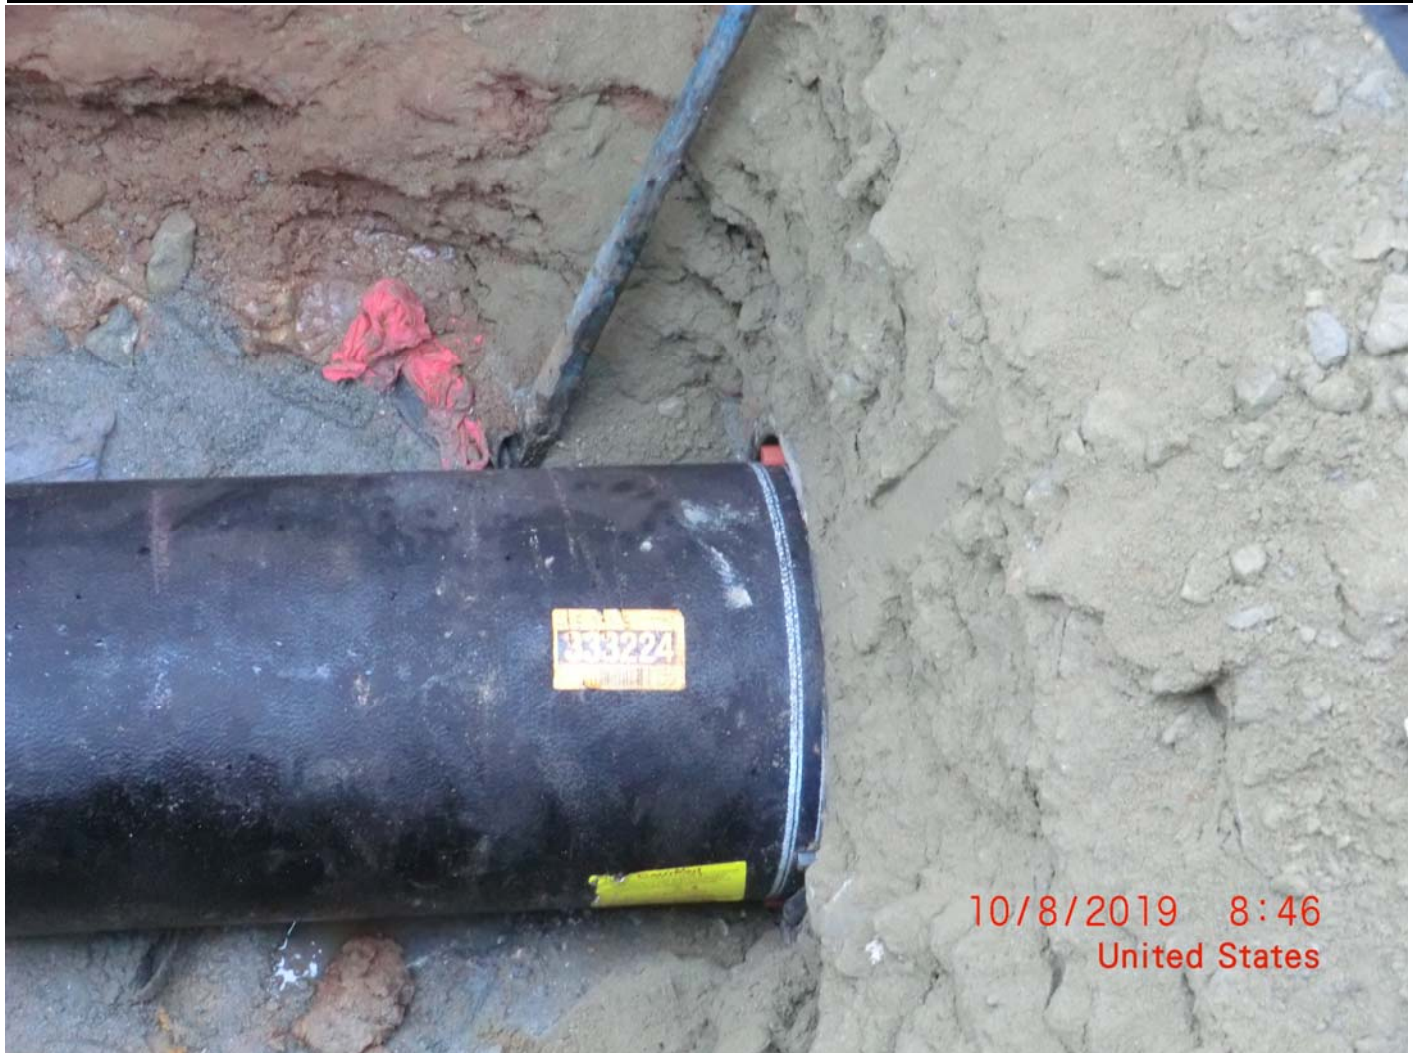
Figure 6 – Typical pipe seating. 16” DI Pipe to left - pipe bell to right (not shown in picture due to fill). Note the orange (top) and black (bottom) lock wedges seated in connection to bell.

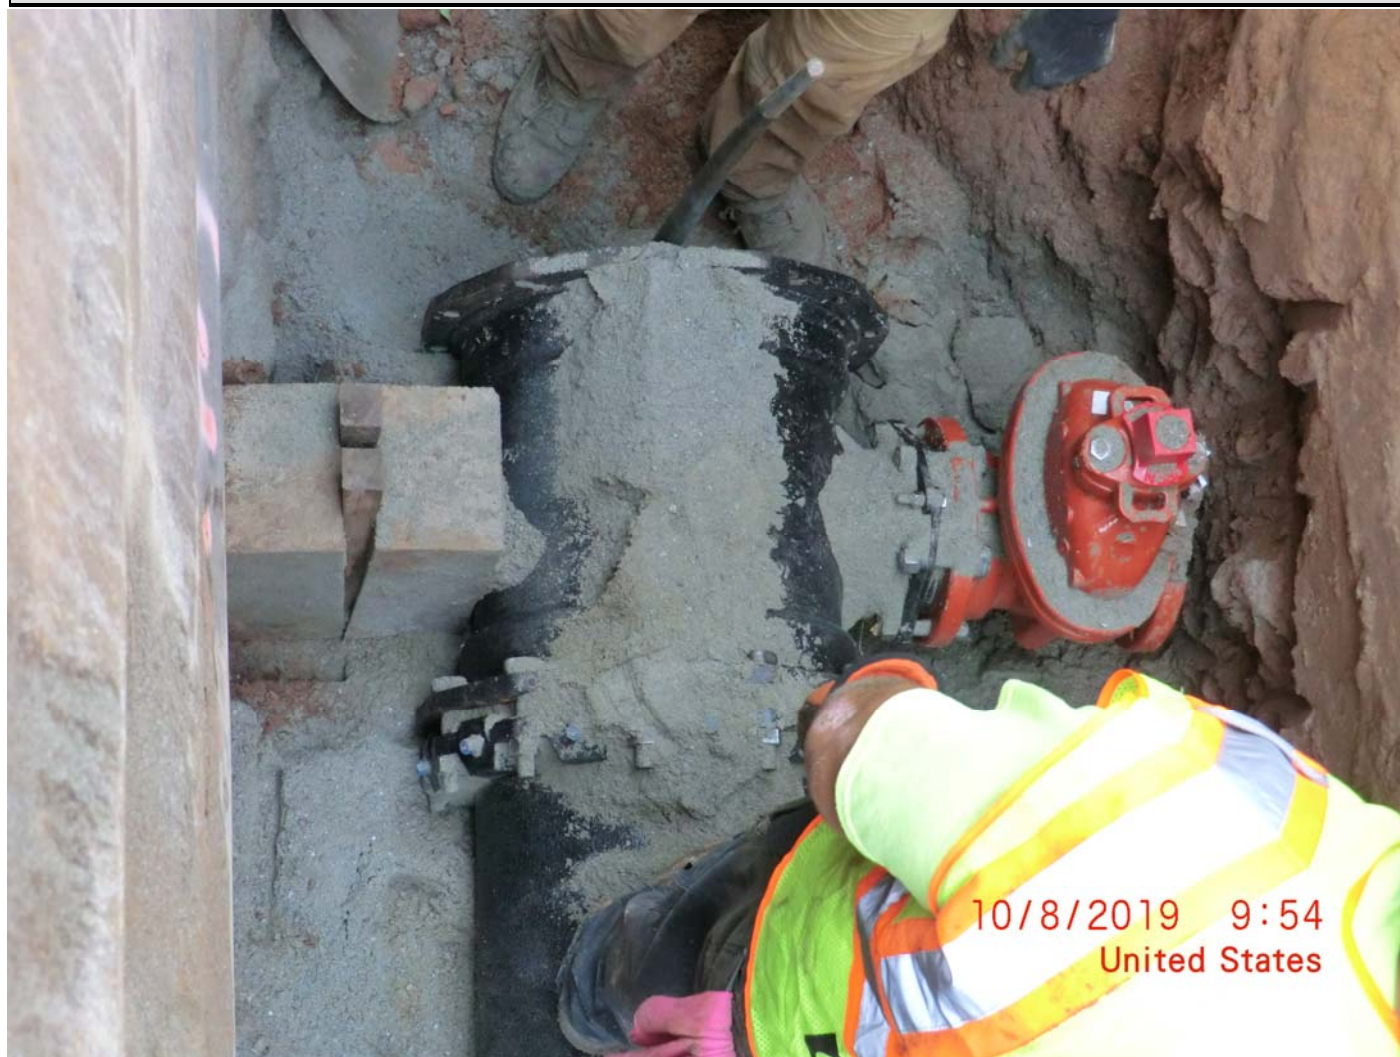
0945 – Second 18-foot section of 16" DI installation, includes New Fire Hydrant Tee at 51+38. Top of Hydrant Tee at elevation 349.70', existing blacktop at 355.78' (6.08' below existing grade). Tie-offs taken to nearest corner of double catch basins located at the intersection of Talcott Ridge Rd. and South Main St. (Rte. 17). Distance to catch basin on south side of Talcott Ridge 46.6', and to catch basin on north side of Talcott Ridge Rd. 37.9'.

**Figure 7 – 16" DI pipe and fire hydrant Tee installed. 51+38, top of Tee is 6.08 feet below existing asphalt surface. Elevation of top of Tee at 349.7 feet. Remaining 6-foot section still to be installed.**

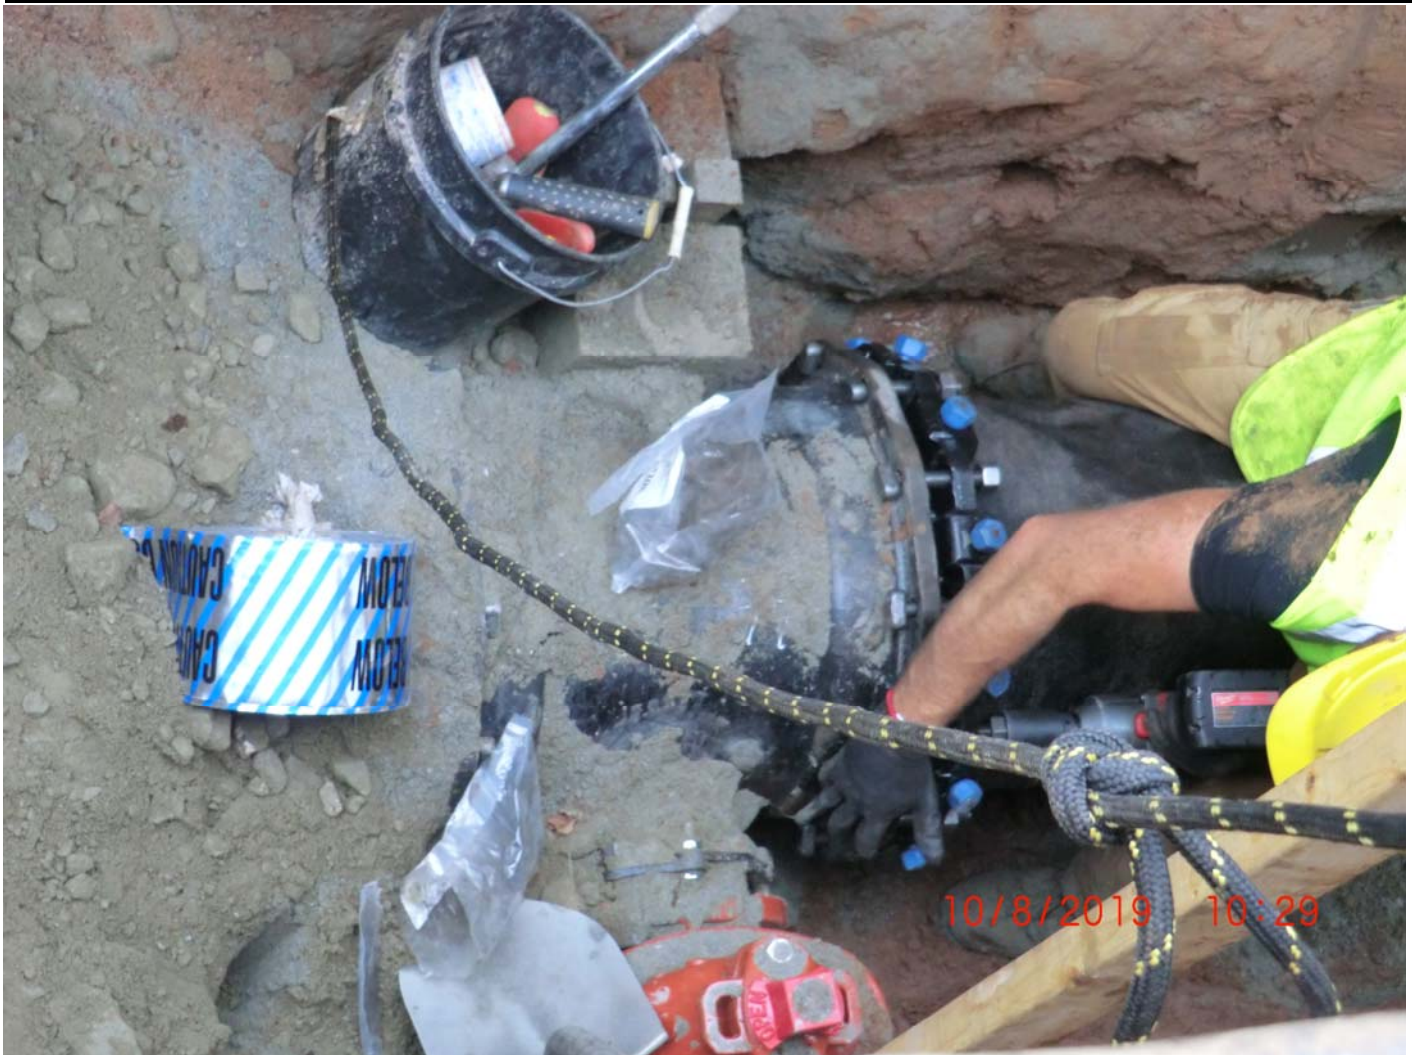
1035 – Installation of remaining section of second 18-foot run that included the new fire hydrant Tee. End at 51+31

Figure 8 – Installation of remaining 6 feet of 18-foot 16" DI pipe, with Megalug restraining gland.

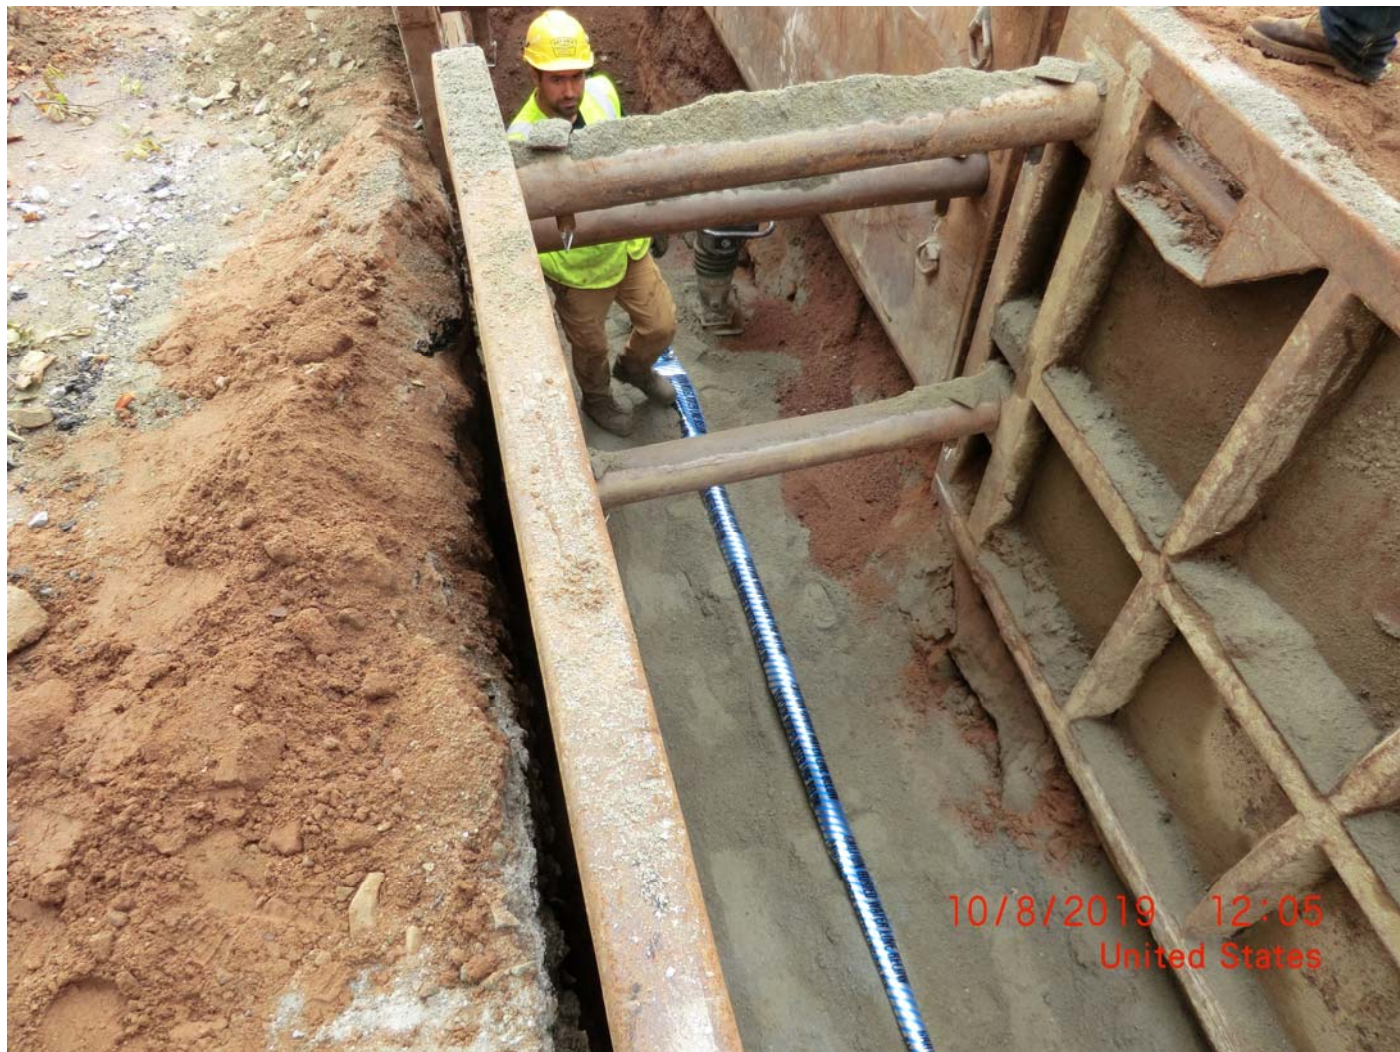
Figure 9 – Top of compacted 12-inch lift of pipe bedding. “Caution Water Line Below” tape on top.

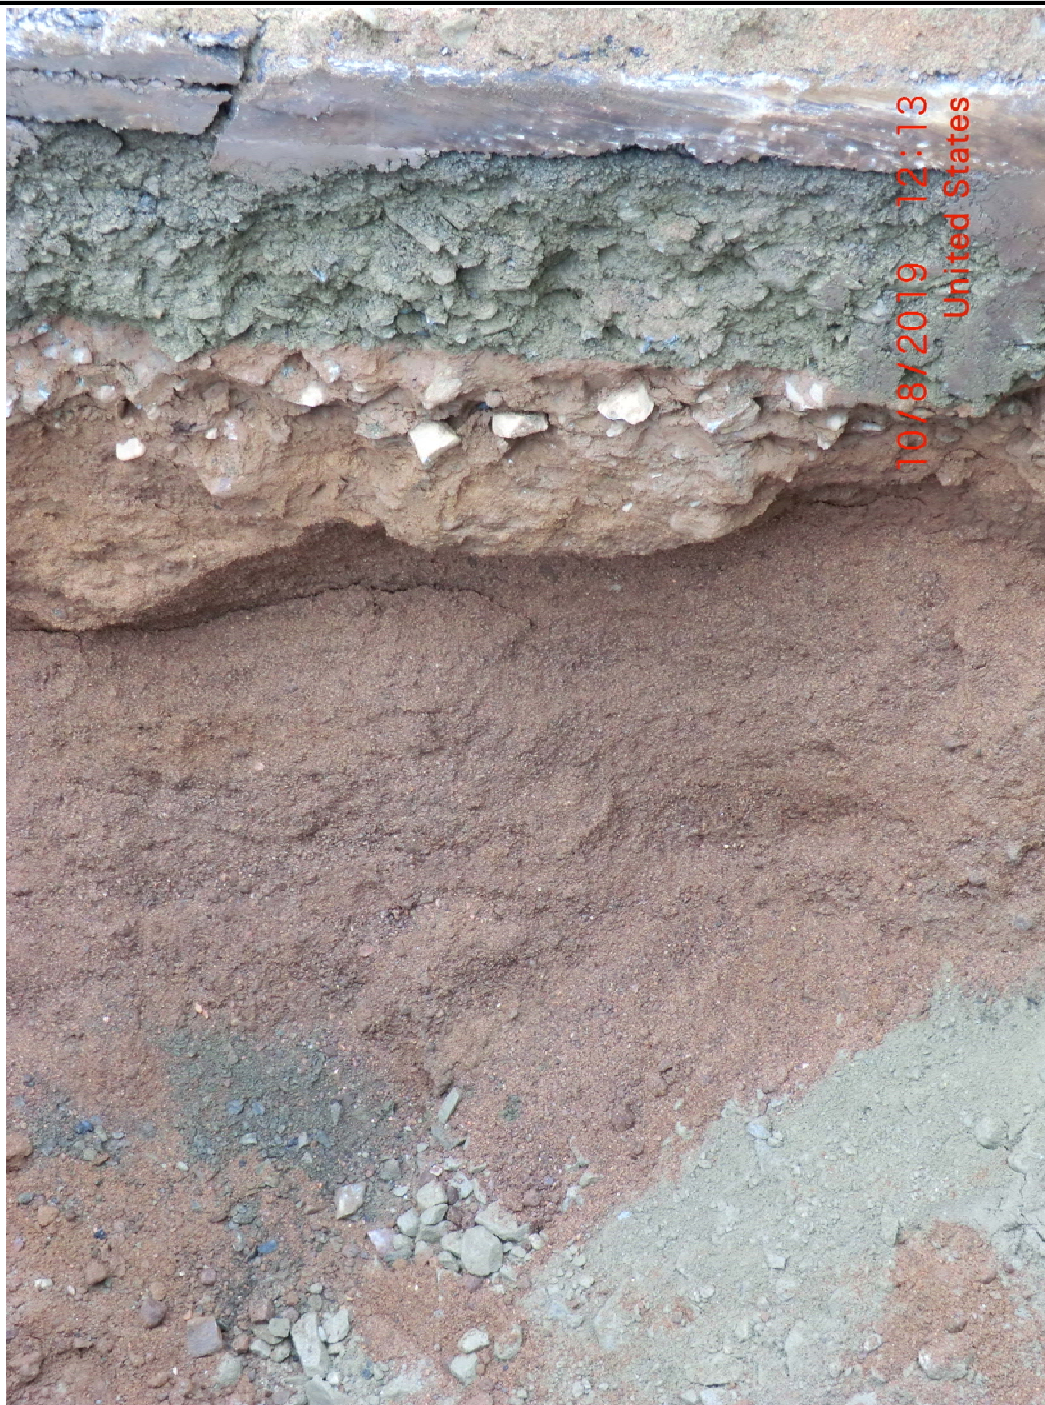
Figure 10 – Typical soil profile section located roughly at 51+00. From top, asphalt, road base, medium-fine sand, sandy silt (not shown – below pipe bedding backfill at bottom of picture).

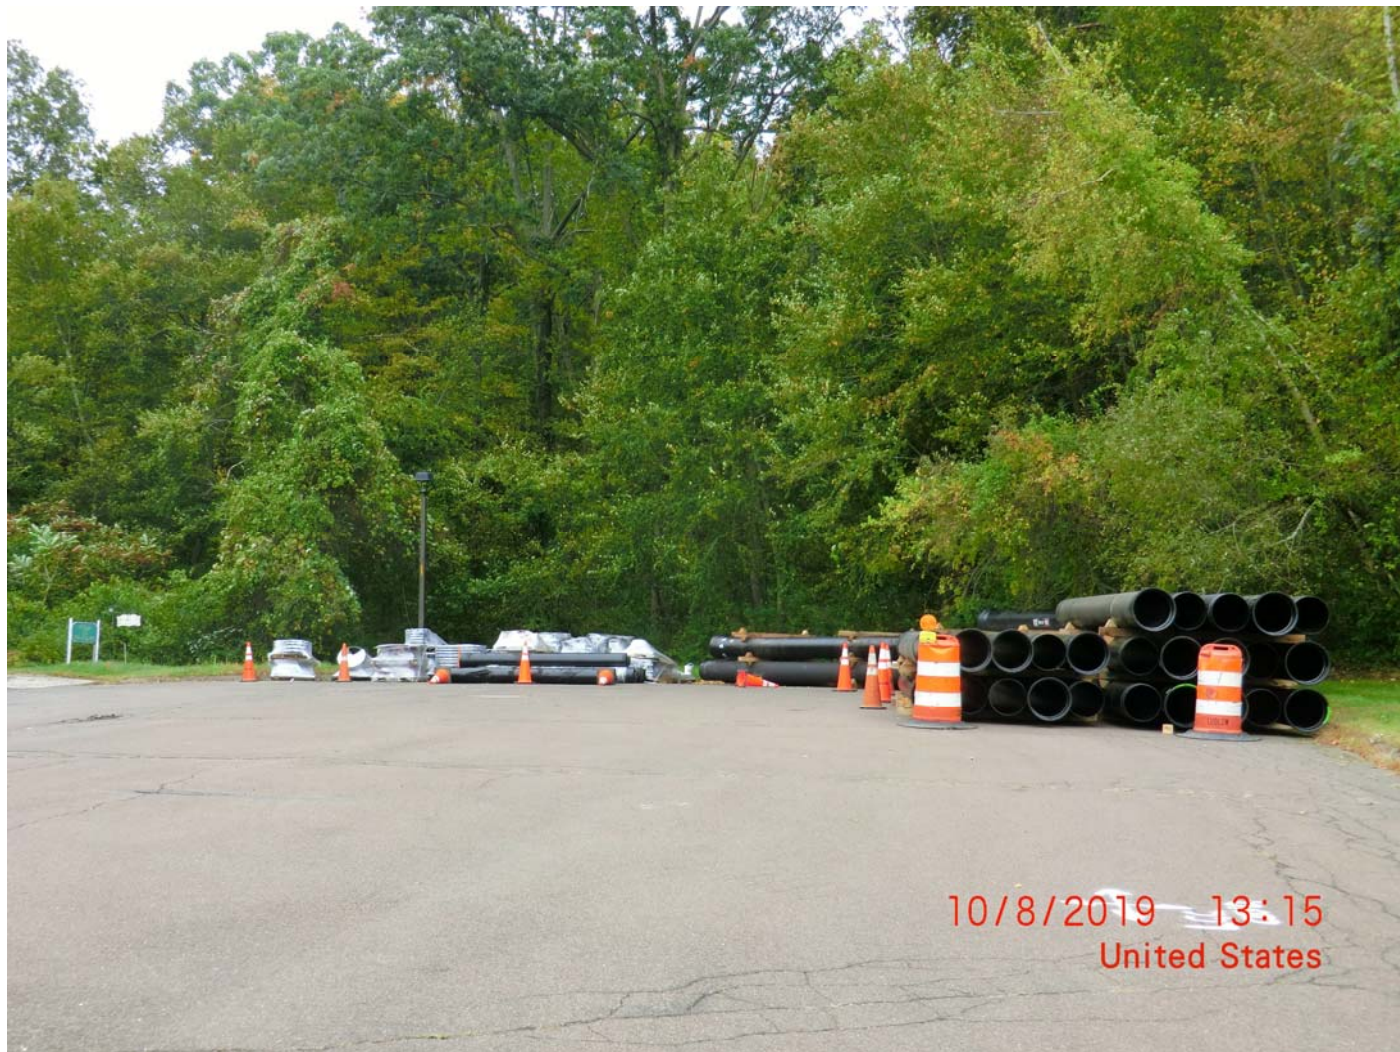
1330 – Drove up to top of Talcott Ridge Dr. A lot of pipe and equipment being staged in the cul-de-sac. Gravel is also being stockpiled along Talcott Ridge Rd. near the intersection of Watch Hill Drive. Off-site.

Figure 11 – Cul-de-sac, top of Talcott Ridge Drive. Staging area for pipe and materials.
