## Daily Report

<b>Project:</b>	Durham Meadows Pipeline Installation	<b>Date:</b>	October 23, 2019
<b>Location:</b>	Talcott Ridge Drive, Middletown CT	<b>Day of Week:</b>	Wednesday
<b>Project #:</b>	AECOM: 60445033	<b>Report No:</b>	19
<b>Contractor:</b>	Ludlow Construction	<b>Page:</b>	1 of 16

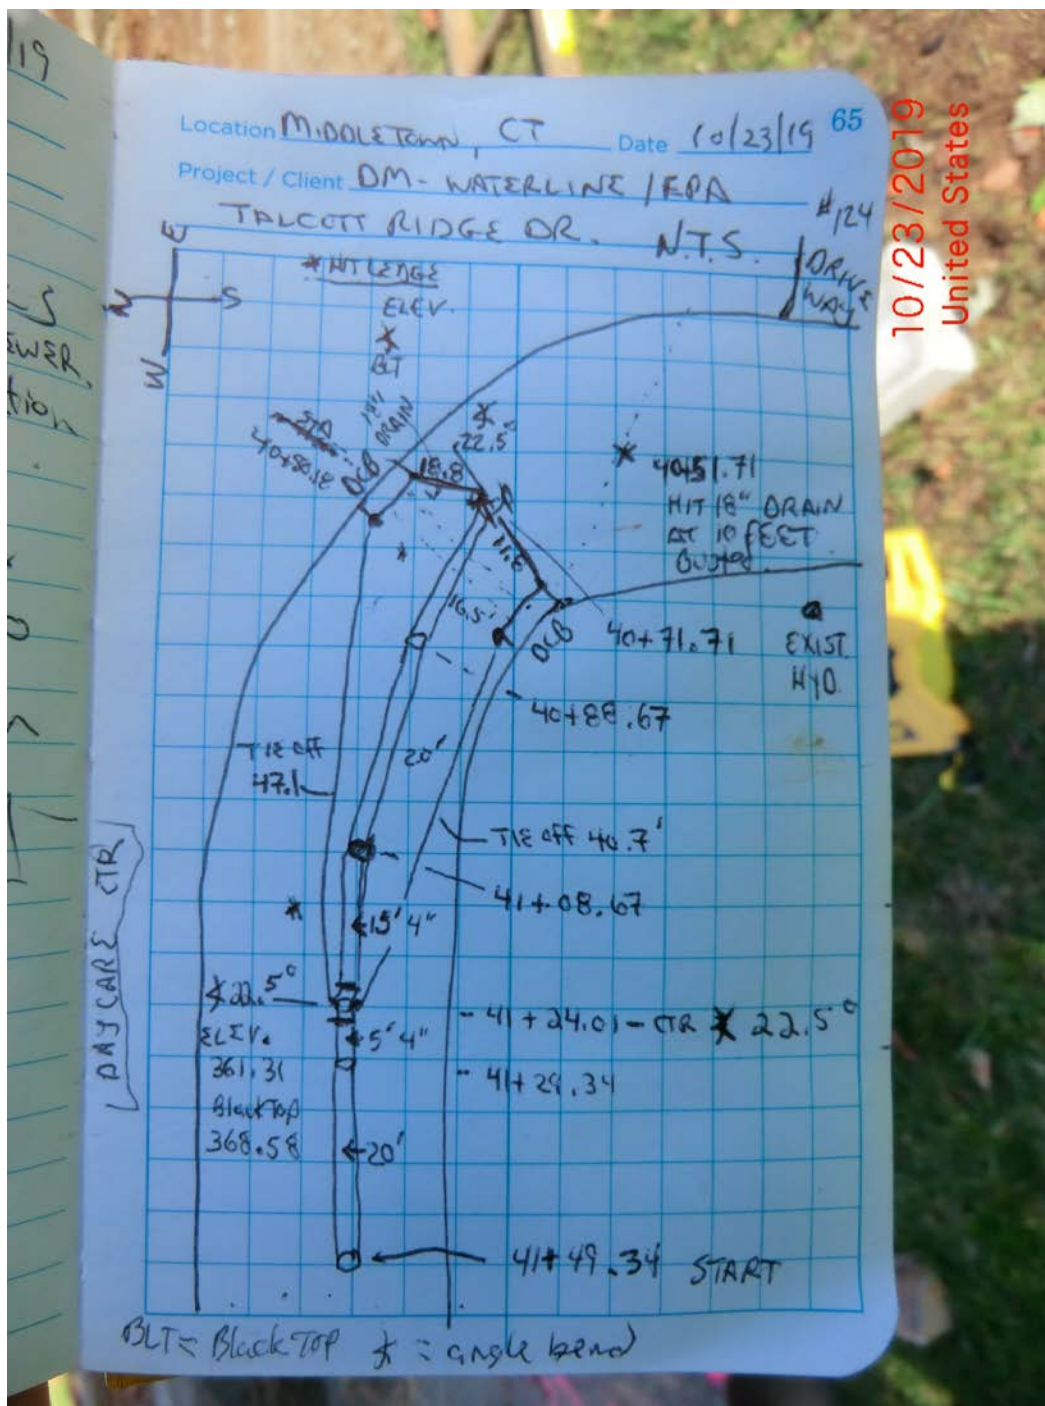
Figure 0 – Tie-offs and elevations for bends.

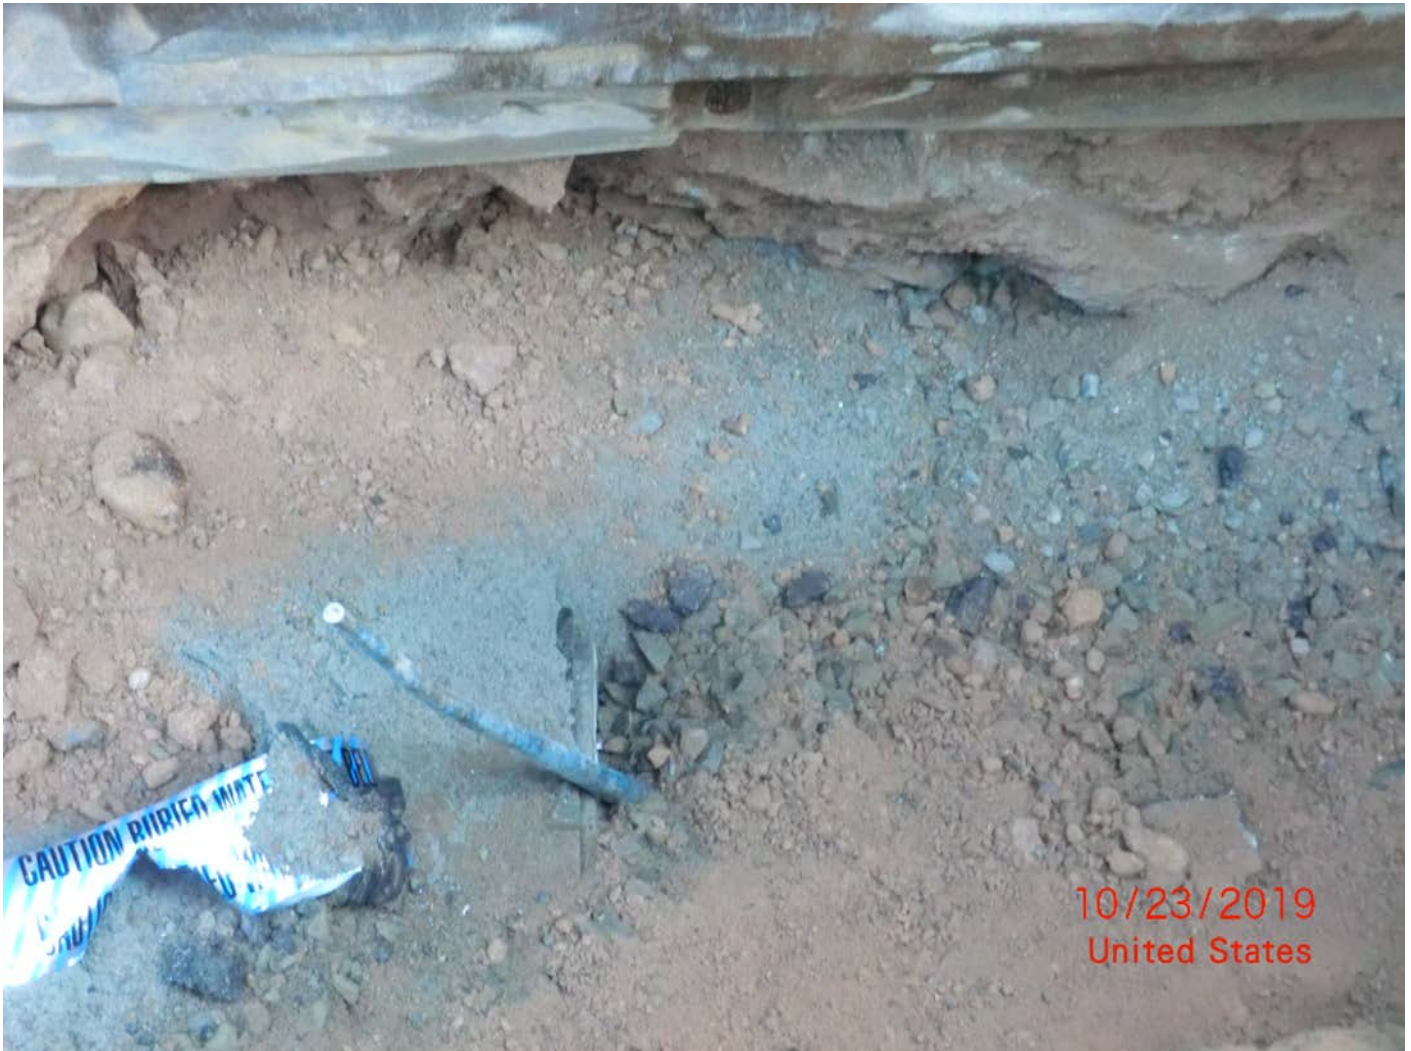
0845 – 25 feet and 4 inches installed to Sta. 41+24.01. This consisted of 1x20-foot 16” DI restrained plus 5-foot of 16” DI restrained and 4-inches for a 16” x 22.5° Bend to the south.

Figure 1 – First 22.5 bend installed at Sta. 41+24.01. Partially covered to turn in excavation and moving of road box to next position. Note pipe is capped and pry bar is placed to hole cap in during this process.

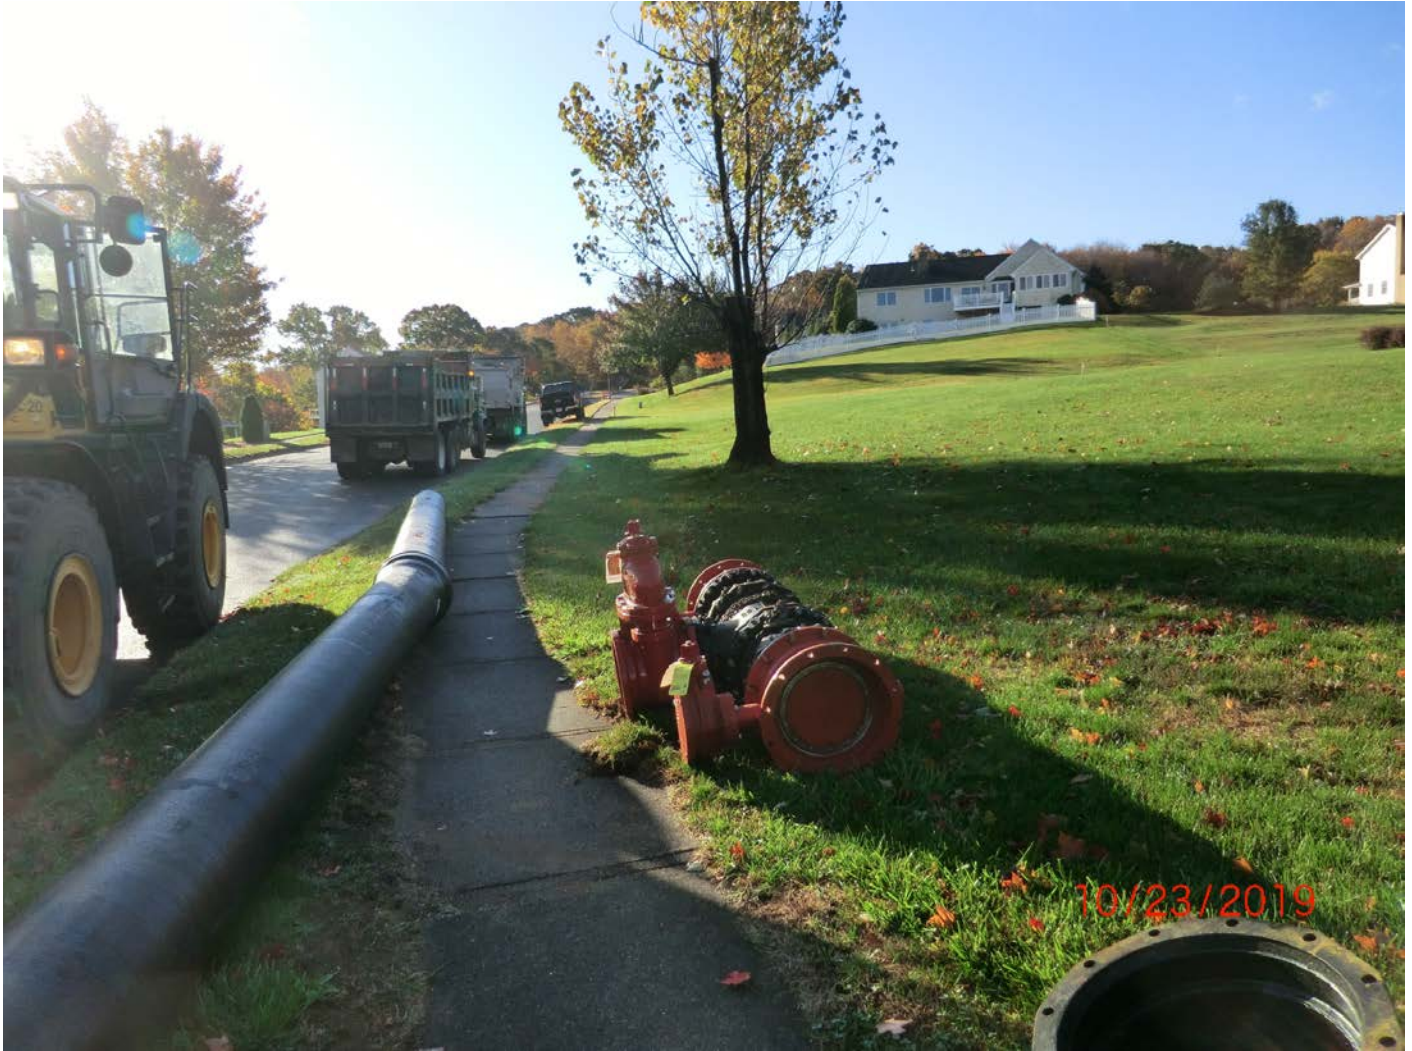
Figure 2 – Facing southeast. Staging pipe and valve assemblies and bends.

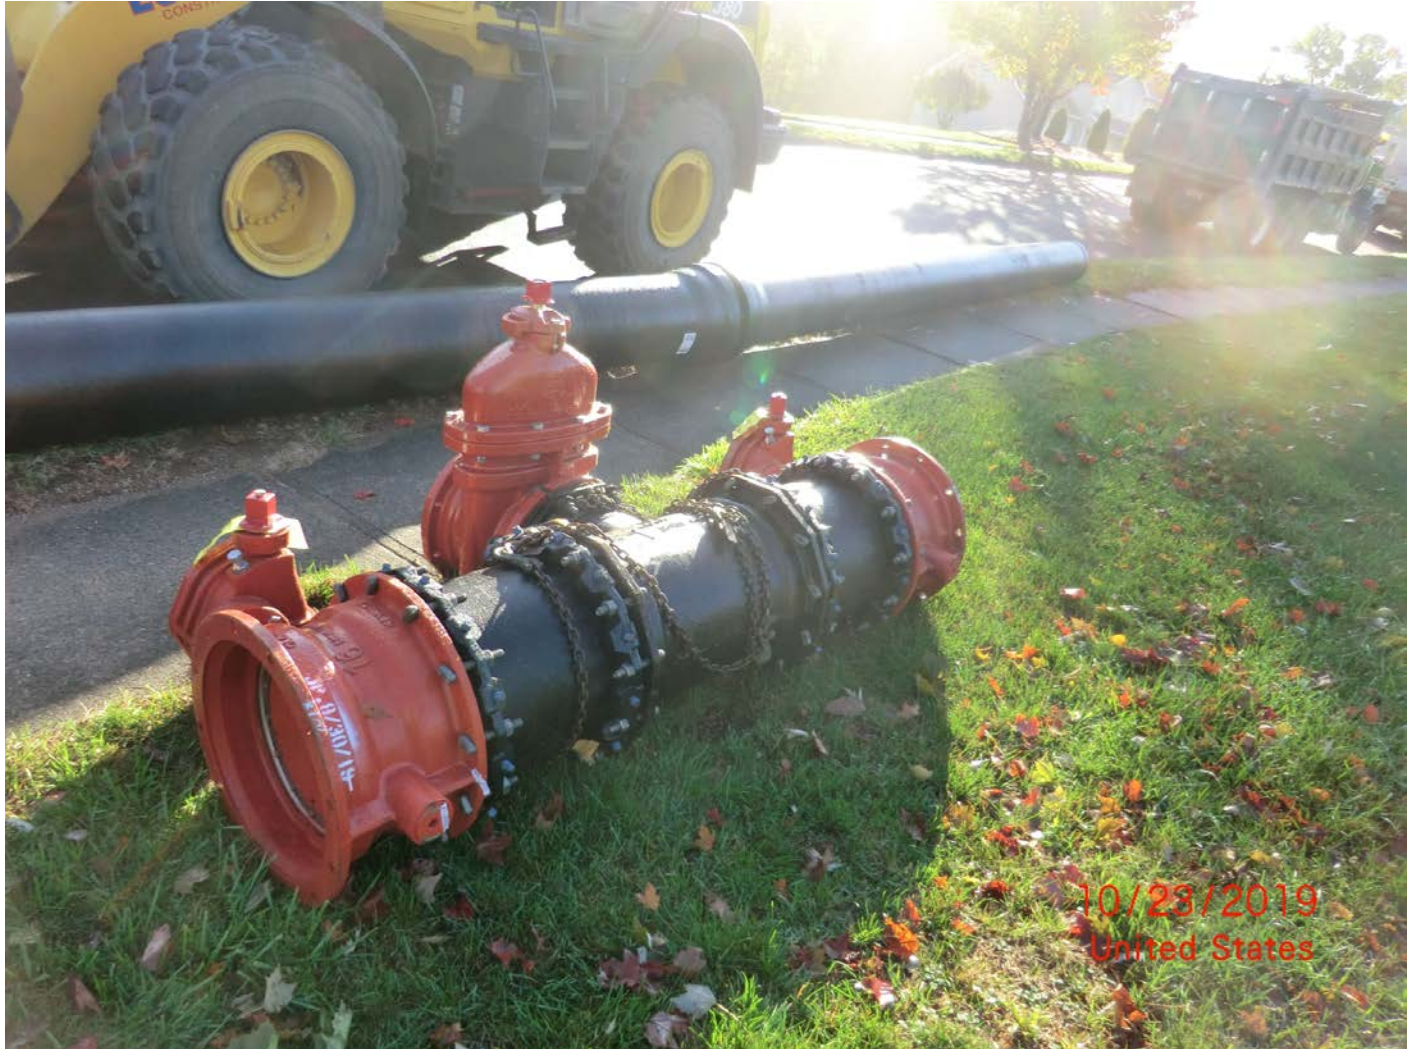
Figure 3 – 6-foot assembly with two 16" butterfly valves on either end and a T section with 12" gate valve. Center of T to gate valve is 25 inches. Center of butterfly to butterfly valve is 72 inches. Note that this assembly will not be installed today due to drain pipe break.

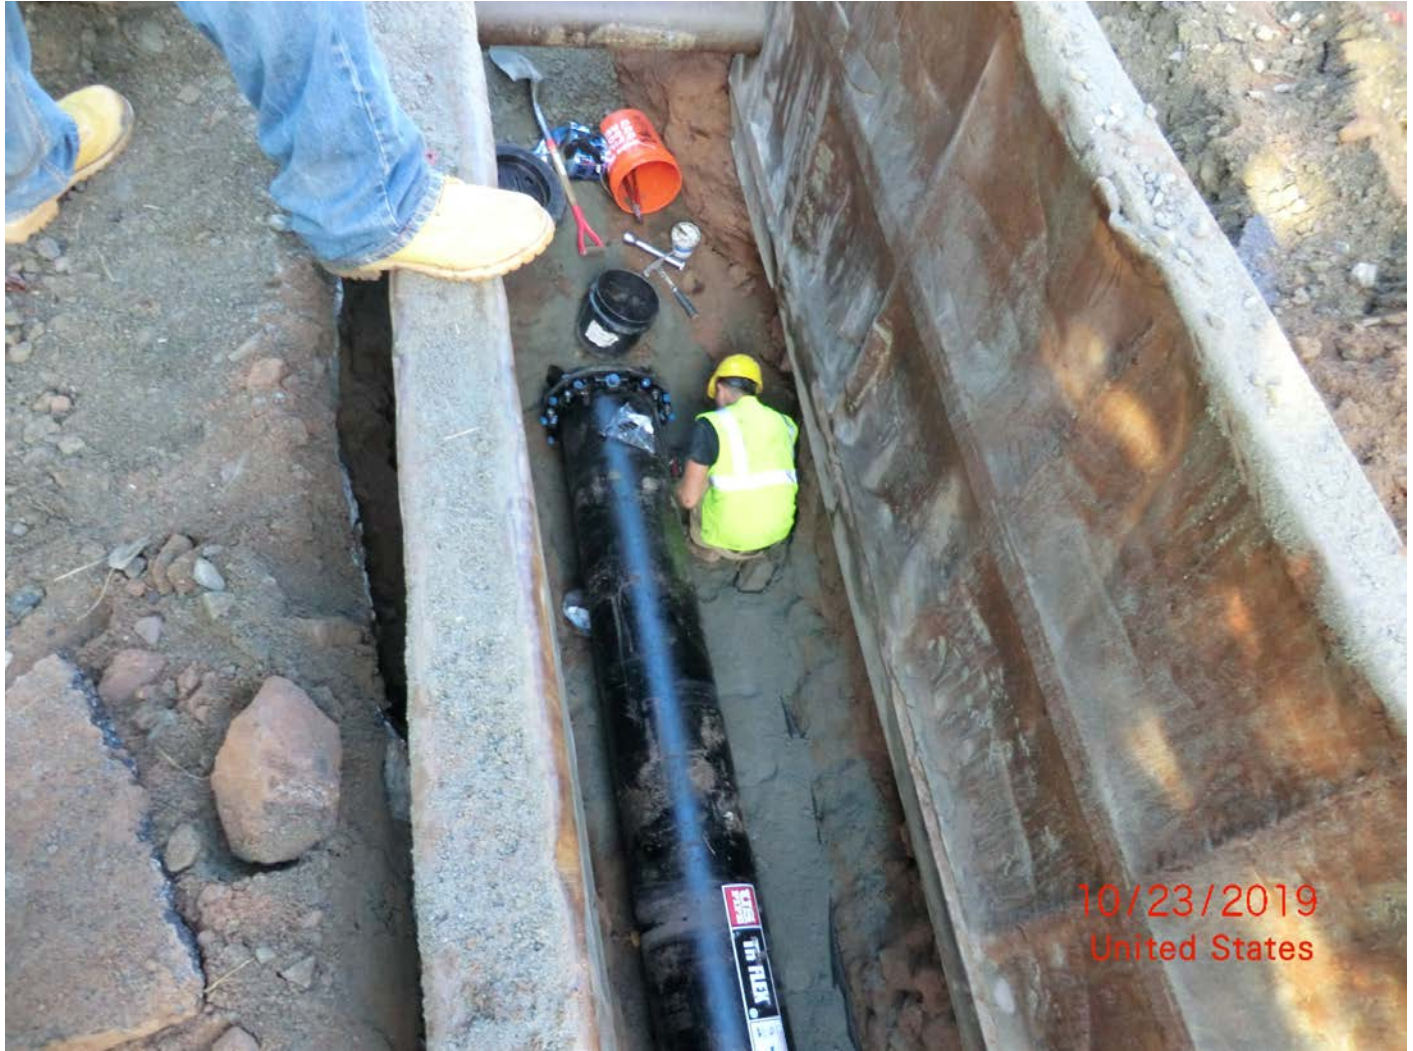
Figure 4 – Picture facing west into trench. Attaching restrained pipe to first 22.5 bend using a mega-lug.

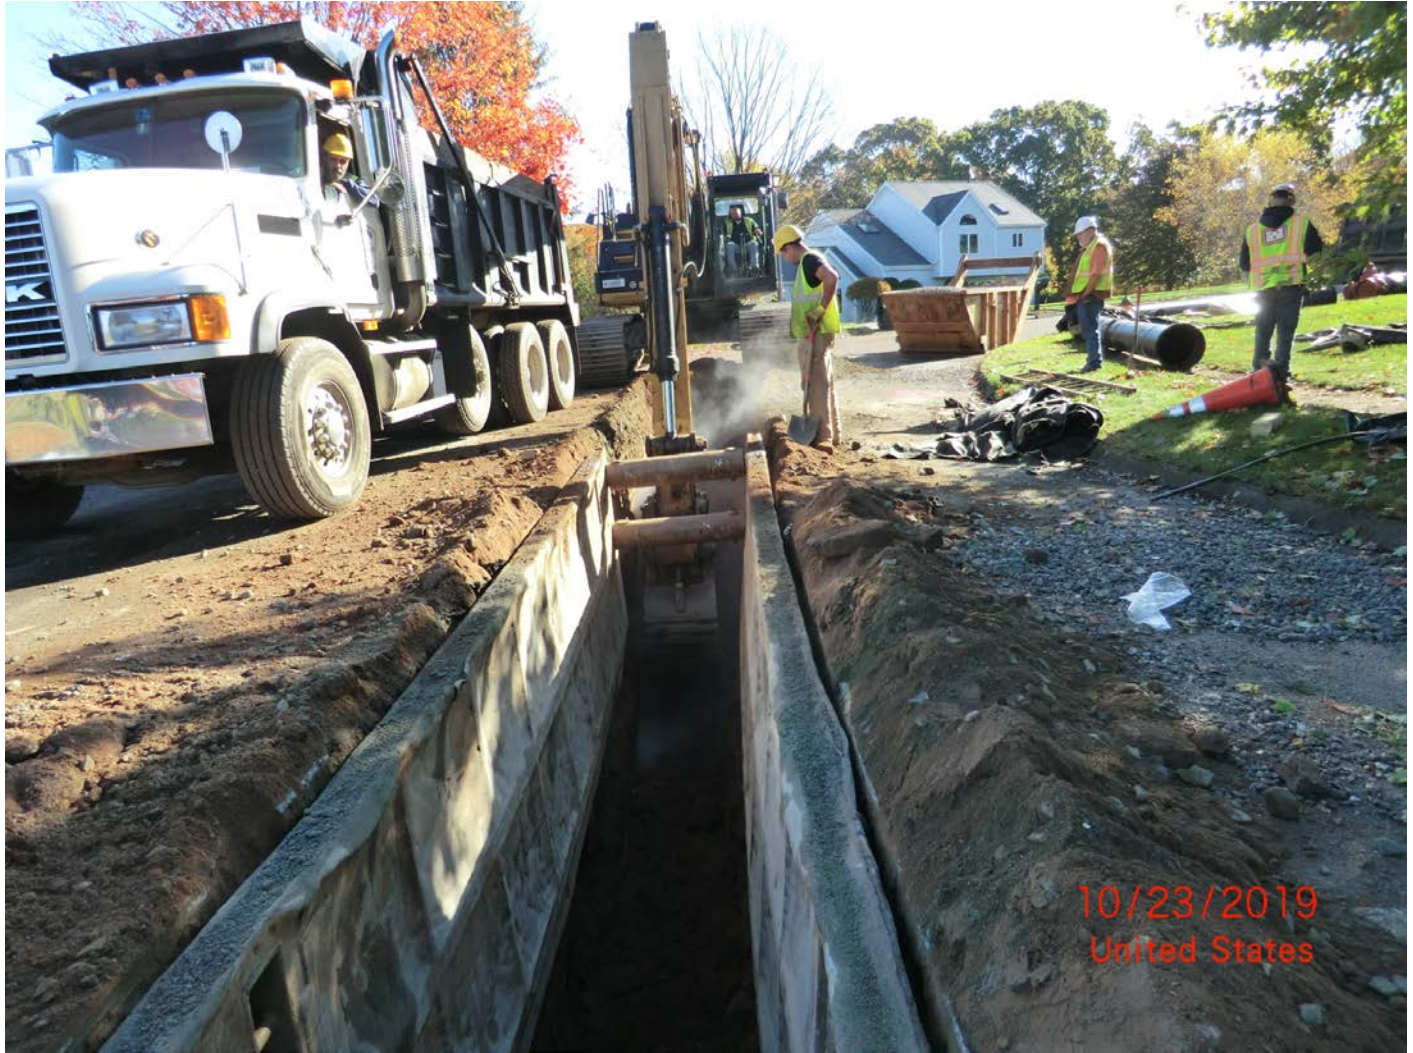
0950 – Have 30-35 feet of open trench. Hitting bedrock along the way, starting roughly at Sta. 41+14. Bedrock is fairly deep and does not appear to be much of an impedance.

Figure 5 – Facing northeast. Extended trench, longer than usual, excavating for shallow drain pipe and positioning of shorter road boxes. Notice the ‘smoke’ coming off the excavator bucket. This is the excavator bucket scraping along bedrock.

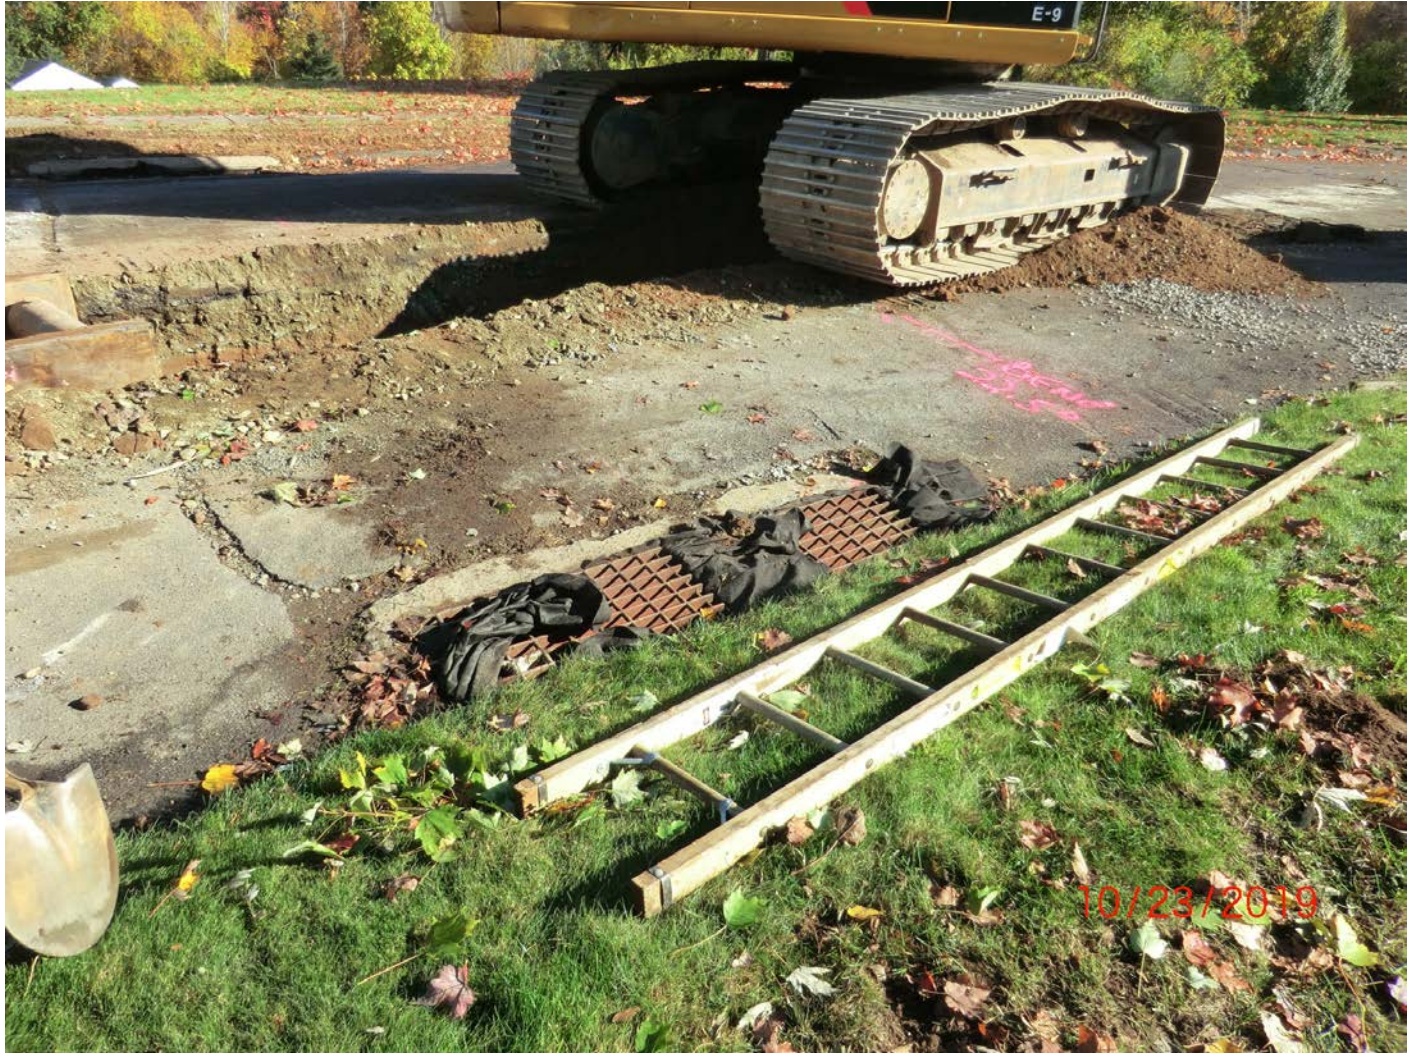
**Sediment Control:** Added to double catch basins either side of Talcott Ridge Drive at the bend in the road to the south.

**Figure 6 – Catch basin silt prevention on bend in Talcott Ridge. Note basin across street is connected by drain pipe shown in Figure 8.**

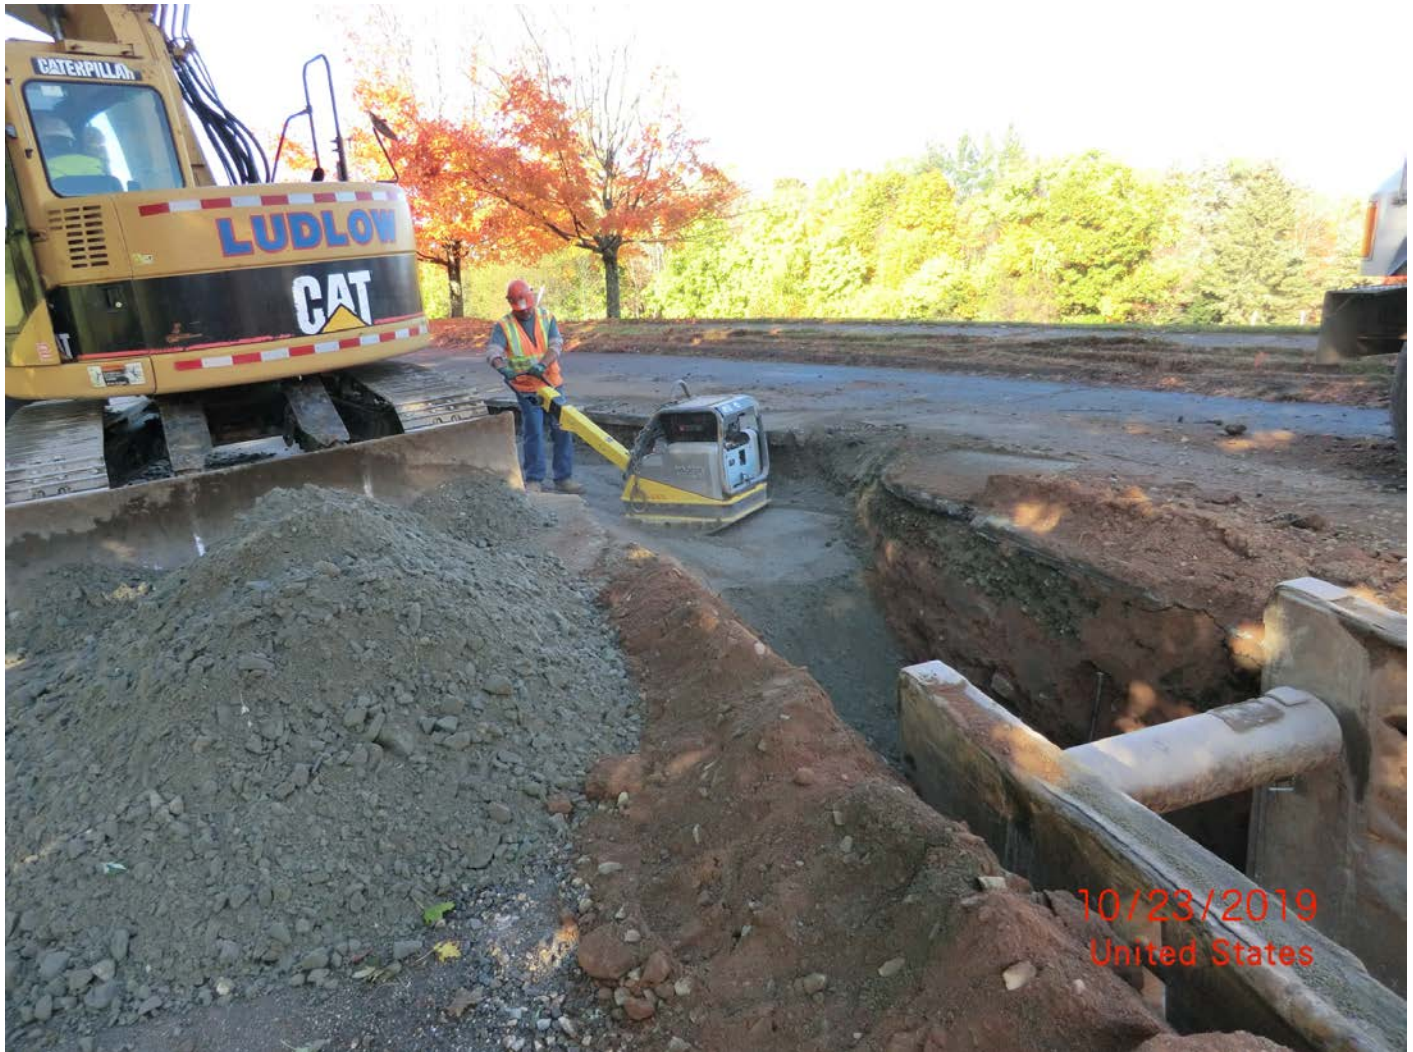
Figure 7 – Facing North. Plate compaction

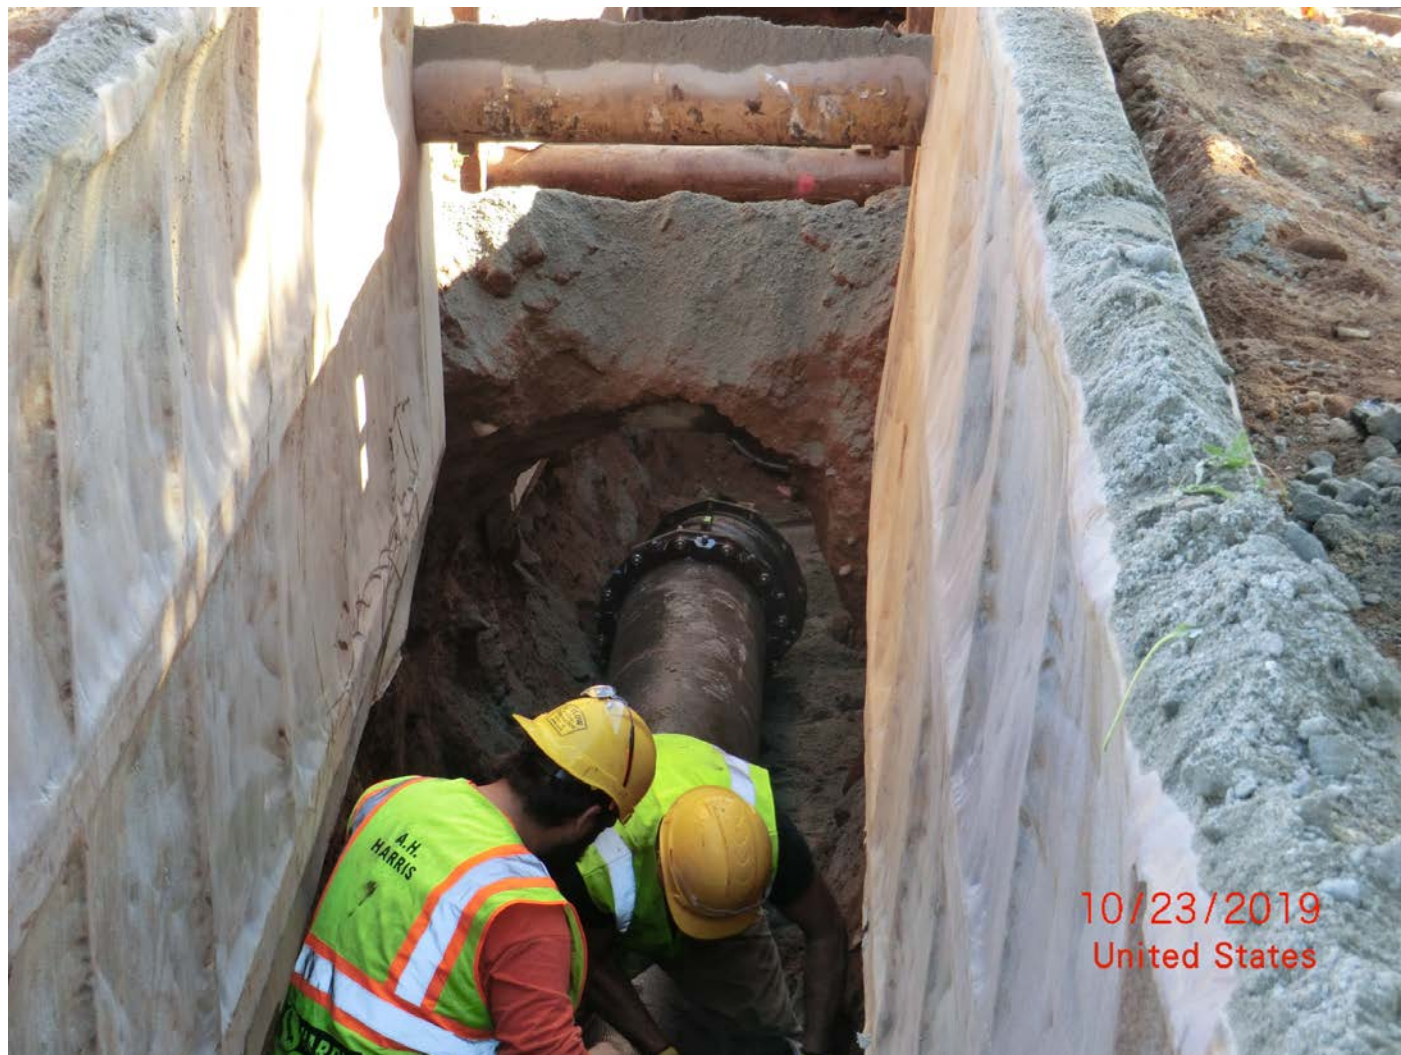
1005 – Installing full 20-foot section of restrained 16” DI installed to Sta. 40+88.67. Next section of pipe will cross under 18” drain pipe connecting the two double catch basins located either side of Talcott at the curve in the road.

Figure 8 – Facing east into trench. Restrained connection, 22.5-degree bend, center of picture, crossing under drain pipe that connects two double catch basins located either side of Talcott where the road turns to the south.

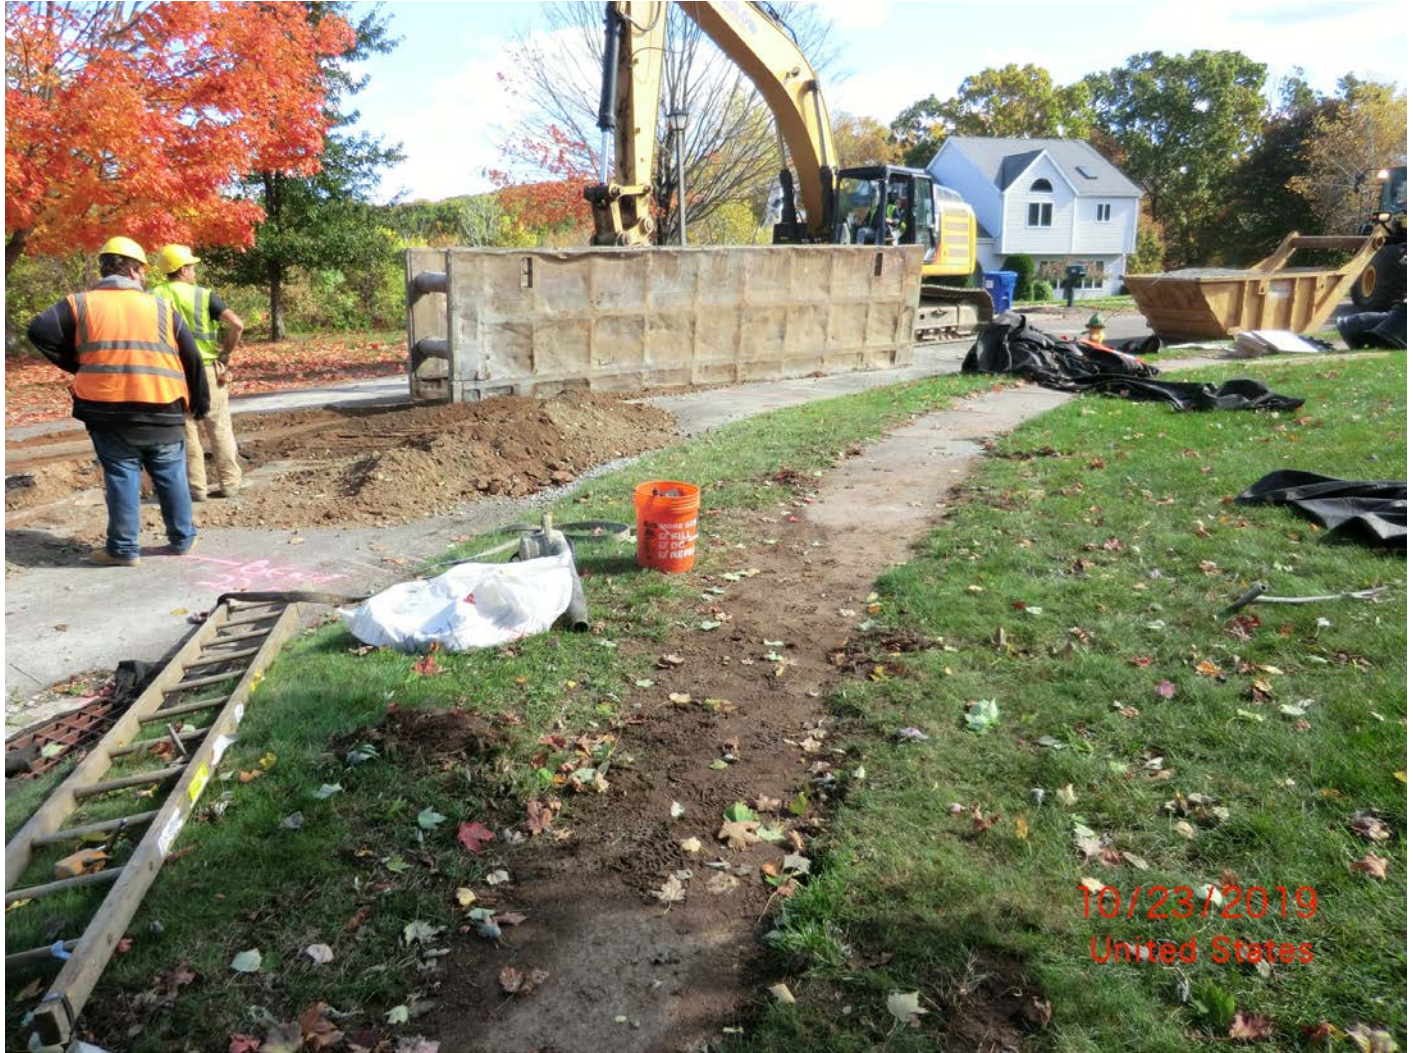
Figure 9 – Facing east-northeast. Maneuvering 24-foot trench box.

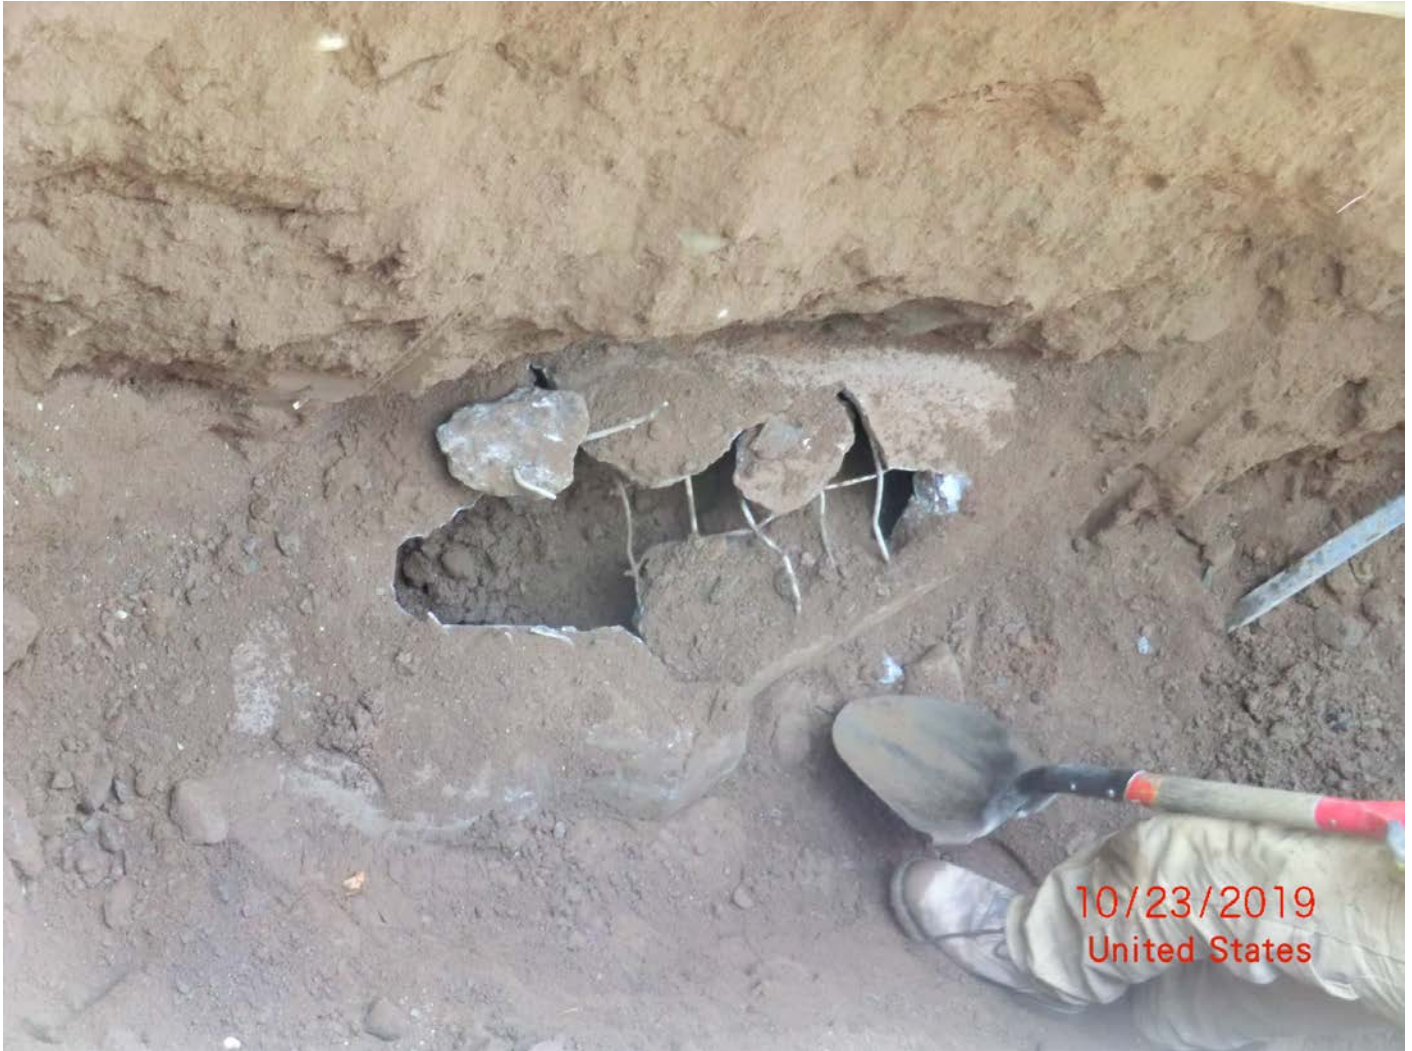
**Drain Pipe Break:** Accidentally broke 18” drain pipe at 10 feet below grade. Trench was being deepened to allow for passage under existing 8” hydrant line and 12” main line at bend in Talcott Ridge Drive from east to south.

1210 – Excavating for next section of pipe. Due to the need to soon cross under an existing hydrant service line and an existing water main the trenching depth was increased. However, the depth went a little to far and an 18” drain line coming from the double catch basin was hit, breaking a hole roughly 1 foot wide by 3 feet long. A measurement was taken from the 22.5<sup>0</sup> bend to determine if one more section of pipe could be installed as the trench was already opened, but the break occurred at almost exactly 20 feet meaning the bell of the pipe would be over the broken drain. This means that the final station for the day was Sta. 40+71.71 and the broken drain pipe was at approximately Sta. 40+52.

**Figure 10 – Broken 18” drain line located at 10 feet below ground surface. Trench depth was being increased to allow for the passage of the 16” DI water pipe underneath the existing 12-inch water main that is buried to 6.5 feet.**

1340 – Bobby Russo (Middletown Public Works) and Billy (Ludlow) agree that an ADS pipe insert will be a good fix for the situation. He leaves his number and business turns to cleaning up for the day. The cleaned out drain pipe is covered by some plywood and stone before being buried and trench filled.

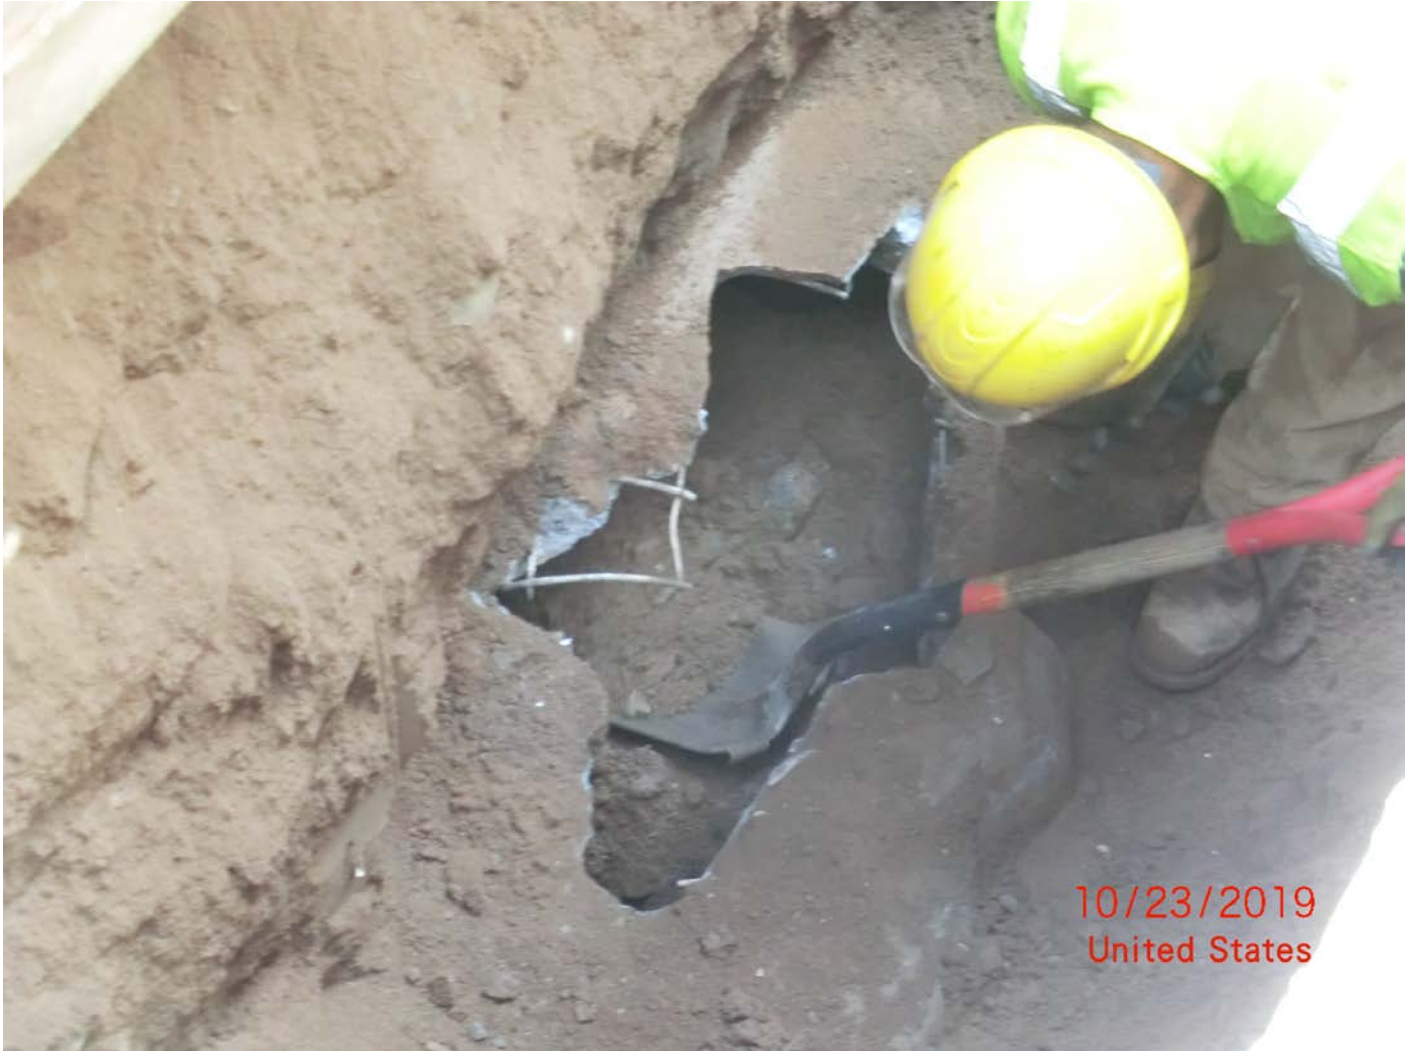
1250 – Working to unbury the break in the pipe and clean the soil out of the pipe. Pipe does not appear to be carrying any water that can be observed. Kurt (USACE) attempted to call Middletown Public Works, but only received an answering machine. He heads off to Public Works to contact them directly.

**Figure 11 –** Some rebar and cement fragments had to be cut from pipe to allow for cleaning the soil out of the pipe. Hole is 8-12 inches wide and about 2-3 feet long. Note that the pipe appears to be dry in this shot and the previous picture.

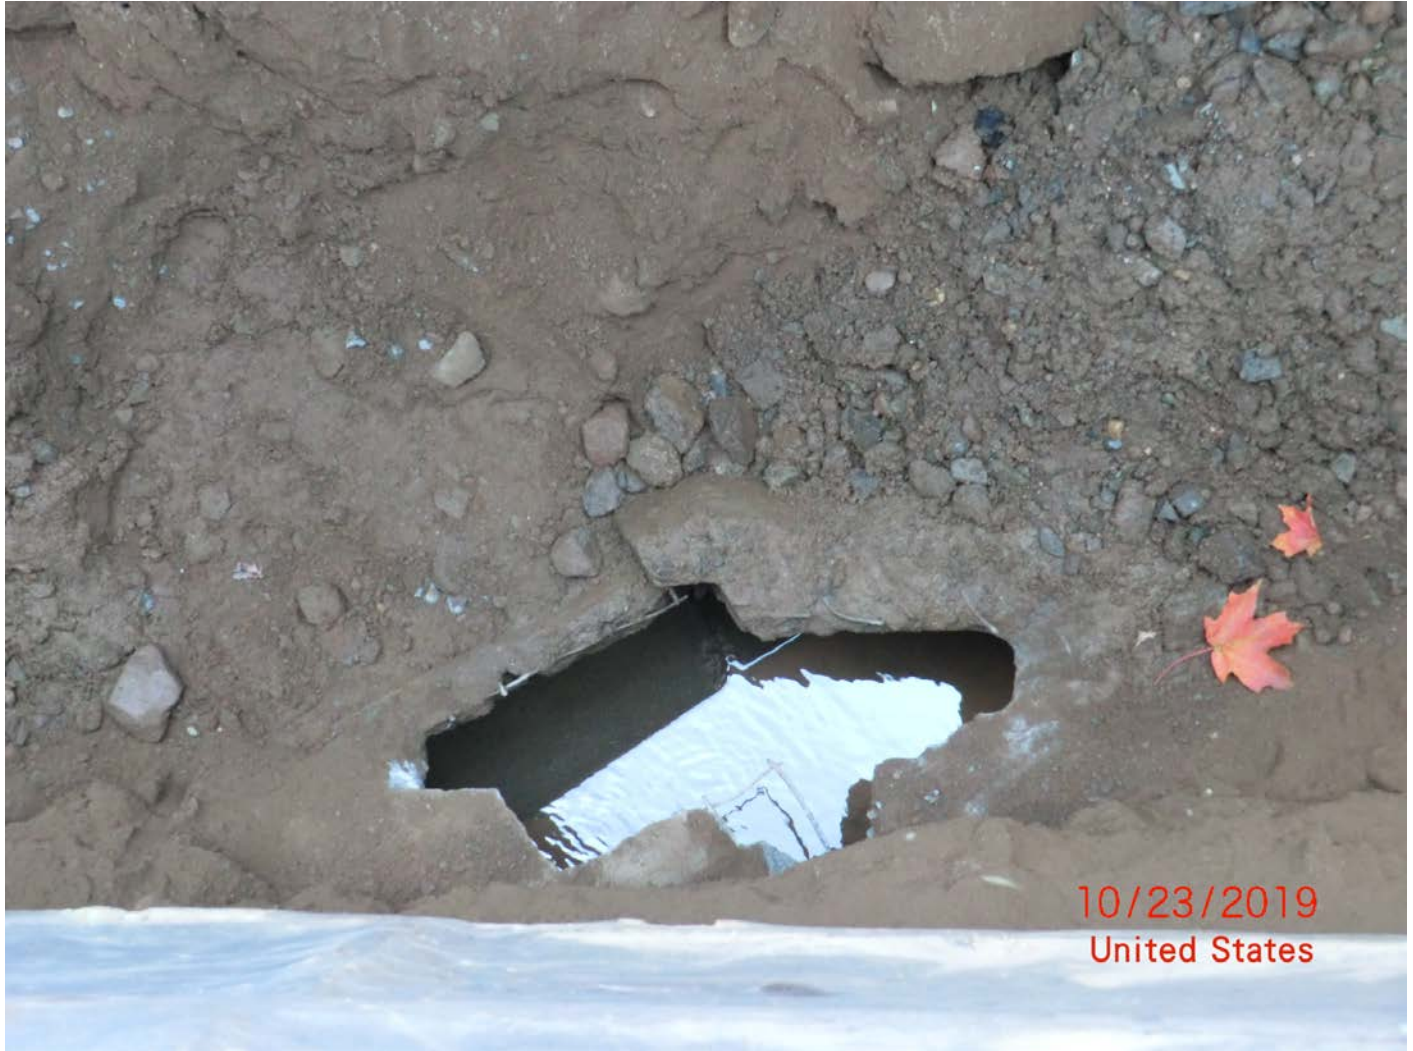
1300 – Andy (Ludlow) making a great effort to uncover and clean out drain pipe of the soil that collapsed into it when it was broken. Up until now the pipe appeared to be dry, but there is a steady stream of water now working its way through the pipe.

Figure 12 – Broken drainage pipe. During the cleaning out of the pipe water started to appear. Unclear as to why it didn't appear to be wet initially after the collapse.

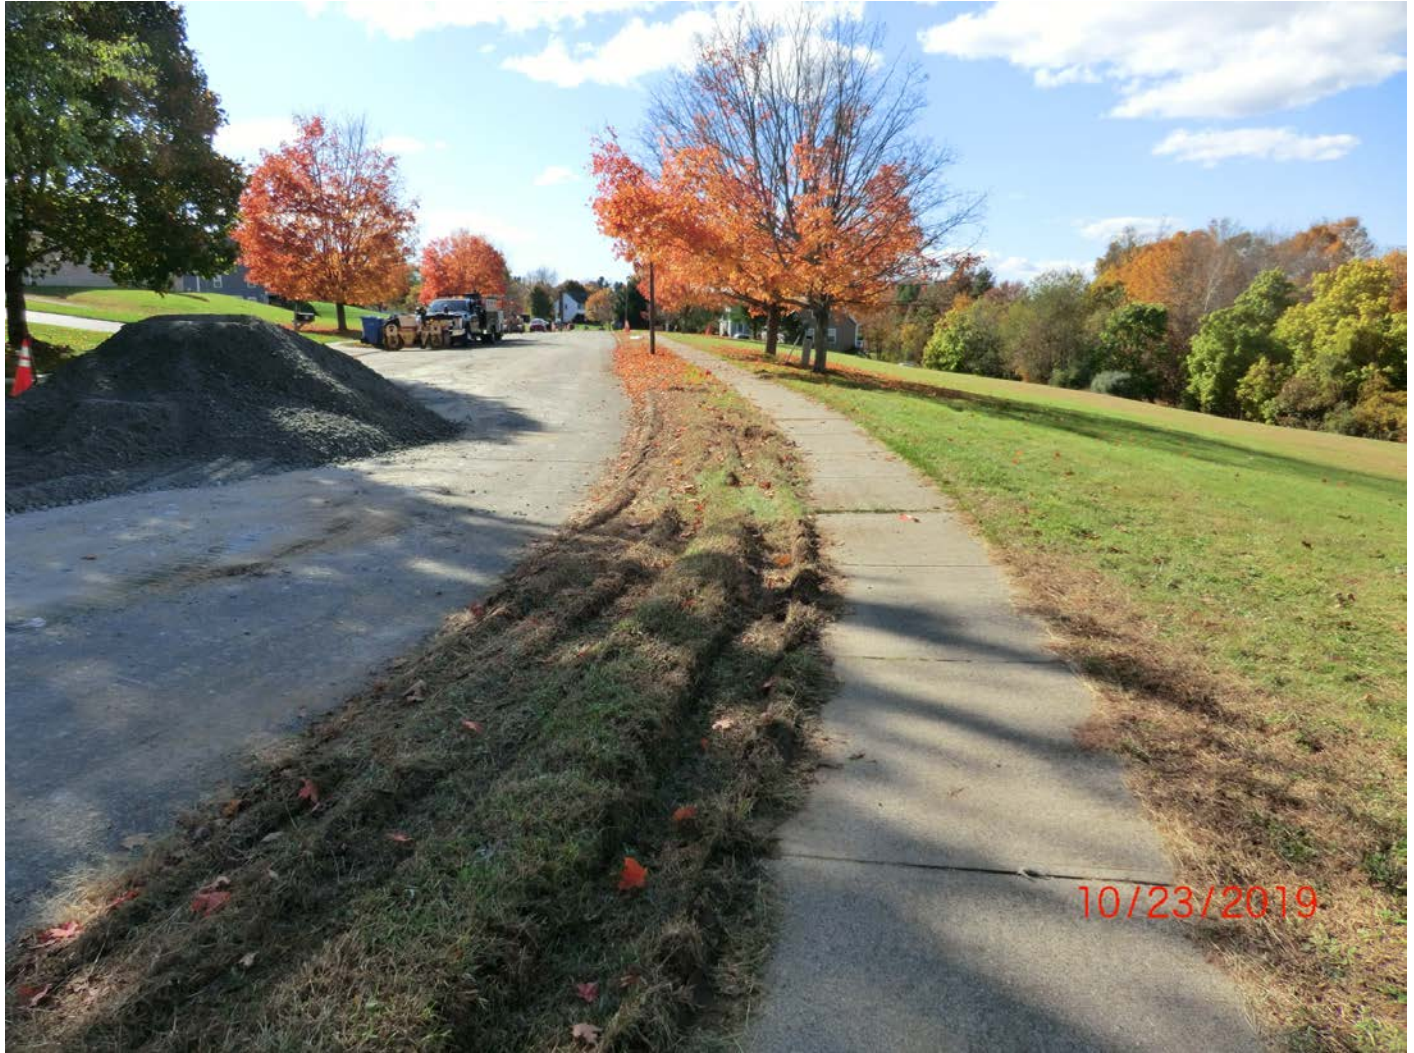
**Figure 13 – Looking west, downhill along Talcott Ridge, ruts in grass along edge of road. Ruts due to dump trucks having to maneuver around the excavator on the tight corner.**
