## Daily Report

<b>Project:</b>	Durham Meadows Pipeline Installation	<b>Date:</b>	November 07, 2019
<b>Location:</b>	Talcott Ridge Drive, Middletown CT	<b>Day of Week:</b>	Thursday
<b>Project #:</b>	AECOM: 60445033	<b>Report No:</b>	26
<b>Contractor:</b>	Ludlow Construction	<b>Page:</b>	1 of 17

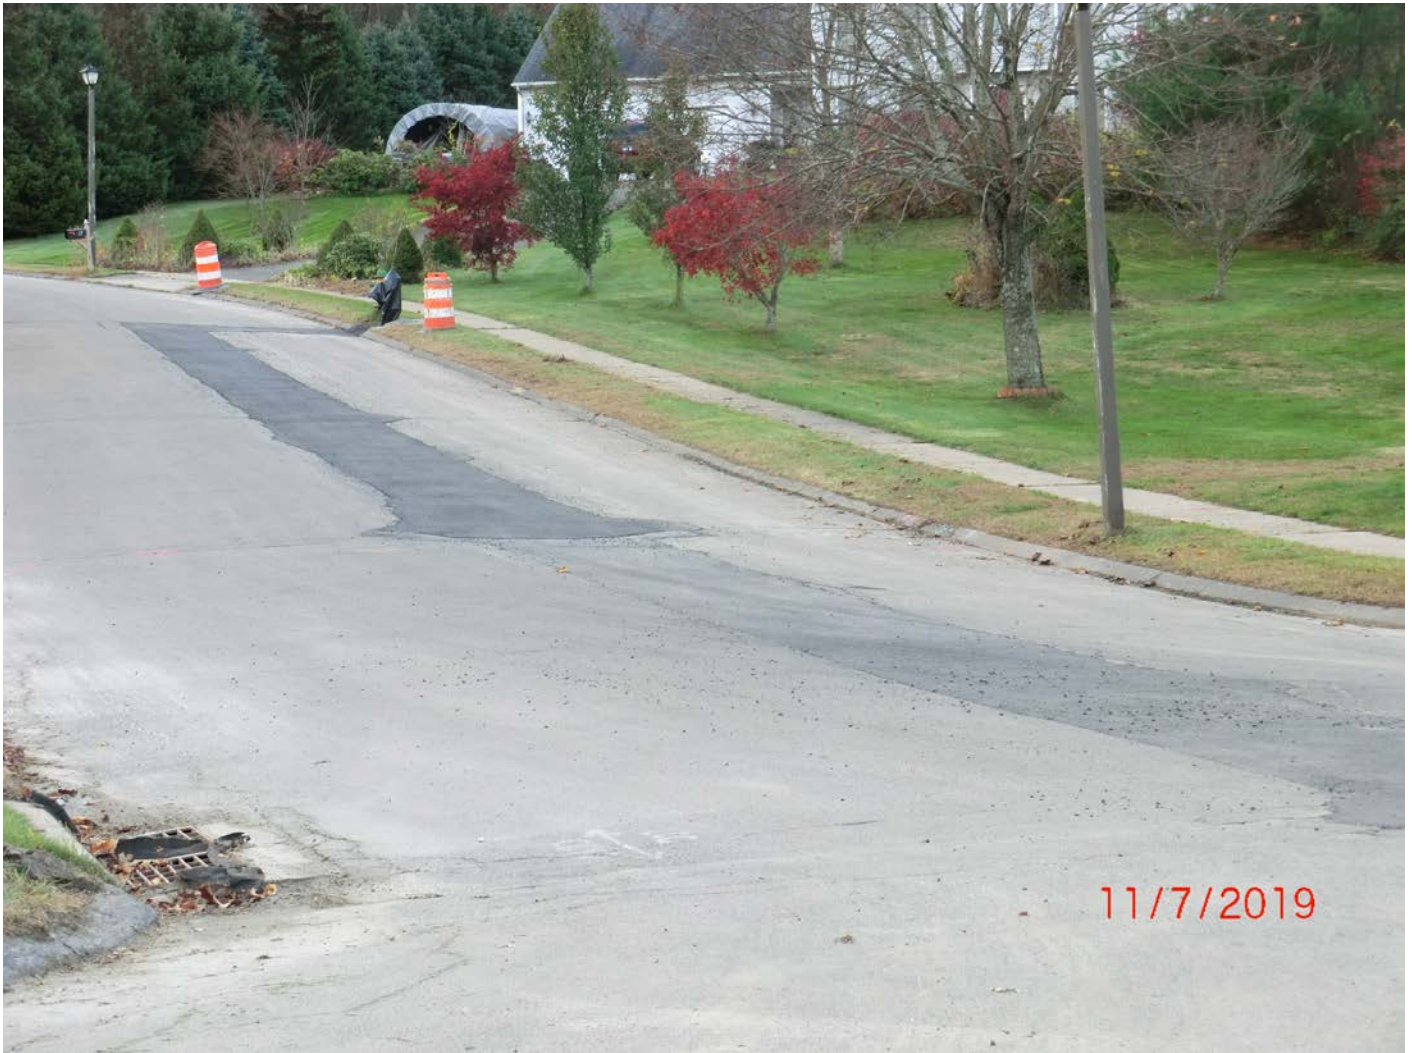
Figure 1 – Facing south-southwest. 8”-DI pipeline up lower Watch Hill Drive to new hydrant.

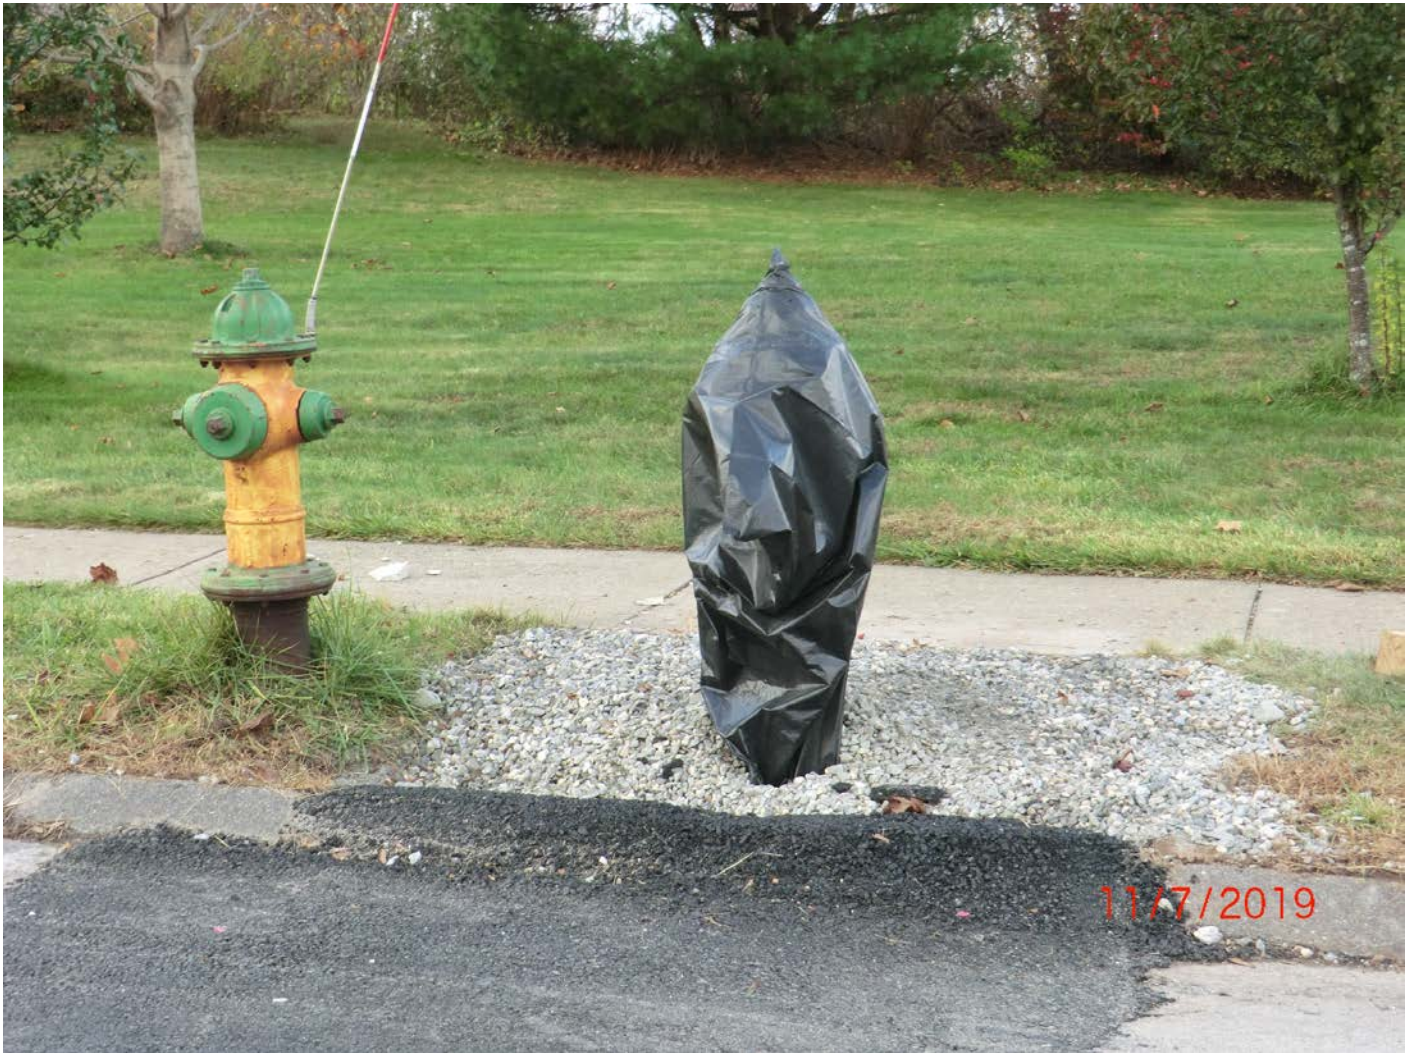
Figure 2 – Facing south – New hydrant installation on lower Watch Hill Drive.

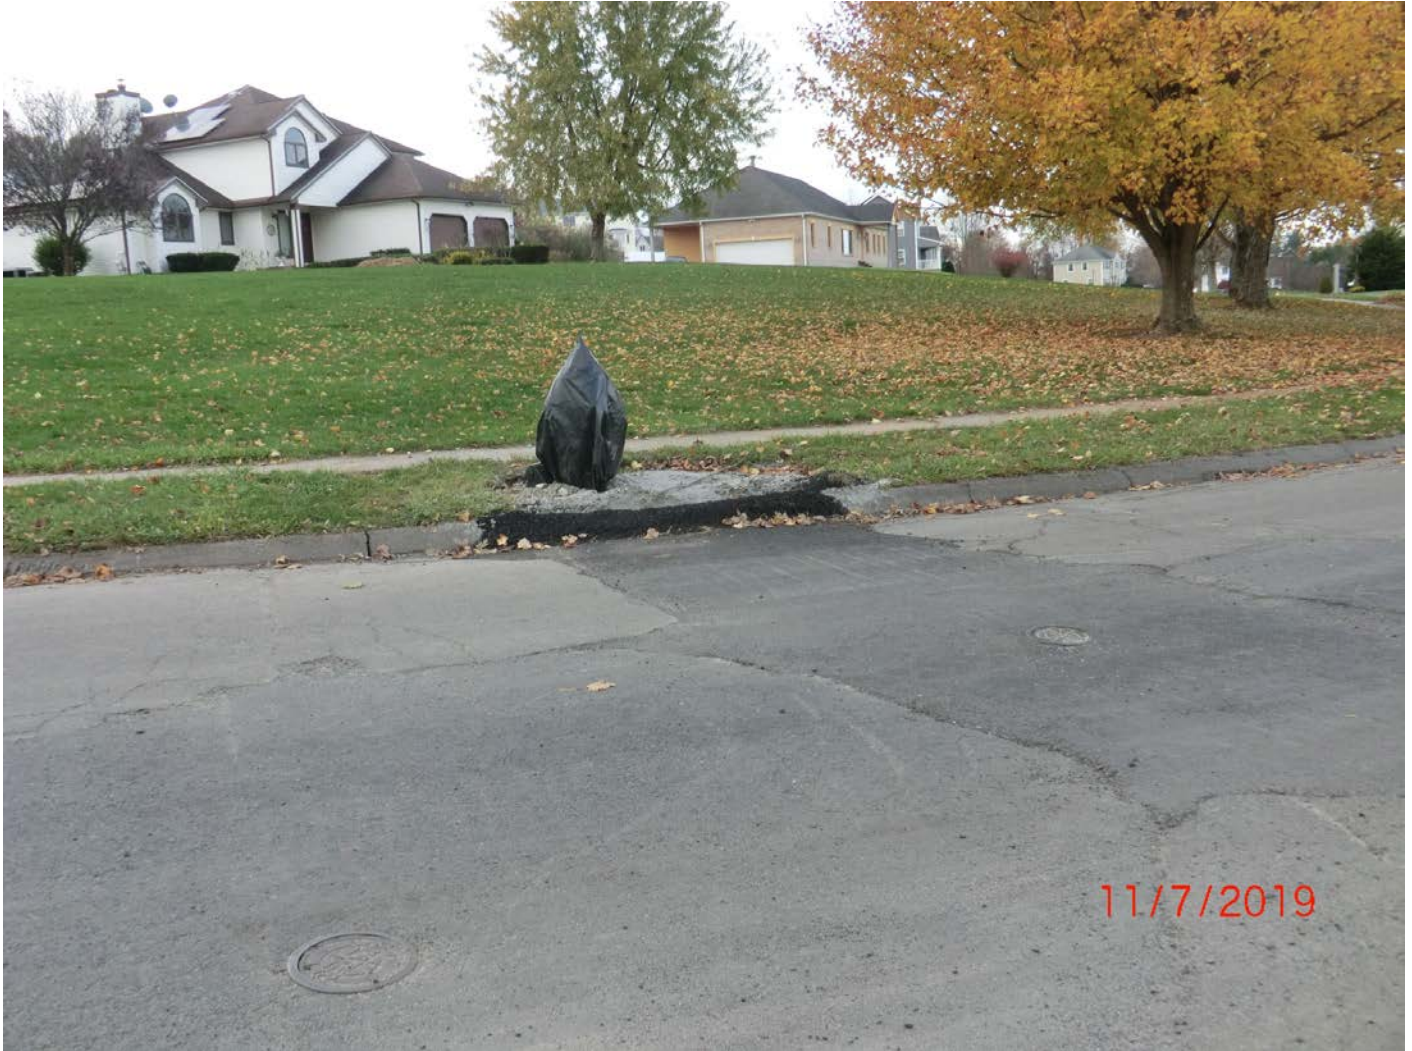
Figure 3 – Facing northwest. New hydrant installation on Talcott Ridge Dr. at intersection with upper Watch Hill Dr. (not shown but located to the left of this shot).

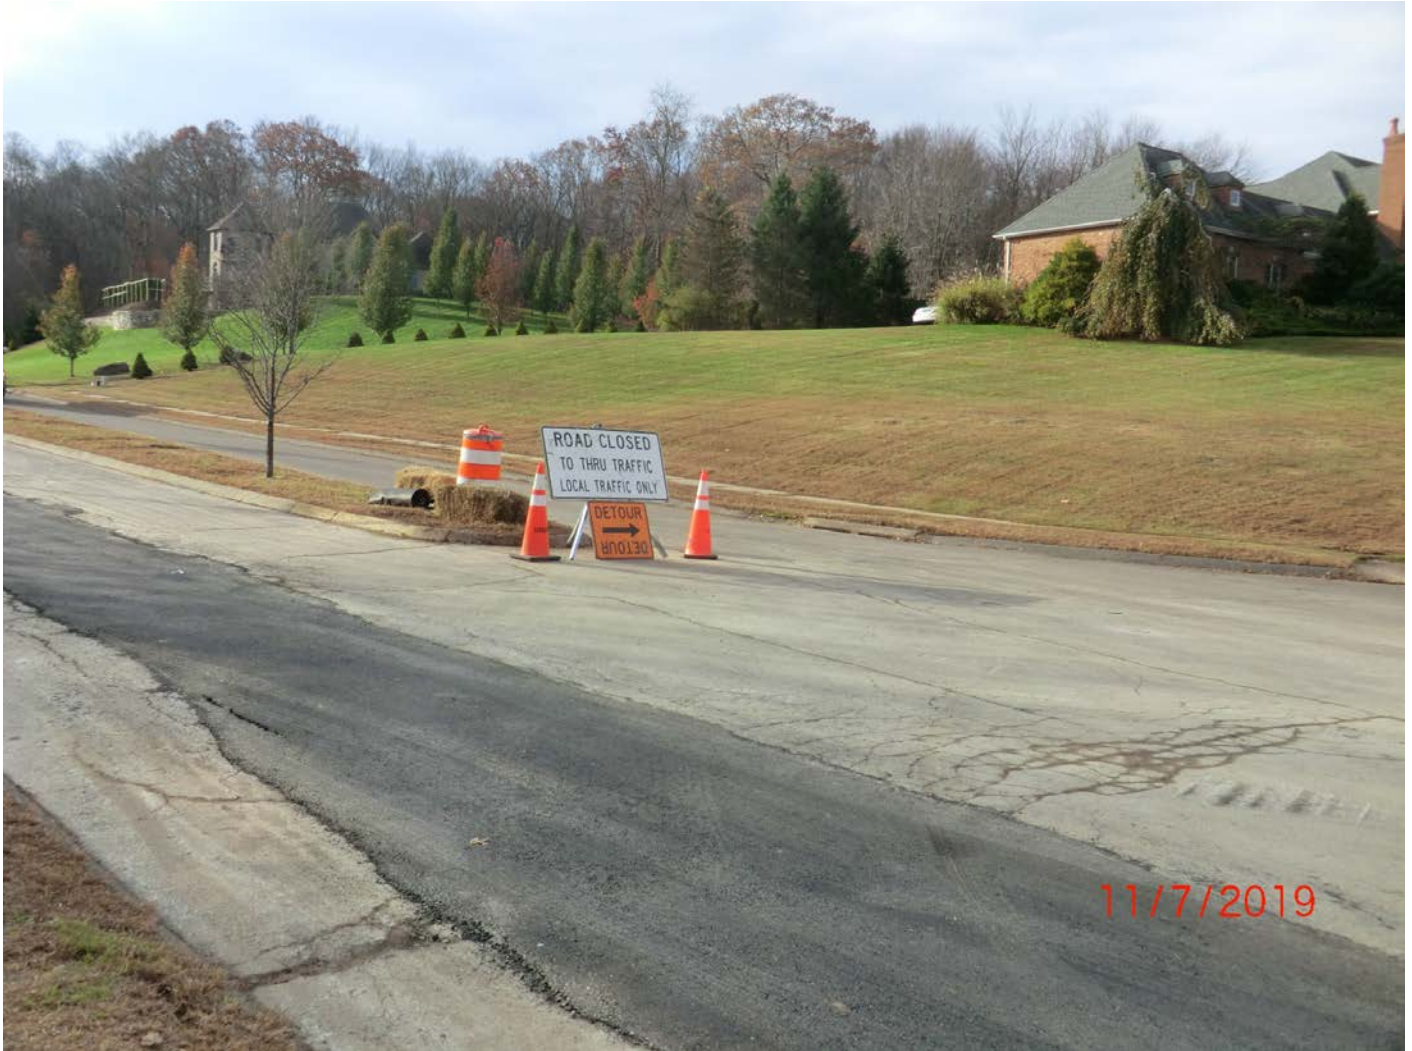
Figure 4 – Facing southwest, road closure sign. Upper Watch Hill Drive to the right of this shot.

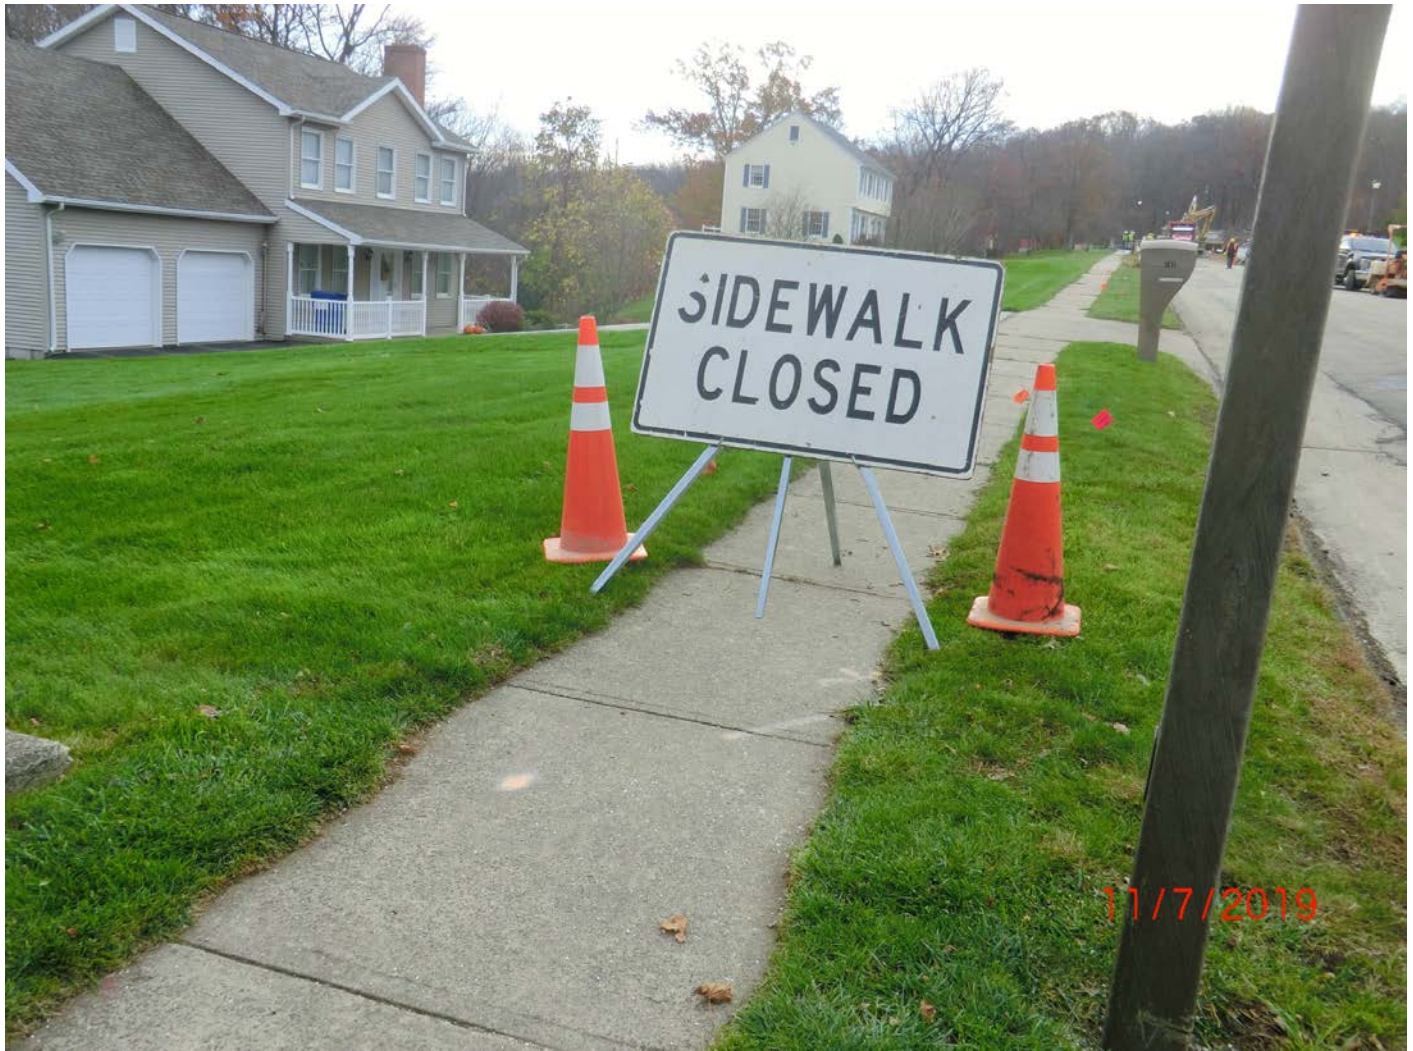
Figure 5 – Sidewalk closure sign. Photo taken facing south.

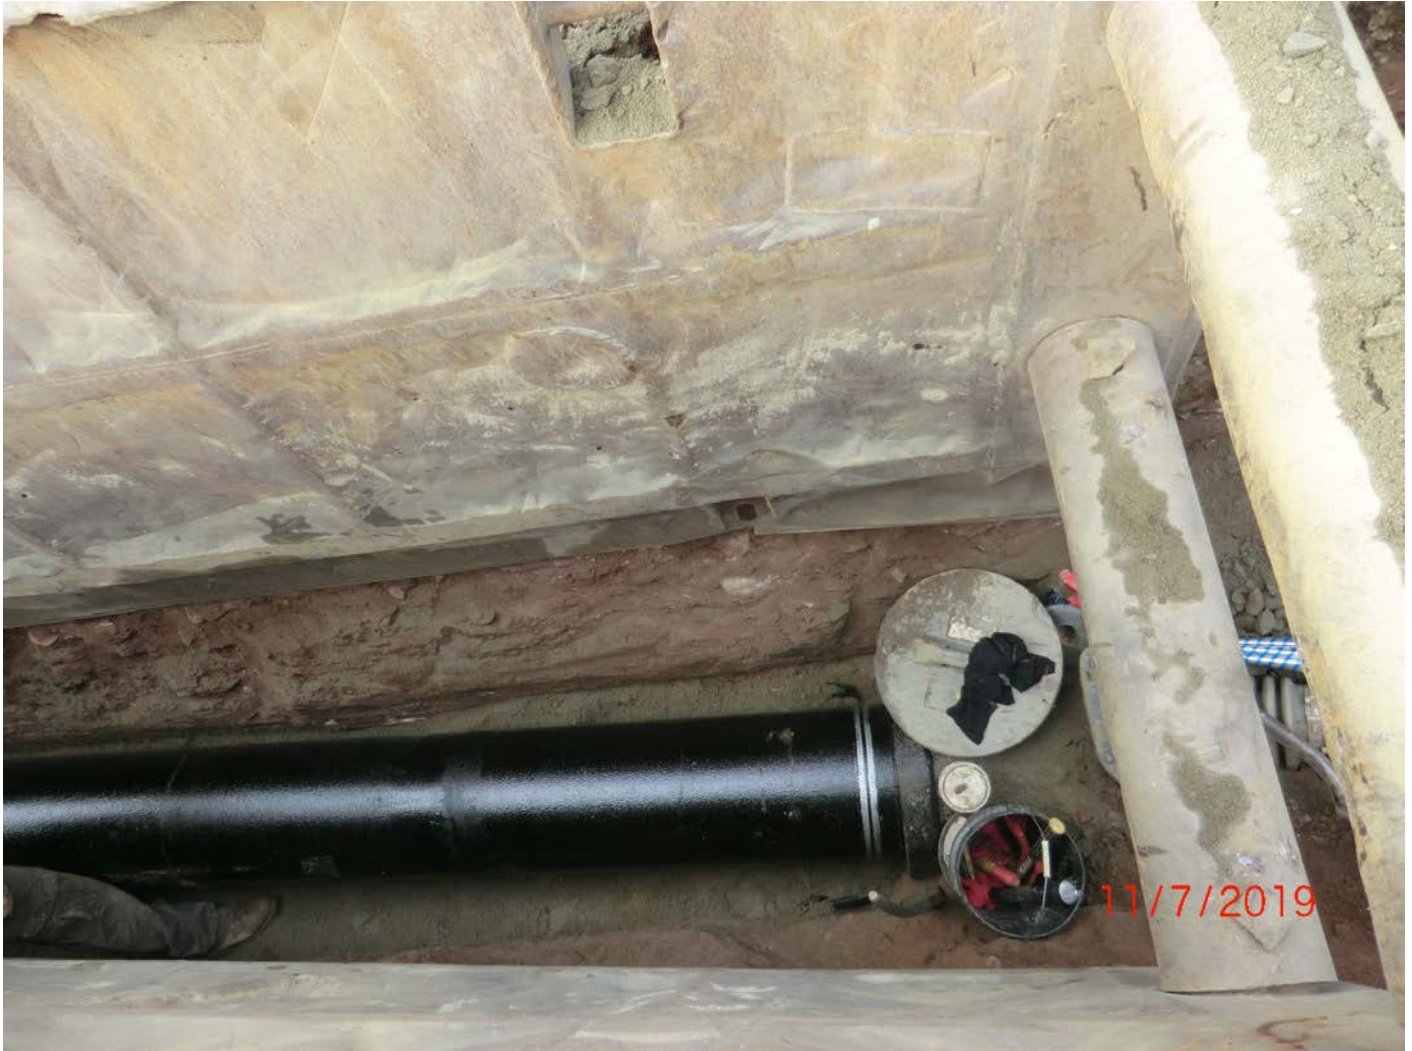
Figure 6 – Setting pipe. Note position of silver rings on pipe. This indicates that the pipe has not yet been fully seated into bell to right.

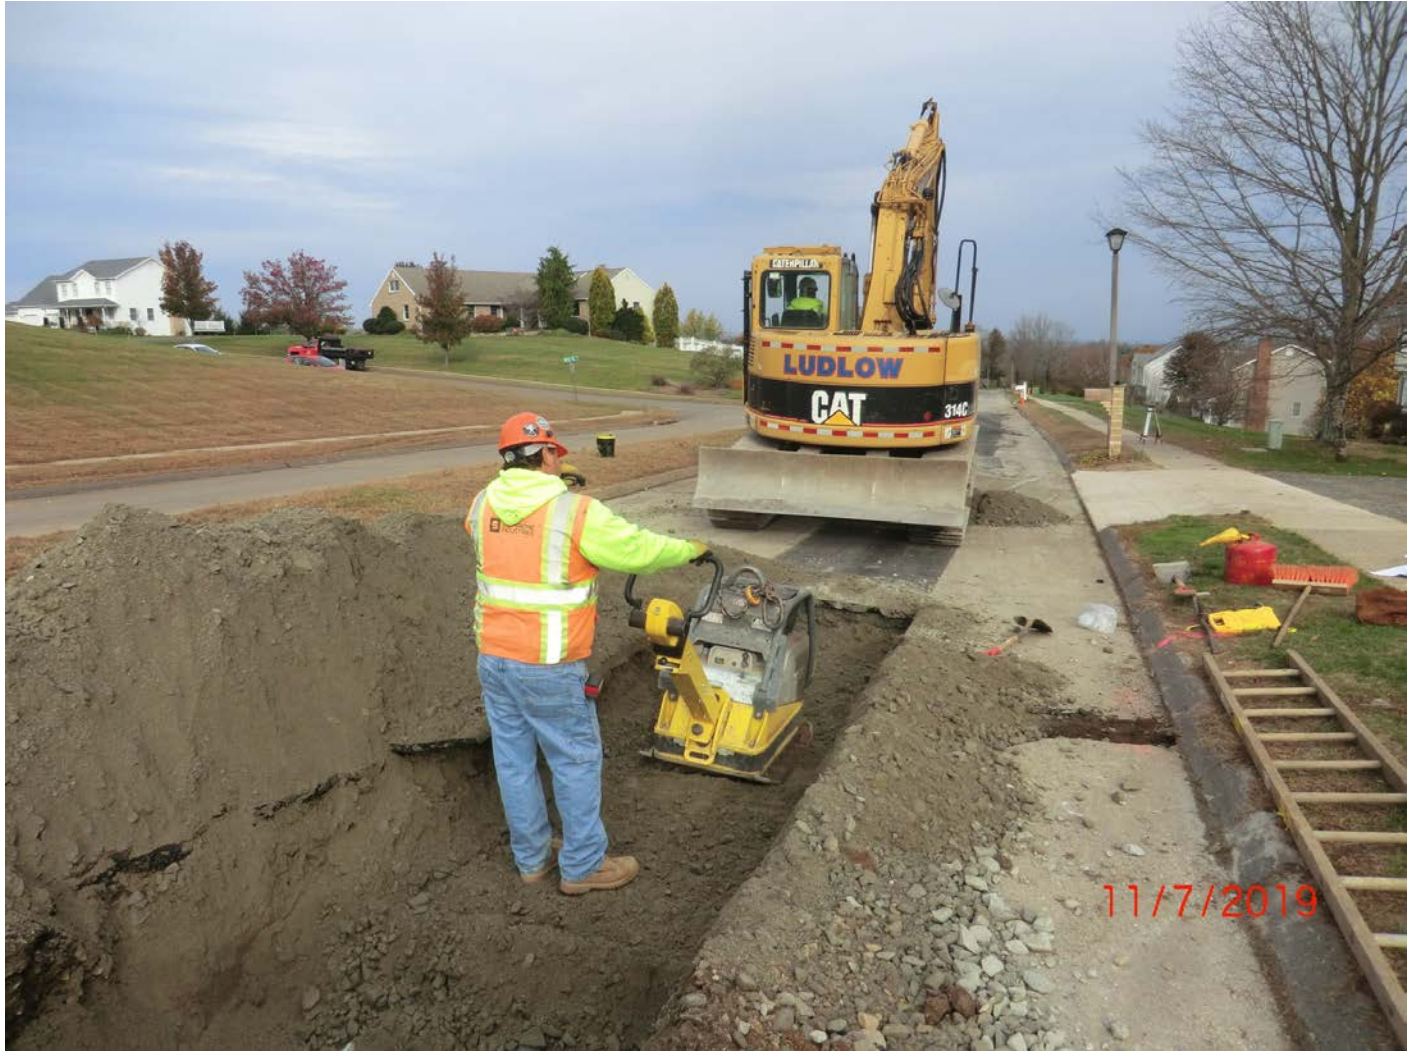
Figure 7 – Facing north. Lift compaction with Wacker plate compactor. Upper Watch Hill Drive seen in background to left.

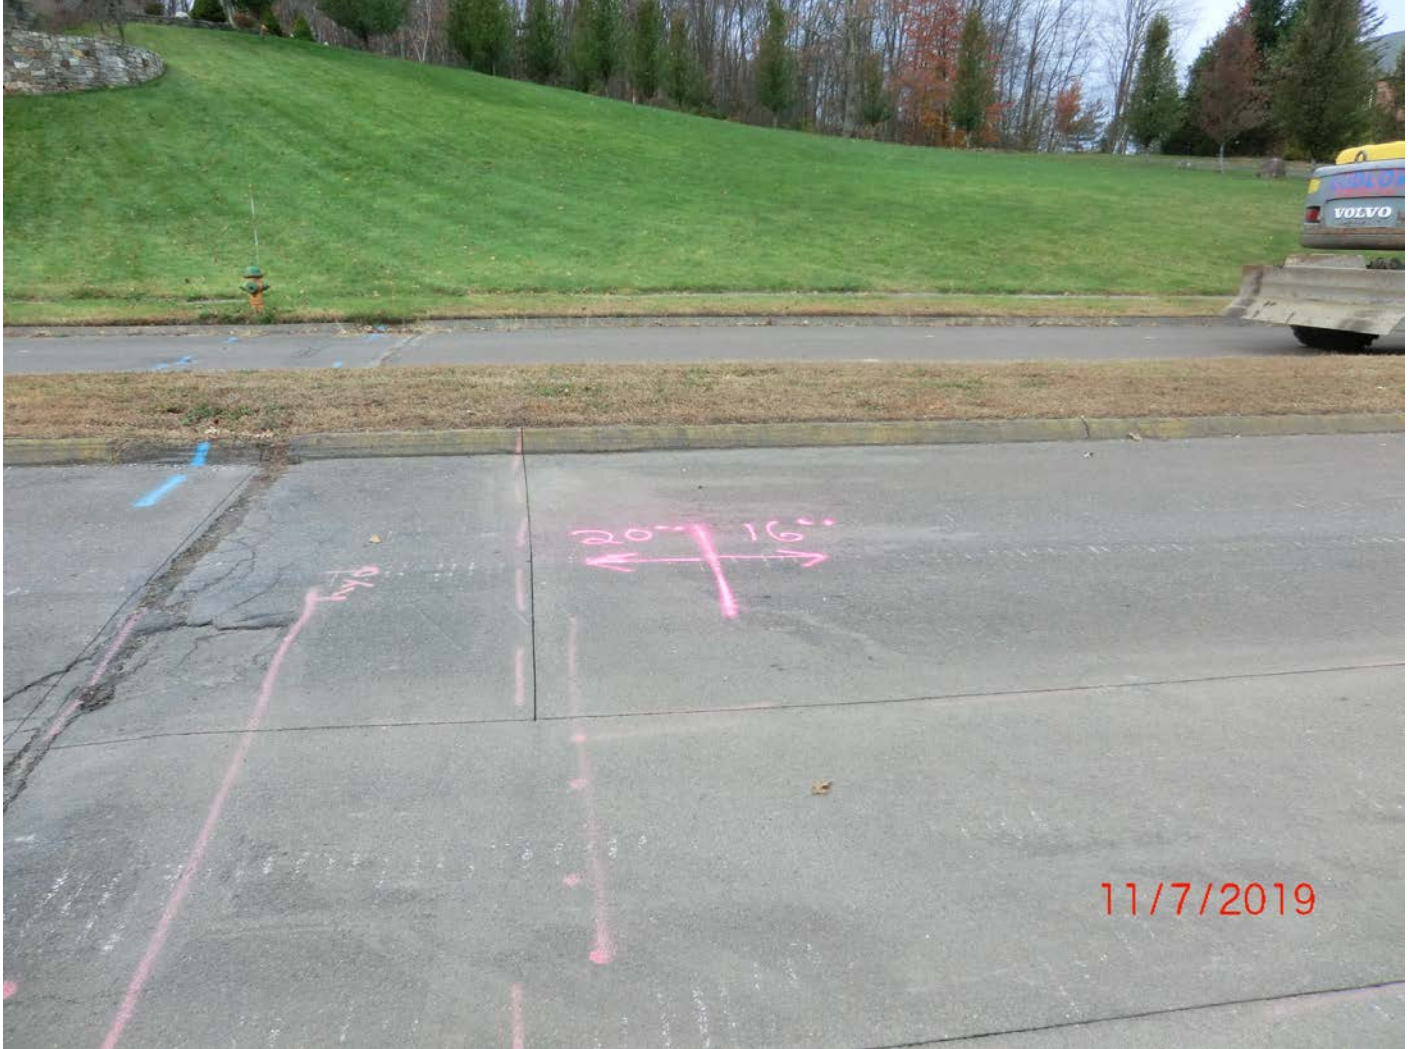
**Pipe Connections:** Restrained pipe connections were used on the first 3 pipes installed today ending at station 33+44.62. The final pipe installation was unrestrained. Unrestrained will return to restrained piping just before pipe size increases to 20” DI at road station 31+84.

Figure 8 – Mark out for cross over from 16” to 20” DIP. Will not likely be reached by end of week given issues with solid bedrock and a number of utility crossings between current location and here.

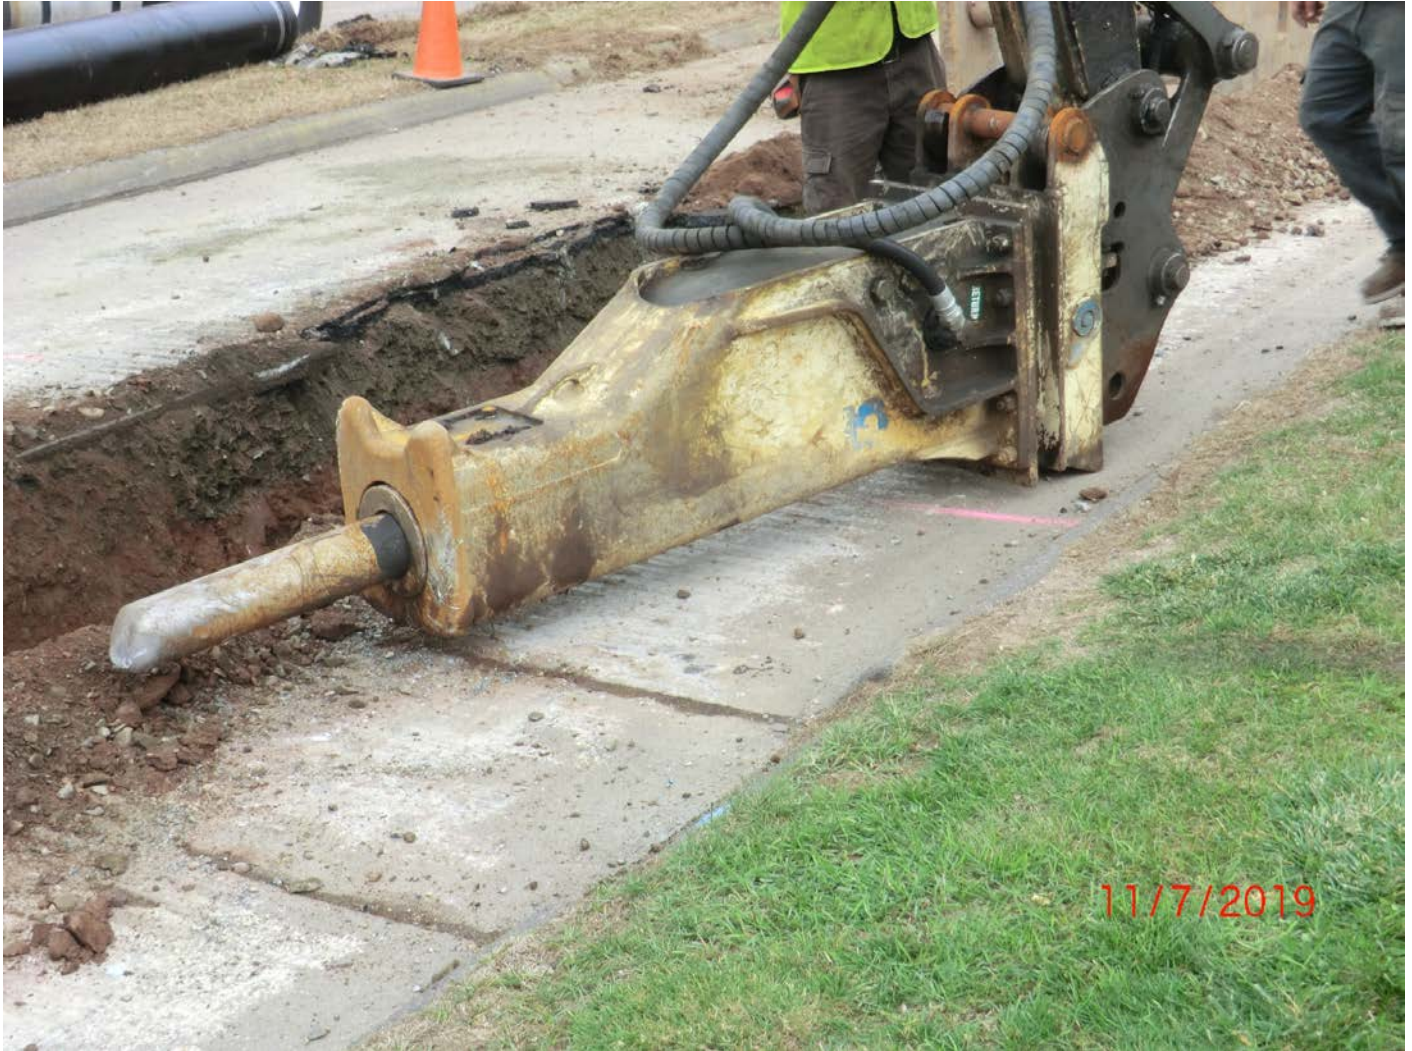
1030 – Break time. Progress slowed by rising bedrock in the trench. Wheeled excavator fitted with a Ram hammer was needed to break up bedrock for removal where the large excavator failed to be able to dig out directly. Also a water service line crossing had to also be dug and hammered around.

**Figure 9 – Ram hammer used to break up bedrock for removal. Process often requires a widening of the trench to be able excavate the width to insert the 16” DI.**

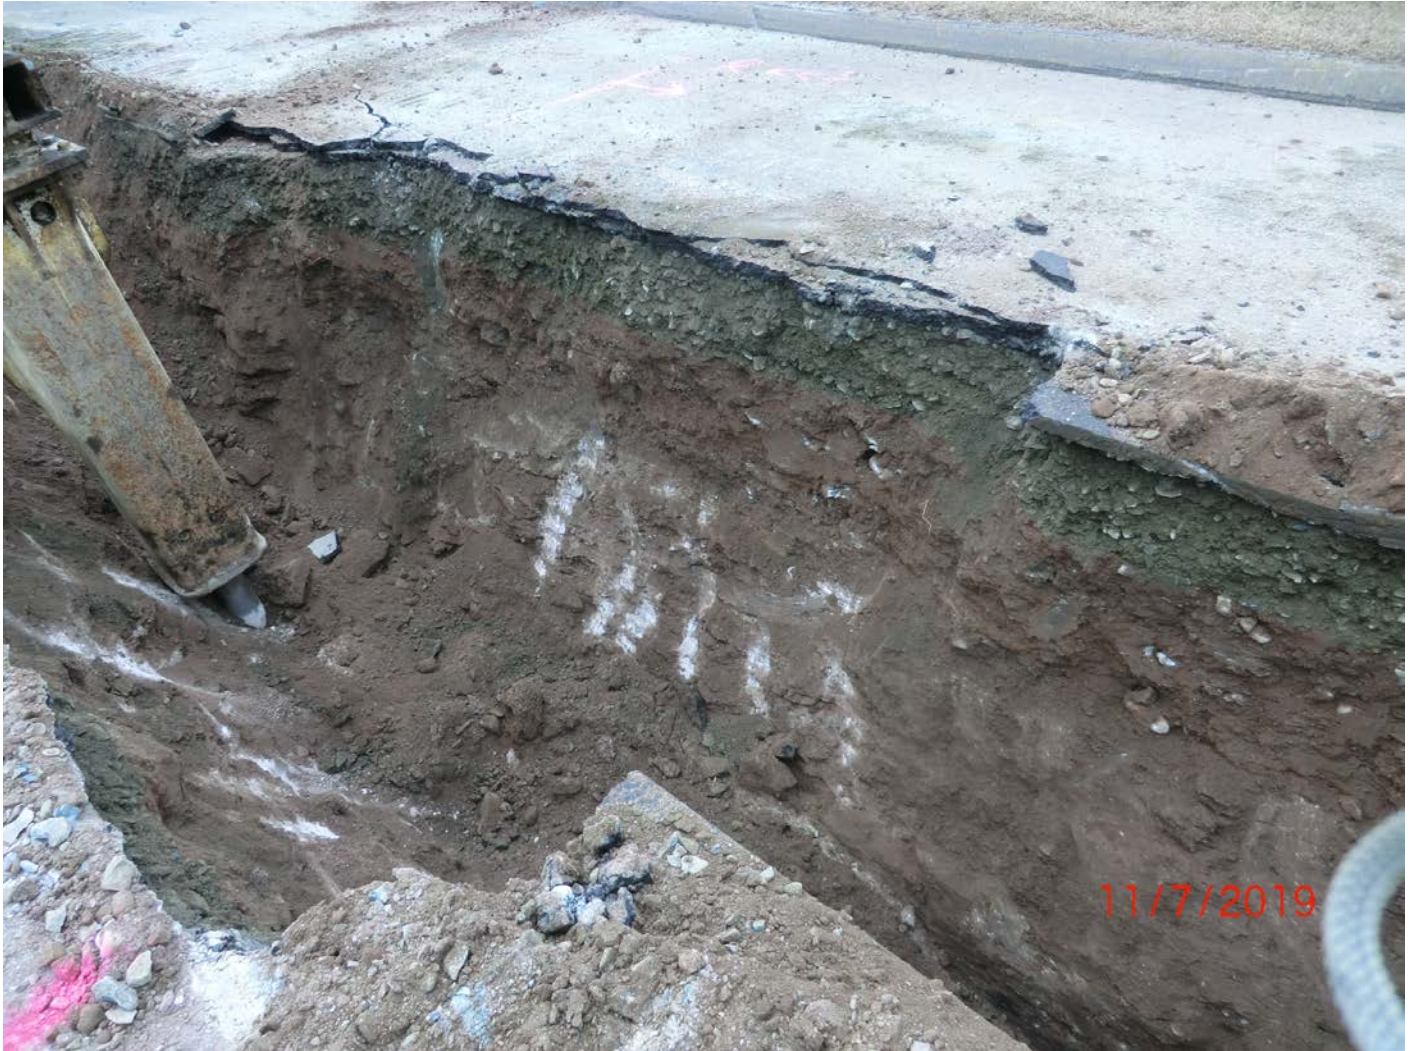
1310 – Setting 4<sup>th</sup> and final stick, this time unrestrained 16” DI to final station 33+24.62. Bedrock was a considerable time slow down. Depth to bedrock was anywhere from 8 feet to 2 feet. A very rough estimate of volume assuming a 4 foot wide trench would be about 60 yards, however, in discussion with Billy (Ludlow) he will have numbers tomorrow for quantity excavated.

**Figure 10 – Facing southwest, bedrock encountered at shallow depth along todays run. Scraped trench sides show the extent of bedrock, which starts just under the red unit.**

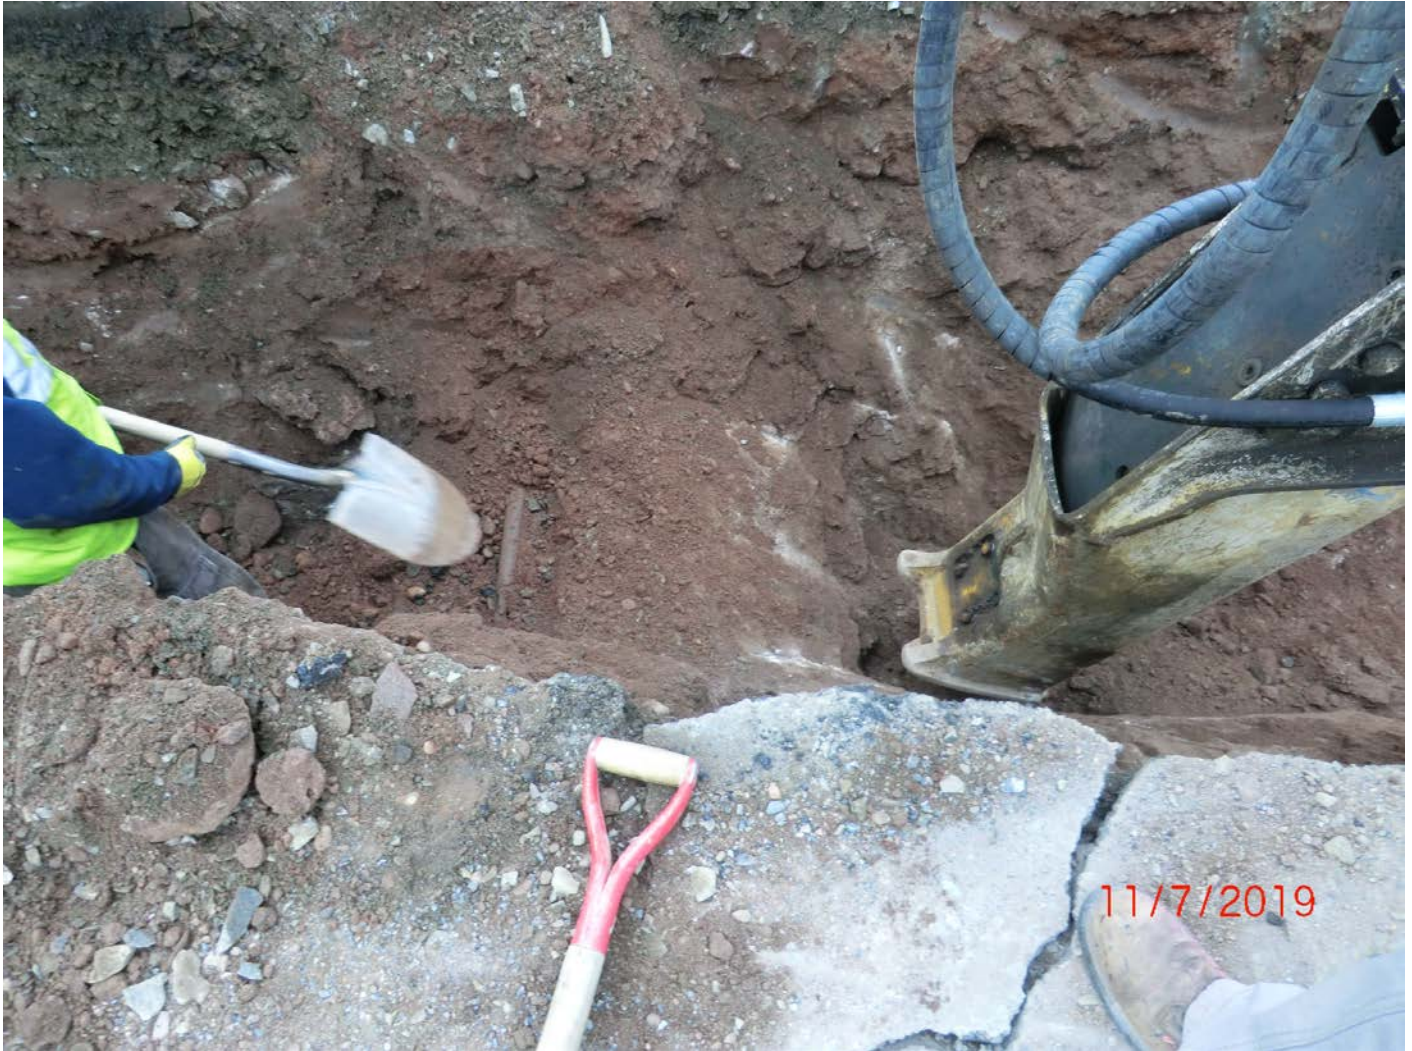
1200 – Trench is nearly out to 40 feet. Bedrock taken out from under 1-1.5 inch water service line. Bedrock appears to be an arkose from the Portland Arkose formation.

Figure 11 – Hammering rock out from under water service line (seen just in front of shovel).

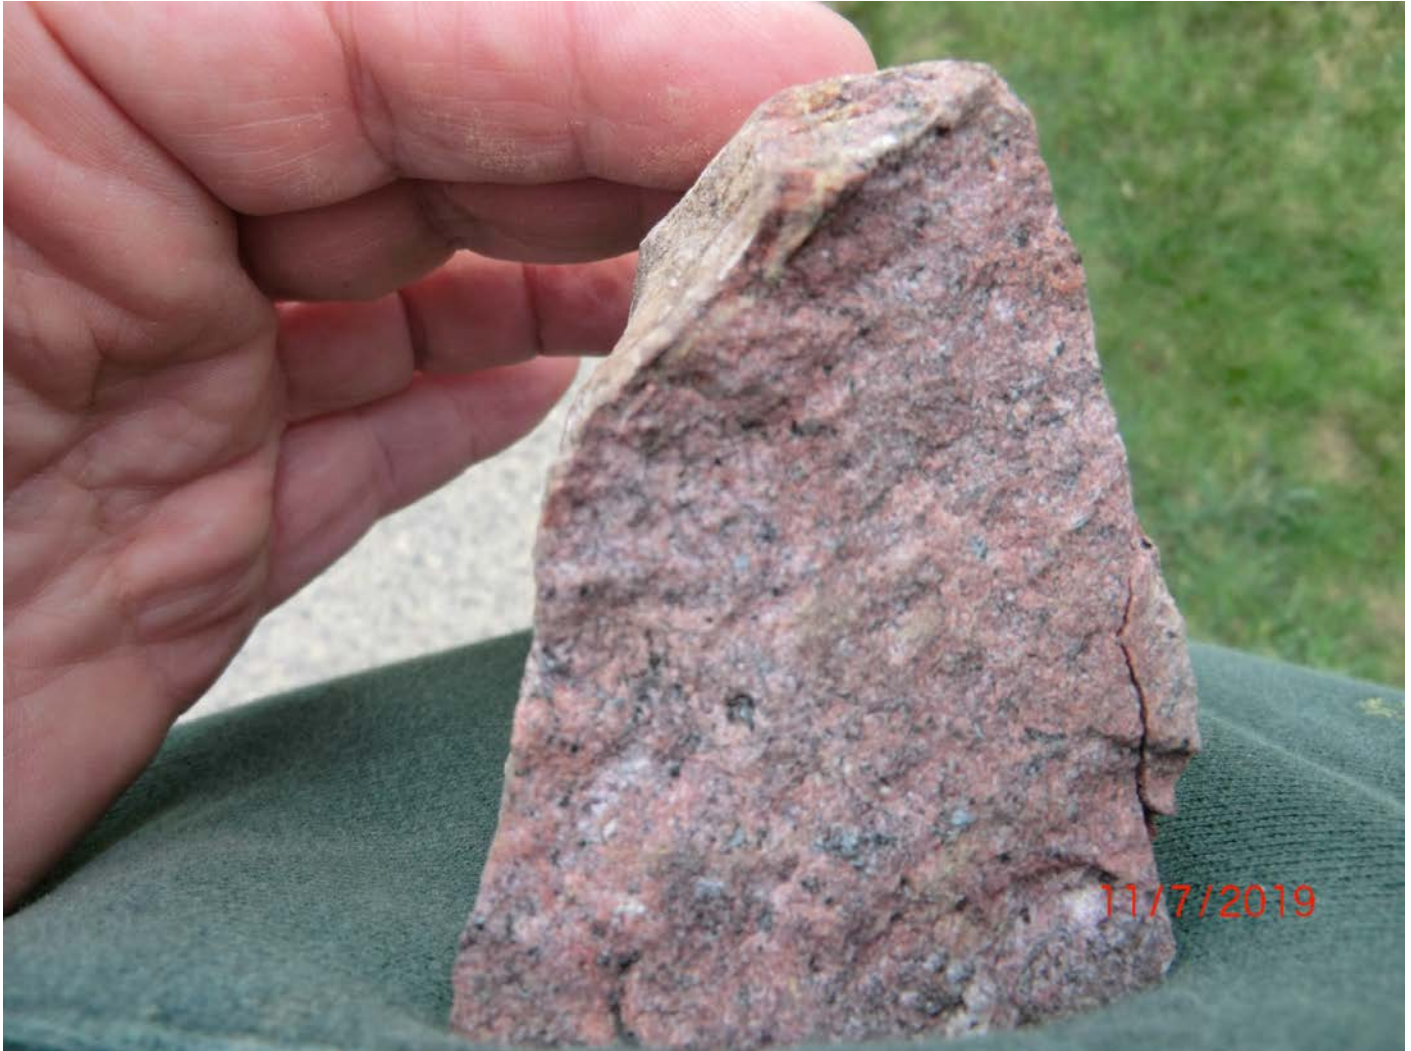
Figure 12 – Arkose bedrock encountered. Part of the Portland Arkose Formation.

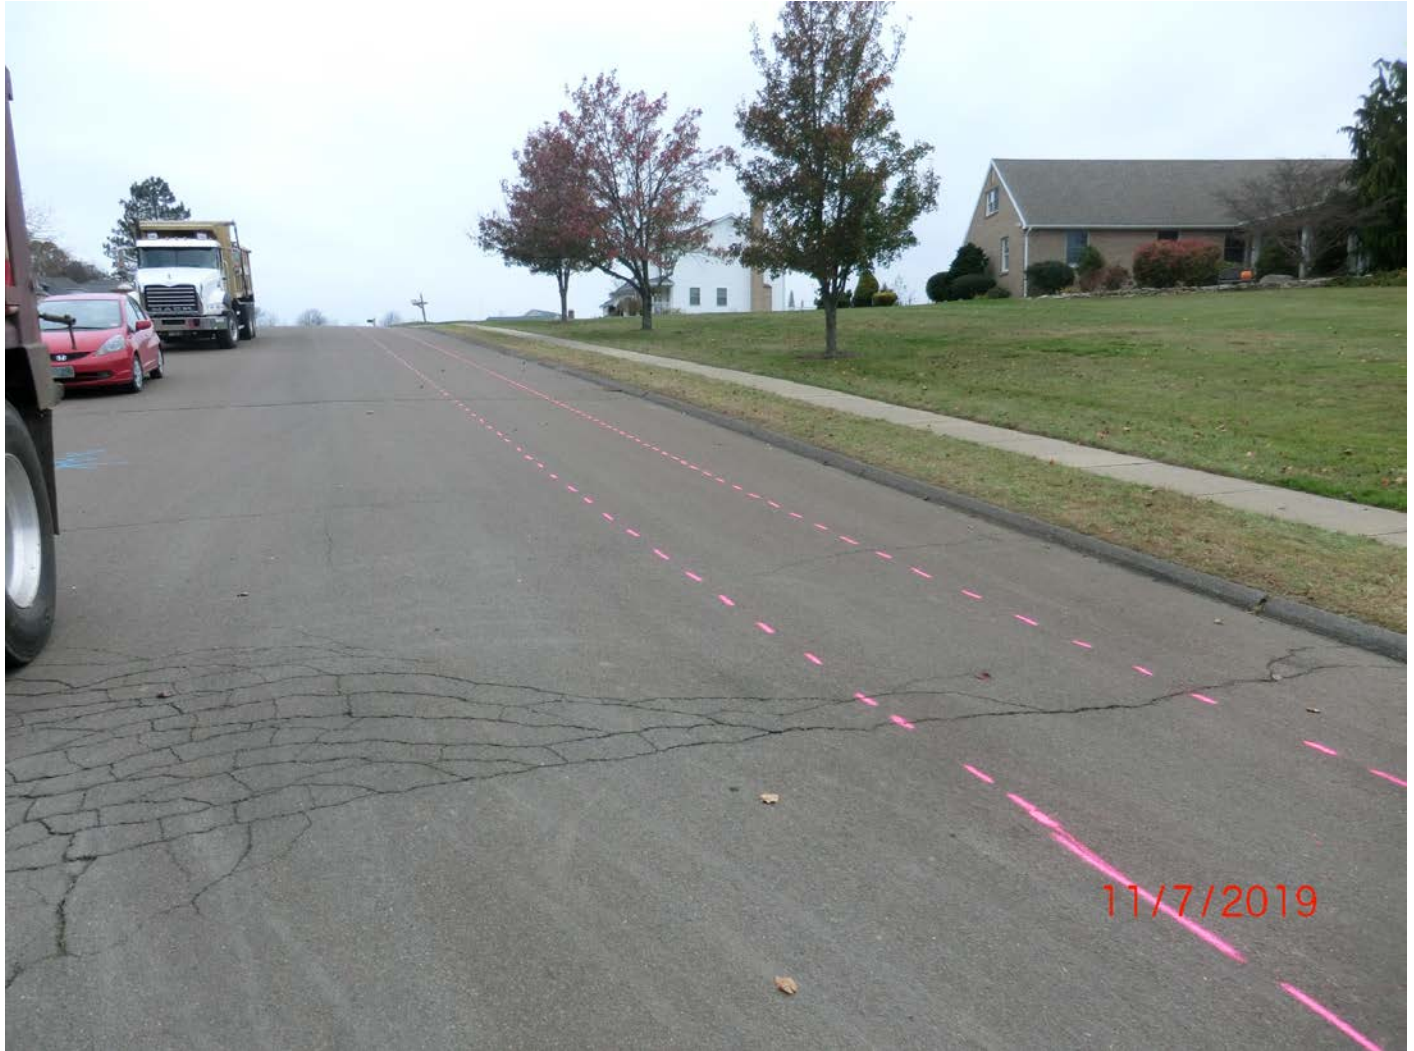
Figure 13 – Road cut mark out for upper Watch Hill Drive replacement hydrant 8” DI line. Photo taken facing west.

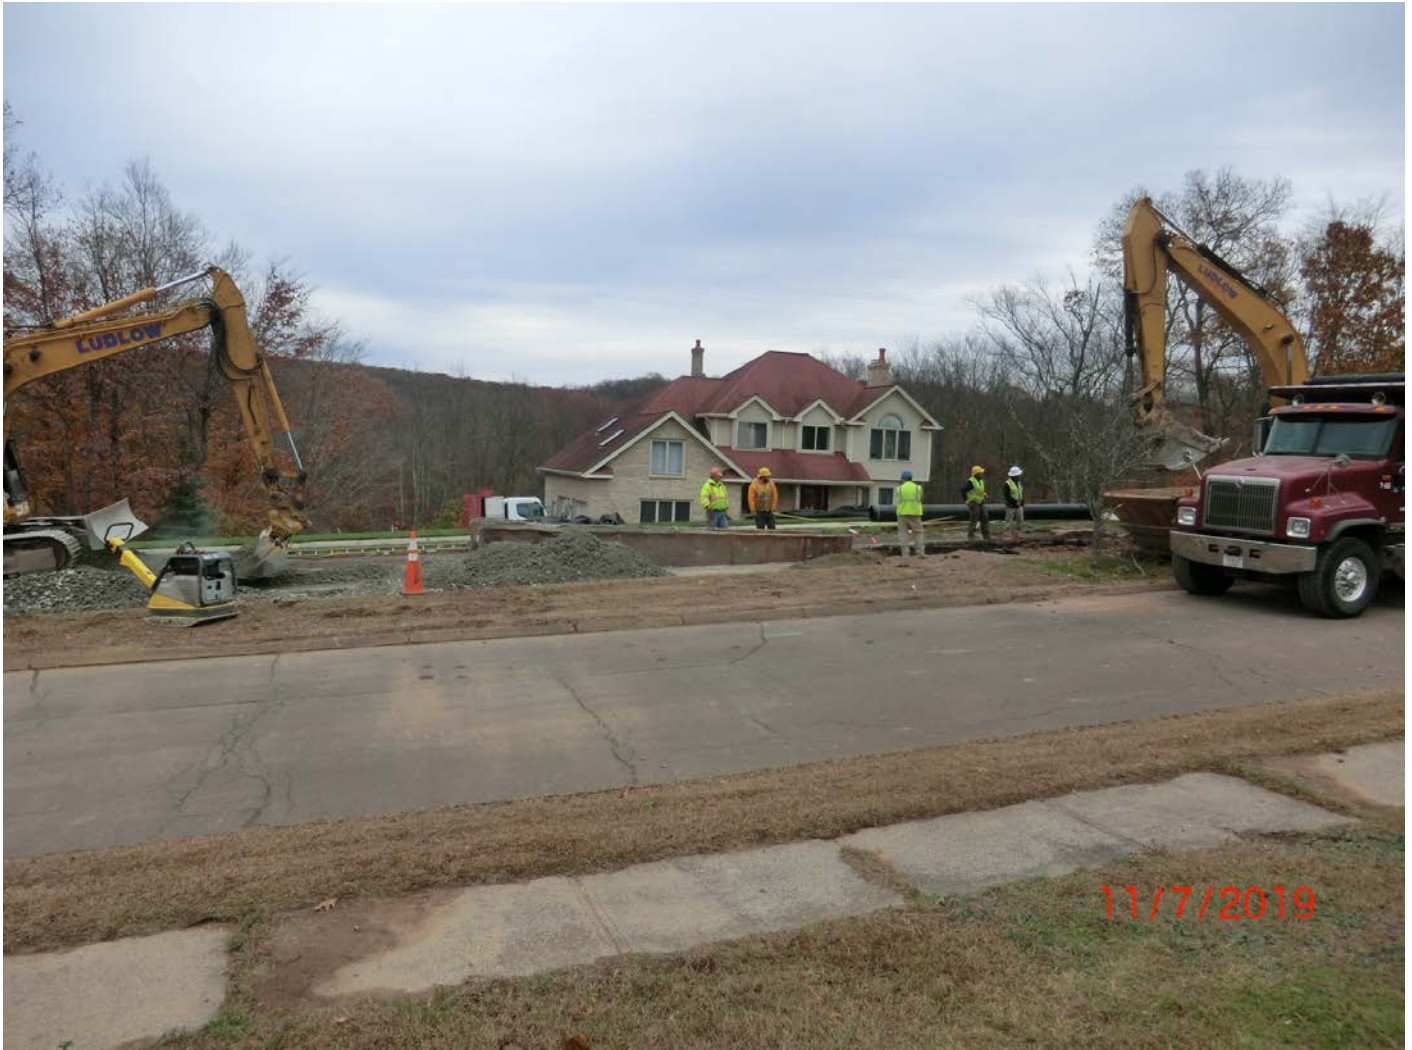
Figure 14 – Broad perspective of today's work. Photo taken facing east.

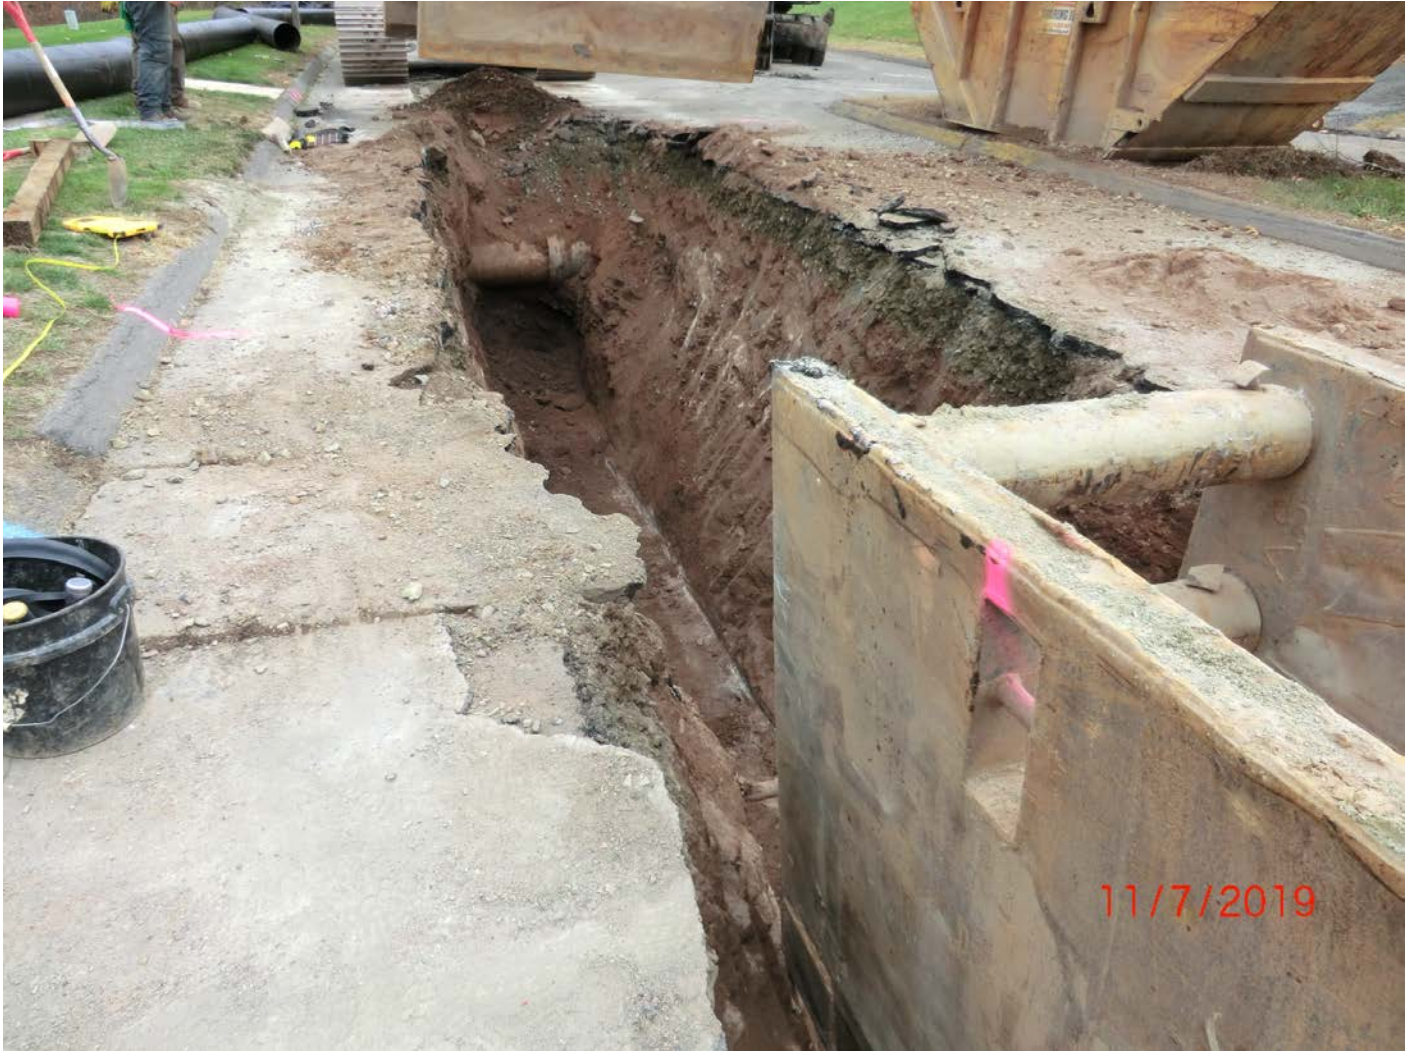
**Figure 15 – Facing south, water service line can be seen just left of the end of the trench box and in the distance, just beyond the end if the final stick of pipe (not yet placed in trench) is the culvert drain line.**
