#### **Daily Report**

Project:	Durham Meadows Pipeline Installation	Date:	November 26, 2019
Location:	Talcott Ridge Drive, Middletown CT	Day of Week:	Tuesday
Project #:	AECOM: 60445033	<b>Report No:</b>	38
<b>Contractor:</b>	Ludlow Construction	Page:	<b>2</b> of <b>21</b>
	-

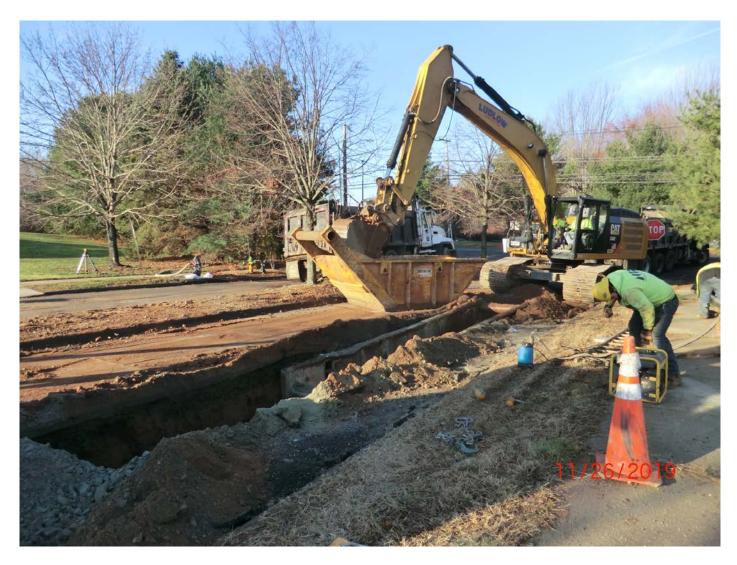
Figure 2 – Facing southwest. Morning progress towards South Main St. Note Stop Sign in background was not damaged during work activities, excavator was able to work about the sign, but ended up creating a bit of a mess to avoid damaging the sign. See later figures showing mess that was later cleaned up.

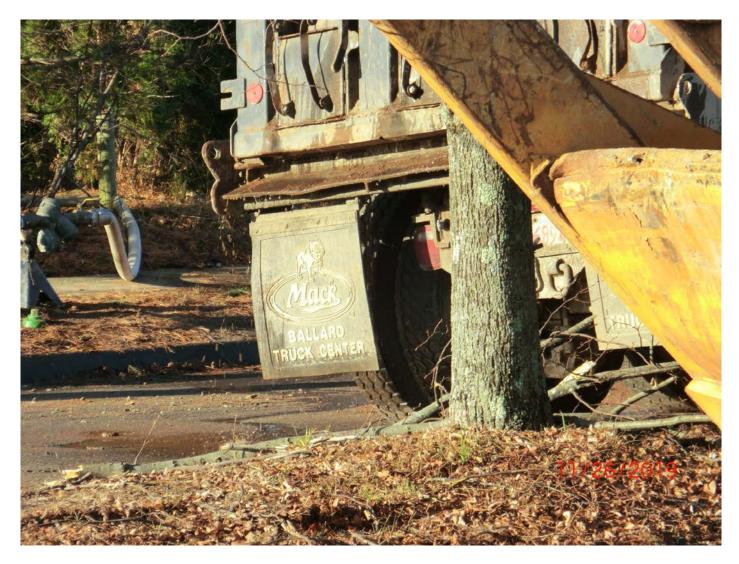
Figure 3 – Facing southwest. Having reached bottom of Talcott Ridge, the trench has again encountered the groundwater. Water can be seen here dripping from the back corner of the dump truck.

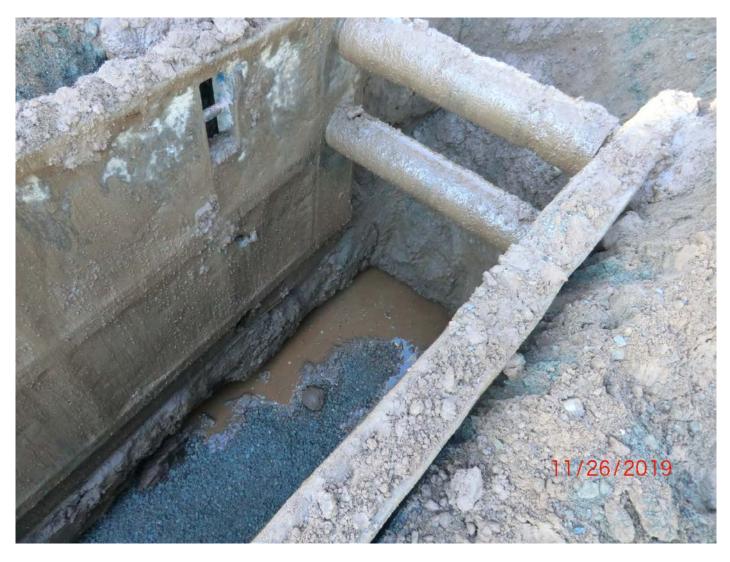
Figure 4 – Water in trench. Sump pump used to dewater to fabric (silt fenced) lined catch basin.

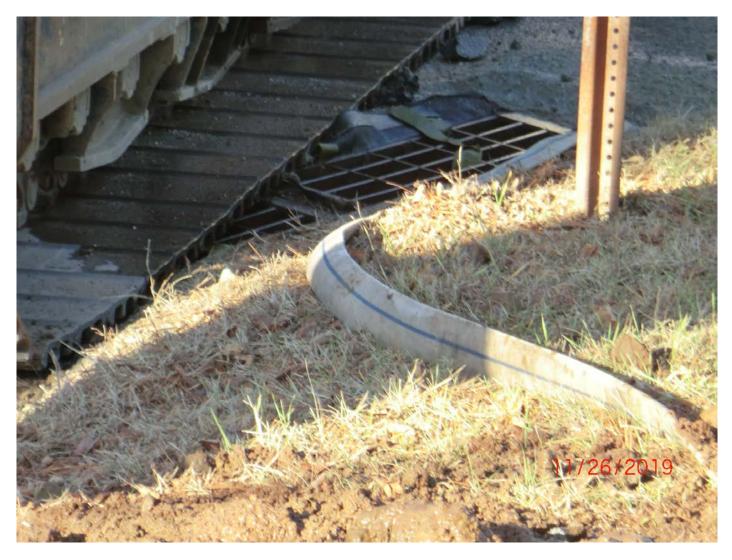
Figure 5 – Sump discharge to protected catch basin.

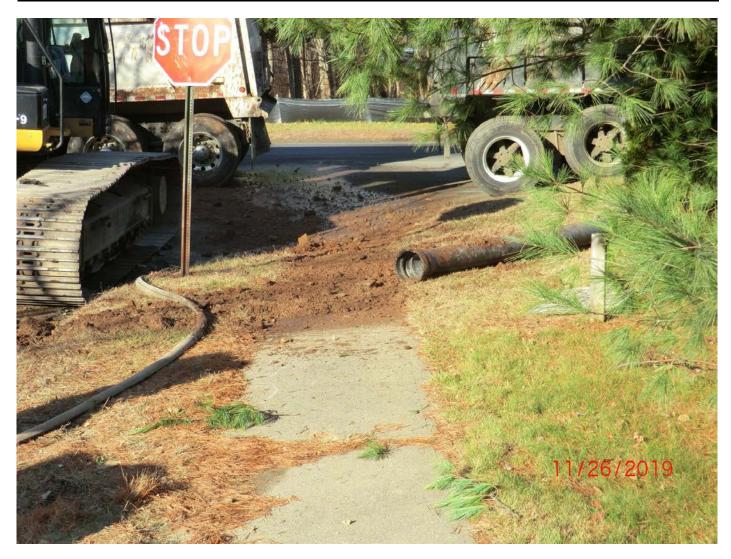
Figure 6 – Facing west along north side of Talcott Ridge (Main St. in background). Mess created in the effort to not destroy or remove the stop sign.

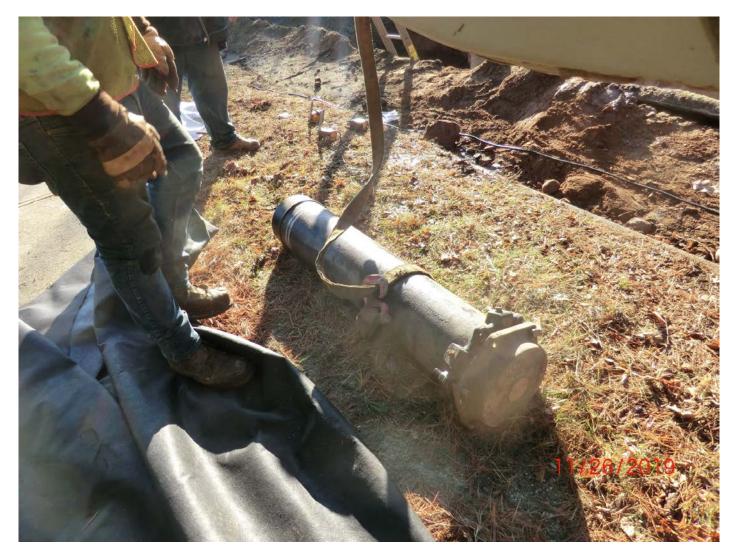
Figure 7 – 4-foot (restrained) stub installed at end of 4<sup>th</sup> stick of 8" DI installed, bringing end of 8" DI to 752+30.

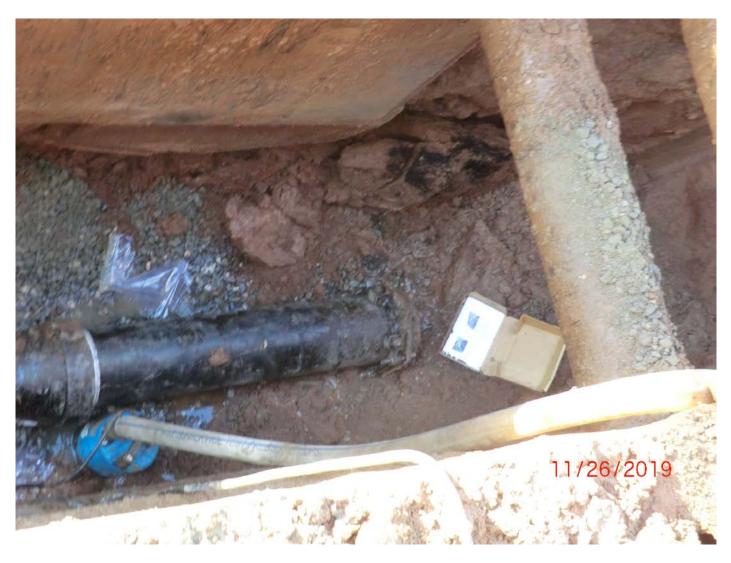
Figure 8 – Installed 4-foot stub.

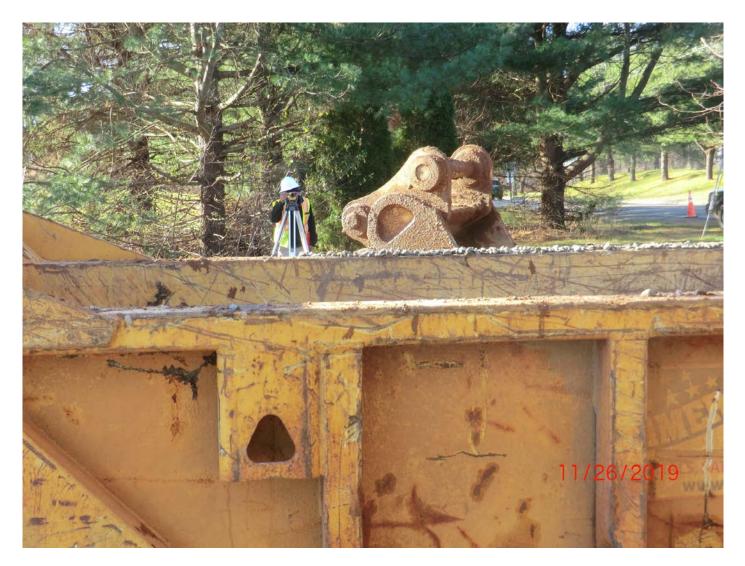
Figure 9 – Billy (Ludlow) taking elevation shots at end of run for today.

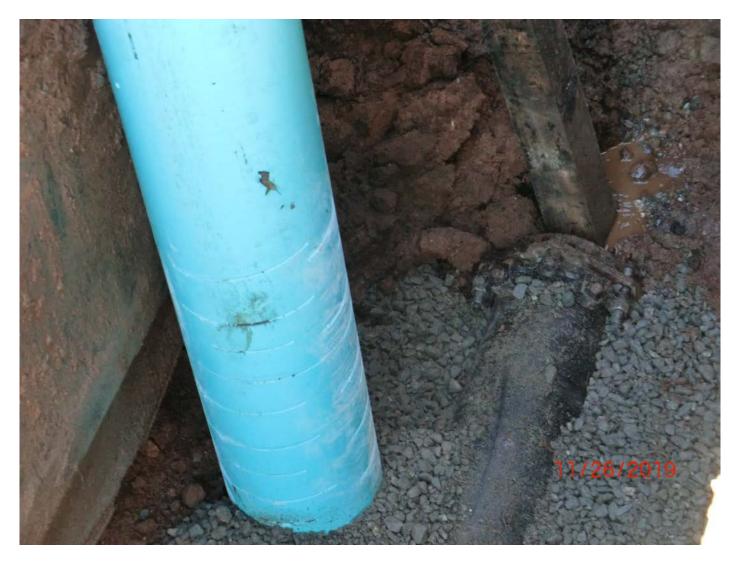
Figure 10 – Installation of 10" pipe cut sump adjacent to stub. Note 4x4 stud at top of picture marking end of todays run.

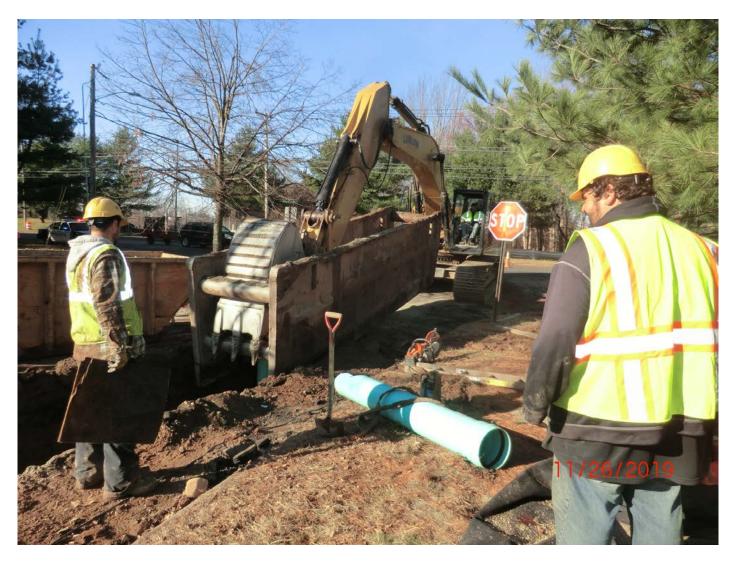
Figure 11 – Facing west. Removing 24-foot trench-box.

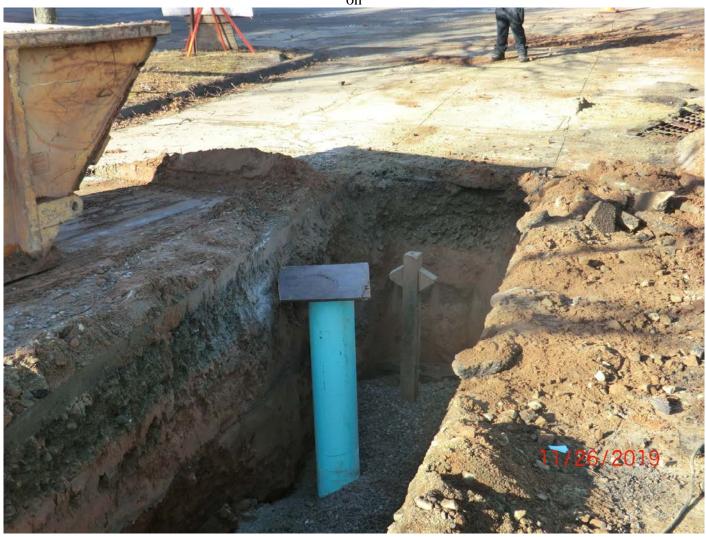
Figure 12 – End of the line 752+30. Facing west, 10"-sump and 4x4 stud at end of 4-foot stub. Starting location for next spring when 8" DIP line will extend into South Main Street. Top of picture is intersection of Talcott Ridge Drive and South Main Street in Middletown, CT.

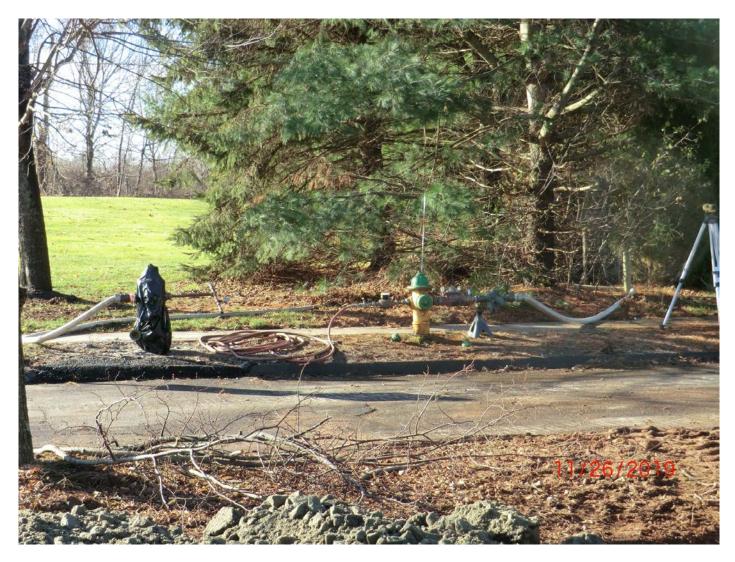
Figure 13 – Cross over from active hydrant to new hydrant. Set up was used by Peter (Ludlow) to fill the water lines going up Talcott Ridge and Watch Hill.

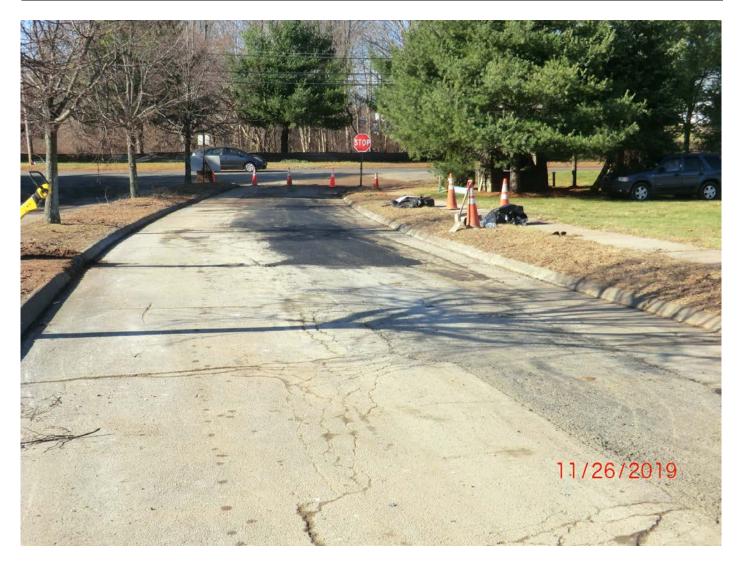
Figure 14 – Facing west, final patch at bottom of Talcott Ridge.

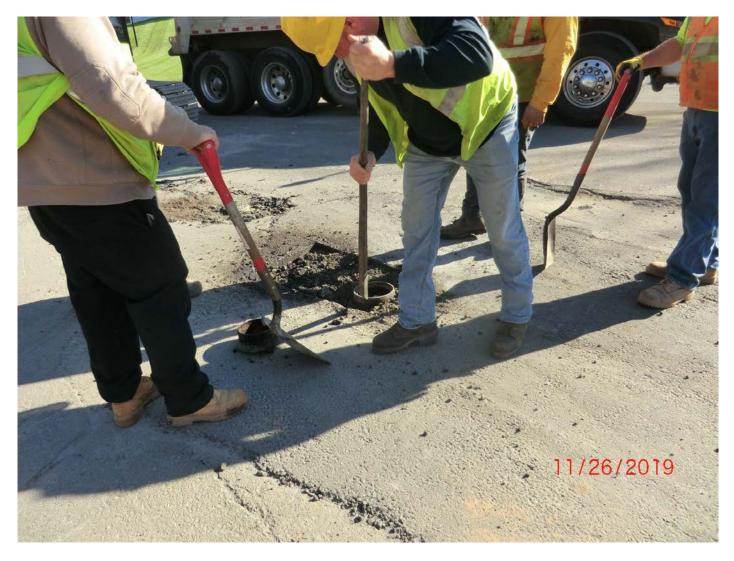
1240 – Talcott Ridge crew are shimming gate boxes on Talcott Ridge. Meaning that where the road boxes for access to valves have sank or were placed too low, the boxes have been dug up and raised – 'shimmed' – to proper height. A trip up to the cul-de-sac found that the circle has been tidied up. More work is needed and will likely occur tomorrow after the final installations are completed in the cul-de-sac. One more stick of 20" DI and a 45<sup>0</sup> bend and gate valve.

Figure 15 – 'Shimming' gate valve covers on Talcott Ridge. Raising structures to be consistent with road surface.

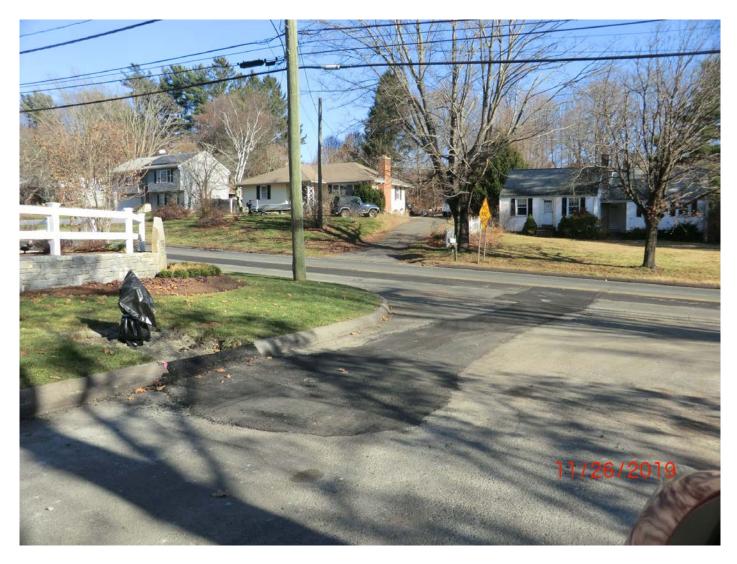
Figure 16 – New hydrant on Winsome Street, at corner with Main St., Durham, CT. Facing east-northeast.

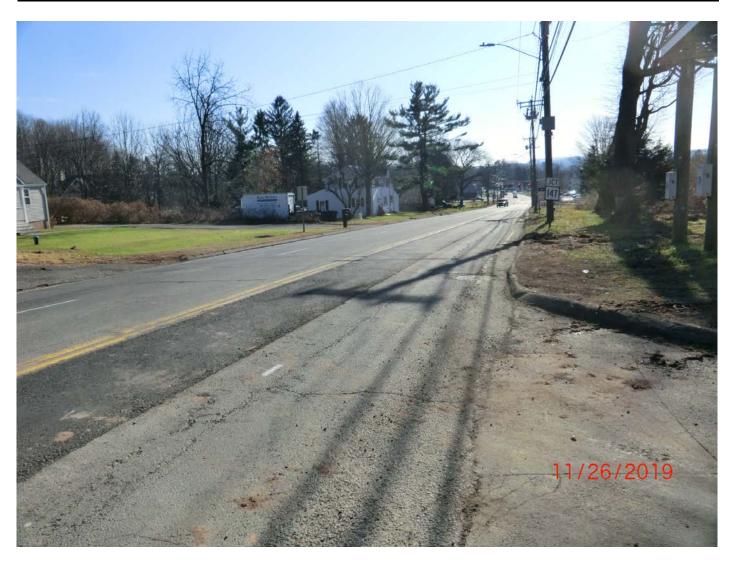
Figure 17 – Facing south, repaired/repaved trench line on Main St. Durham. Winsome St. to right of photo.

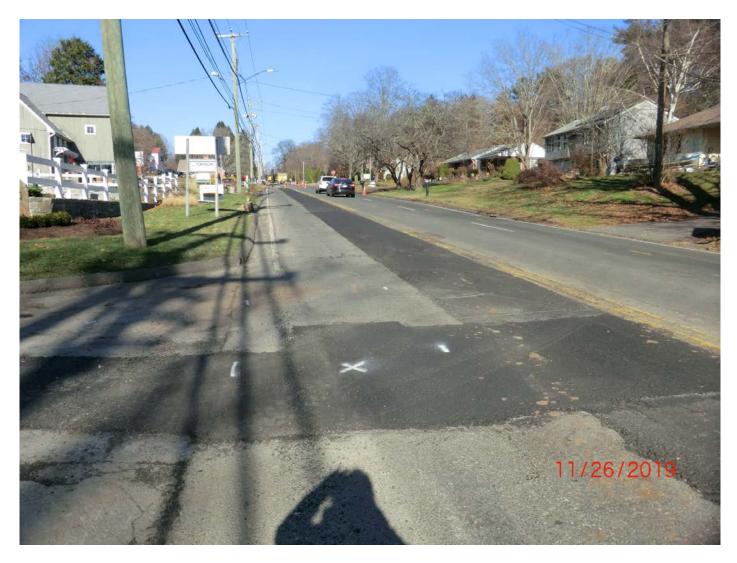
Figure 18 – Facing North, Main Street, Durham, Winsome St. to left. Appears that a stretch to the north was also repaved.

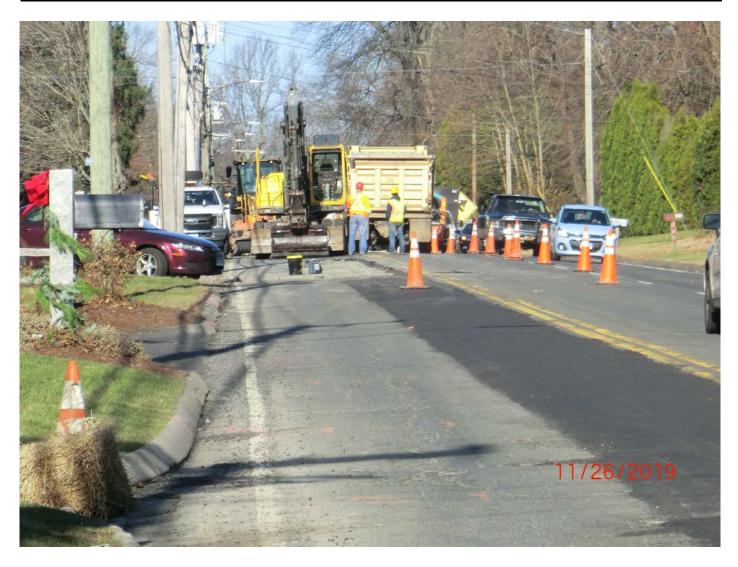
Figure 19 – Completing work at Parsons Street, installing hydrant of Tee in Main St. Water line. Picture facing north.
