## Daily Report

<b>Project:</b>	Durham Meadows Pipeline Installation	<b>Date:</b>	December 4, 2019
<b>Location:</b>	Talcott Ridge Drive, Middletown CT	<b>Day of Week:</b>	Wednesday
<b>Project #:</b>	AECOM: 60445033	<b>Report No:</b>	40
<b>Contractor:</b>	Ludlow Construction	<b>Page:</b>	1 of 19

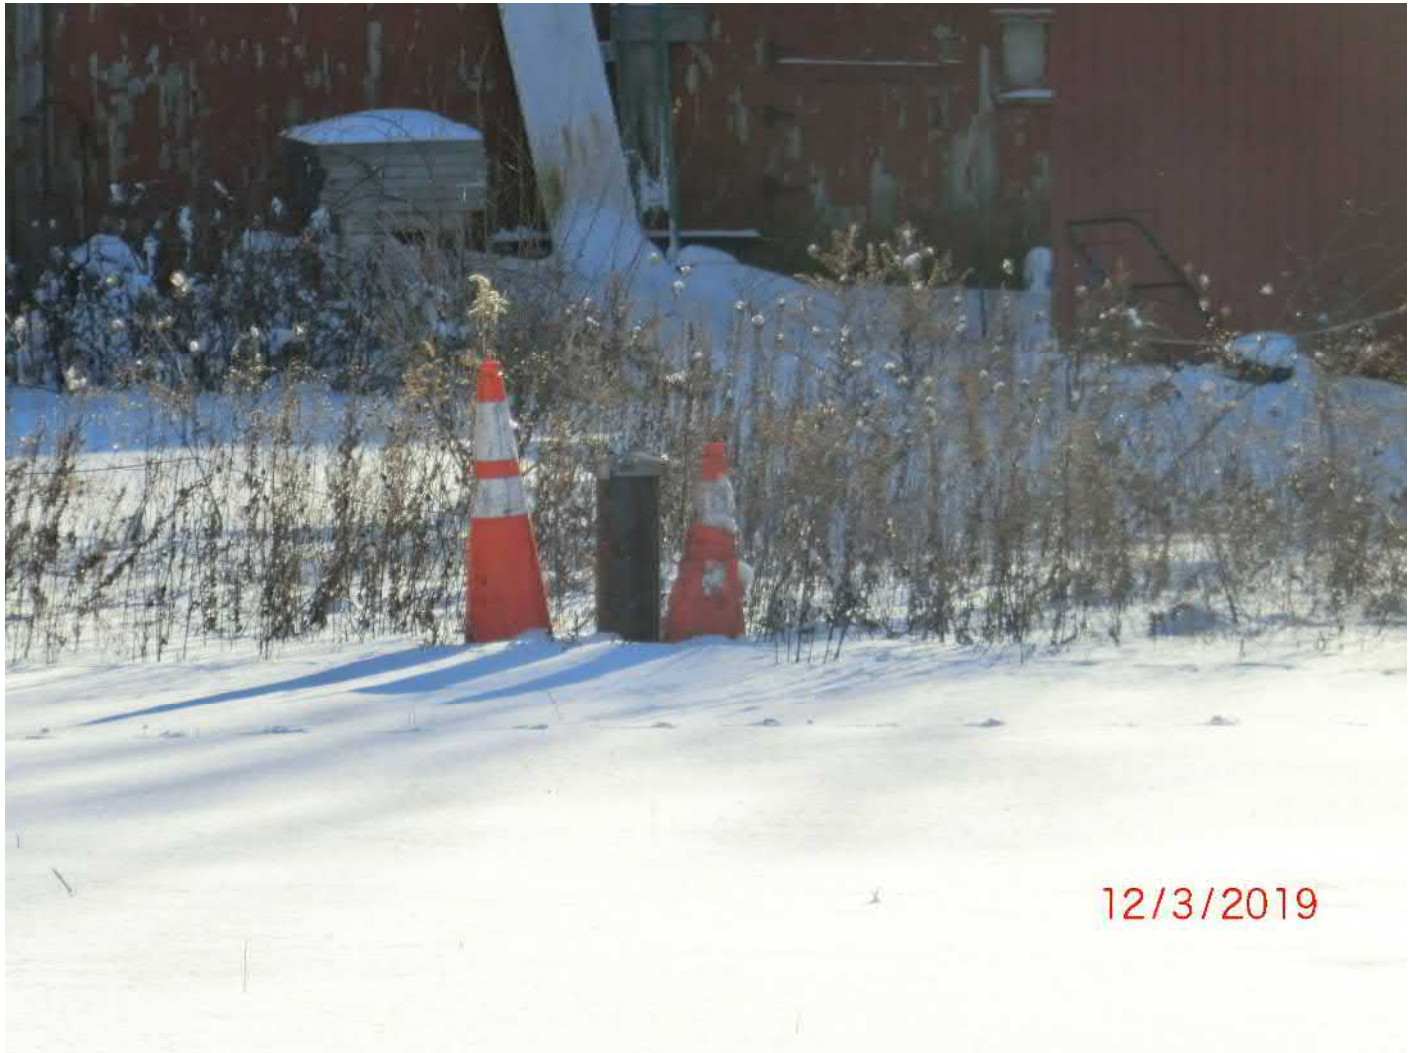
**Figure 1 – MW-4 well located on MMC. Still visible above the snow line.**

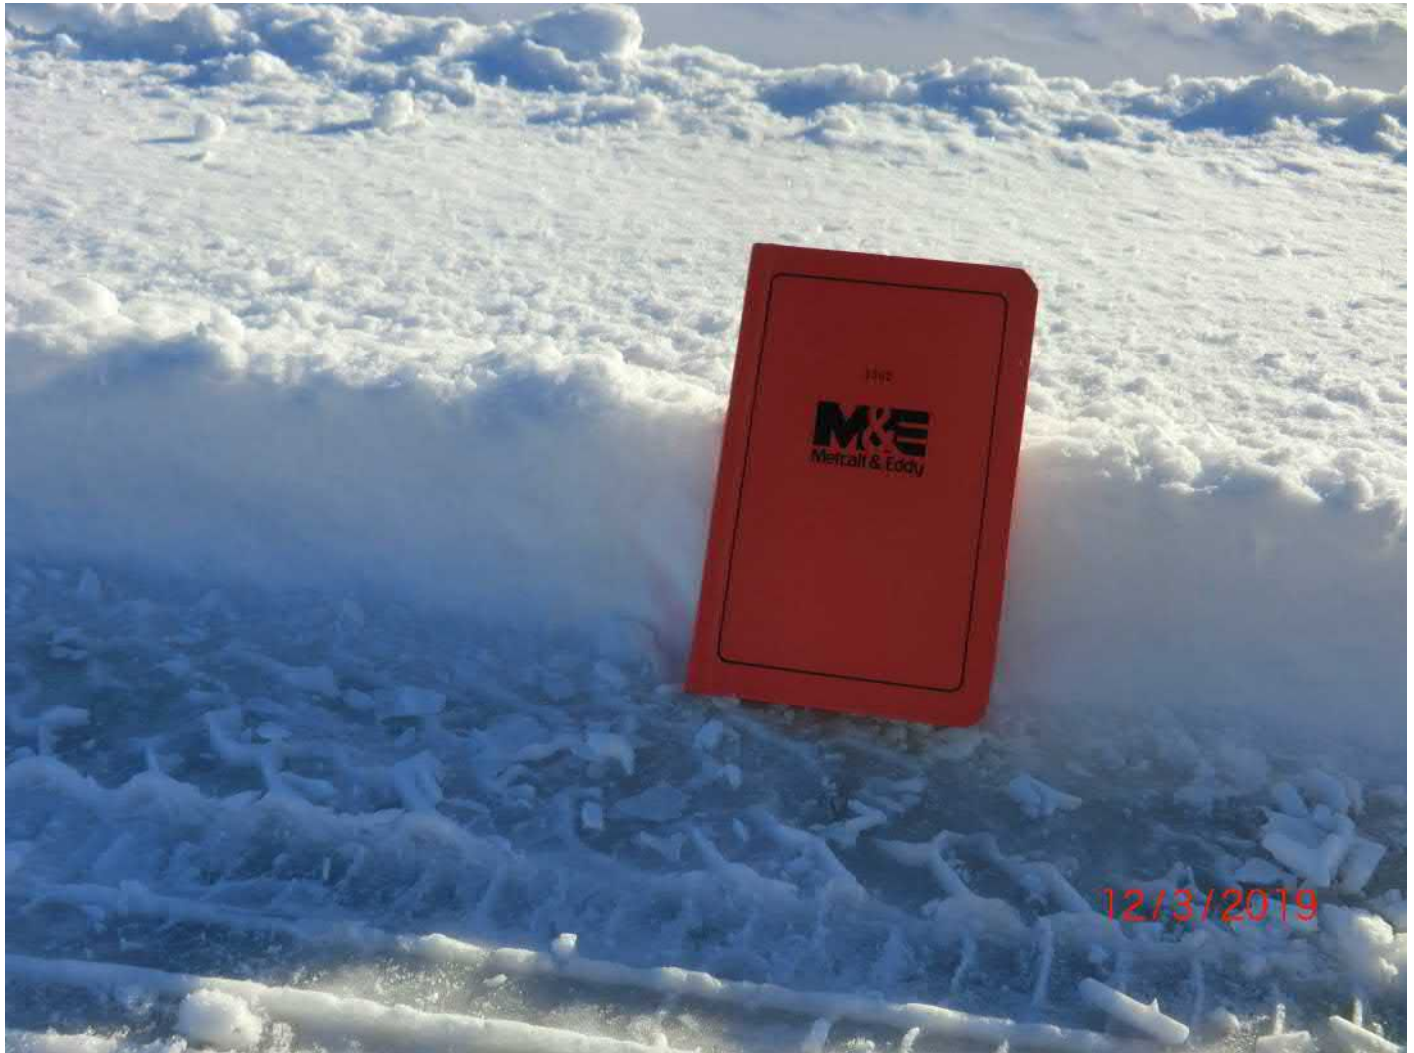
Figure 2 – Area covered by 4-6 inches snow. Roadways are completely clear. This is shot of MMC driveway entrance.

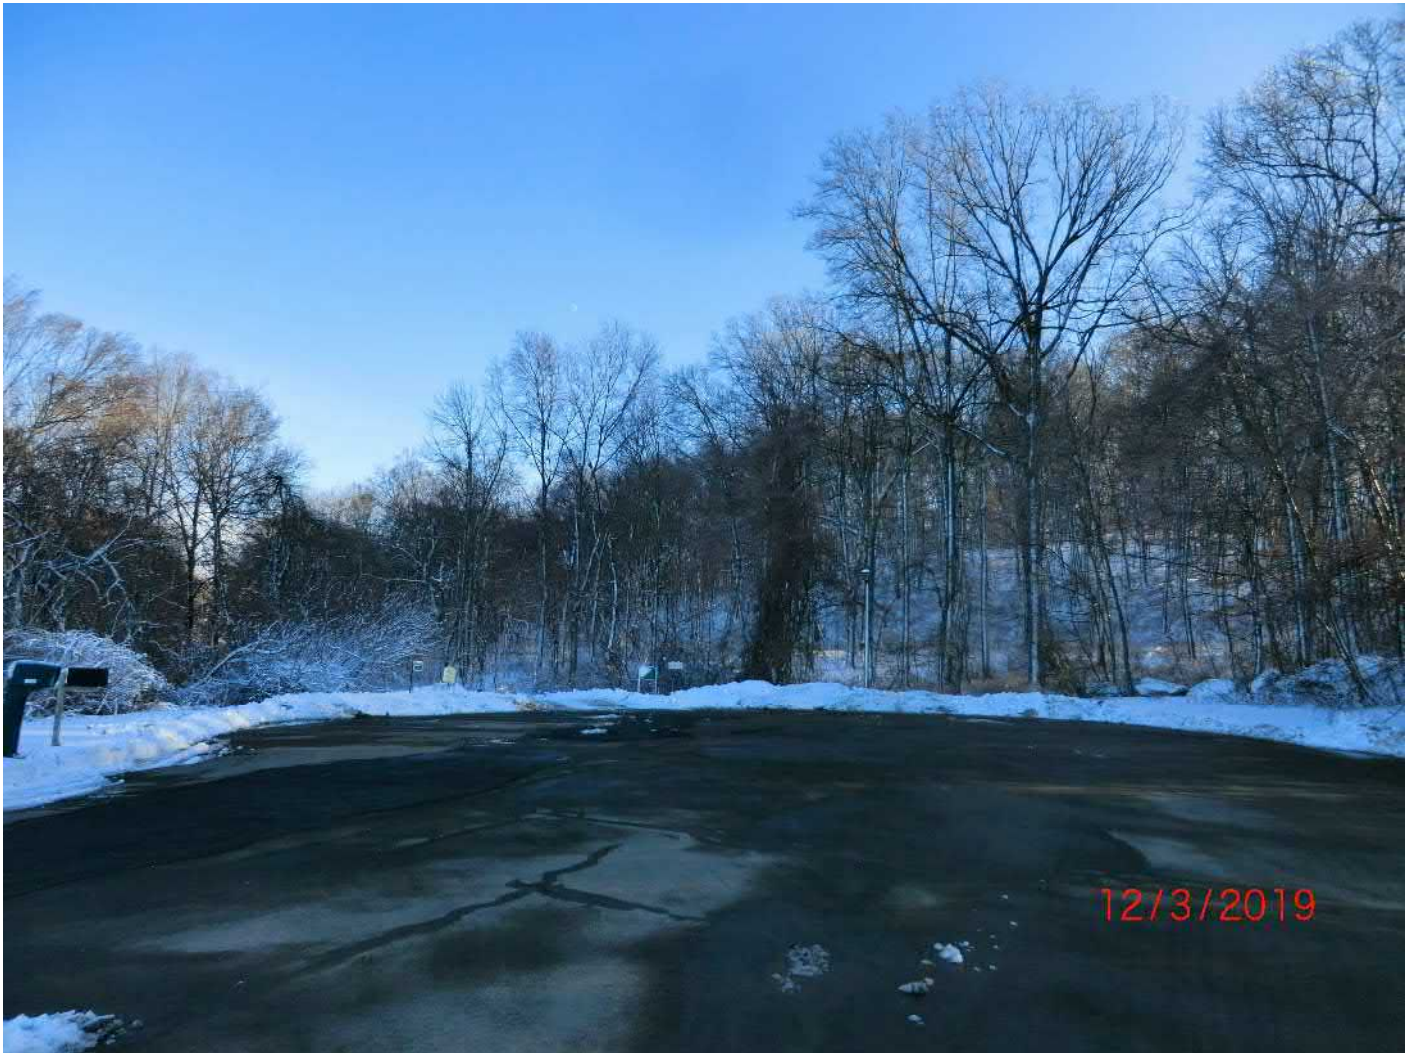
Figure 3 – Talcott Ridge cul-de-sac facing southeast. Cul-de-sac cleaned up and all materials removed.

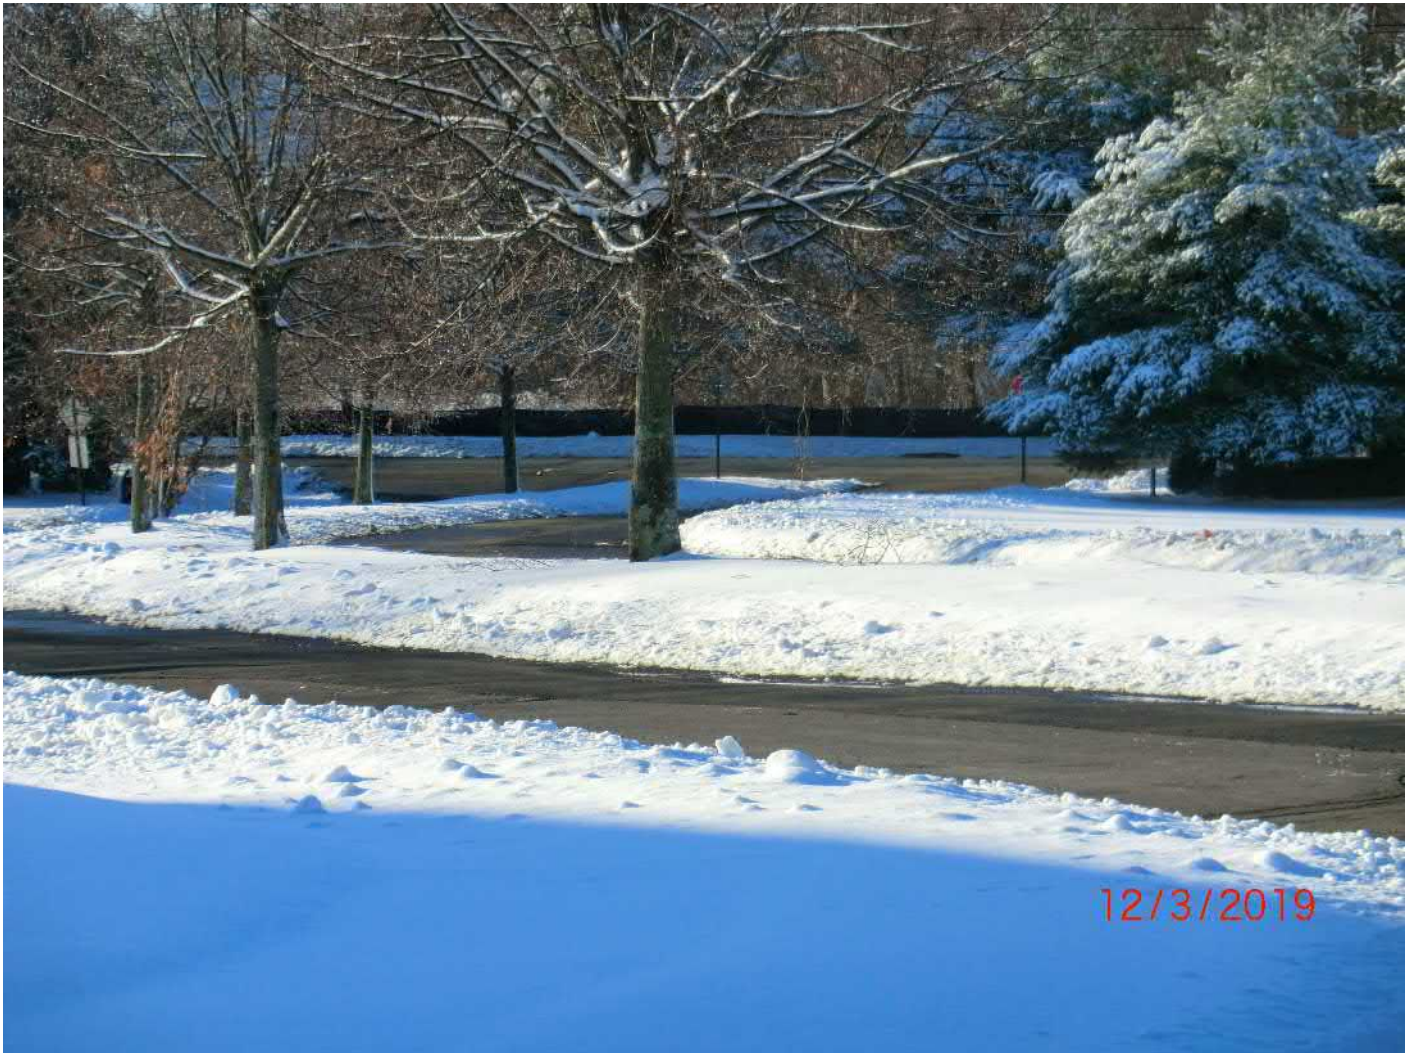
Figure 4 – Facing west, shot taken from lower Watch Hill Dr. Talcott Ridge Dr. and Main St. intersection. Roads clear and dry.

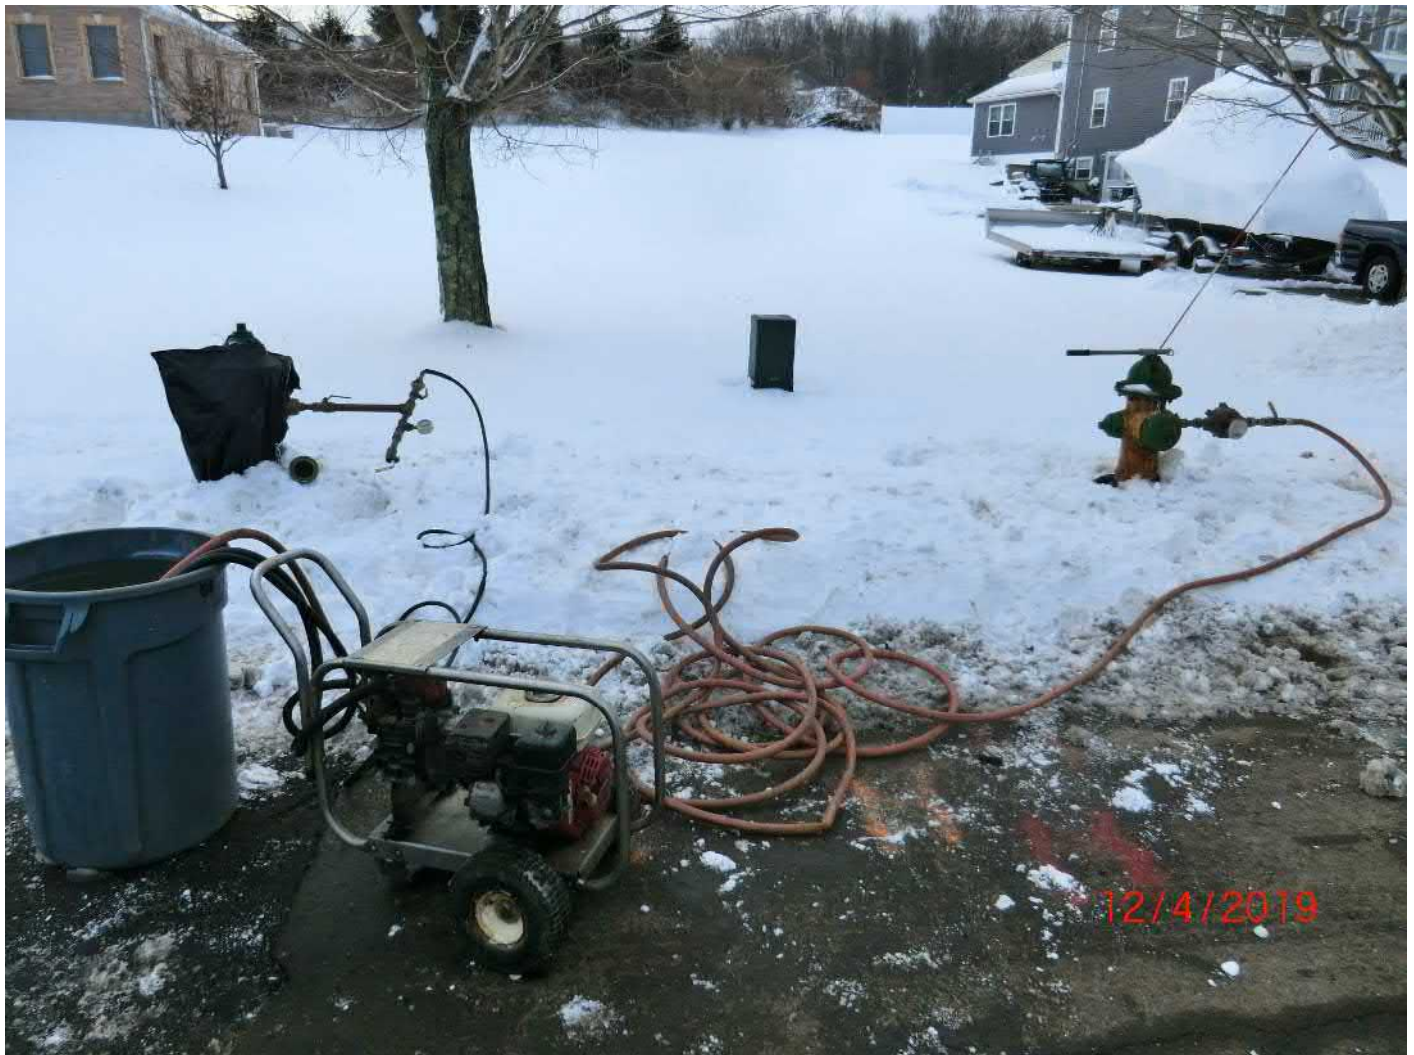
0830 – Pete (Ludlow) up on Talcott Ridge Dr. filling water lines for testing. Pulling water from active hydrant into new hydrant. Located halfway between the two ends of Watch Hill Dr.

Figure 5 – Facing south midway between lower and upper Watch Hill Dr. on Talcott Ridge Dr. Taking water from existing hydrant and pumping into new water line through new hydrant. Part of the testing procedure.

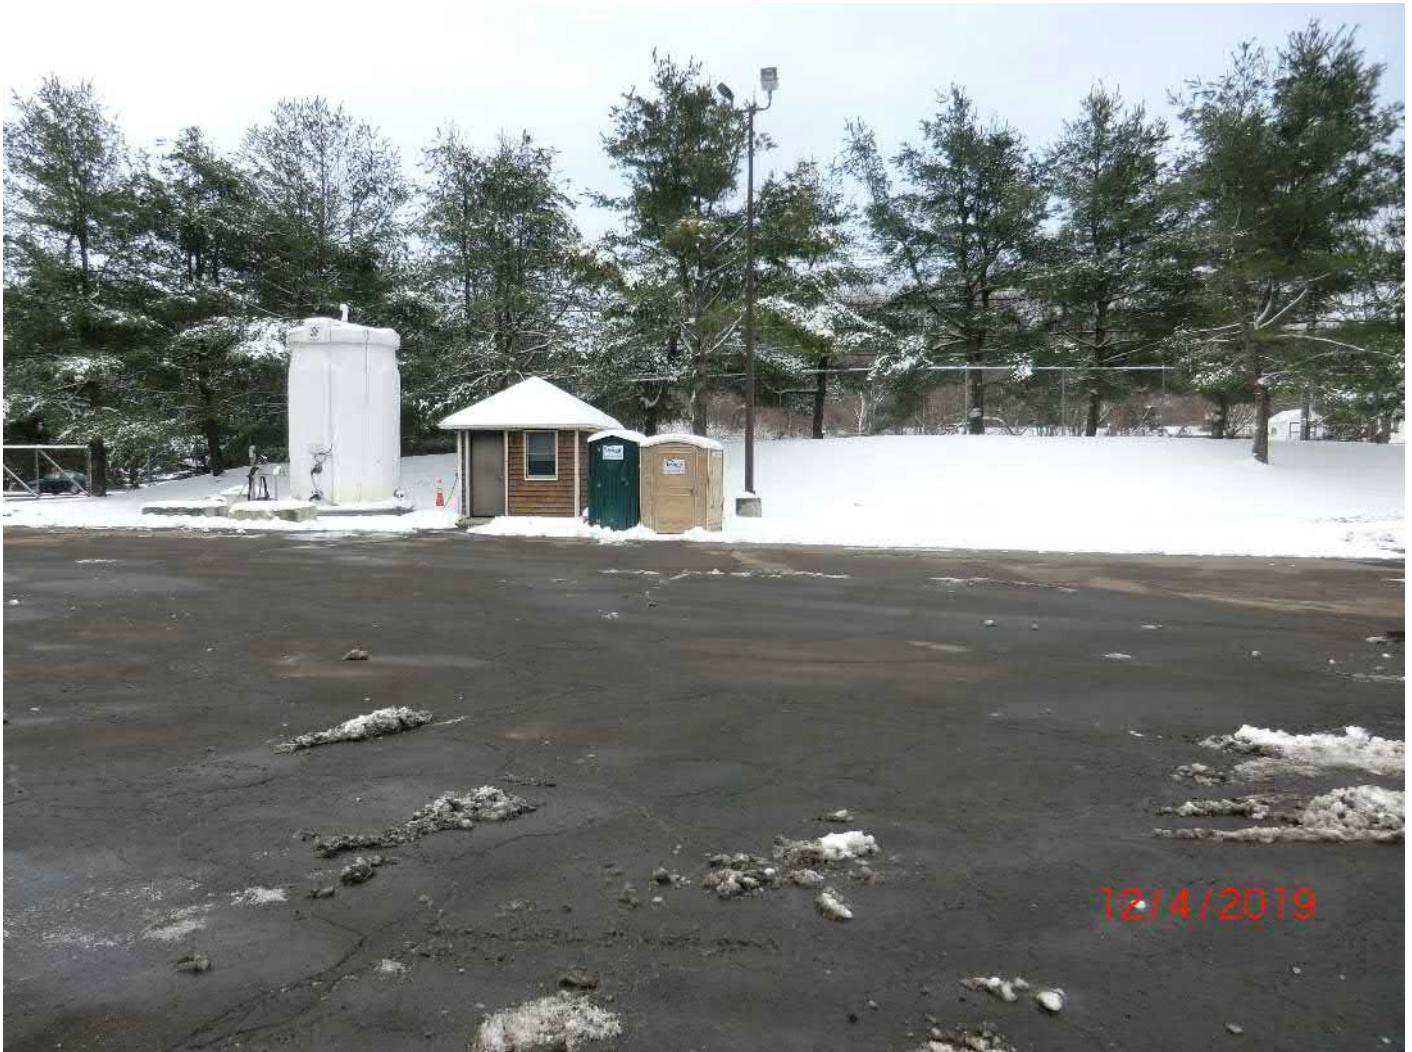
0910 – CT DOT salt shed yard cleaned up and all parts and equipment stored there by Ludlow has been removed to the MMC site.

Figure 6 – Facing east northeast. CT DOT yard cleared of equipment and materials. Appears that all materials and equipment have been moved down to the MMC site (trailer area).

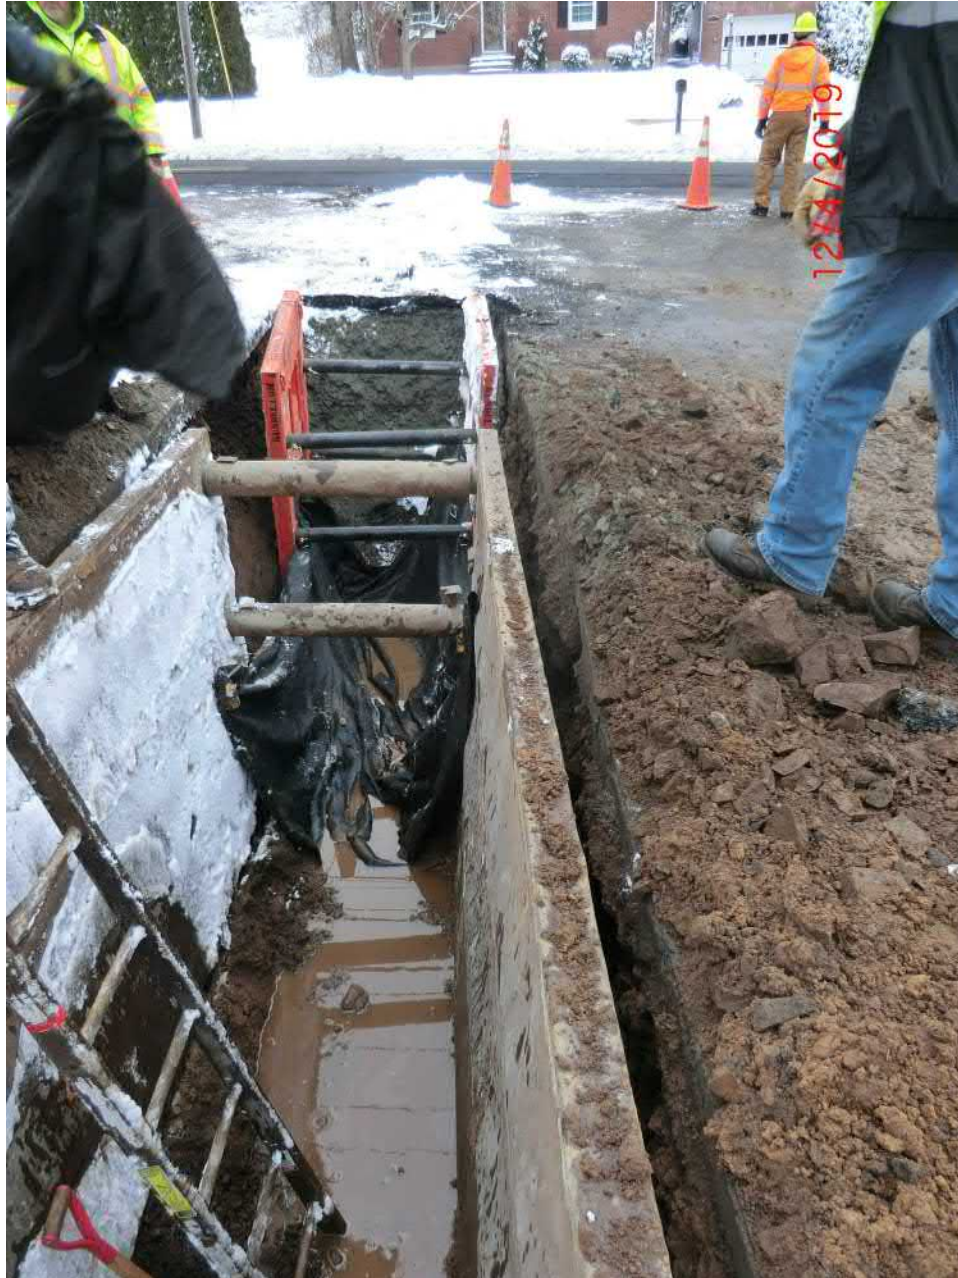
Figure 7 – Facing east. Bringing 6” DIP to hydrant. Note that the starting point is out of the State ROW. A section of pipe was added last week to get the hook-up out of the ROW for hydrant install this week. Pipe in trench is just above the groundwater line. Picture shows the installation of the stone ‘burrito’ that will underlay the 6” DIP.

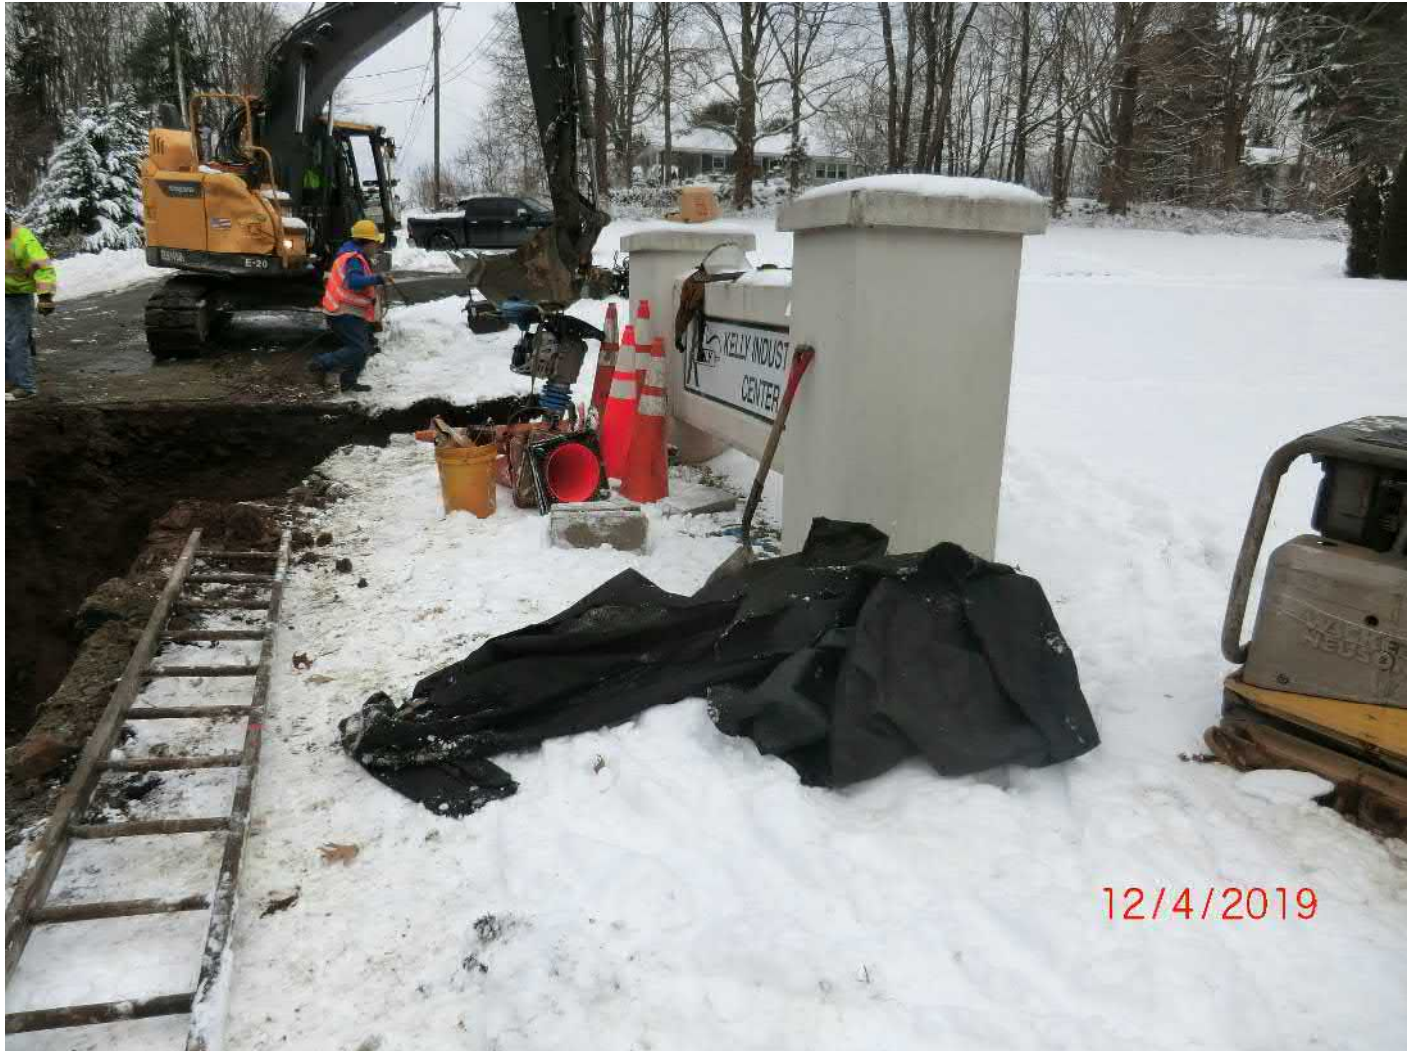
Figure 8 – Facing west up Parsons St. Turn for new hydrant. Hydrant will be set just beyond the business sign in center of shot.

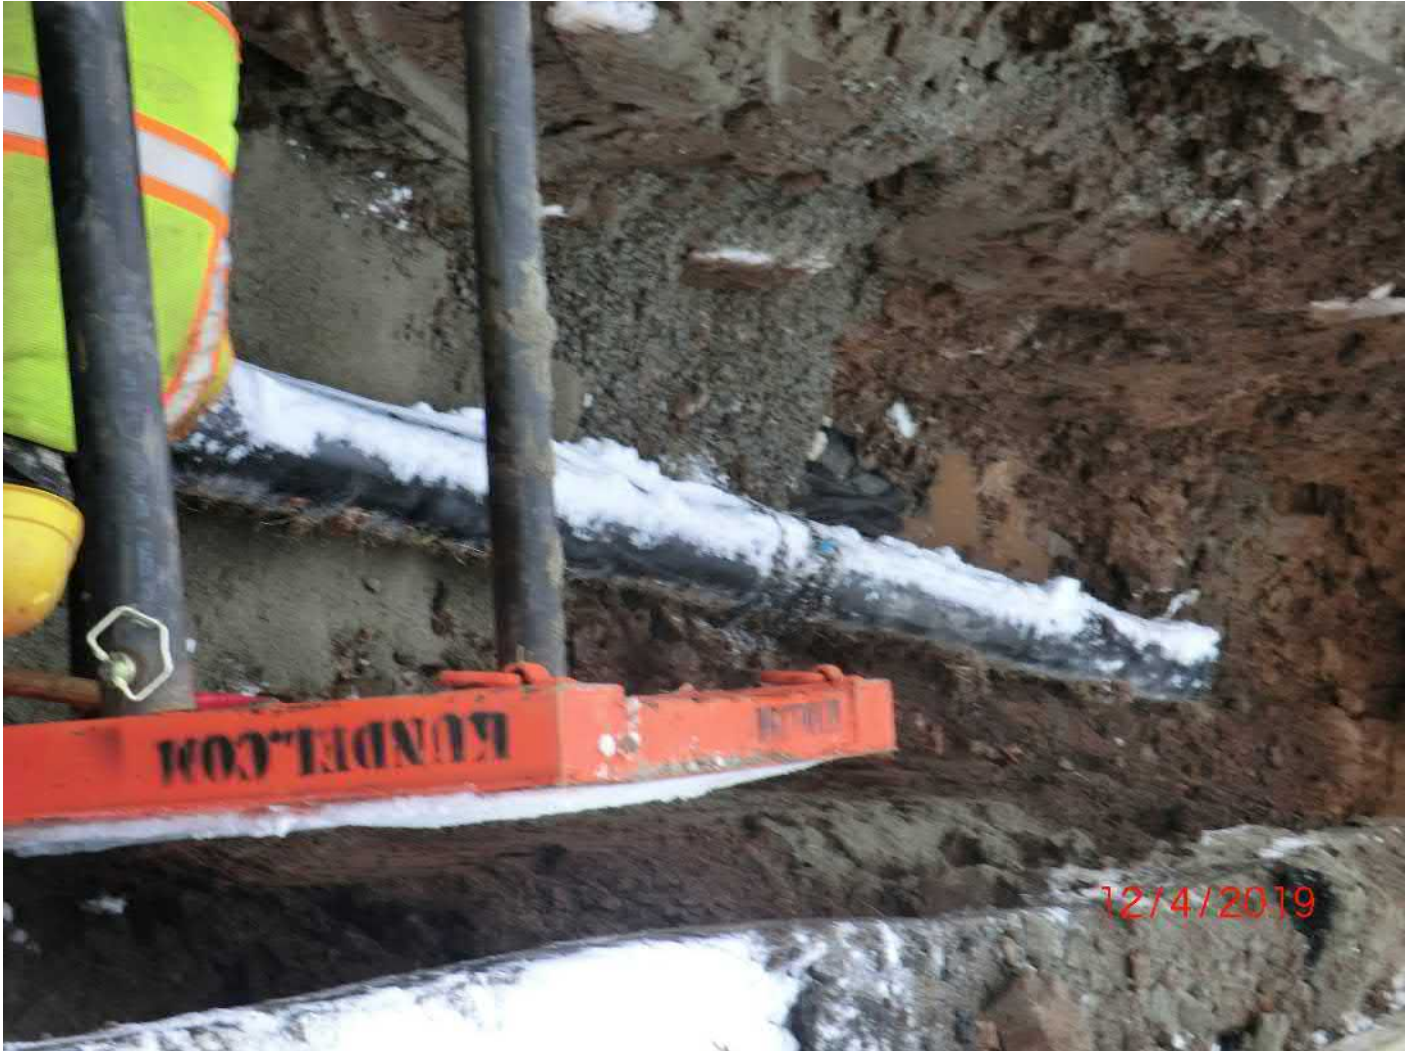
0930 – Setting 20 feet of 8" restrained piping to be followed by 4 feet of 8" pipe, tee and gate valve for hydrant.

Figure 9 – Installing 20 feet of 8” DI pipe with restrained fittings.

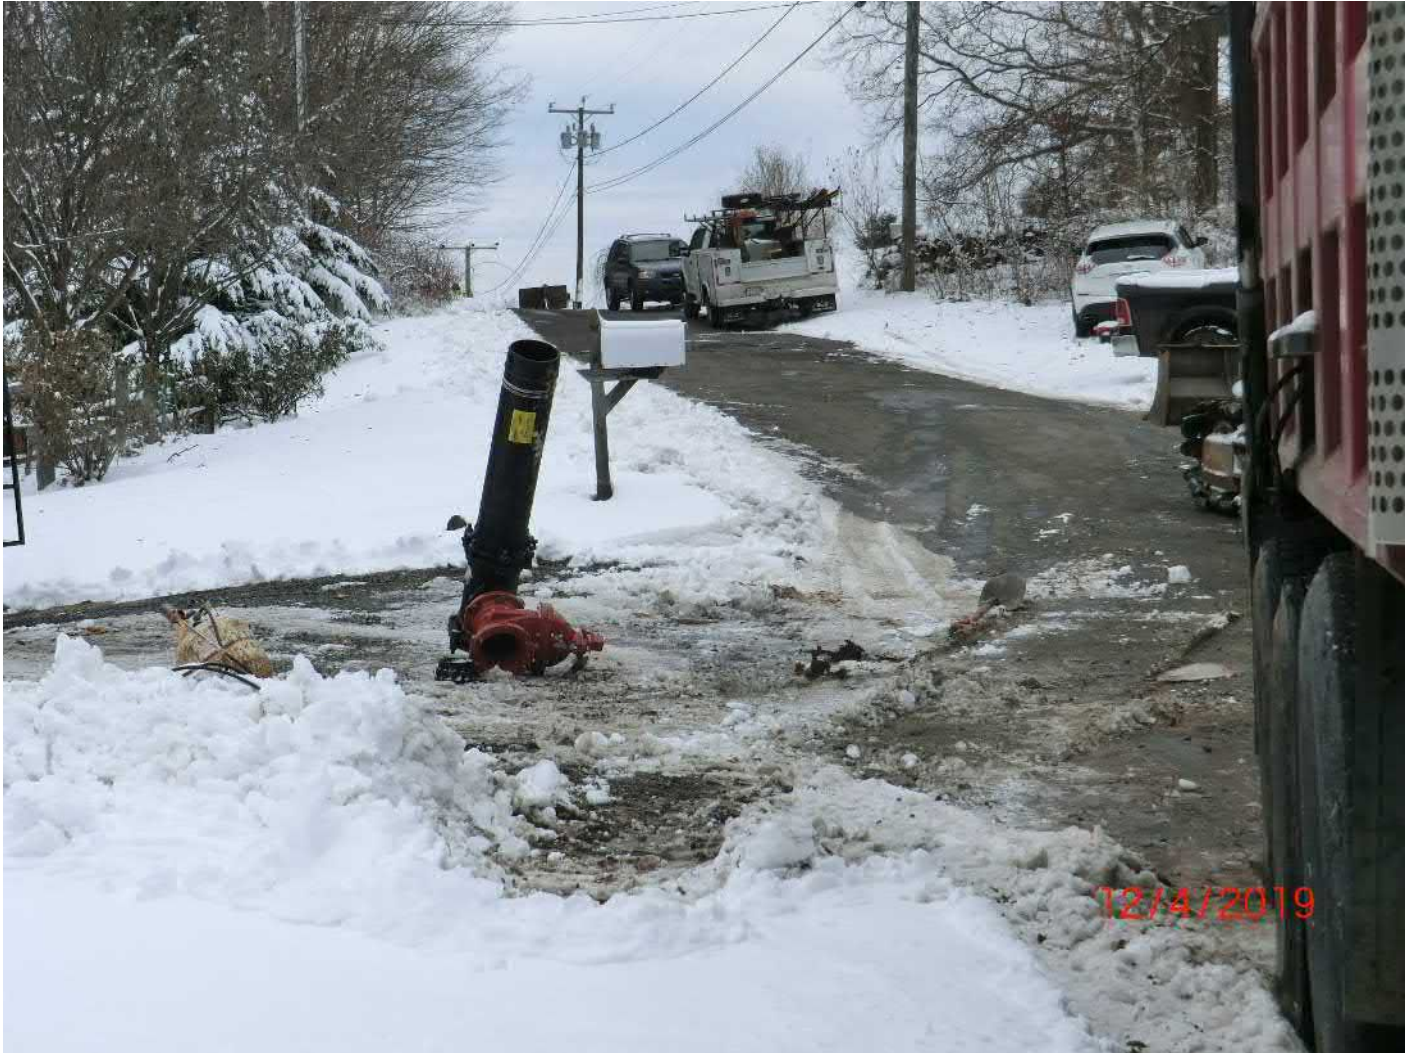
Figure 10 – Facing west. Additional 4.5 feet of 8” DIP, 6” gate valve, and 8”x6” Tee to be installed to end of stick seen in previous figure.

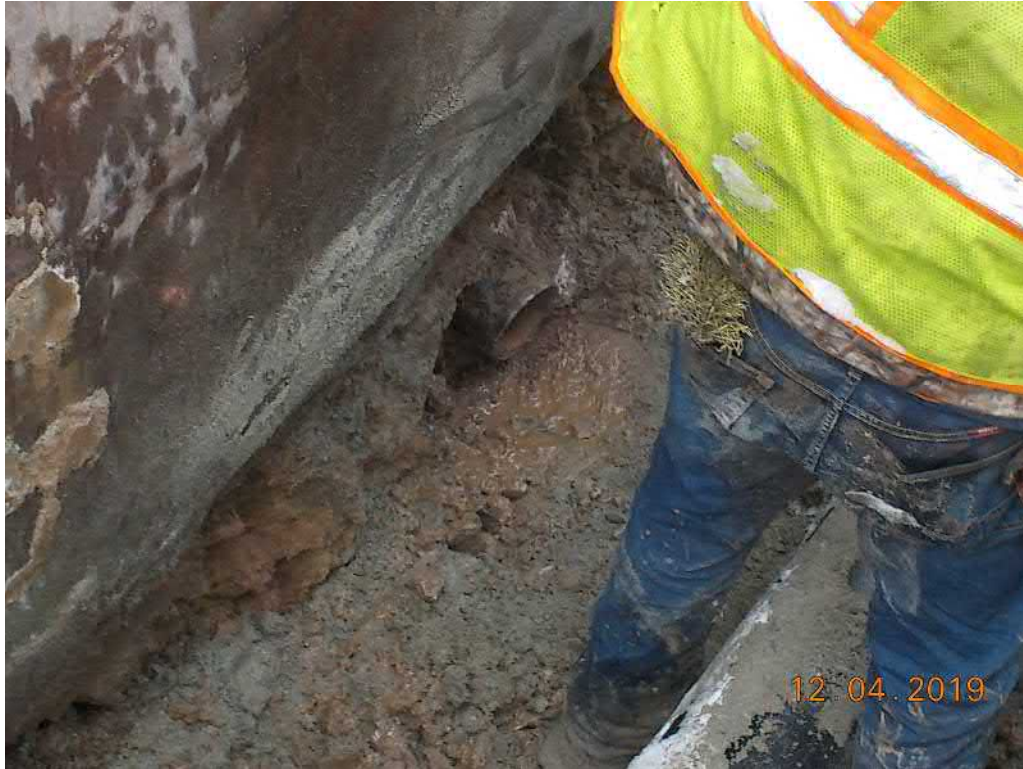
0945 – Ludlow noted that they broke out a 4-foot section of 4" drain pipe that crossed directly in front of the hydrant stand. Pipe section to be repaired.

**Figure 11 – Unexpected 4-inch drain line cutting across Parsons St. Cut out during excavation for lateral line off of Main St.**

1015 – Ludlow repaired 4” drain line by inserting 4” PVC and Fernco connectors to the existing line. Still preparing to set hydrant.

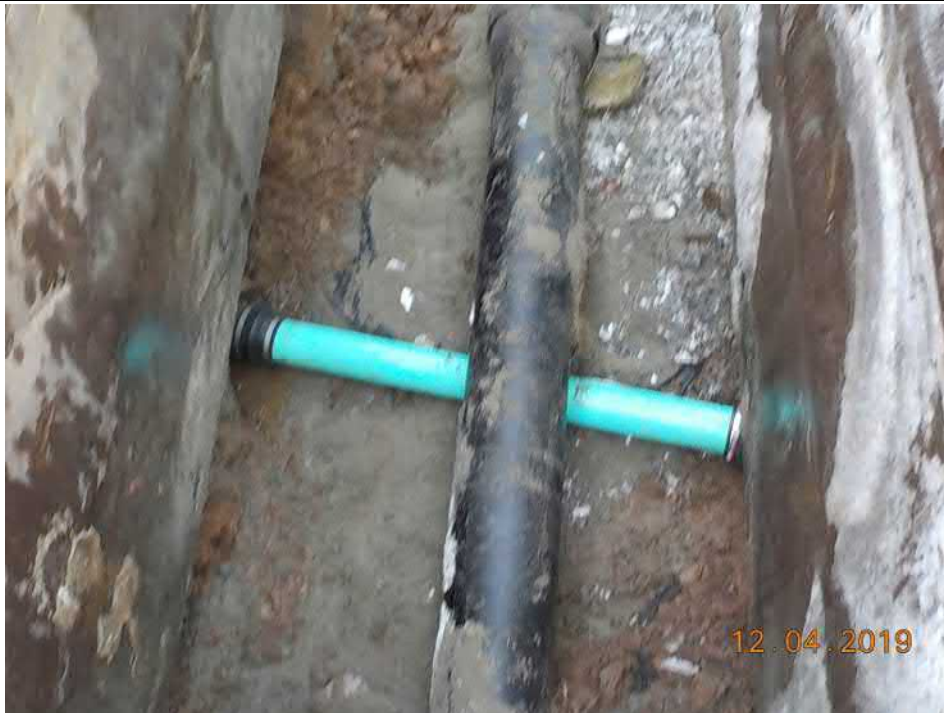
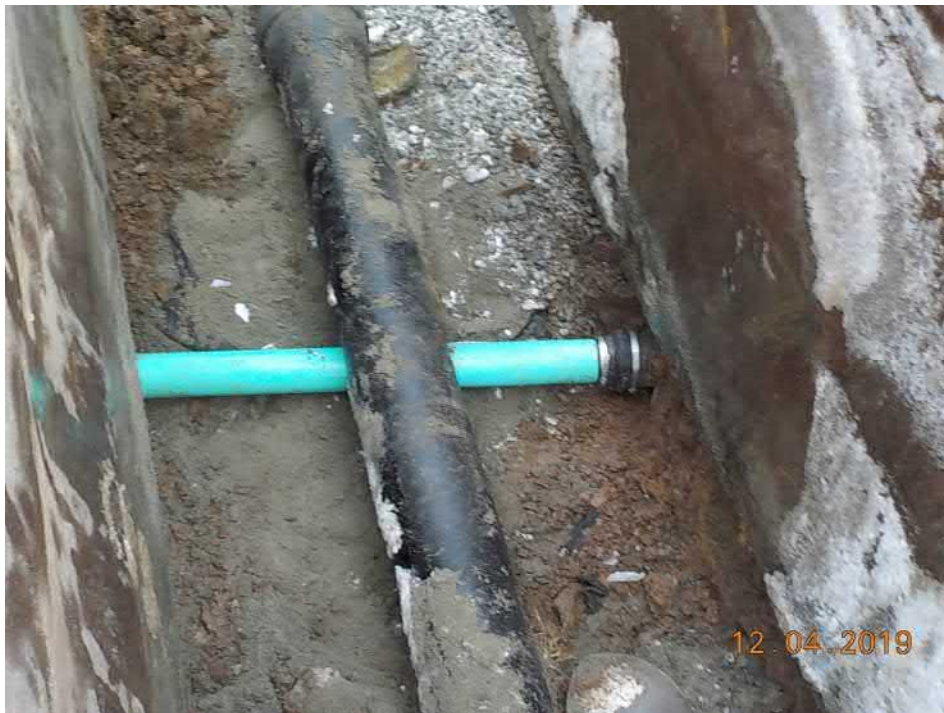
Figure 12 – Drain line repair: 4-inch PVC and Fernco couplings.

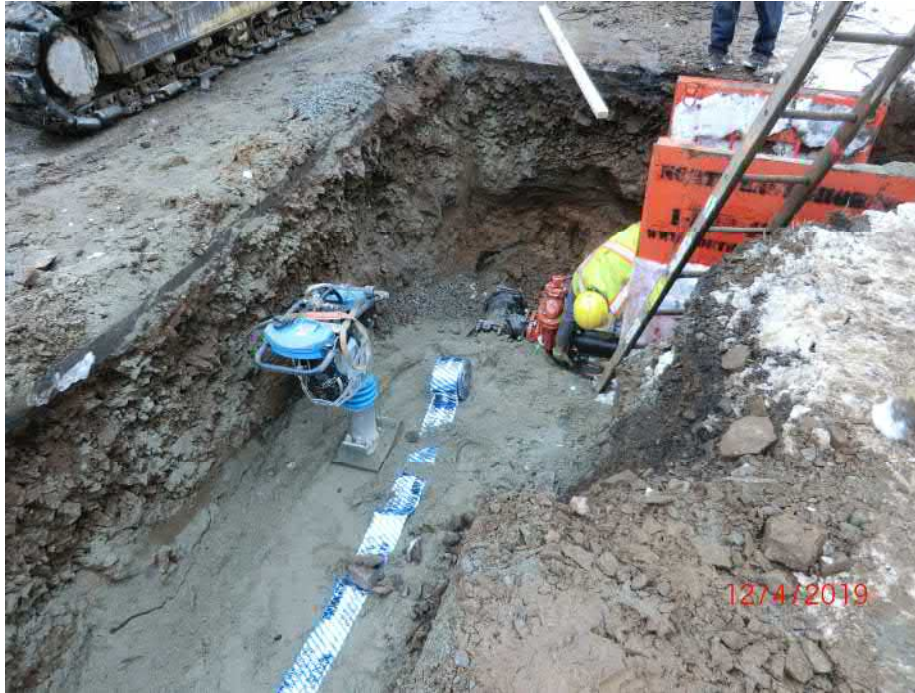
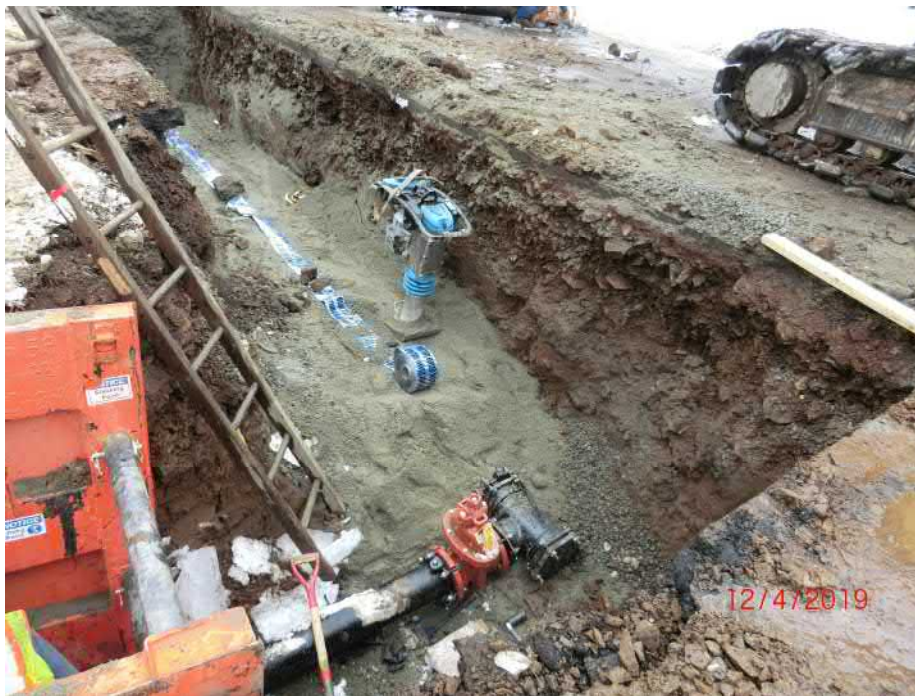
Figure 13 – End of 24 feet of 8” restrained DI pipe. End is 8x8x6 Tee with gate valve installed to feed hydrant installation to right of top picture.

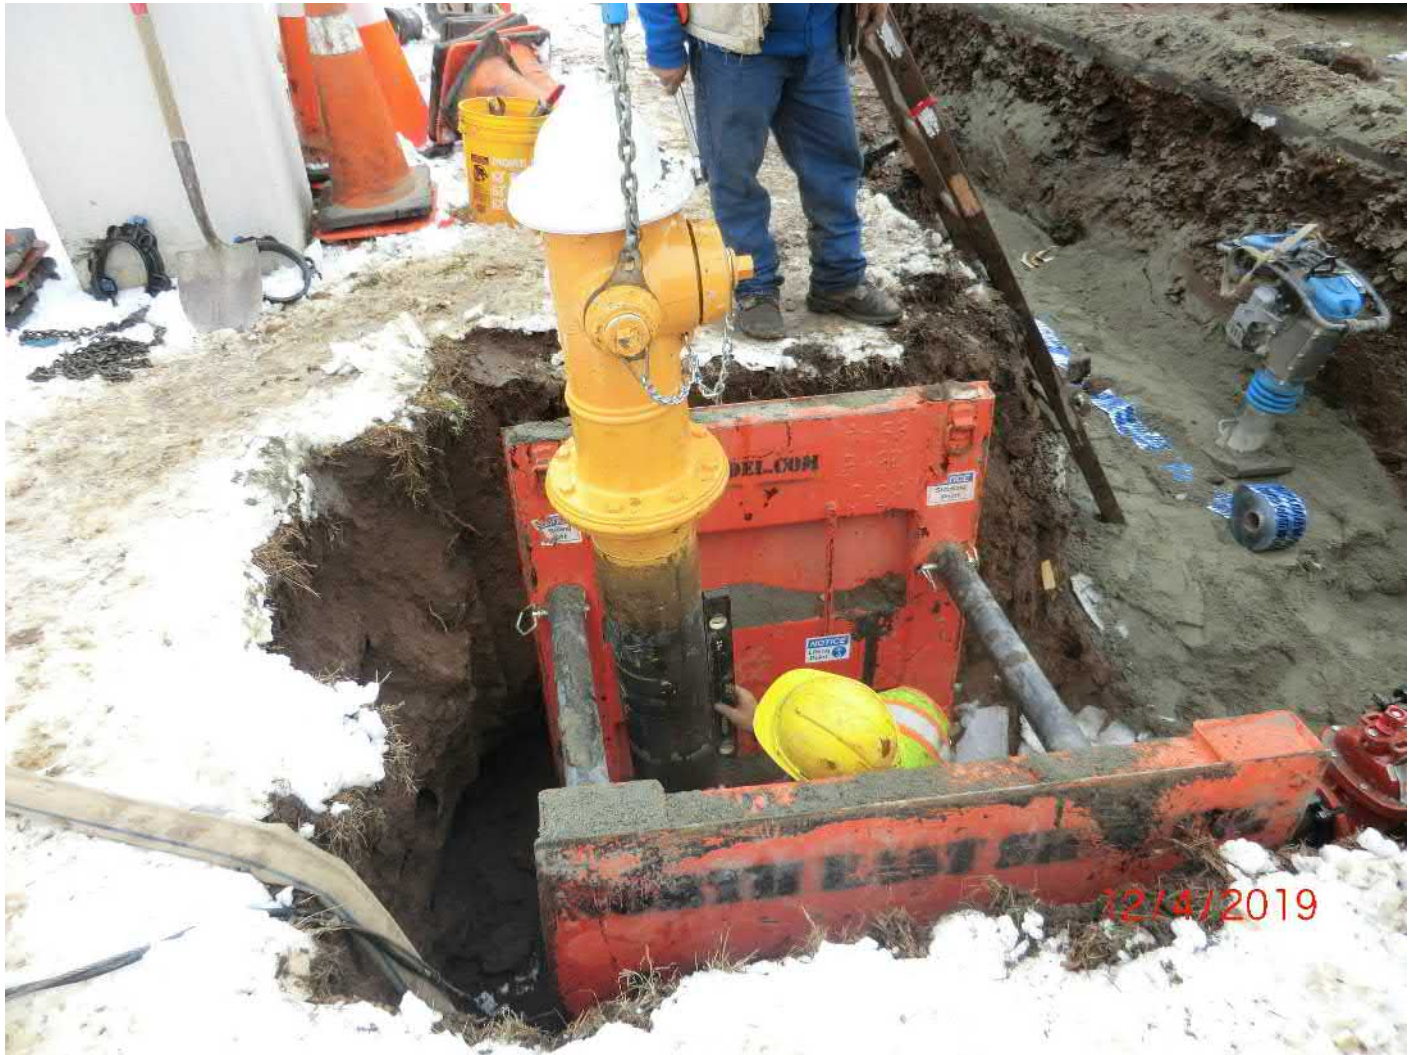
Figure 14 – Setting hydrant and checking for plumb.

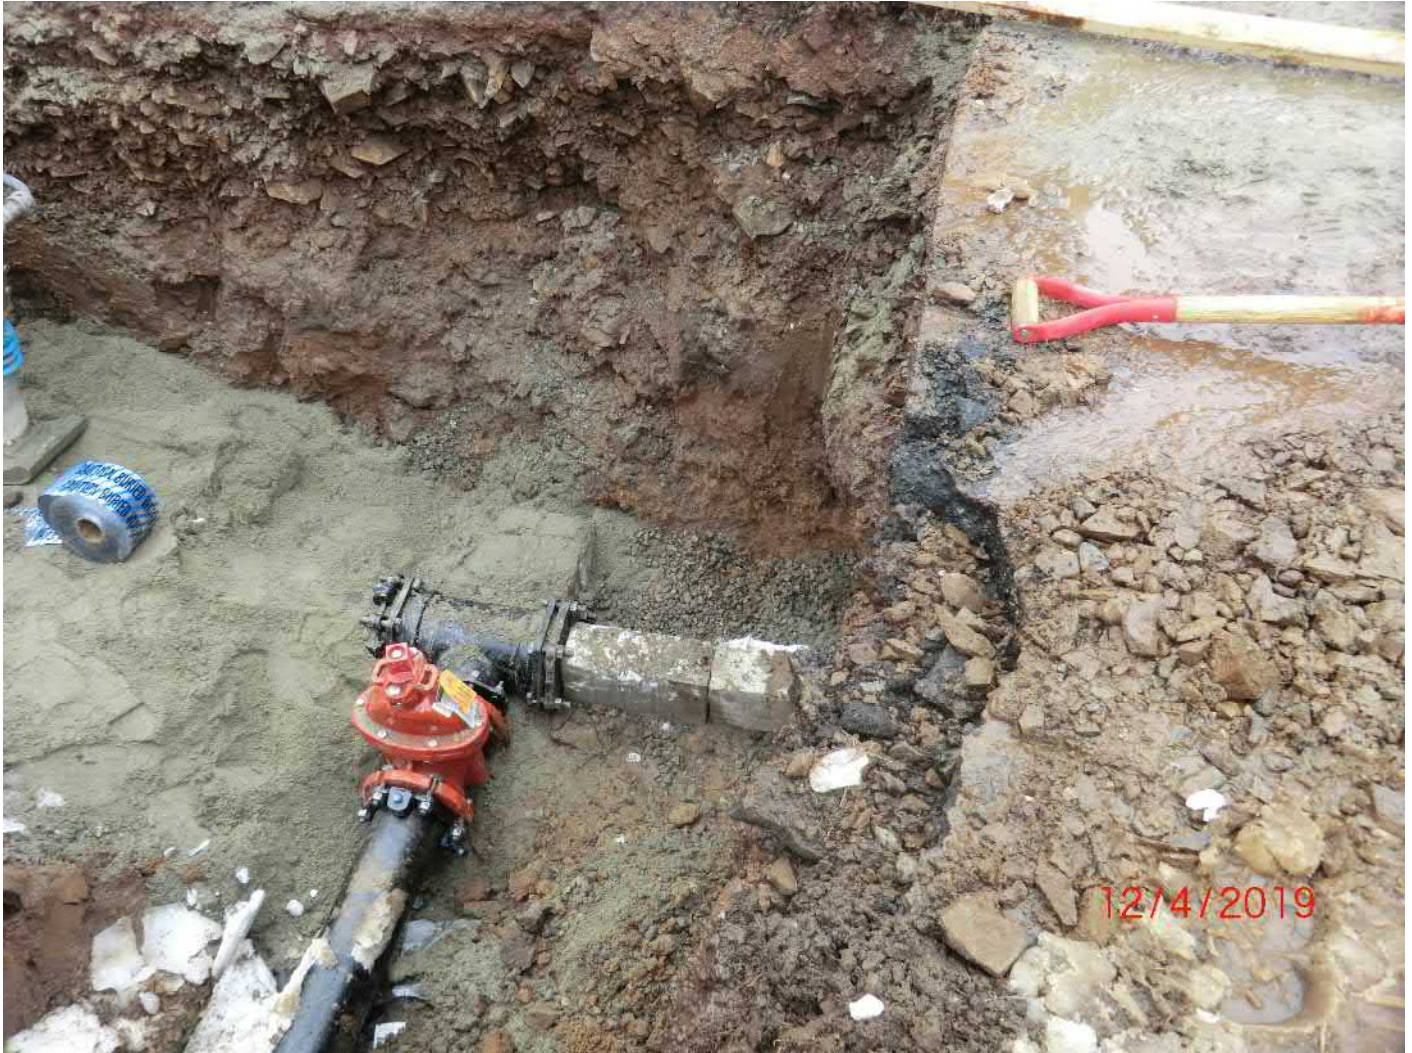
1210 – Thrust blocks placed at end of lateral from Main Street and behind the hydrant base. Additional blocks were place under hydrant lateral, and under hydrant vertical stem. The blocks under the hydrant had to be shimmed up to support the hydrant and maintain plumb.

Figure 15 – Facing south into trench. End of lateral thrust blocking. Red 6” gate valve leads to hydrant, off bottom of picture.
