## Daily Report

<b>Project:</b>	Durham Meadows Pipeline Installation	<b>Date:</b>	December 4, 2019
<b>Location:</b>	Talcott Ridge Drive, Middletown CT	<b>Day of Week:</b>	Wednesday
<b>Project #:</b>	AECOM: 60445033	<b>Report No:</b>	40
<b>Contractor:</b>	Ludlow Construction	<b>Page:</b>	1 of 19

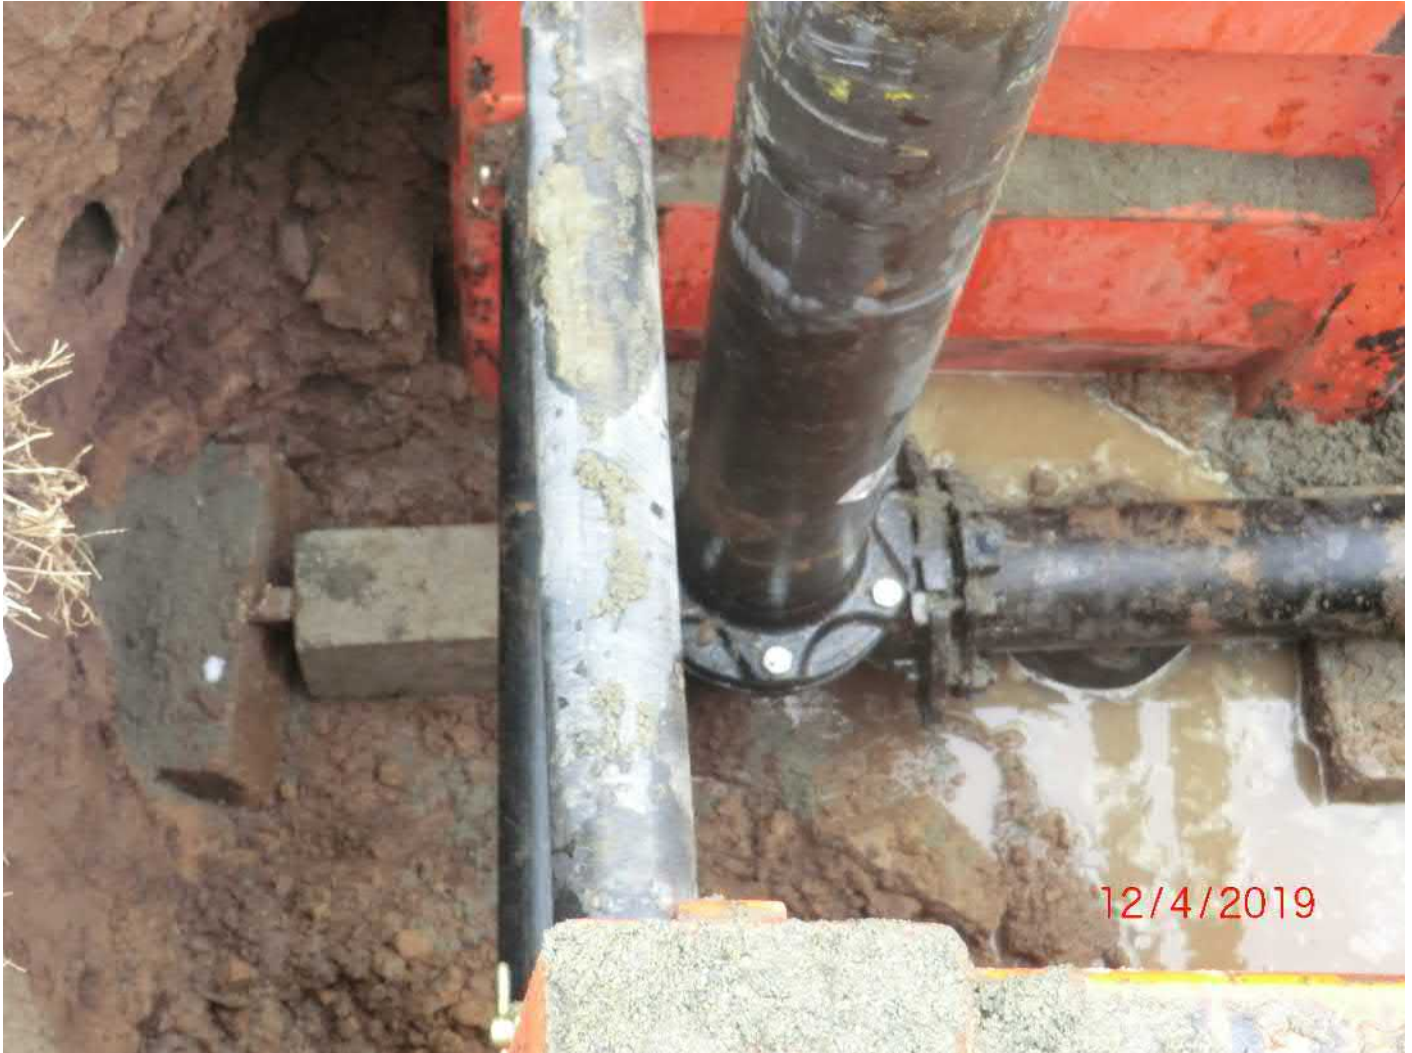
1210 – Thrust blocks placed at end of lateral from Main Street and behind the hydrant base. Additional blocks were place under hydrant lateral, and under hydrant vertical stem. The blocks under the hydrant had to be shimmed up to support the hydrant and maintain plumb.

Figure 16 – Thrust blocking behind hydrant elbow. Also note support blocking for hydrant lateral on right side of picture. Shimmed blocking under hydrant elbow is not visible in this picture.

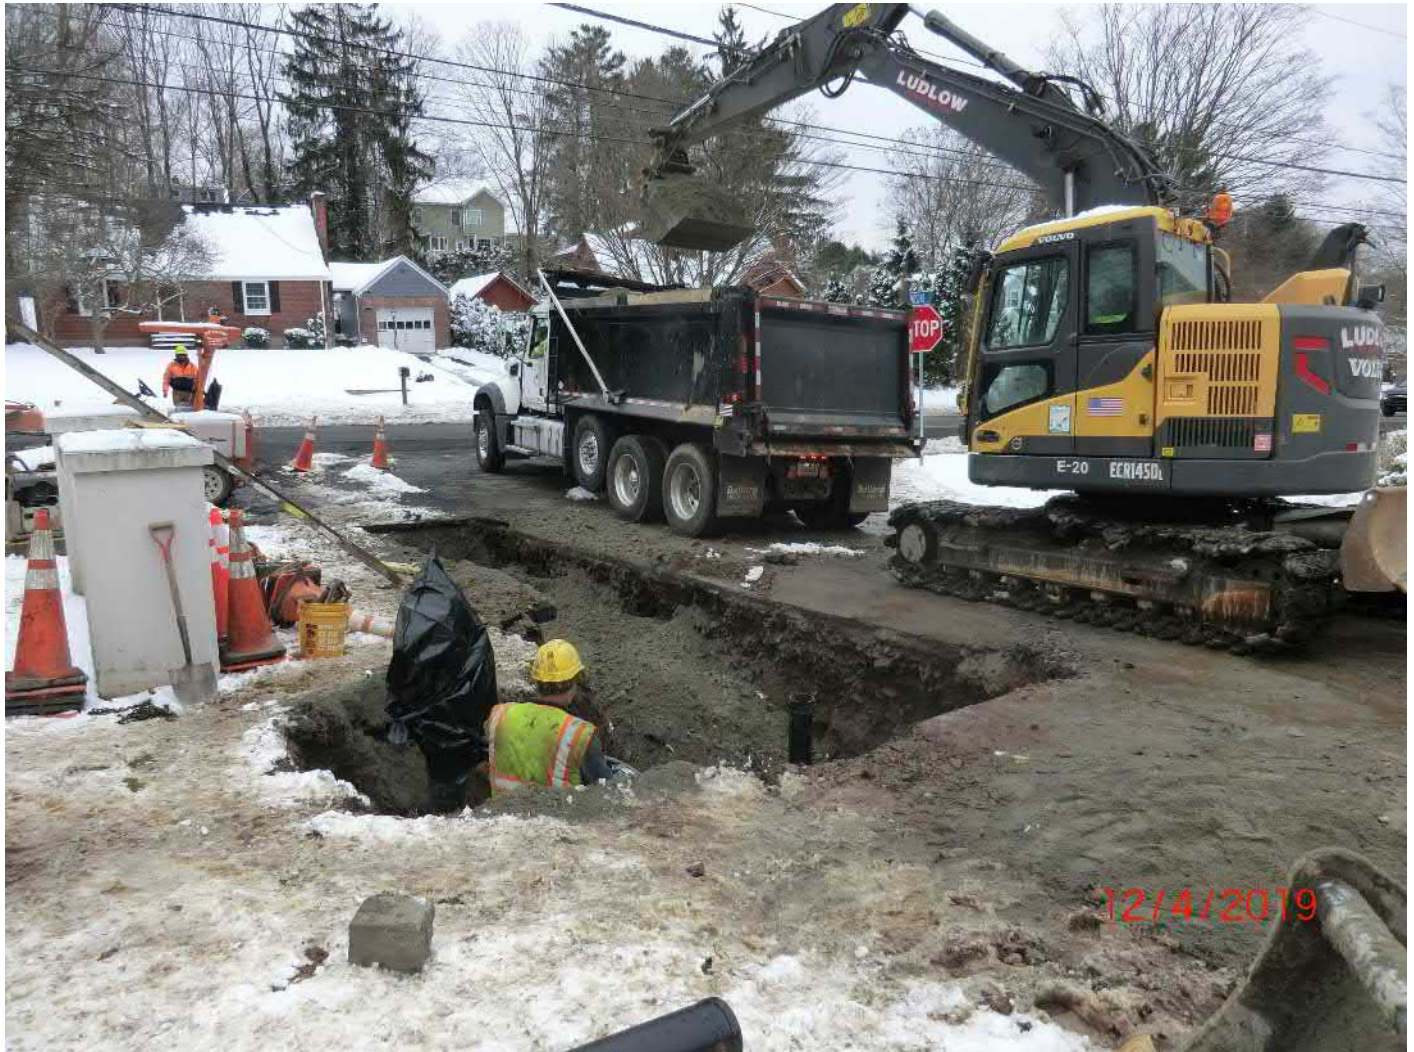
1220 – Minor gas spill from generator off the back of the utility pick-up. Unclear why the leak occurred. Pick-up removed from the excavation area and sand placed on spill area. No gas entered the trench. Sand is to be picked up at end and properly disposed.

Figure 17 – Entire installation trench. On far end is connection to lateral (off Main St. line) previously installed last week to bring connection point outside of State ROW for Route 17 (Main St.). On near side is hydrant (covered in plastic). In center of picture (roughly) is the valve box. On bottom right corner of picture just above the date stamp is the sand that was laid down on the small gas spill. The sand is to be removed later.
