Daily Report

Project:	Durham Meadows Pipeline Installation	Date:	December 10, 2019
Location:	Middletown and Durham, CT	Day of Week:	Tuesday
Project #:	AECOM: 60445033	Report No:	44
Contractor:	Ludlow Construction	Page:	1 of 25

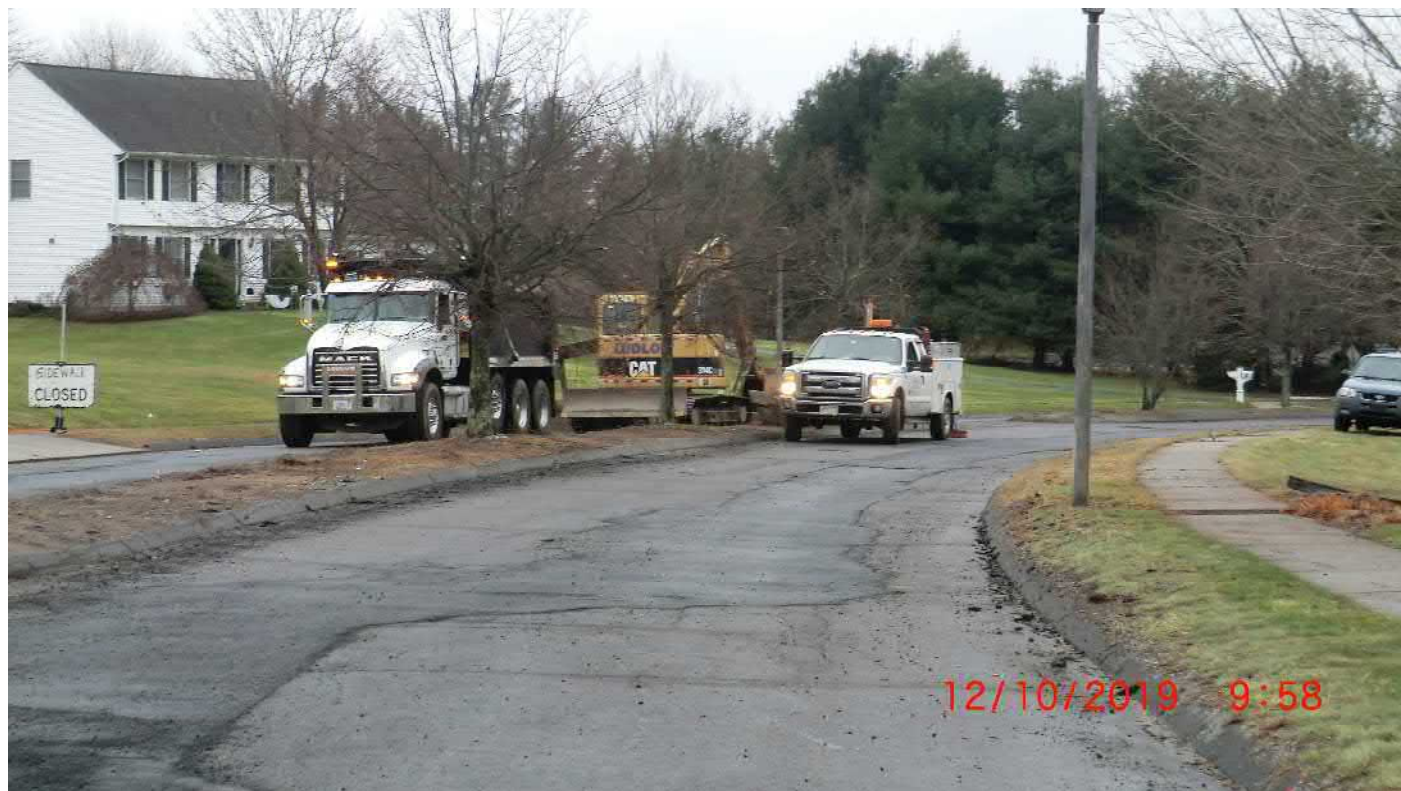
Figure 1 –Looking east southeast to location of today’s work at Station 49+30 ±. S. Main Street is behind evergreens.

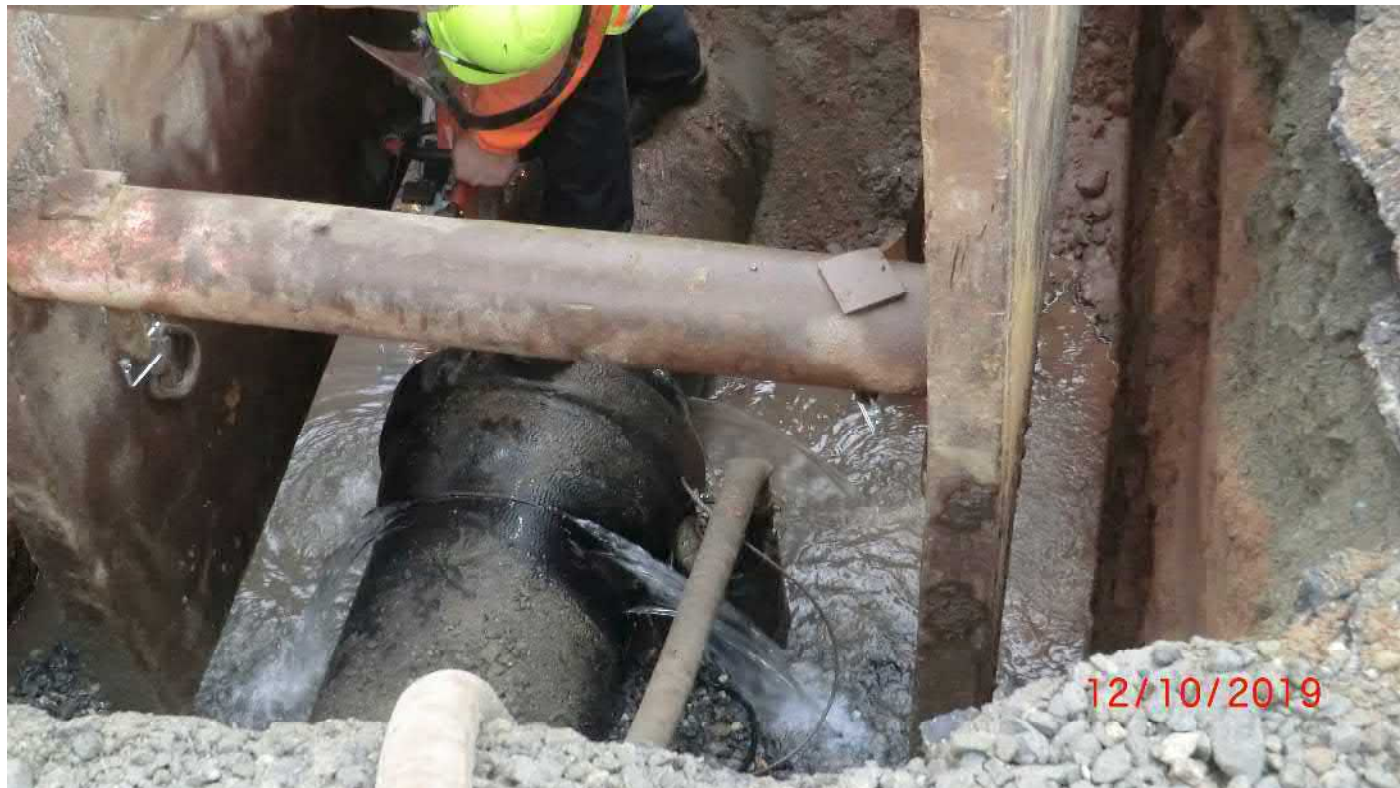
Notes: Repair leak on Talcott Ridge Drive, located roughly at Station 49+30. The leak was at a bell connection where there was a slight down deflection due to change in slope. The repair required cutting out approximately 4 feet of pipe, including the bell, draining the water from the system during the process, and inserting 4 feet of 16" DIP with two 14" collars and 4 Mega-lugs. Each 14" collar straddled the cut line of the removed pipe. Site clean-up also started today. Some minor progress in removing signs from Route 17 (Main St.) and equipment from DPW yard (Broce Broom and Roller – likely put there for today's work).

Figure 2 – Cutting drain slits and sump hole in pipe. Leak was detected at the bell connection.

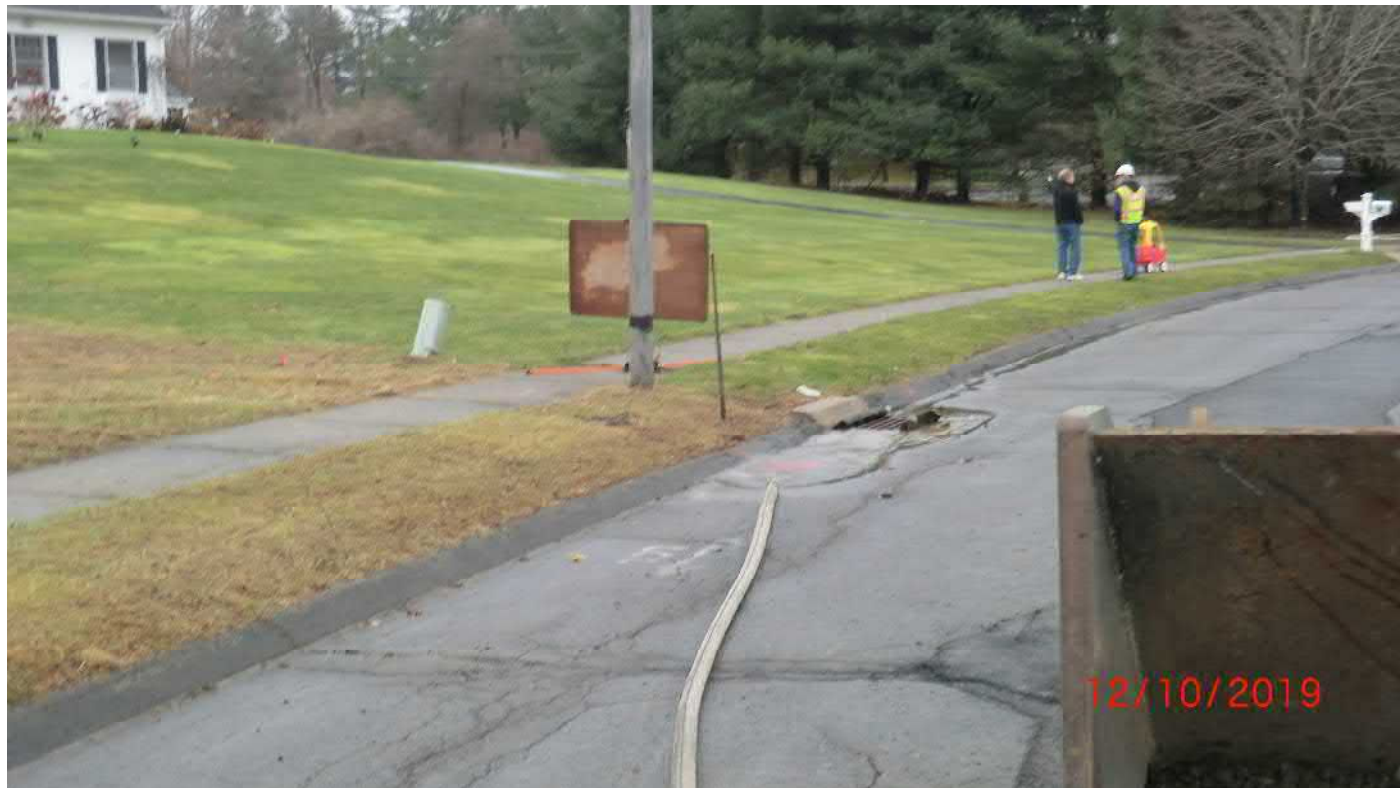
Figure 3 – Facing east southeast clean (town) water being purged from well to lined catch basin. The silt sock had been removed and cleaned earlier because it was so full that water was draining straight past basin to the double catch basin at the corner of S. Main St. and Talcott Ridge Drive.

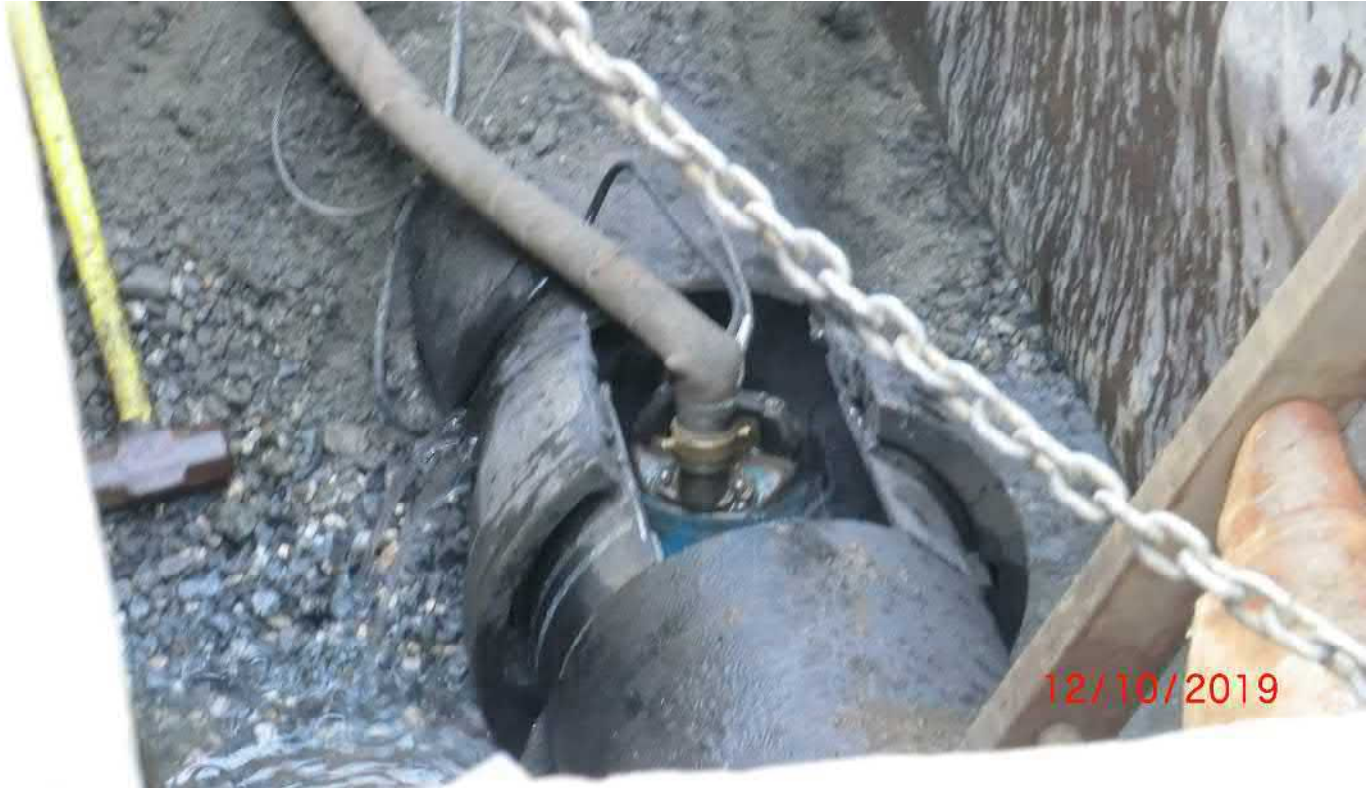
Figure 4 – Sump hole cut into bell. Sump draining to catch basin.

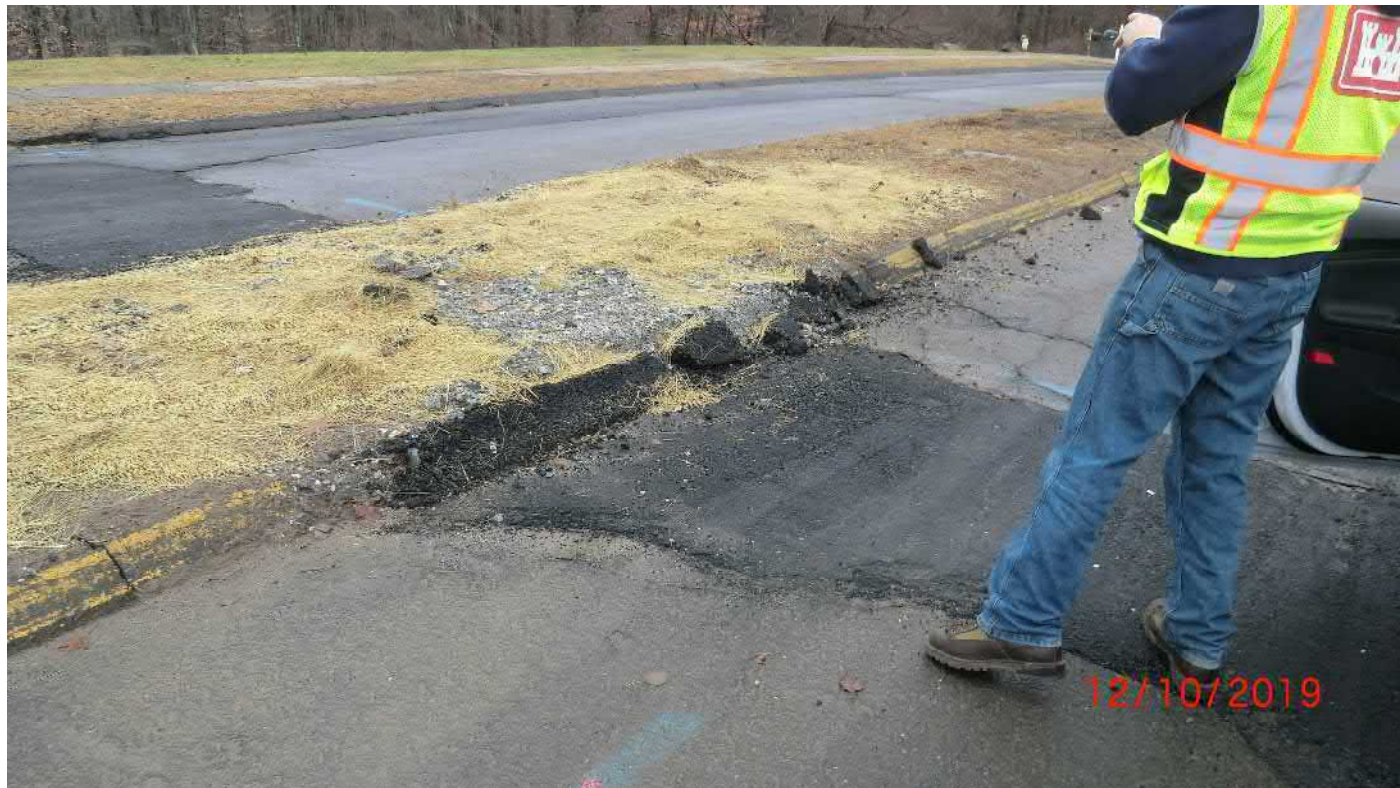
Figure 5 – View southeast, Talcott Ridge cul-de-sac to the right of picture. Curb repair failure at location that was breached to run 6" DIP across Talcott for new hydrant on other side of road. Unclear if damage was due to plowing (snow) or equipment.

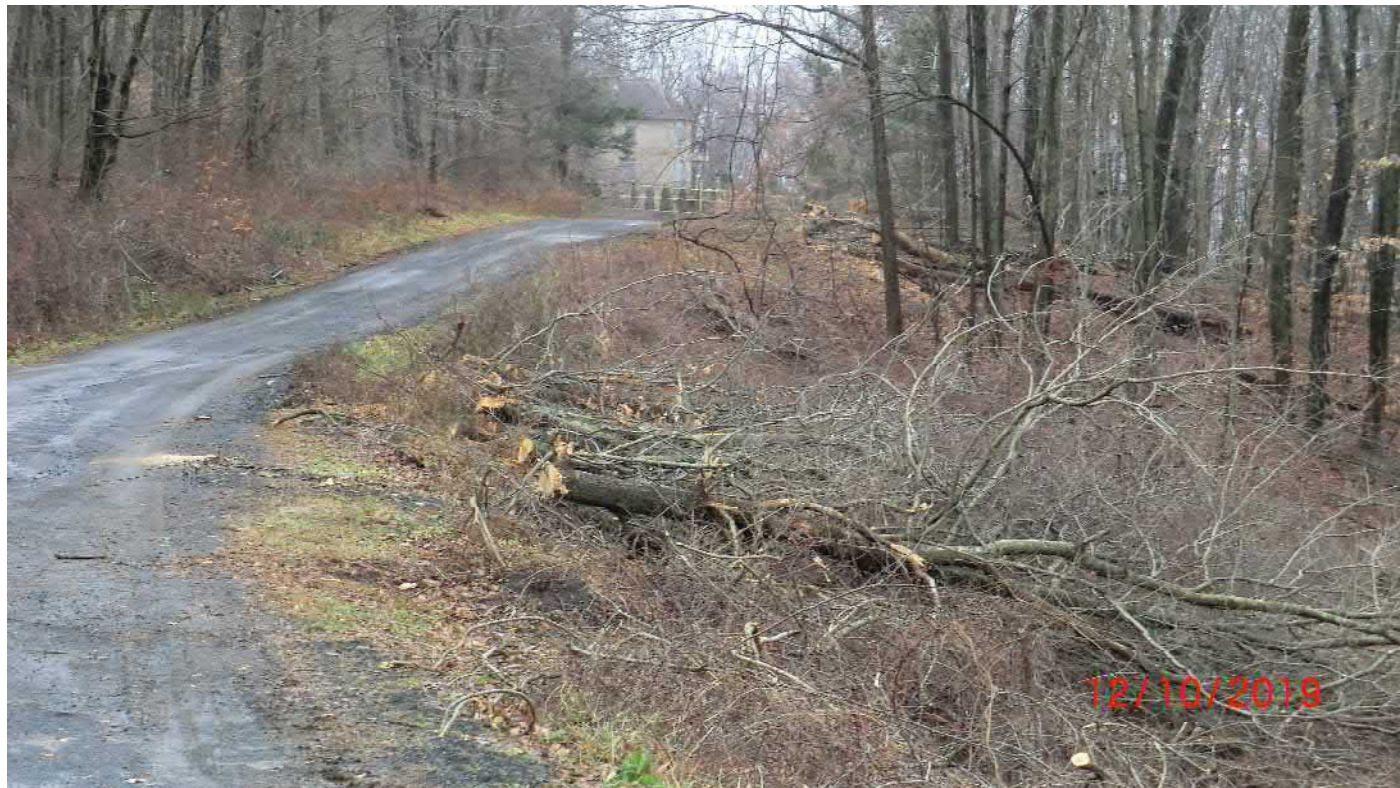
Figure 6 – West northwest view from private drive up to the cul-de-sac (Talcott). Tree clearing awaiting chipping.

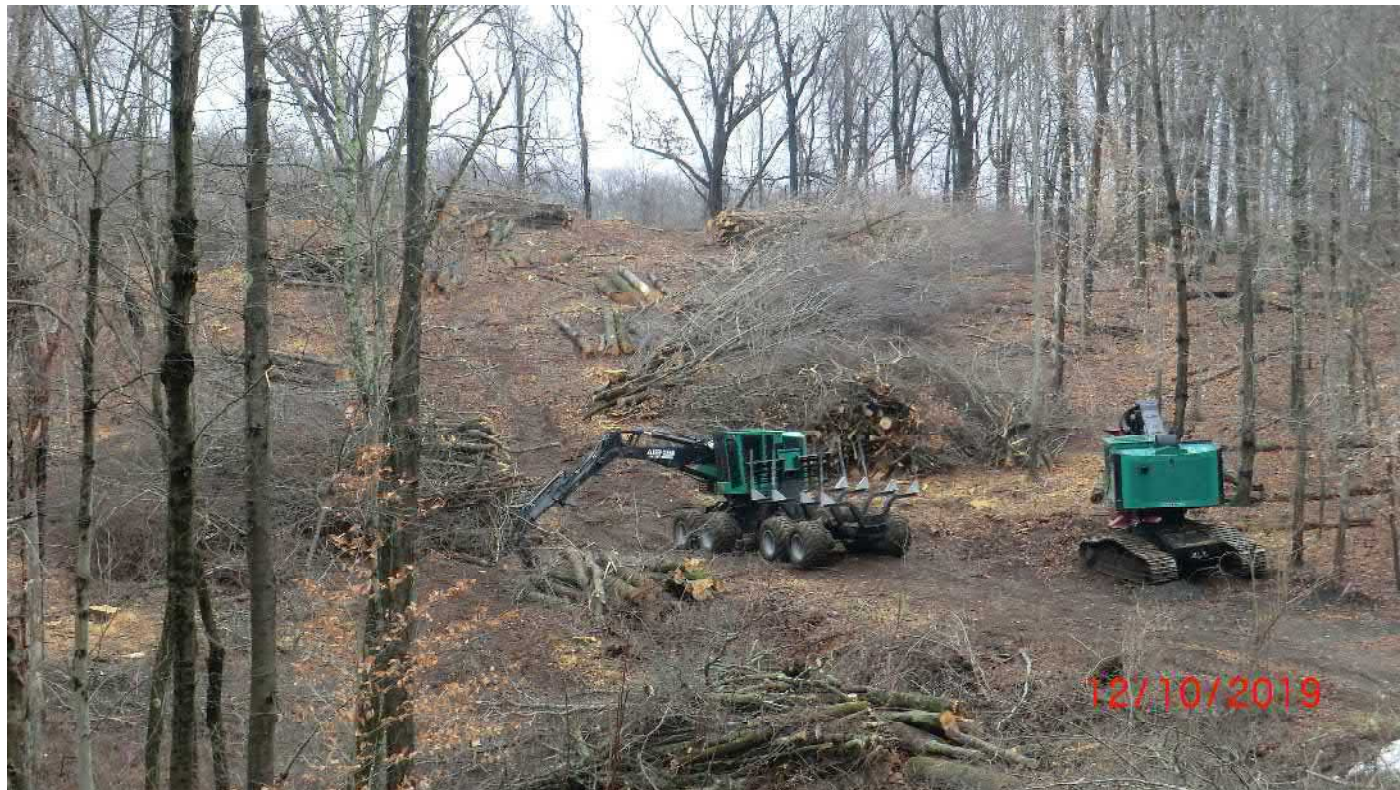
Figure 7 – View eastwardly up access to tank location. Driveways to neighboring houses to the bottom right corner of picture.

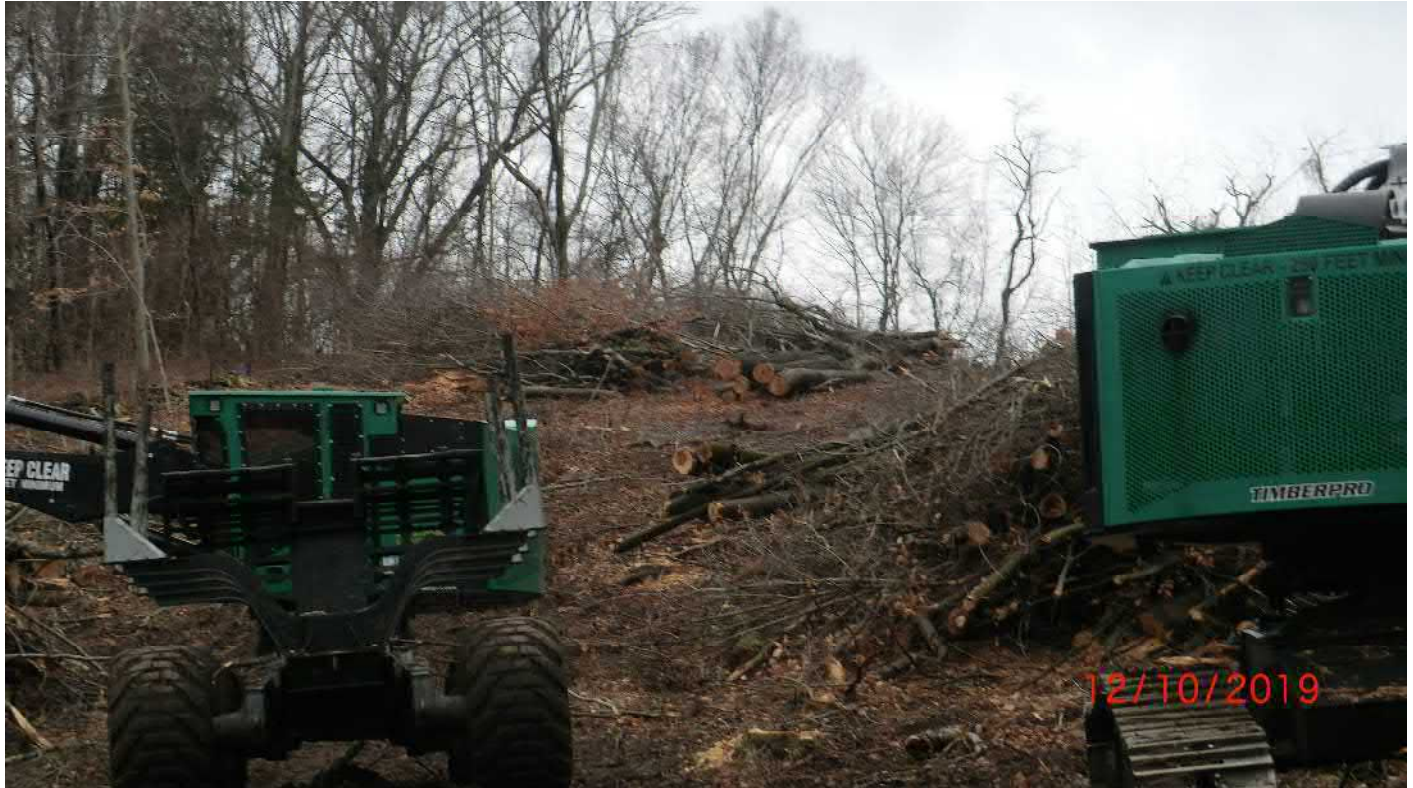
Figure 8 – Same view as Figure 7, but closer.

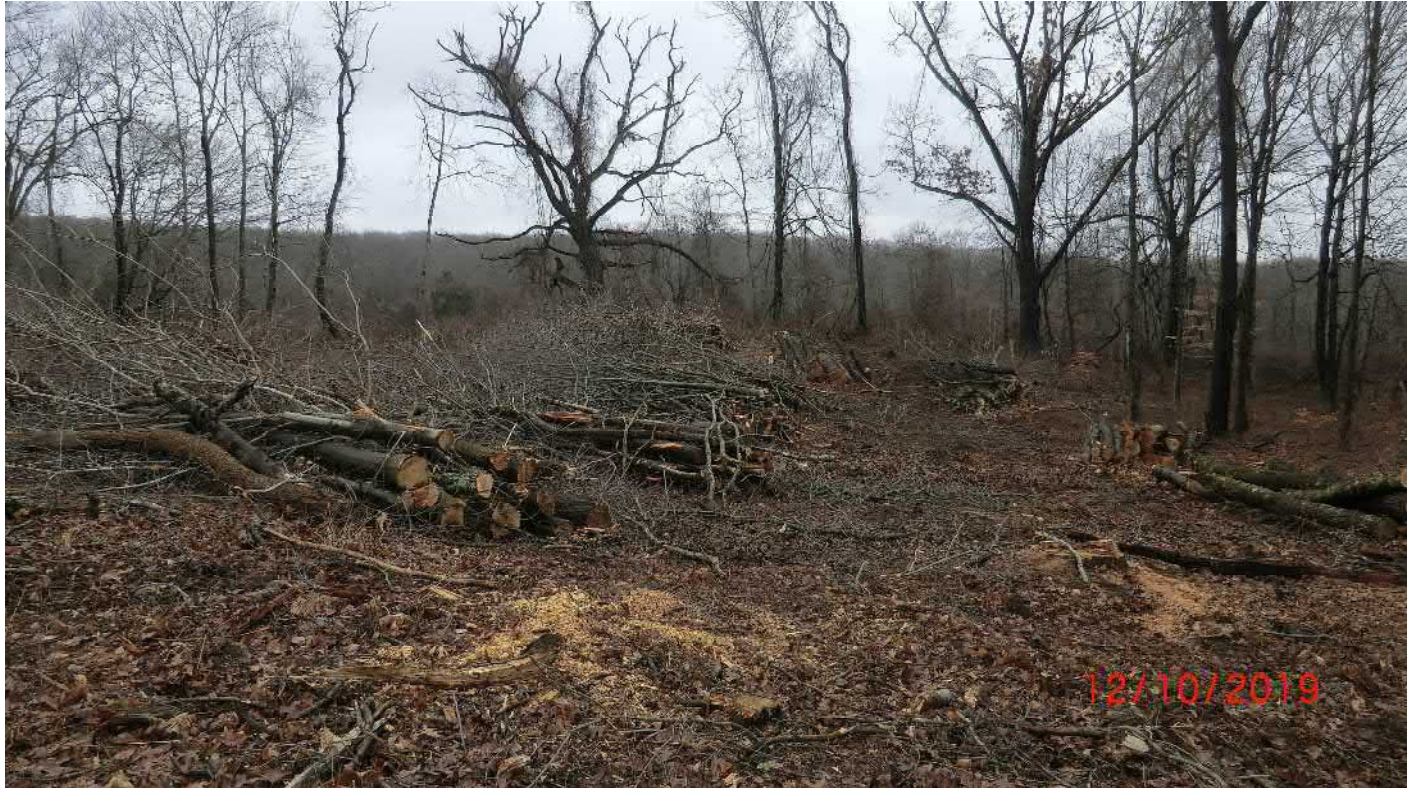
Figure 9 – Facing easterly, view of tank area.

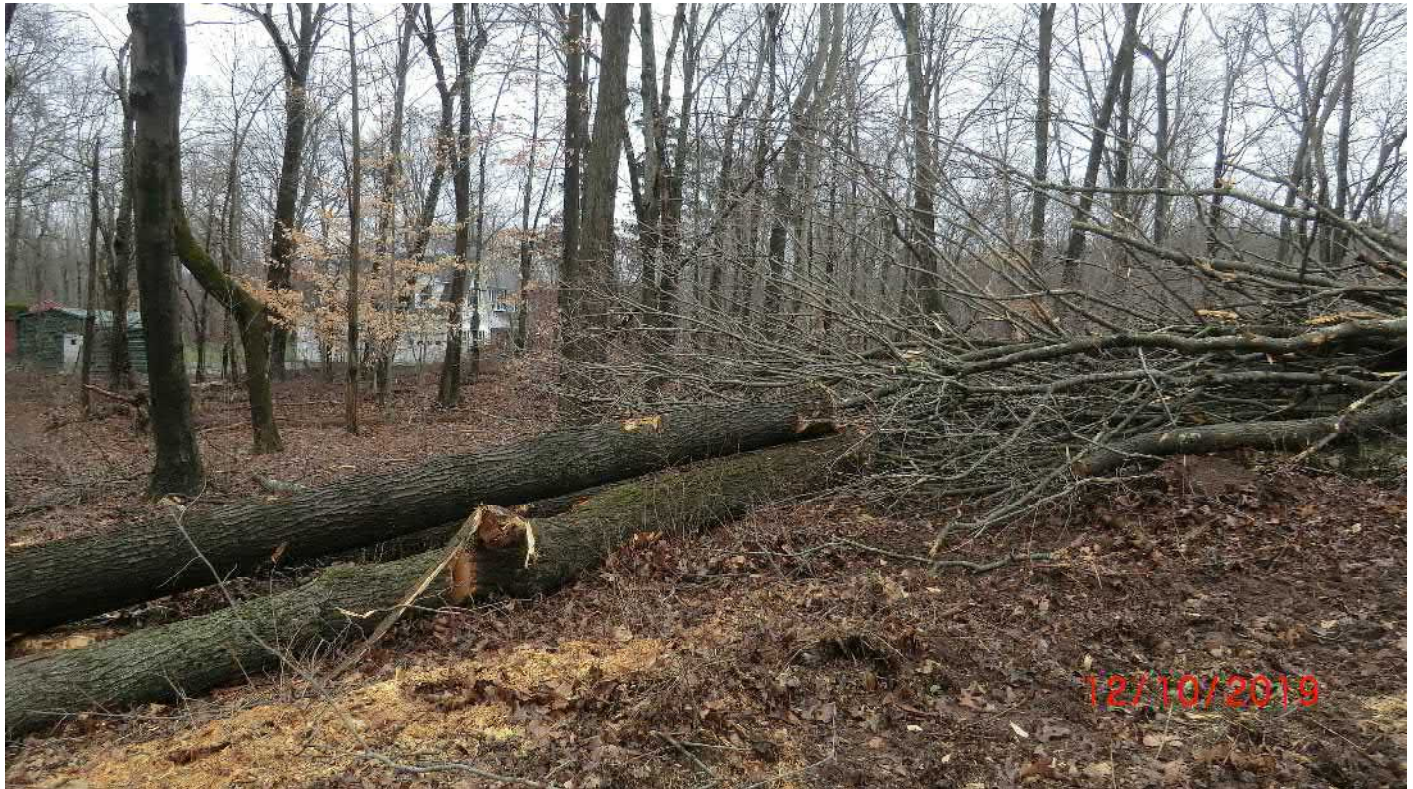
Figure 10 –southwesterly view, edge of tank area facing nearest neighbor to tank site.

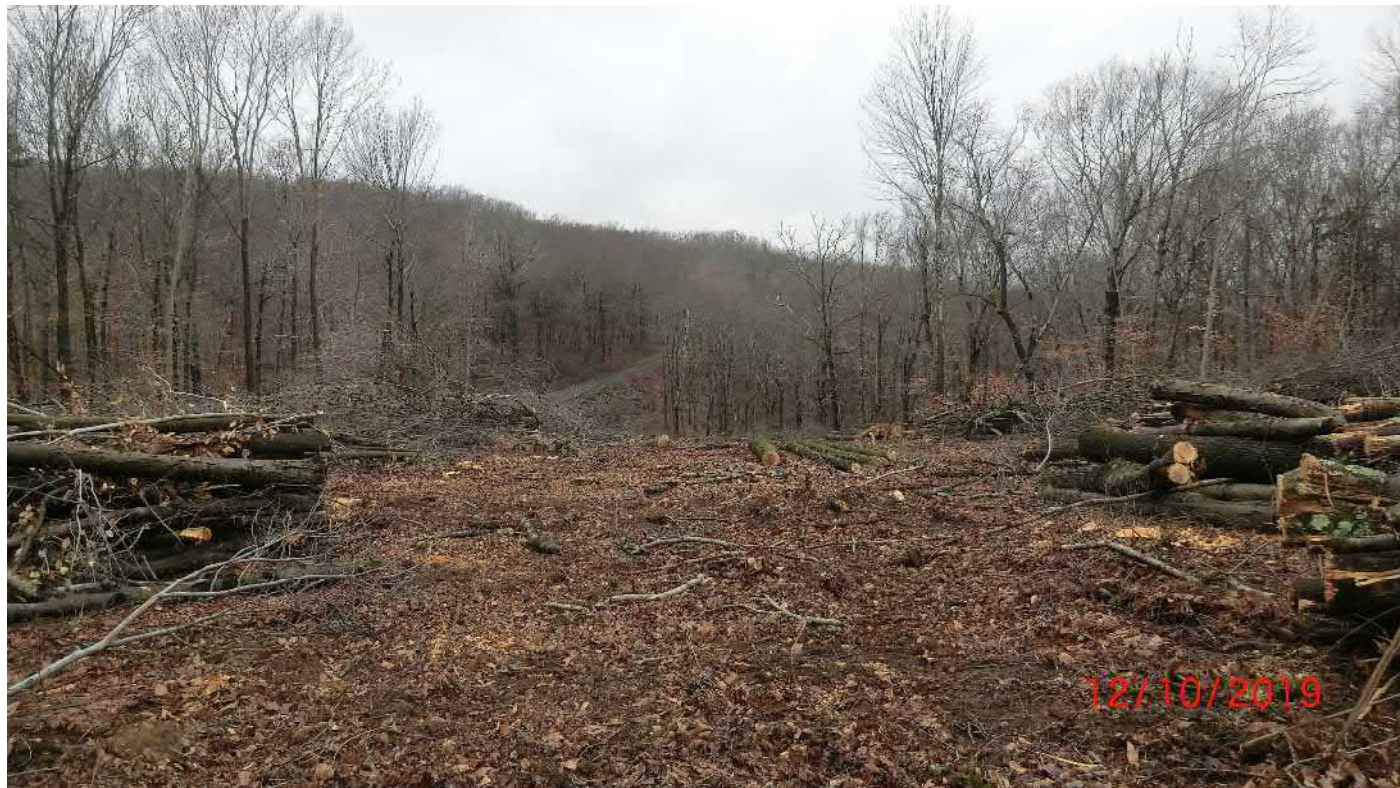
Figure 11 – Westerly view from water tank area to access road. Note that the private drive in to the access road can be seen in the distance.

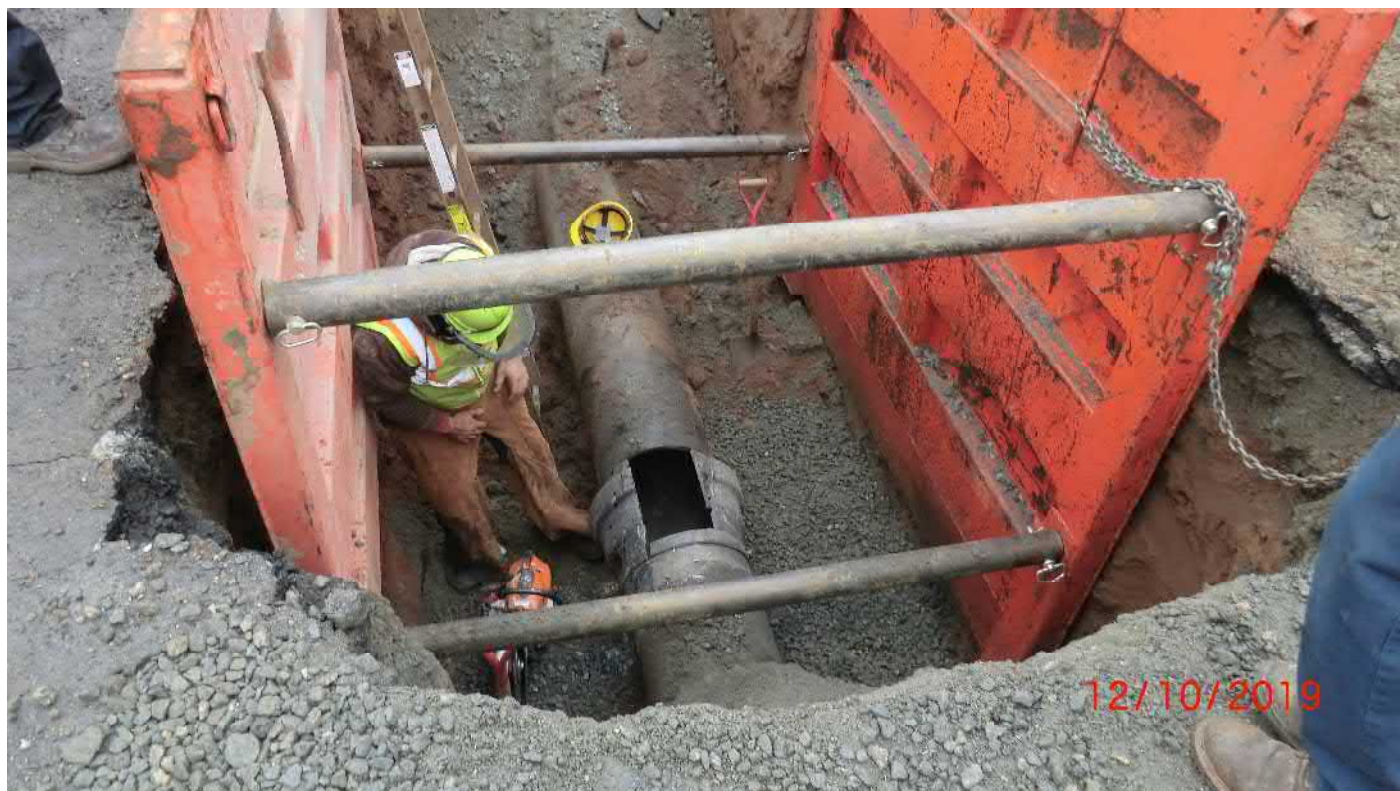
Figure 12 – Pipe drained. Preparing to cut section out.

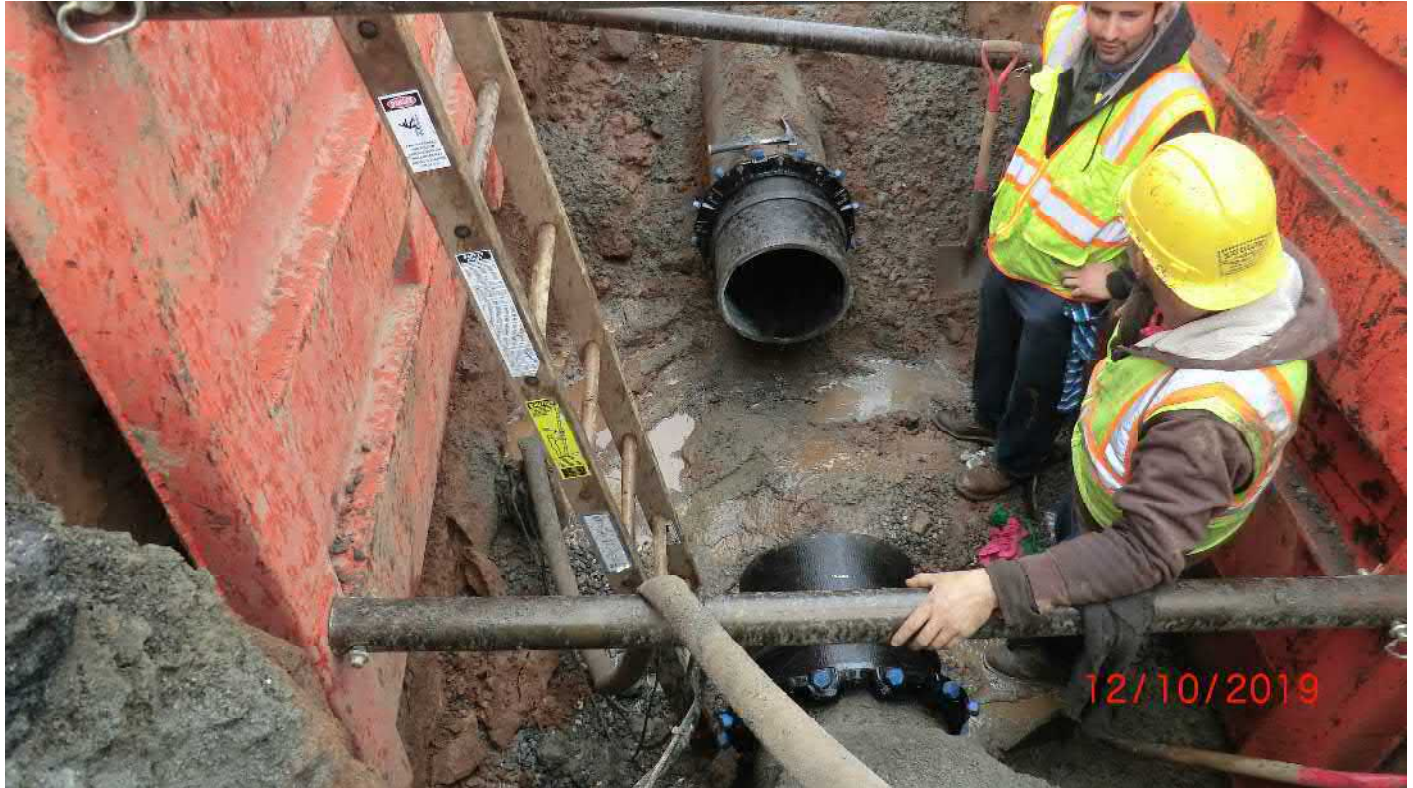
Figure 13 – Roughly 4 foot section cut from pipe line. Notice Megalug restrained glands on either side for connecting to replacement section.

0900 – Cutting out approximately 4 feet of line, including the leaking bell, from the water line.

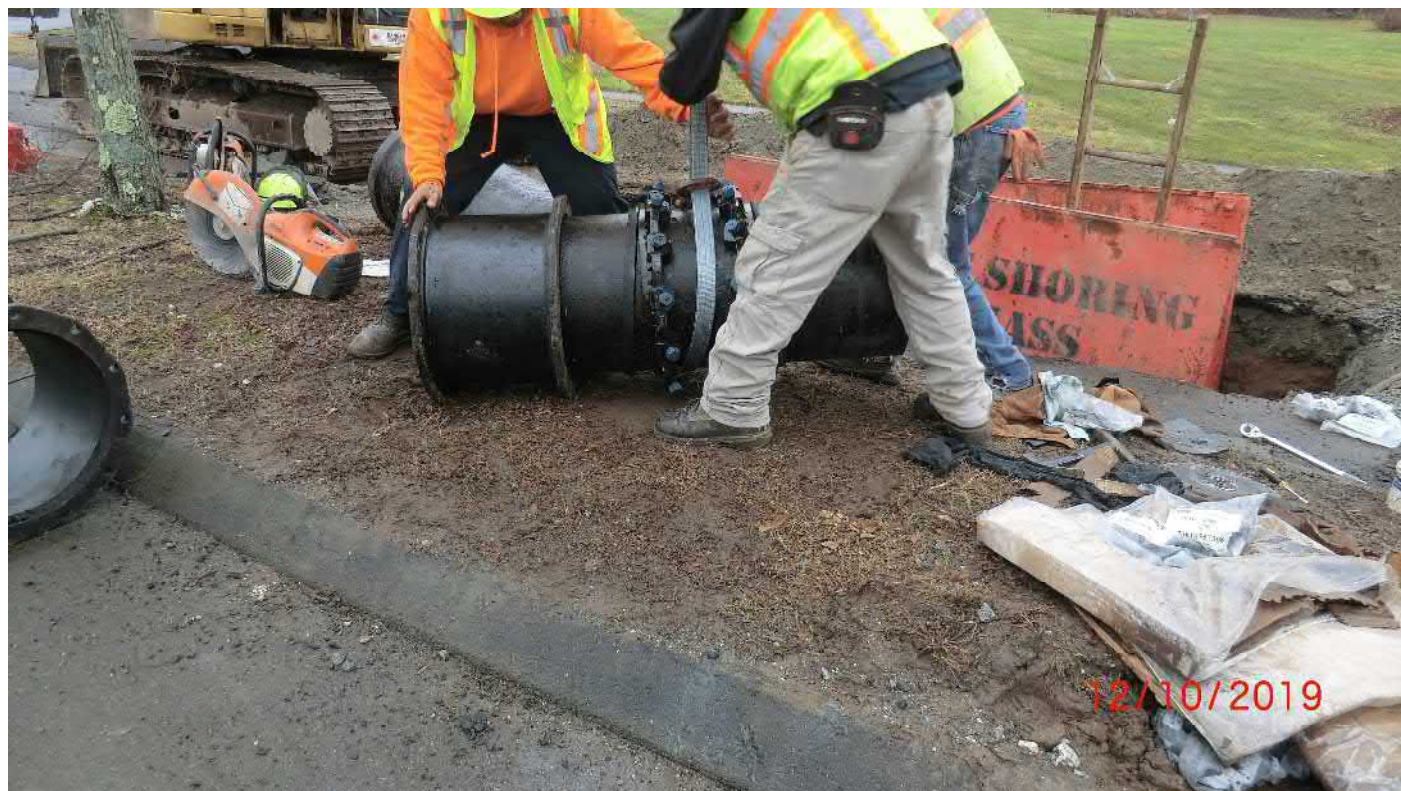
Figure 14 – Replacement section of 16” DIP being fitted with the first of two solid sleeves (second sleeve is seen in left of frame). Note Mega-lugs un inside by strap.

Pipe Connections: Two connections using Mega-lug restraints and pipe collars.

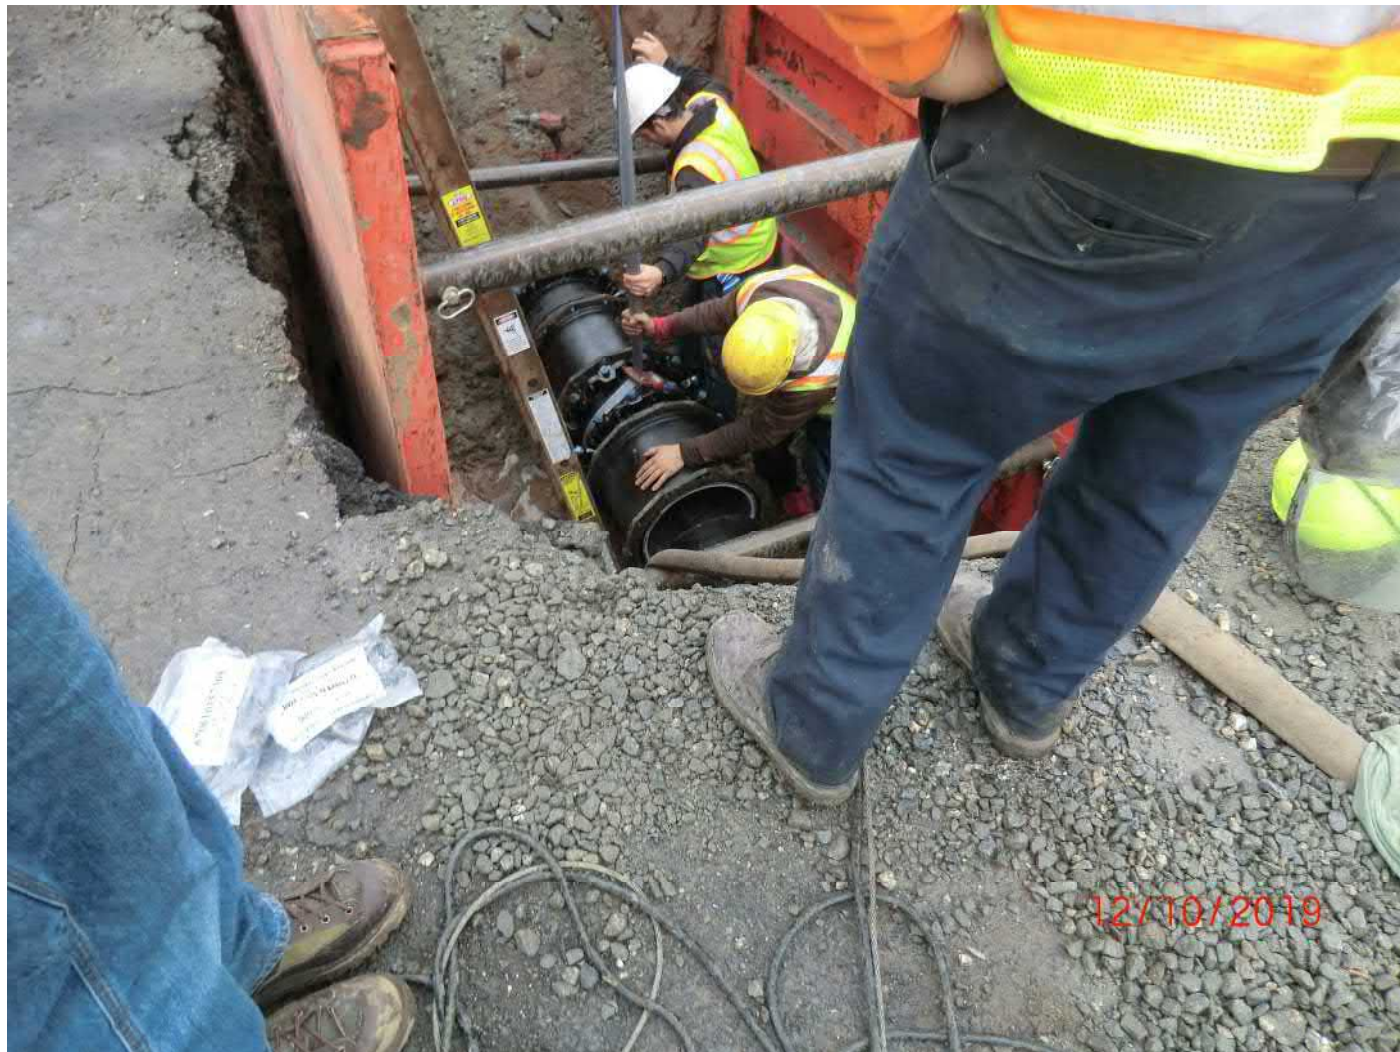
Figure 15 – Lowering replacement section of pipe into hole.

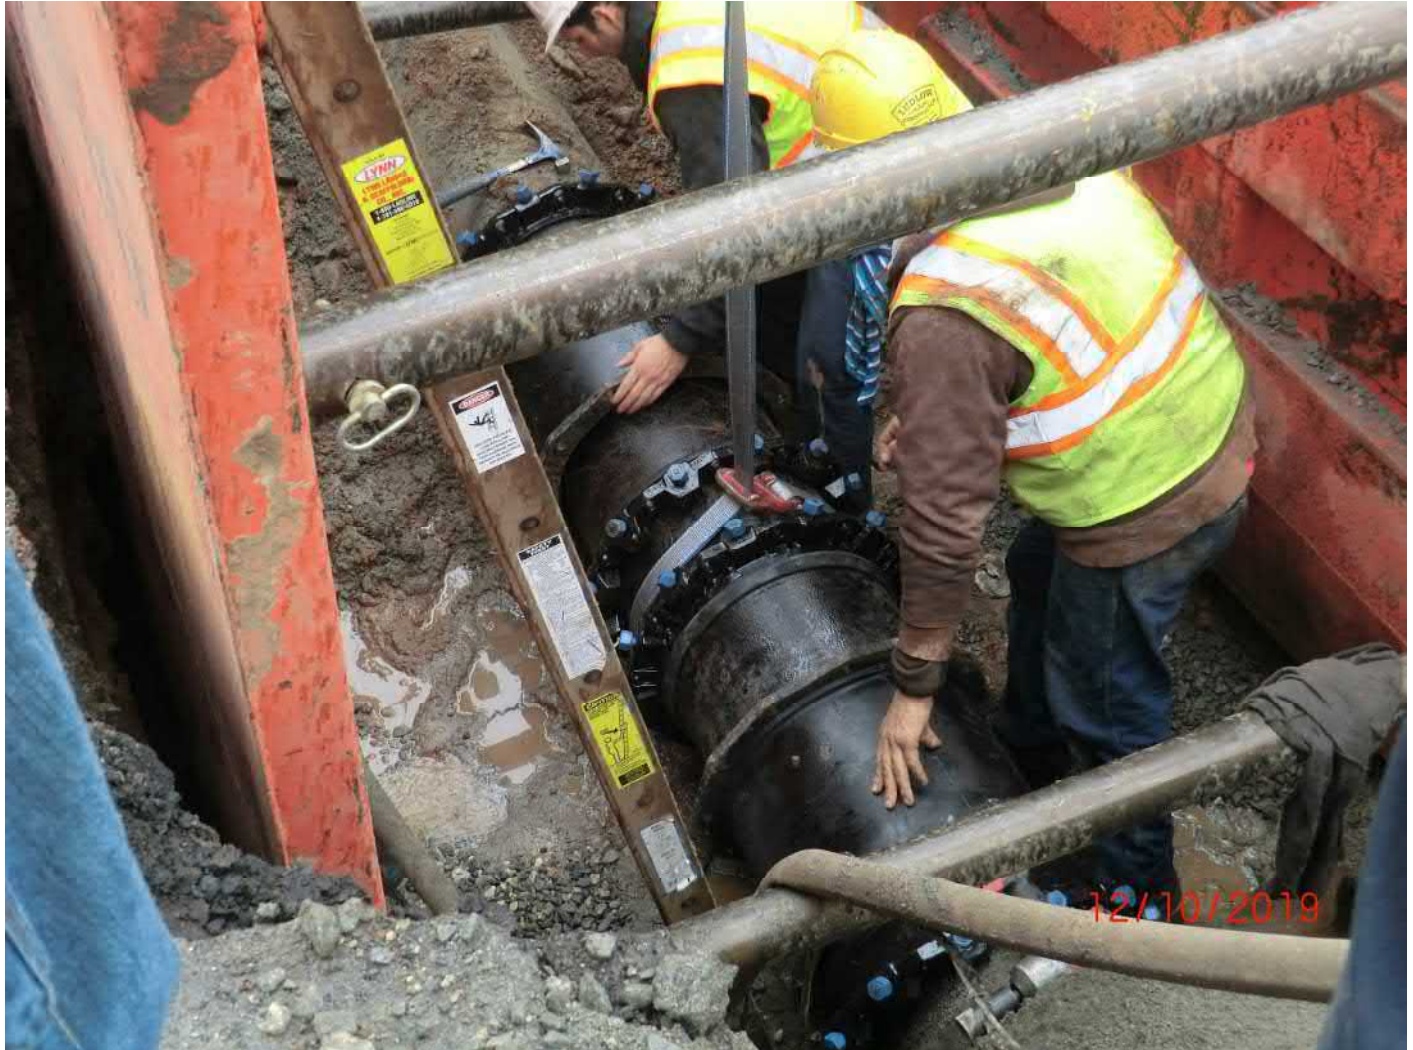
Figure 16 – Sliding/extending solid sleeves into place. 16” sleeves centered over cuts but using marks on the pipe.

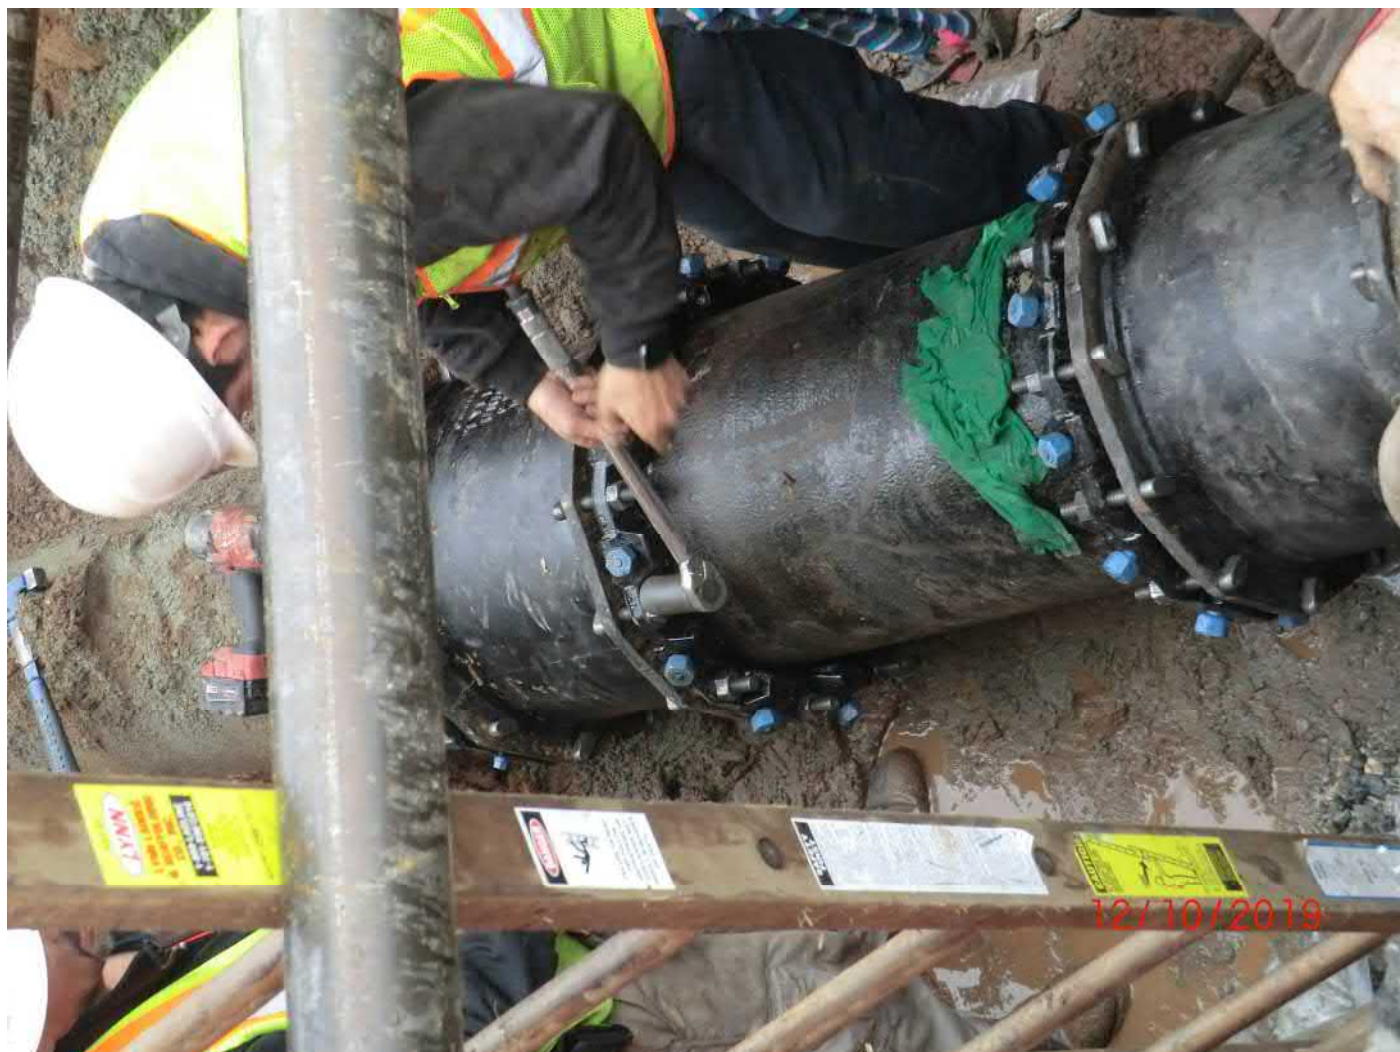
Figure 17 – Torquing bolts on Mega-lug restraints. Note the pair to the left and the pair to the right. The center is the 4-foot length of replacement pipe.

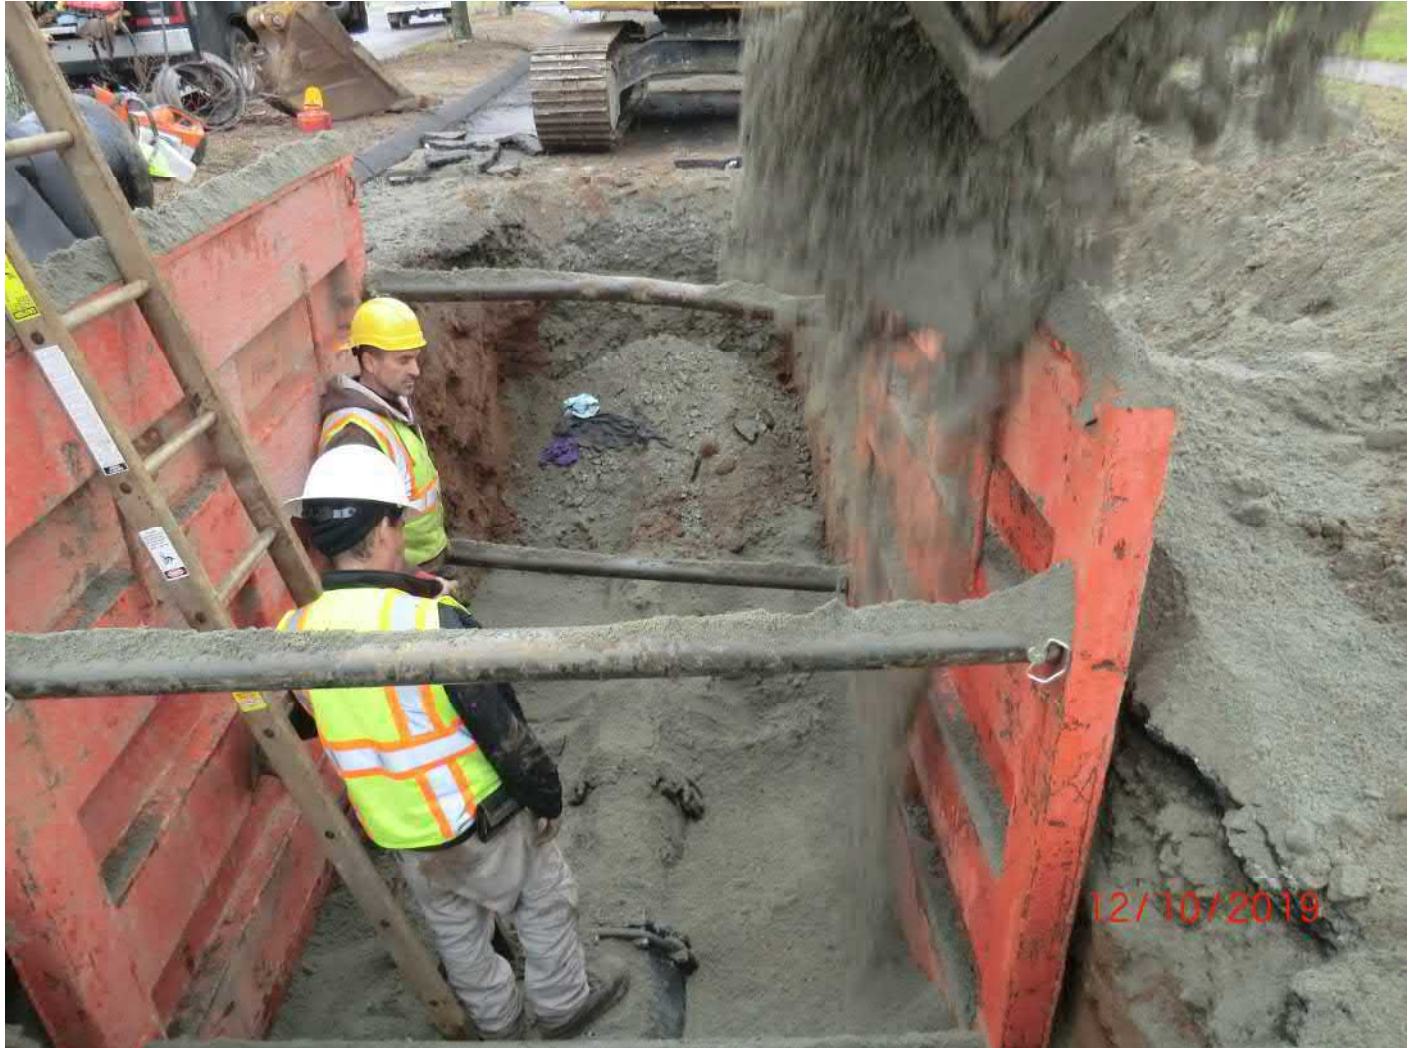
Figure 18 – Facing east, backfilling the repair.

1330 – Excavated area backfilled and awaiting asphalt. Road sweeping and clean up under way.
