Daily Report

Project:	Durham Meadows Pipeline Installation	Date:	December 10, 2019
Location:	Middletown and Durham, CT	Day of Week:	Tuesday
Project #:	AECOM: 60445033	Report No:	44
Contractor:	Ludlow Construction	Page:	1 of 25

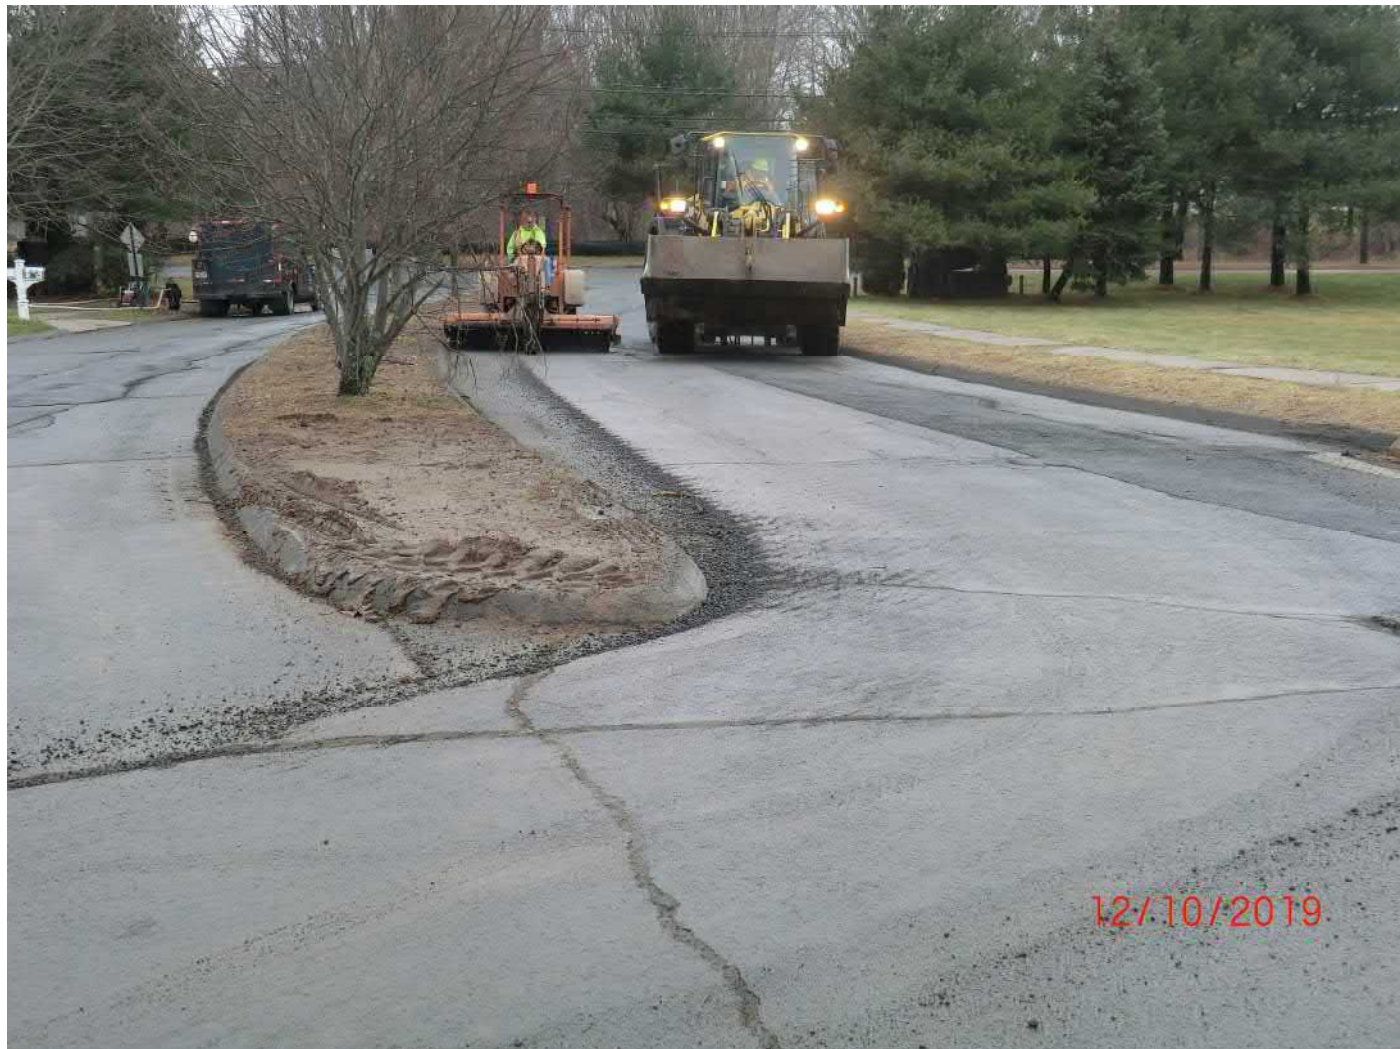
Figure 19 – Facing west, street sweeping activities. Cleaning up loose asphalt and gravel from Talcott Ridge. S. Main Street is seen in the distance.

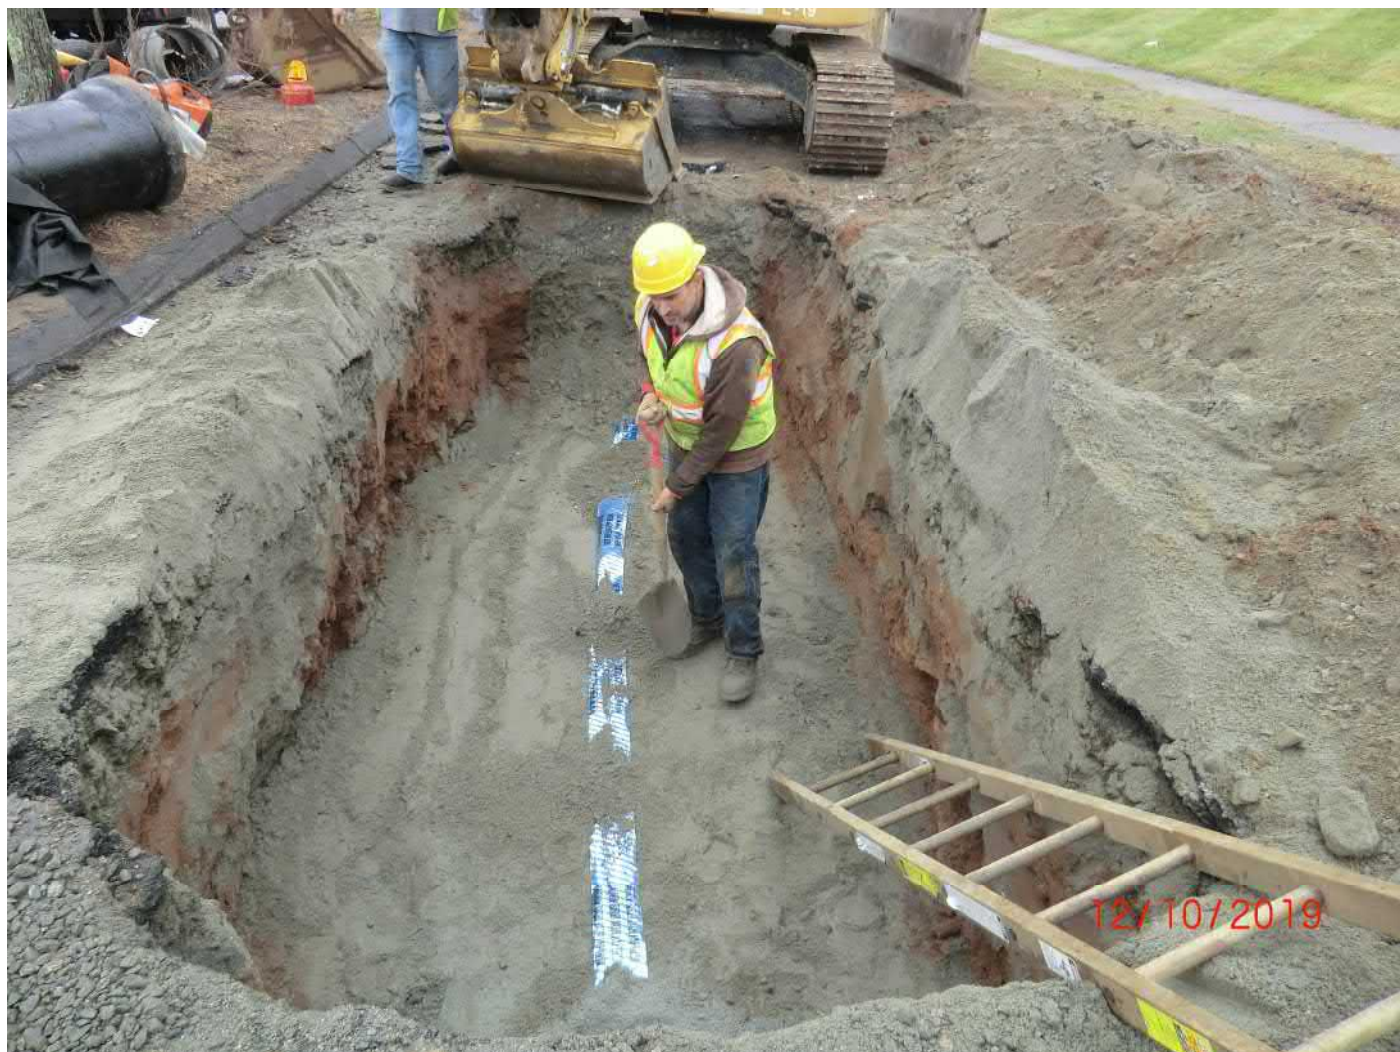
Figure 20 – Facing east, pipe bedding in and compacted by jumping jack. Warning tape set down on top.

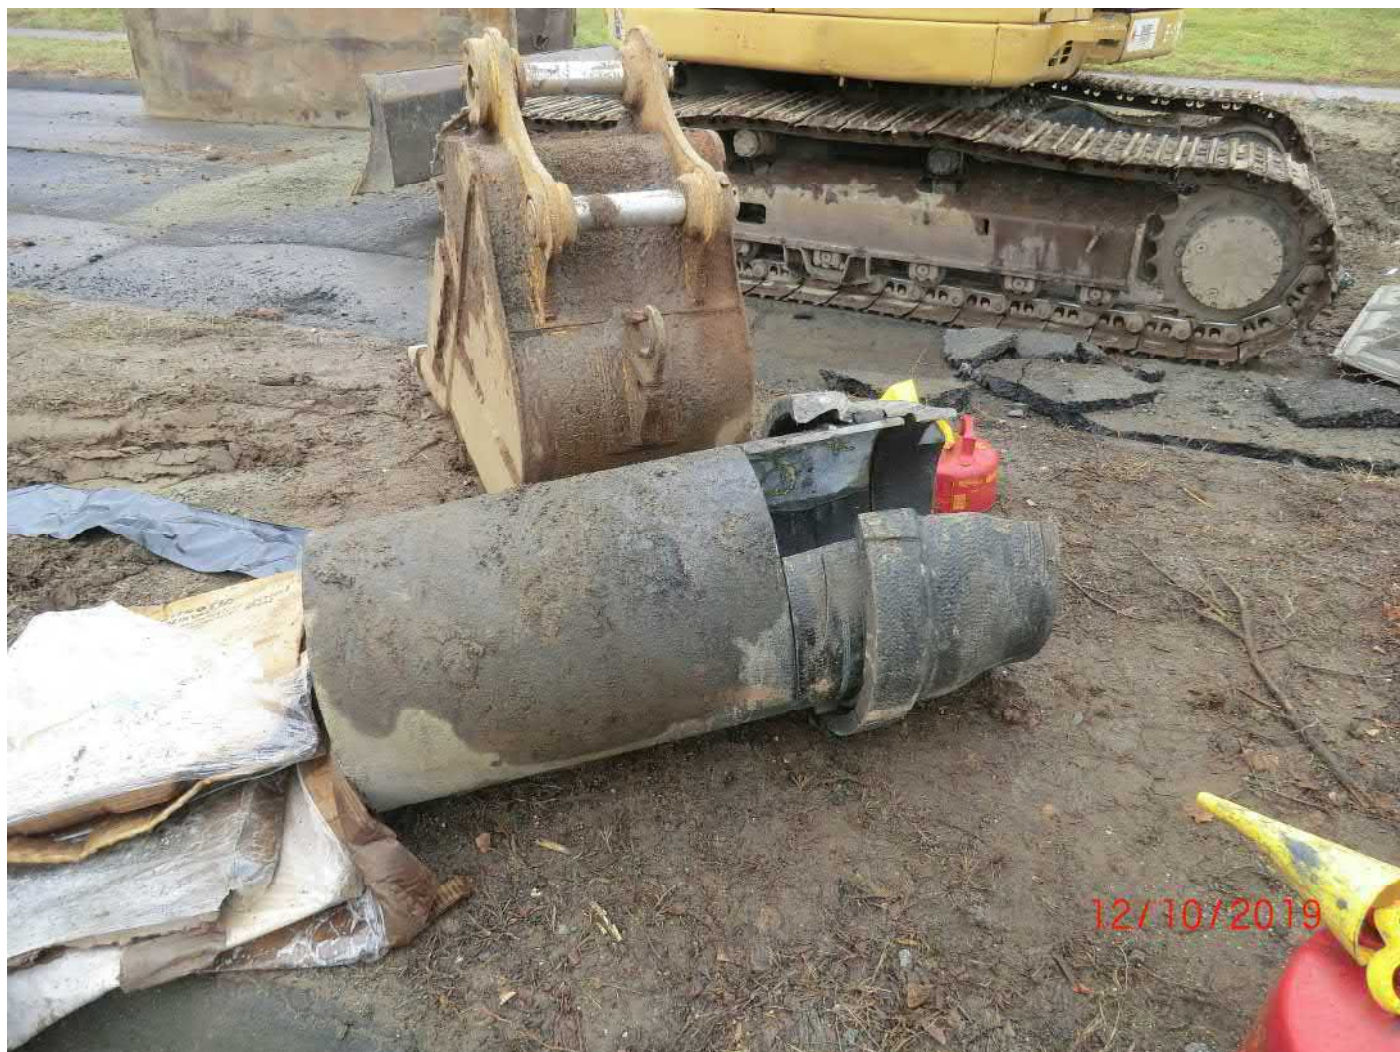
Notes: Repair leak on Talcott Ridge Drive, located roughly at Station 49+30. The leak was at a bell connection where there was a slight down deflection due to change in slope. The repair required cutting out approximately 4 feet of pipe, including the bell, draining the water from the system during the process, and inserting 4 feet of 16" DIP with two 14" collars and 4 Mega-lugs. Each 14" collar straddled the cut line of the removed pipe. Site clean-up also started today. Some minor progress in removing signs from Route 17 (Main St.) and equipment from DPW yard (Broce Broom and Roller – likely put there for today's work).

Figure 21 – Section of pipe removed from line due to leak at bell.

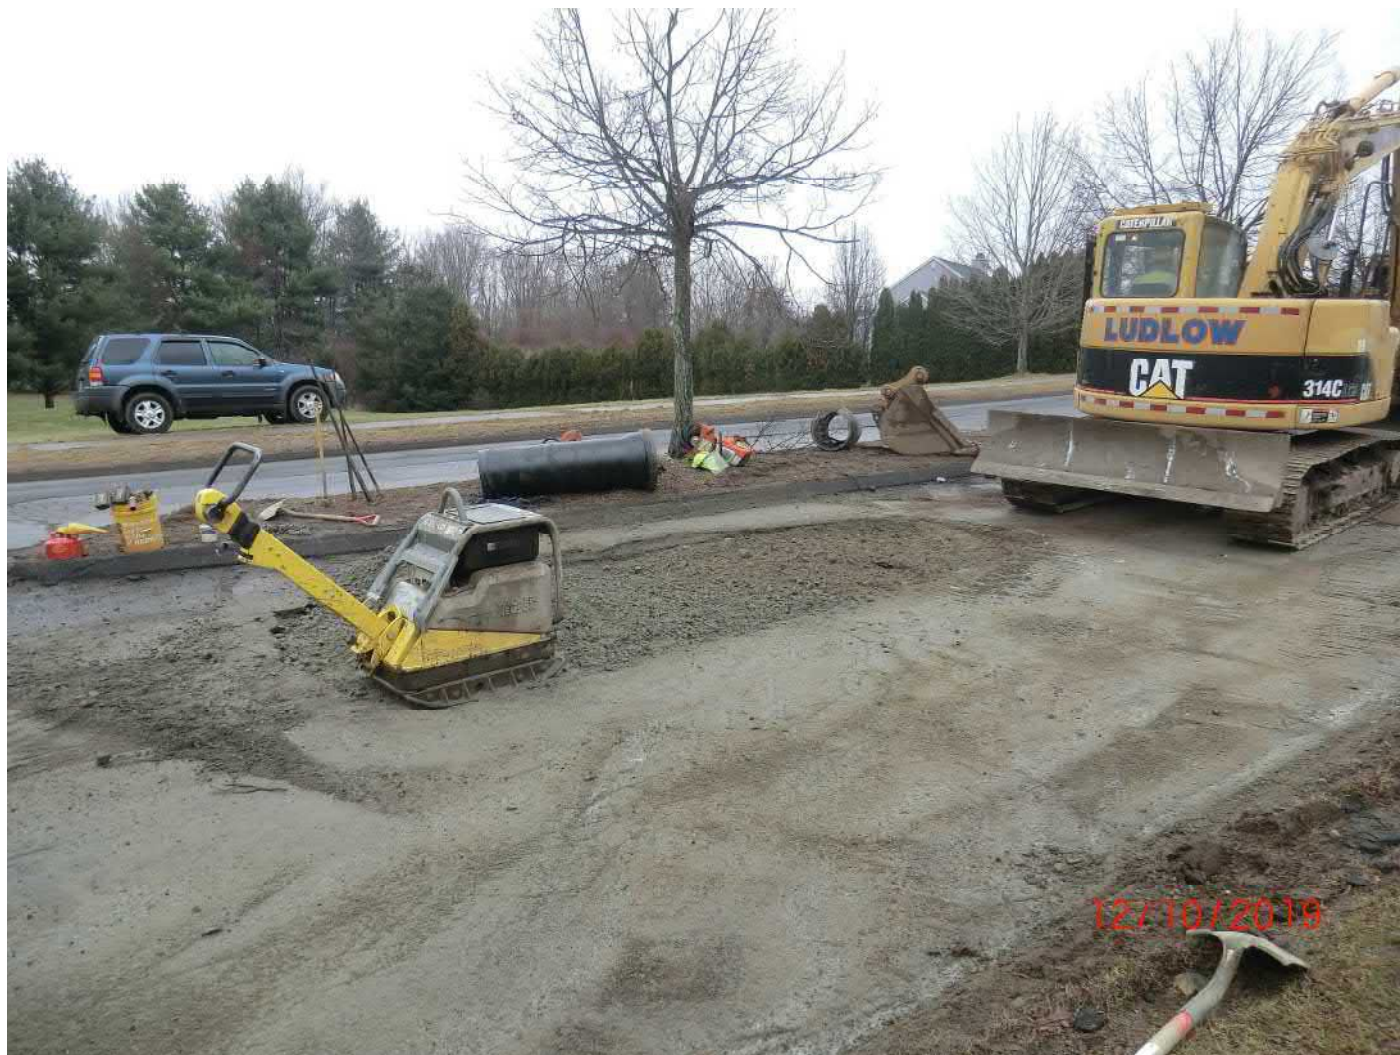
Figure 22 – Facing northeast. Preparing to plate compact final lift of fill.

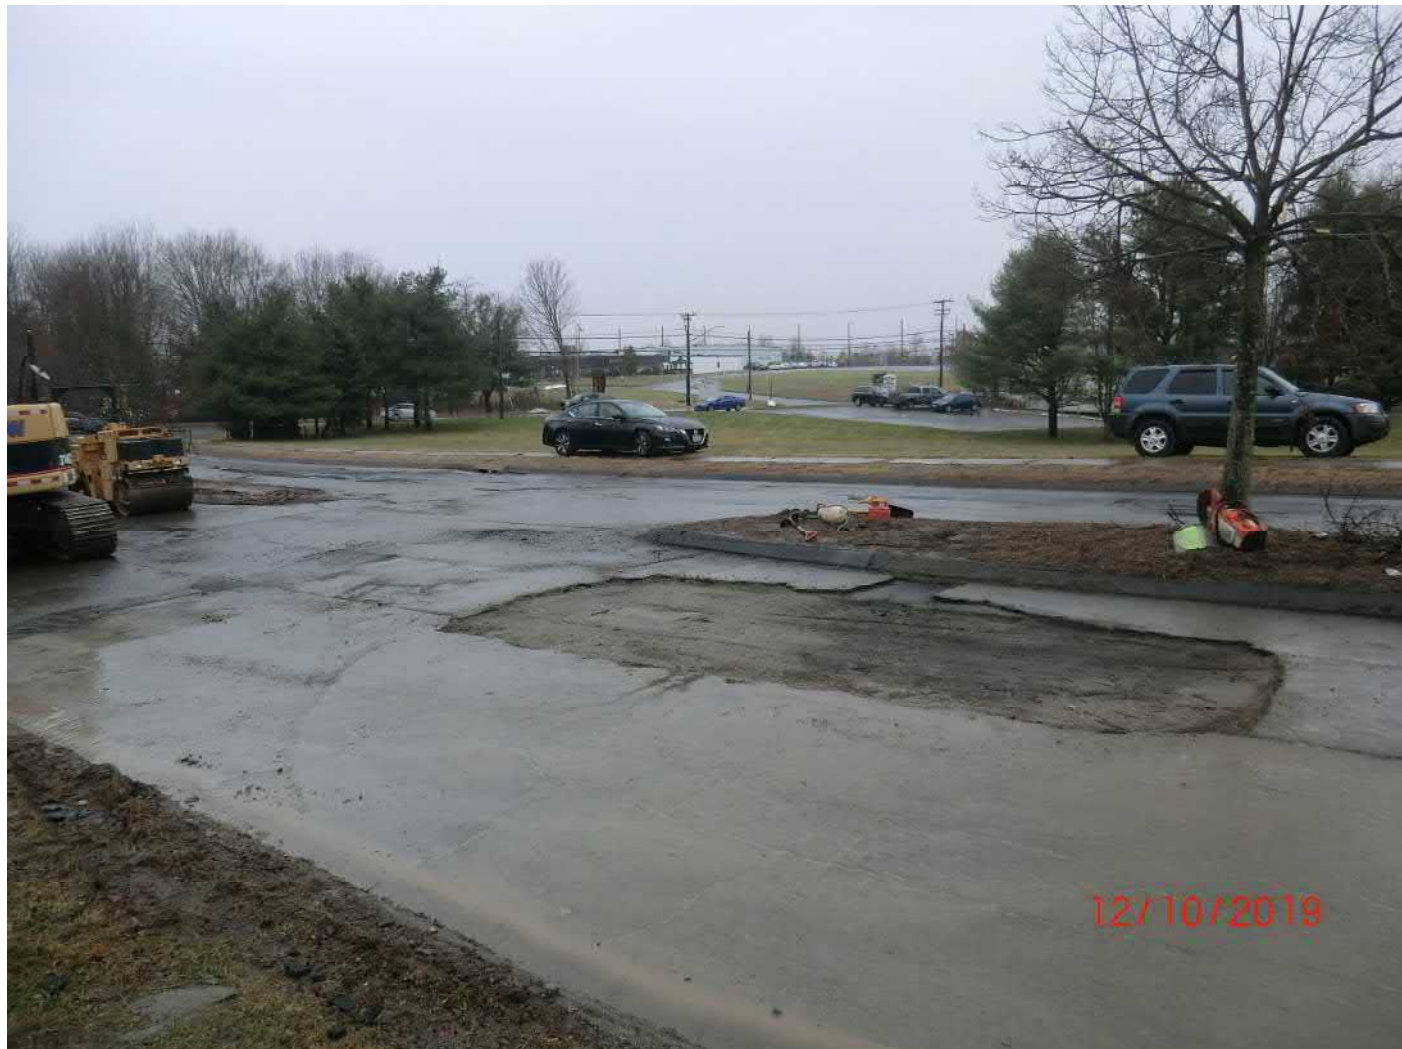
Figure 23 – Facing north east, waiting for asphalt patch.
