Daily Report

| Project: | Durham Meadows Pipeline Installation | Date: | April 1, 2020 |
| Project #: | AECOM: 6061487 | Report No: | 52 |
| Contractor: | Ludlow Construction | Page: | 1 of 11 |

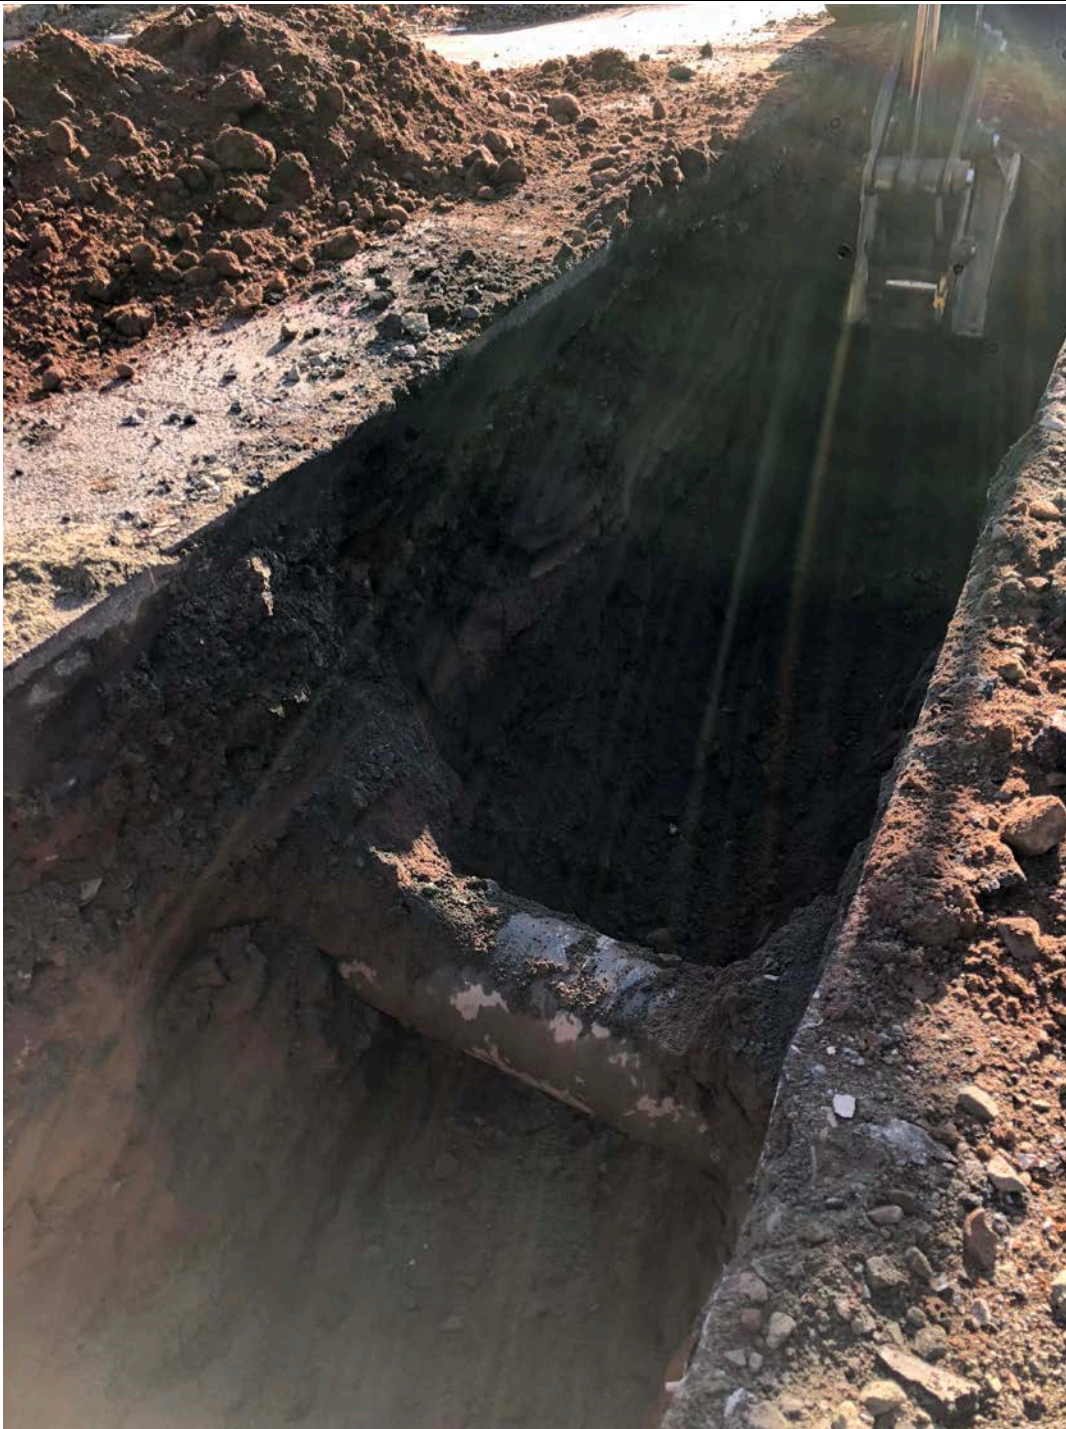
0837: Ludlow daylights ~ 16" diameter natural gas transmission main running down the northbound side of Route 17: 8" DIP will be placed beneath it.

Picture 1: Natural gas transmission main located on the north-bound side of Main Street. View to the northeast.

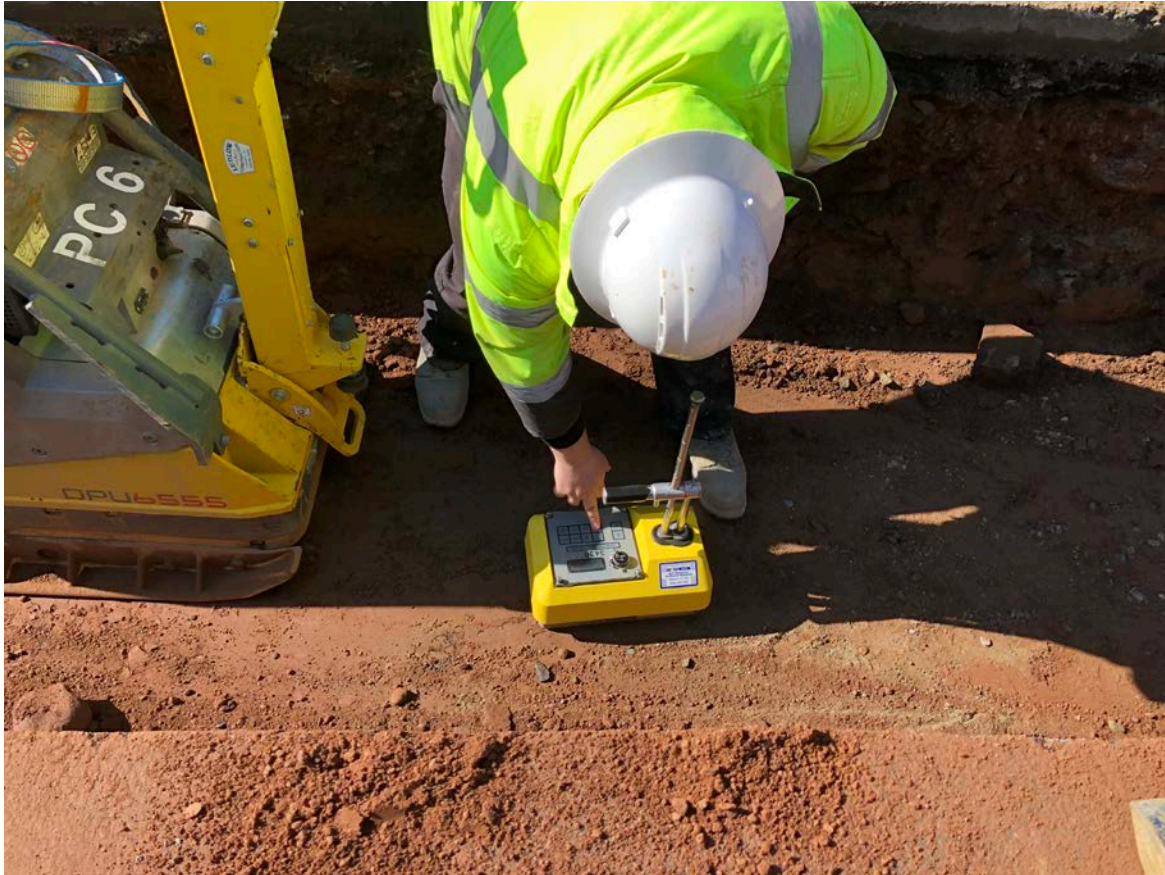
Compaction Testing: JTC performed compaction testing today at the Royal Oak Drive hydrant installation.

Picture 2: Soil compaction testing being performed by JTC personnel.

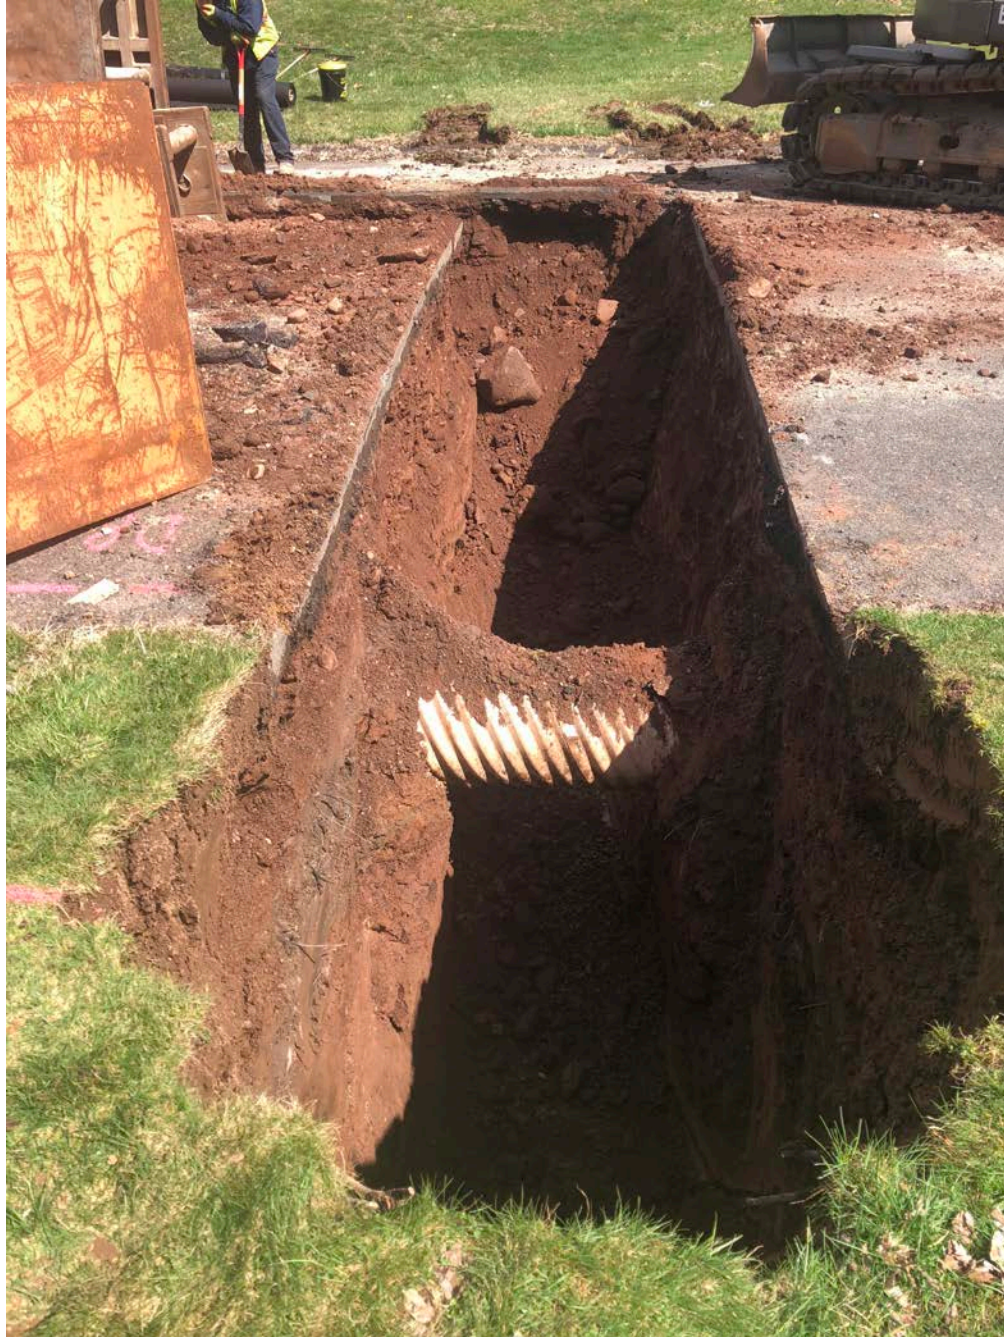
0905: Ludlow daylights a galvanized corrugated storm drain pipe that lies across (perpendicular to) Royal Oak Drive. This pipe was observed to daylight into catch basins on either side of Royal Oak Drive.

Picture 3: Corrugated storm drain pipe running down (parallel to Royal Oak Drive). View to the north.

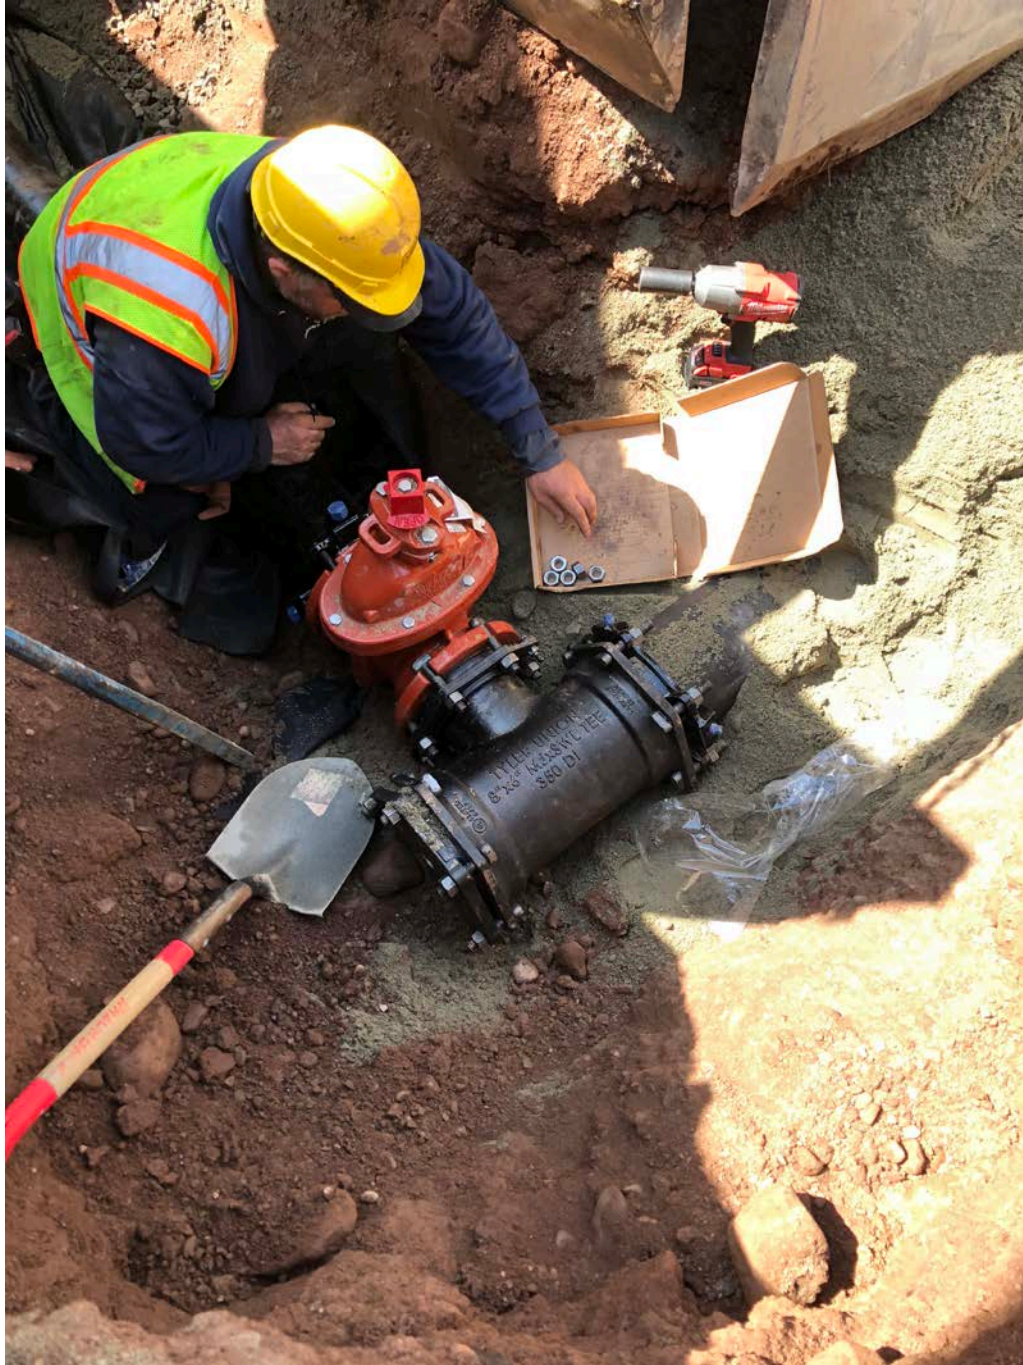
Picture 4: T-fitting and valve assembly placed at the end of 8" DIP to transition to 6" DIP.

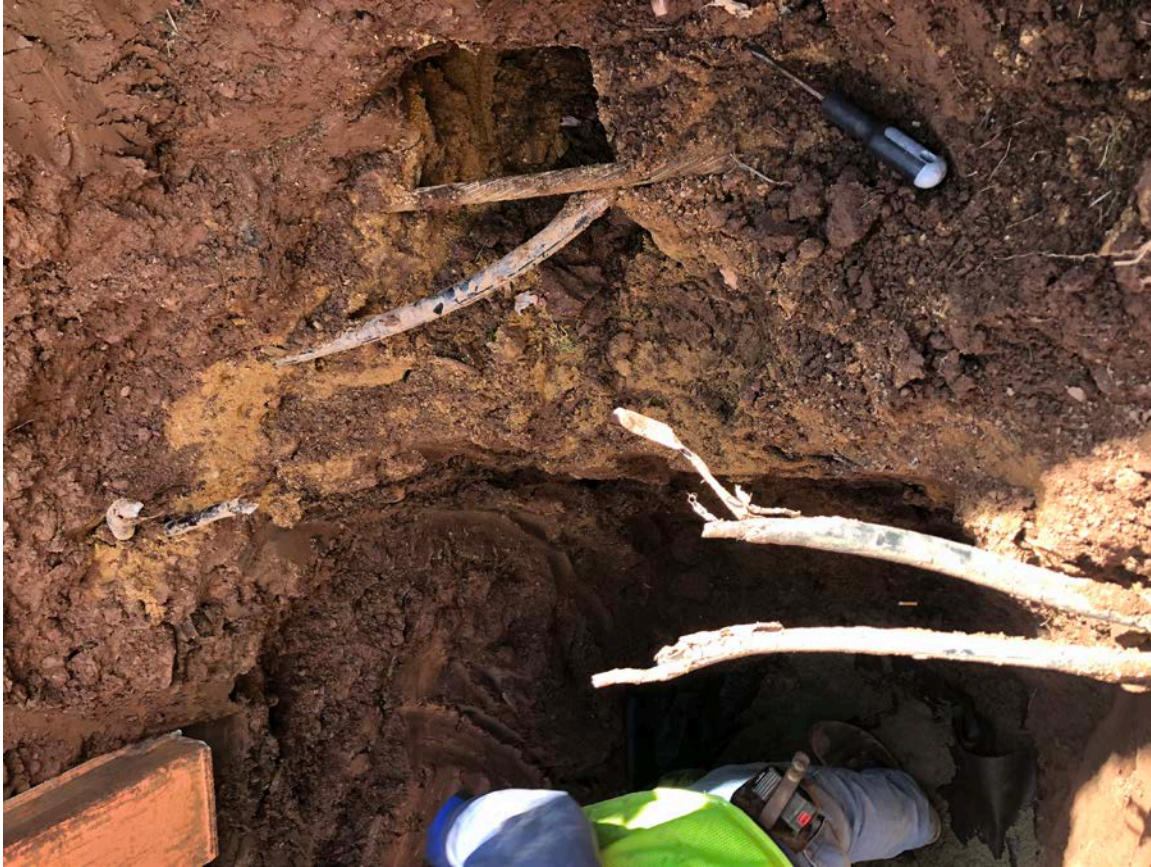
Other: Ludlow severed two Comcast lines during excavation for the installation of a fire hydrant assembly and narrowly missed two adjoining power lines. No Call Before You Dig markings were observed by Ludlow or Comcast personnel in the vicinity of the severed lines. Comcast was at the scene and repaired the lines.

1210: A 9' section of 8" DIP was installed in the trench, and a T-fitting and valve assembly was attached to the end of this 9' section. A Comcast representative arrives to inspect two Comcast lines that Ludlow severed while excavating area where the fire hydrant assembly was going to be placed. Two additional lines (power lines) were narrowly missed during this incident.

Picture 5: Comcast lines severed by Ludlow. Undamaged powerlines also visible.

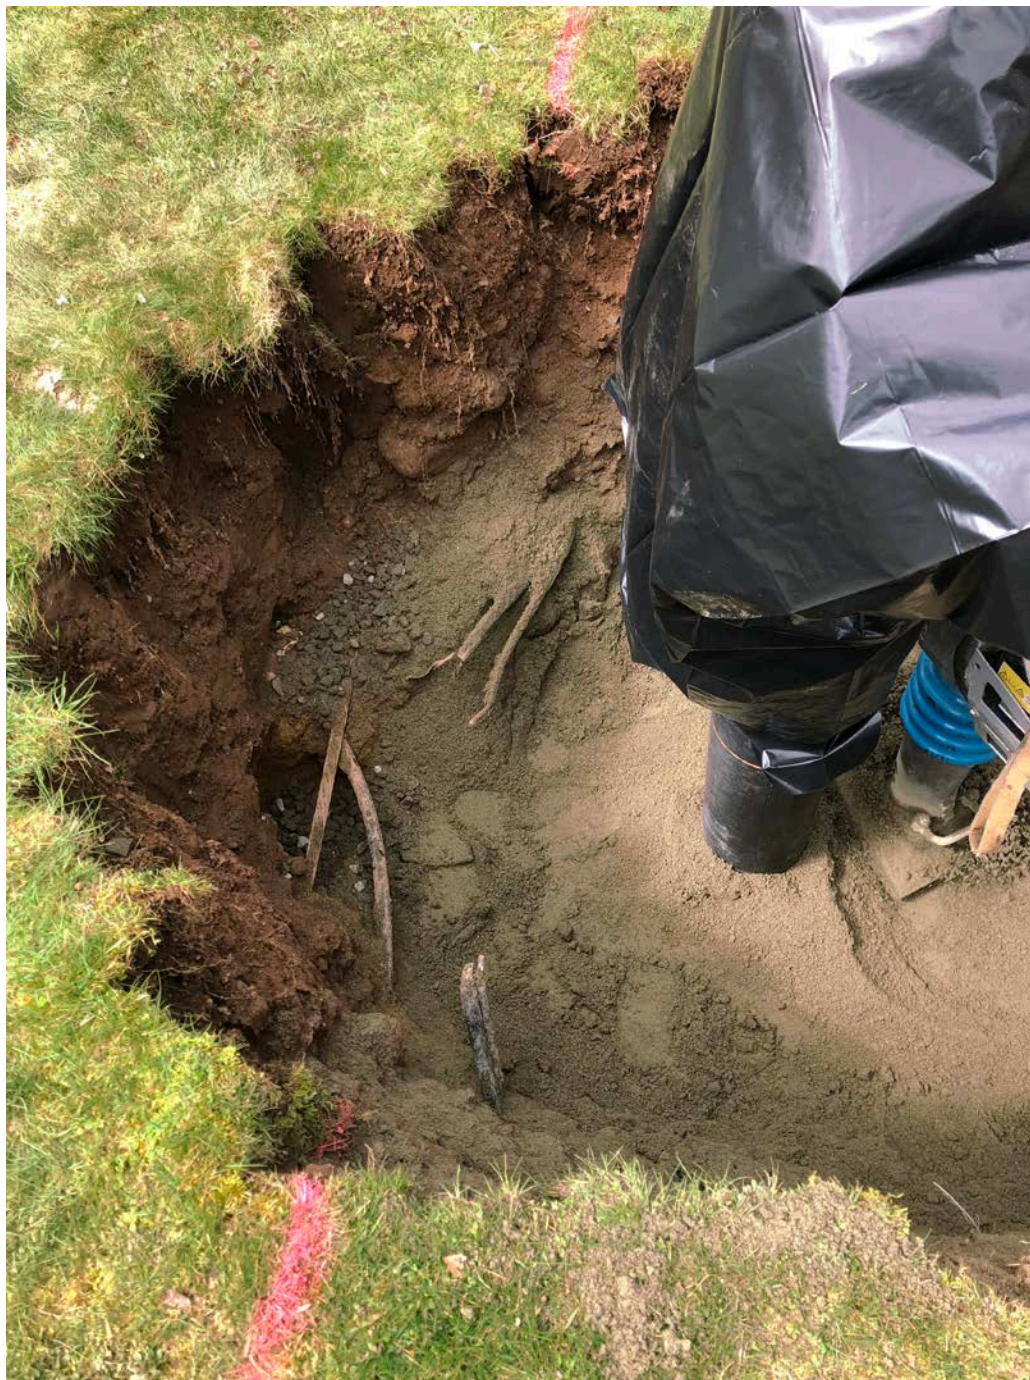
Picture 6: Another view of severed Comcast lines; installed fire hydrant assembly visible on the right-hand side of the photograph. View to the west.

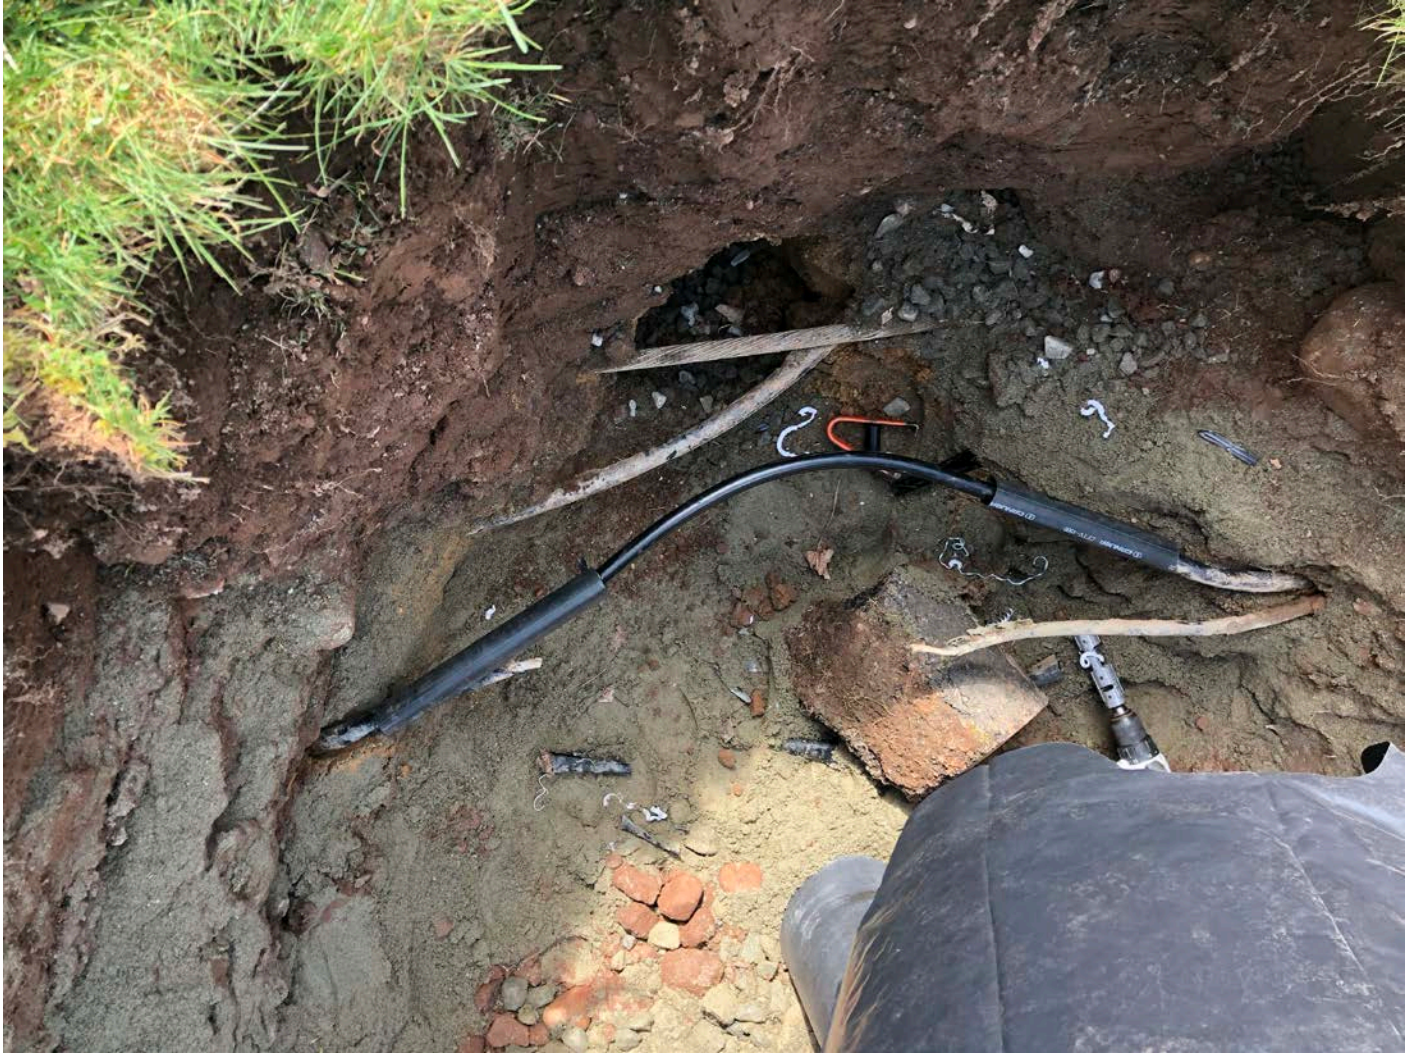
Picture 7: Damaged Comcast lines in the process of repair.

1305: Comcast working on repairing severed cables. Ludlow backfilling trench and compacting fill with Volvo rolling compactor. Also using street sweeper to clean area up.

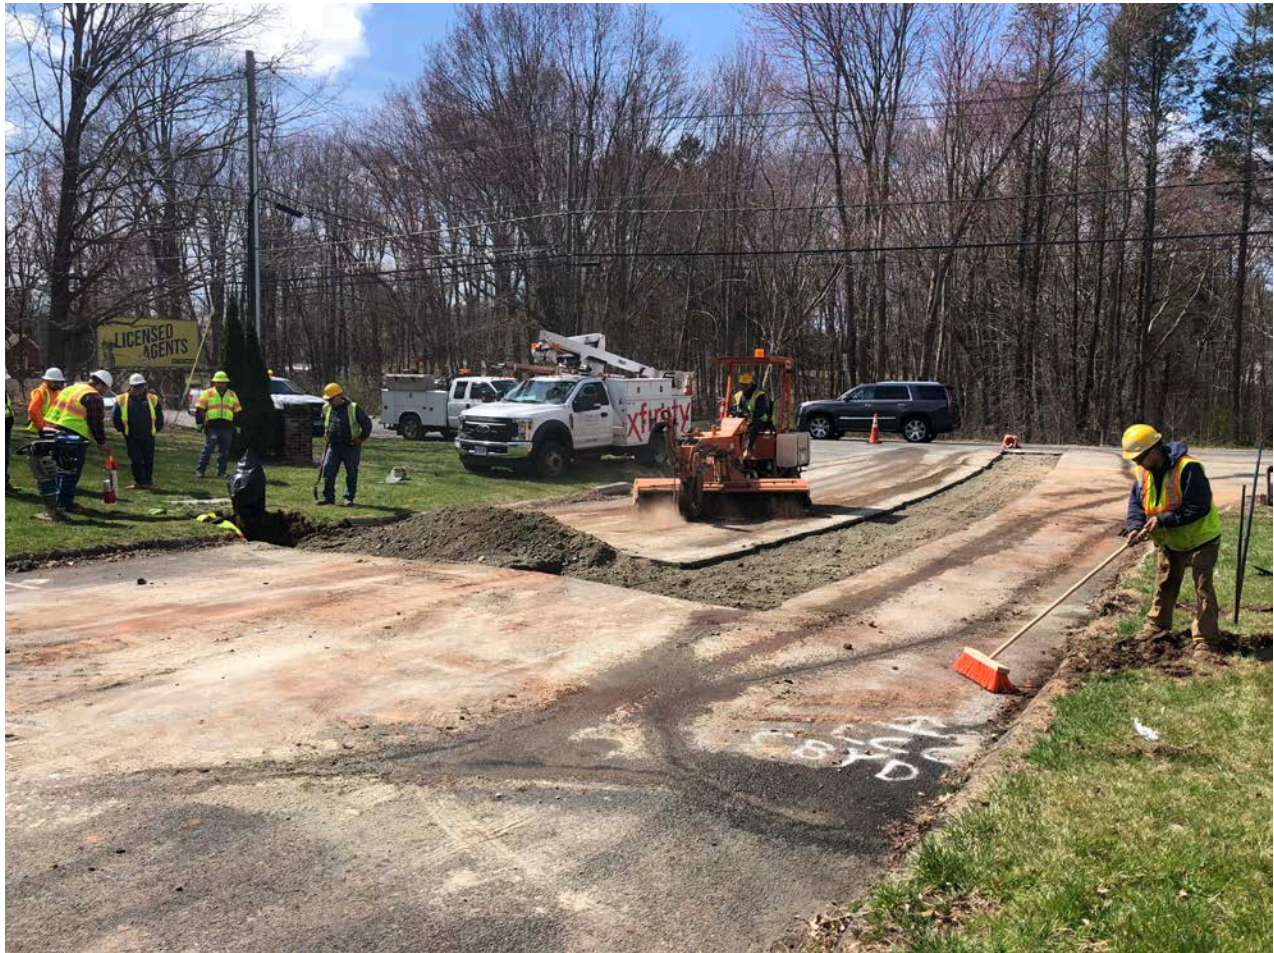
Picture 8: Overview of Royal Oak Drive work area once pipe and hydrant assembly installed; view to the west.

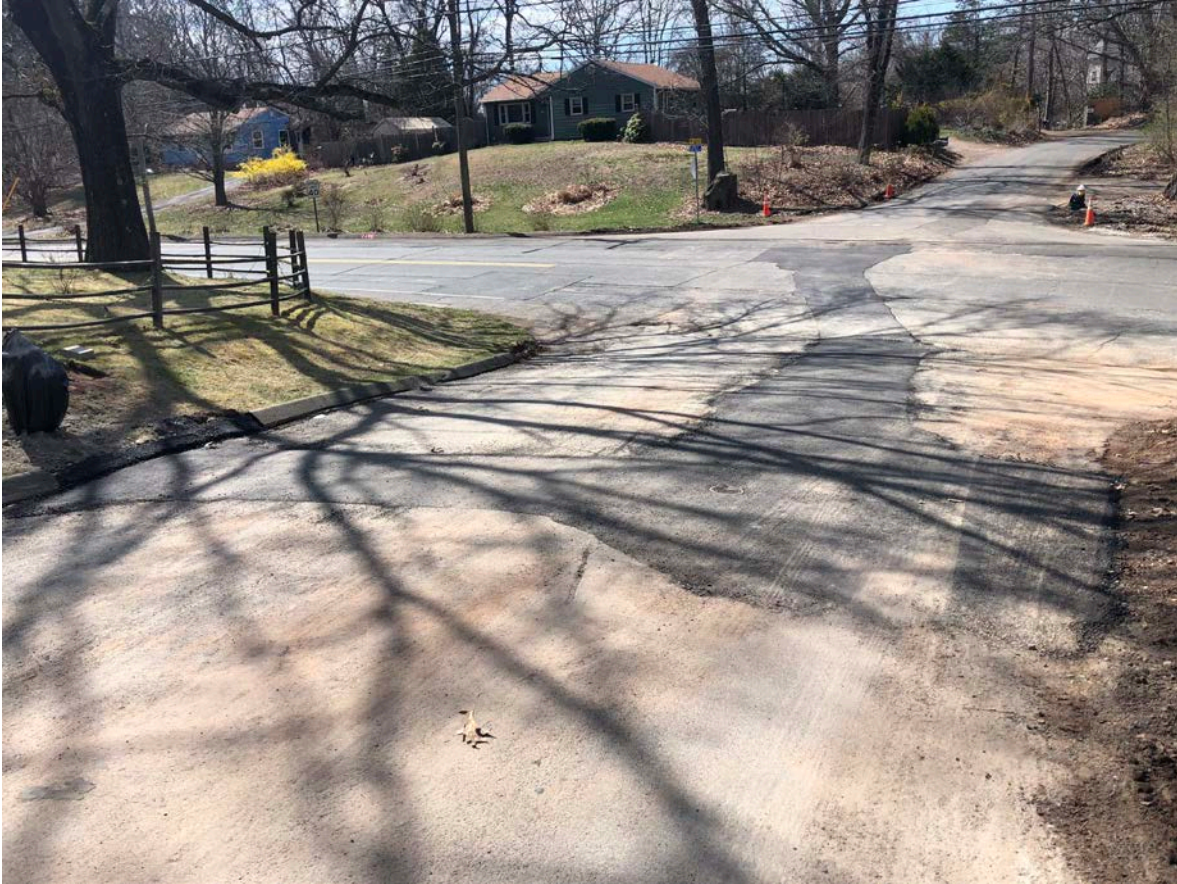
Picture 9: Overview of Oak Terrace work area once paving on was performed on 3-31-20.
