Daily Report

| Project: | Durham Meadows Pipeline Installation | Date: | April 7, 2020 |
| Project #: | AECOM: 6061487 | Report No: | 55 |
| Contractor: | Ludlow Construction | Page: | 1 of 13 |

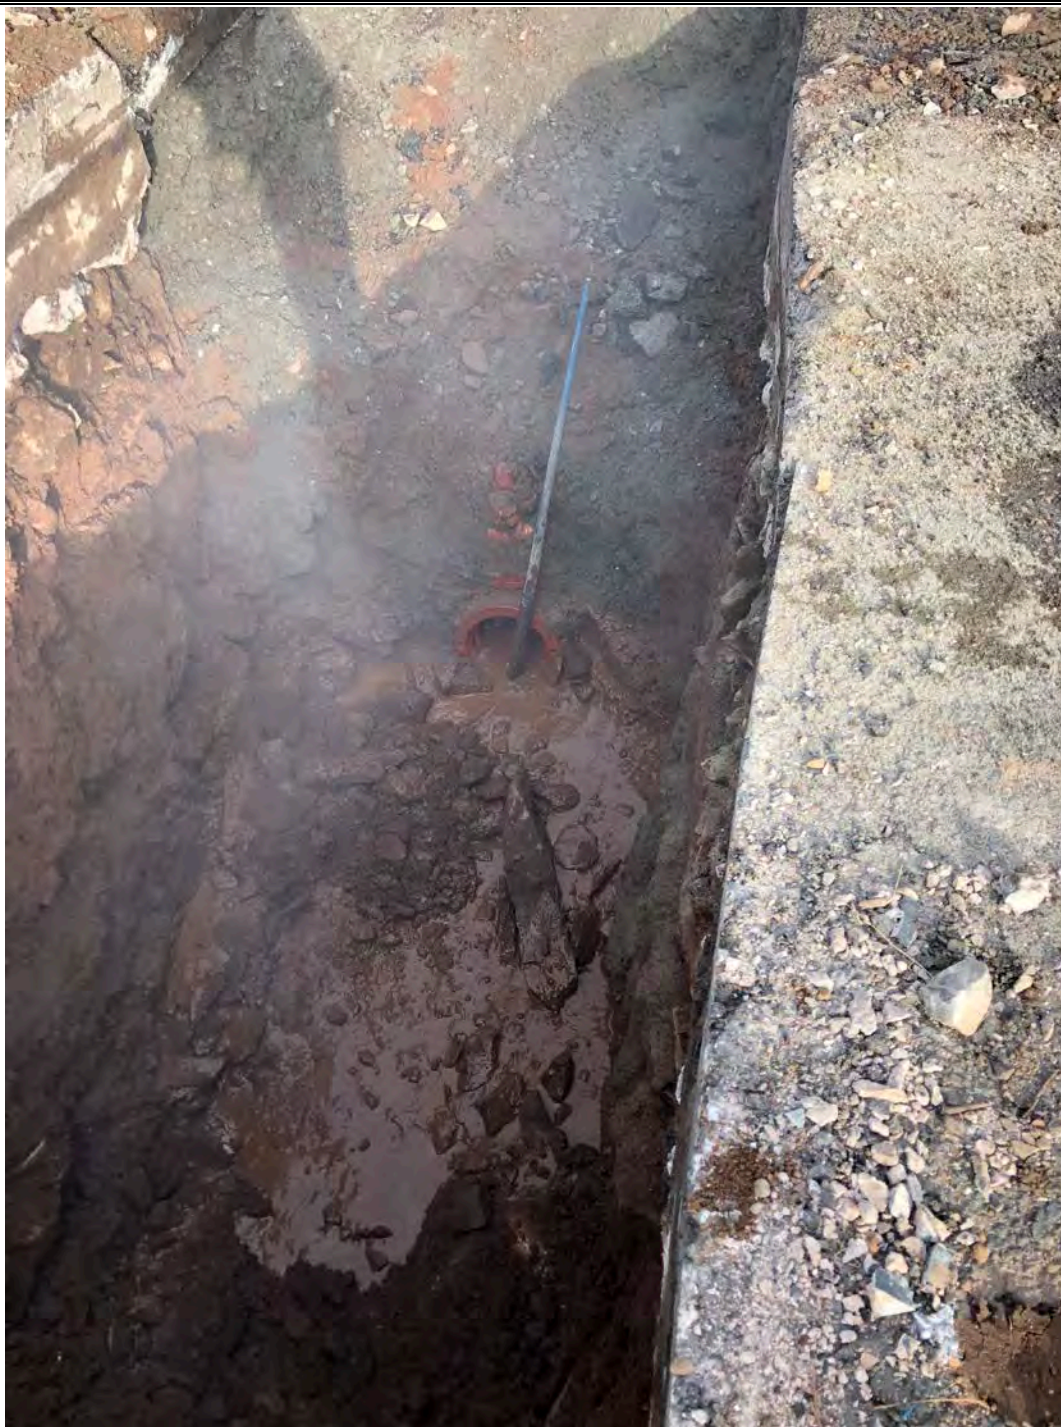
0800: Ludlow has excavated down to approximately 7' below surface grade, where 3-4 inches of water is visible. Ludlow is pumping the water out of the excavation and down the western-most edge of Main Street through ¾" gravel and filter fabric. In speaking with one of the Ludlow laborers, he said that the source of the water in this excavation is from the valve that they are connecting pipe to this morning. The valve was installed last year. It was suspected to be leaking when Ludlow performed pressure testing of the line last week. Apparently the valve wasn't closed completely last year when it was installed. Ludlow tightened the valve.

Picture 1: Water observed in excavation at Station 108+50 South Main Street. The valve assembly that turned out to be the source of the water can be seen at the top of the photograph. View to the west.

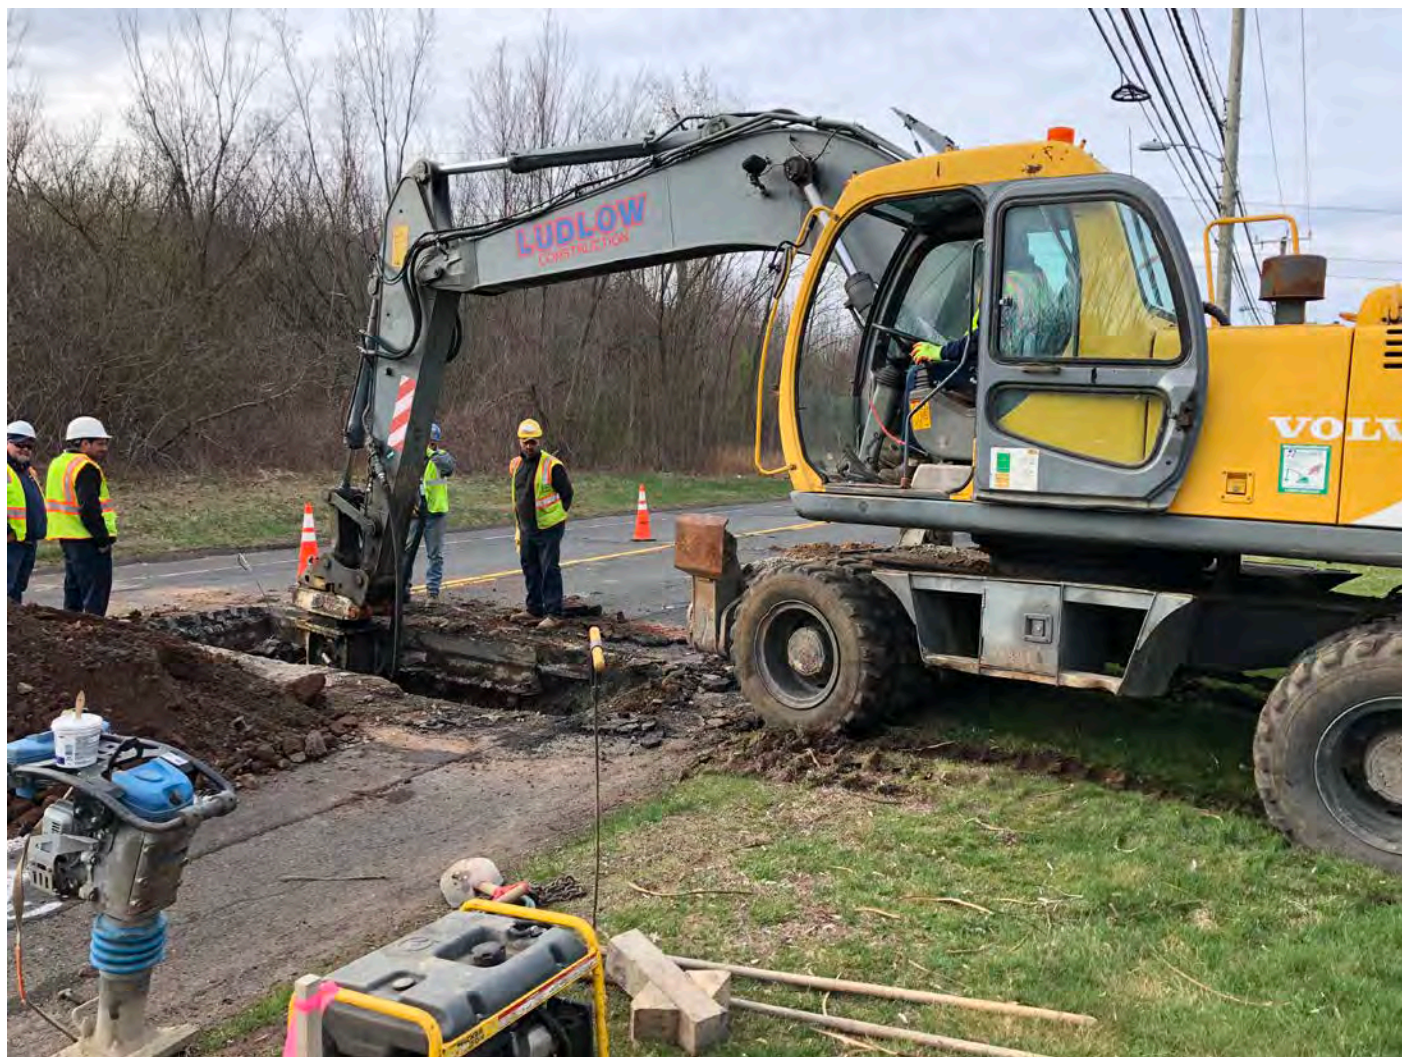
1040: Ludlow resumes excavating across northbound side of South Main Street. They have encountered more rock at the bottom of the trench and are using the pneumatic hammer to break it up.

Picture 2: Ludlow using hammer to break up rock that was encountered while excavating. View to the southeast.

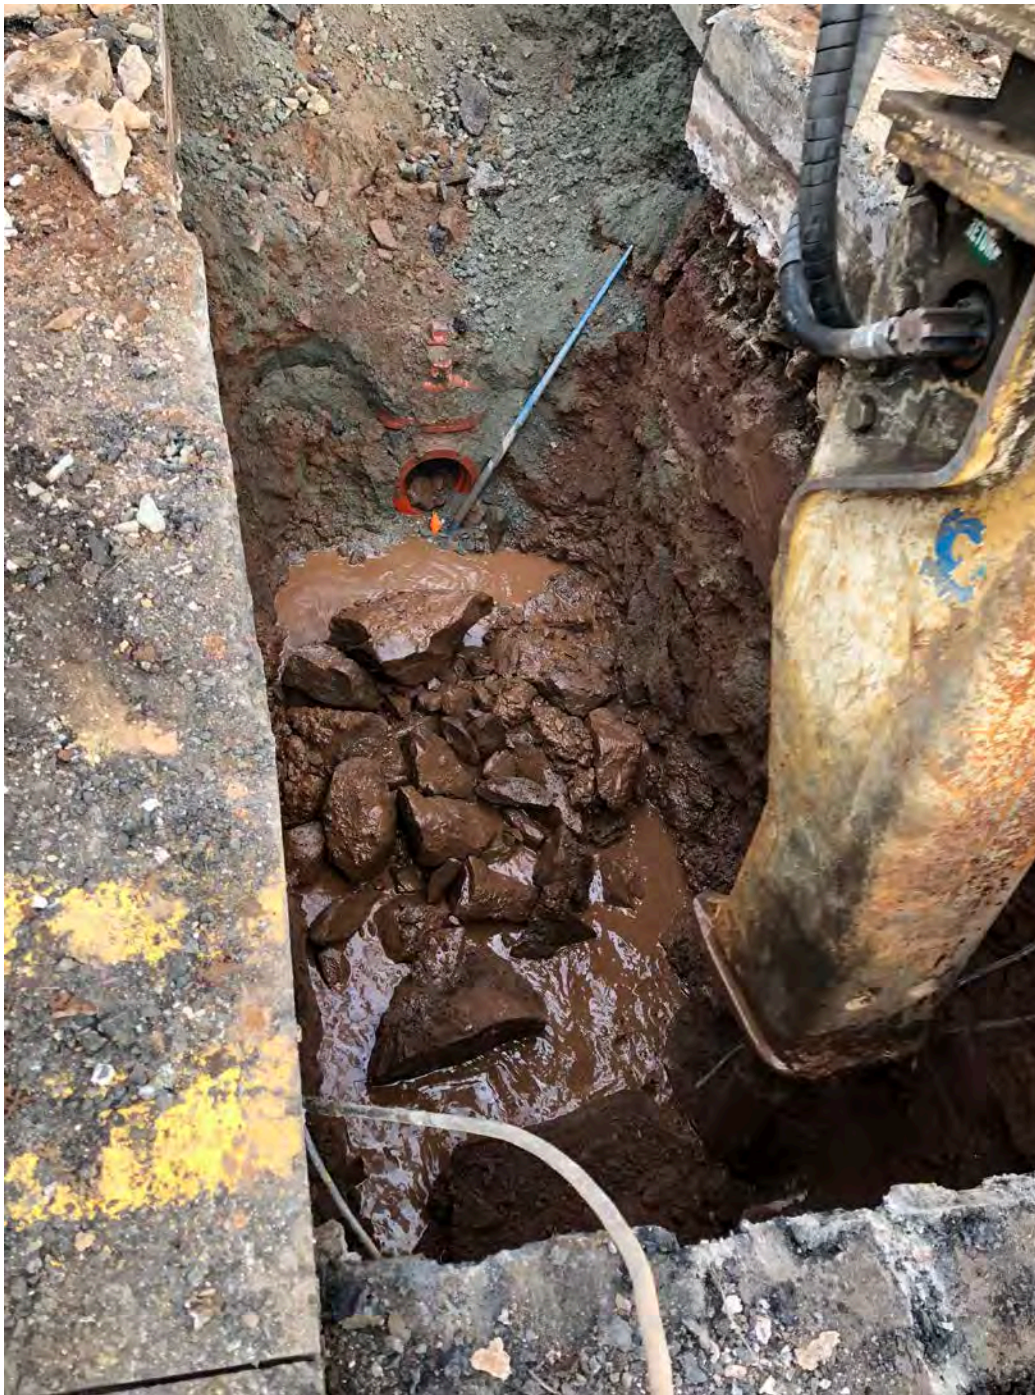
0813: Ludlow using pneumatic hammer on a Volvo EW170 excavator to bust up rock at the bottom of the trench at Station 108+50. A second excavator (Volvo ECR145D) is being used to perform excavation.

Picture 3: Water and rock encountered while excavating at Station 108+50 South Main St.

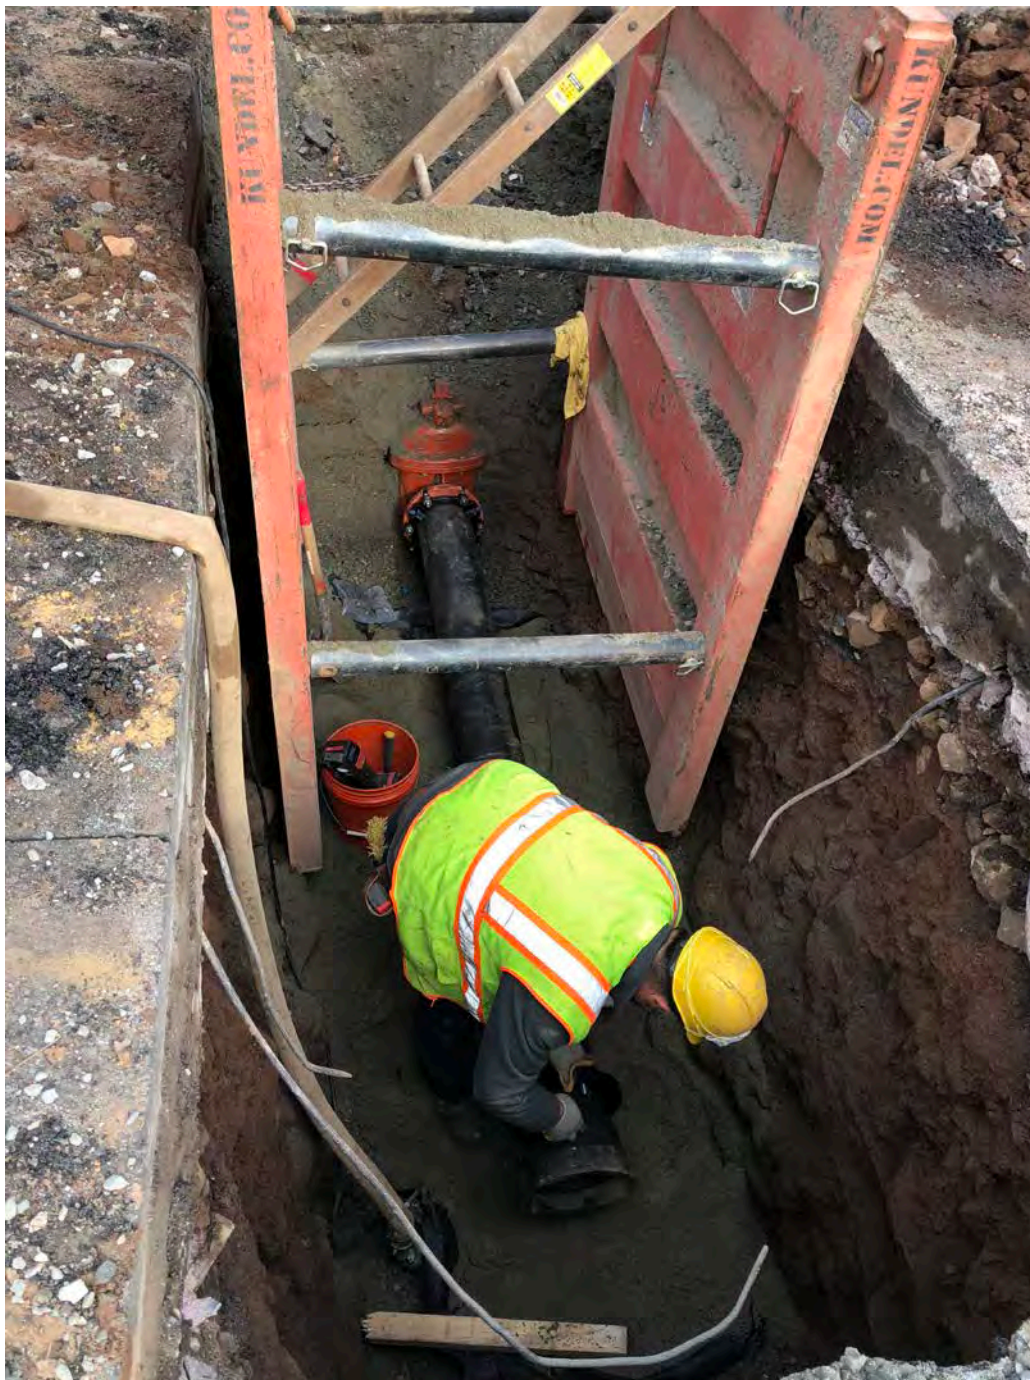
0900: Ludlow has placed a ~9.5' section of 8" DIP at Station 108+50 to the formerly unseated valve. A valve box is placed on top of valve stem extension that was placed on top of the 8" valve.

Picture 4: Section of 8" DIP connected to previously installed valve assembly at Station 108+50. View to the west.

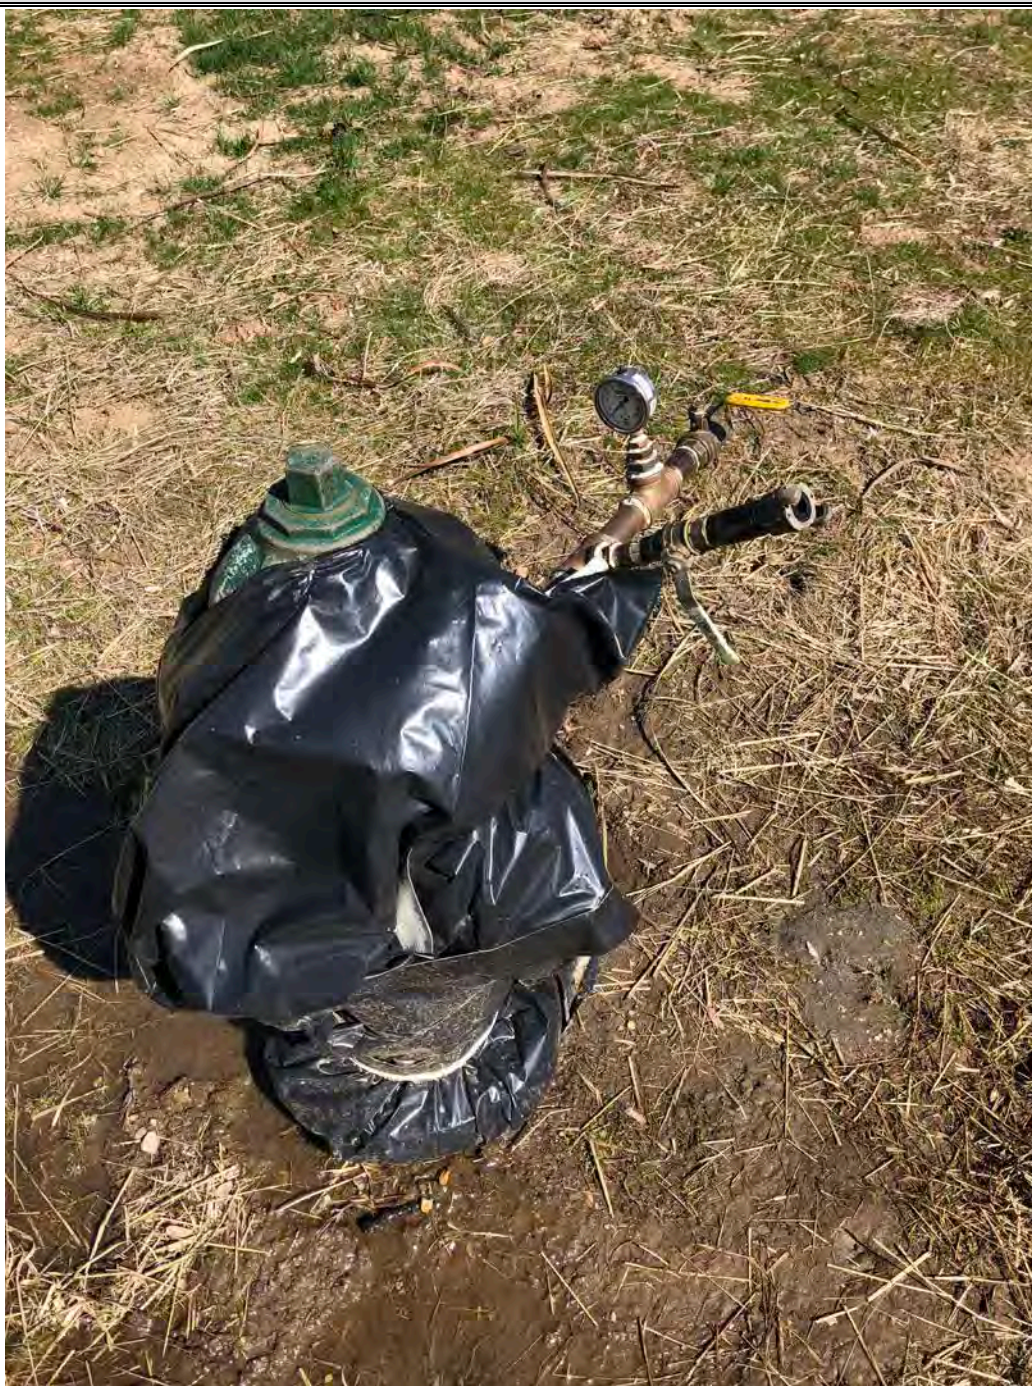
1055: Water observed in bottom of the excavation. Ludlow has daylighted the high-pressure gas line located beneath the northbound lane of South Main Street. Ludlow is performing additional pressure testing on previously installed water main on Main Street in Middletown.

Picture 5: Hydrant with pressure gauge attached to it for pressure testing water line on South Main Street in Middletown.

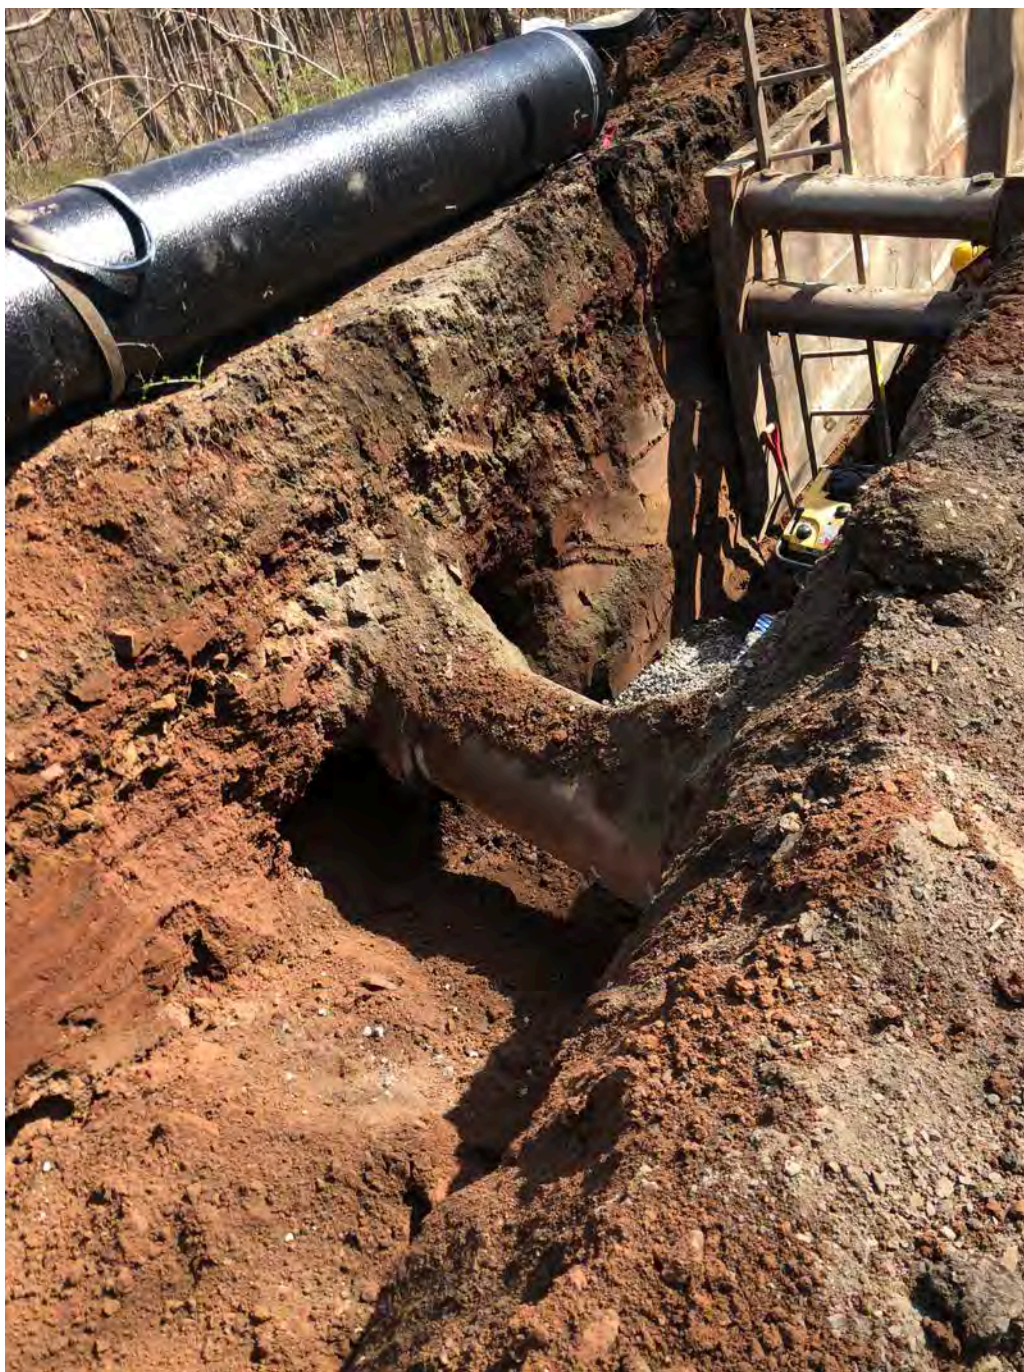
Picture 6: Storm water culvert that crosses the tank access road. View to the east.

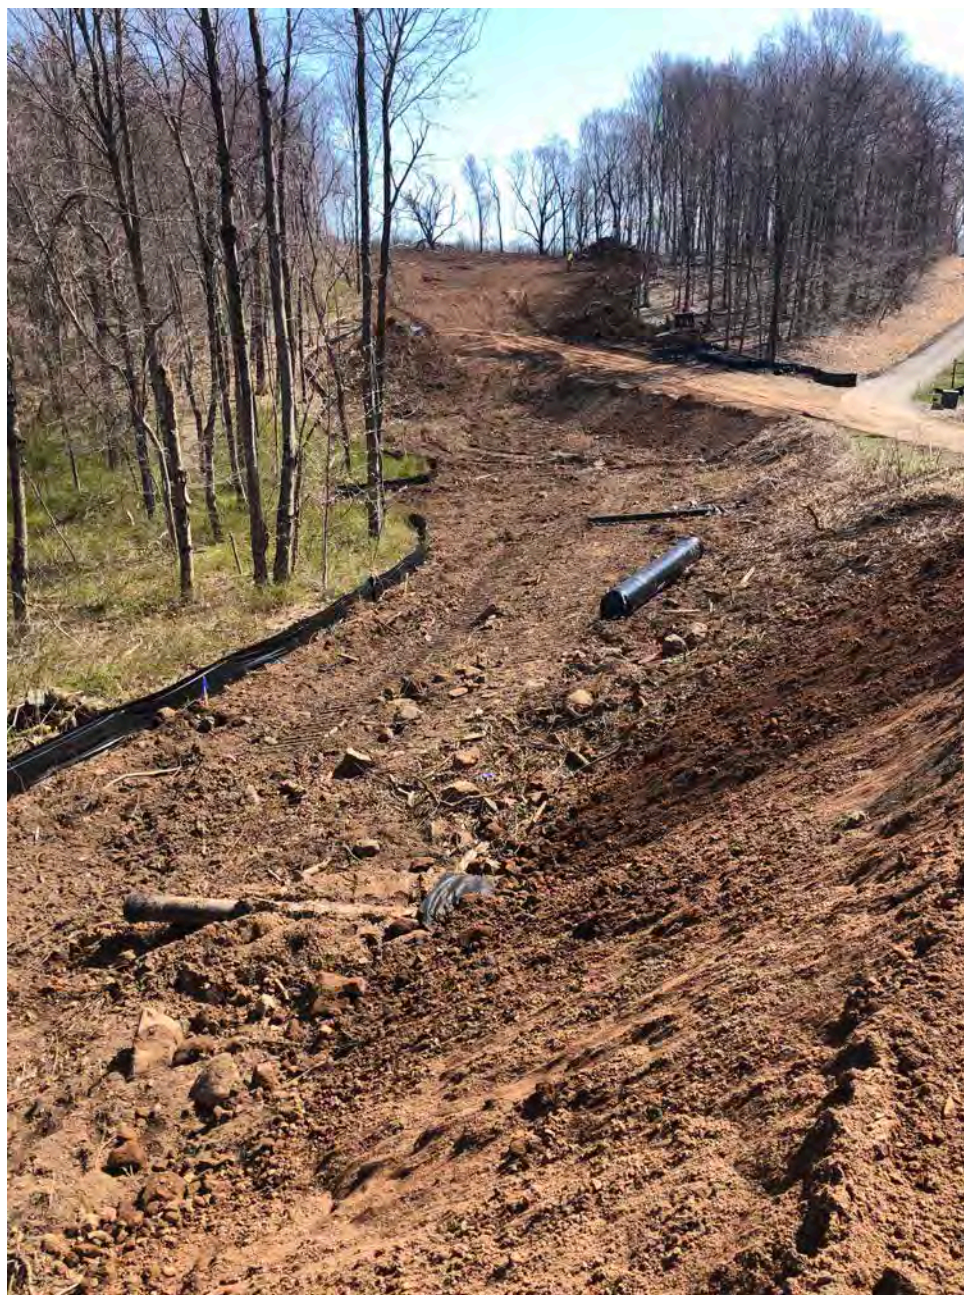
Picture 7: Overview of clearing and grading activities at the tank access road. One of the three storm water culverts extended by Ludlow is visible in the foreground of the photograph. View to the south.

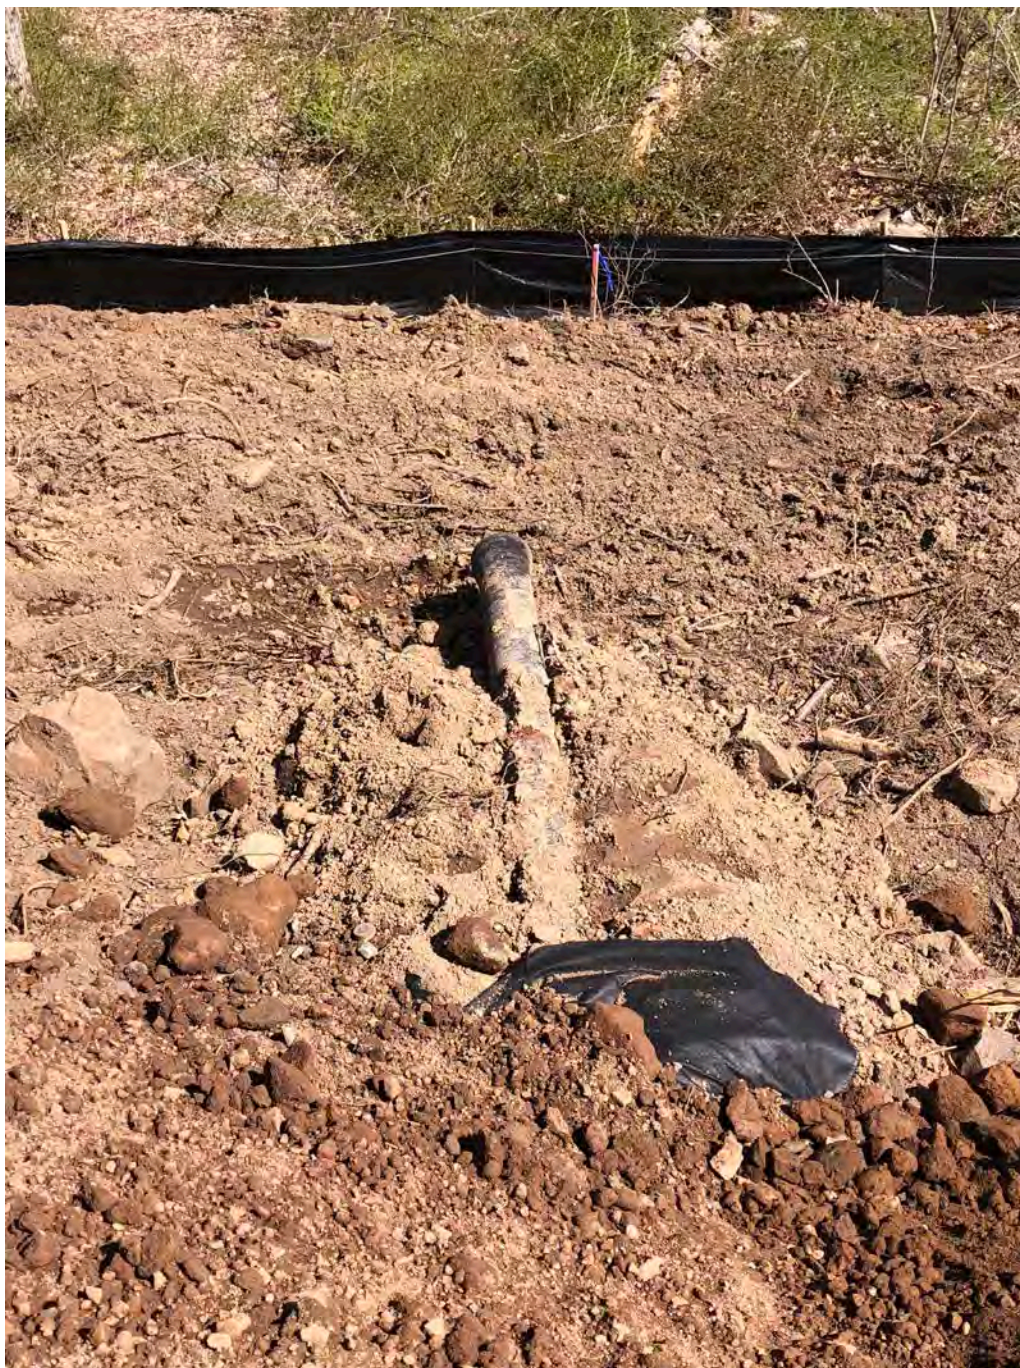
Picture 8: One of three storm water culverts extended by Ludlow; located on the east side of the tank access road. View to the east.

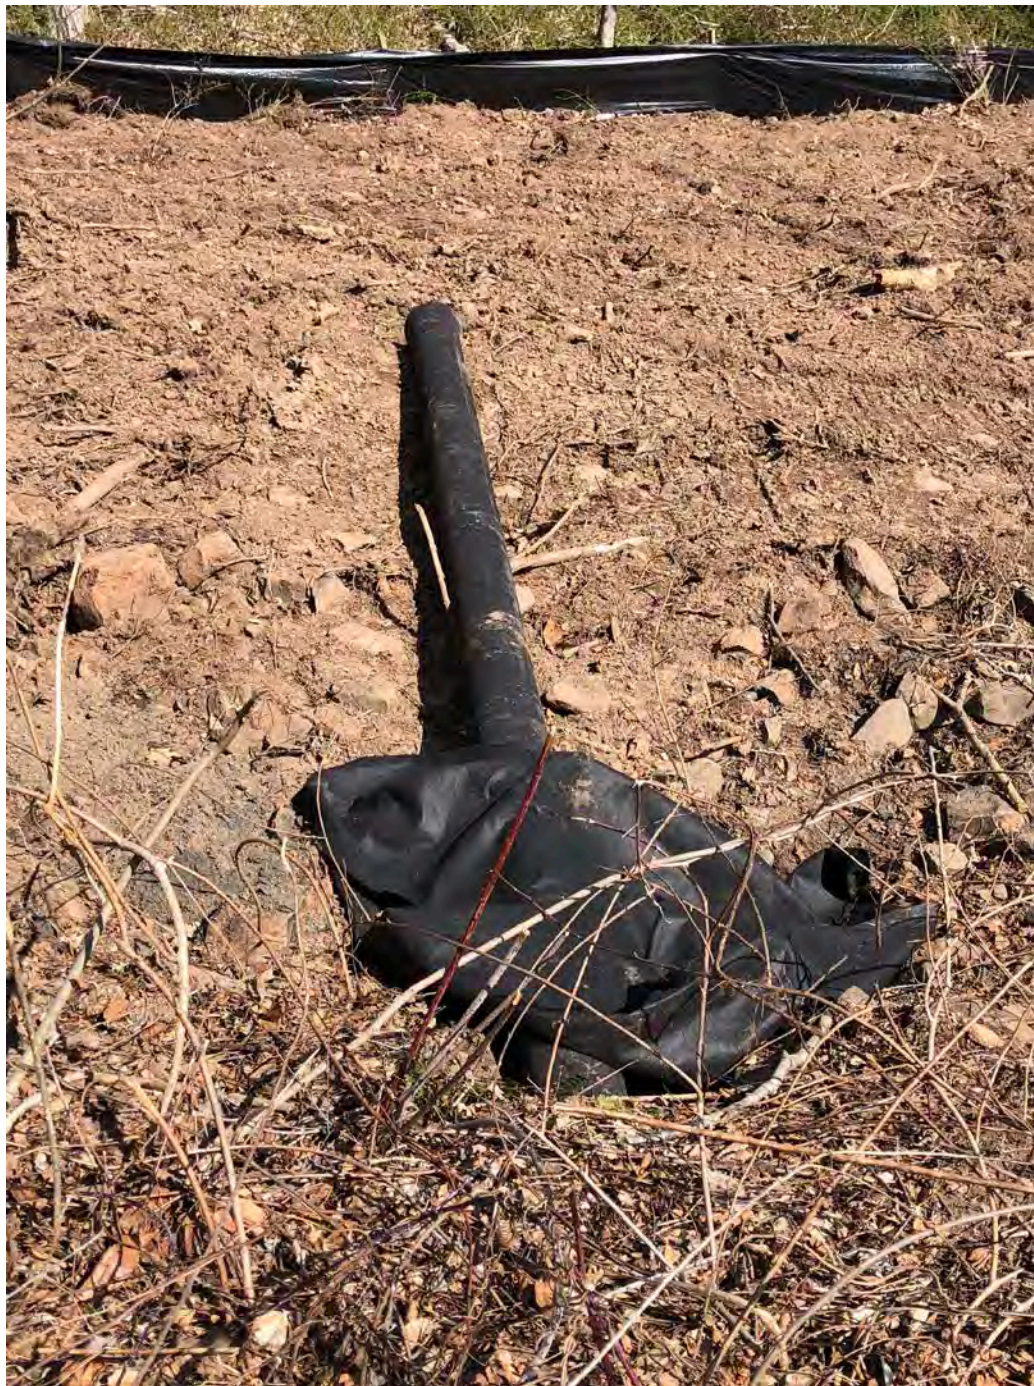
Picture 9: The second of three storm water culverts extended by Ludlow; located on the east side of the tank access road. View to the east.

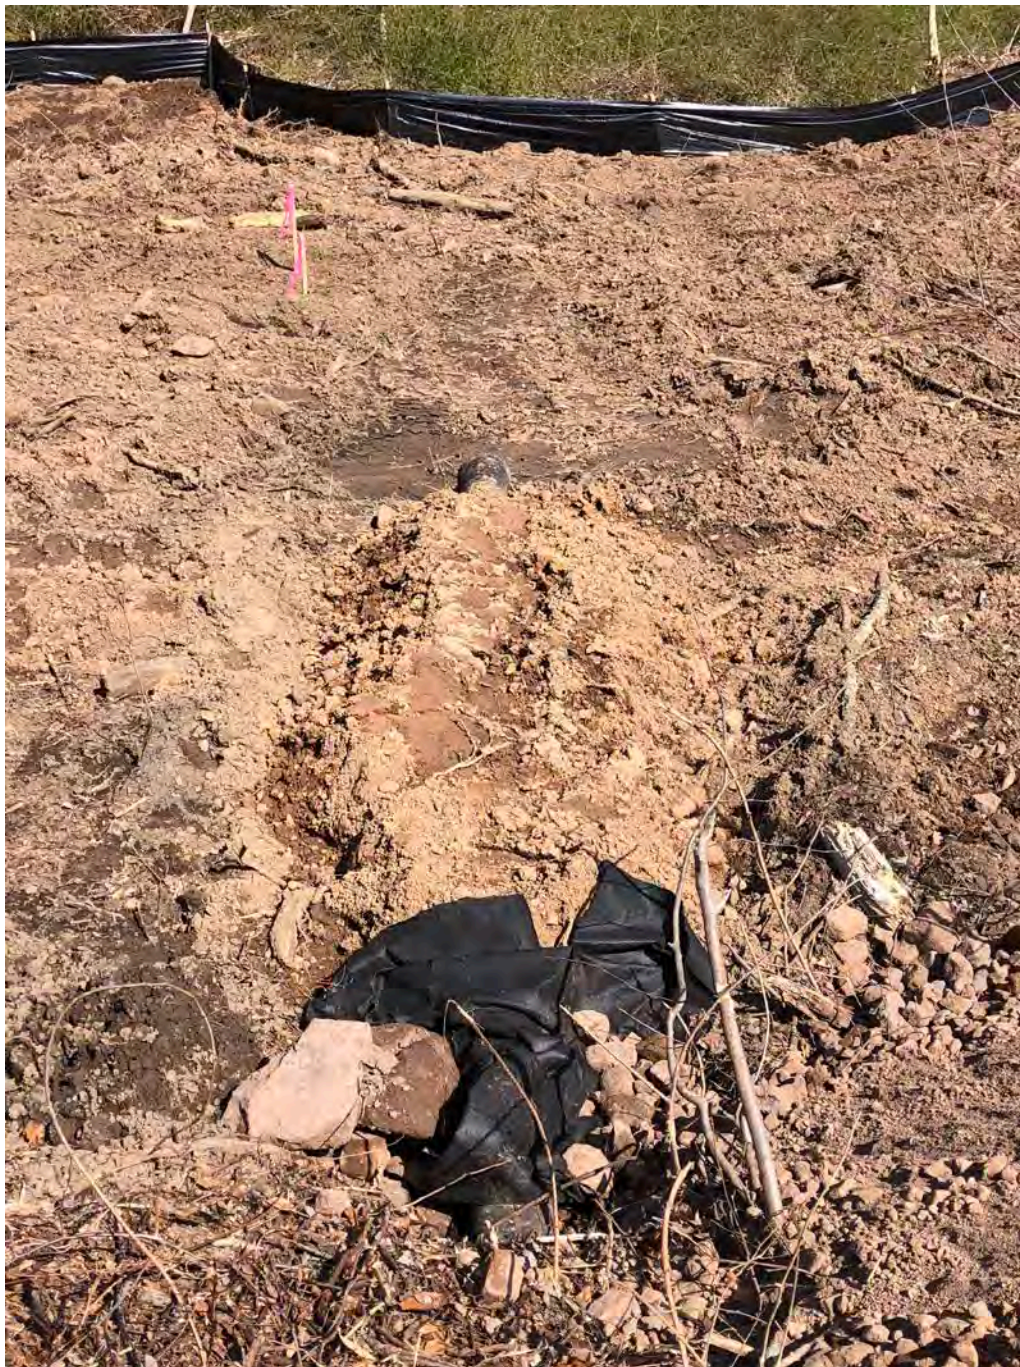
Picture 10: The third of three storm water culverts extended by Ludlow; located on the east side of the tank access road. View to the east.
