## Daily Report

<b>Project:</b>	Durham Meadows Pipeline Installation	<b>Date:</b>	April 24, 2020
<b>Location:</b>	Main Street, Water tank access road, Durham & Middletown, CT	<b>Day of Week:</b>	Friday
<b>Project #:</b>	AECOM: 6061487	<b>Report No:</b>	65
<b>Contractor:</b>	Ludlow Construction	<b>Page:</b>	1 of 20

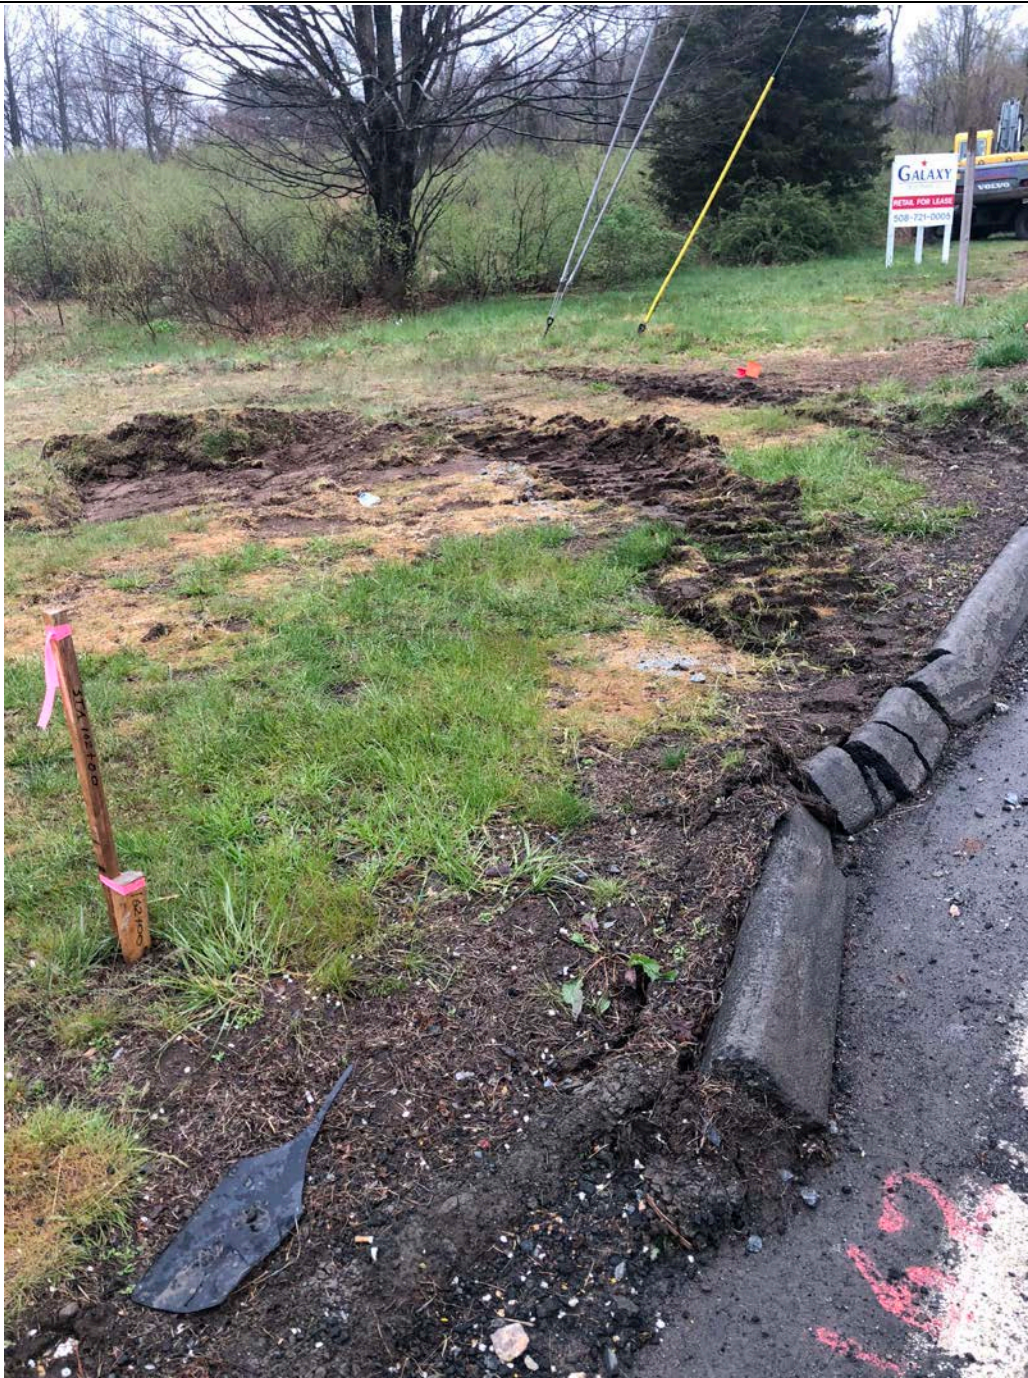
Picture 1: Damage to curbing on the west side of Main Street, just south of Station 159+30. View to the northwest. Durham, CT.

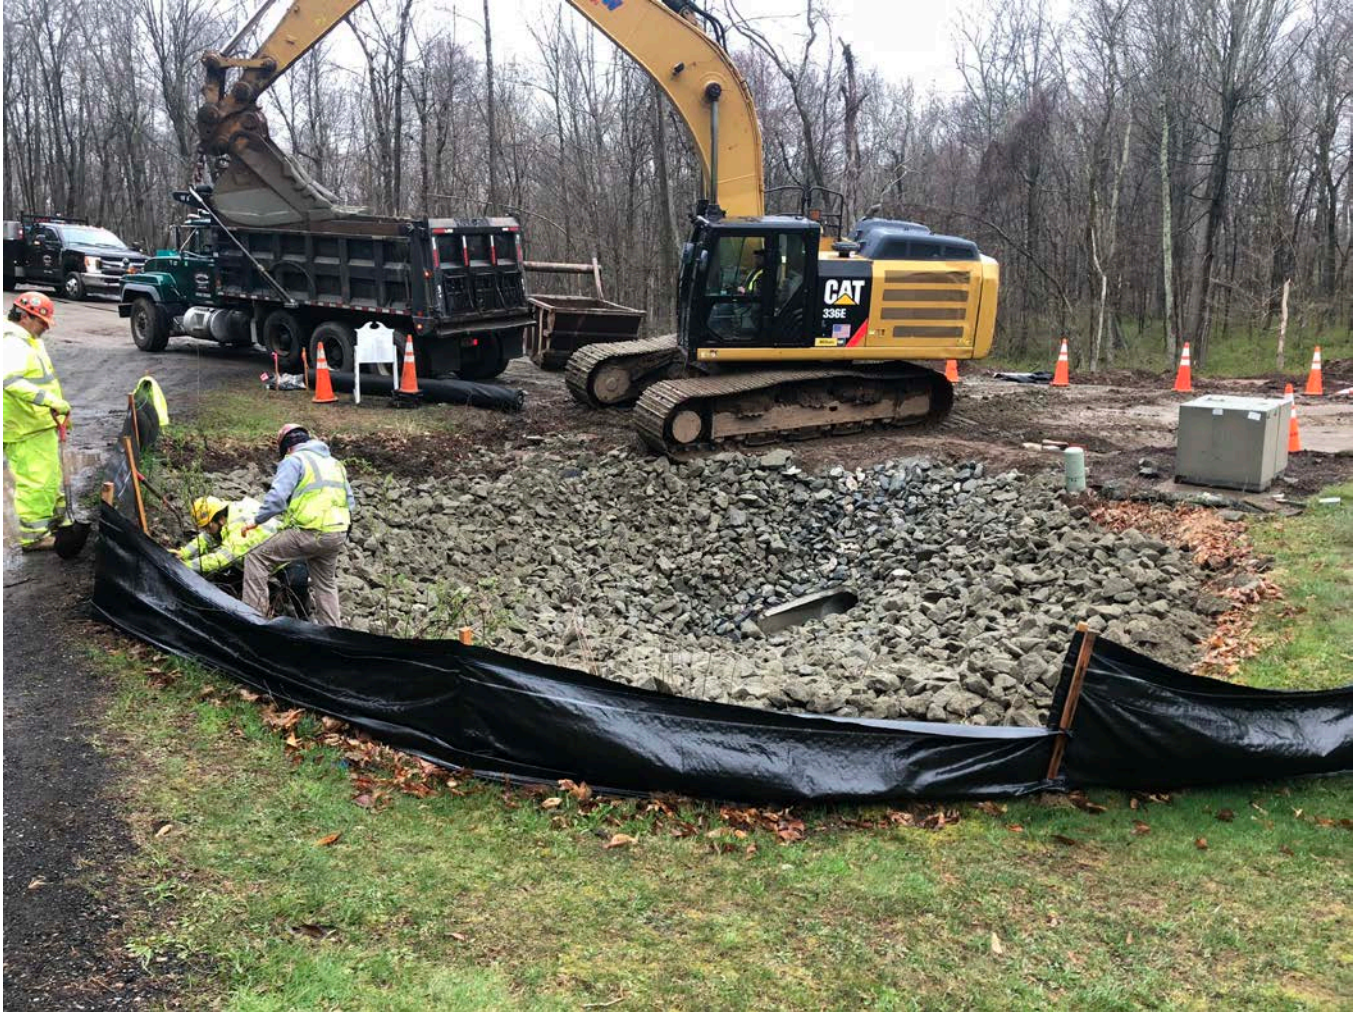
Picture 2: Ludlow just about finished placing riprap in the plunge bowl located at ~Station 14+40 (between the driveways of 214 and 216 Talcott Ridge Drive). View to the north. Middletown, CT.

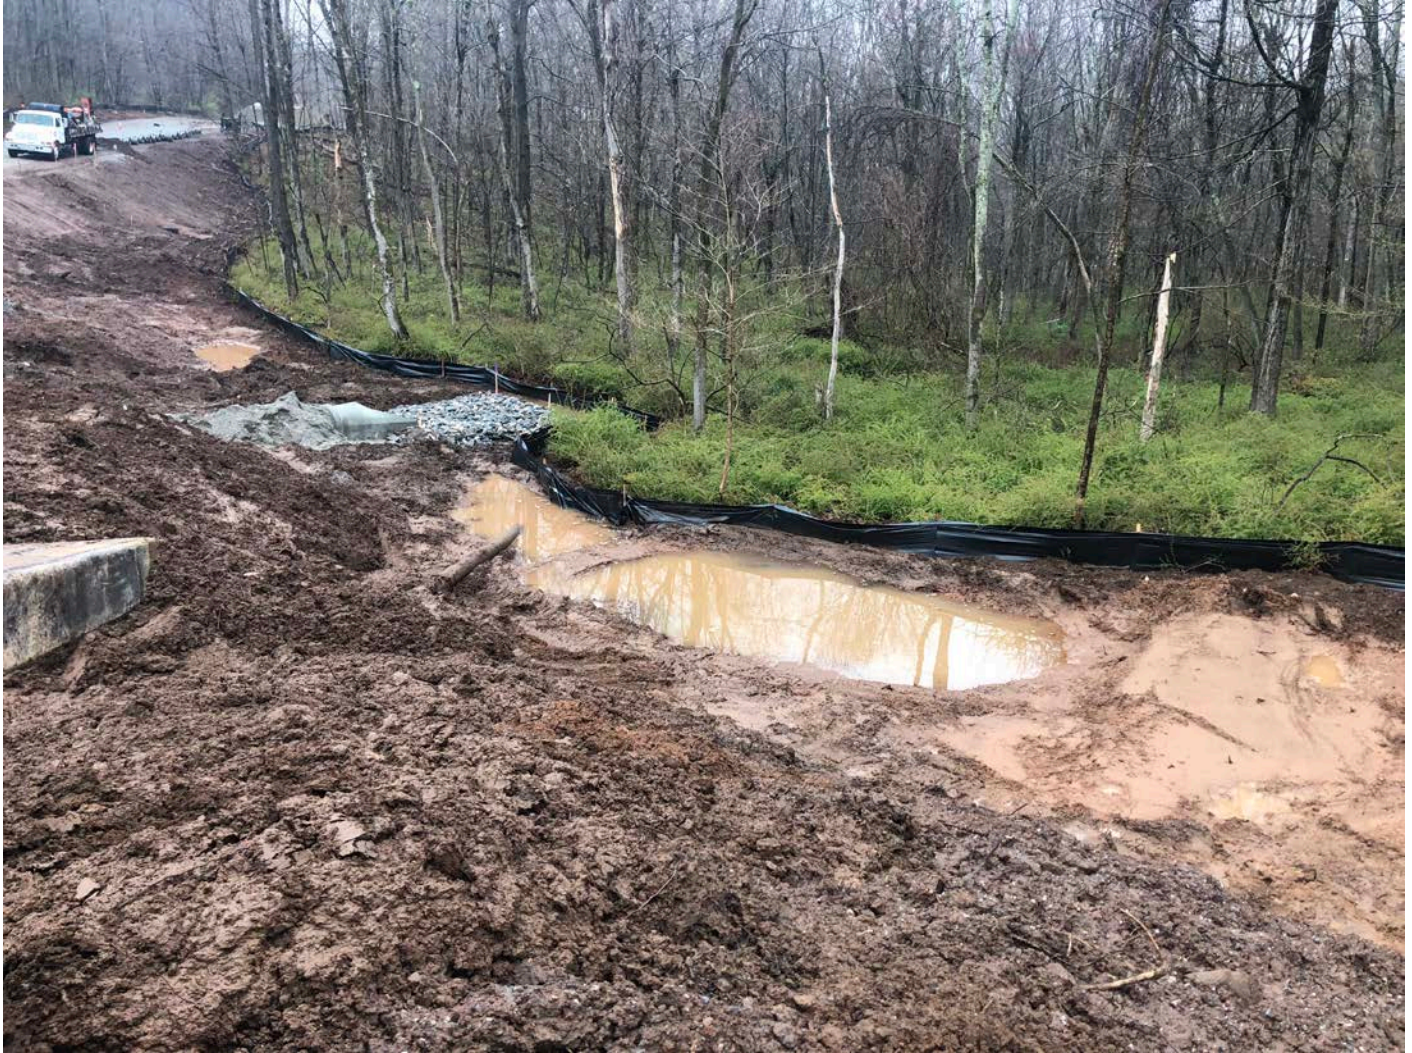
Picture 3: Water accumulated due north of the culvert located north of the Type C catch basin located at Station 14+40. View to the northwest. Middletown, CT.

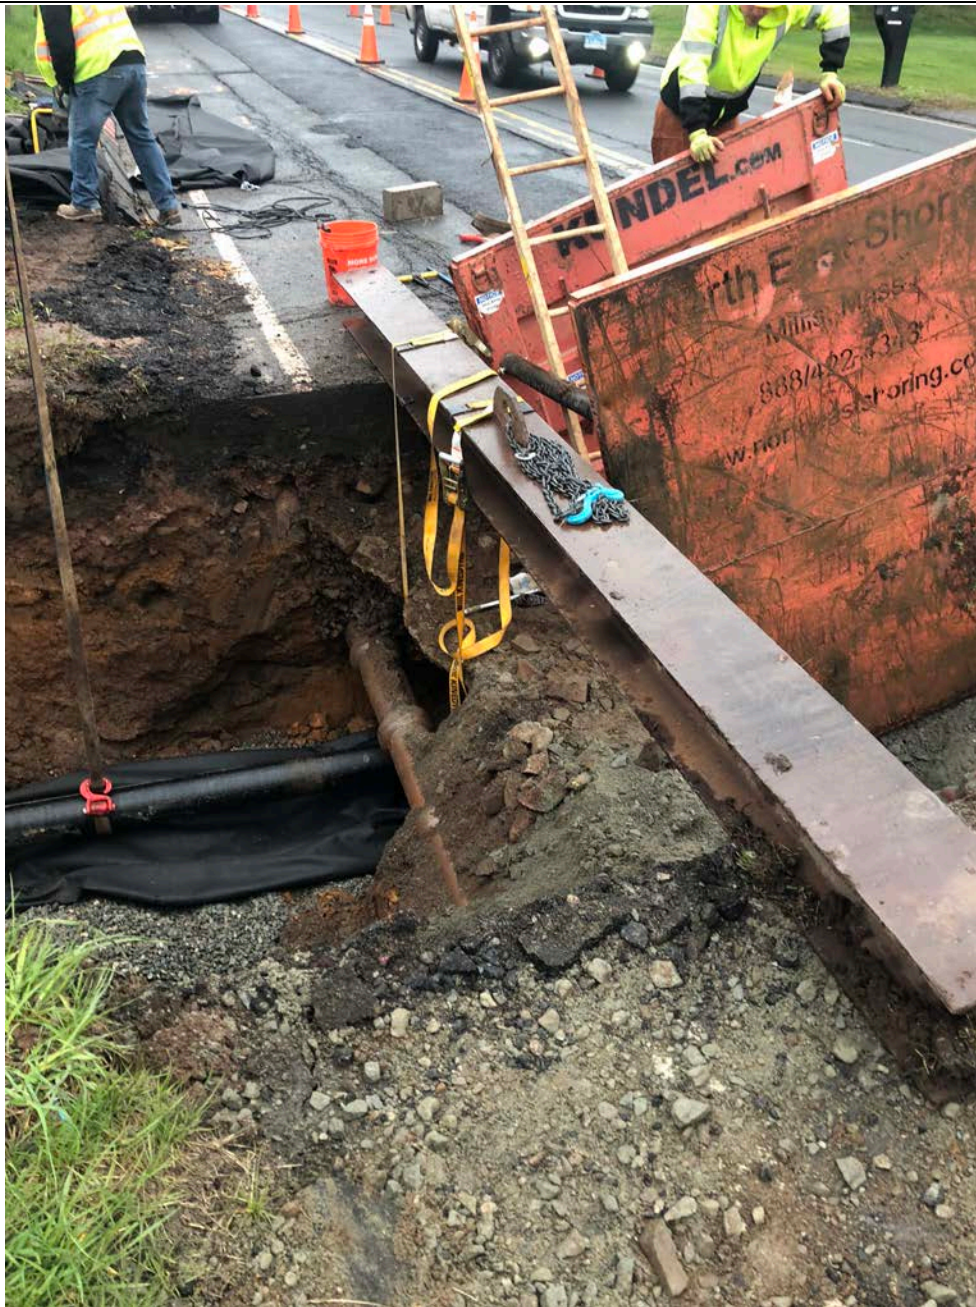
0925: Ludlow has a 20' section of 6" DIP placed beneath a 6" clay drain line that runs down the southbound lane of Main Street. A protective layer of concrete that lies over the clay pipe is being supported by web strapping and an I-beam.

Picture 4: 6" DIP being placed at Station 159+25 beneath an existing 6" clay drain pipe. Note the concrete that overlies the clay pipe being supported with web strapping attached to an I-beam. View to the northeast. Durham, CT.

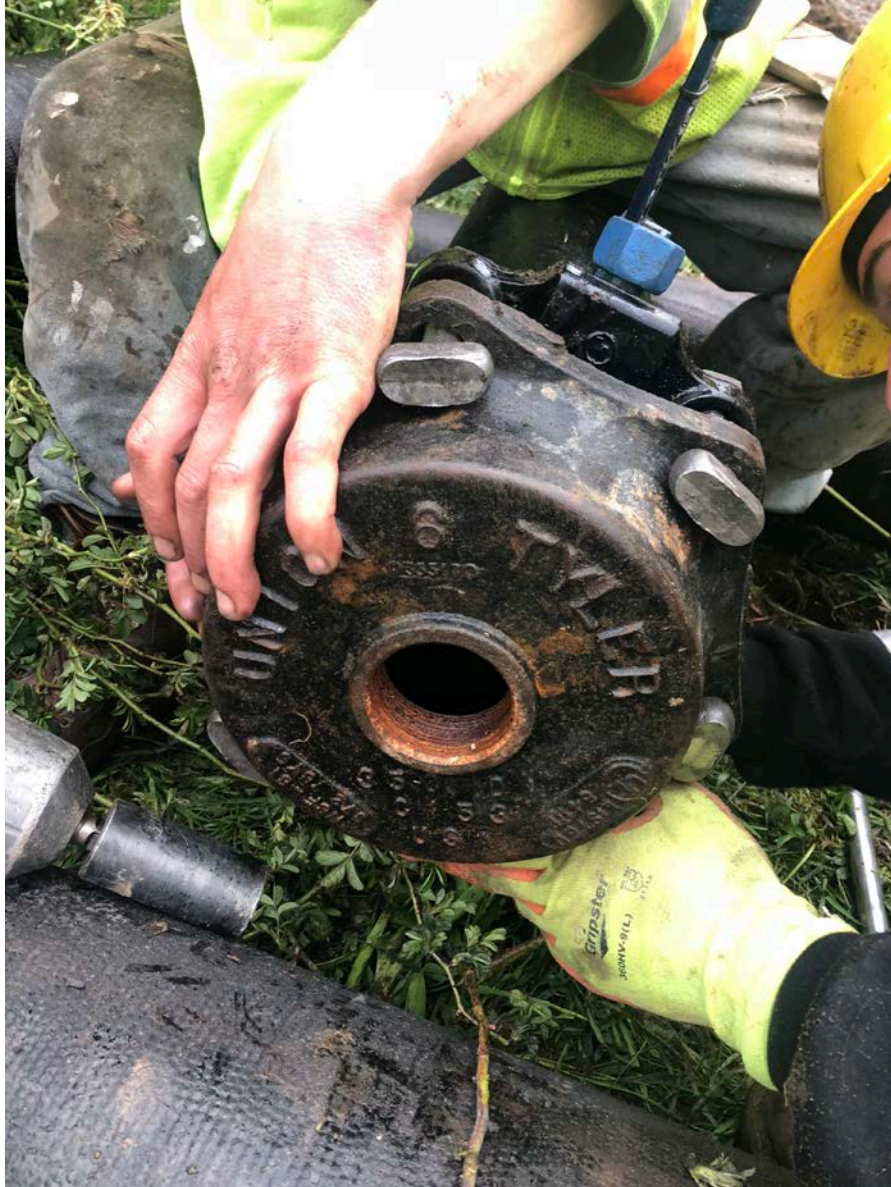
**Picture 5: Cap placed on end of 6" DIP with port for connection to 1" copper service line (which was subsequently attached and installed). Durham, CT.**

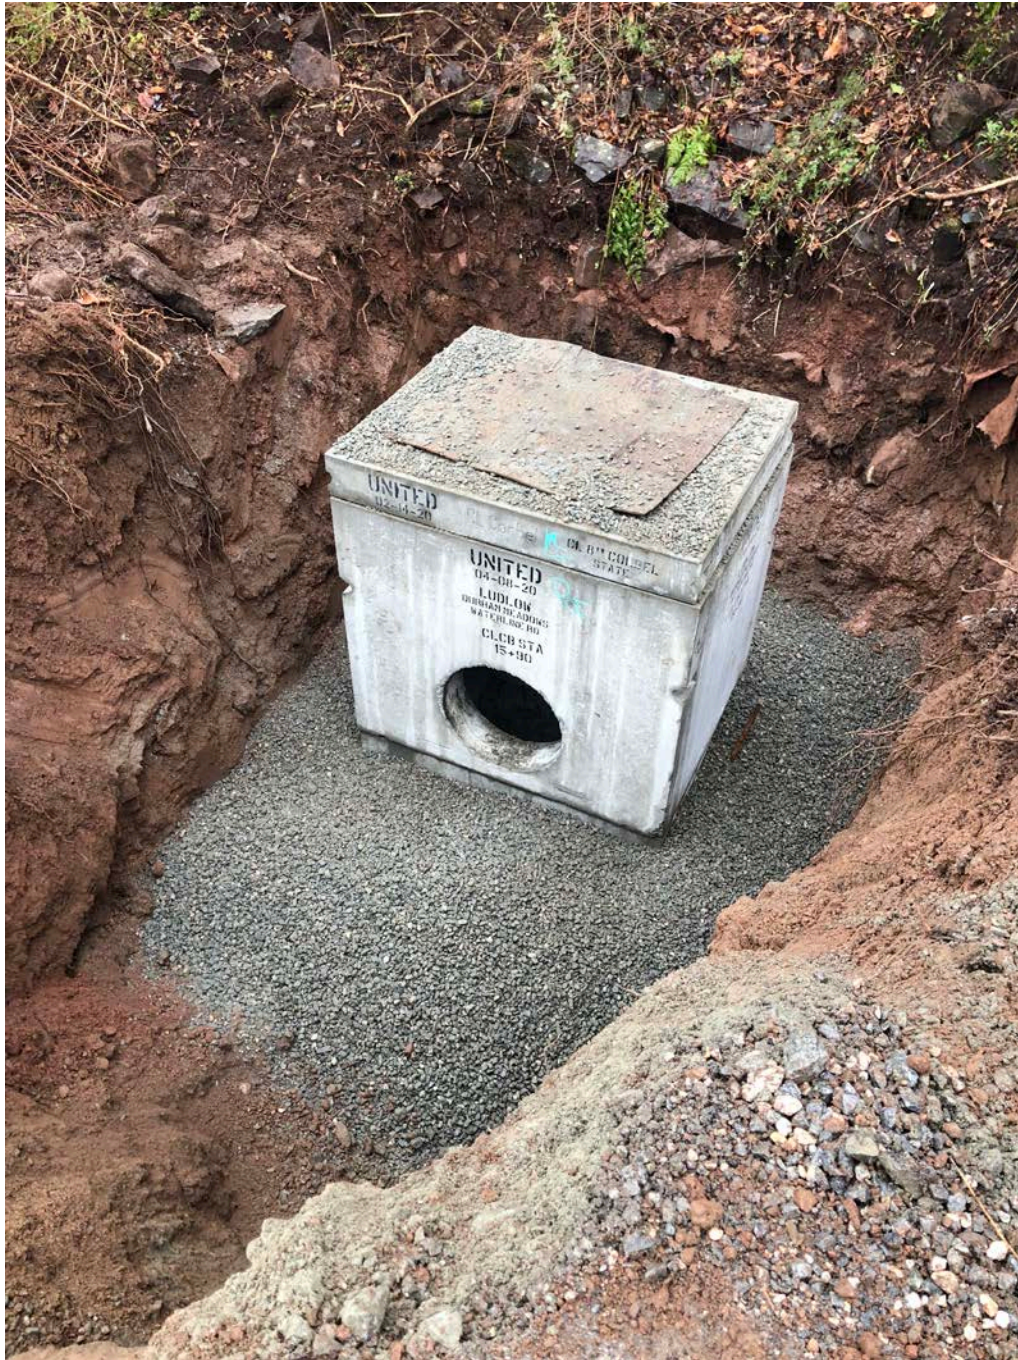
Picture 6: Type CL catch basin placed on the south side of the shared access road.  $\frac{3}{4}$ " gravel has been placed around the catch basin. View to the southeast. Middletown, CT.

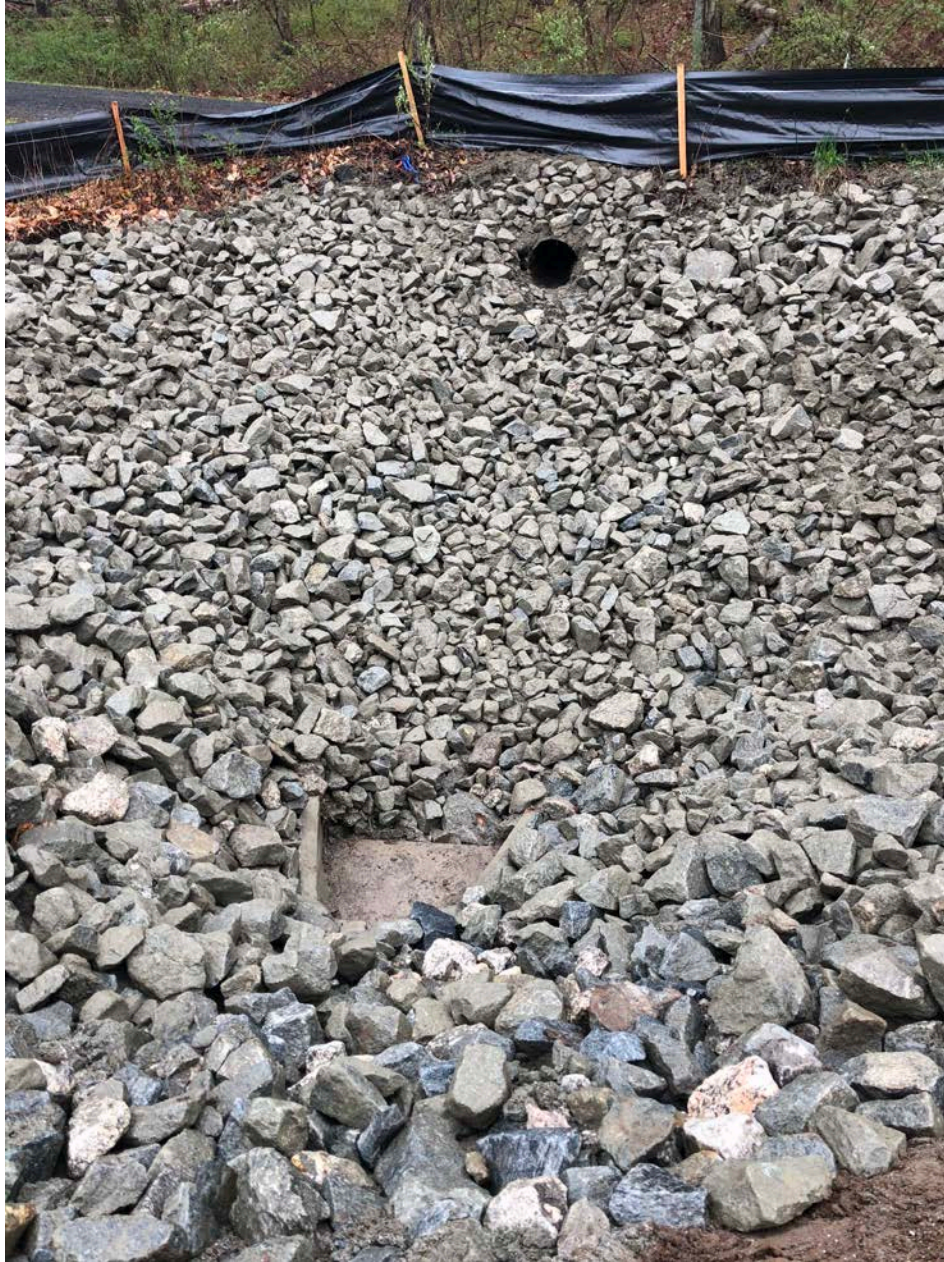
**Picture 7: Inlet to the plunge bowl located on the south side of the shared access road, between the driveways for 214 and 216 Talcott Ridge Drive. View to the south. Middletown, CT.**

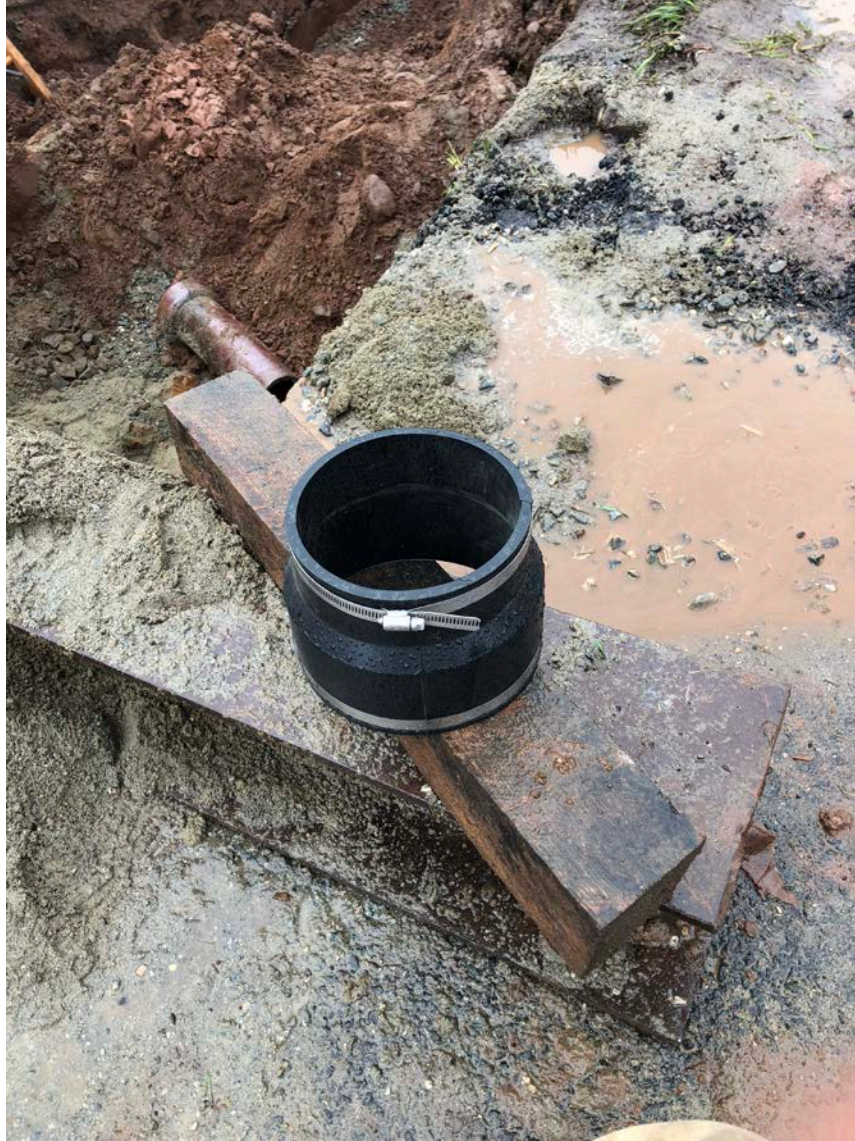
Picture 8: One of two Fernco boots used to repair break in clay pipe at ~Station 159+30. Durham, CT.

1130: The 6" clay pipe at Station 159+25/159+30 was damaged during the work at these stations. Ludlow is repairing the break with two Fernco boots and a section of 6" PVC.

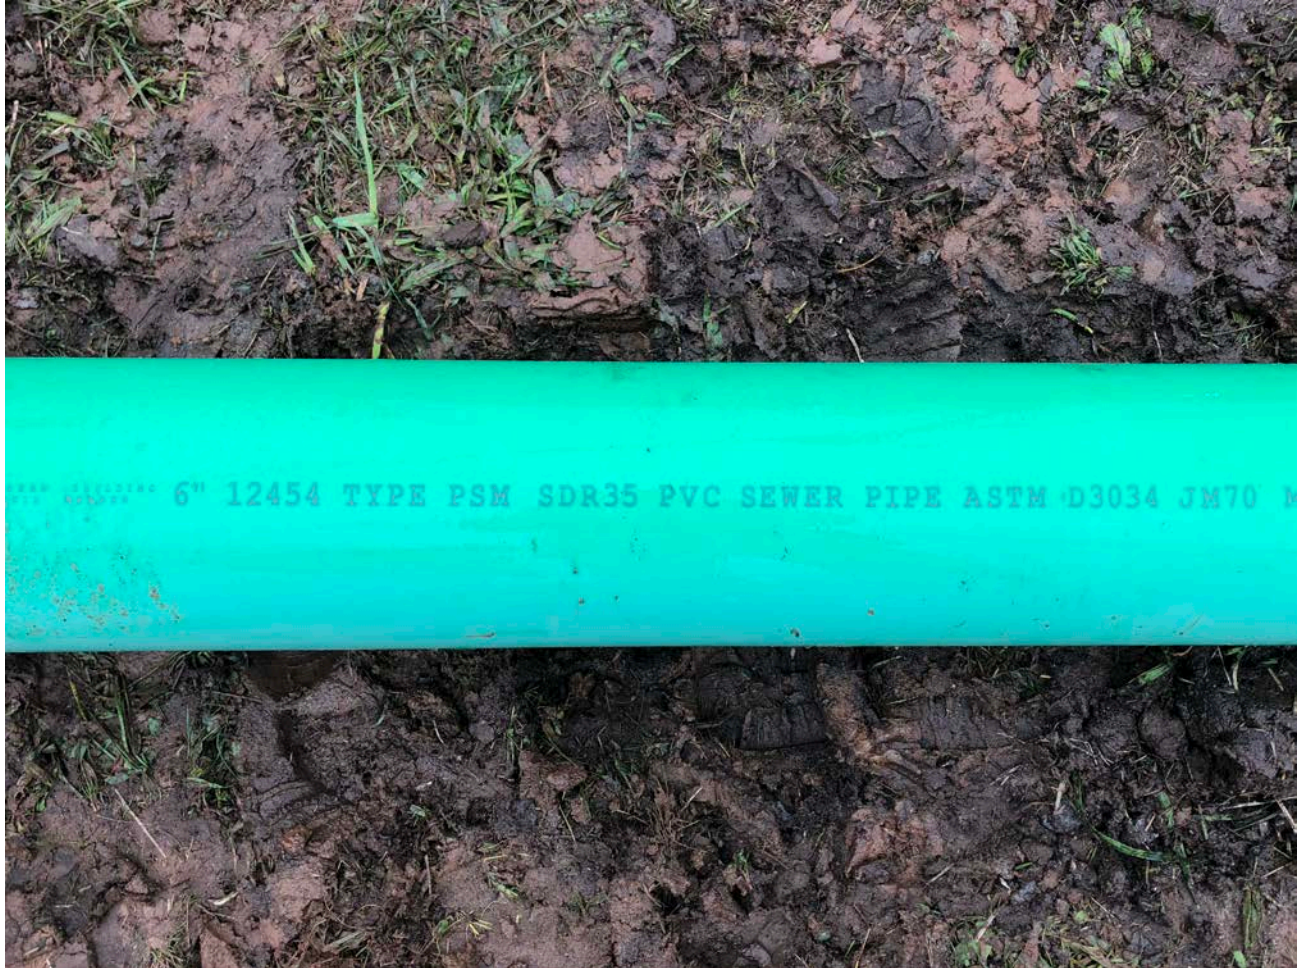
Picture 9: PVC used to repair break in clay pipe at ~Station 159+30. Durham, CT.

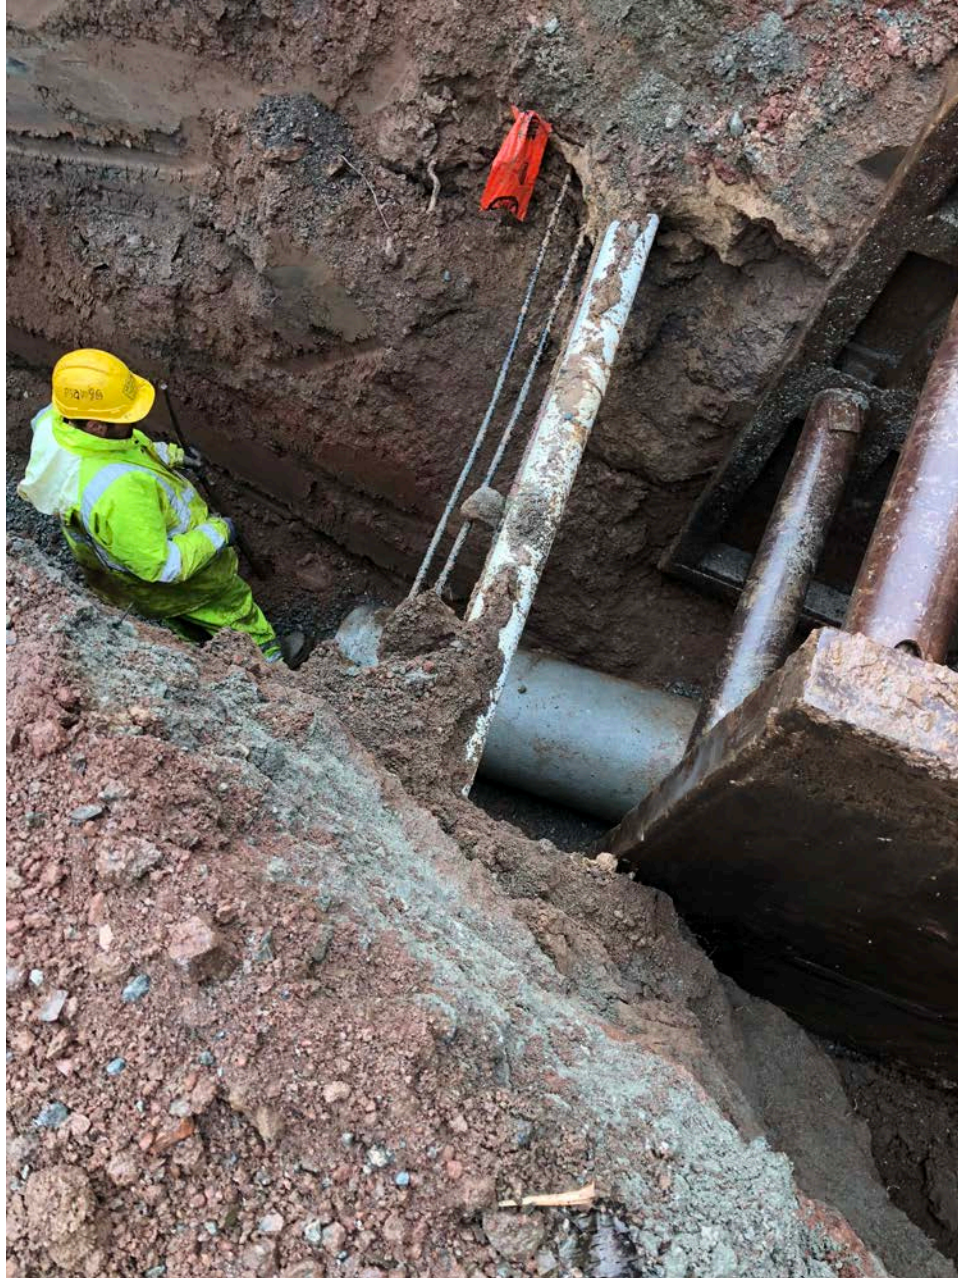
1150: Ludlow is trenching perpendicular to the shared access road (moving to the north from the catch basin they just placed) in order to place 15" RCP. In the process, they have daylighted electric and communication lines. The communication lines are unshielded; the electric line is protected by a 4" white PVC conduit.

Picture 10: Electric and communication lines daylighted while placing 15" RCP across the shared access road at ~Station 15+90 (just north of the Type CL catch basin Ludlow installed earlier today). Middletown, CT.

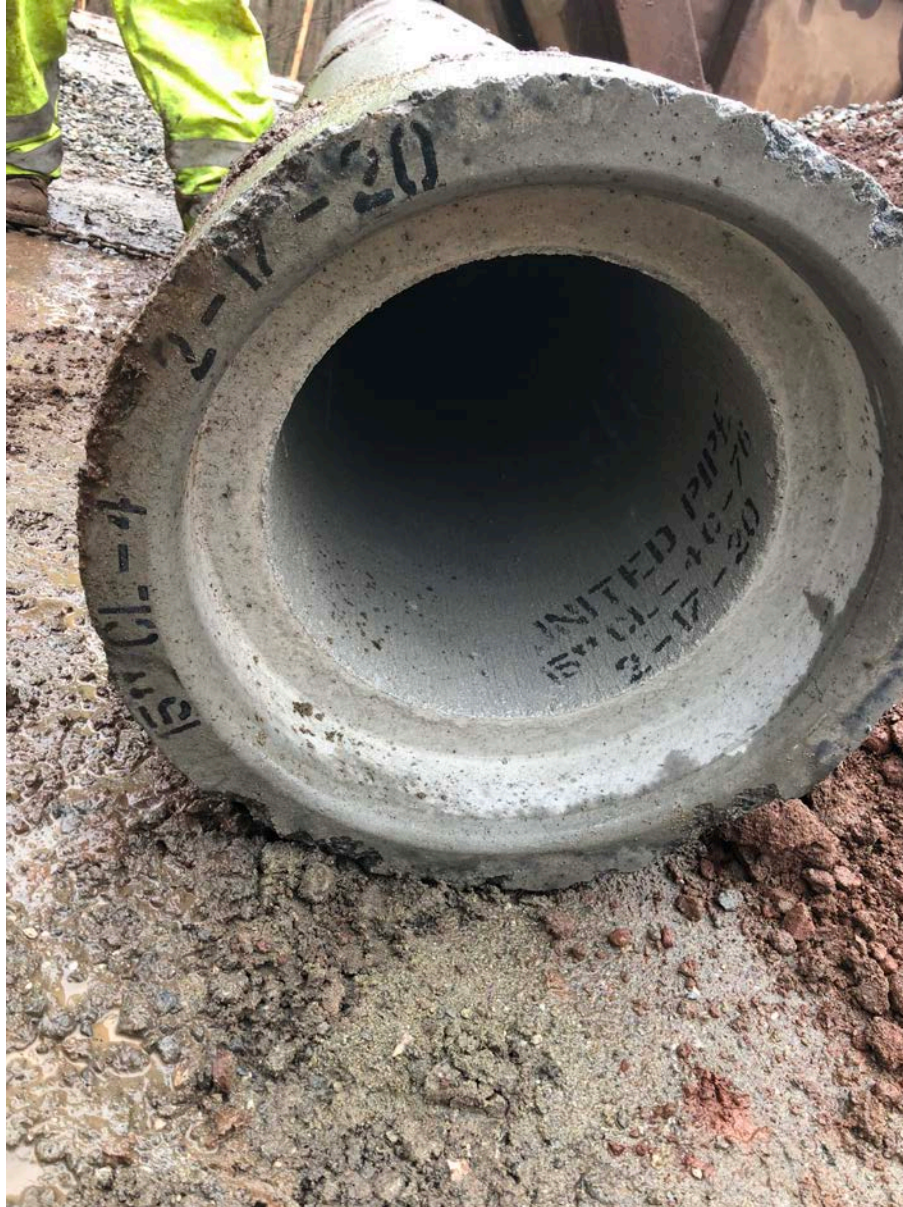
Picture 11: 15" RCP that was placed across the shared access road at ~Station 15+90 (just west of the Type CL catch basin Ludlow installed earlier today). Middletown, CT.

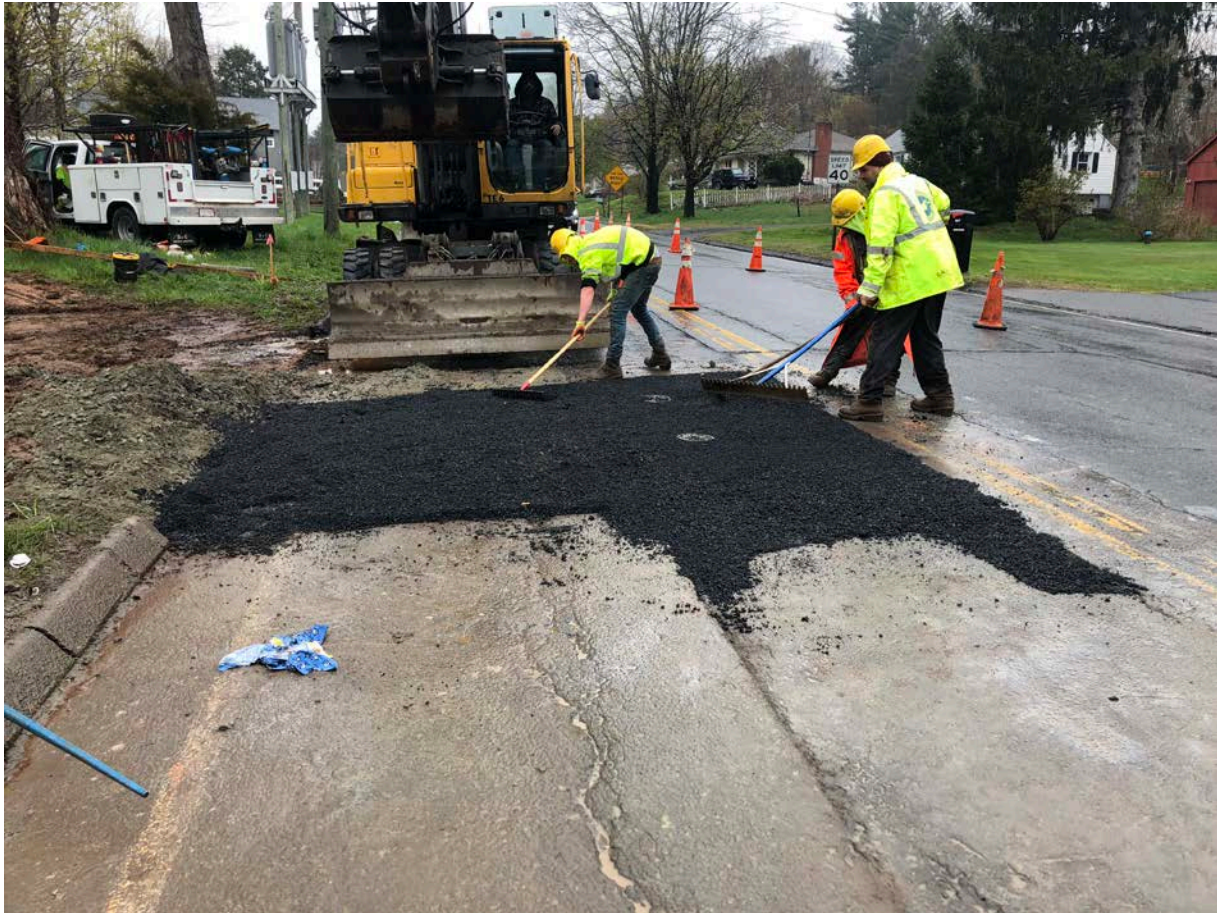
Picture 12: Hot patch being placed at Station 159+25. View to the north. Durham, CT.

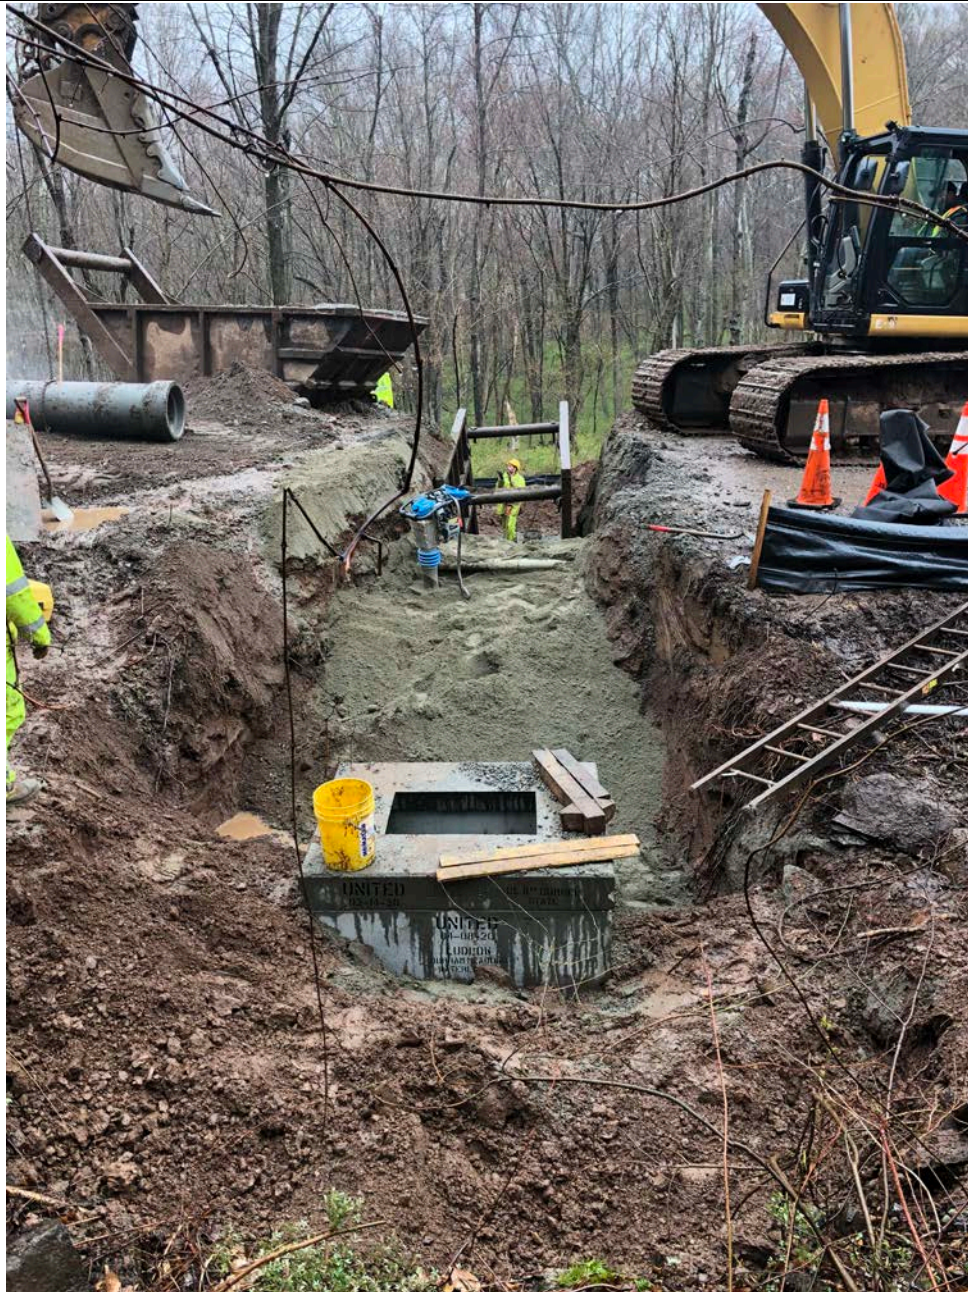
Picture 13: Ludlow covering placed 15" RCP with sand. Partially installed Type CL catch basin in the foreground. View to the north. Middletown, CT.

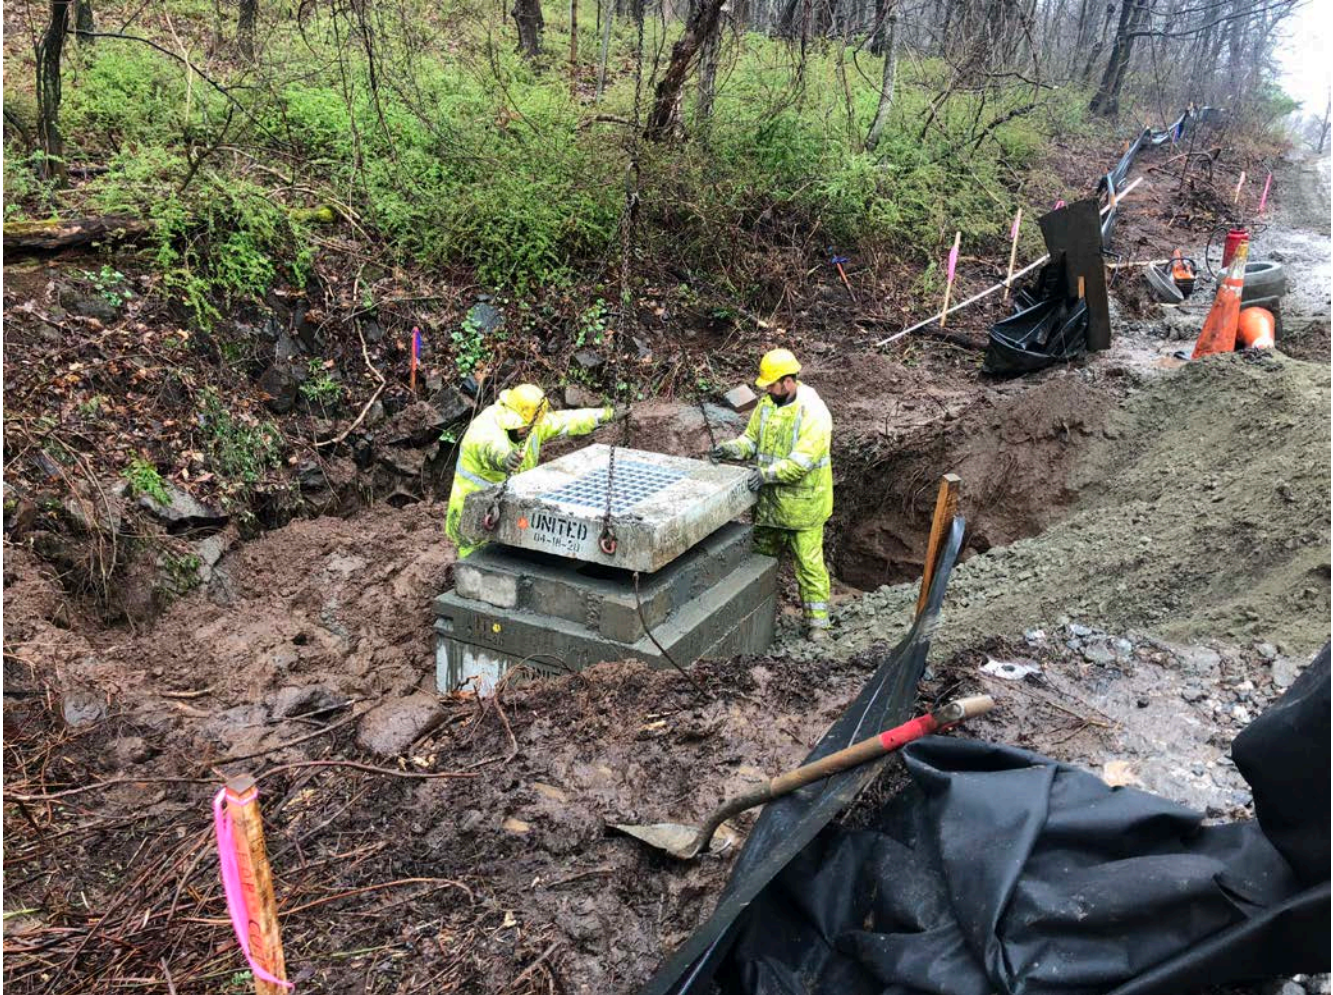
Picture 14: Ludlow finishing installation of Type CL catch basin at ~Station 15+90. View to the southwest. Middletown, CT.

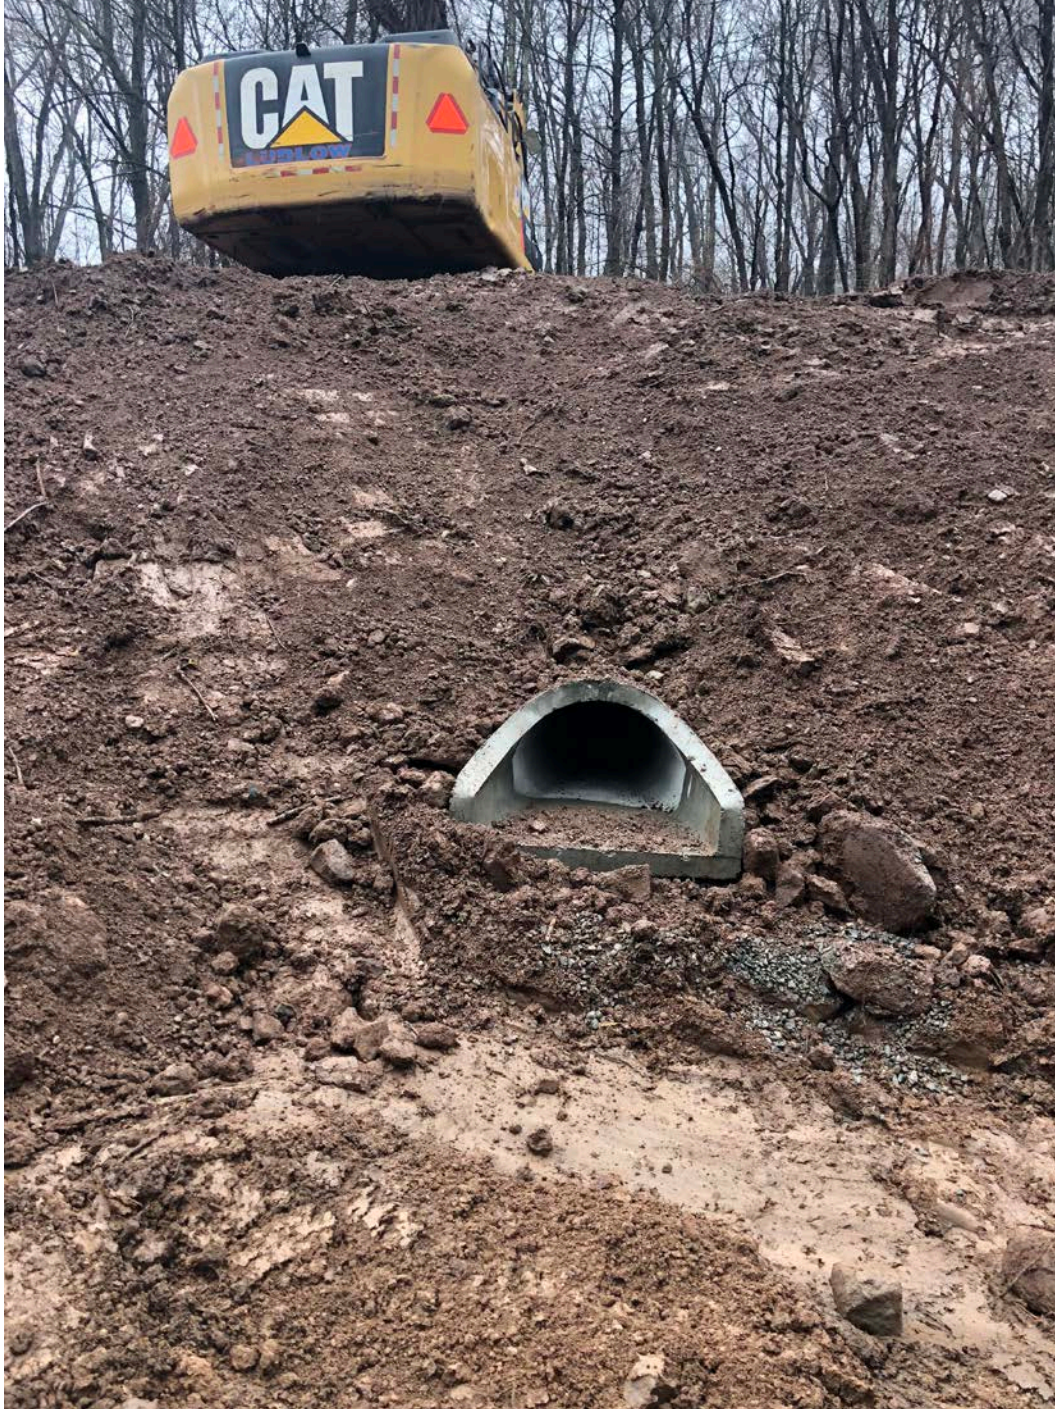
Picture 15: Flared end of newly installed 15" RCP at Station 15+90. View to the south. Middletown, CT.

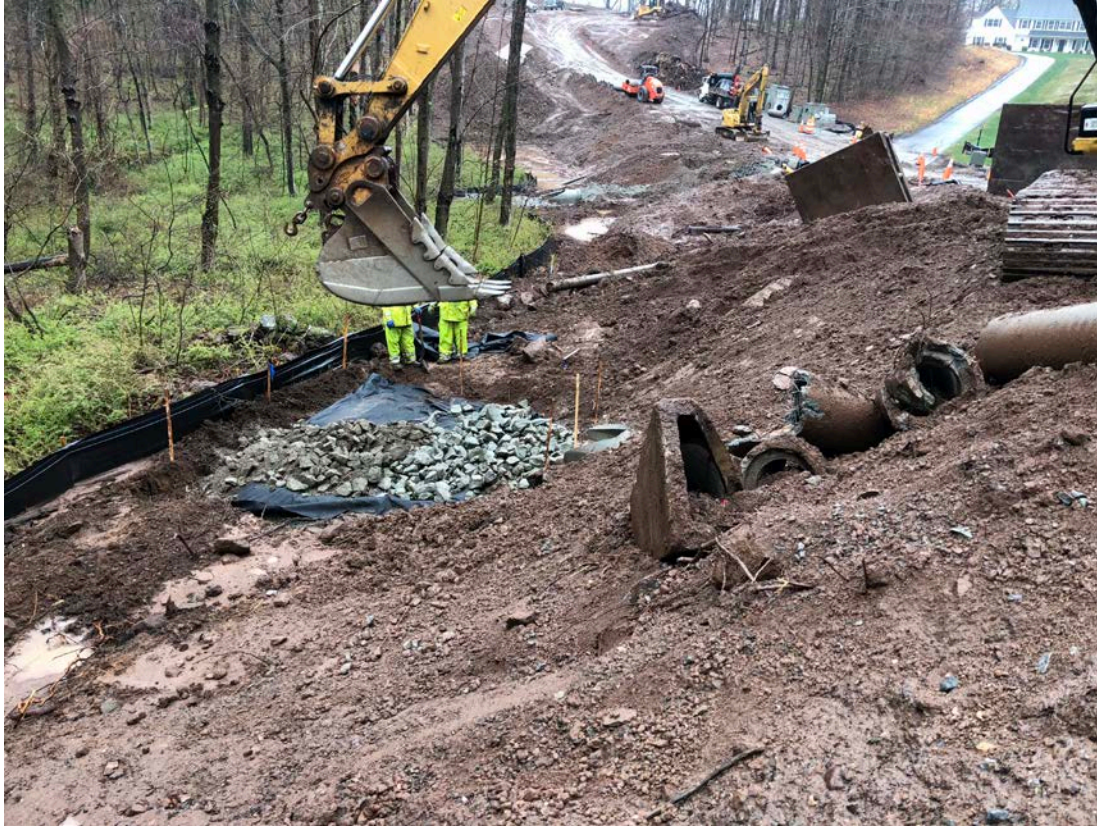
Picture 16: Ludlow placing riprap to the north of 15" RCP installed today. View to the east. Middletown, CT.

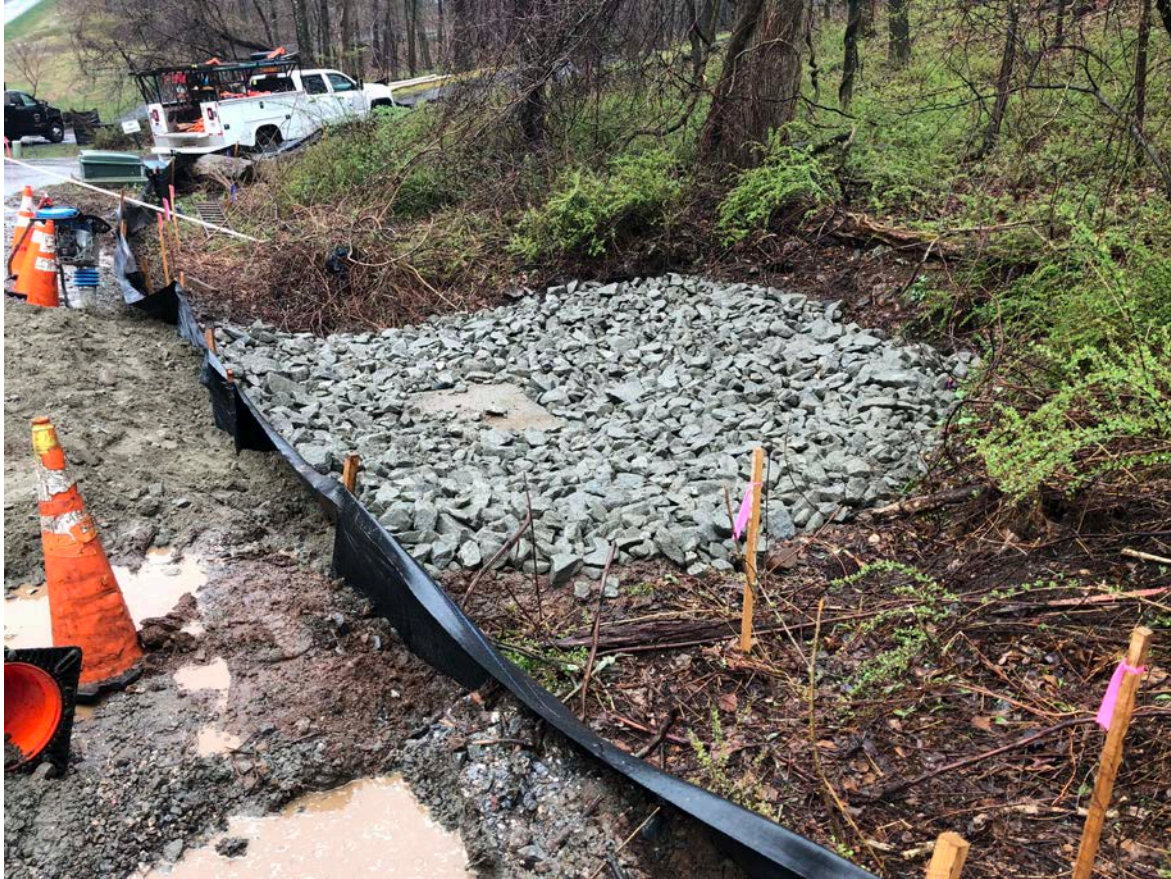
Picture 17: Riprap placed around Type CL catch basin that was installed today. View to the east. Middletown, CT.
