Daily Report

| Project: | Durham Meadows Pipeline Installation | Date: | May 01, 2020 |
| Location: | Main Street and shared access road, Durham & Middletown, CT | Day of Week: | Friday |
| Project #: | AECOM: 6061487 | Report No: | 70 |

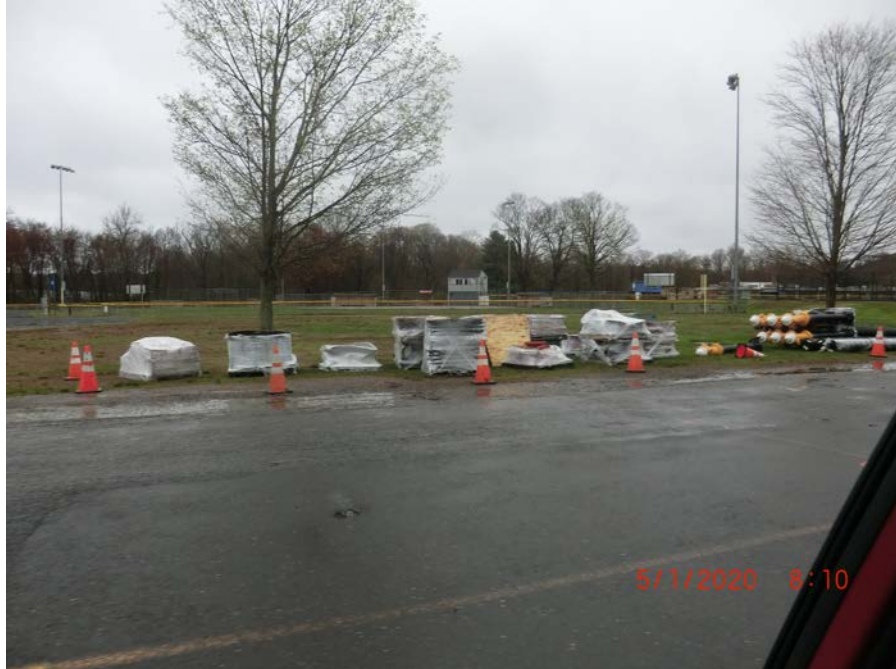
0810: Drove over to review Pickett Lane laydown area. Site appears to be well maintained. No work will be occurring on Pickett Lane due to the shutdown on Main St.

Picture 1: Pickett Lane laydown area.

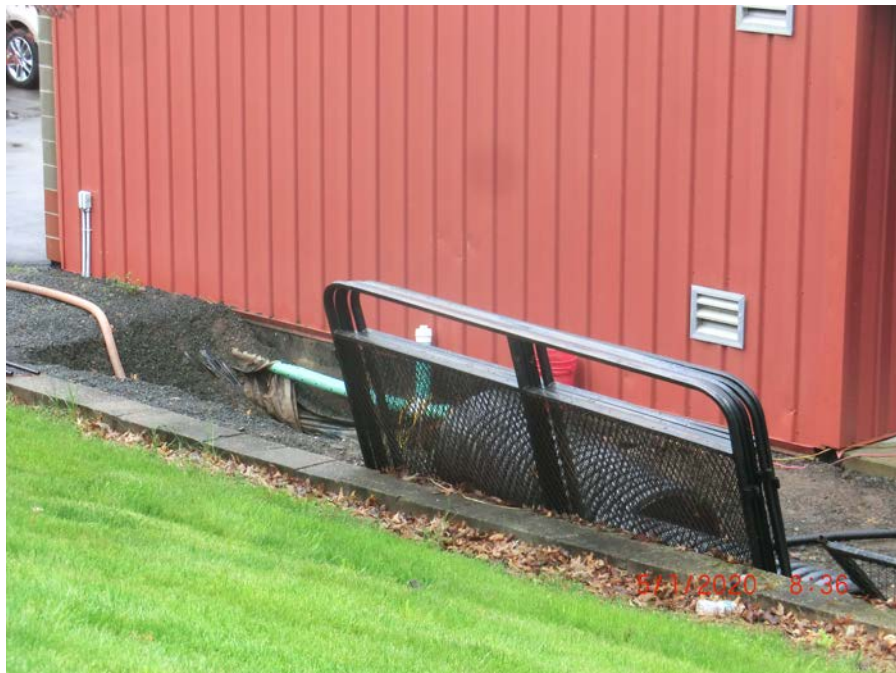
During travels along Main Street, it was noted that Durham Auto Center has excavated a hole on the north side of the building (unpaved area) and appears to have installed PVC drainage piping. There were also sump discharge hose coming out of the pit, though not currently running.

Picture 2: Durham Auto Center 4" Sch35 Perforated PVC drainpipe being installed or repaired along north side of building. Drain hose seen to left, not currently flowing.

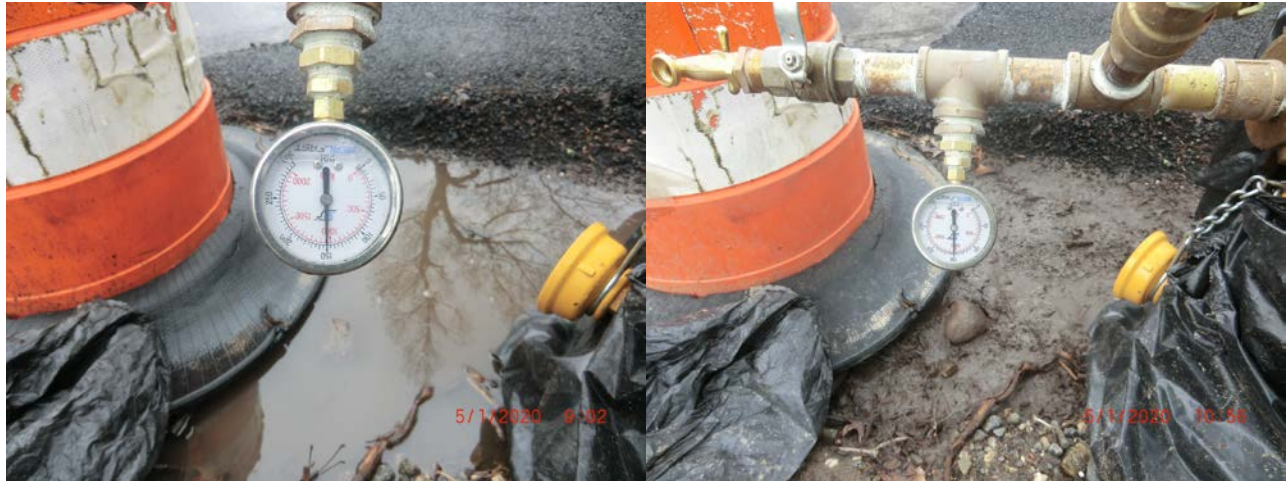
The only activity on Main Street Durham today was a pressure test that was conducted from 132+32 (Middletown/Durham Line) to 141.27 (Little Lane, Durham). The test started at 0900 hours and ended at 1100 hours. Test passed. A pressure of 150 PSI was maintained throughout the test.

Picture 3: Little Lane (141+27) Durham water line test station at 0900 and 1100 hours. 150 PSI maintained for two hours. Other end of test was at 132+32

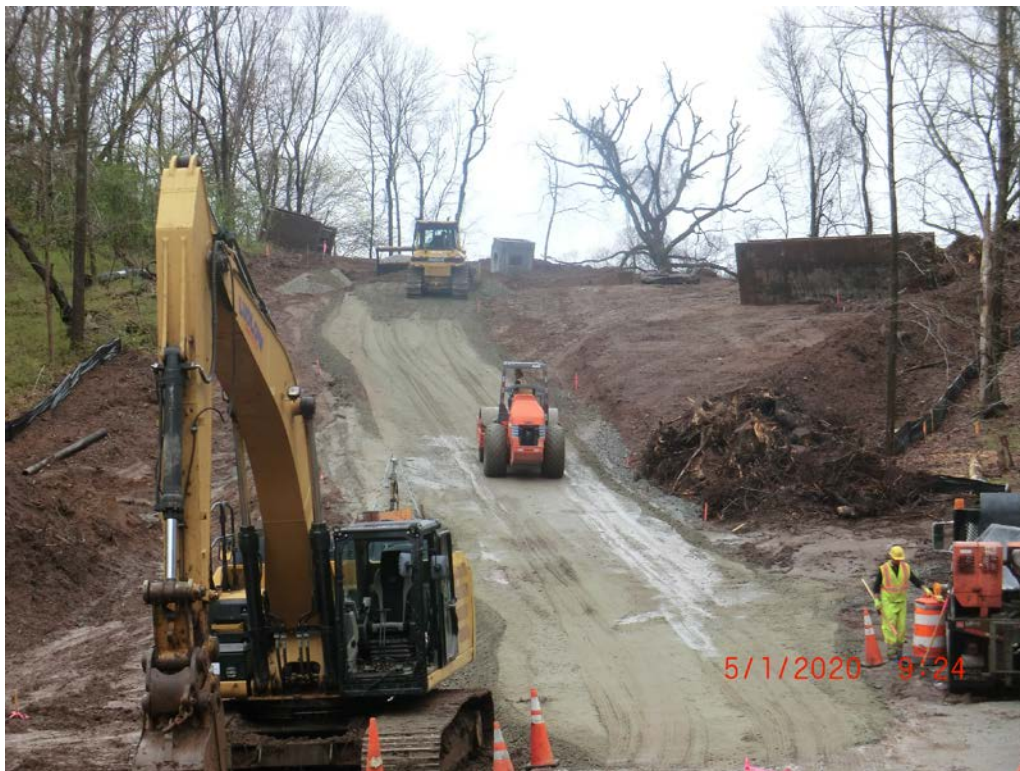
Picture 4: View facing east on shared access road. Laying road base and compaction on slope up to water tower.

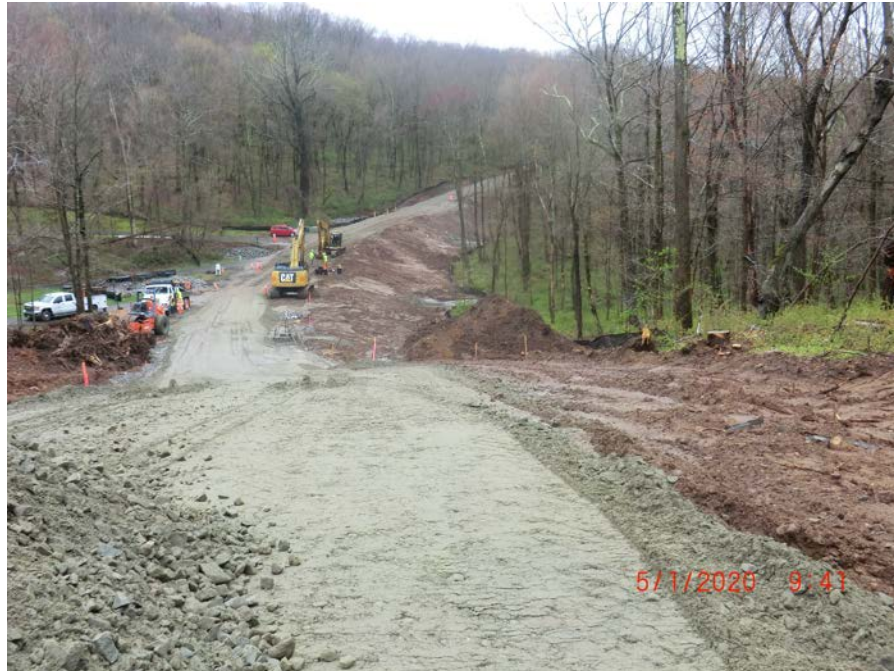
Picture 5: View facing west from top of slope.

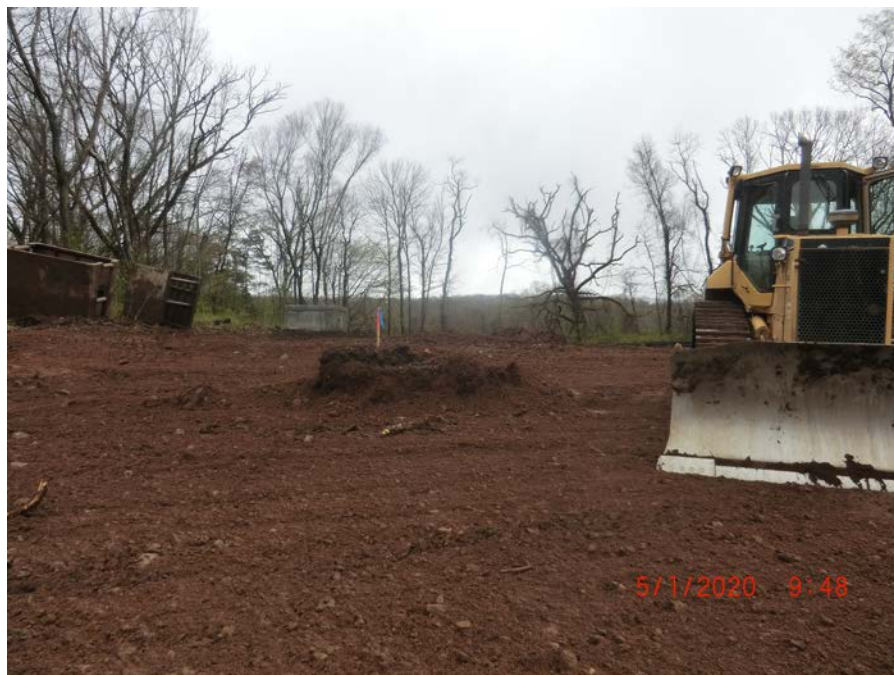
Figure 6: View facing east. Center of water tower grade stake.

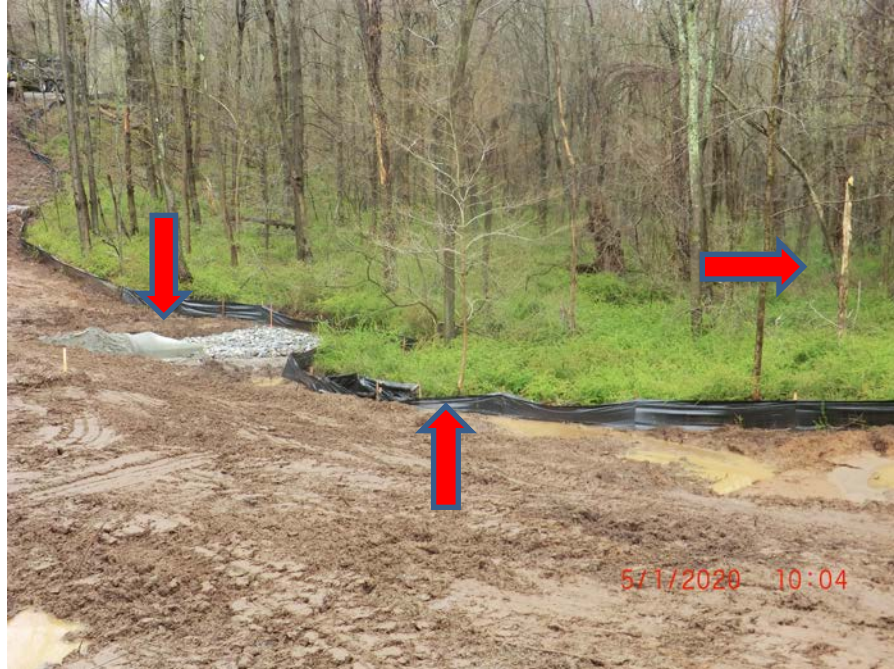
Figure 7: View facing northwest. Down arrow is the large culvert referred to in the following pictures. Up arrow is roughly 50 feet east of large culvert and is the other area referred to. Horizontal arrow is pointing to area approximately 100 feet down drainage to the north of the large culvert.

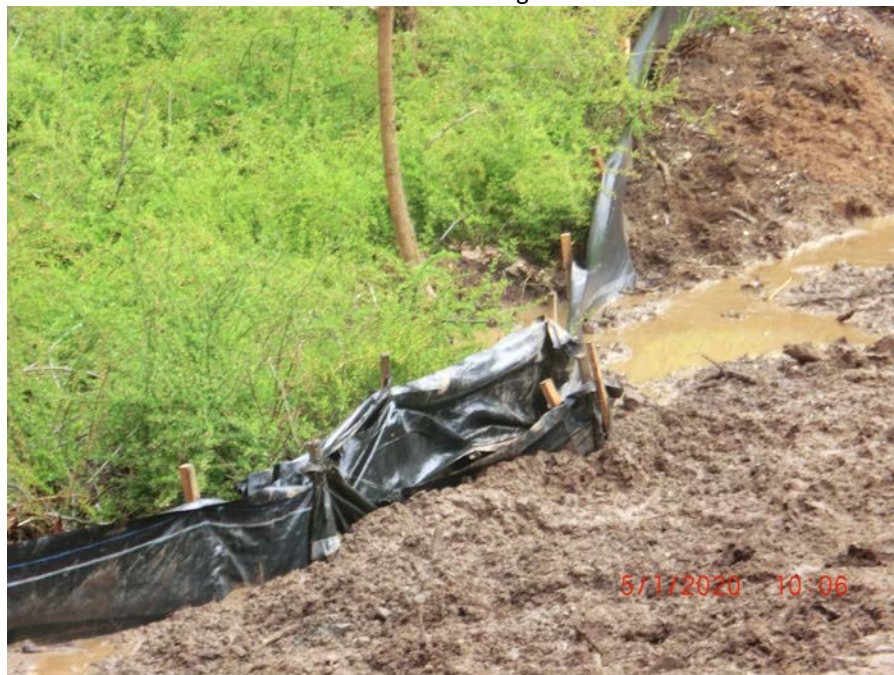
Figure 8: Potential issue Location A: Facing northeast. Approximately 50 feet east of large culvert. Small silt ponding behind silt fence. Trouble area reported by Ludlow and repaired/reinforced over last two days.

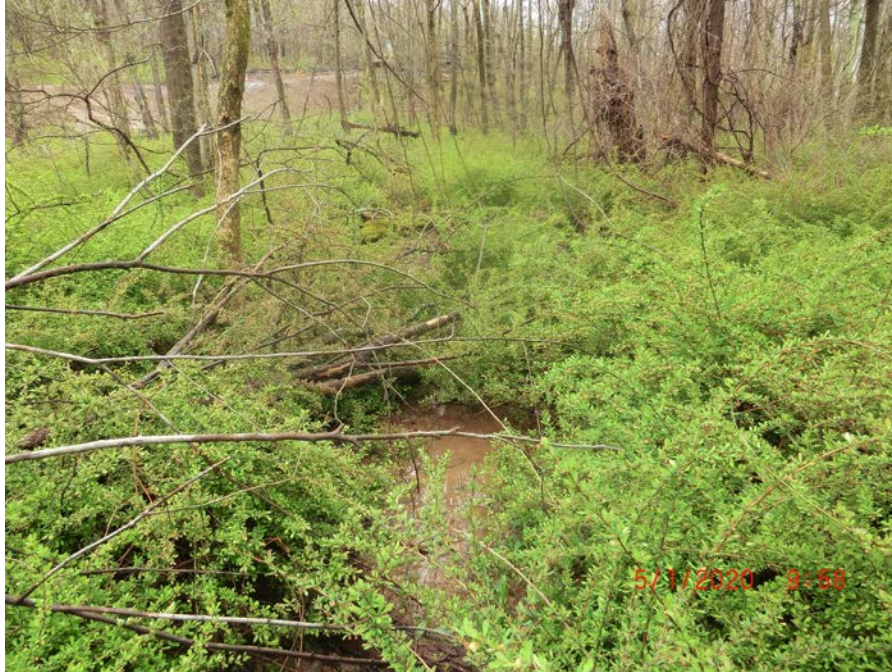
Figure 9: Small silty puddle approximately 15 feet north of previous picture. Previous shot is to the left of this photo which faces west-southwest. Shared access road is seen in distance.

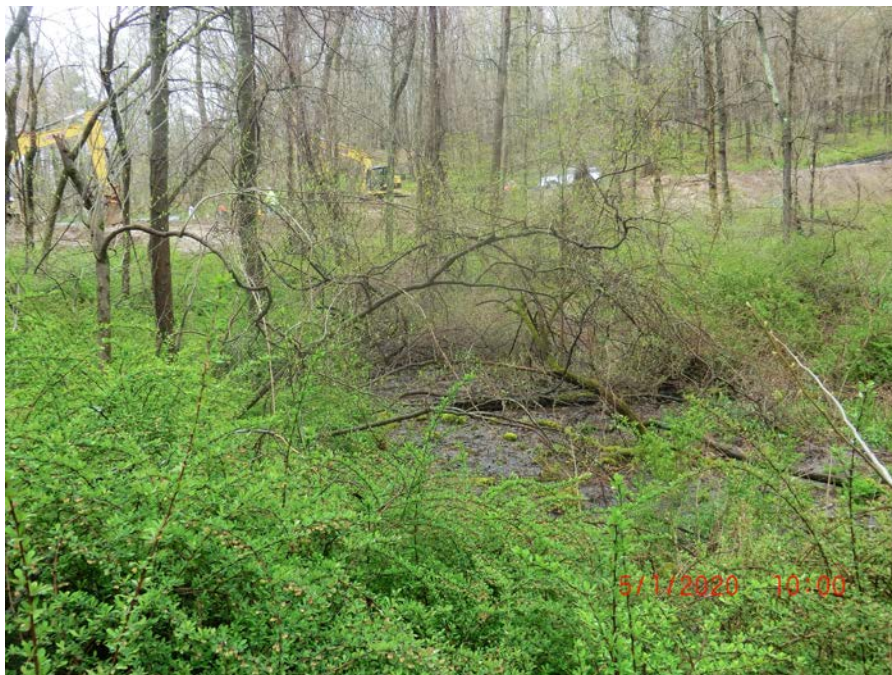
1010: Conducted an inspection of the silt fencing along the access road from water tower location to large drain discharge. This area to the north side of the access road is the most likely to have issues due to the current grade and work. Observations show that the silt fencing is holding up well given the heavy downpour the previous evening. There was one area where a couple of silty puddles were noted outside, but after discussion with Ludlow, it appears that this was a troubled area that they had repaired. The puddles likely before the repairs. It was noted that 50 feet further on, by the large discharge, that there was no breakthrough and 100 feet down stream (to the north) in the drainage swale there was no indication of sediment.

Figure 10: Facing south. Water flowing in drainage swale approximately 100 feet north of the Large culvert. Water is running clean with no indication of silt transport.

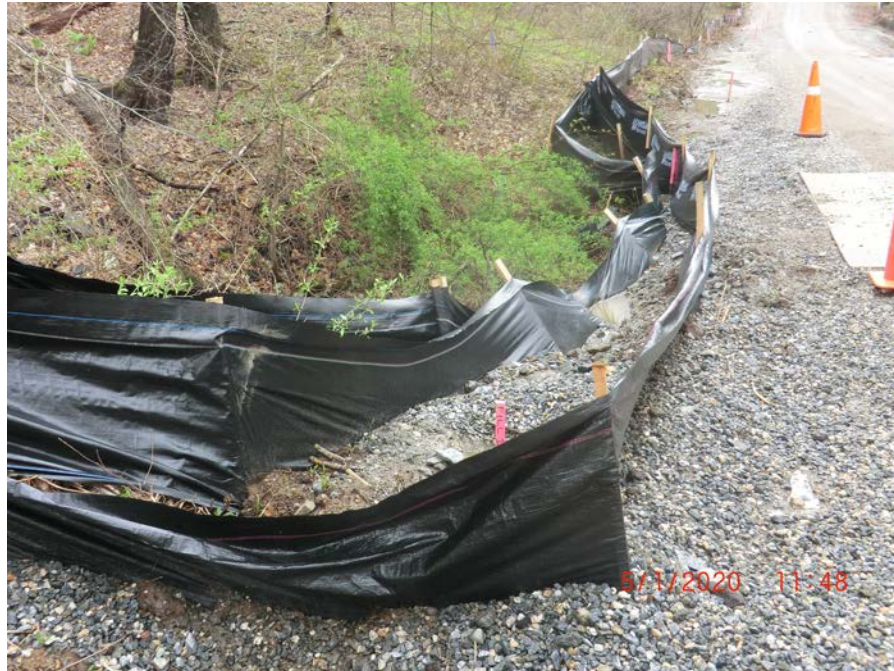
Figure 11: Potential issue location B. Facing west and on the south side of the shared access road. Multilayer silt fence over small brook that runs through culvert under road.

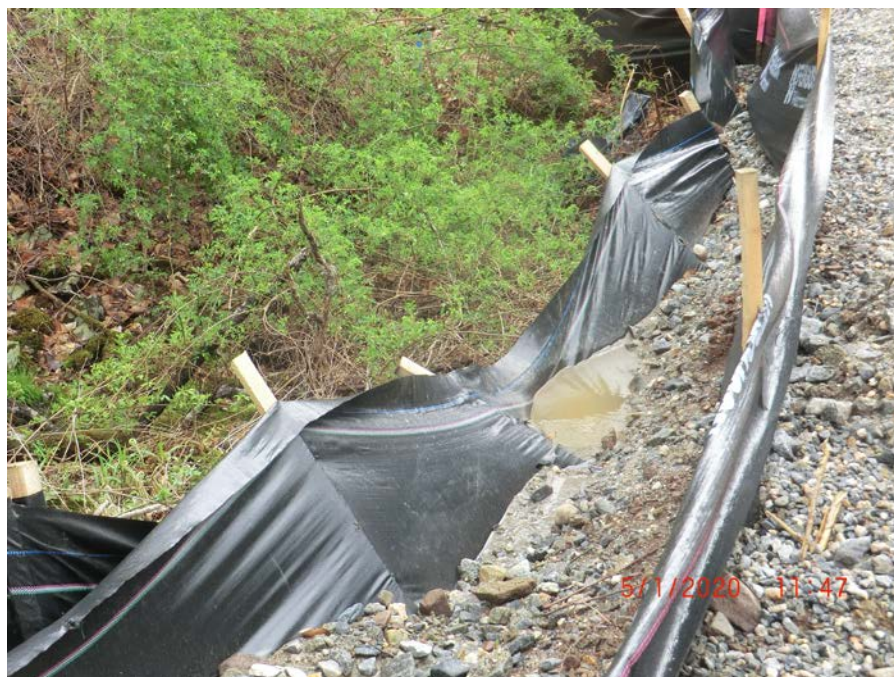
Figure 12: Close up of previous shot. Water could possible drain over. Not shown in shot is downhill side of this silt fence where clean filtered water drains down to brook.

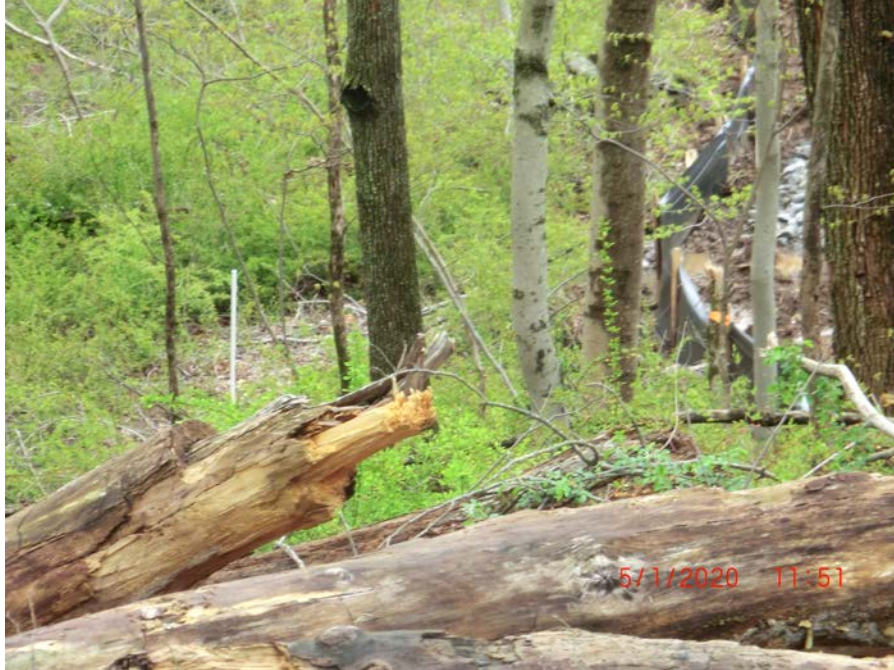
Figure 13: Potential issue location C. View from high point to low point (roughly halfway down access road). Note white piezometer(?) left of center in shot.

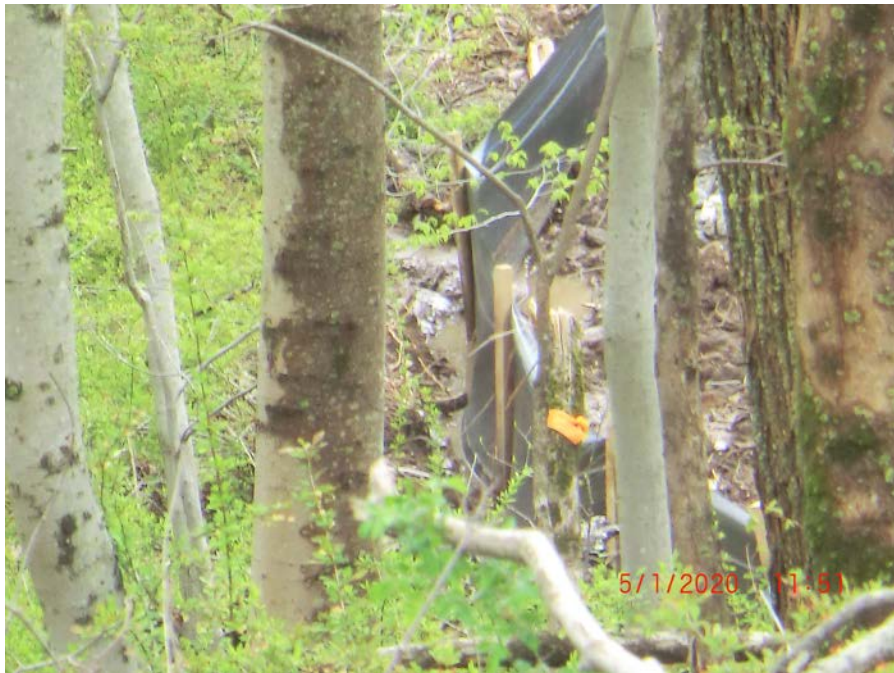
Figure 14: Super-zoomed shot of previous photo. Facing east. North side of road. Piezometer is to left of shot. What appears to be a small puddle behind the barrier. Many of these locations are difficult to get close to due to the depth of muddy soils from recent heavy rains. Figures 7-14 represent the three areas where there could be issues potentially and should be watched.
