AECOM

Daily Report

Project:	Durham Meadows Pipeline Installation	Date:	June 25, 2020
Location:	Maiden Lane, Route 68, Maple St., and Shared Access Driveway	Day of Week:	Thursday
Project #:	AECOM: 60614871	Report No:	106
Contractor:	Ludlow Construction	Page:	1 of 11

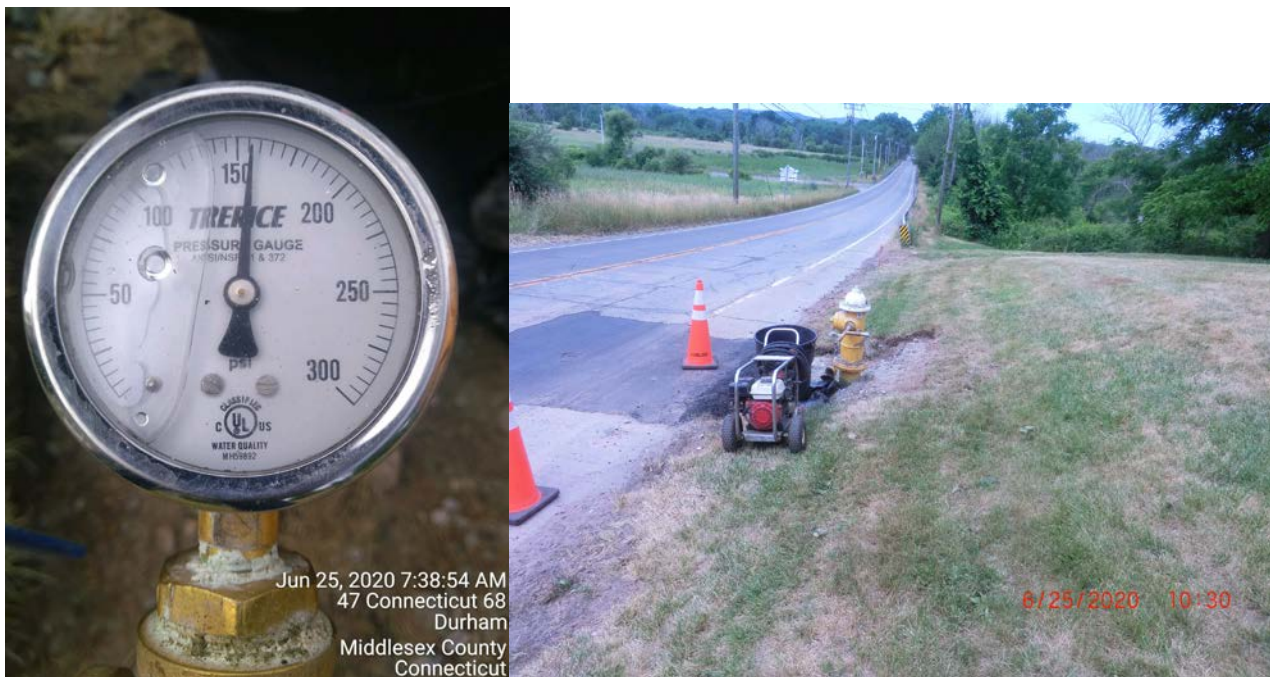
0730: Ludlow preps the hydrant and sets pressure at 155 PSI for water line test along Route 68. Test begins at 0735.

Picture 1: Ludlow begins pressure test. This is a shot taken by Ludlow on left and hydrant on right.

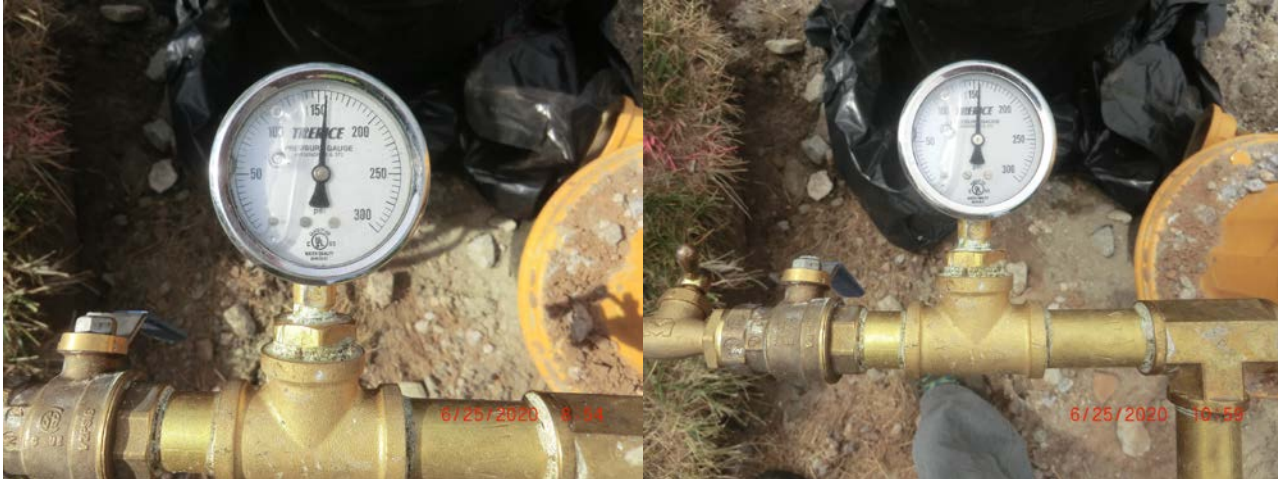
1055: Final check on pressure test. System held pressure for 3 hours.

Picture 2: Two additional shots of pressure gage for test on Route 68, Wallingford Road. System held pressure for over three hours.

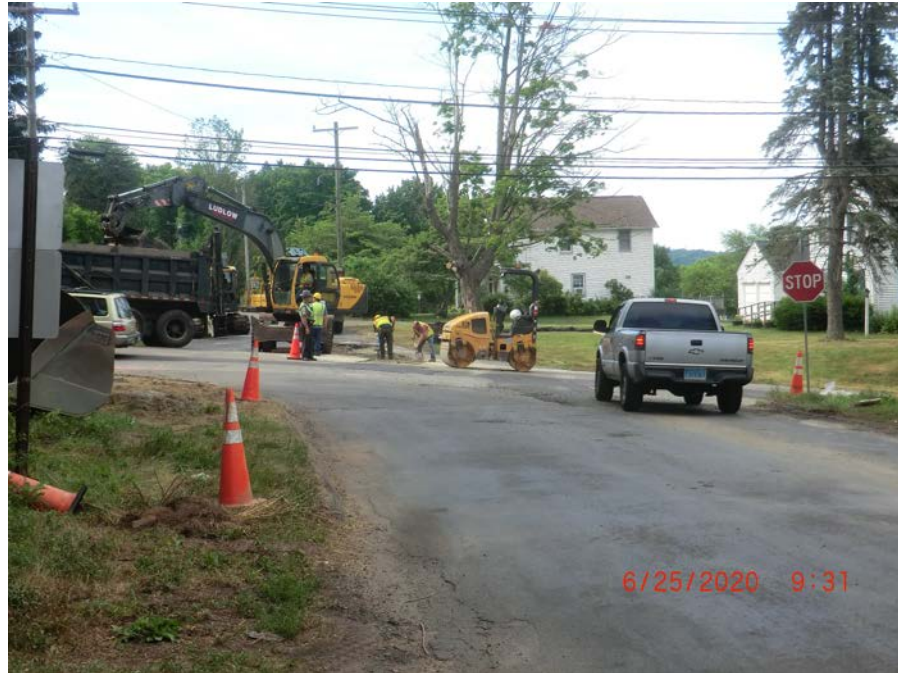
Picture 3: Ludlow completing backfill and compaction at Maple Ave. and Wallingford Road (Route 68). View to the south.

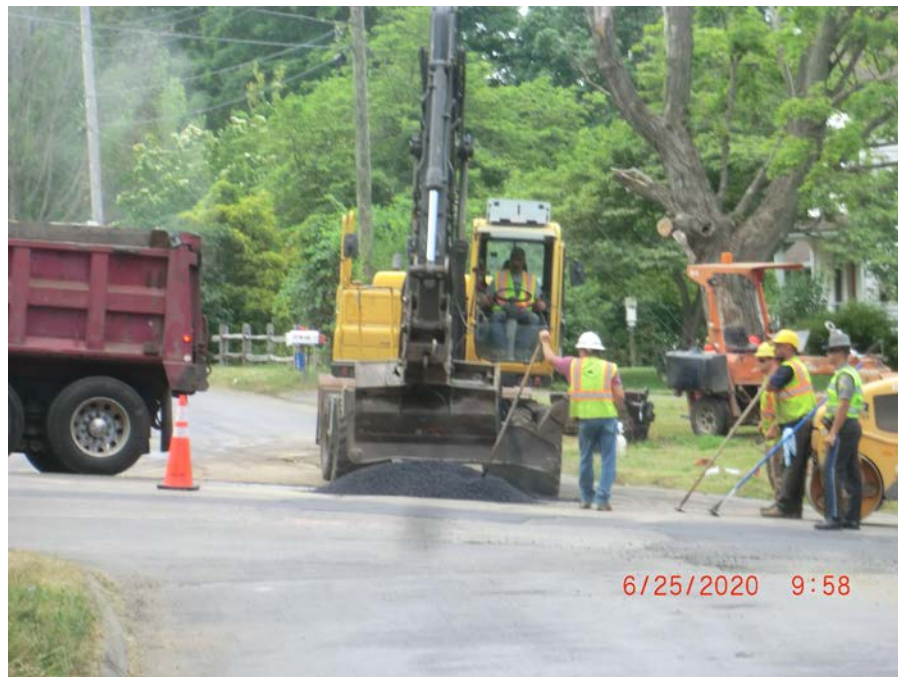
Picture 4: Starting hot patch at Maple Ave. and Wallingford Road (Route 68). View to the south.

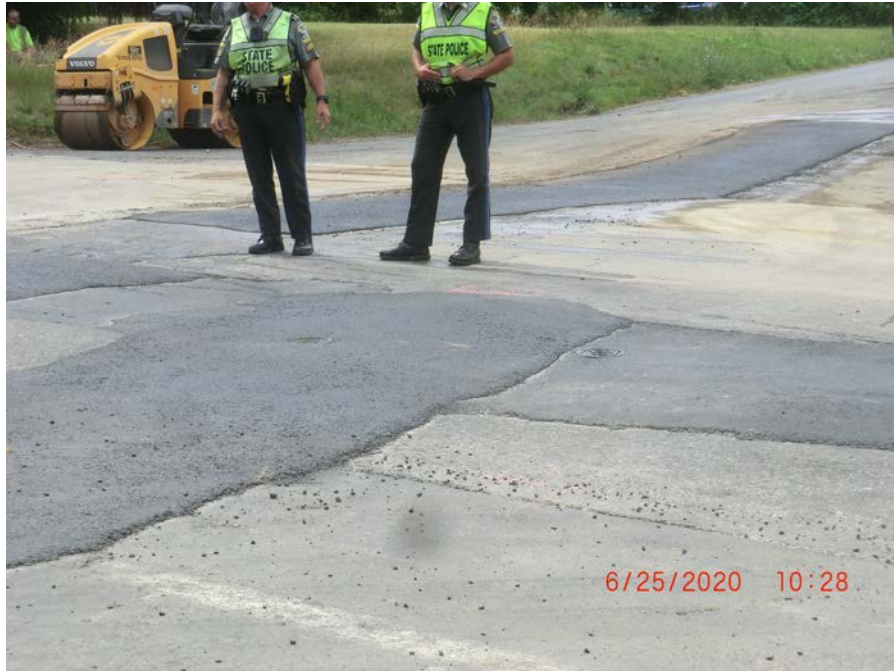
Picture 5: Completed patch (behind police detail) at Maple Ave. and Wallingford Road (Route 68). View to the southeast.

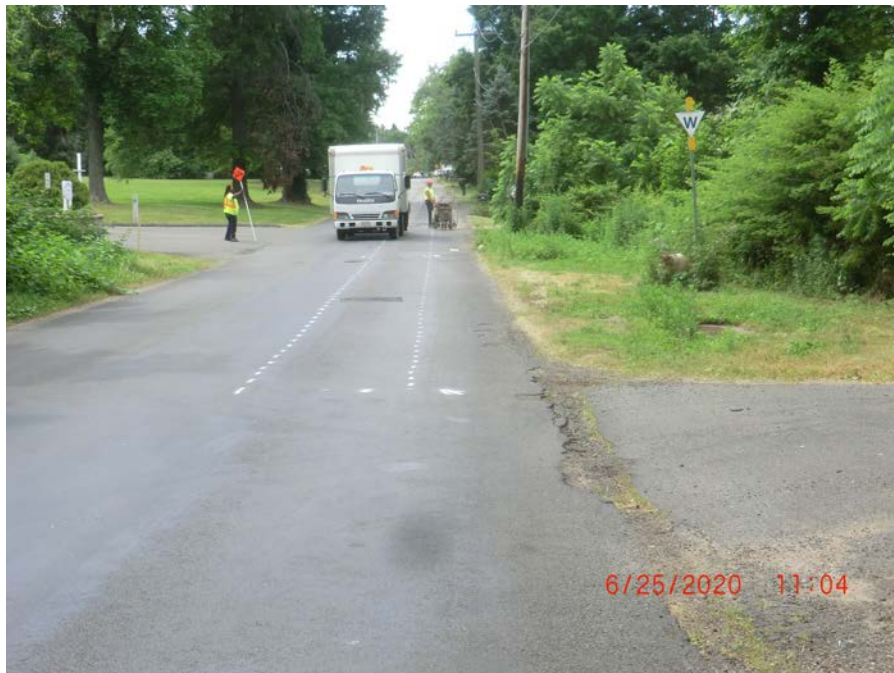
Picture 6: View facing south on Maple Ave. Road cutting. Driveway to the right is 212 Maple Ave., driveway to the left is the back entrance to the Notre Dame church that faces Main St.

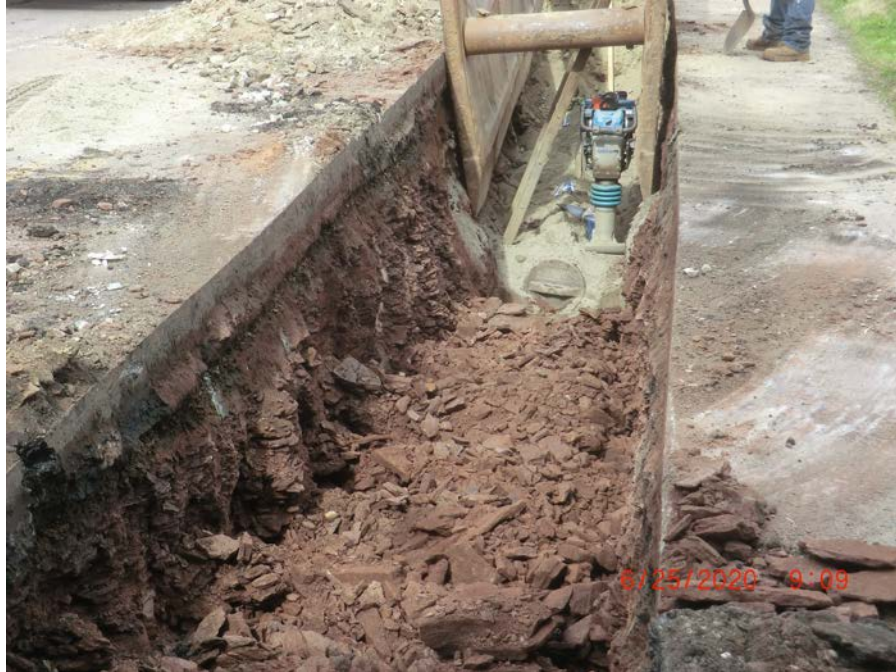
0900: Ludlow resumes the installation of 12" DIP on Maiden Lane starting at Station 403+34 and working east. A 20-foot section is already in the ground and the next section is being hammered due to shallow ledge, which appears to run the course of trenching at various depths.

Picture 7: Shallow ledge at roughly 403+70 feet on Maiden Lane. This was the shallowest ledge section in today's trenching. It required hammering before removal. View is to the west.

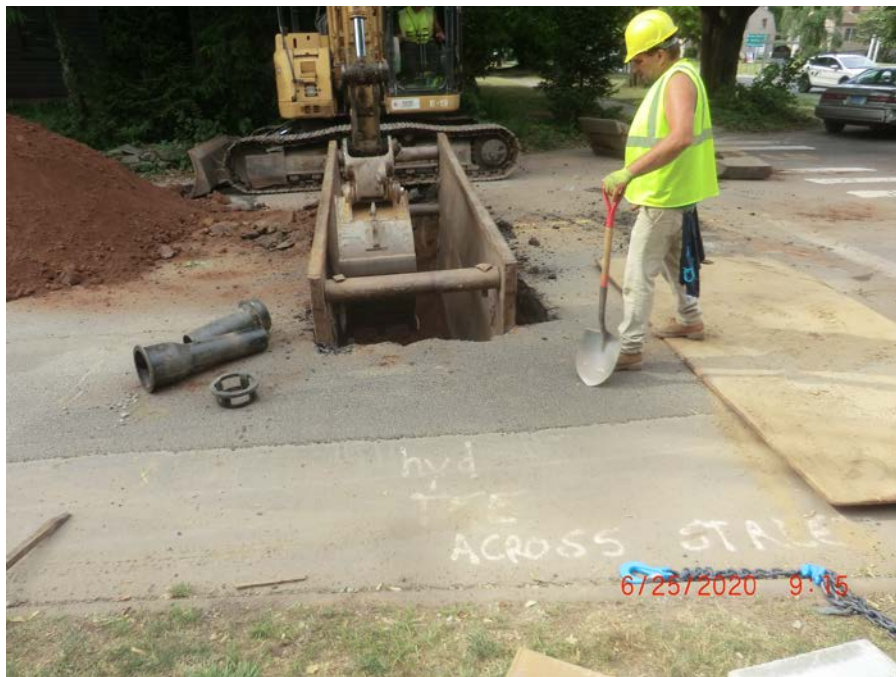
Ludlow began the installation of a Fire Hydrant at the corner of Maiden Lane and Route 17 (Main St.). The hydrant was to be on the south side of the Maiden Lane, however, there was insufficient room according to USACE, who stopped the installation with the idea that the hydrant be installed on the opposite side of Maiden Lane. There has been no confirmation from the Durham Fire Department on this change at this point.

0915: Ludlow is installing road box at corner of Maiden Lane and Main Street. This is for a hydrant installation that was later stopped by the Corps. due to space issues at the edge of the road. Trench refilled.

Picture 8: Facing south, intended hydrant at corner of Maiden and Main (to right). Hydrant not installed. Near station 401+00

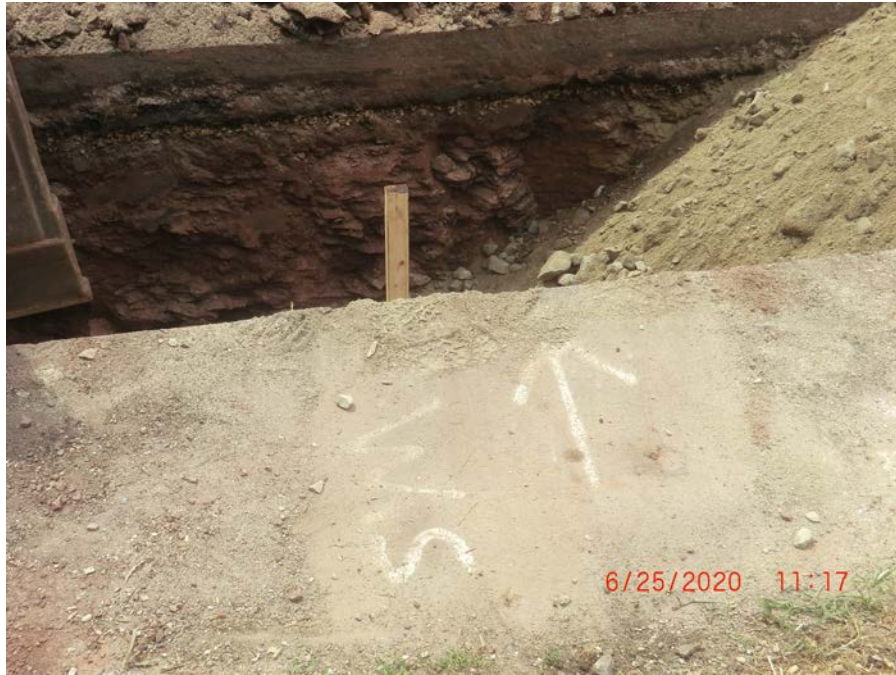
Picture 9: One of two curb stops installed on Maiden Lane, marked by 2x3 stake. View to the south.

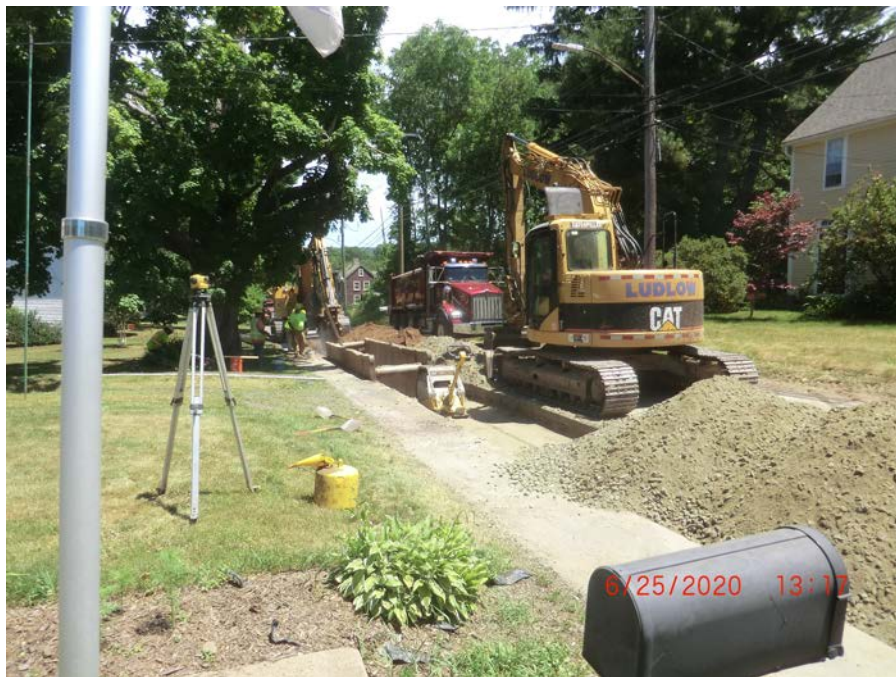
Picture 10: Facing southeast (Mailbox is 18 Maiden Lane), setting final pipe of the day.

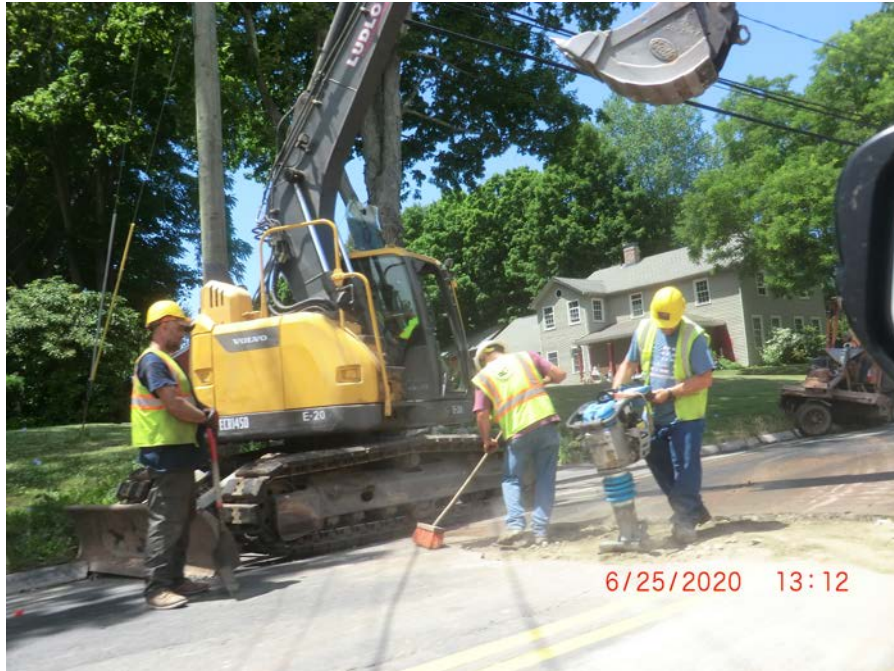
1312: Service line, 4" Pipe x 7.5 feet installed from Station 198+10. Crew has backfilled and awaiting hot patch. Decision not to cross entire road today because of the amount of bedrock excavation encountered.

Picture 11: Ludlow finishing up road closing on Route 17, Main Street, across from Durham Manufacturing. Due to amount of bedrock encountered, Ludlow decided to only go halfway across today. View is to northwest.

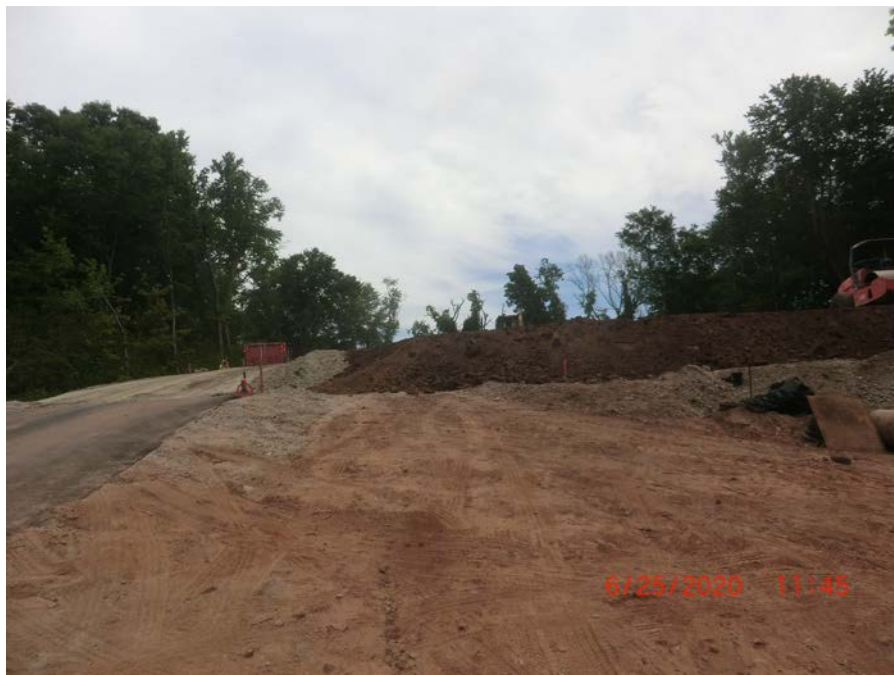
Picture 12: Facing east. View to top of slope to tank area.

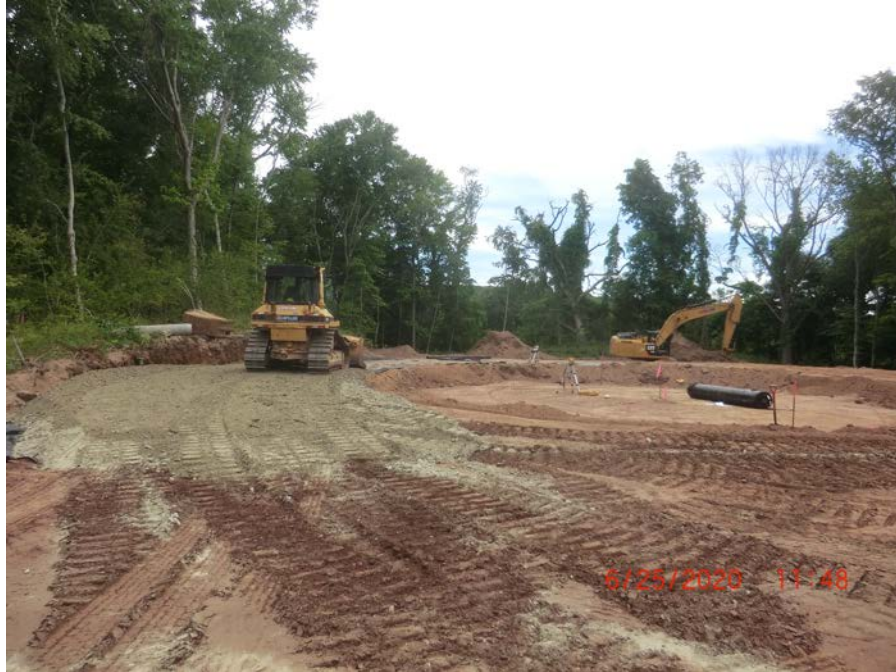
Picture 13: Facing east. Filling on top of matting gravel base for road around tank.

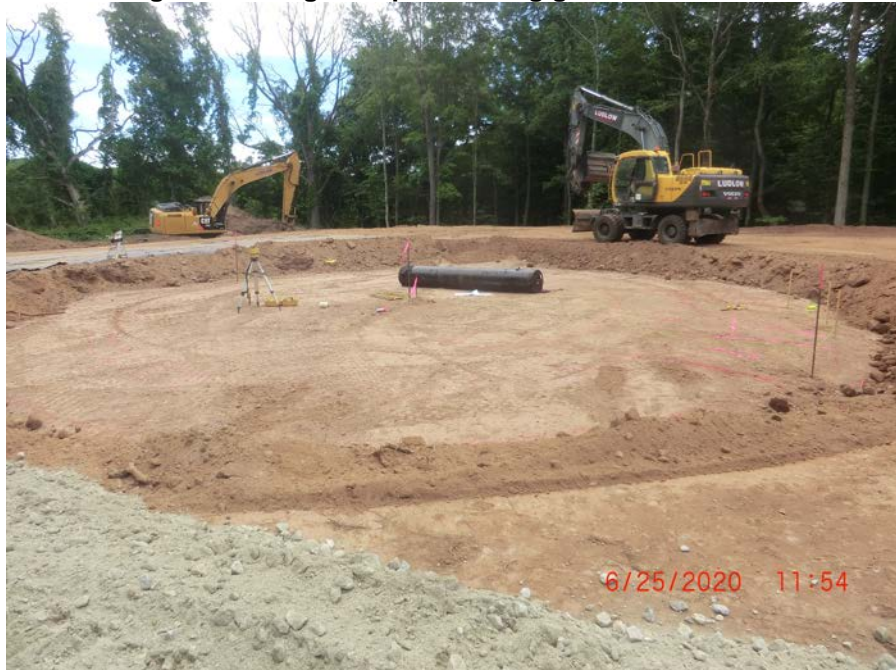
Picture 14: Facing southeast. Gravel filled road base in foreground. Tank base with mark outs (to right) for pipe trenches. Another 2.8 feet of fill to still be placed on tank base.
