## Daily Report

<b>Project:</b>	Durham Meadows Pipeline Installation	<b>Date:</b>	June 30, 2020
<b>Location:</b>	Maiden Lane, Pickett Lane, and the Shared Access Driveway	<b>Day of Week:</b>	Tuesday
<b>Project #:</b>	AECOM: 6061487	<b>Report No:</b>	110
<b>Contractor:</b>	Ludlow Construction	<b>Page:</b>	1 of 14

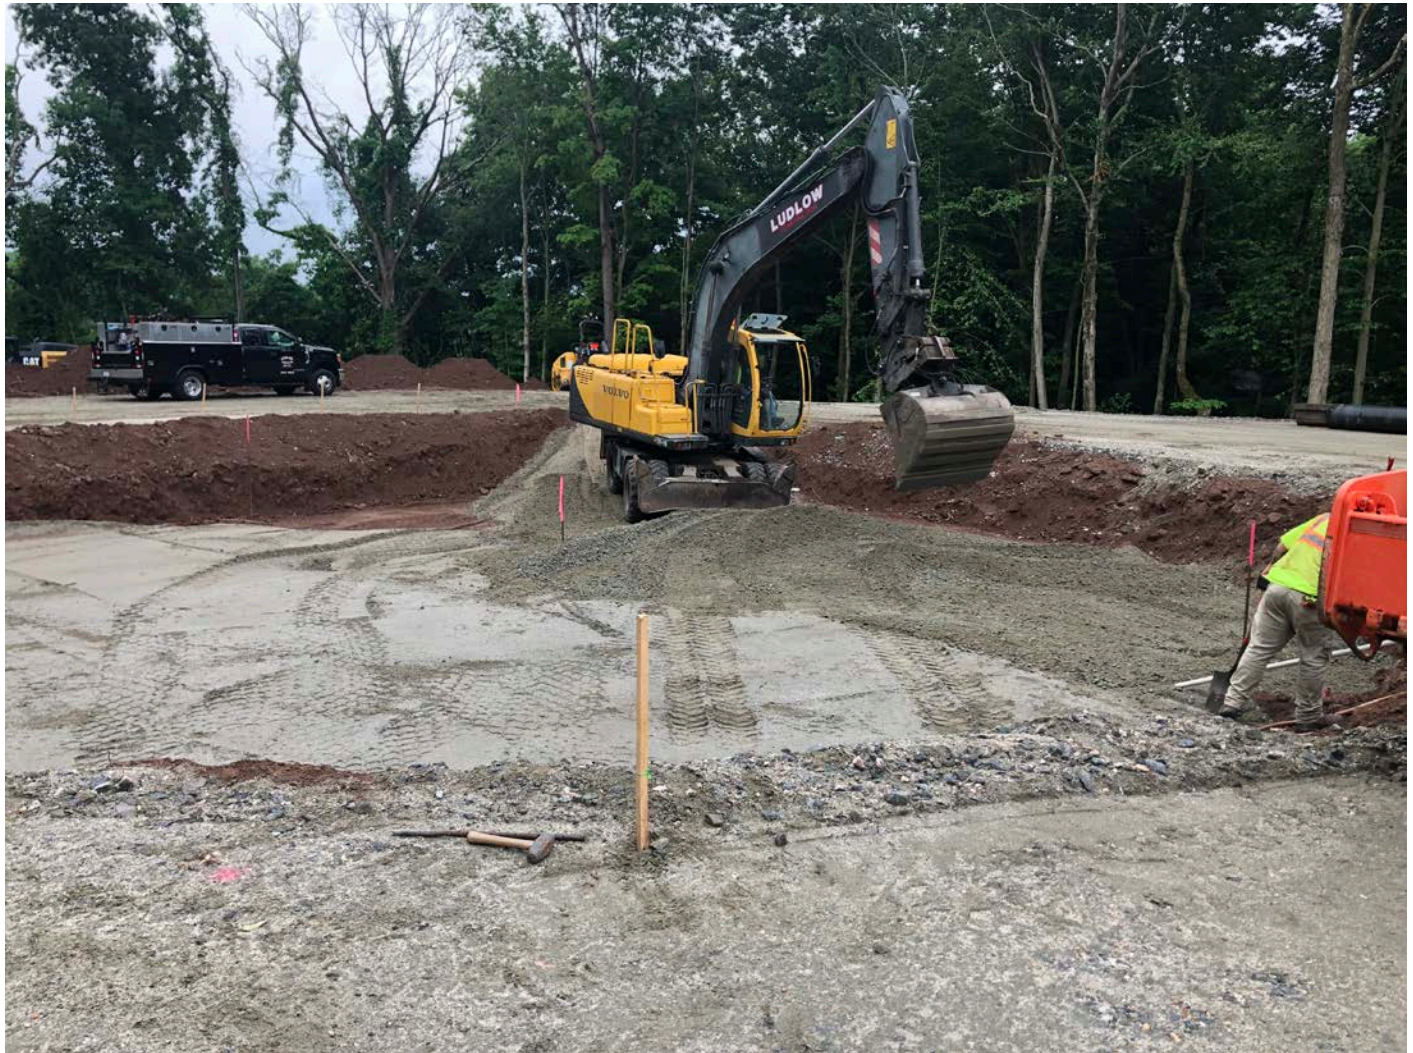
0715: Ludlow continues to place and compact structural fill at the tank pad footprint in 12" lifts.

**Picture 1: Ludlow placing structural fill at the water tank footprint, bringing the elevation from 435 to 436. Shared Access Road, Middletown. View to the southeast.**

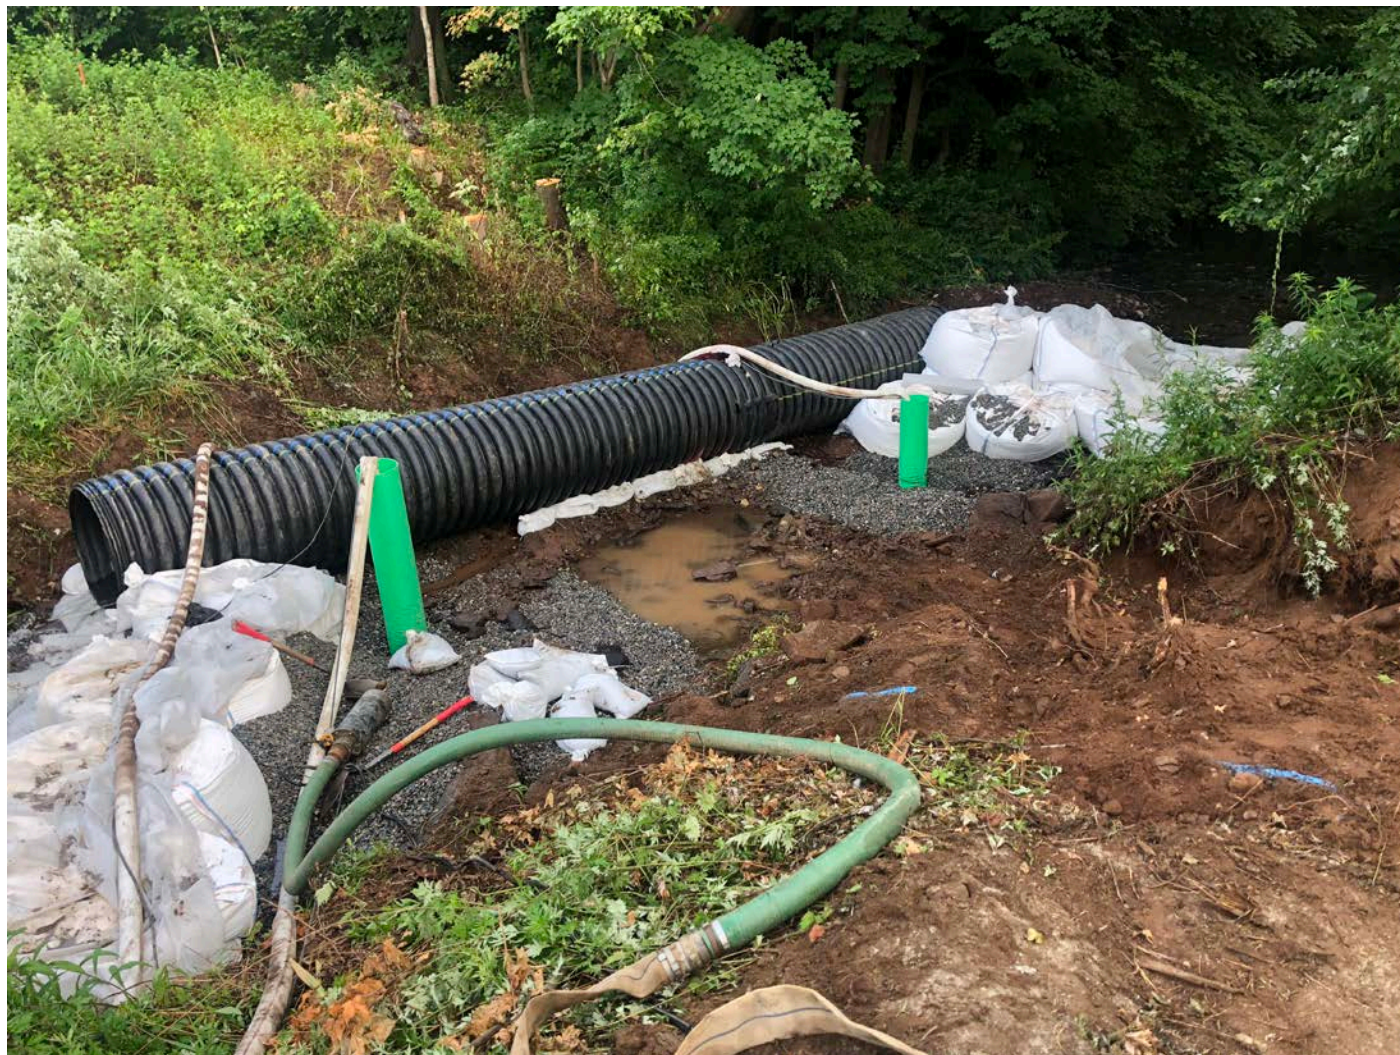
Picture 2: Work zone at the stream crossing located at Station ~511+00. Pickett Lane, Durham. View to the northwest.

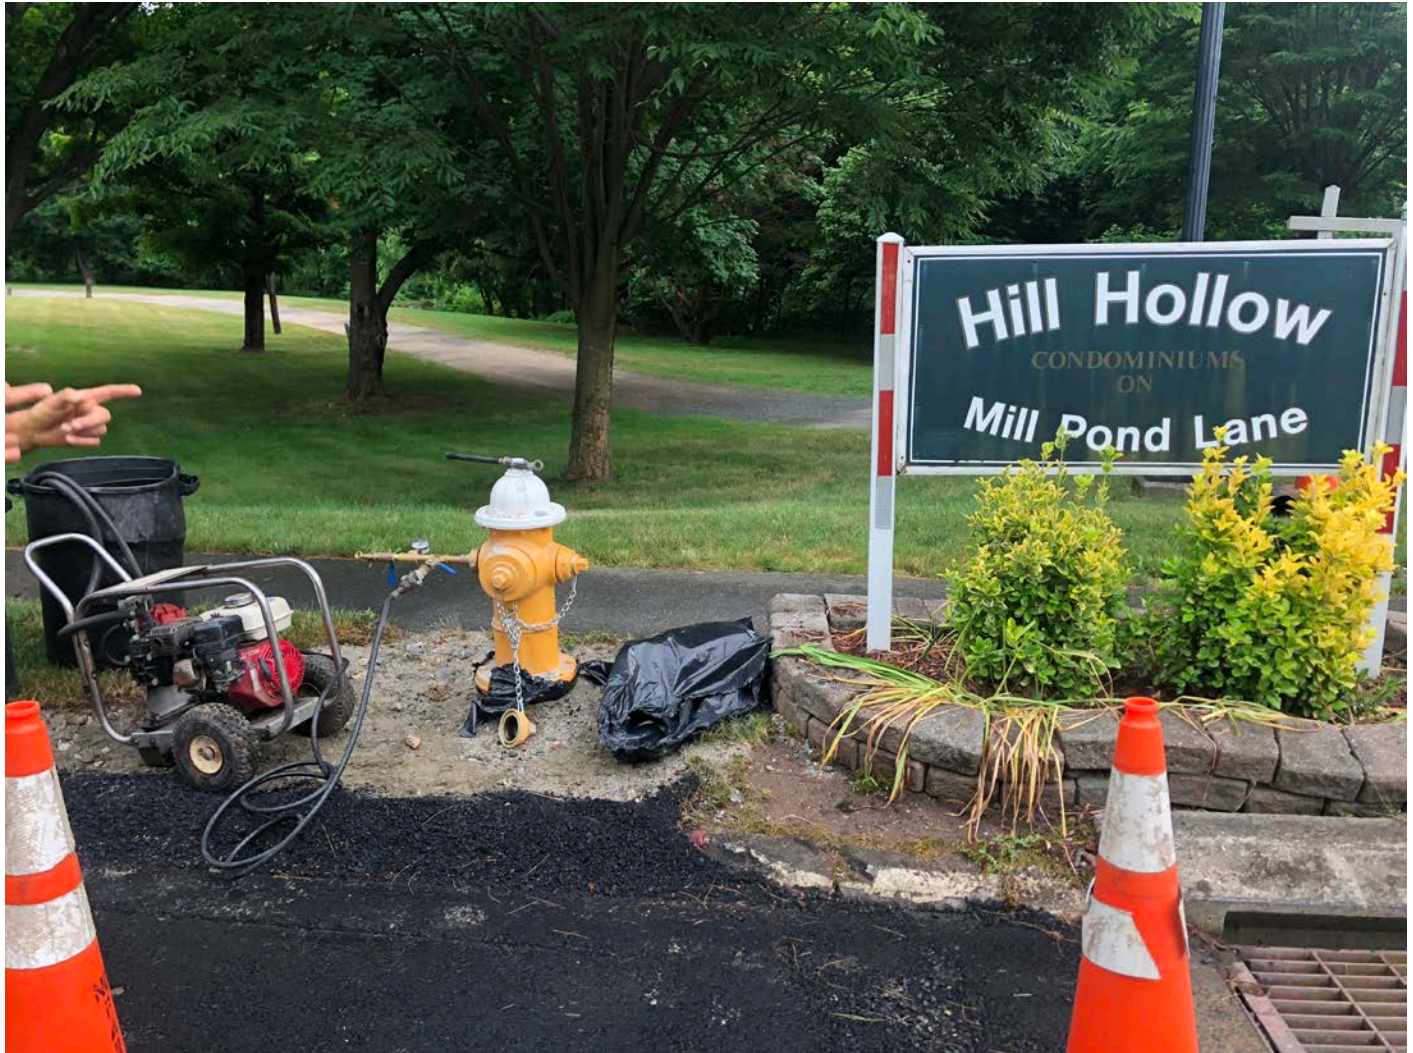
Ludlow conducted a pressure test on the 6" DIP that Ludlow installed on Mill Pond Lane on June 26, 2020. The test ran from 0827 to 1027. The test passed with both start and end pressures at 150 PSI.

Picture 3: Pressure test set up on the hydrant installed on Mill Pond Lane on June 26, 2020. View to the south.

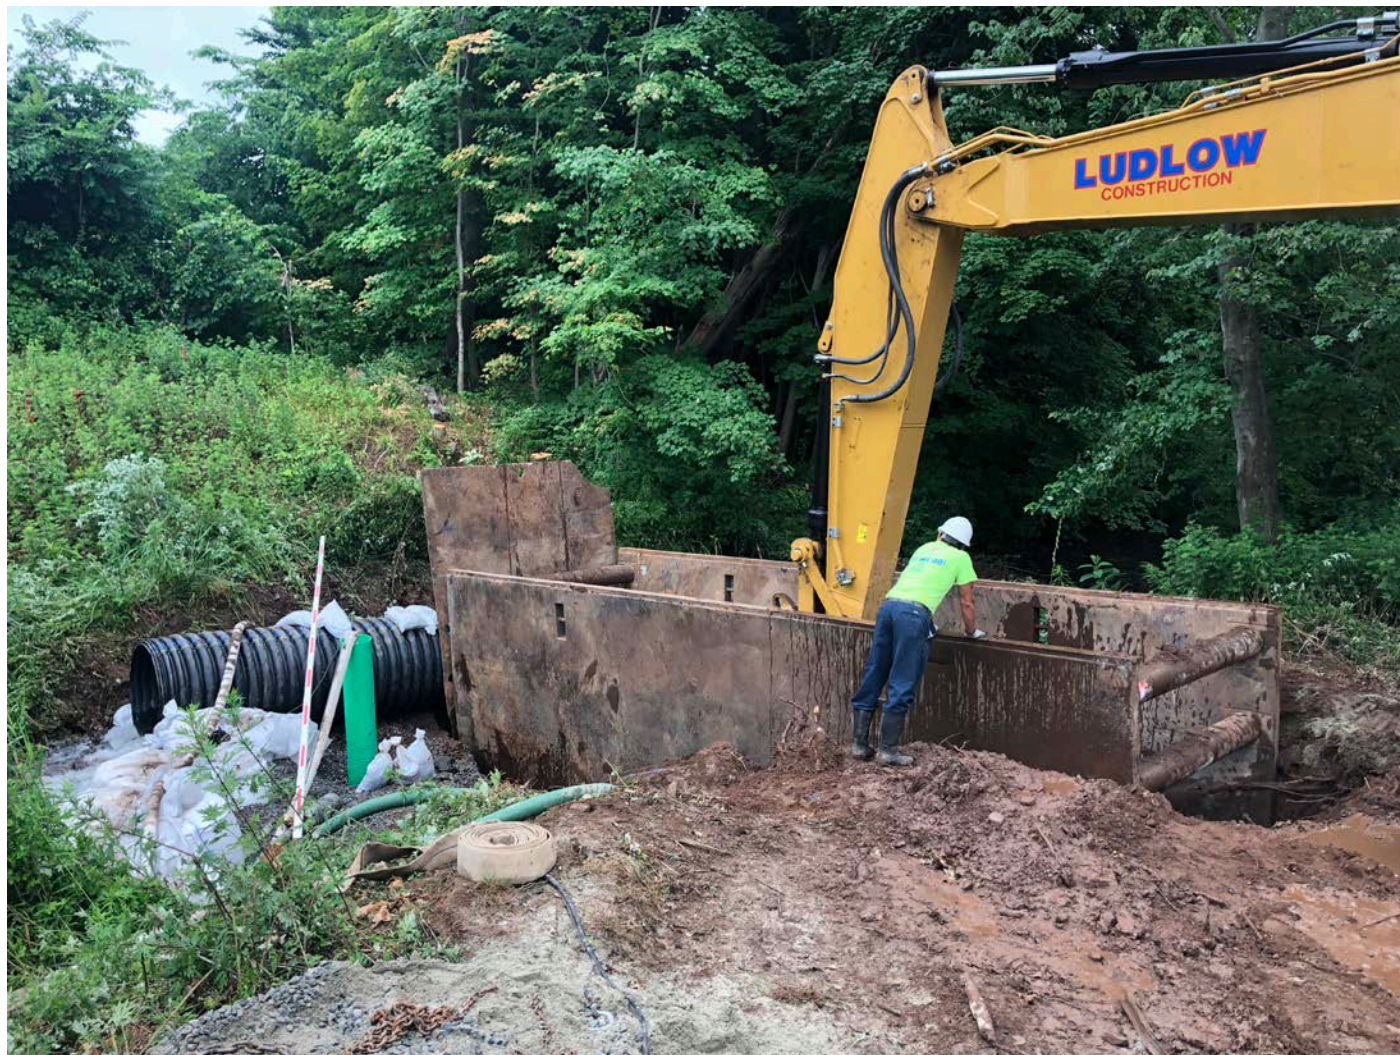
0813: Ludlow has trench box placed partially across Allyn Brook and inside a portion of excavated stream bank east side of the stream. Ludlow has begun to excavate material within the trench box and live load it into dump trucks.

**Picture 4: Ludlow excavating within trench box placed at the stream crossing located at Station ~511+00. Pickett Lane, Durham. View to the northwest.**

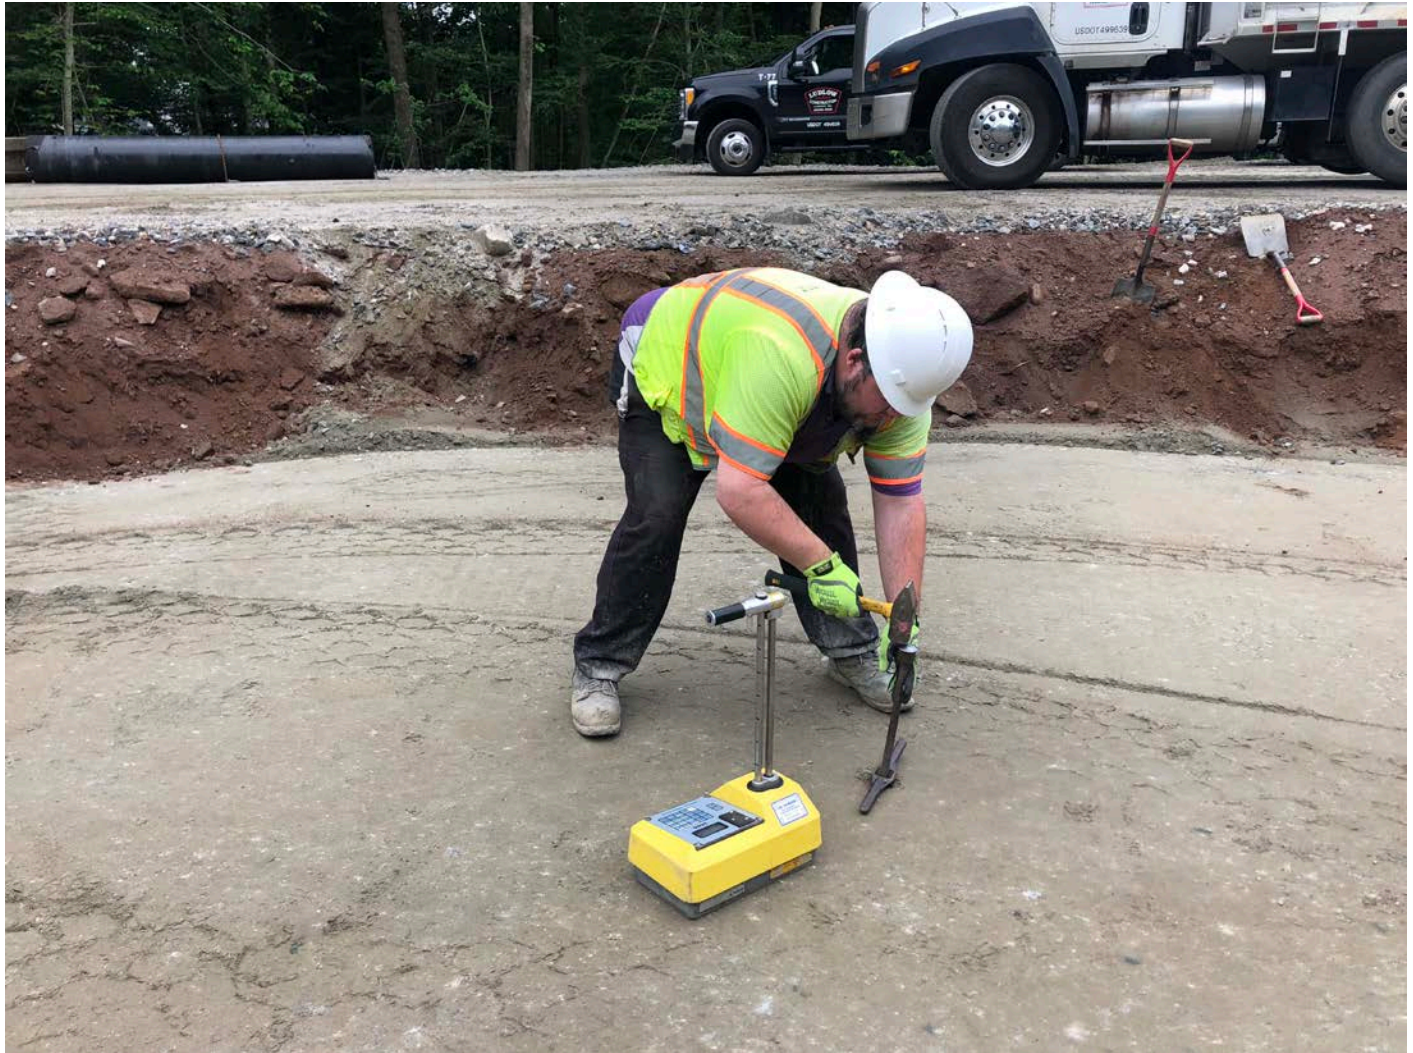
0852: Ludlow has structural fill within the water tank footprint brought up to elevation 436. JTC is present to collect compaction data from 4 quadrants on this lift.

1031: Ludlow surveyor Juliano Associates is on site to bring the benchmark up to the top of the hill. All four compaction tests on elevation 436 lift passed (>95%).

Picture 5: JTC collecting soil compaction data from the top of compacted structural fill at elevation 436 at the water tank footprint. Shared Access Driveway, Middletown. View to the south.

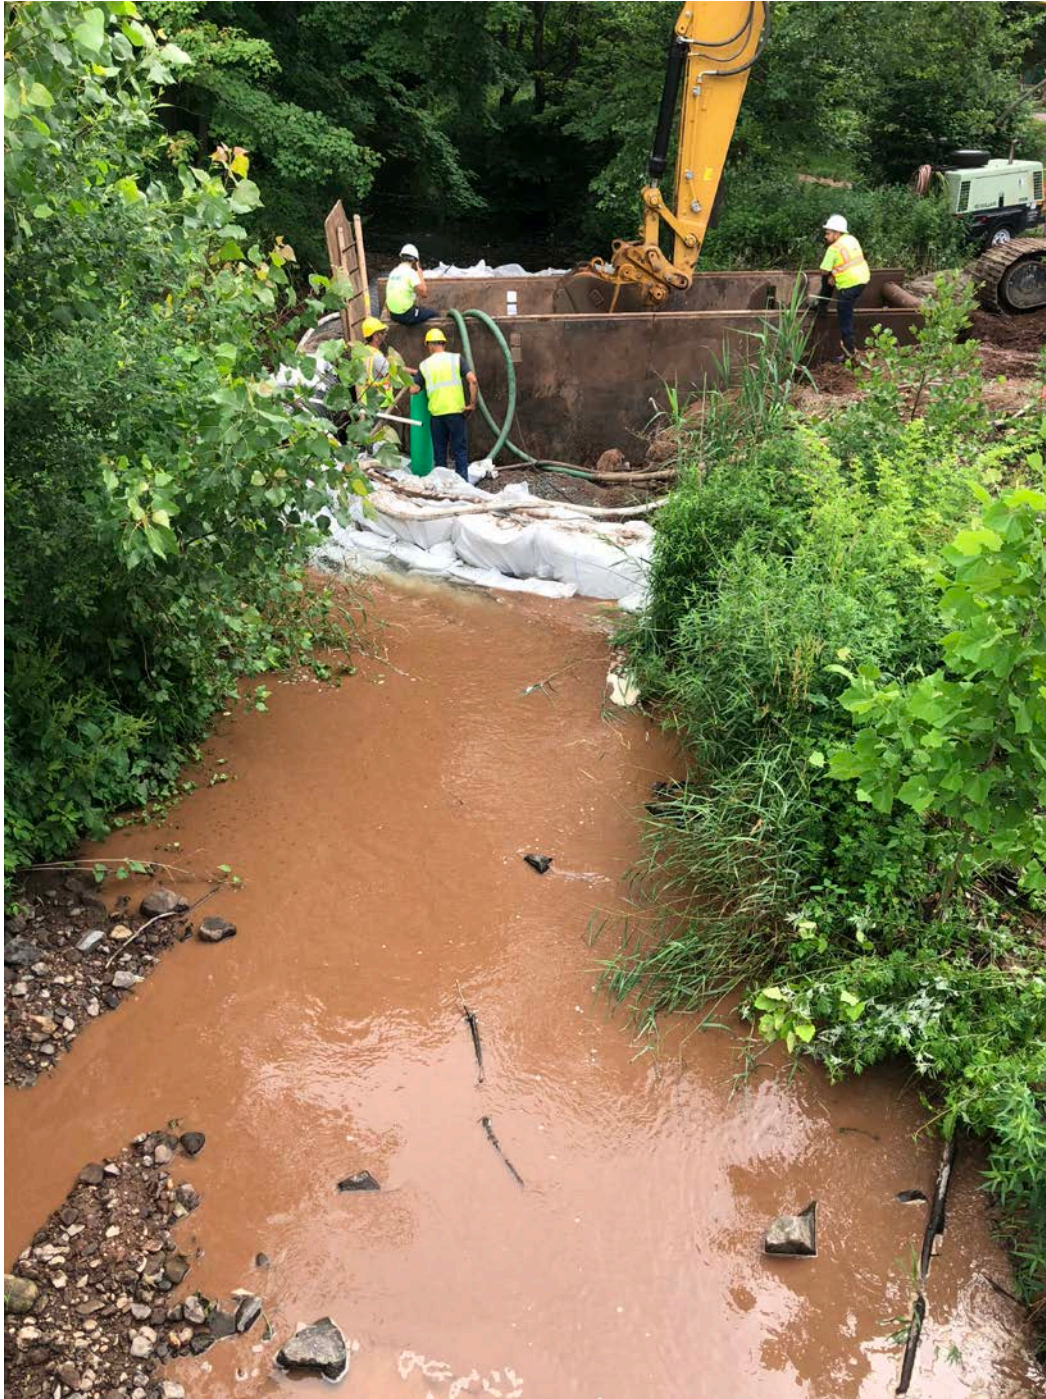
1200: Ludlow has the 30" conduit in place and backfilled at Station ~511+00. Turbidity downstream of the work zone is still elevated but has begun to diminish.

**Picture 6: High turbidity observed downstream of the work zone at the stream crossing located at Station ~511+00. View is upstream and to the north. Pickett Lane, Durham.**

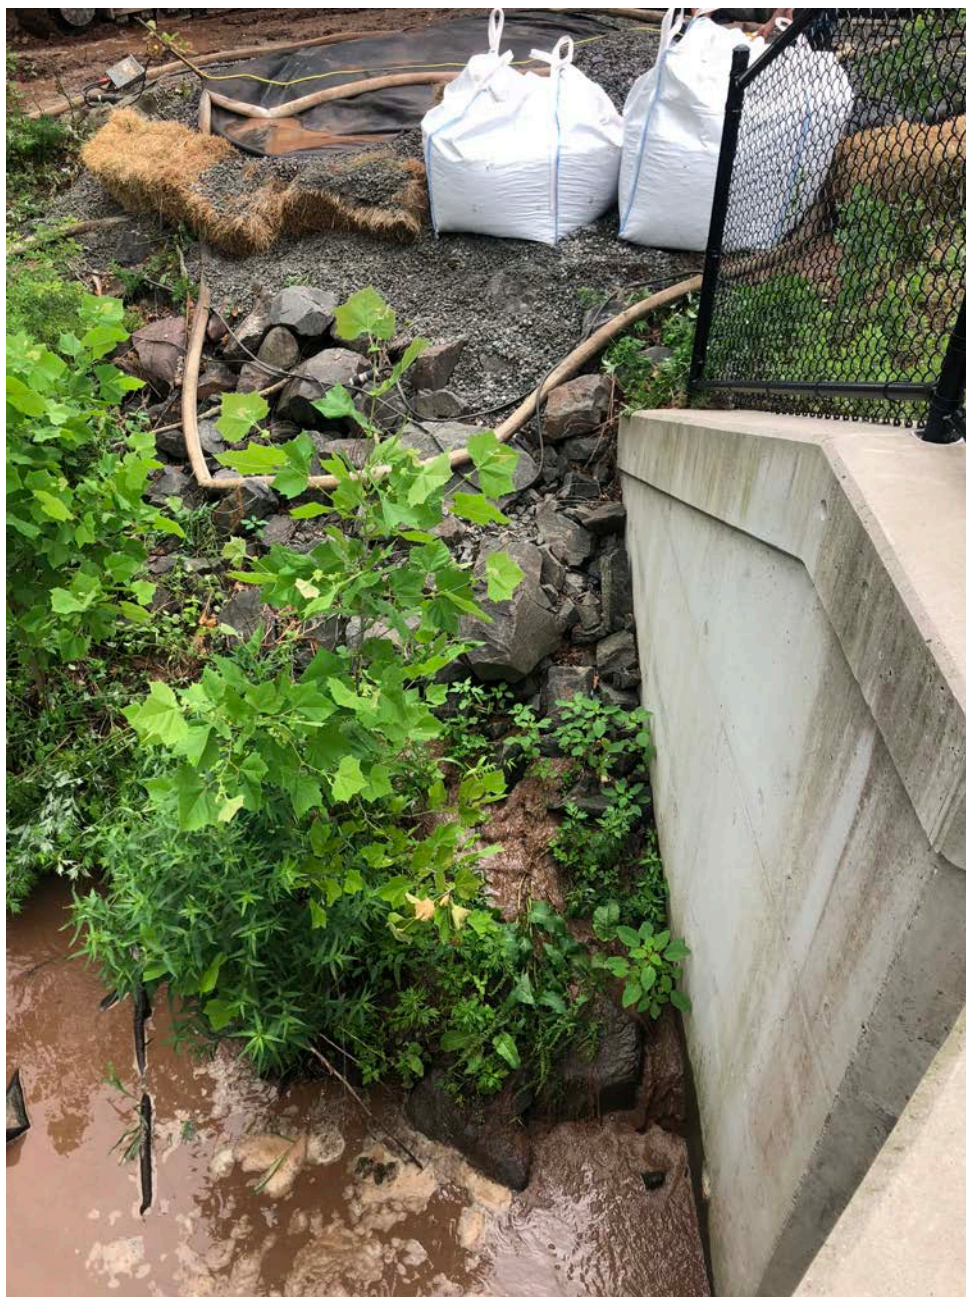
0925: Ludlow continues to work at Station 511+00. An excessive amount of silt is entering the stream from three silt bags which are overwhelmed with the amount of water and silt being pumped into them. AECOM notified USACE field engineer Kurt Mintell. Ludlow is trying to filter turbid water escaping the silt bags with 3/4" gravel and hay bales, which is not working.

**Picture 7: Ludlow employed 3 silt bags to filter water pumped from the stream crossing work zone while placing 30" conduit. The bags (visible at the top of the picture) were not able to keep up with the water flow and silt load and failed, resulting in high turbidity downstream of the work zone. Station ~511+00, Pickett Lane, Durham. View to the northeast.**

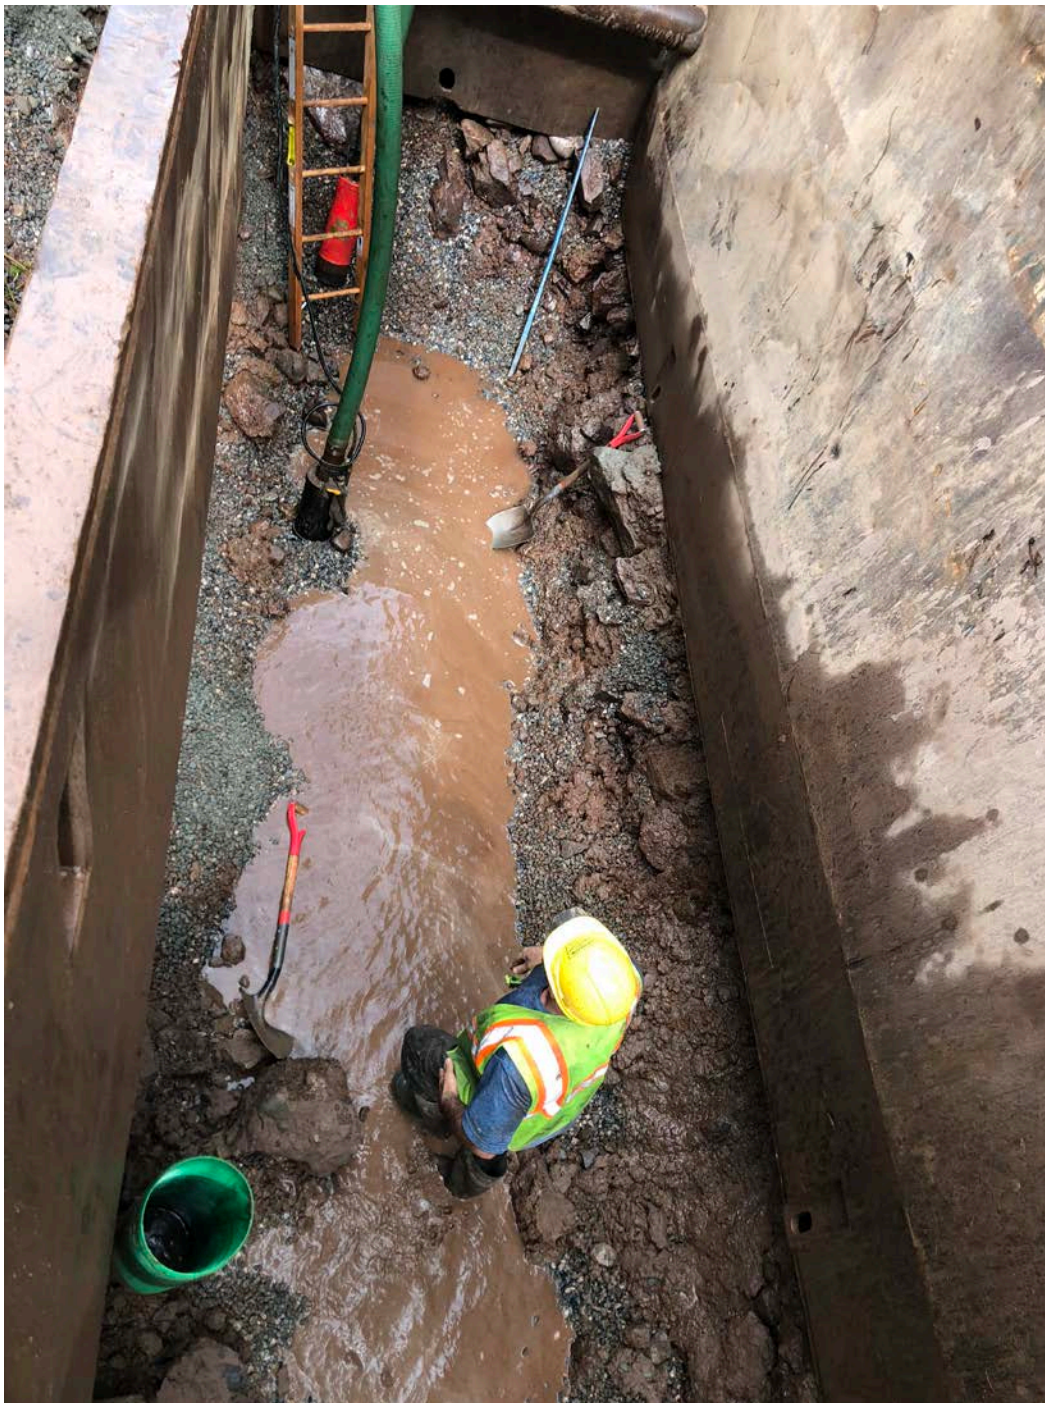
**Picture 8: Ludlow working within the trench box while preparing to place 30" conduit as part of the stream crossing at Station ~511+00. Pickett Lane, Durham. View to the west.**

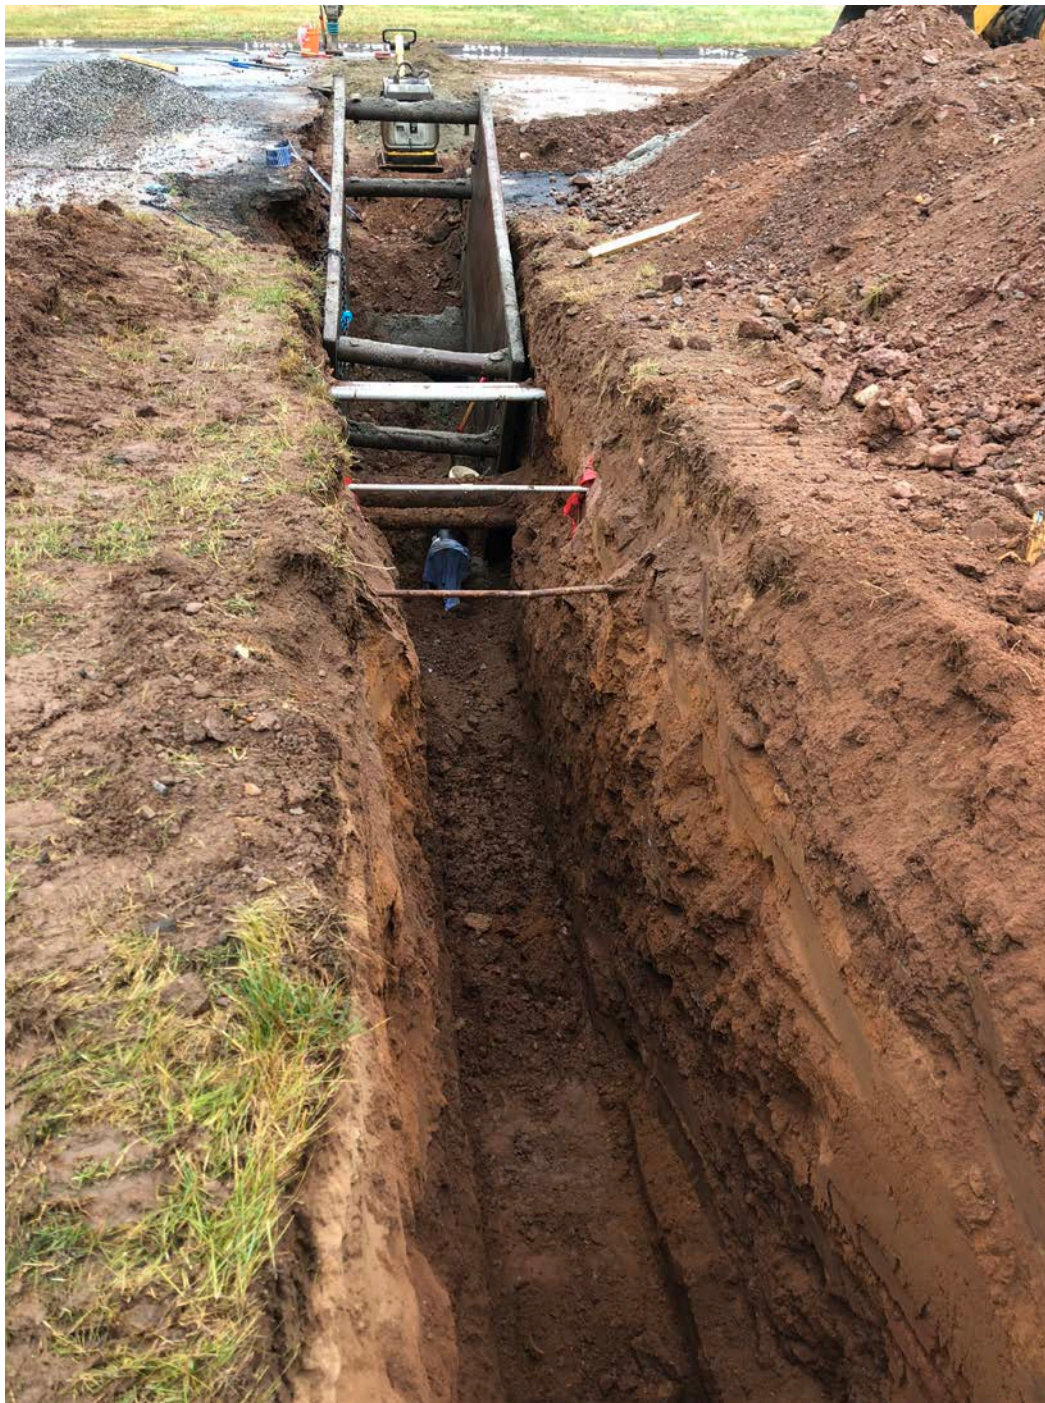
0918: Ludlow is daylighting an existing 8" DIP waterline and several 2" PVC conduits that run parallel with Pickett Lane to the east of the road. The PVC conduits are located about 15" BSG and the 8" DIP water line is located about 4' BSG.

**Picture 9: Trench at Station 529+56 after having daylighted a number of utilities. View to the east. Pickett Lane, Durham.**

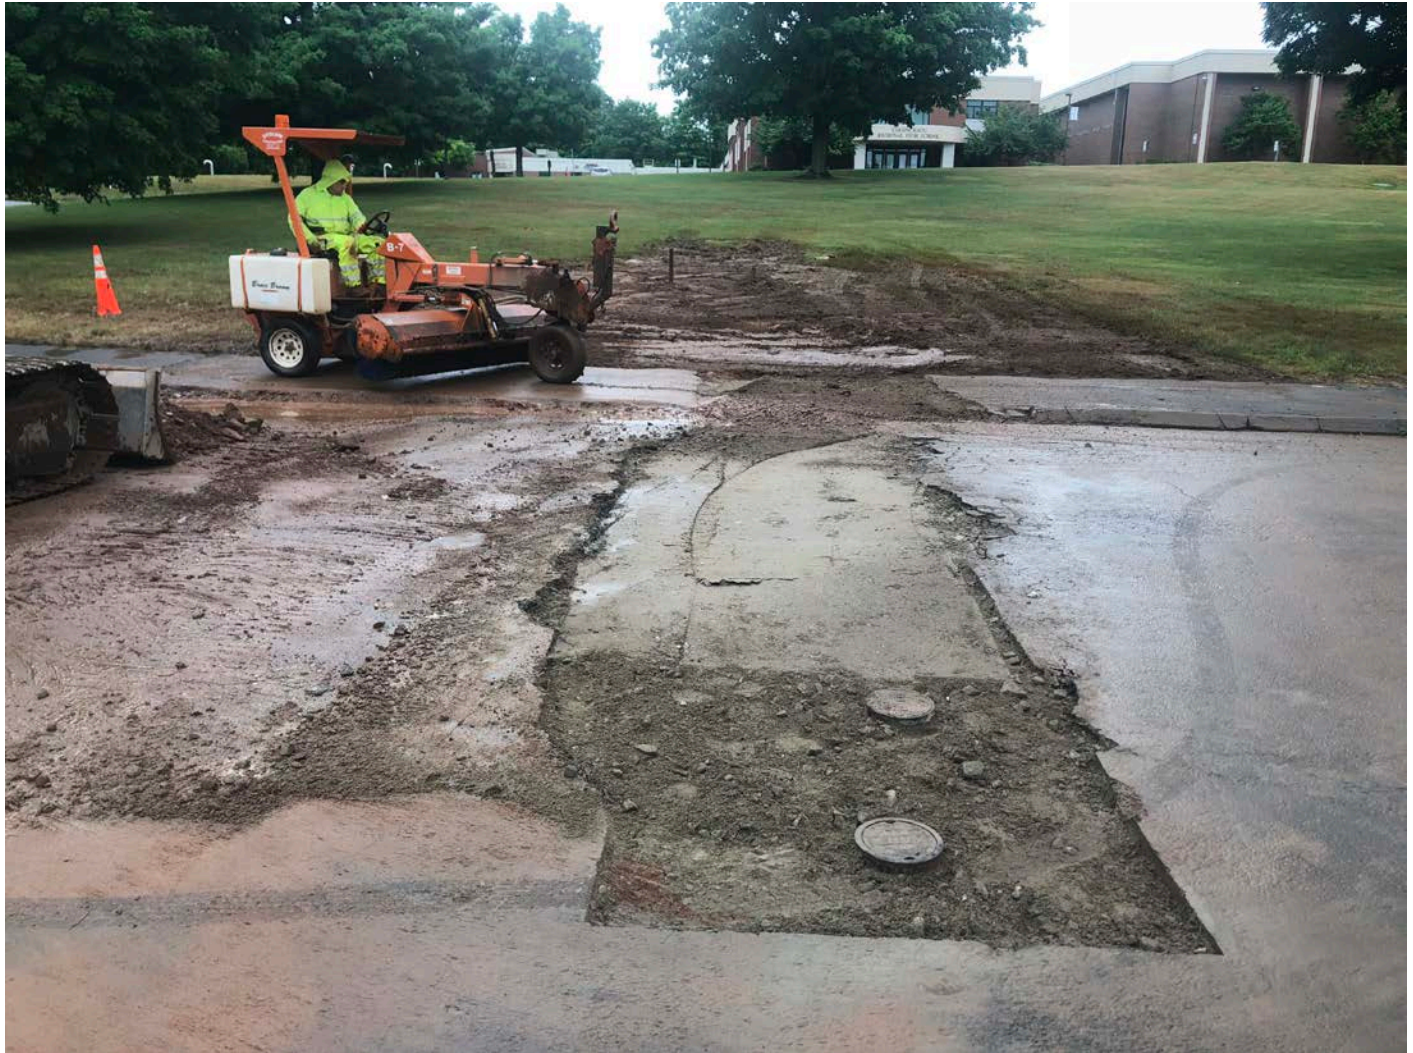
1258: Ludlow has backfilled the trench at Station 529+56 and is currently cleaning up the work zone with the Bocce Broom.

Picture 10: Ludlow cleaning up work zone at Station 529+56 with a Bocce Broom. Pickett Lane, Durham. View to the east.

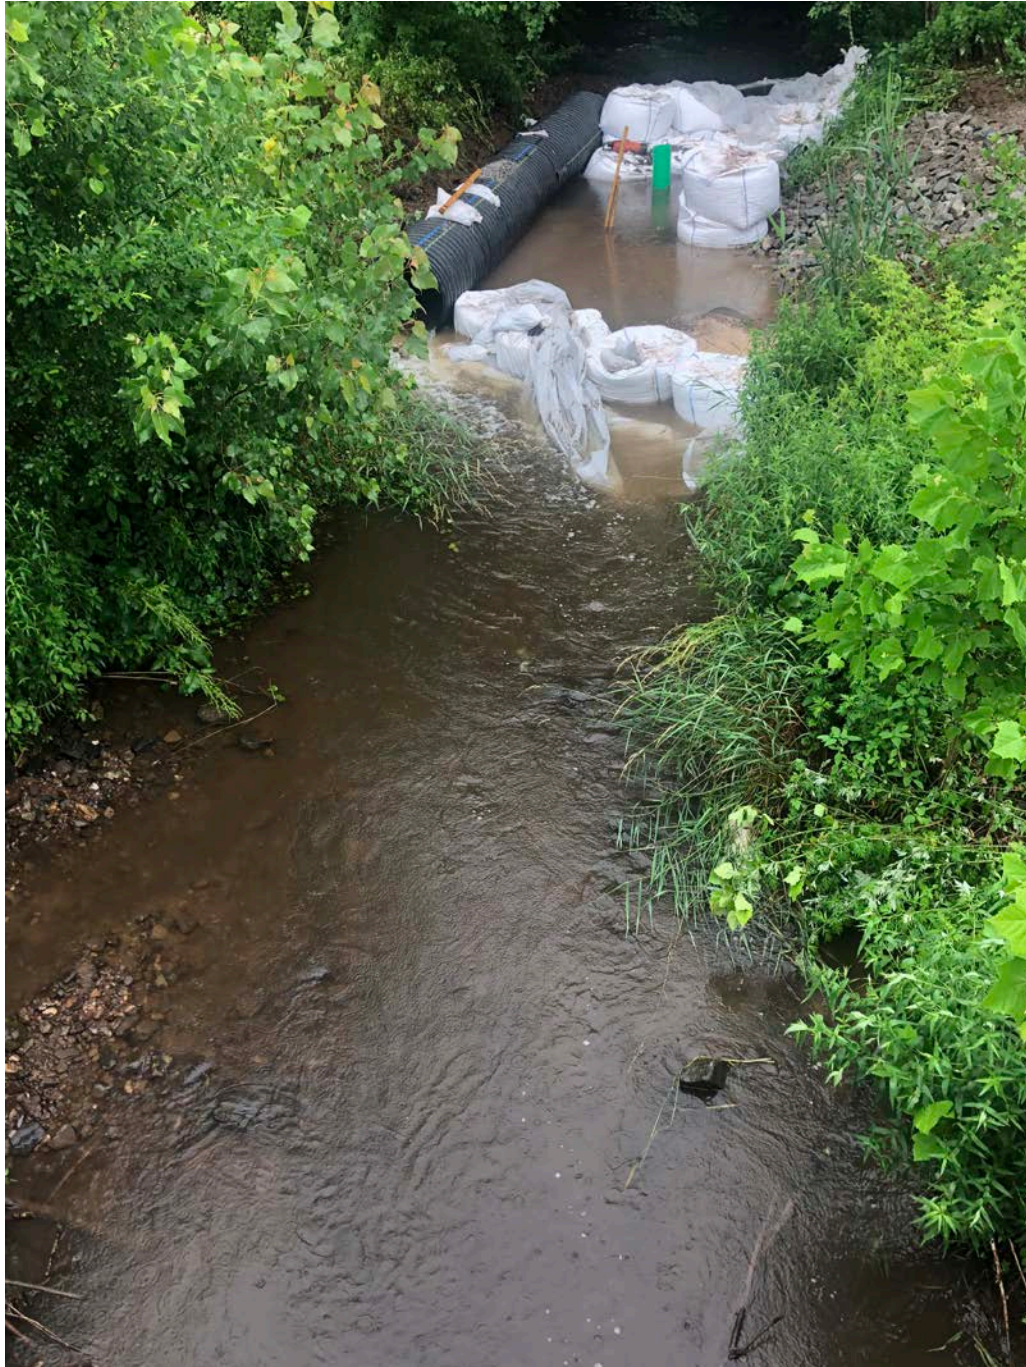
1318: Ludlow has finished work for the day at Station ~511+00. The stream flow bypass culvert (40" corrugated plastic pipe) and the sandbag dams located upstream and downstream of the work zone have been left in place. All pumps have been pulled from the stream. The ground surface to the east of the work area has been leveled but will need additional restoration work.

**Picture 11: Allyn Brook looking upstream after trench box was removed and work ceased for the day. Turbidity has dropped significantly. View is to the north. Pickett Lane, Durham.**
