Daily Report

Project:	Durham Meadows Pipeline Installation	Date:	July 1, 2020
Location:	Main Street, Pickett Lane, and the Shared Access Driveway	Day of Week:	Wednesday
Project #:	AECOM: 6061487	Report No:	111
Contractor:	Ludlow Construction	Page:	1 of 18

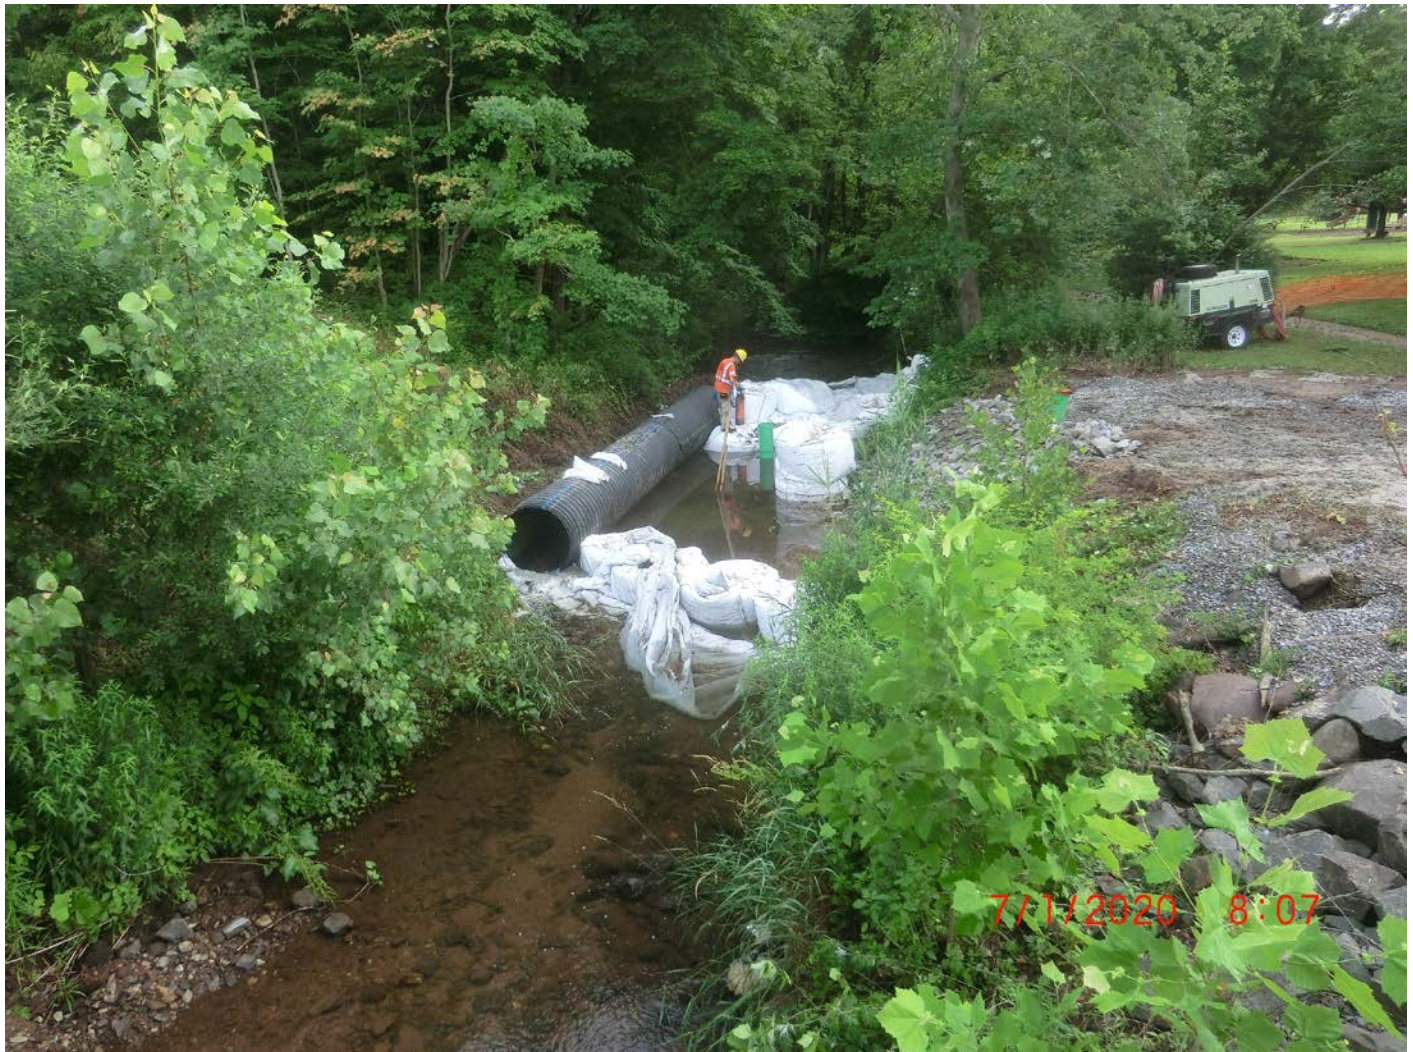
0654: AECOM inspects Allyn Brook at Station 511+00. Turbidity in the brook appears to have returned to normal levels.

Picture 1: Work Zone on Allyn Brook at Station ~511+00 before Ludlow began work today. Pickett Lane, Durham. View to the north.

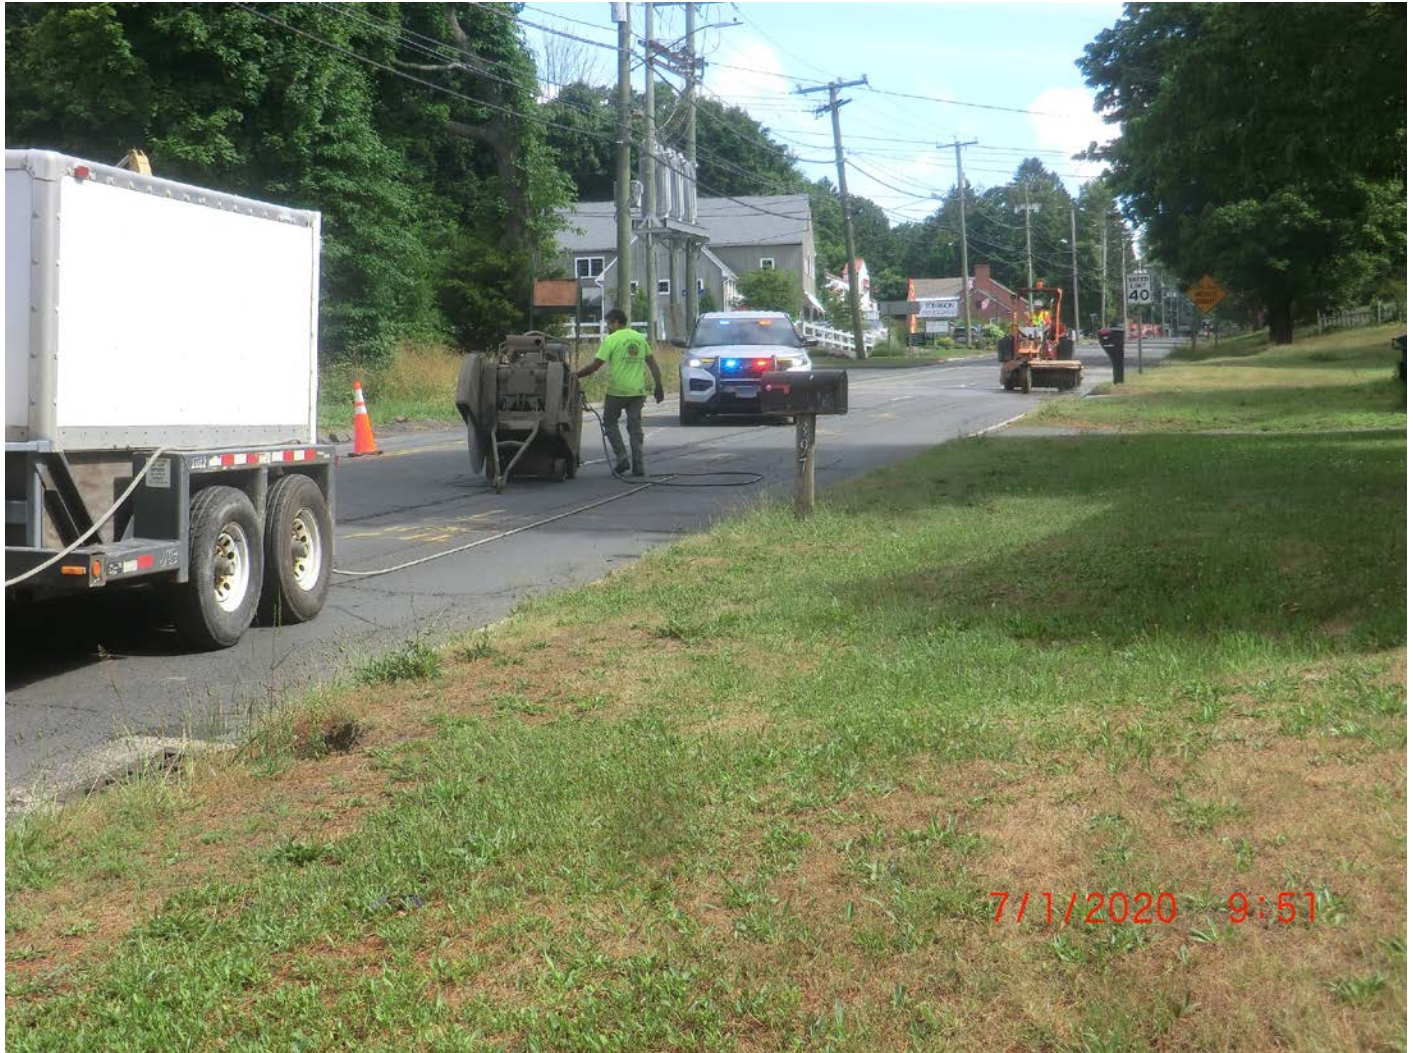
Picture 2: Ludlow subcontractor saw cutting pavement on Main Street in Durham. View to the north.

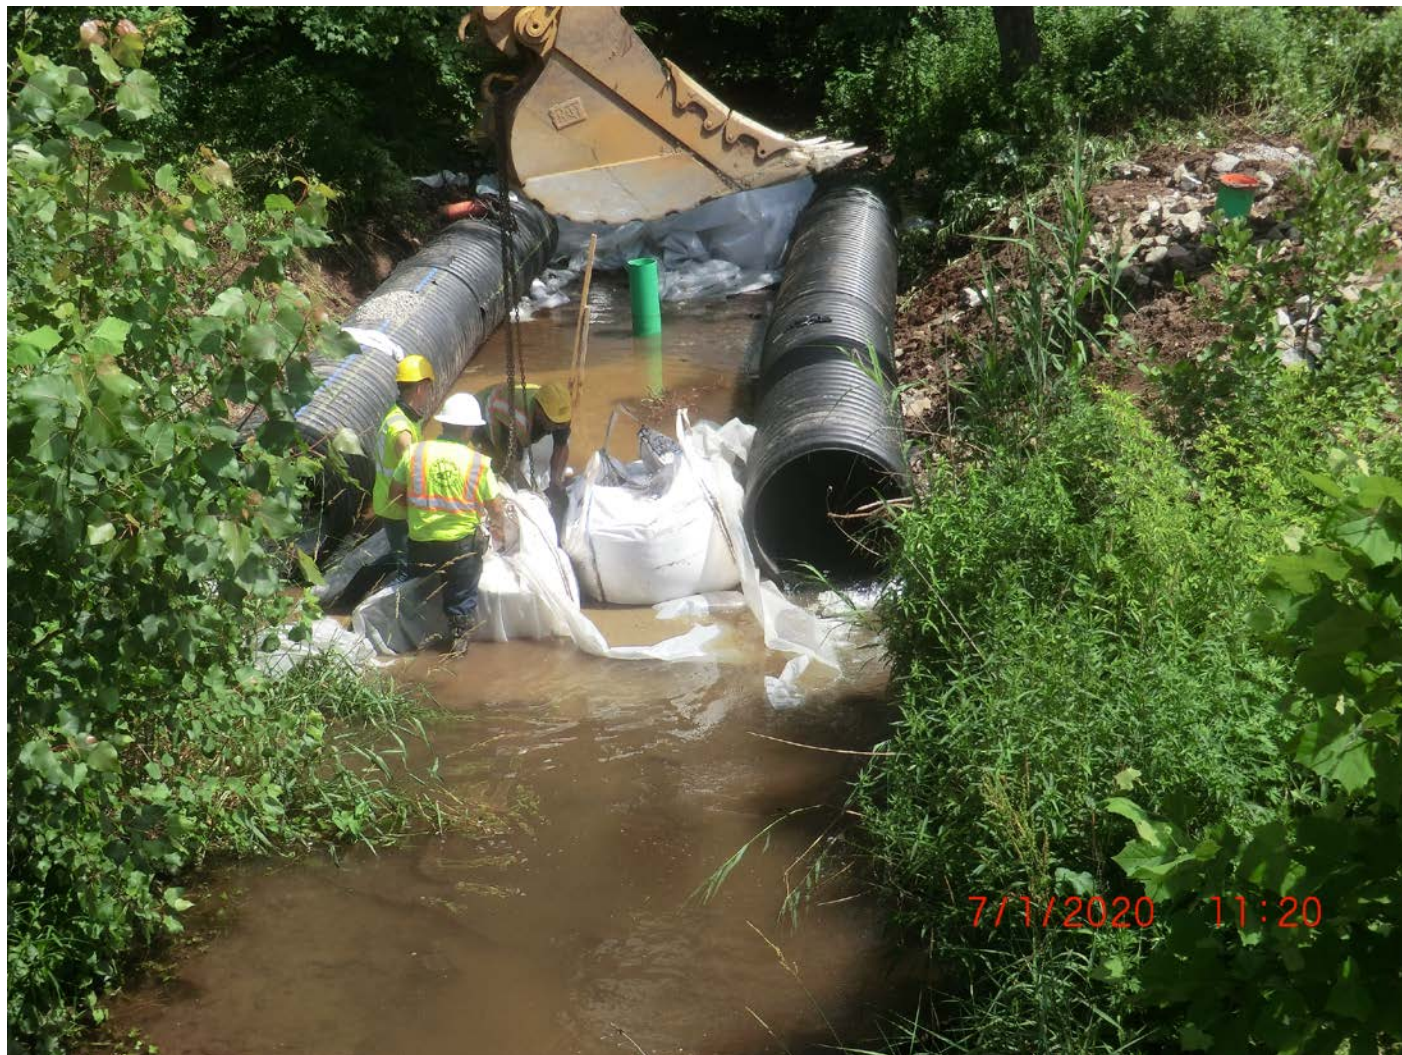
0915: Ludlow begins to excavate revetment stone from the east bank of Allyn Brook at the work zone in order to create a straight line of the stream bank for the placement of the 40" stream flow bypass culvert. This work causes silt to breach the line of sandbags located downstream of the work zone.

0925: Turbidity is clearly visible 200' downstream of the work zone at Station ~511+00.

Picture 3: Ludlow in the process of moving sandbags after placing 40" stream flow bypass culvert on the east bank of Allyn Brook. View to the north. Pickett Lane, Durham.

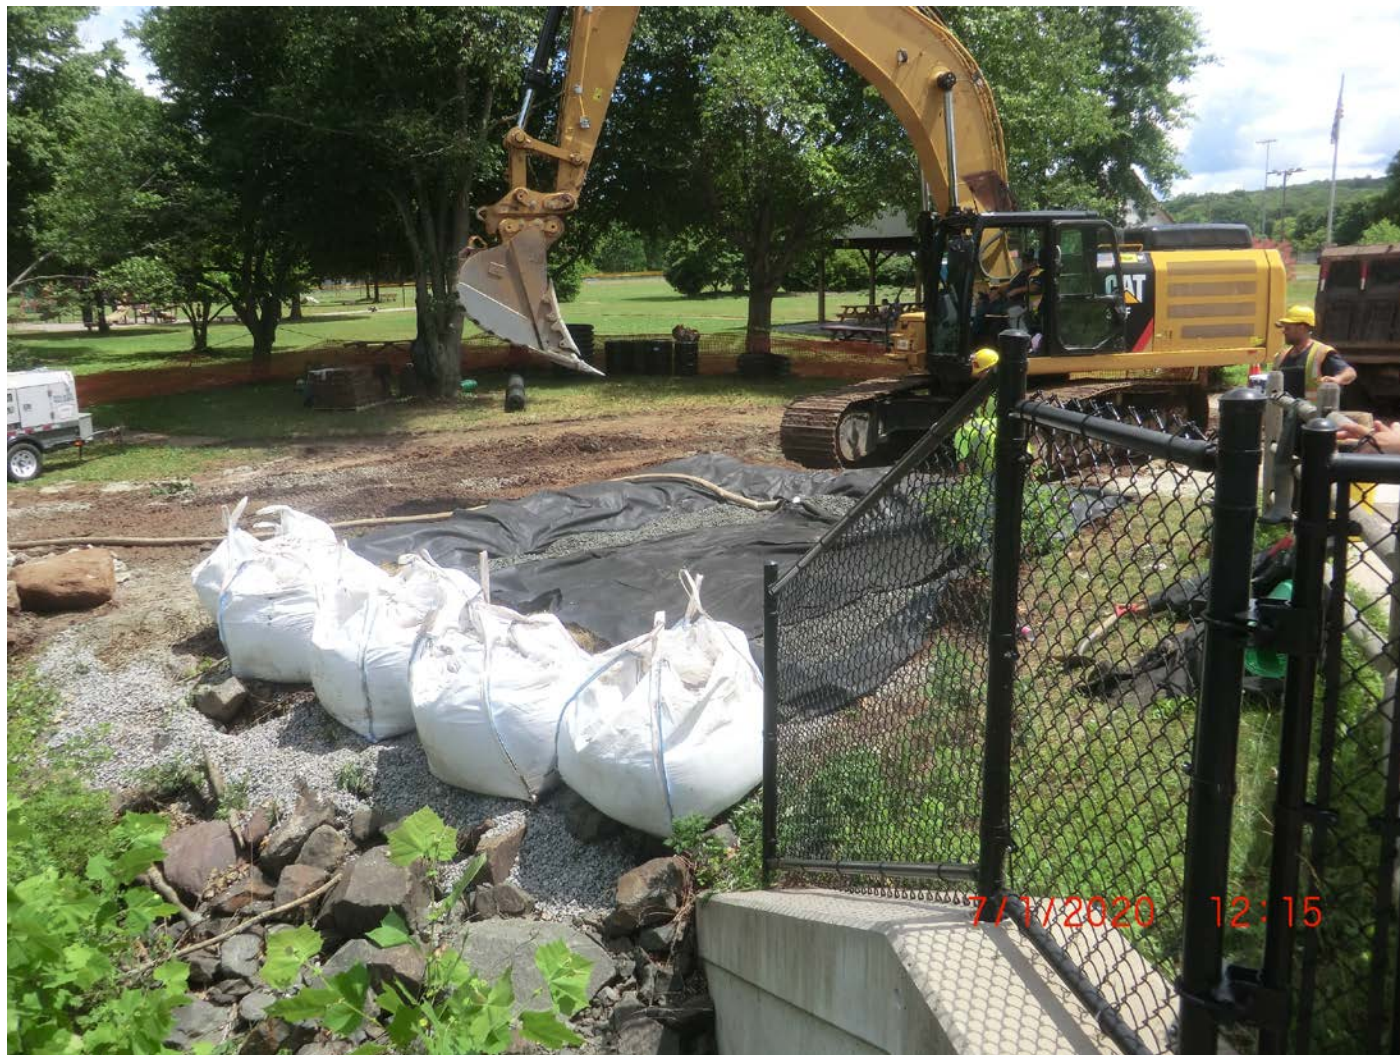
1210: Ludlow is constructing a silt basin for water pumped from the work zone to be discharged into. The basin is constructed of gravel and filter fabric. The downslope side of the basin has been lined with hay bales supported with sandbags. While excavating the silt basin, Ludlow encountered a concrete structure – possibly a drainpipe. Silt is getting past the 40" stream flow bypass culvert along the east side of Allyn Brook. Elevated amounts of silt are also observed to be bypassing the silt basin and flowing into the brook.

Picture 4: Ludlow building a silt retention basin on the east side of Allyn Brook at Station ~511+00. Pickett Lane, Durham. View to the northeast.

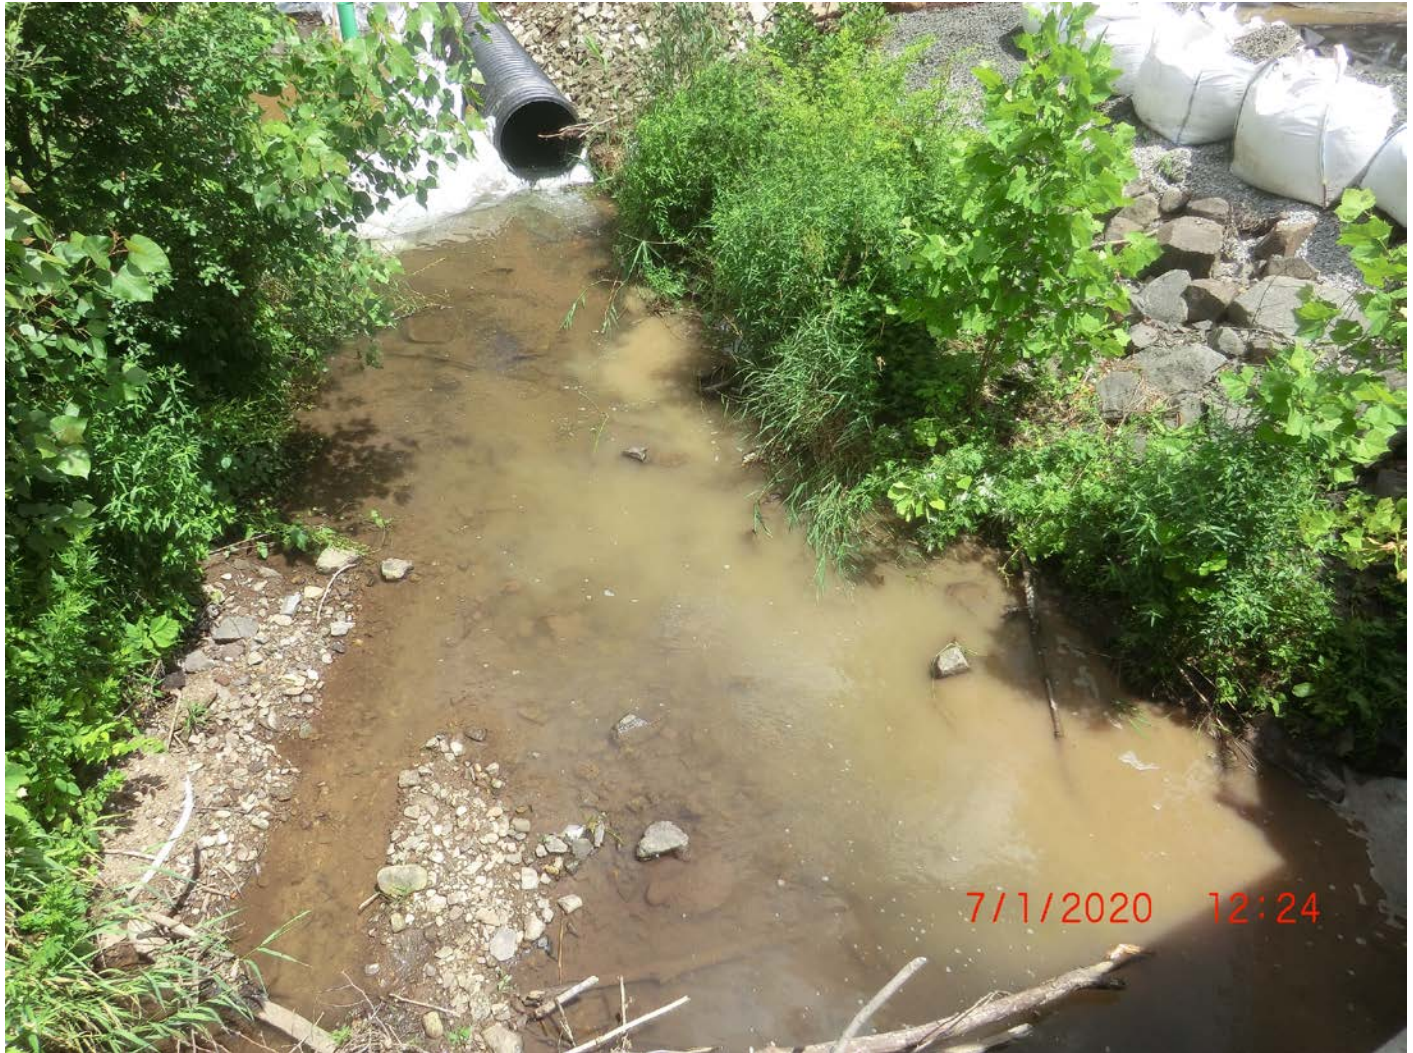
1140: Ludlow has installed the new 40" stream flow bypass culvert along the east side of Allyn Brook at the Station ~511+00 work zone. Elevated turbidity is still being observed downstream of the work zone. Ludlow installs a pump in the work zone.

Picture 5: Elevated silt load entering Allyn Brook at Station ~511+00 from silt retention basin. Pickett Lane, Durham. View to the north.

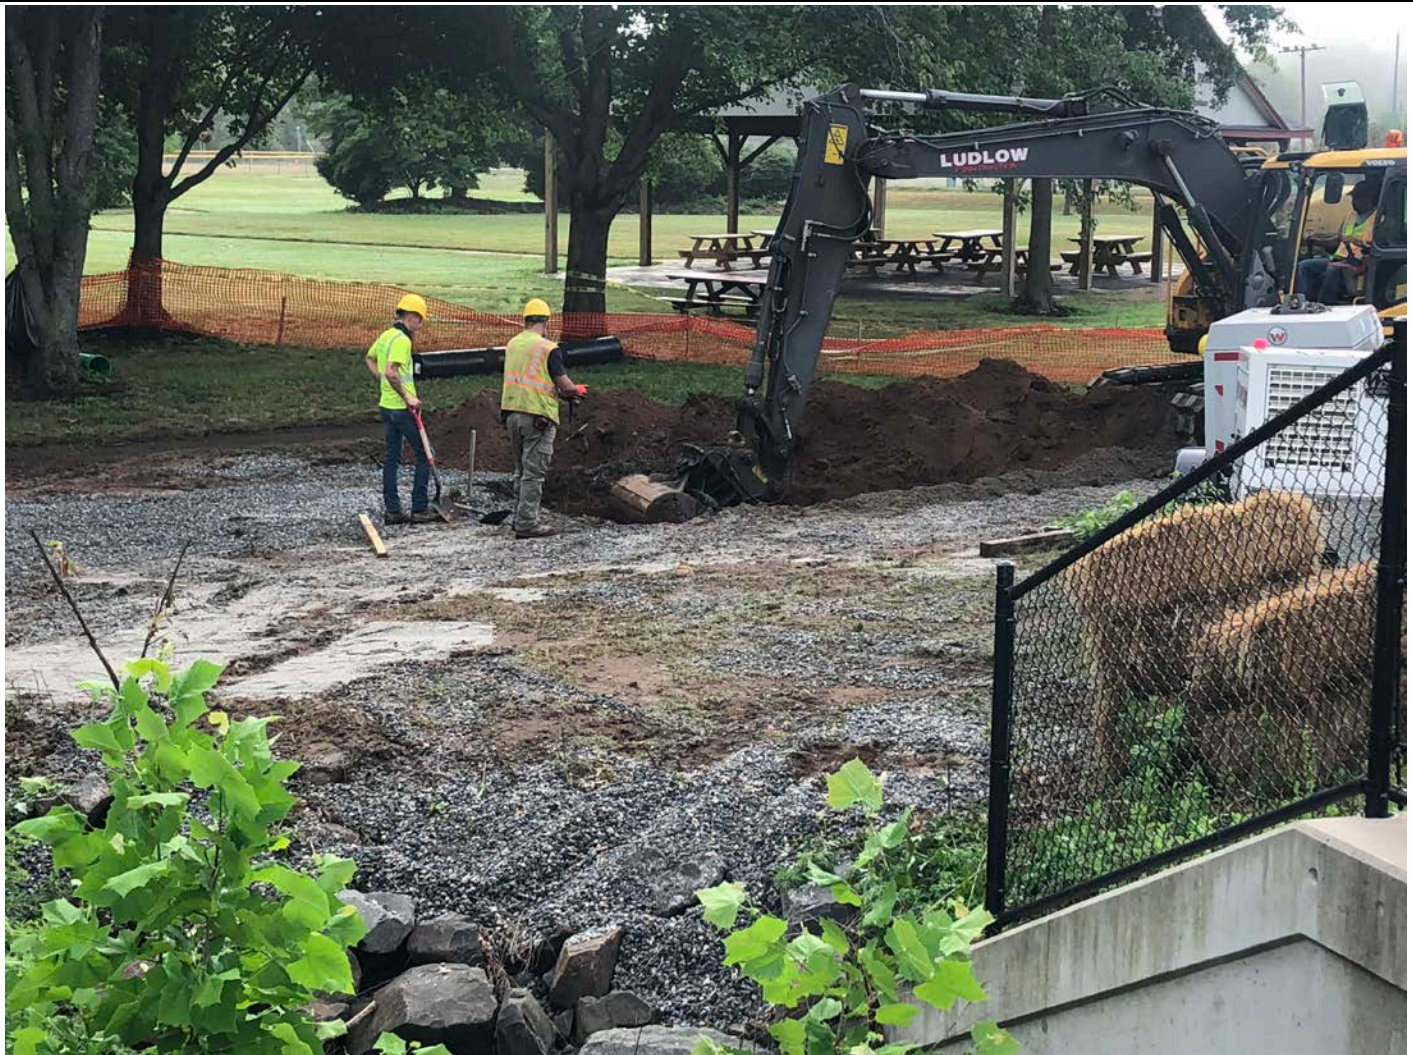
0721: Ludlow is excavating a test pit about 40 feet east of the shoreline of Allyn Brook at Station ~511+00 to daylight an existing water line and other utilities.

Picture 6: Ludlow excavating test pit to the east of Allyn Brook at Station~511+00. Pickett Lane, Durham.

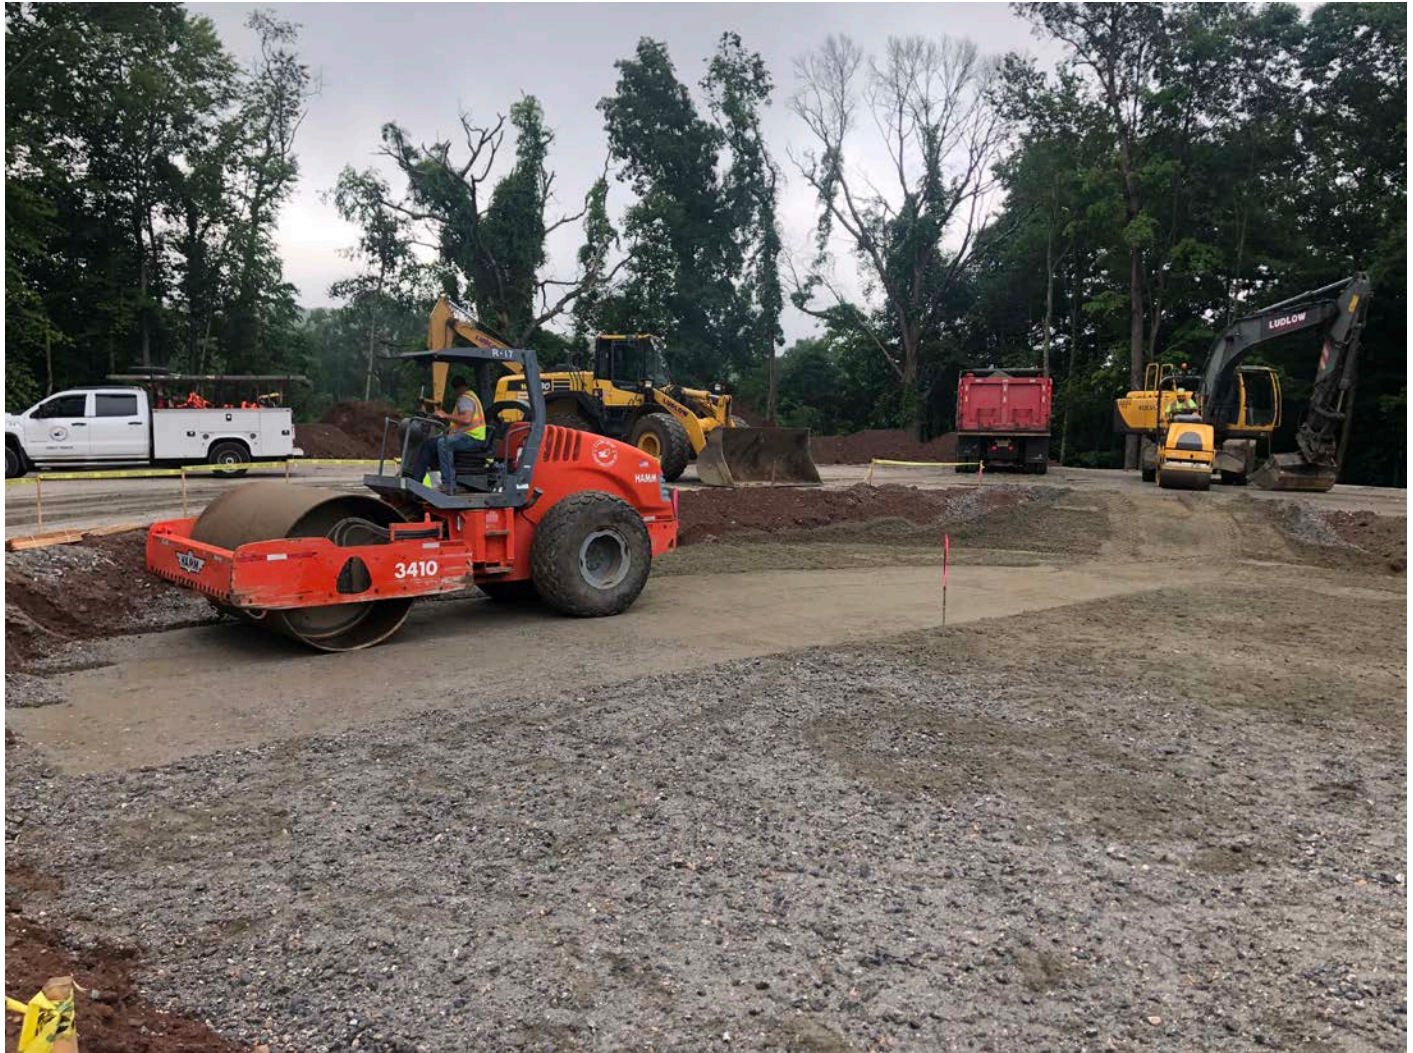
0751: Ludlow has resumed earth work at the water tank footprint. Ludlow is finishing up with a 4" lift to bring structural fill to elevation 437. Ludlow is currently rolling the fill with a 15-ton roller.

Picture 7: Ludlow compacting 4" lift of structural fill that brought the elevation within the water tank footprint up to 437. Shared Access Driveway, Middletown. View to the southeast.

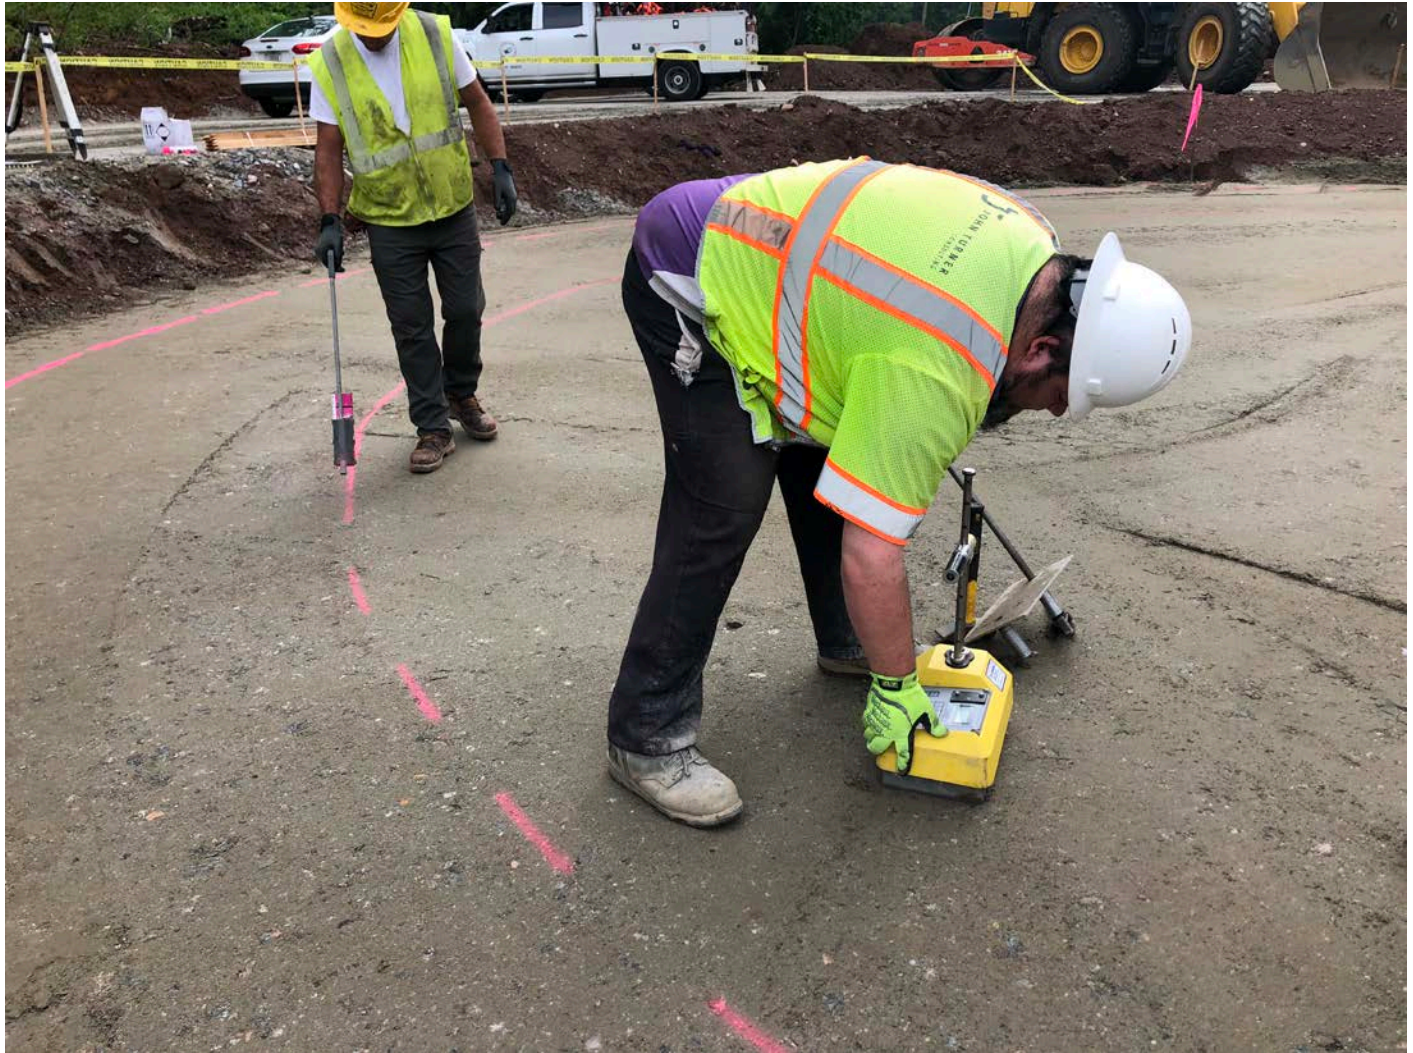
0804: JTC is performing compaction test at elevation 437 on the 4" lift of structural fill they just finished placing.

Picture 8: JTC collecting soil compaction data at elevation 437 at the water tank footprint. Shared Access Driveway, Middletown. View to the southeast.

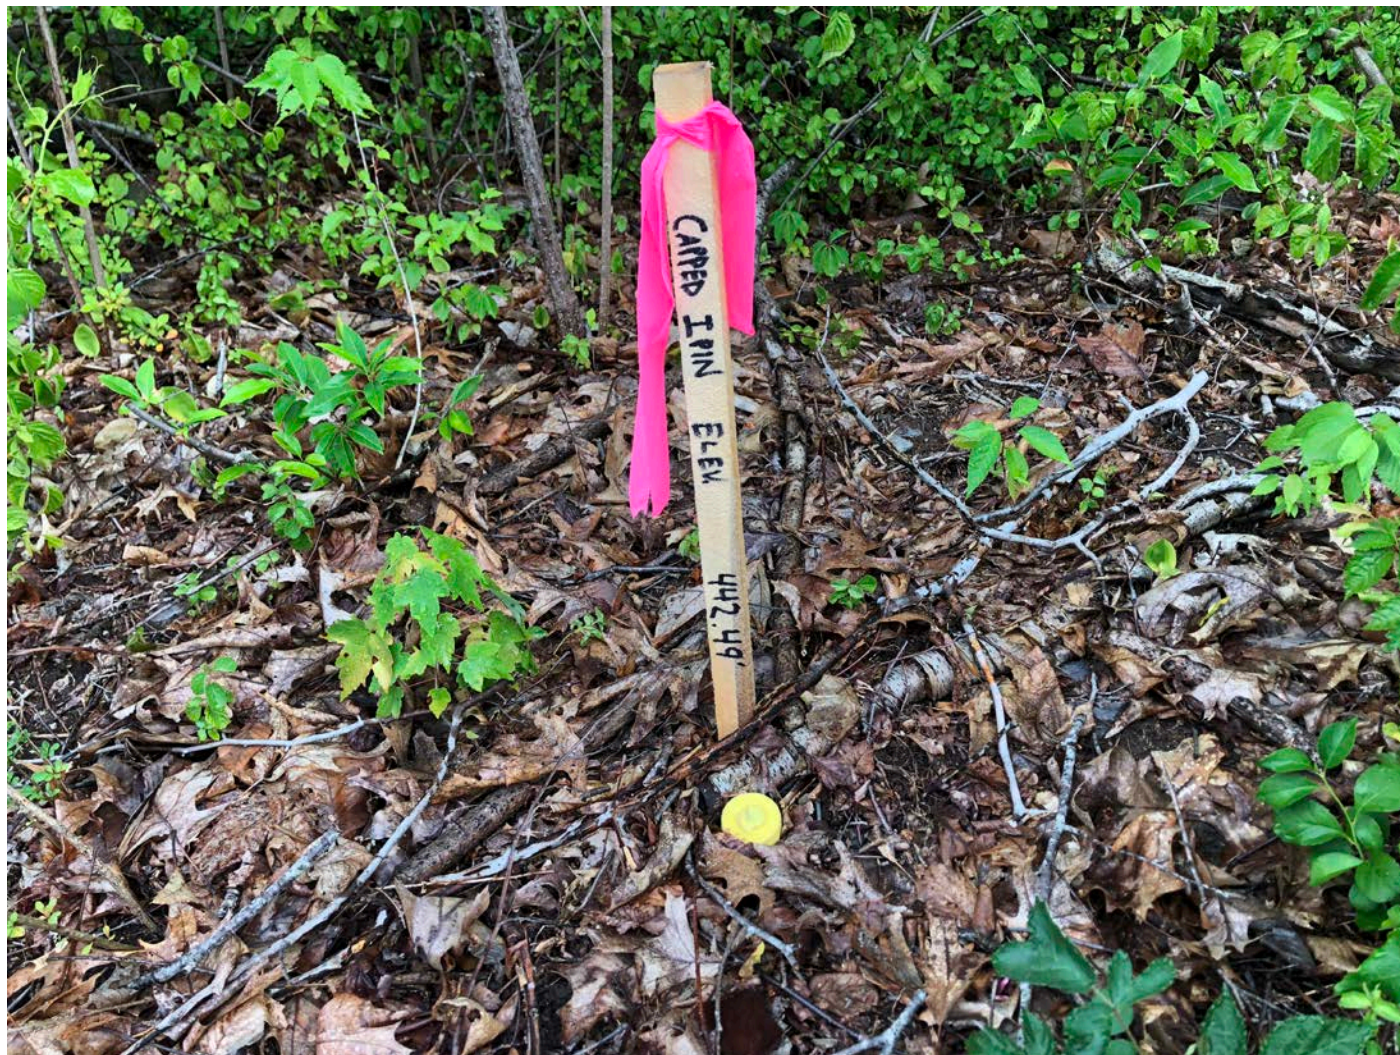
Picture 9: Benchmark that Ludlow surveyor Juliano Associates brought to the top of the Shared Access Driveway yesterday. View to the north.

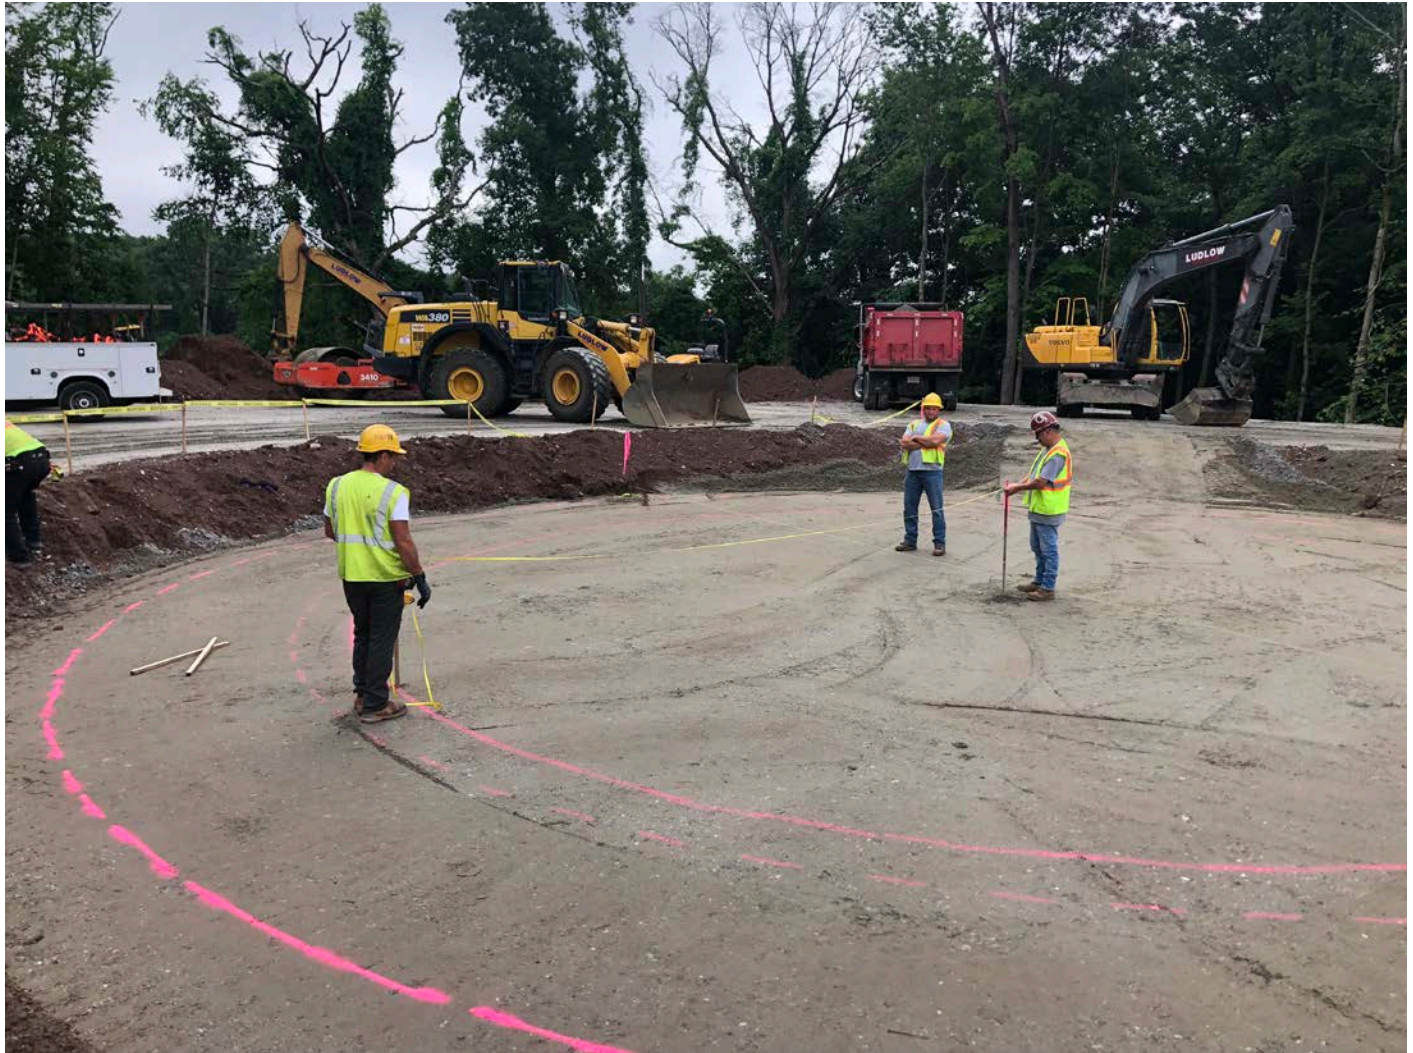
0847: Ludlow is placing grade stakes in the water tank footprint.

Picture 10: Ludlow setting up grade stakes on the water tank footprint at elevation 437. Shared Access Road, Middletown. View to the southeast.

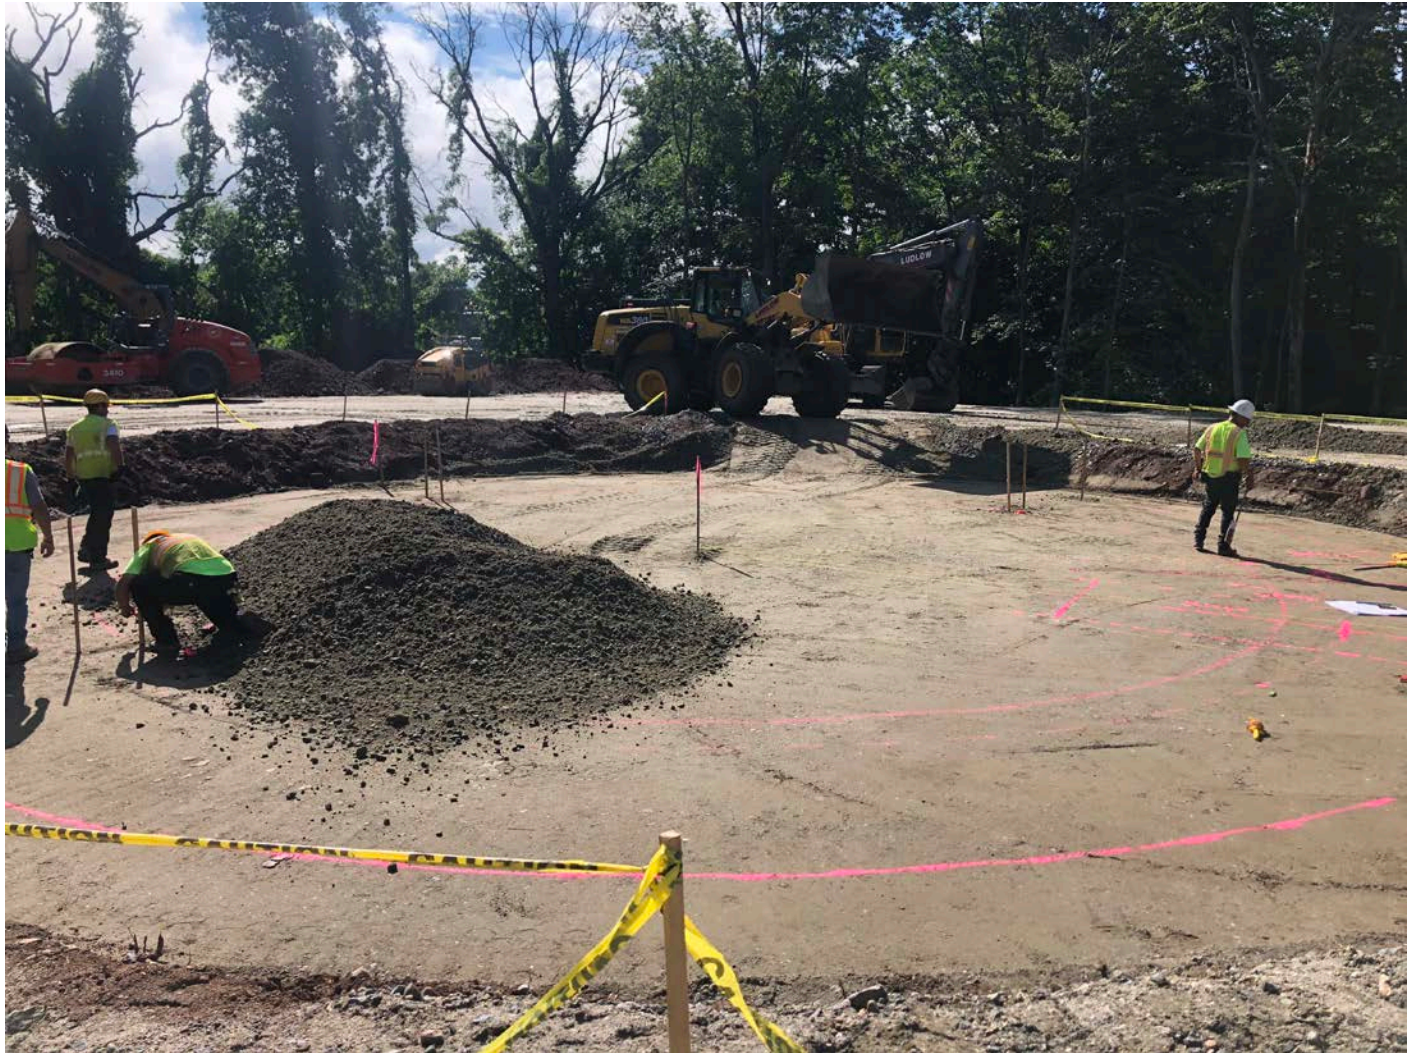
Picture 11: Ludlow begins to place structural fill in an 8" lift at elevation 437. Shared Access Driveway, Middletown. View to the southeast.

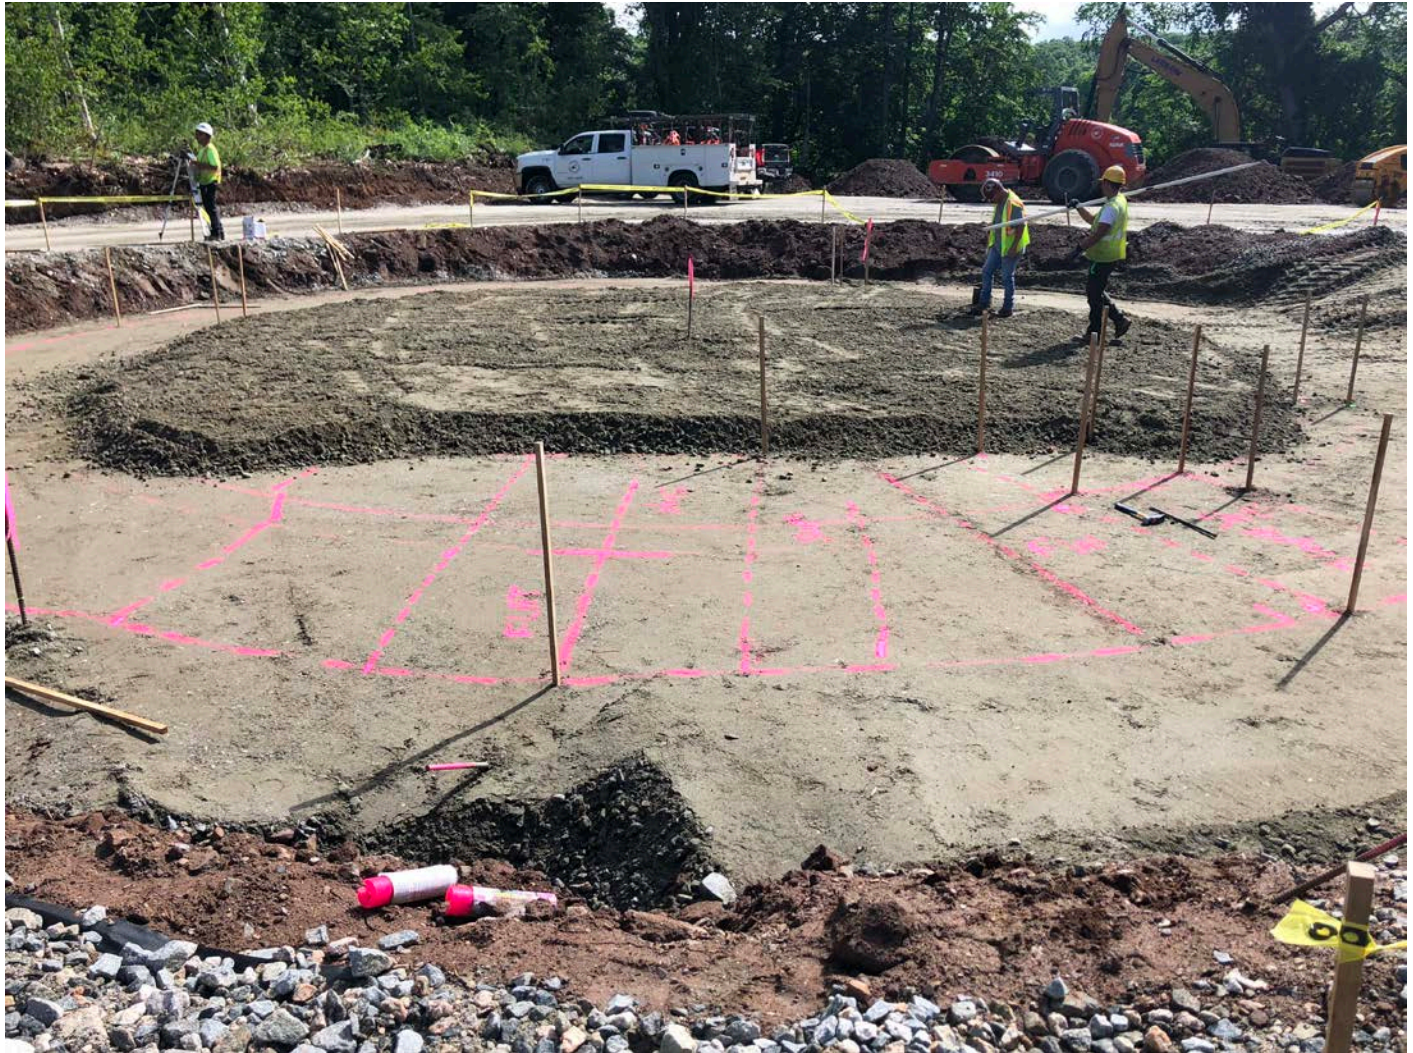
Picture 12: Ludlow continues to place structural fill in an 8" lift at elevation 437. Shared Access Driveway, Middletown. View to the southeast.

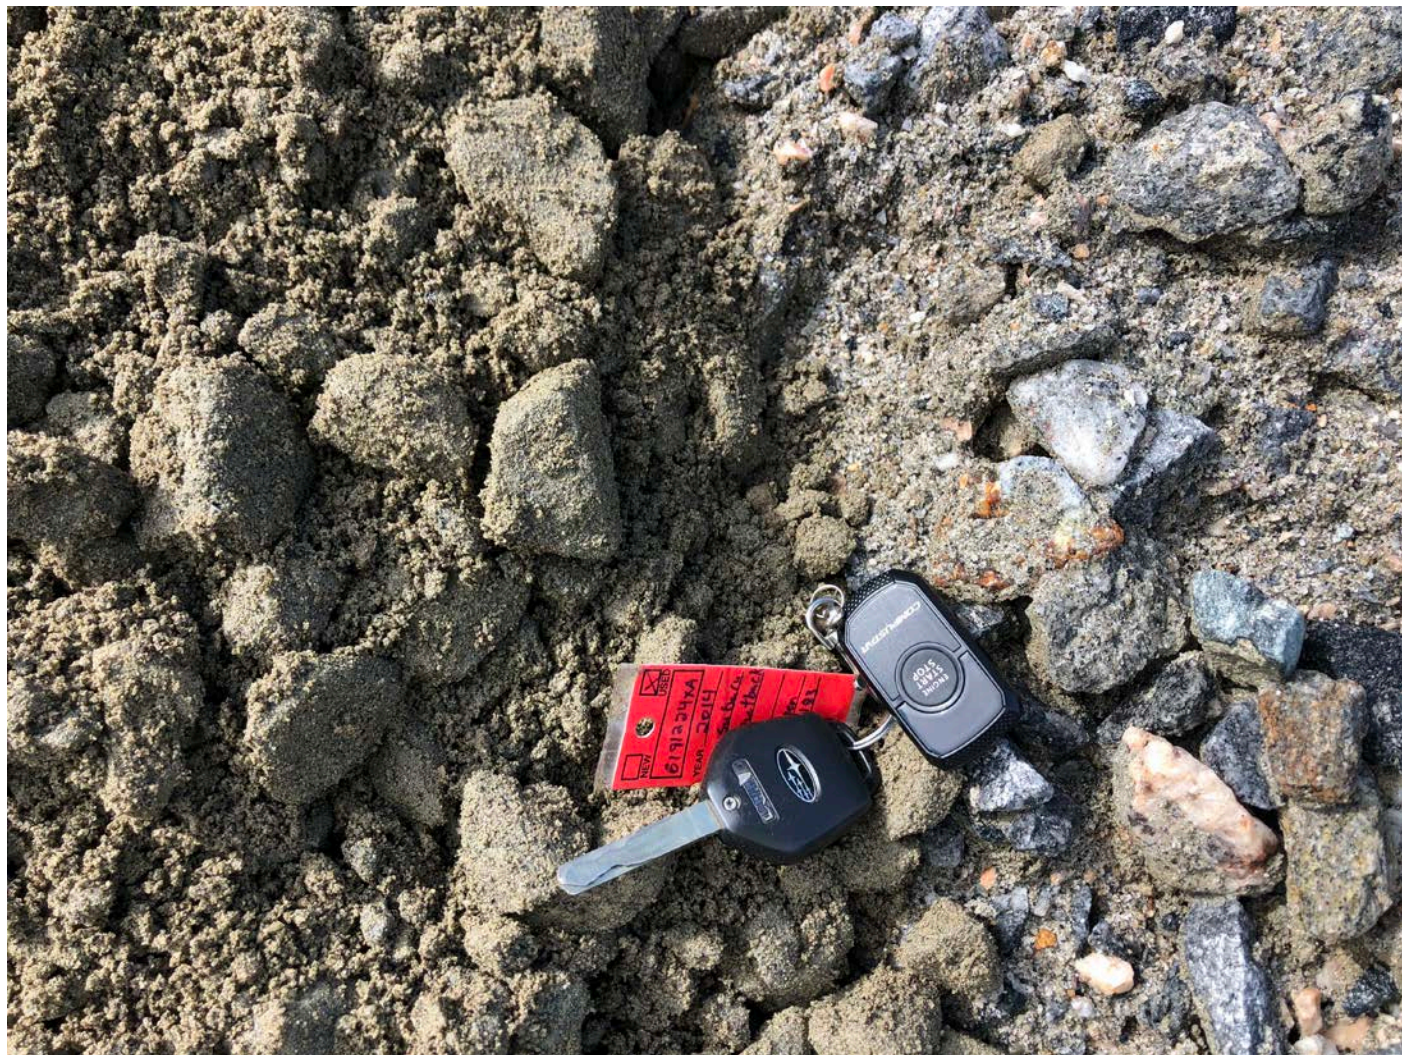
Picture 13: Closeup of the structural fill being placed in the water tank footprint. Shared Access Driveway, Middletown. View to the southeast.

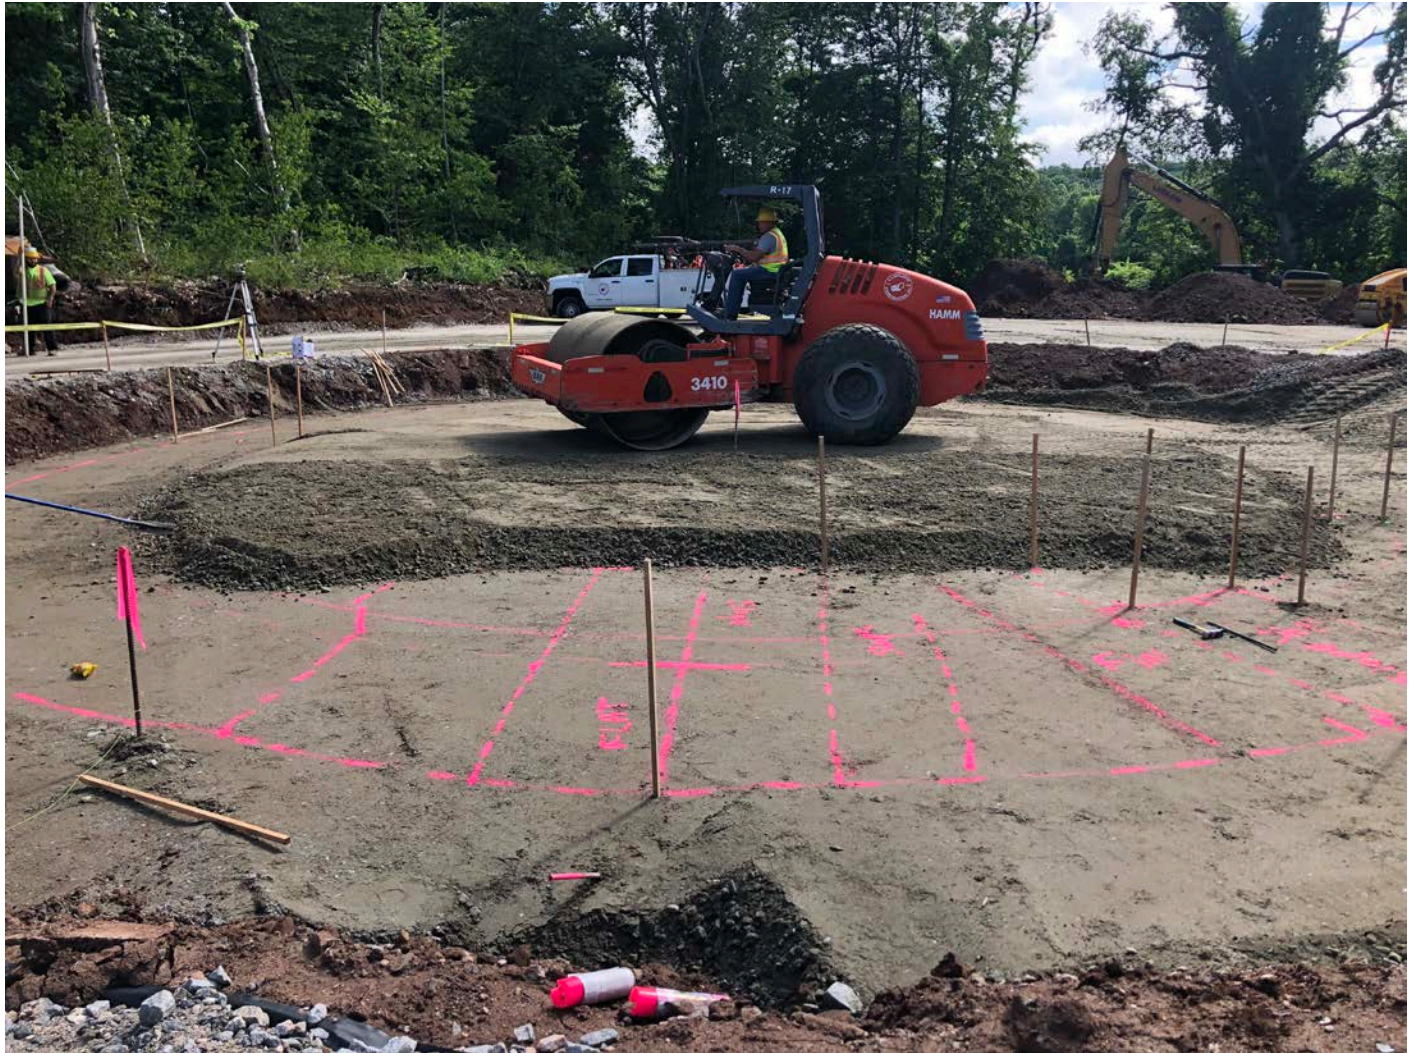
Picture 14: Ludlow compacting structural fill at elevation 437. Shared Access Driveway, Middletown. View to the southeast.
