Daily Report

Project:	Durham Meadows Pipeline Installation	Date:	July 1, 2020
Location:	Main Street, Pickett Lane, and the Shared Access Driveway	Day of Week:	Wednesday
Project #:	AECOM: 6061487	Report No:	111
Contractor:	Ludlow Construction	Page:	1 of 18

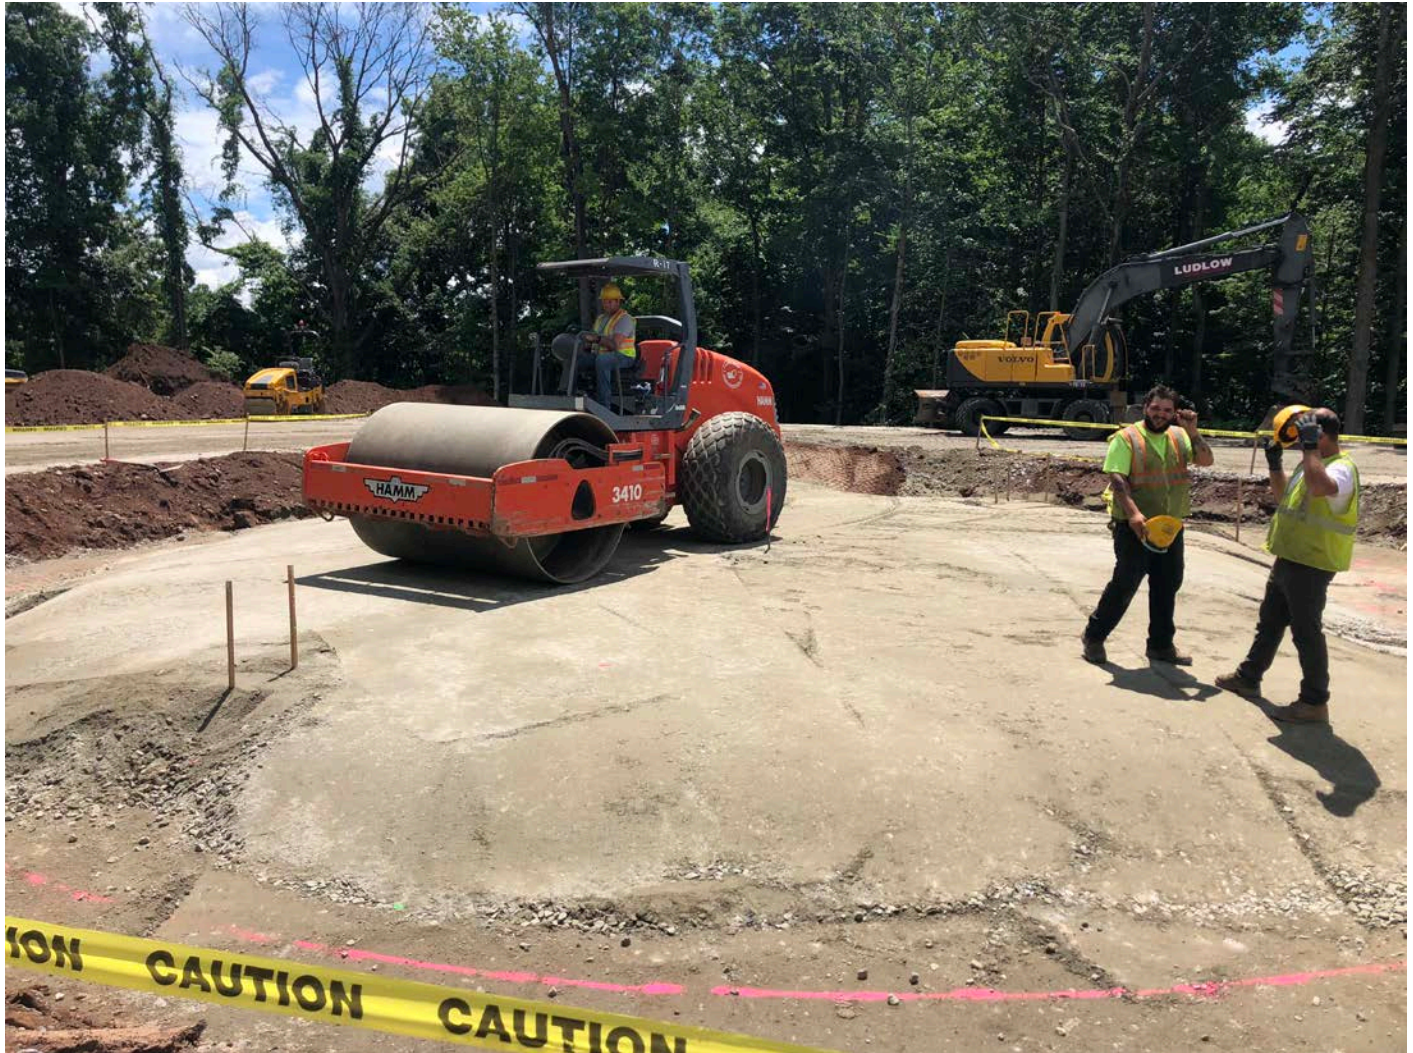
1253: JTC performs soil compaction tests at four locations on the 438.34 lift. Ludlow resumes the placement of structural fill up to elevation 439.

Picture 15: Ludlow compacting structural fill at elevation 438.34. Shared Access Driveway, Middletown. View to the southeast.
