Daily Report

Project:	Durham Meadows Pipeline Installation	Date:	July 6, 2020
Location:	Pickett Lane, and the Shared Access Driveway	Day of Week:	Monday
Project #:	AECOM: 6061487	Report No:	113
Contractor:	Ludlow Construction	Page:	1 of 17

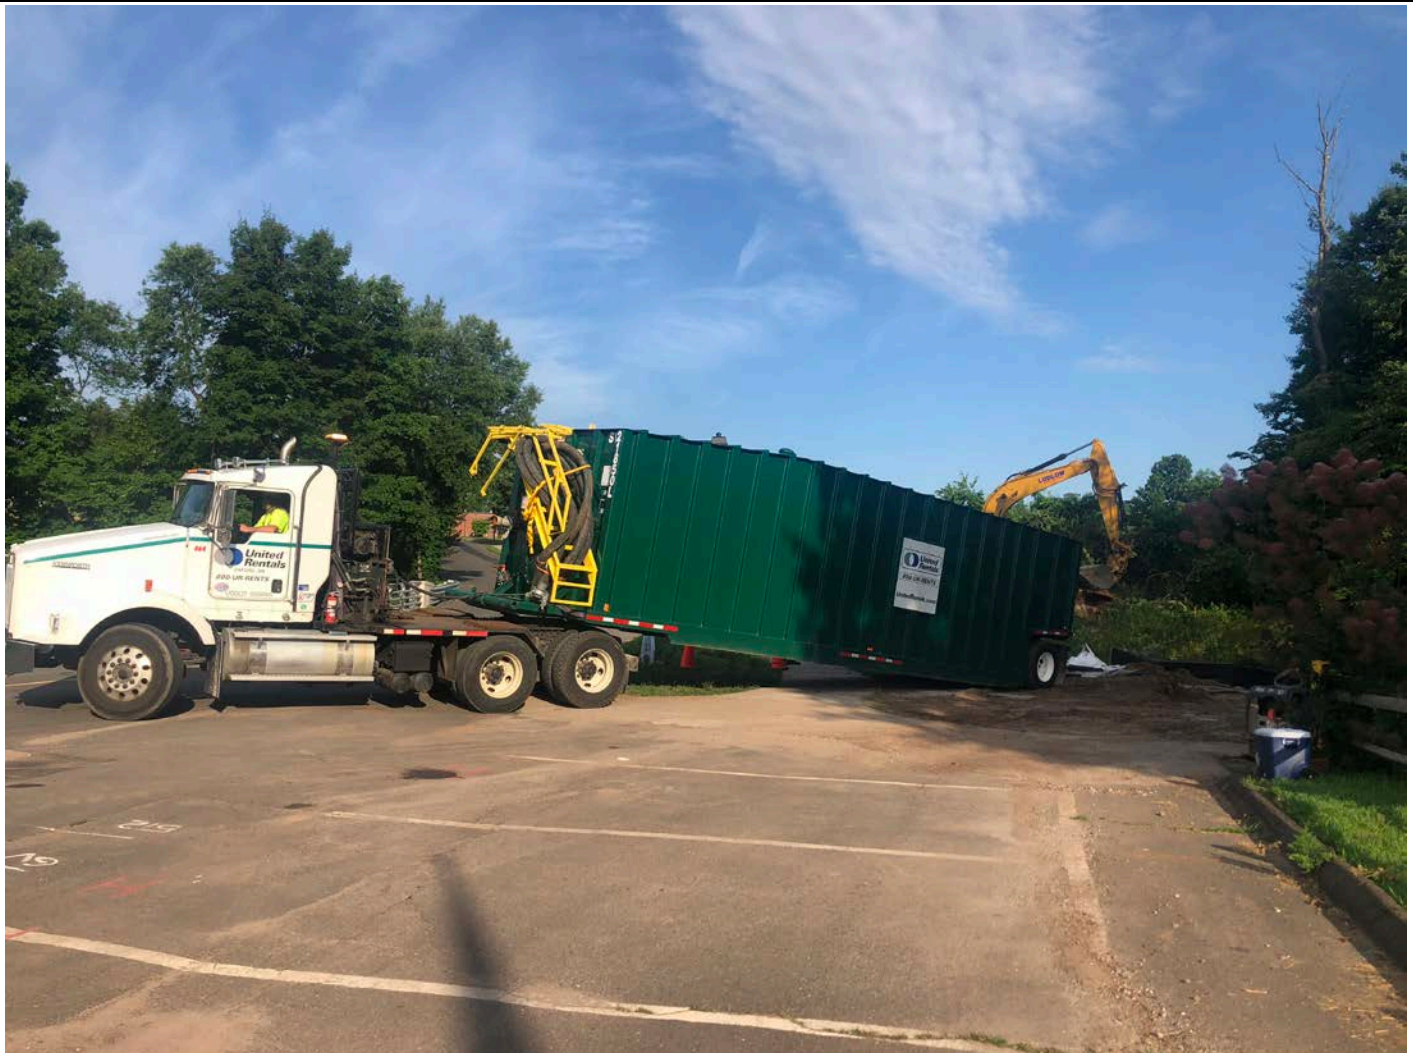
Picture 1: United Rentals placing frac tank at Station ~511+00 as part of ongoing stream crossing activities. Pickett Lane, Durham. View to the northwest.

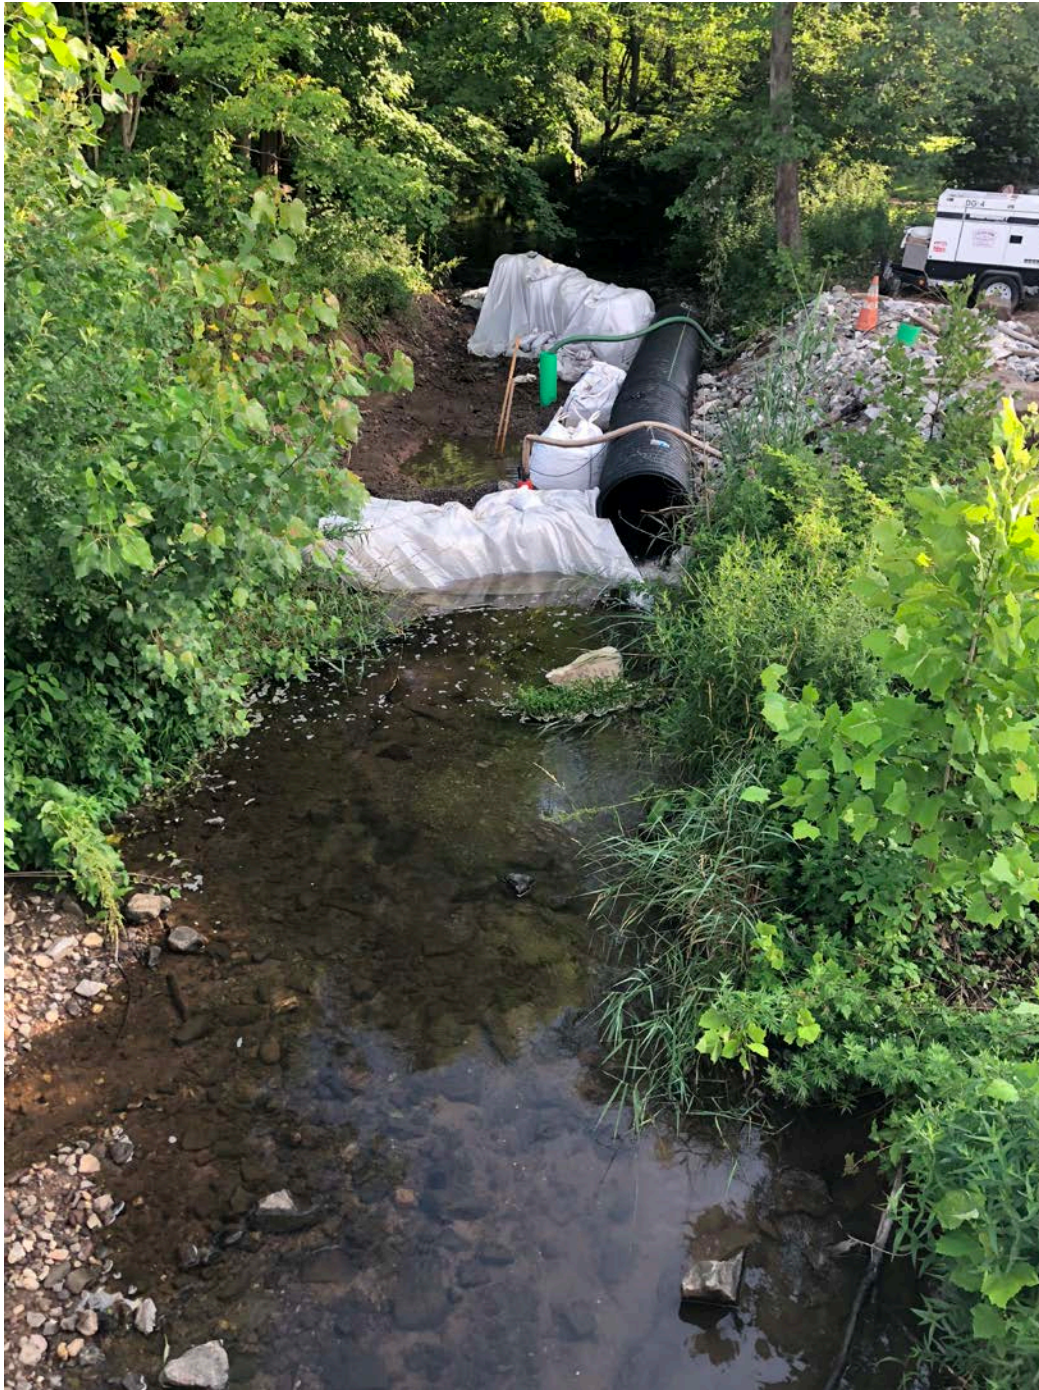
Picture 2: Condition of Allyn Brook prior to stream crossing activities today. Station ~511+00, Pickett Lane, Durham. View to the north.

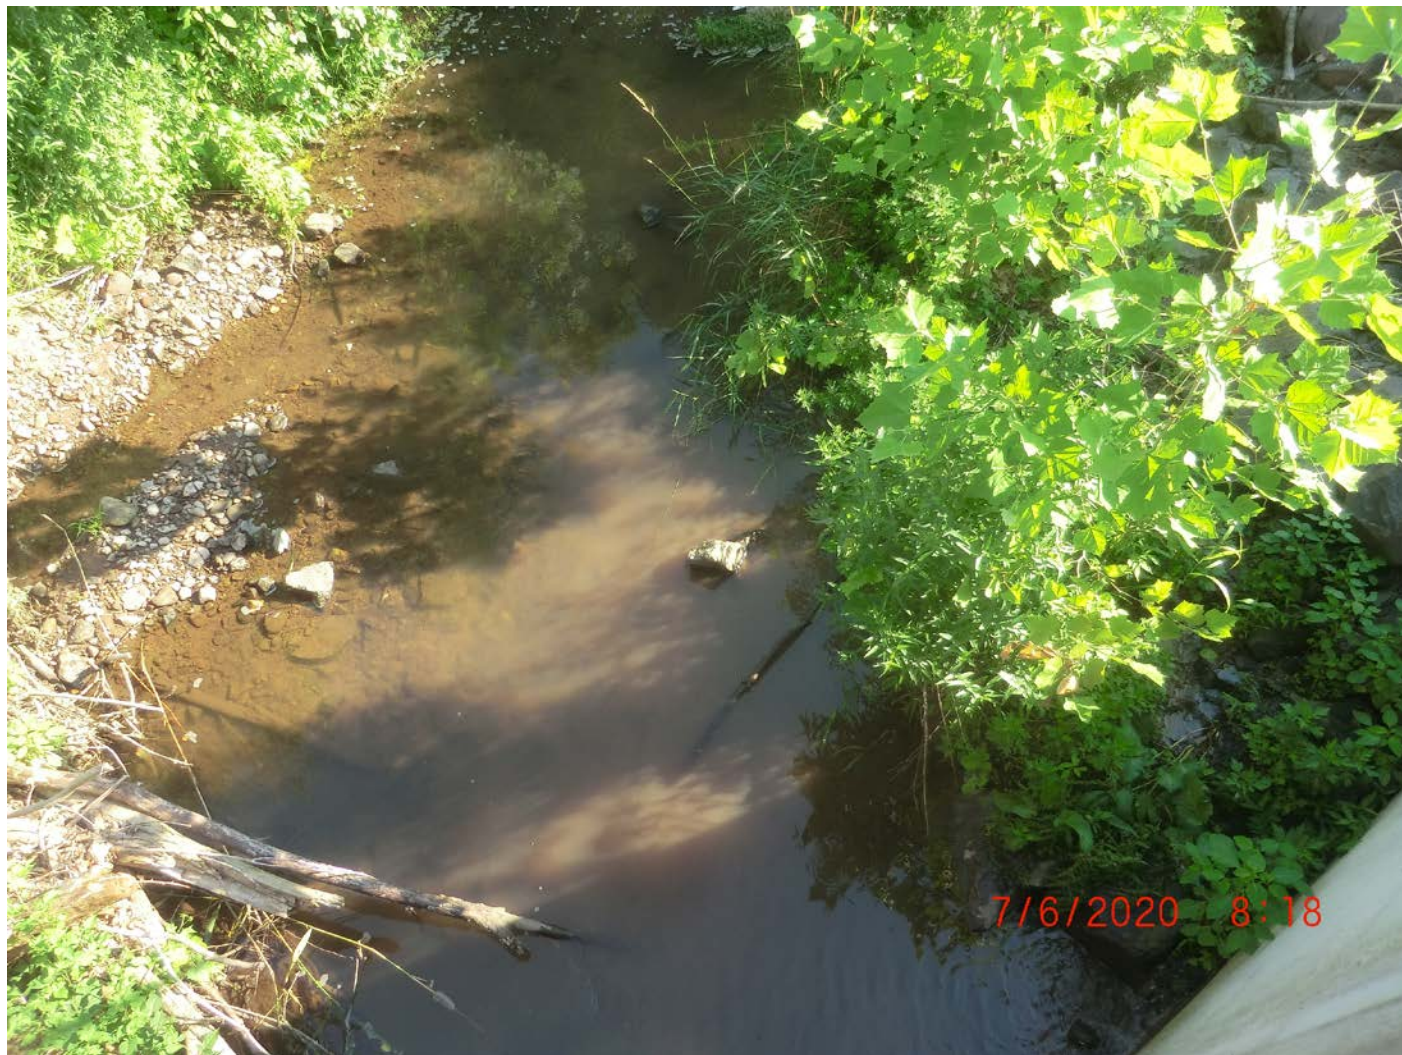
0840: Ludlow has started trenching and has encounter bedrock. Little silt is observed to be released downstream of the work zone.

Picture 3: Turbidity in Allyn Brook downstream of the work zone at Station ~511+00 after stream crossing activities began. Pickett Lane, Durham. View to the north.

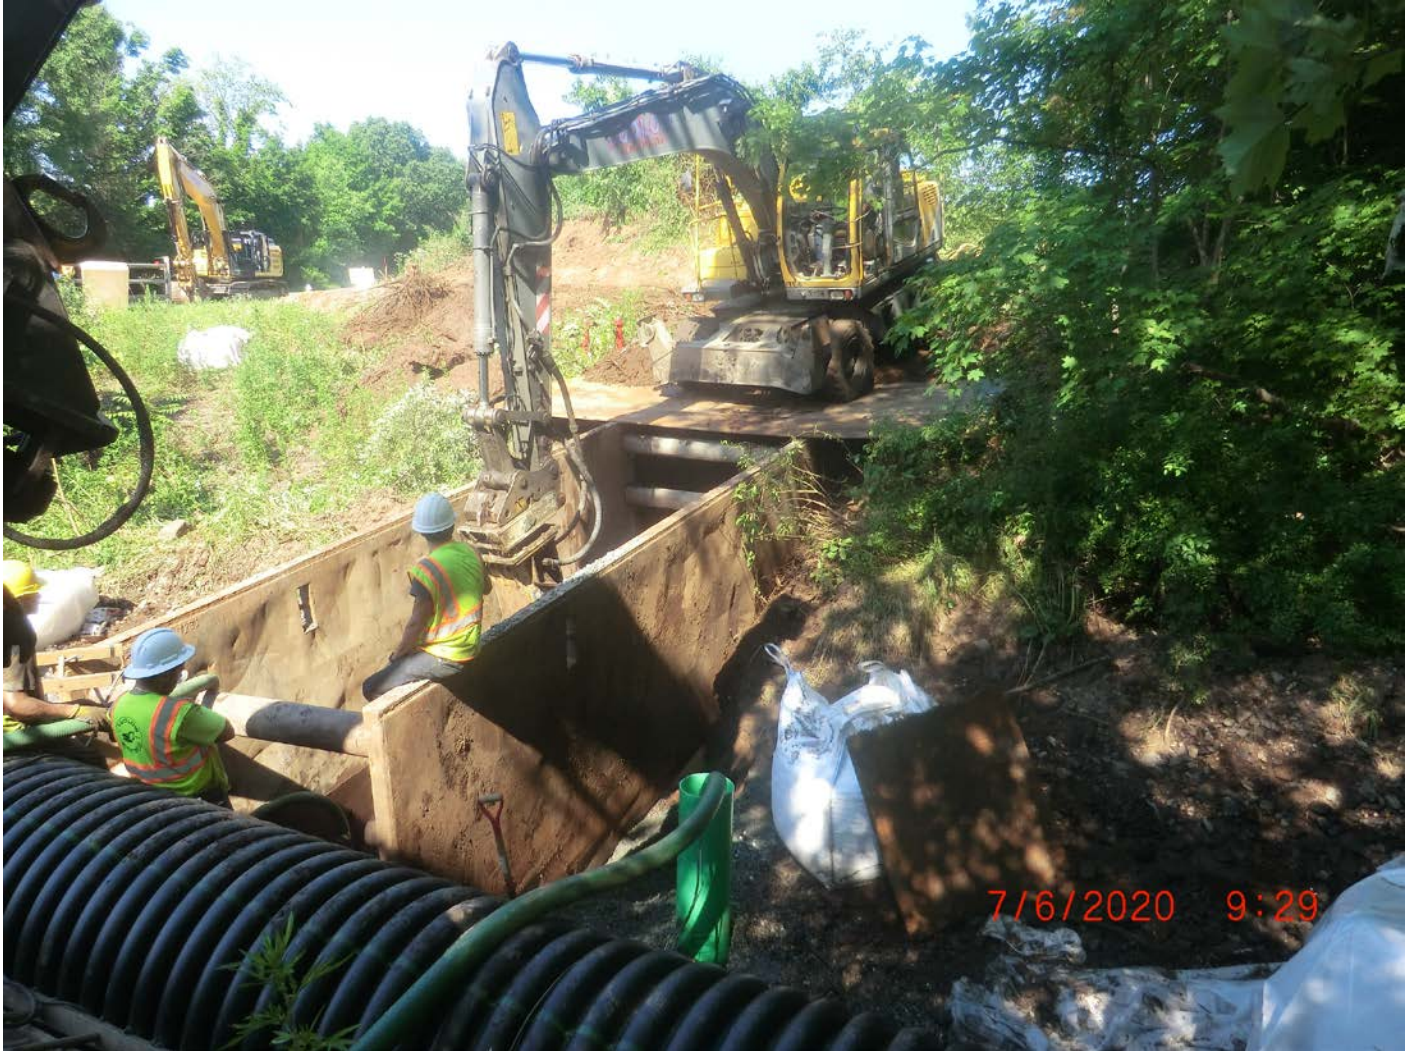
Picture 4: Ludlow staged on the west bank of Allyn Brook as they begin to excavate the bank and stream bed for the placement of 36" conduit. Station ~511+00, Pickett Lane, Durham. View to the west.

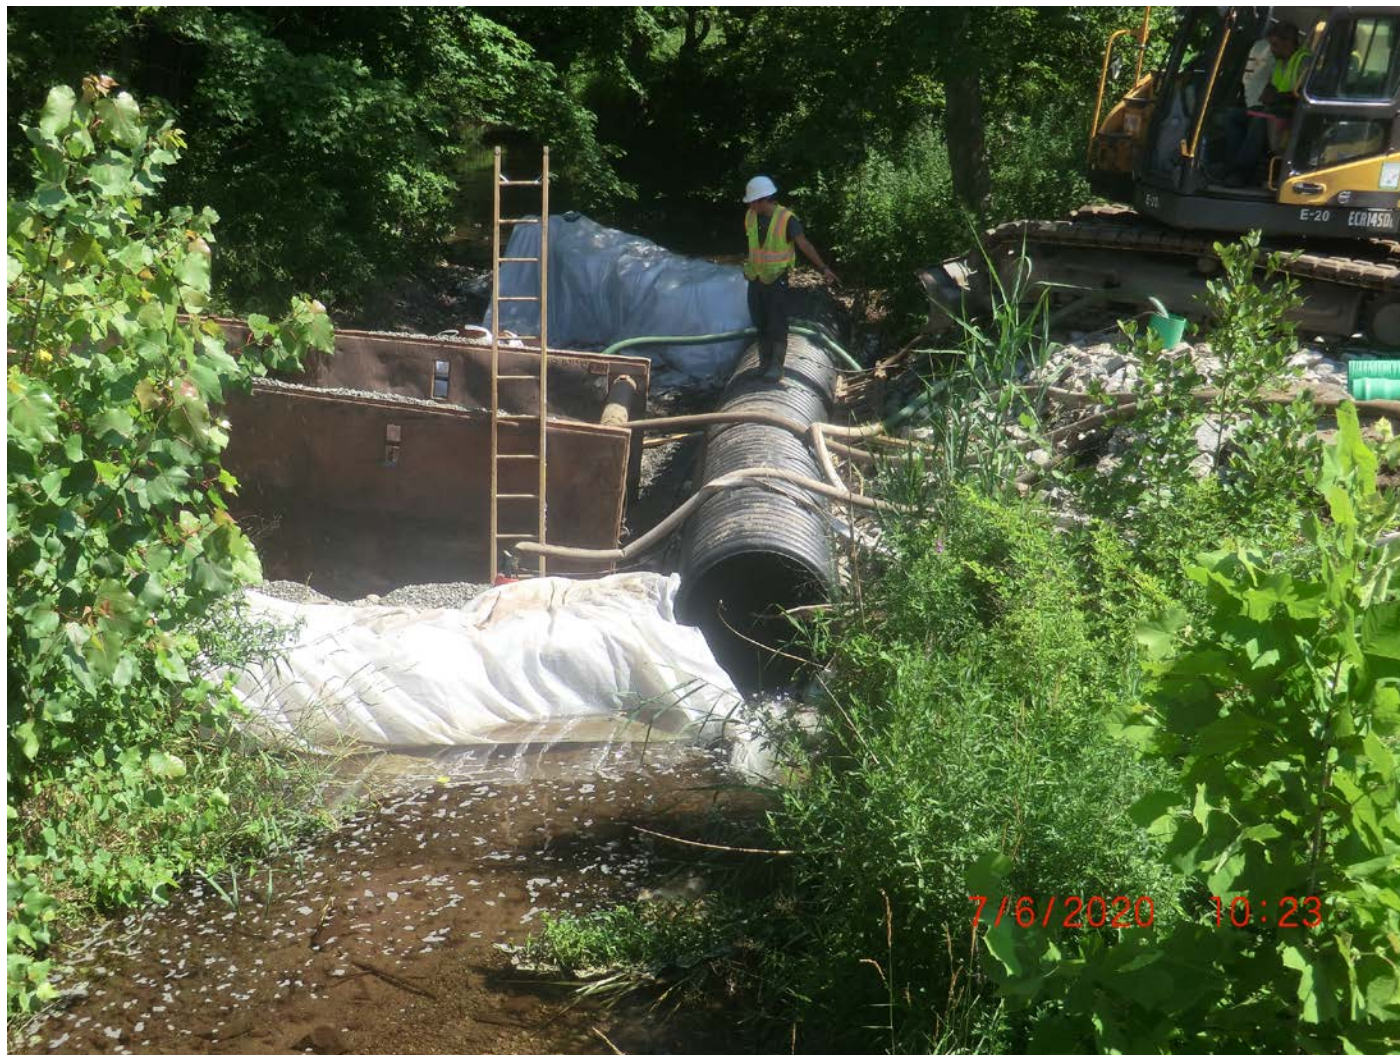
Picture 5: View of trench box installed on the west bank of Allyn Brook for the excavation of the stream bank and stream bed for the placement of 36" conduit. Station ~511+00, Pickett Lane, Durham. View to the north.

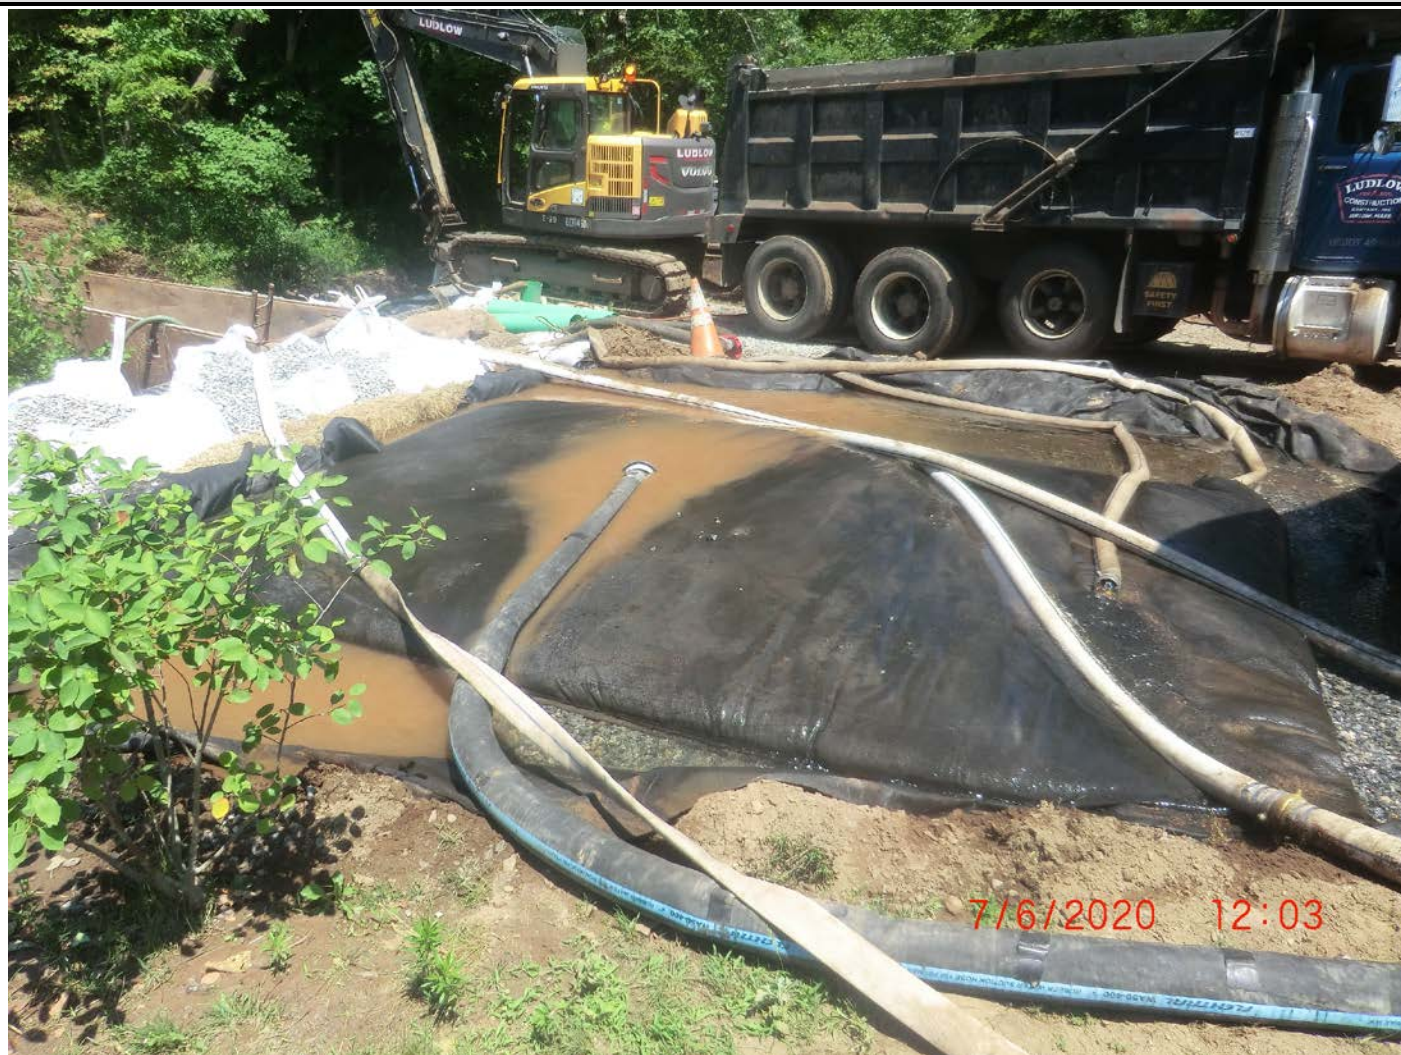
Picture 6: Water being pumped from work zone into filter bed that Ludlow placed on the east bank of Allyn Brook. Station ~511+00, Pickett Lane, Durham. View to the northwest.

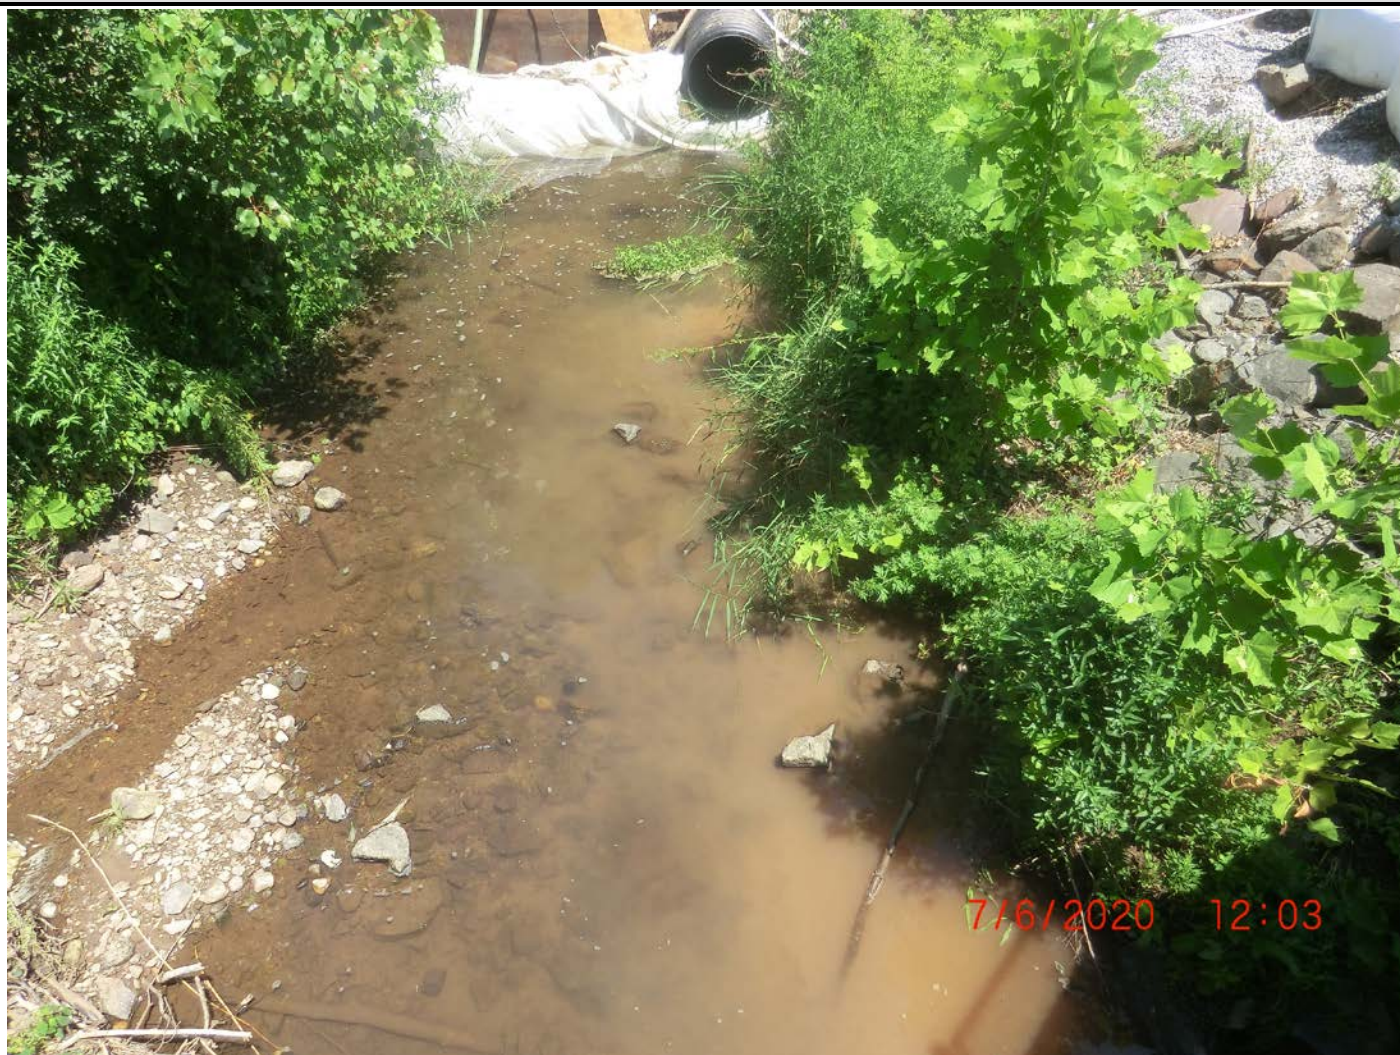
1030: Ludlow adjusts stream flow bypass culvert to redirect water away from work zone in stream; minimal release of silt downstream of the work zone observed.

Picture 7: Turbidity in Allyn Brook downstream of the work zone at Station ~511+00 during stream crossing activities. Pickett Lane, Durham. View to the north.

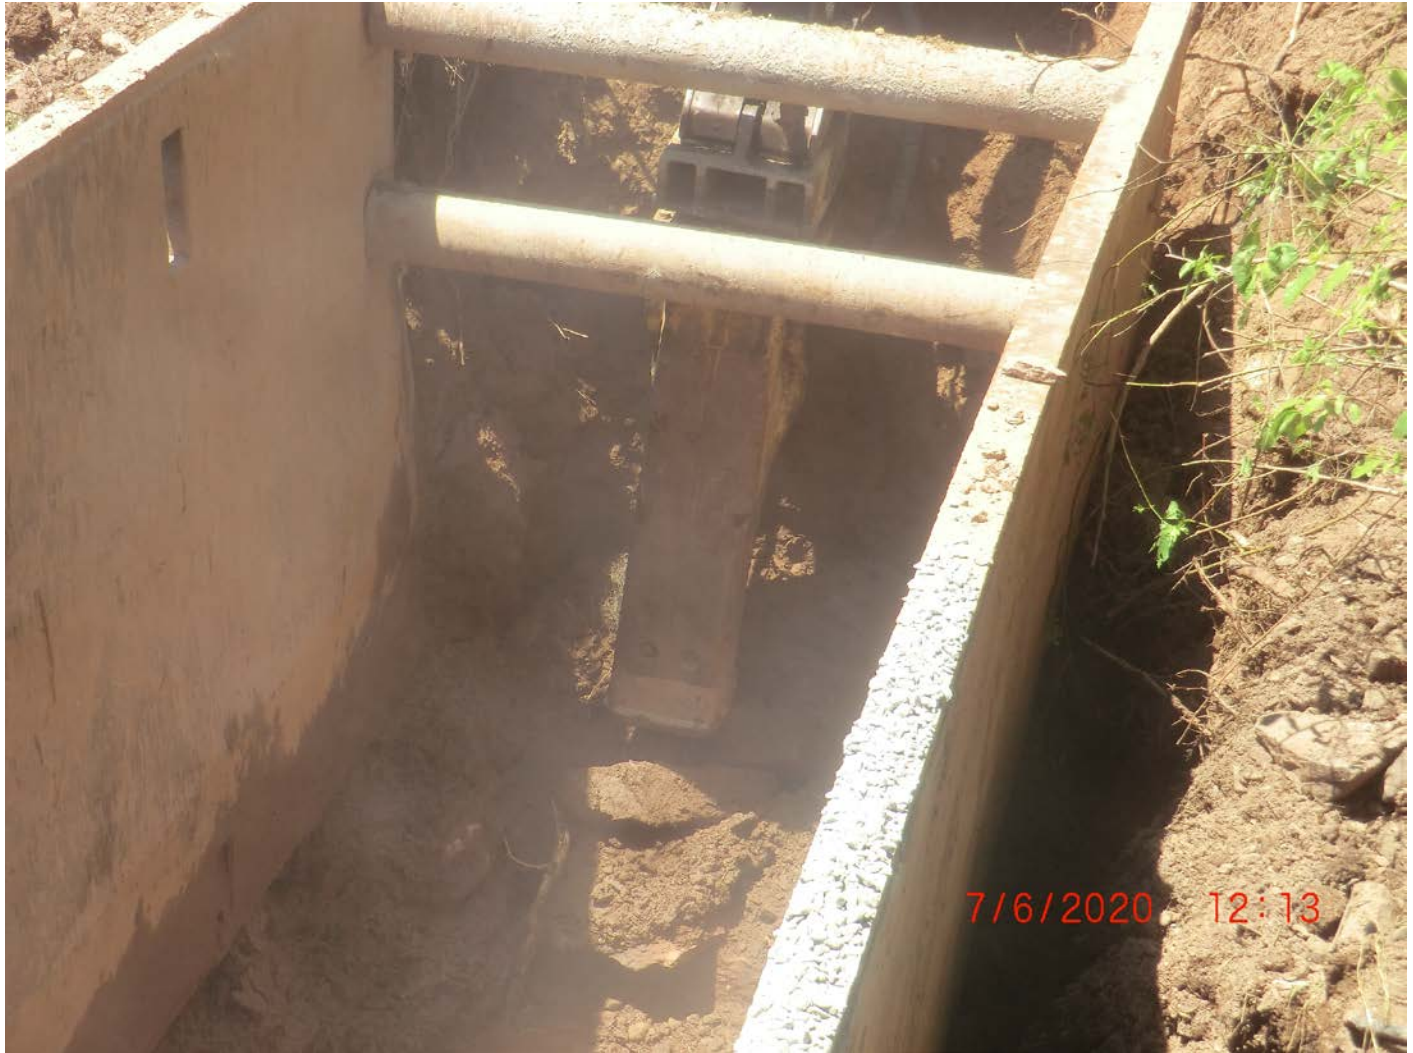
Picture 8: Ludlow hammering rock on the west bank of Allyn Brook. Station ~511+00, Pickett Lane, Durham. View to the west.

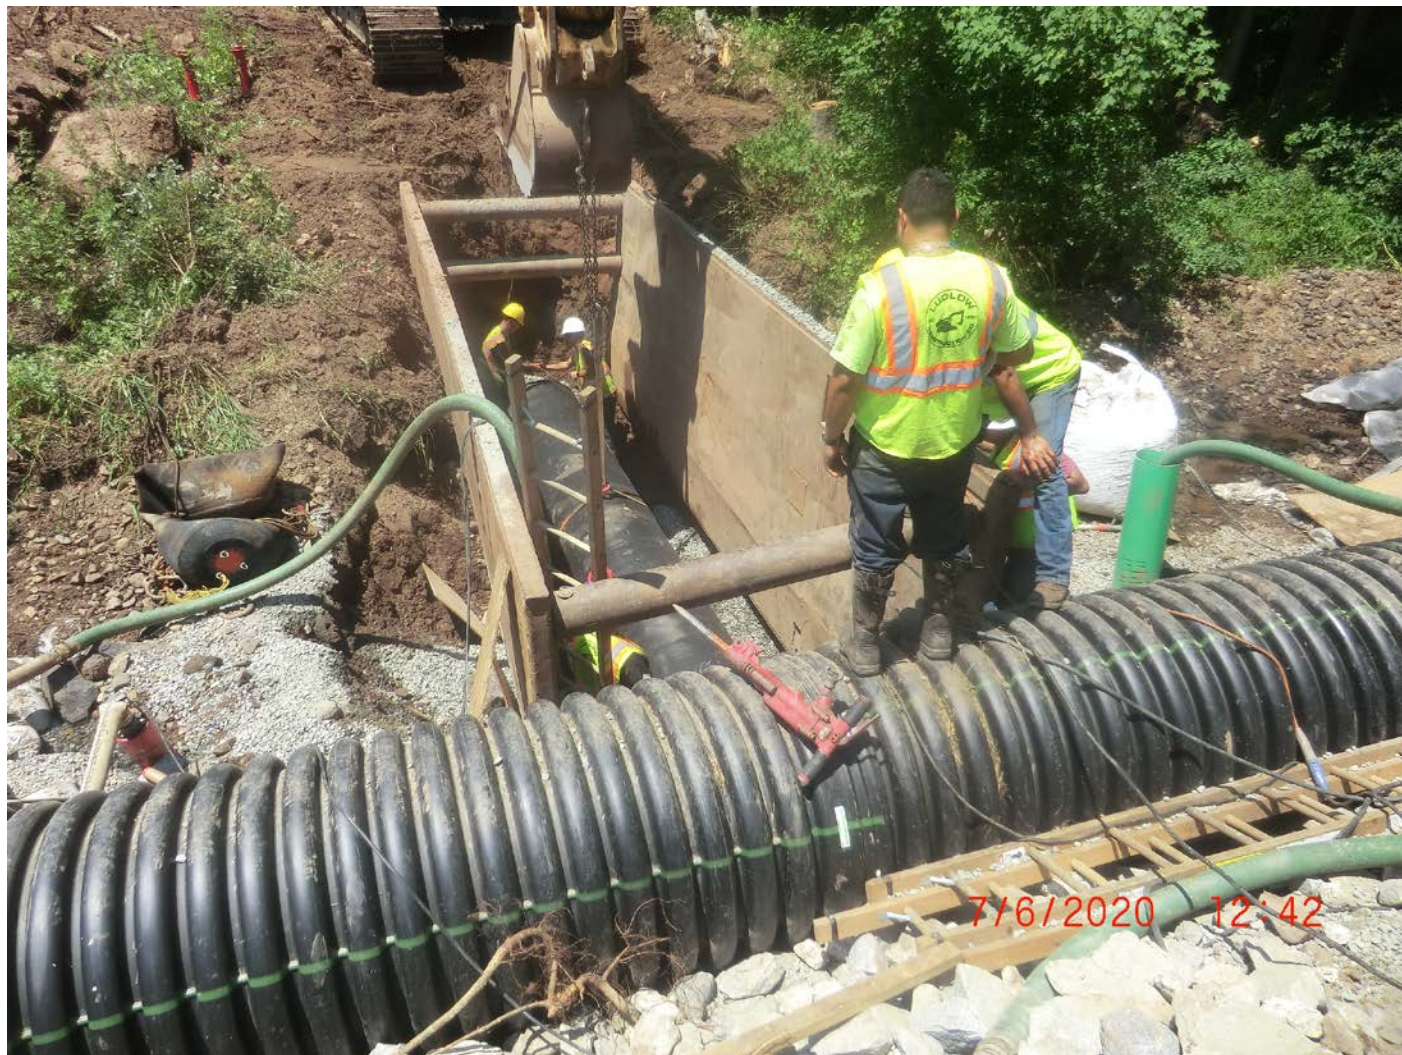
Picture 9: View of 36" conduit being placed across stream bed to meet another piece of 36" conduit that was installed last week. Station ~511+00, Pickett Lane, Durham. View to the east.

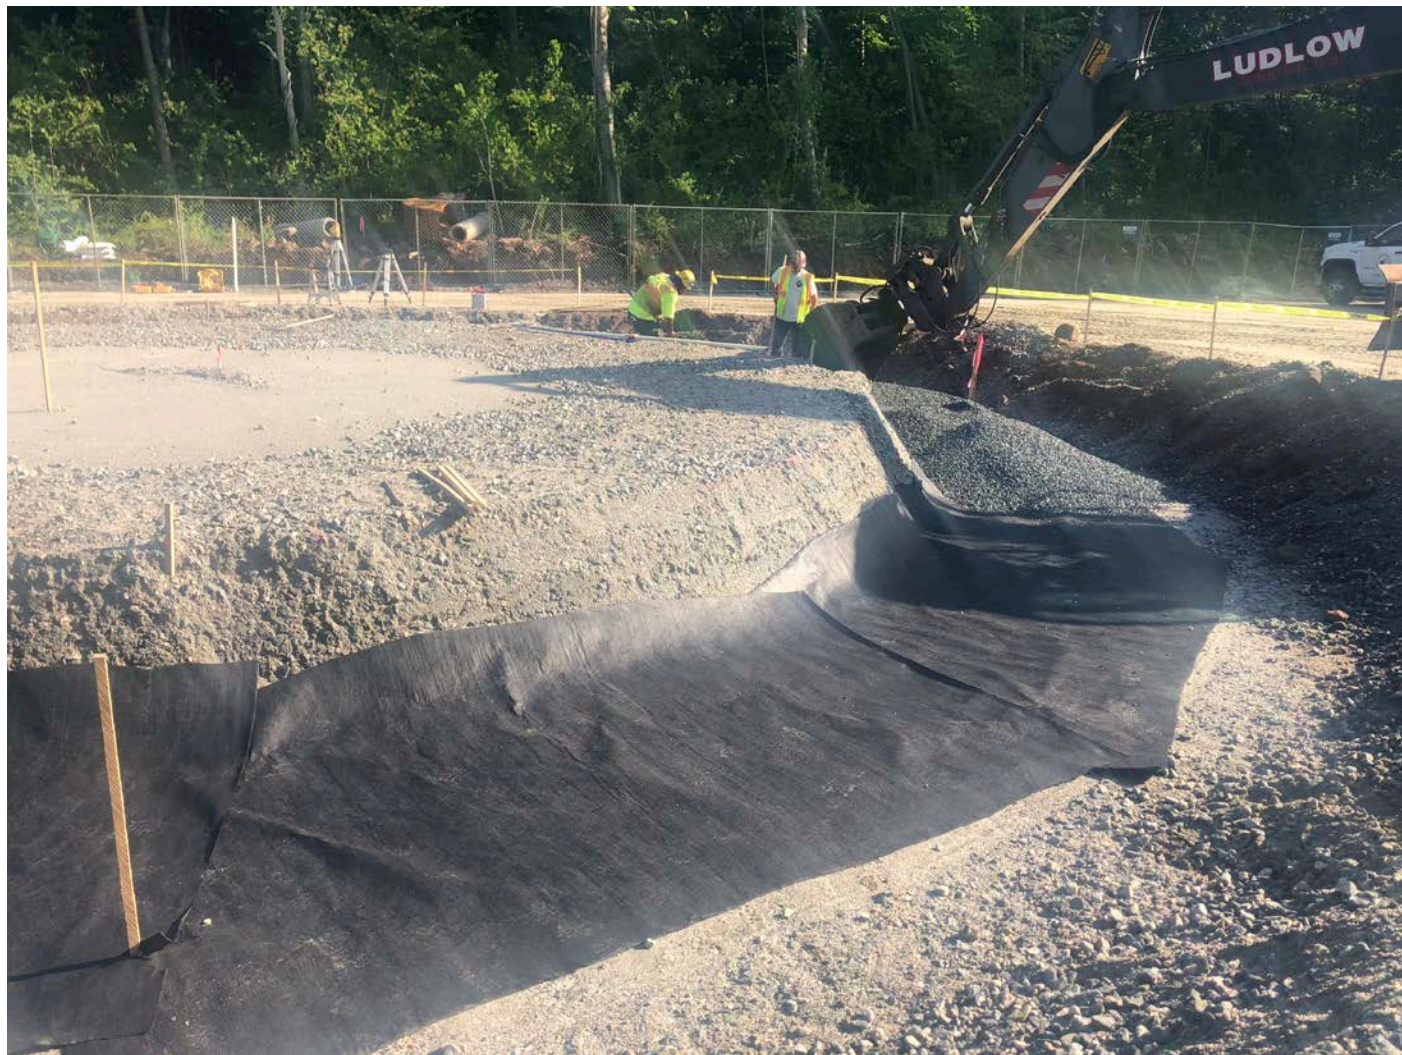
Picture 10: Ludlow placing No.67 ½" gravel on top of filter fabric on the ring of soil at elevation 437 within the water tank footprint. Shared Access Driveway, Middletown. View to the southeast.

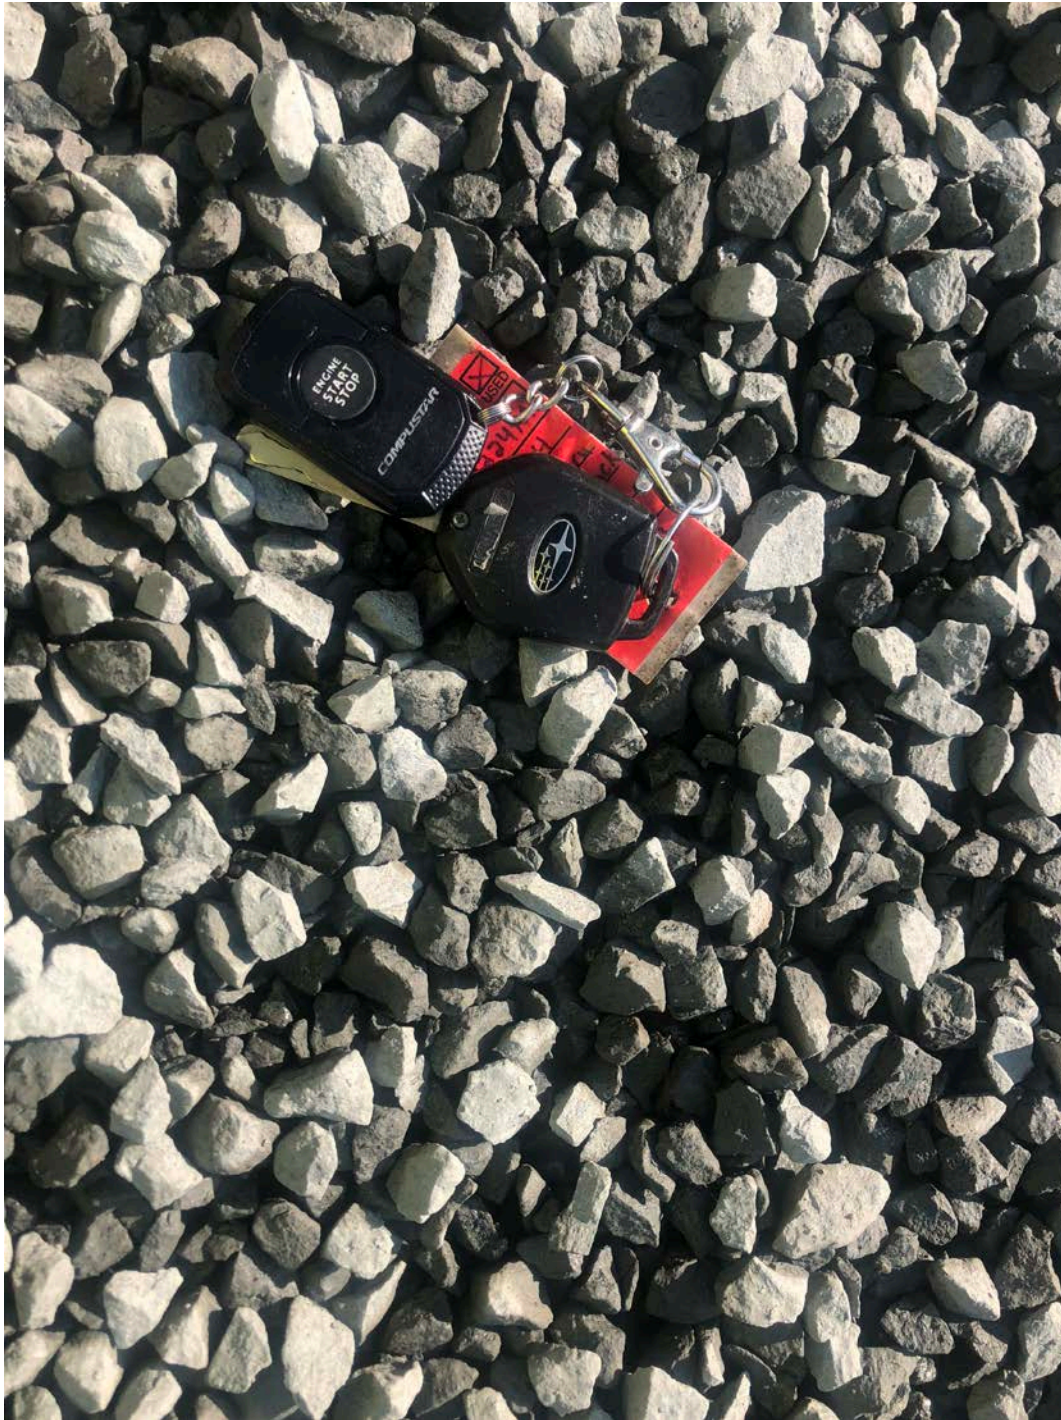
Picture 11: Close-up of No. 67 1/2" gravel being placed in Picture 10. Water tank footprint, Shared Access Driveway, Middletown.

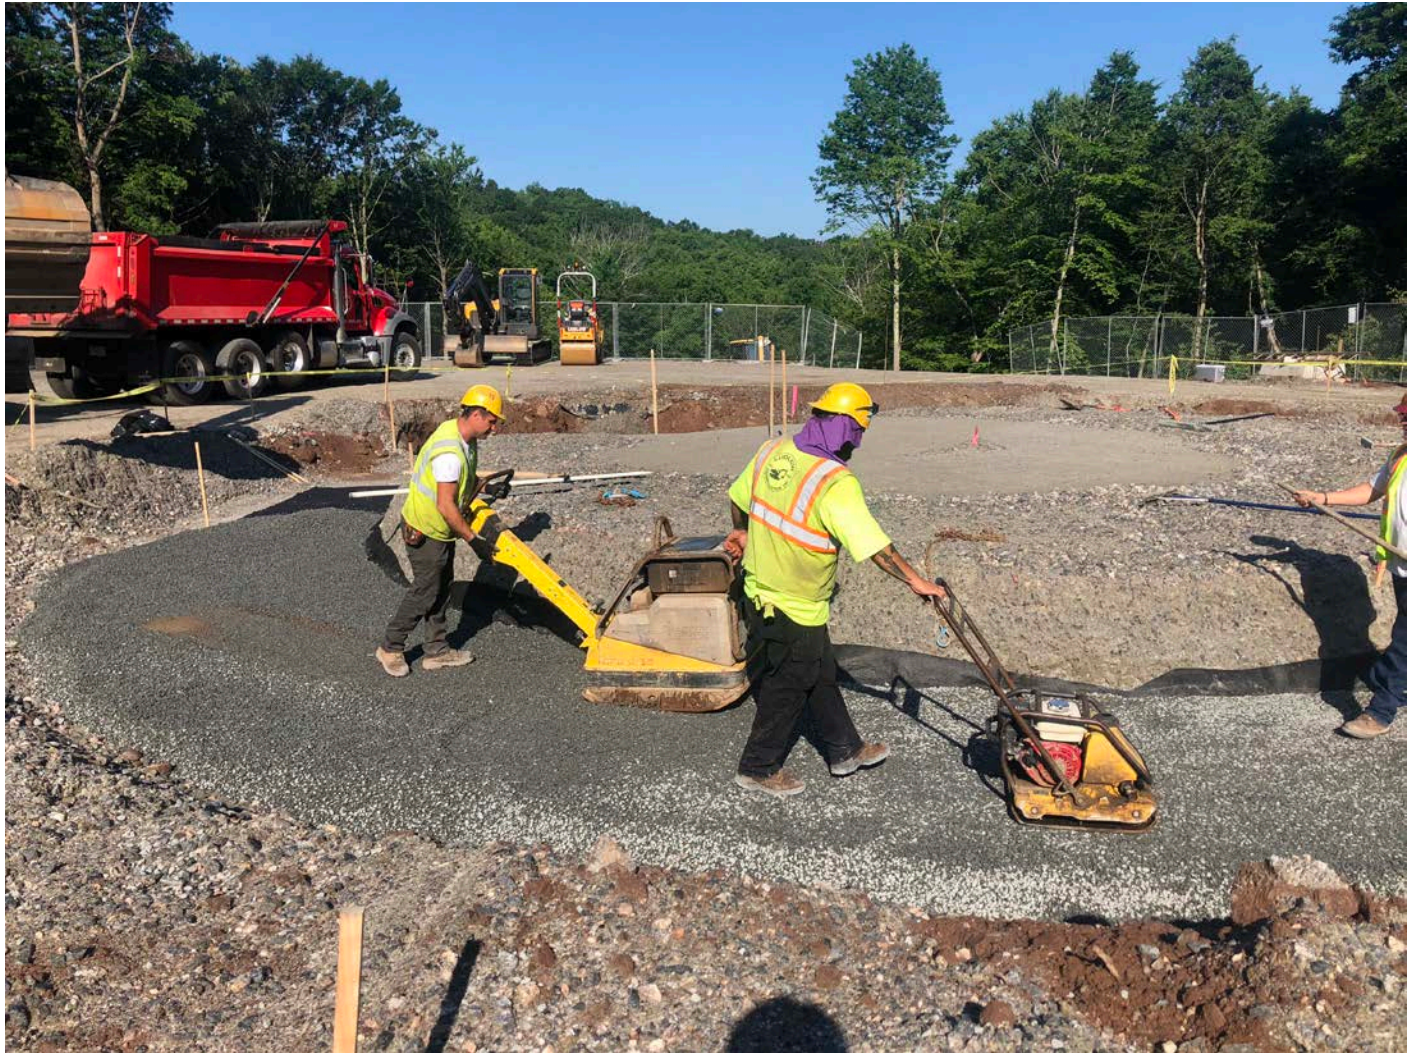
Picture 12: Ludlow compacting ½" gravel at elevation 437.5 within the water tank footprint. Shared Access Driveway, Middletown. View to the west.

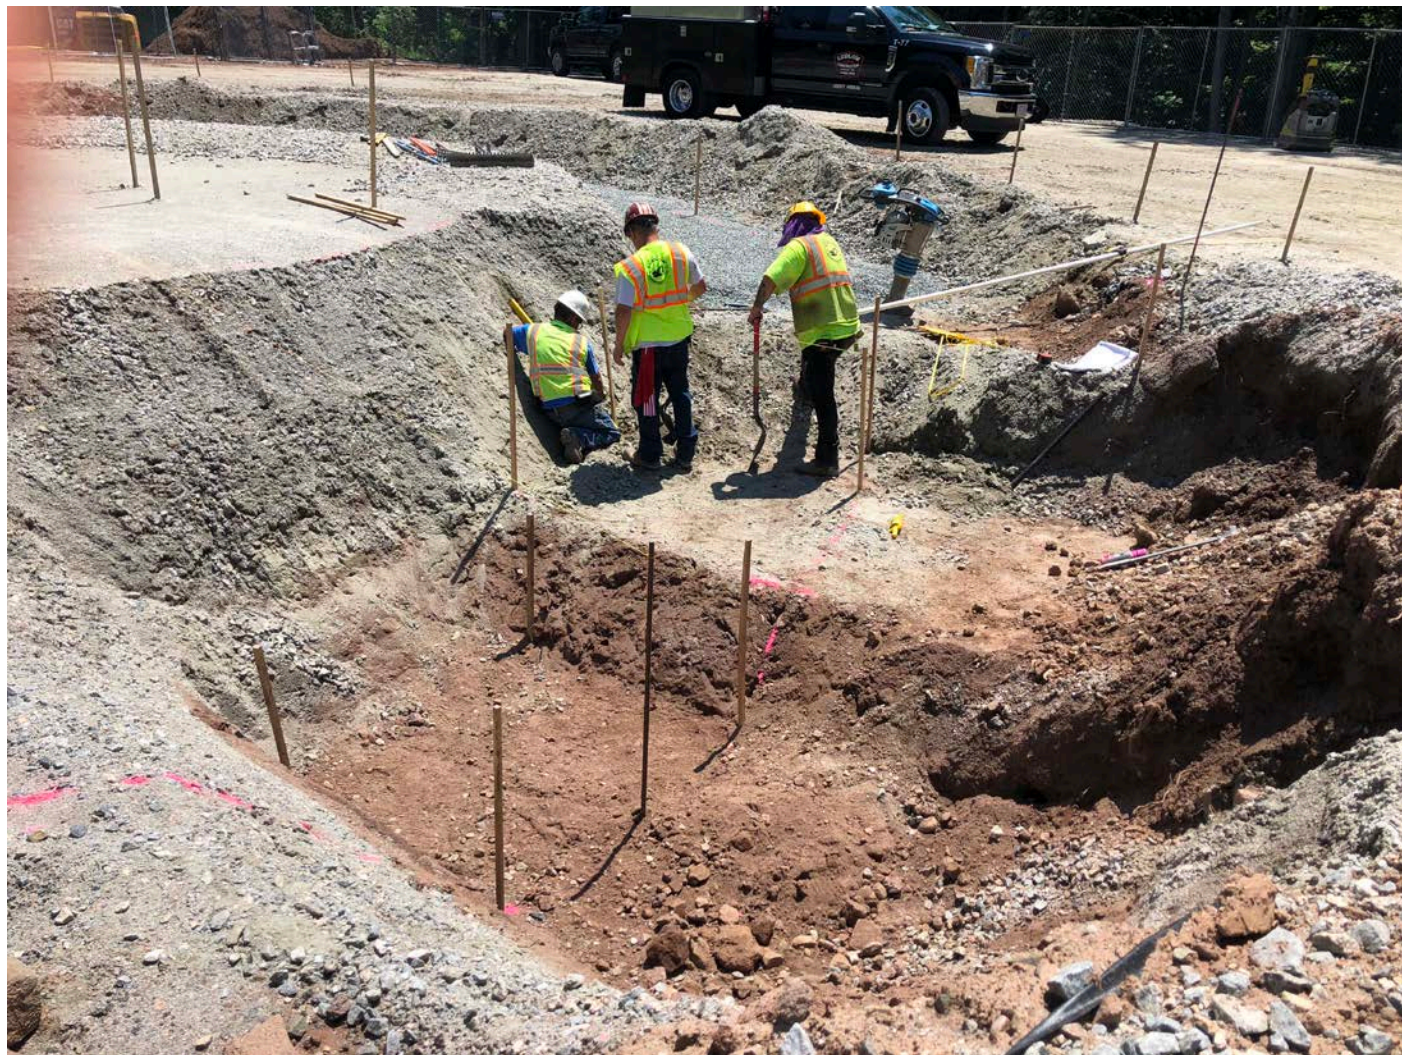
Picture 13: Ludlow refining grades and cuts in fill at the water tank footprint where the tank's supply and feed lines will be placed. Shared Access Driveway, Middletown. View to the southeast.

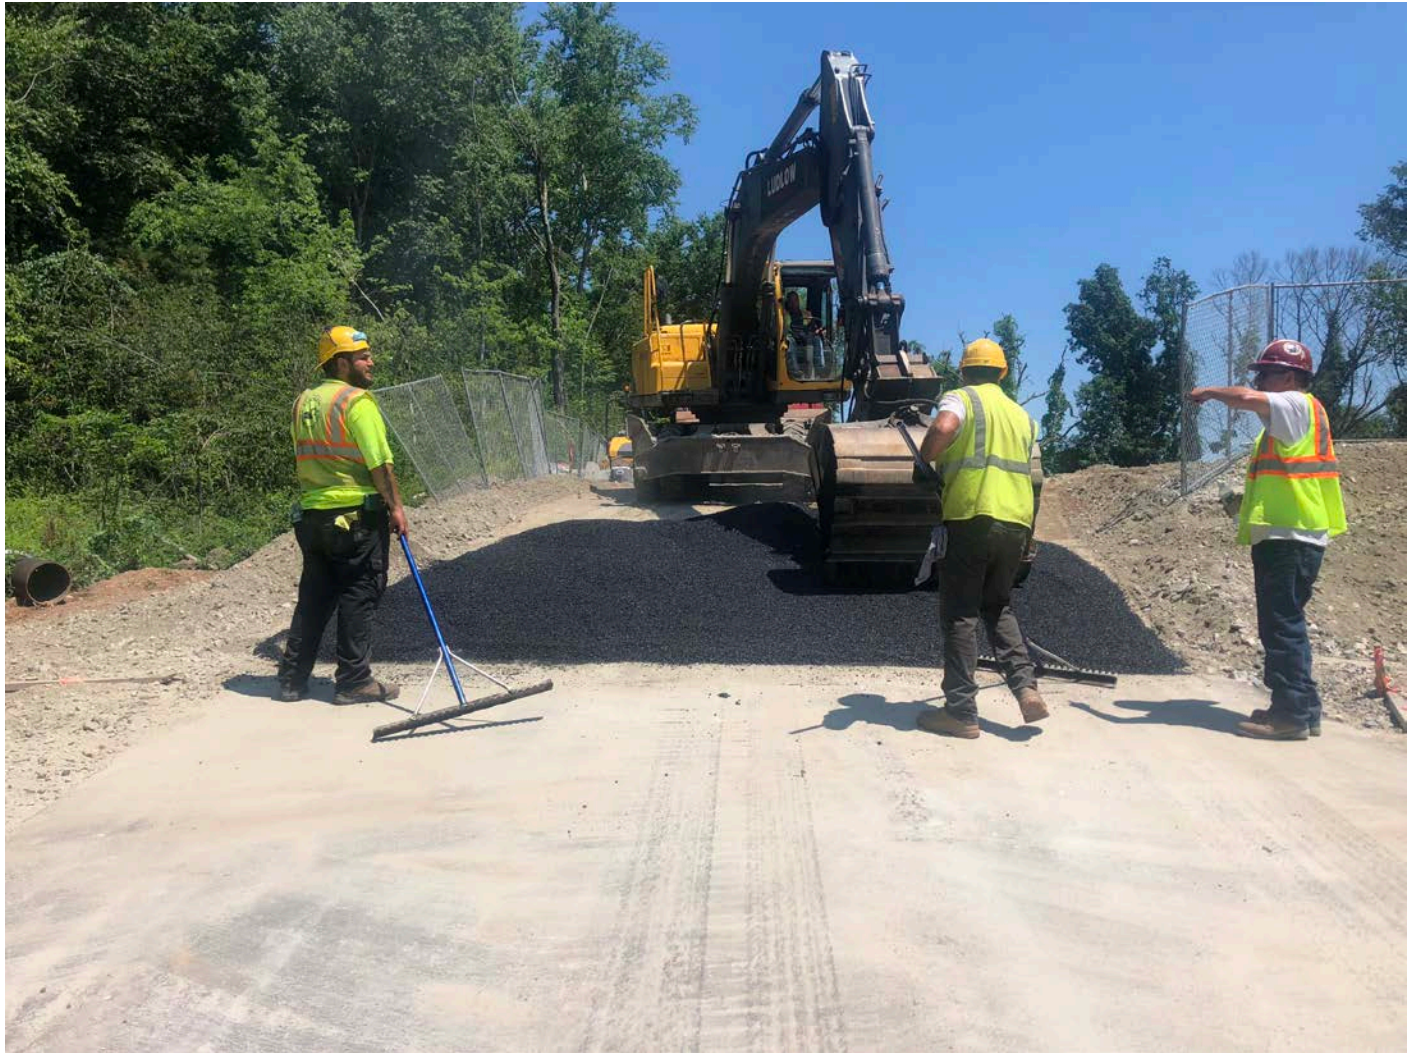
Picture 14: Ludlow extending the Shared Access Driveway to the east by ~30'. View to the east.
