Daily Report

Project:	Durham Meadows Pipeline Installation	Date:	July 27, 2020
Location:	Maple Avenue, Main Street, and the Shared Access Driveway	Day of Week:	Monday
Project #:	AECOM: 6061487	Report No:	128
Contractor:	Ludlow Construction	Page:	3 of 17

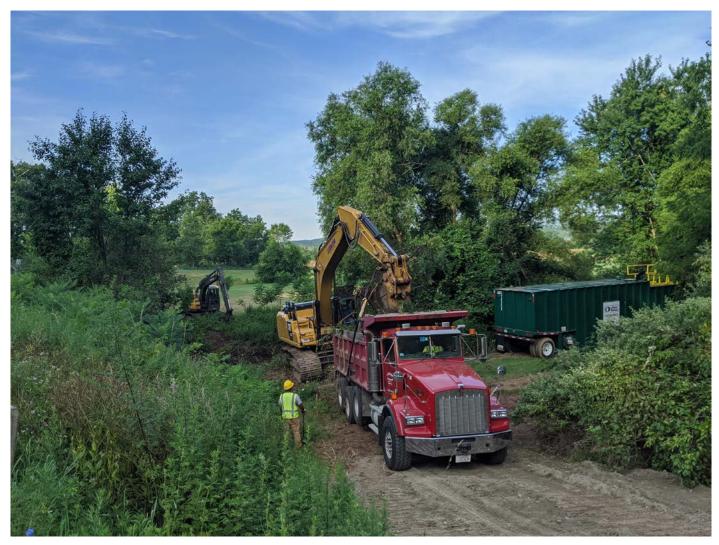
0716: Ludlow began to remove brush from the stream bed and load it into a dump truck.

Picture 1: Ludlow construction removing brush, Maple Avenue, Station 905. View to the south.

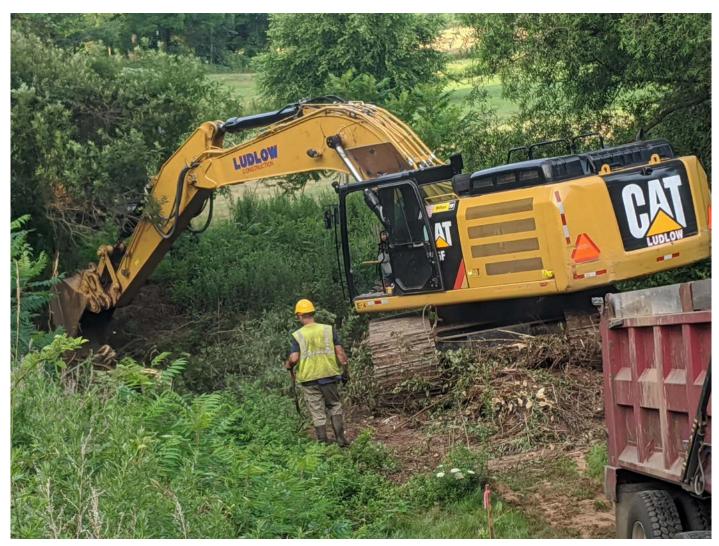
Picture 2: Ludlow construction removing brush, Maple Avenue, Station 905. View to the south.

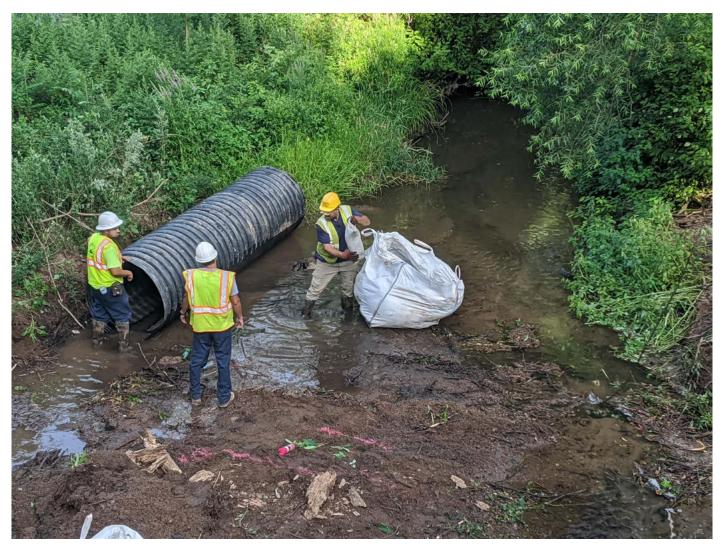
0740: Ludlow began to place large sandbags and sheets of poly in the stream bed.

0800: Ludlow began to place two sections of corrugated pipe parallel with the stream bed to divert the flow.

Picture 3: Ludlow construction installing sandbags and corrugated piping in the stream bed, Maple Avenue, Station 905. View to the west.

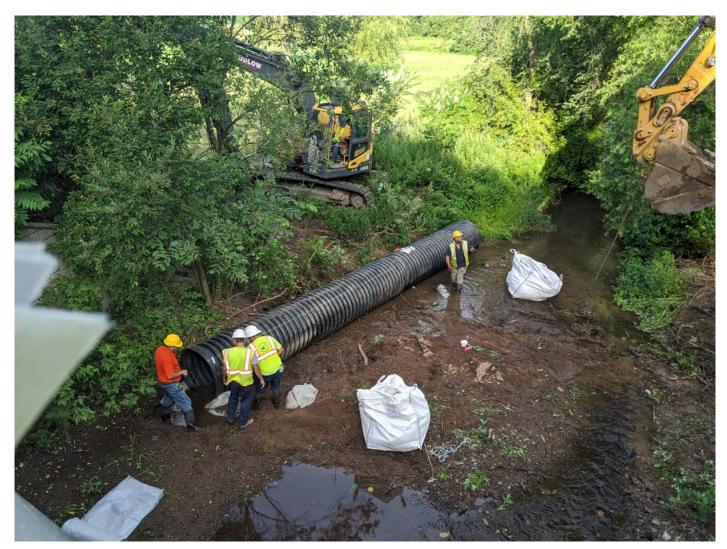
Picture 4: Ludlow construction installing sandbags and corrugated piping in the stream bed, Maple Avenue, Station 905. View to the west.

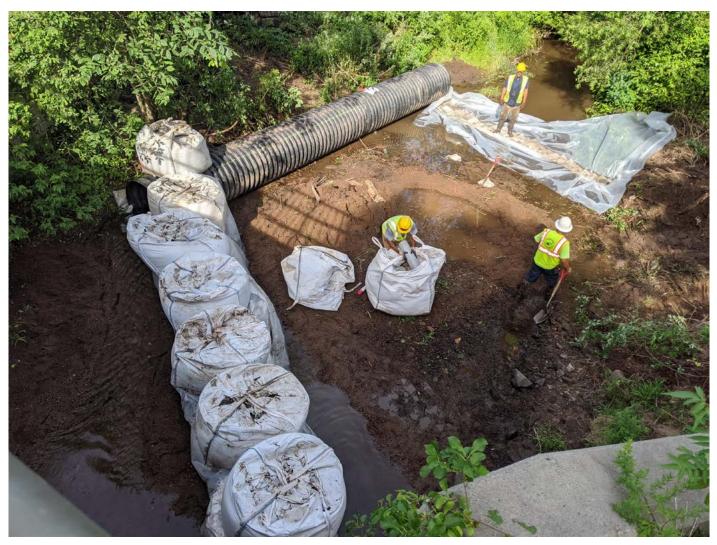
Picture 5: Ludlow construction installing sandbags and corrugated piping in the stream bed, Maple Avenue, Station 905. View to the west.

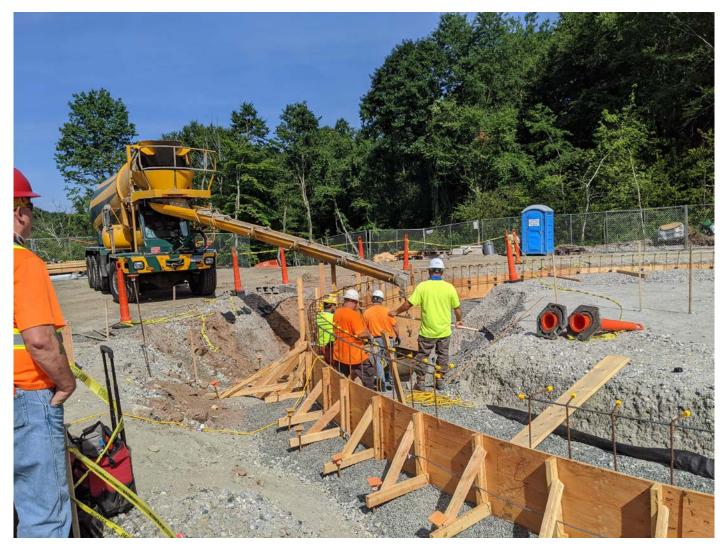
DN Tanks continued to construct forms for the water tank. Four (4) yards of concrete was poured at the tank site.

Picture 6: DN Tanks placing concrete around a pipe for the water tank, Shared Access Driveway. View to the west.

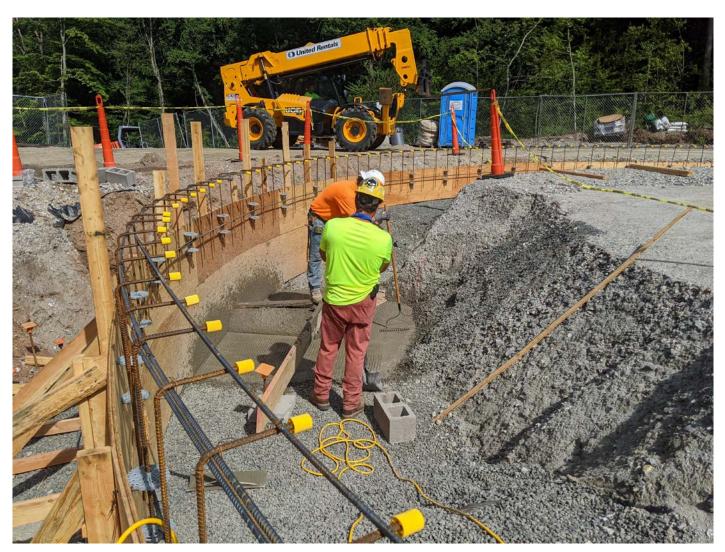
Picture 7: DN Tanks placing concrete around a pipe for the water tank, Shared Access Driveway. View to the west.

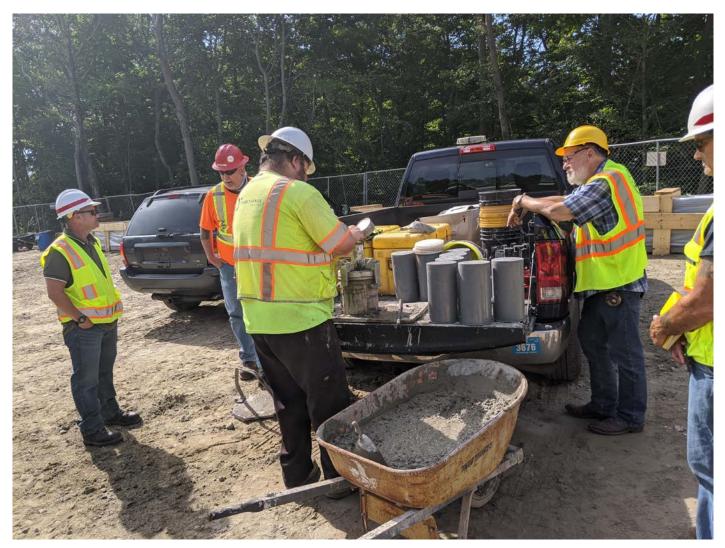
0930: Concrete mixer onsite to begin concrete pour. JTC and ACE onsite to see pour and conduct testing on the concrete.

Picture 8: JTC testing the concrete being placed, Shared Access Driveway. View to the east.

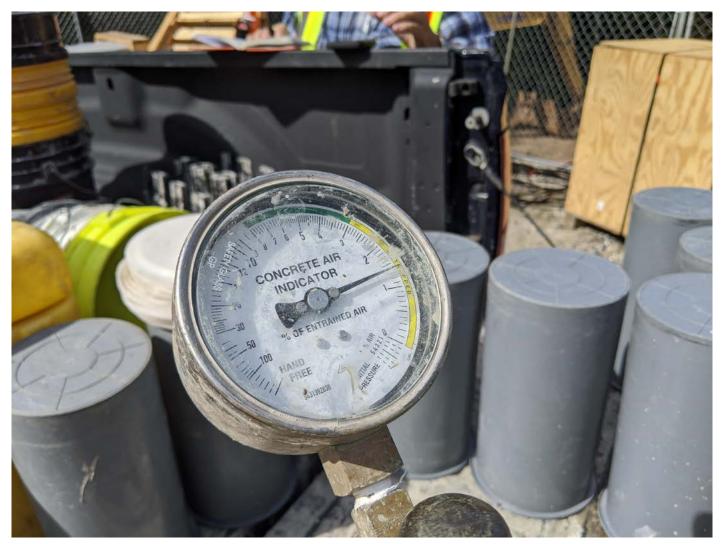
Picture 9: Concrete air entrainment indicator reading 1.4, Water Tank, Shared access driveway.

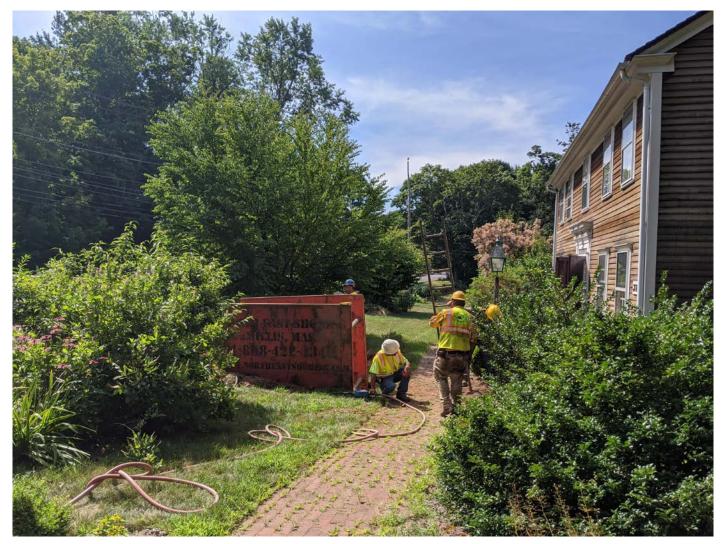
1028: Ludlow began to install curb stop at the property on 308 Main Street (178+50). The curb stop is approximately 50' from the curb.

Picture 10: Ludlow construction installing curb stop, 308 Main Street, Station 178+50. View to the south.

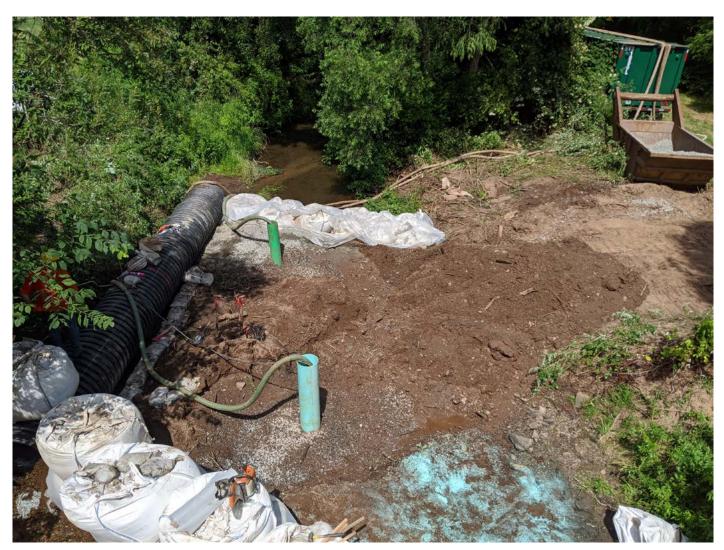
1055: Ludlow created to sumps in the stream bed and began to pump water into a large frac tank.

Picture 11: Water being pumped from sumps into frac tank, Maple Avenue, Station 905. View to the west.

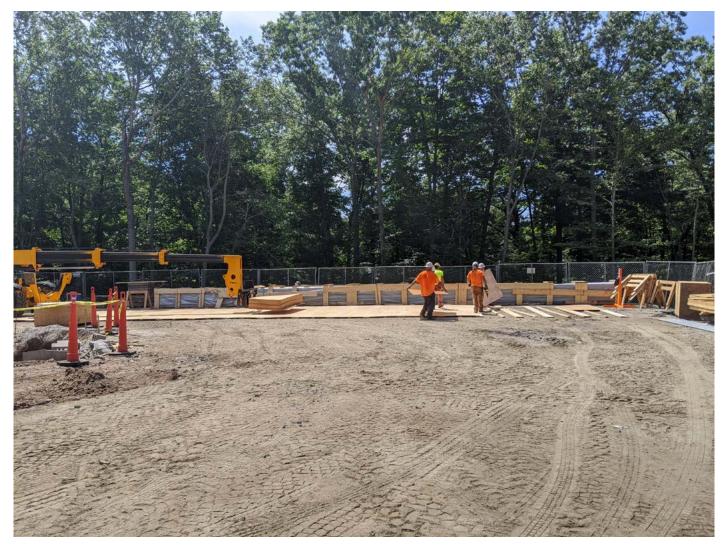
1123: DN Tanks building forms for the tank wall.

Picture 12: DN Tanks constructing concrete forms for water tank side panels, Shared access driveway. View to the east.

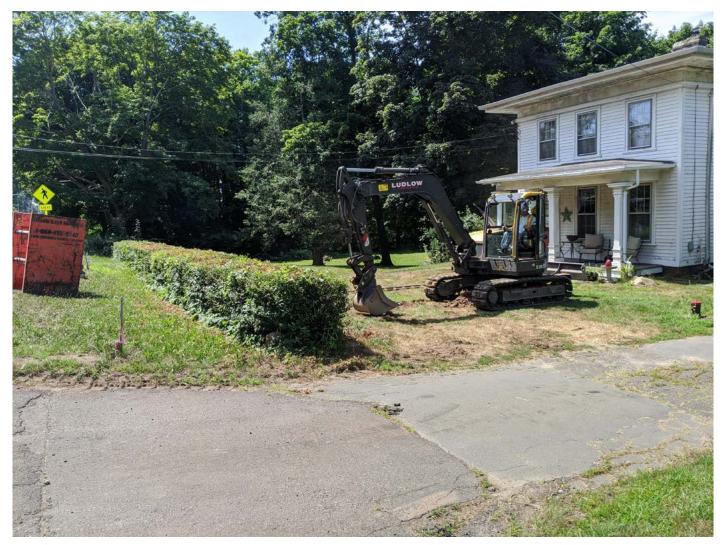
1316: Ludlow installed the curb stop at 289 Main Street. The curb stop is approximately 37' from the curb.

Picture 13: Ludlow construction installing curb stop, 289 Main Street, Station 180+00. View to the south.

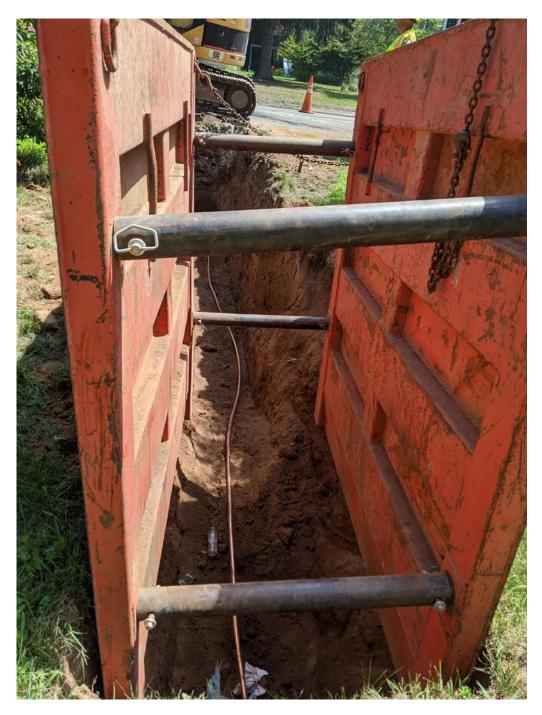
0830: Ludlow began to rock hammer in front of the house on 318 Main Street (176+50). The trench line was dug for the service line and the curb stop. The curb stop is approximately 27' off the curb. An 8*4*4 piece of sidewalk was removed due to ledge.

Picture 14: Ludlow construction installing curb stop, 318 Main Street, Station 178+50. View to the east.
