## Daily Report

<b>Project:</b>	Durham Meadows Pipeline Installation	<b>Date:</b>	August 20, 2020
<b>Location:</b>	Maple Avenue and Main Street, Durham; Shared Access Driveway, Middletown	<b>Day of Week:</b>	Thursday
<b>Project #:</b>	AECOM: 6061487	<b>Report No:</b>	142
<b>Contractor:</b>	Ludlow Construction	<b>Page:</b>	1 of 11

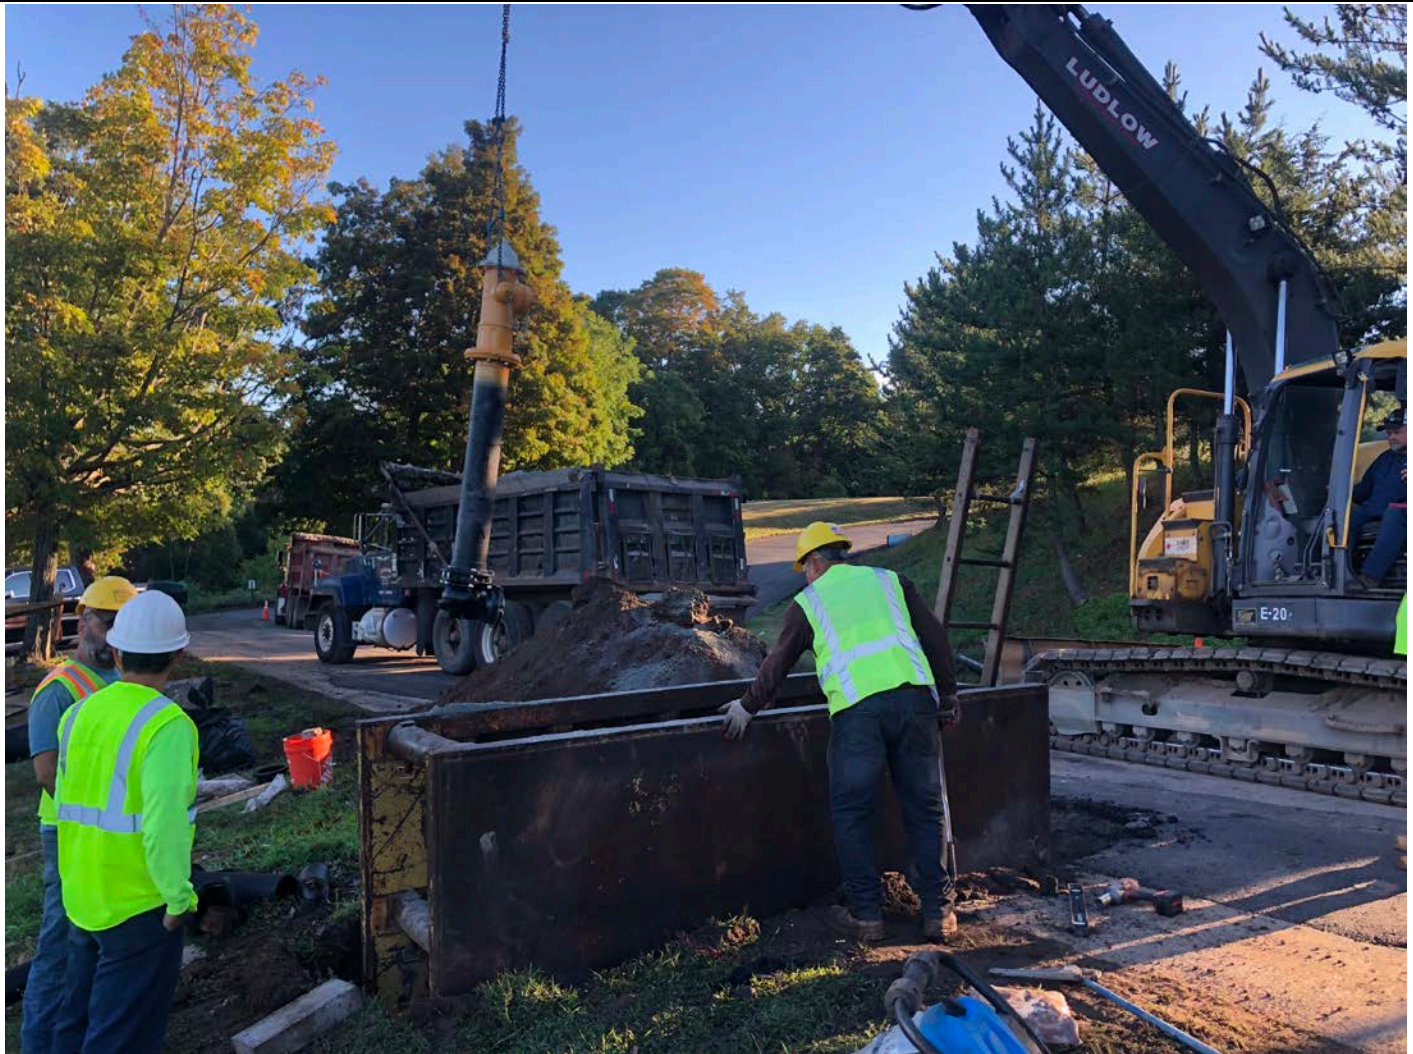
0811: Ludlow has the hydrant at Station 900+87.5 installed and is currently backfilling.

Picture 1: Ludlow installing a hydrant at Station 900+87.5. Maple Avenue, Durham. View to the north.

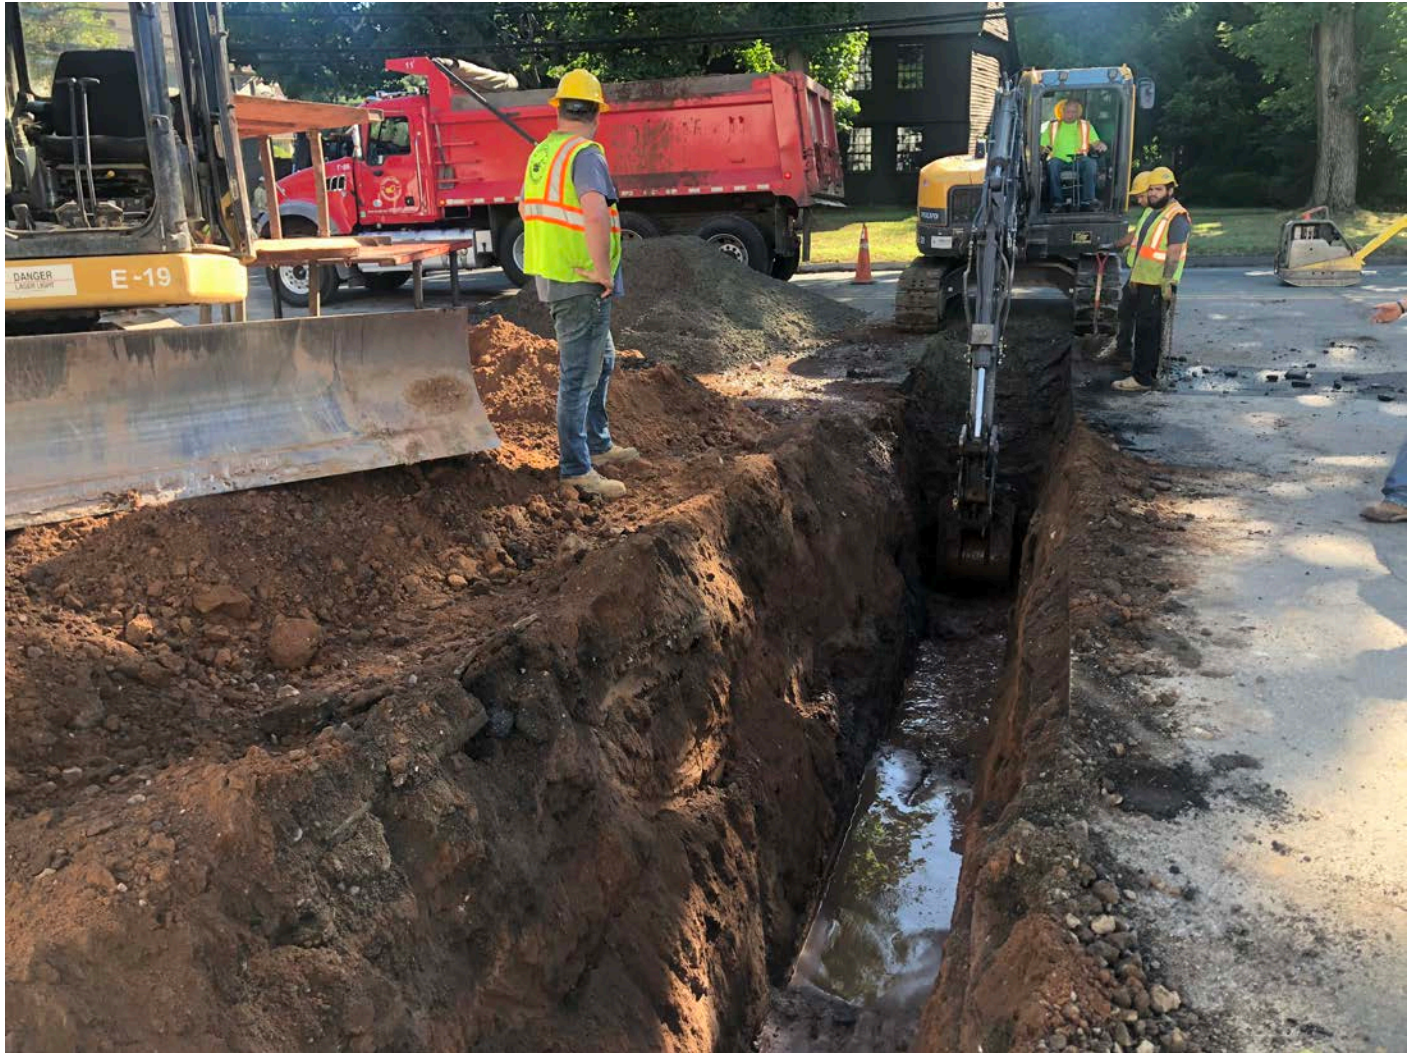
0850: Ludlow encounters some water in the trench at Station 193+18 while installing a curb stop. Ludlow is not pumping the water from the trench.

Picture 2: Ludlow trenching at Station 193+18 (238 Main Street, Durham) for the installation of a curb stop. View to the east.

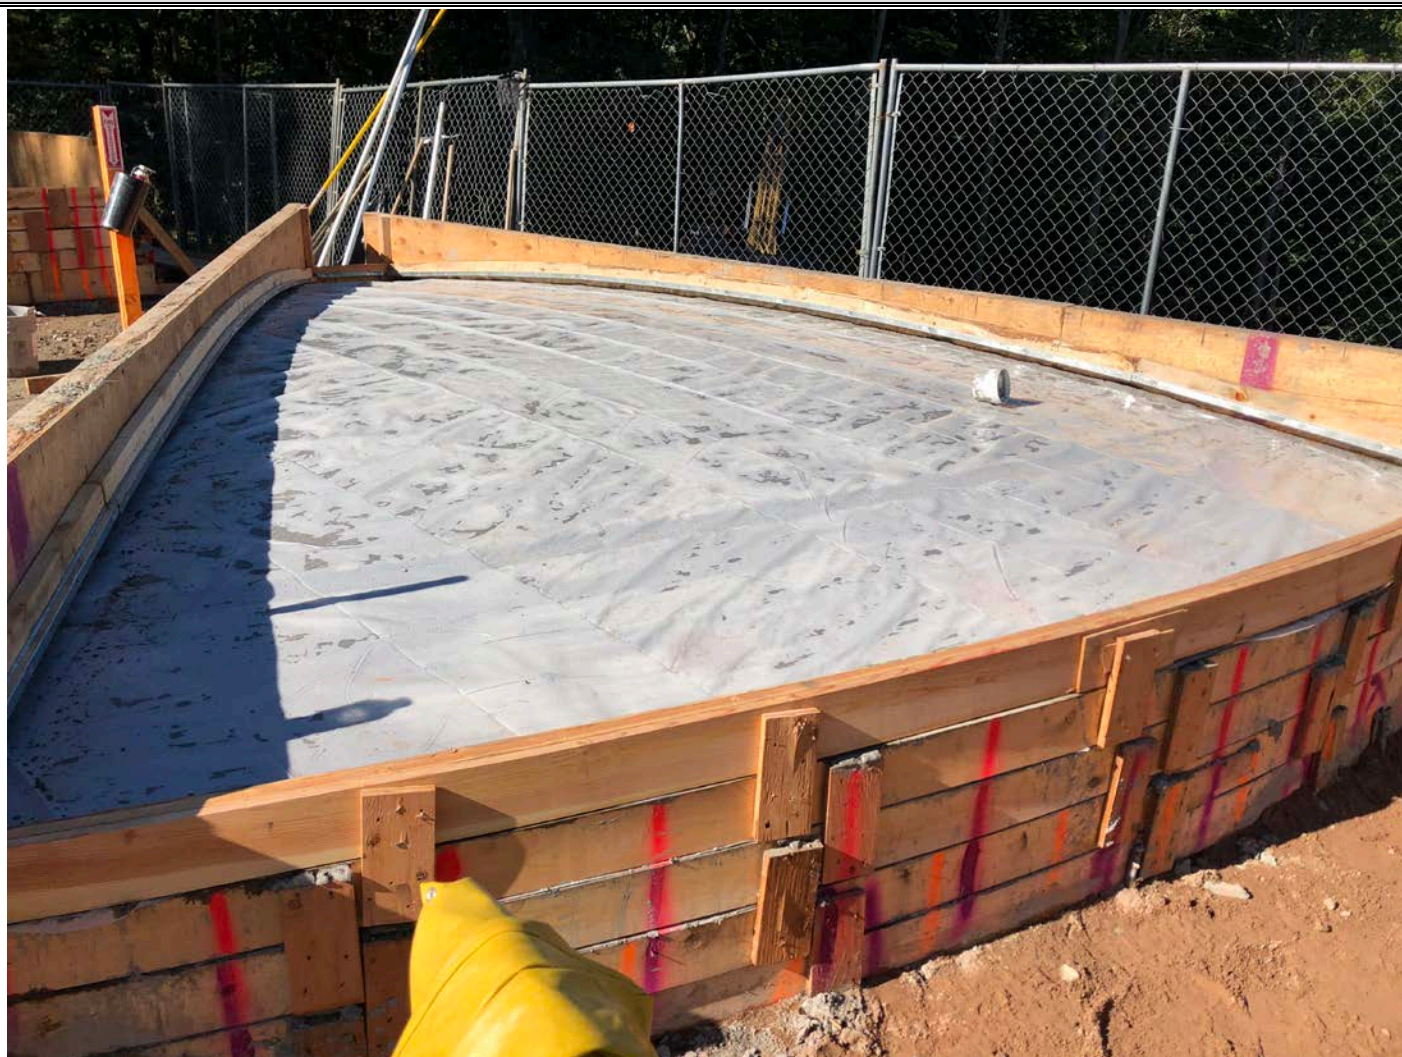
**Picture 3: One of the two concrete forms for the water tank's top, where poly sheeting was placed over setting concrete. Water tank work zone, east of the Shared Access Driveway, Middletown.**

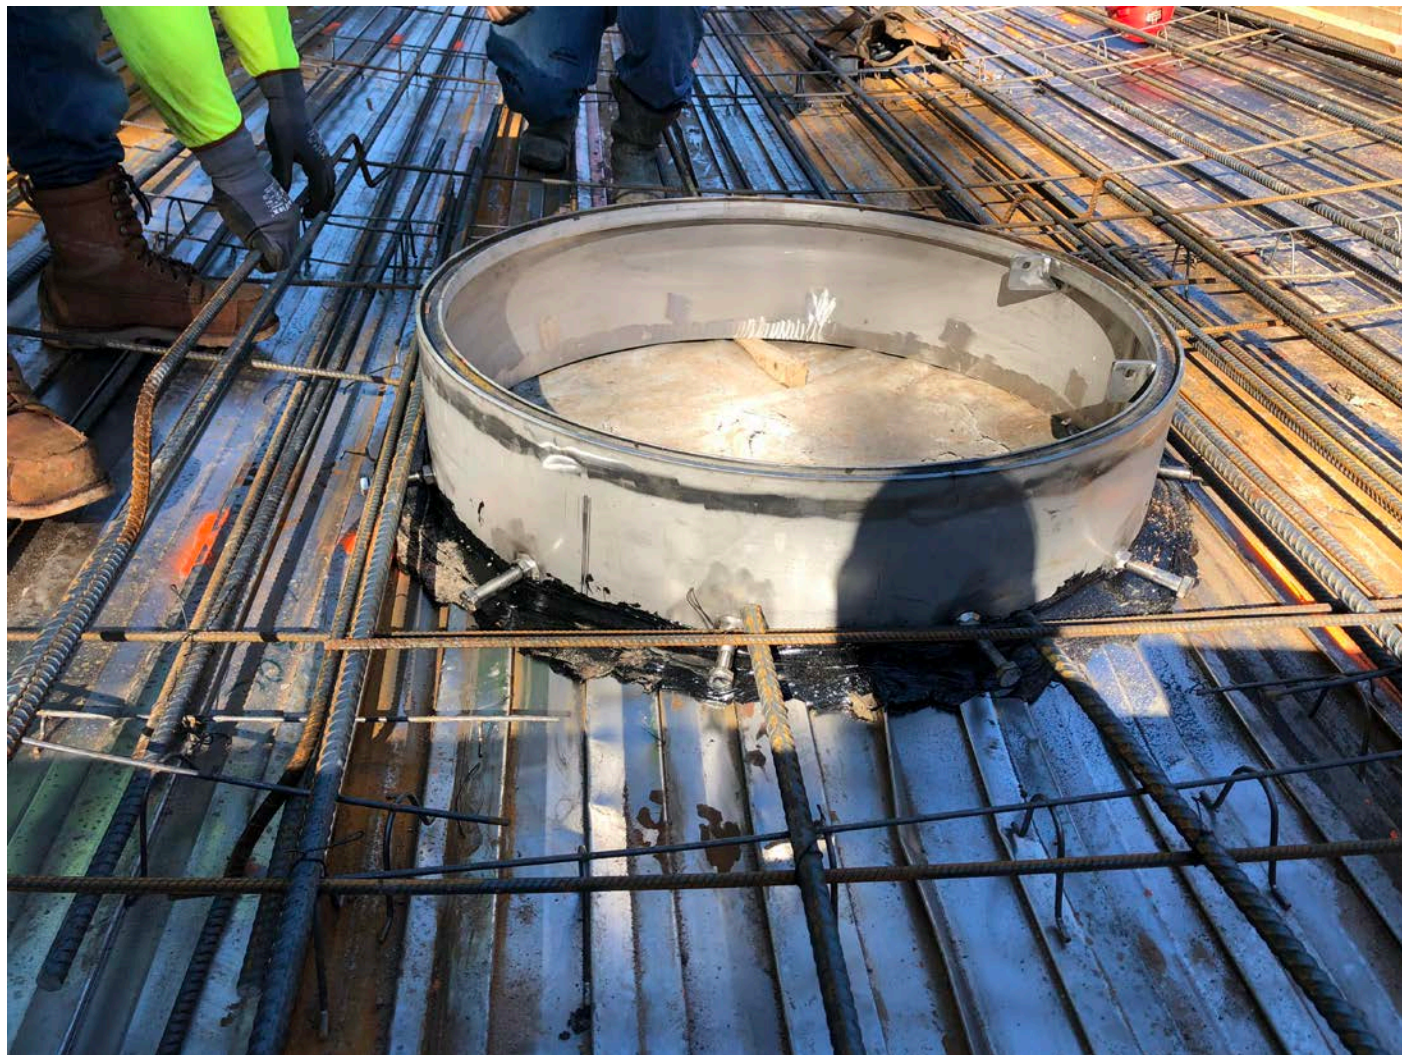
0916: Northeastern Steel has 4 laborers placing and fastening rebar on the concrete forms for the water tanks. Rebar has already been placed on the first of two water tank side panel forms. This includes the placement of a steel manway that is 37" in diameter. JTC is on site waiting for the first truck of 4000 PSI concrete to arrive in order to collect samples for field and lab analysis.

Picture 4: Rebar placed and fastened on one of the side panel concrete forms, with a 37" diameter manway also secured onto the form. Water tank work zone, east of the Shared Access Driveway, Middletown. View to the west.

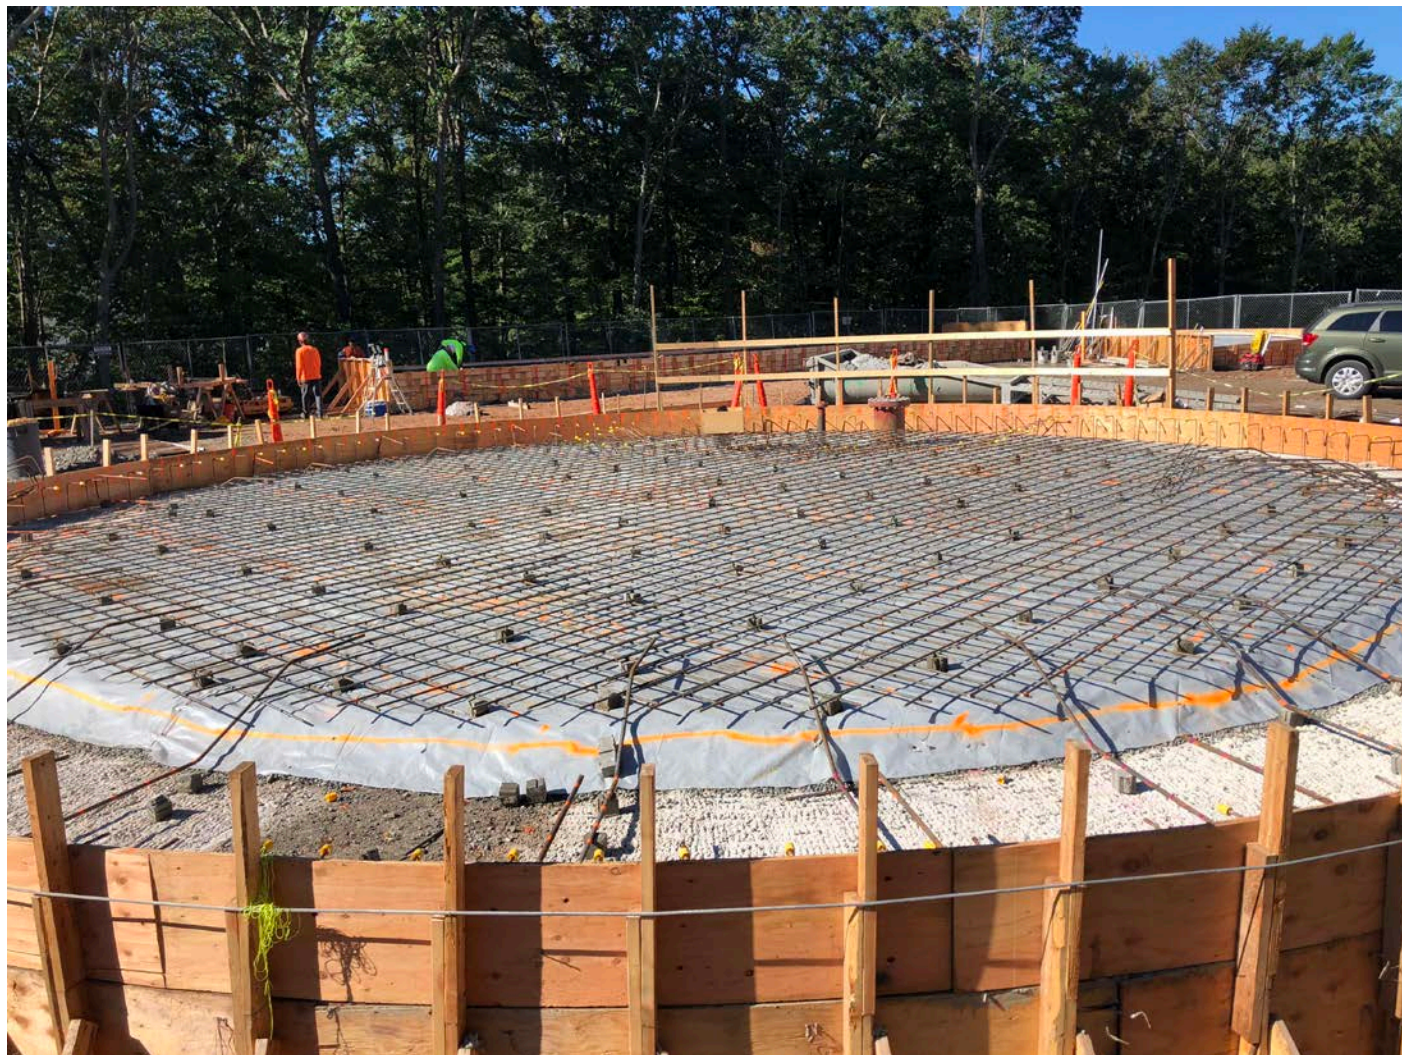
Picture 5: The footprint of the water tank with additional rebar placed since yesterday. Water tank work zone, east of the Shared Access Driveway, Middletown. View to the south.

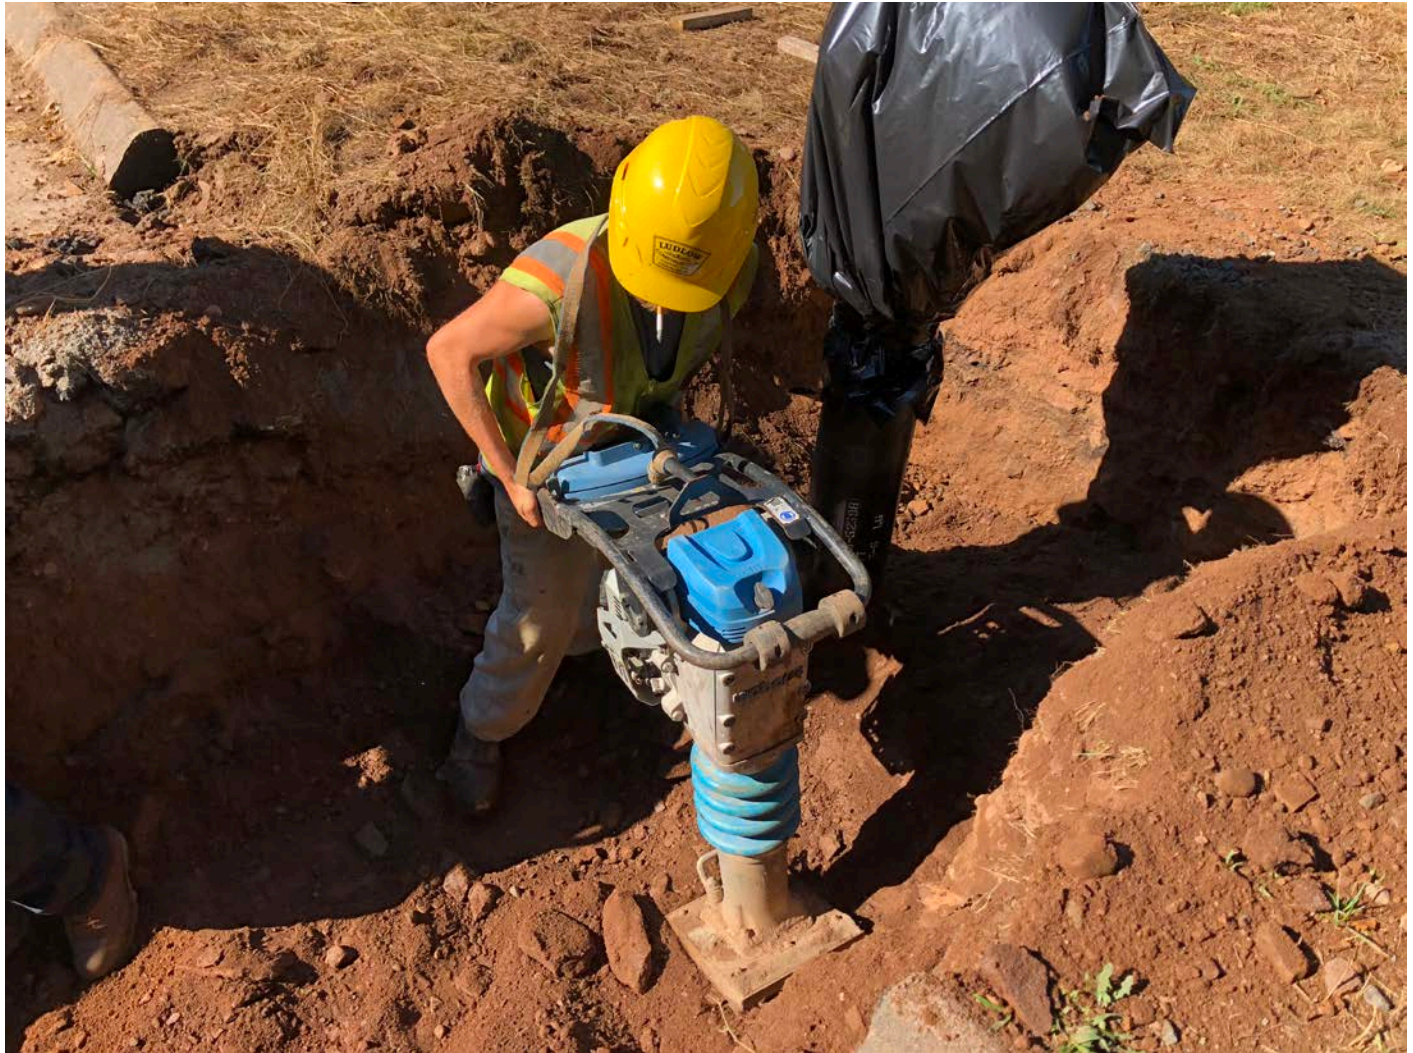
0842: Ludlow is excavating at Station 906+90 on Maple Avenue, Durham, in order to install a hydrant.

**Picture 6: Ludlow compacting soil around a hydrant that they are in the process of installing at Station 906+90. Maple Avenue, Durham.**

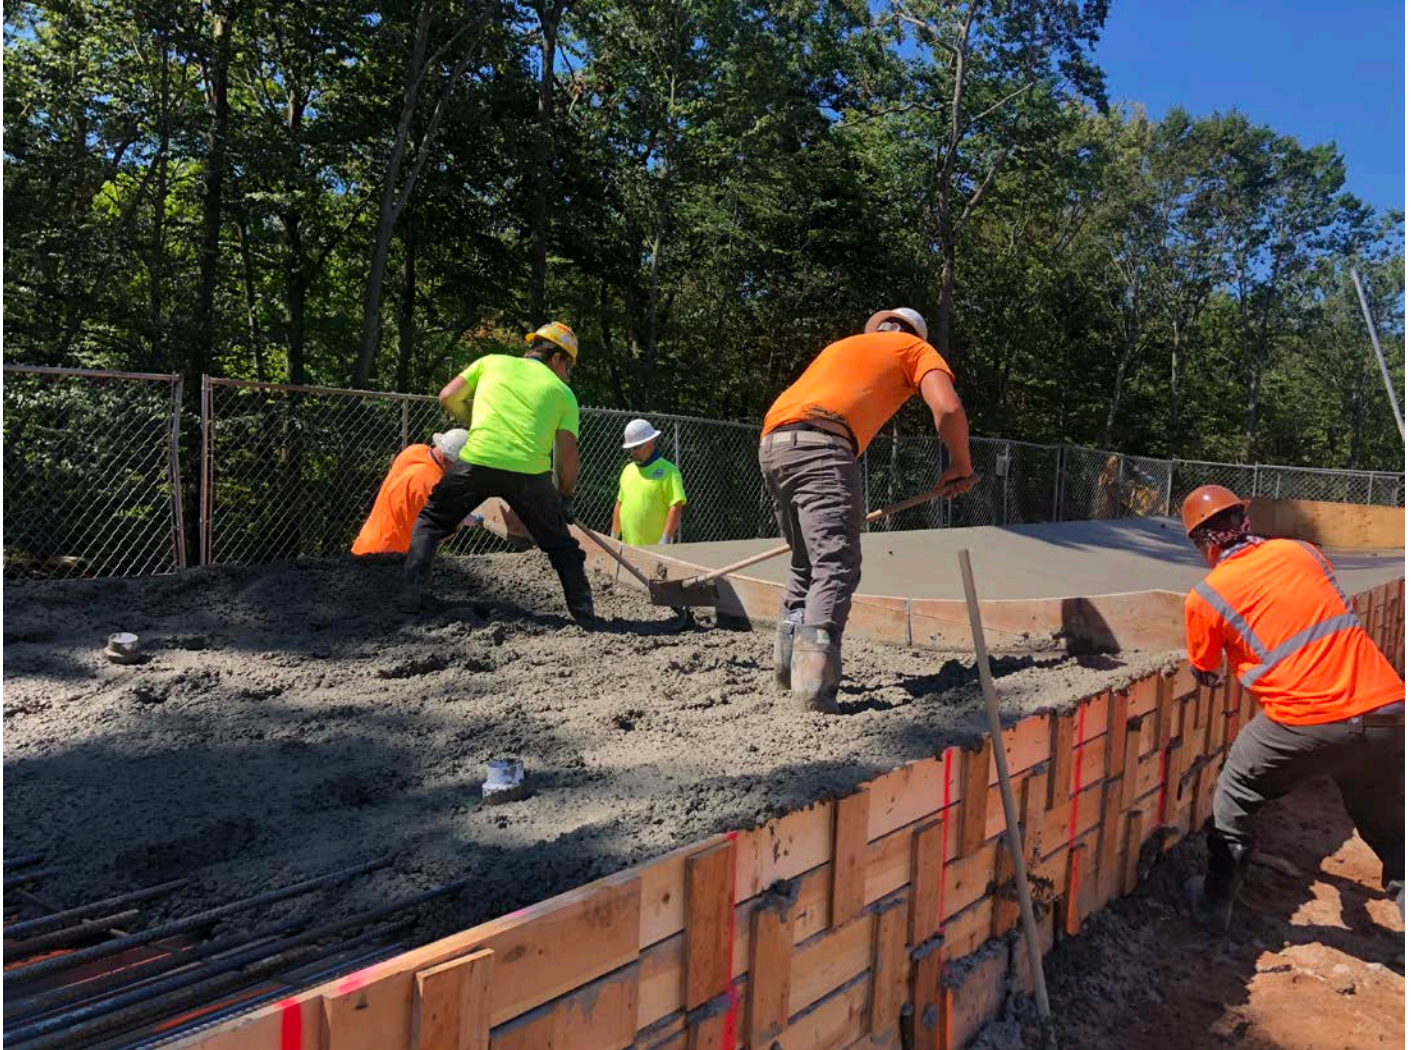
1402: The fourth truck of 4000 PSI cement has just arrived at the water tank work zone. DN Tanks has covered the concrete that was placed on the first water tank side panel form with poly sheeting. They have the second water tank side panel form half-filled with concrete. Ludlow rejected the third truck of concrete, as the percent air was 9.0%.

**Picture 7: DN Tanks placing 4000 PSI concrete on the first of two concrete forms for the side panels of the water tank. East of the Shared Access Driveway, Middletown. View to the west.**

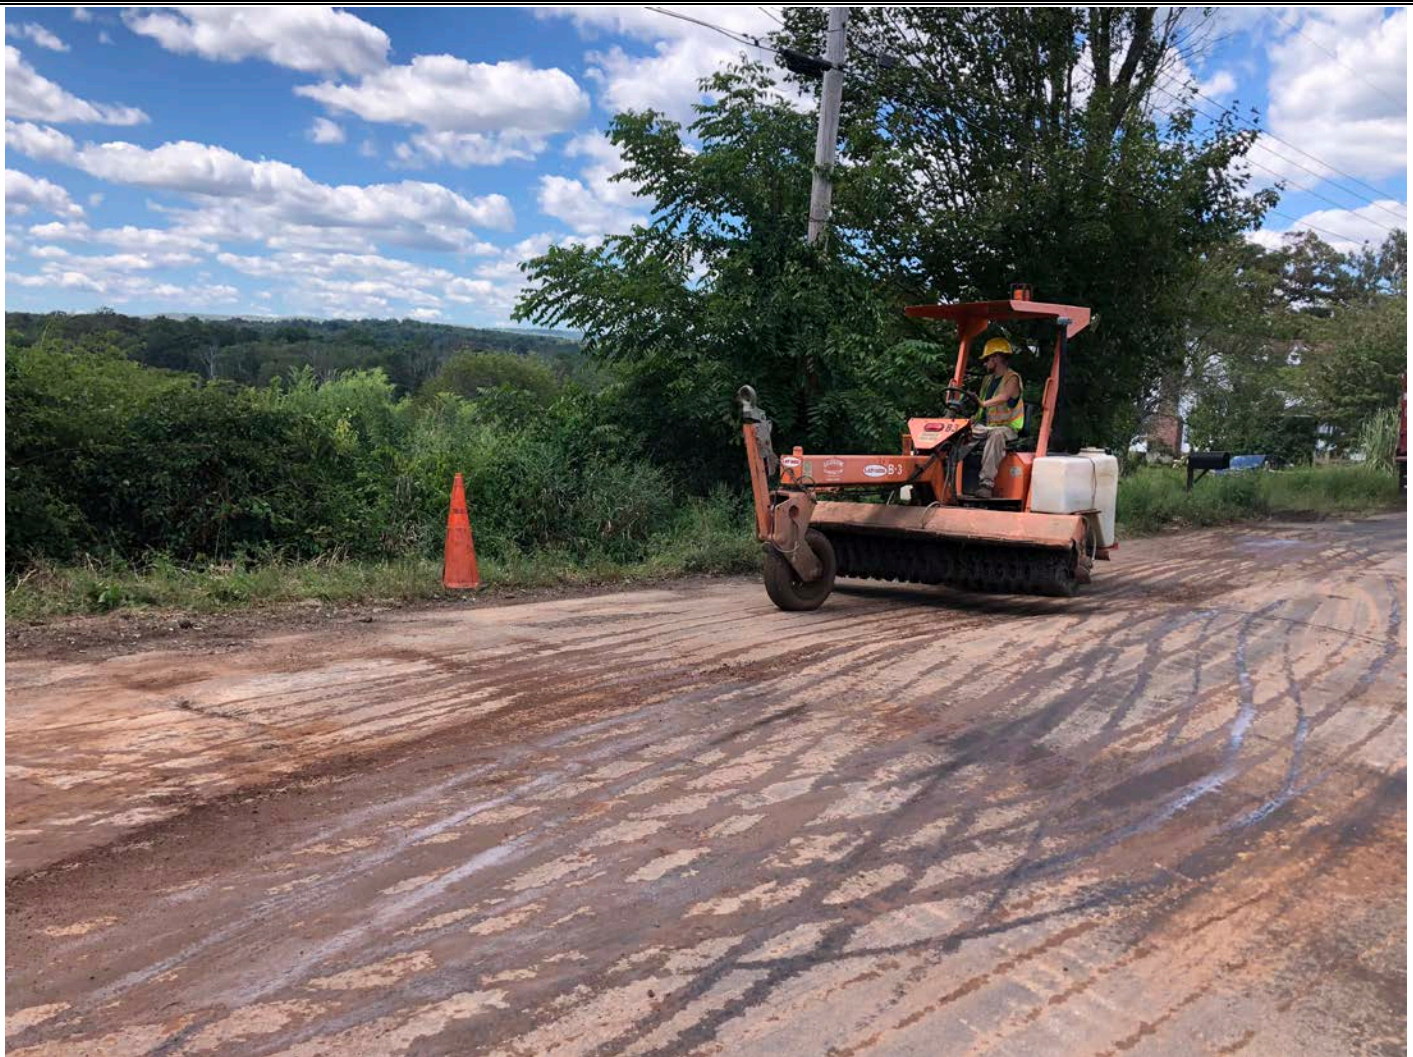
1304: Ludlow has finished installing a hydrant at Station 918+38 on Maple Avenue, Durham. Ludlow is currently cleaning up the road with the Broce Broom and demobilizing equipment from the work zone.

Picture 8: Ludlow cleaning up work zone after having installed a hydrant at Station 918+38. Maple Avenue, Durham. View to the west.
