Daily Report

Project:	Durham Meadows Pipeline Installation	Date:	August 28, 2020
Location:	Maple Avenue and the Shared Access Driveway, Middletown	Day of Week:	Friday
Project #:	AECOM: 6061487	Report No:	148
Contractor:	Ludlow Construction	Page:	1 of 13

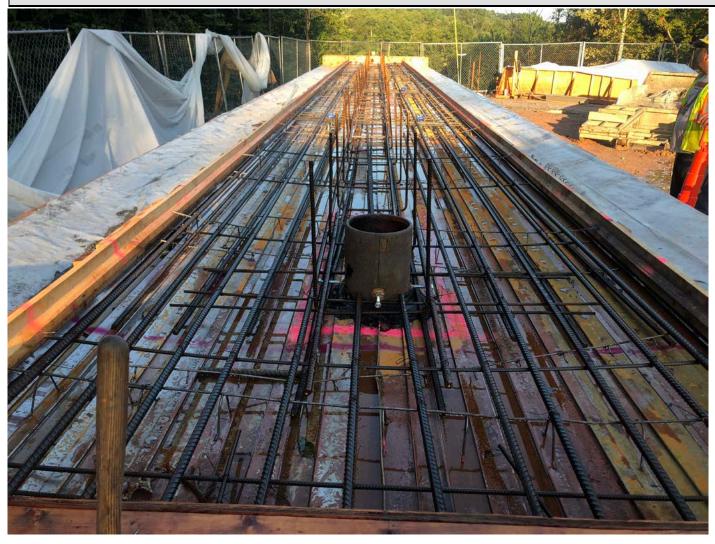
Picture 1: Narrow water tank side panel concrete form with rebar fastened into place and ready for concrete pour. Pipe shown is for water tank overflow. Water tank work zone, east of the Shared Access Driveway, Middletown. View to the west.

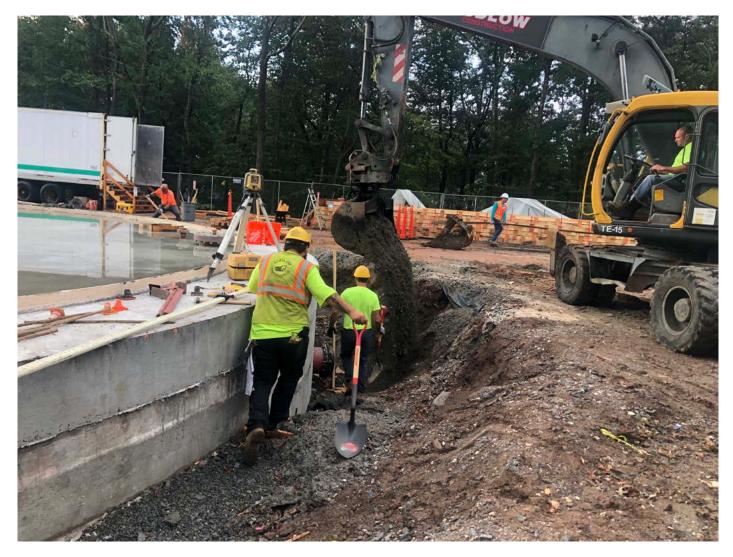
Picture 2: Ludlow placing fill around the periphery of the water tank base. Water tank work zone, east of the Shared Access Driveway, Middletown. View to the south.

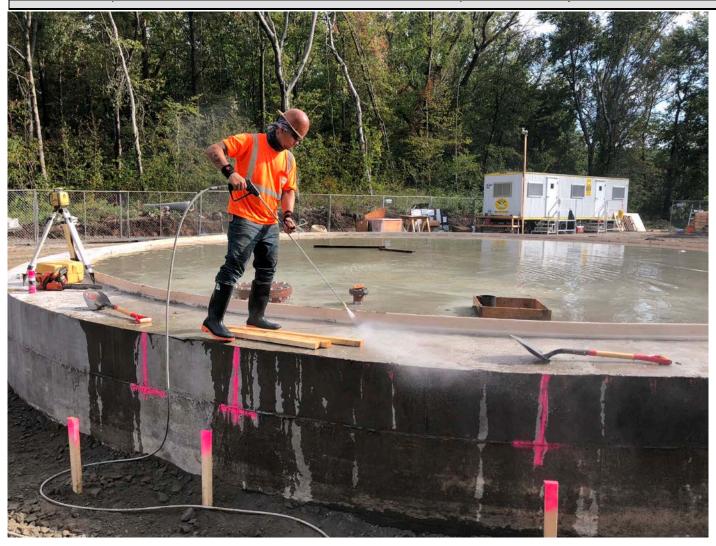
Picture 3: DN Tanks using pressure washer to clean concrete from top of PVC water stop on the water tank base. Water tank work zone, east of the Shared Access Driveway, Middletown. View to the north.

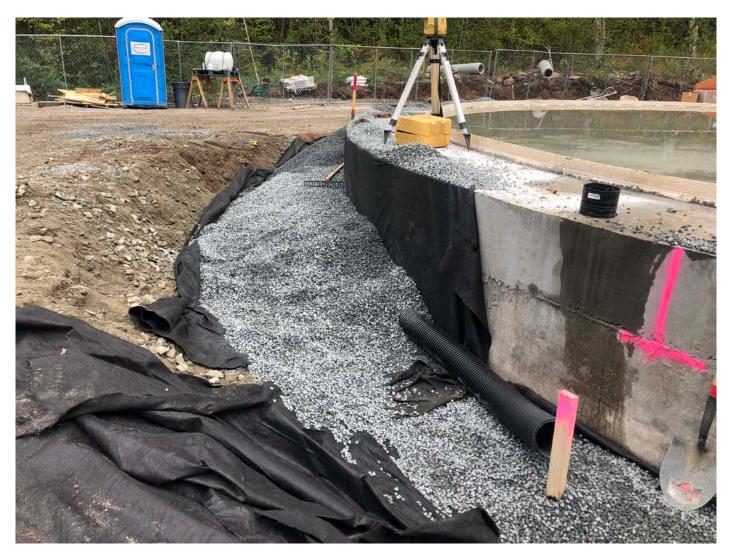
Picture 4: Ludlow installing 6" plastic underdrain pipe around the periphery of the water tank base. Water tank work zone, east of the Shared Access Driveway, Middletown. View to the north.

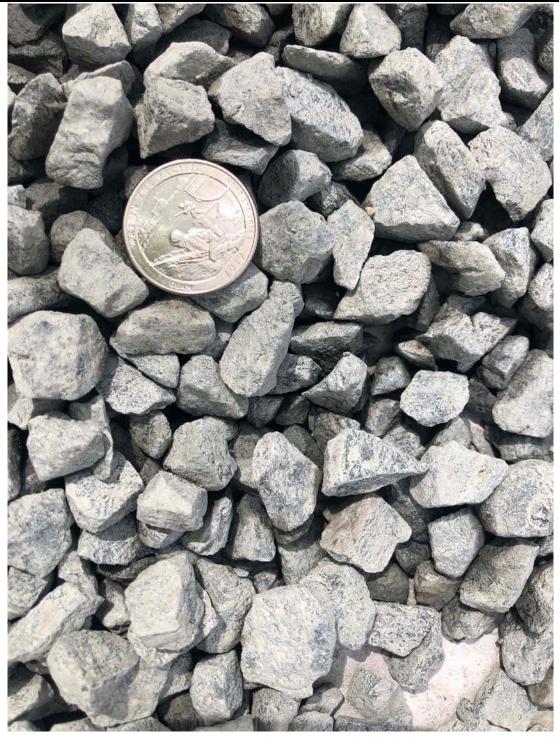
Picture 5: Stone placed around the 6" underdrain pipe placed by Ludlow around the periphery of the water tank base. Water tank work zone, east of the Shared Access Driveway, Middletown.

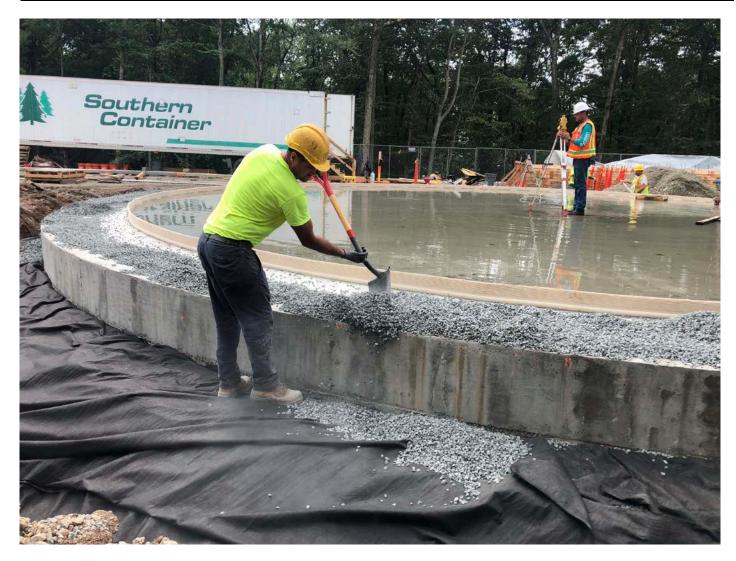
Picture 6: Ludlow placing geotextile fabric covered with stone over the 6" underdrain pipe they just installed around the periphery of the water tank base. Water tank work zone, east of the Shared Access Driveway, Middletown. View to the south.

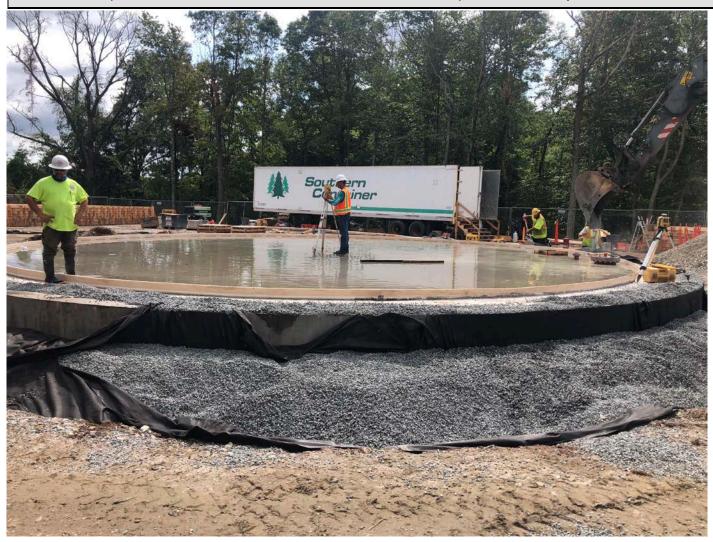
Picture 7: Another view of the geotextile fabric covered with stone that was placed over the 6" underdrain pipe that Ludlow installed around the periphery of the water tank base. Water tank work zone, east of the Shared Access Driveway, Middletown. View to the west.

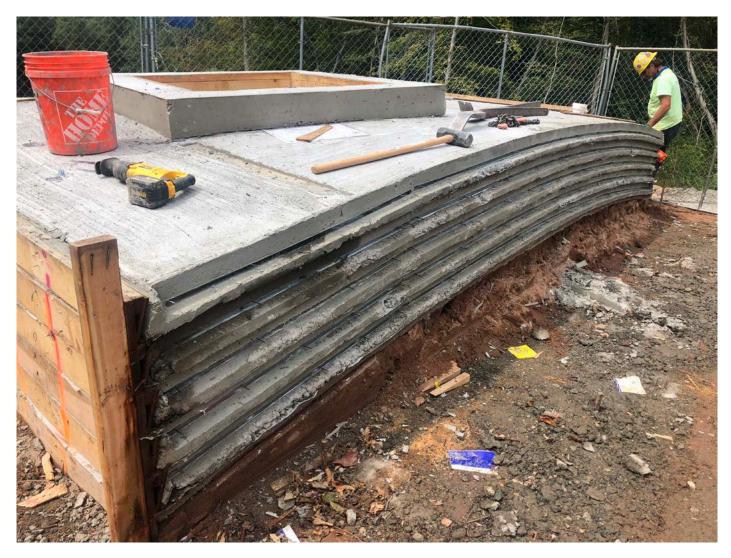
Picture 8: Water tank dome panels with the side of the concrete form removed. Water tank work zone, east of the Shared Access Driveway, Middletown. View to the northwest.

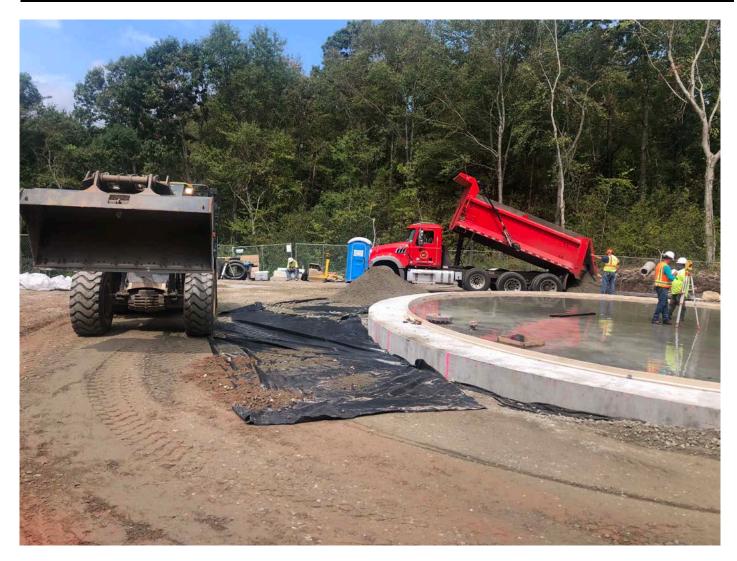
Picture 9: Ludlow placing geotextile fabric covered with gravel to finish the installation of the 6" underdrain pipe they just installed around the periphery of the water tank base. Water tank work zone, east of the Shared Access Driveway, Middletown. View to the north.

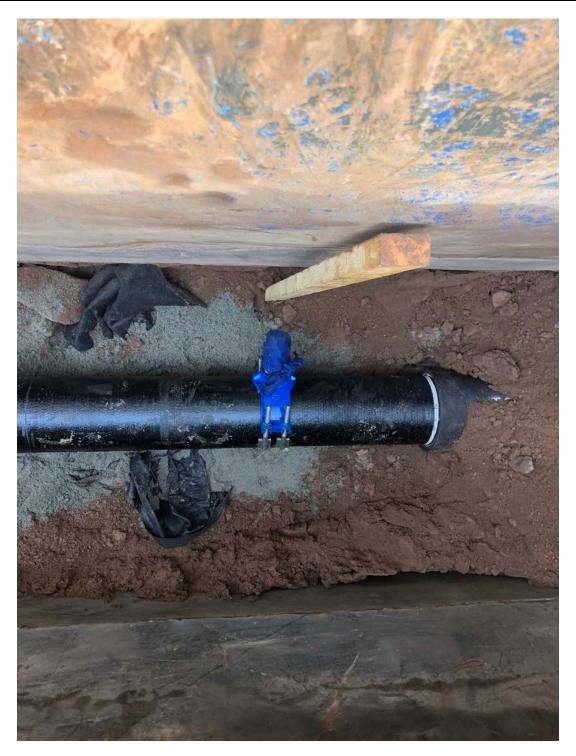
Picture 10: 1.5" corporation stop installed by Ludlow on Maple Avenue, Durham at Station 934+68.
