Daily Report

| Project: | Durham Meadows Pipeline Installation | Date: | August 3, 2020 |
| Project #: | AECOM: 6061487 | Report No: | 133 |
| Contractor: | Ludlow Construction | Page: | 1 of 12 |

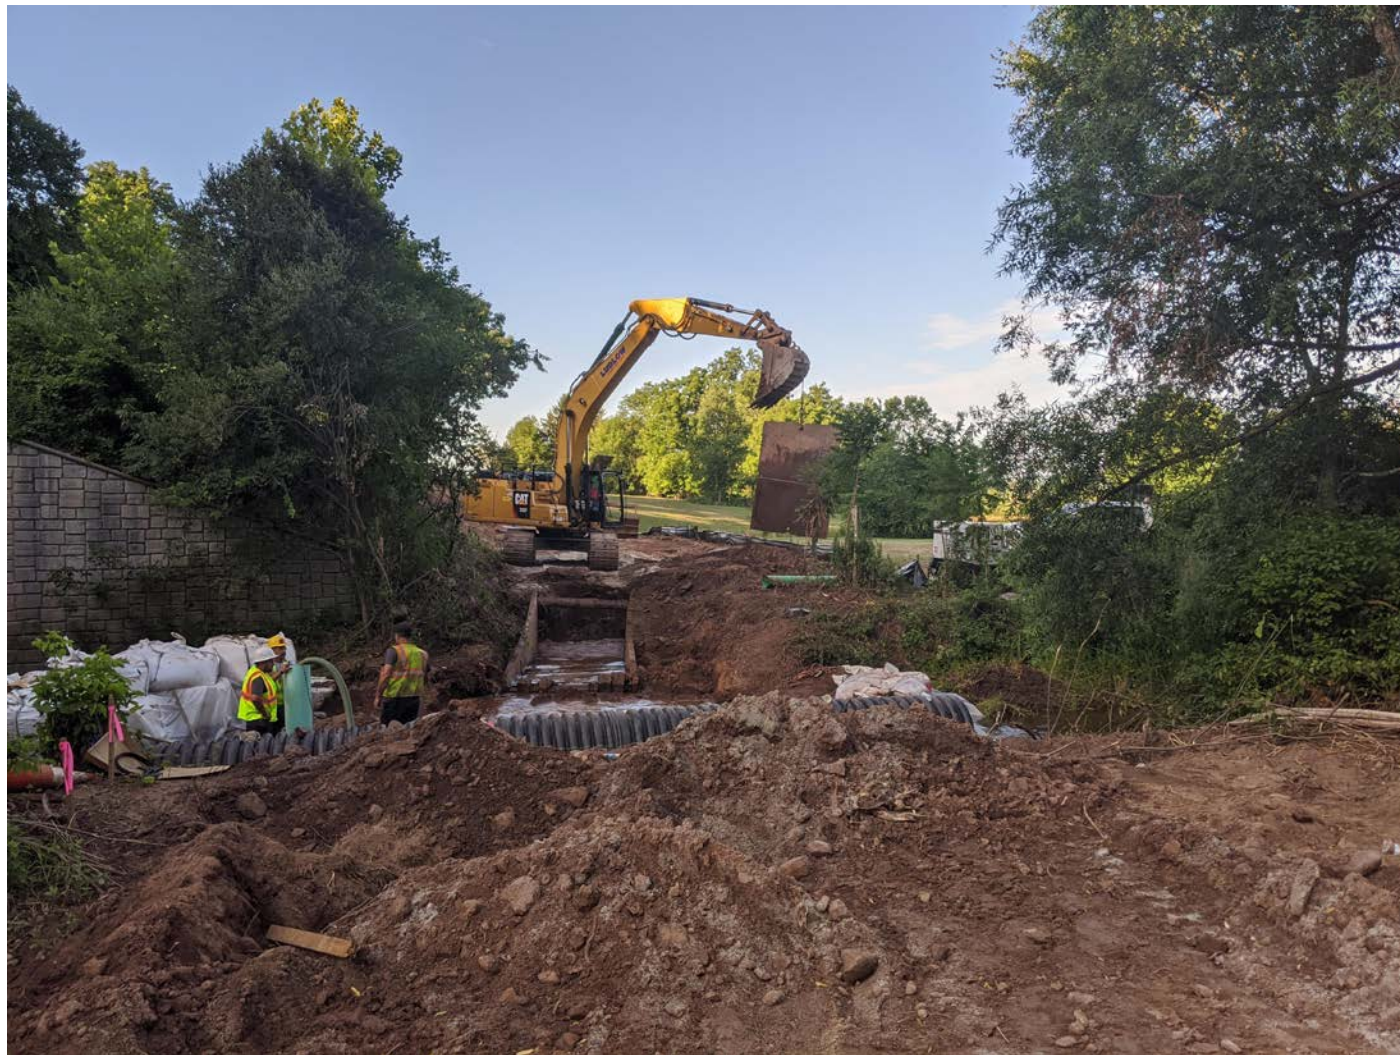
0717: Ludlow is removing shoring from the previous excavation. The excavation is full of water.

Picture 1: Ludlow construction removing shoring from the excavation area, Station 905 + 00. View to the south.

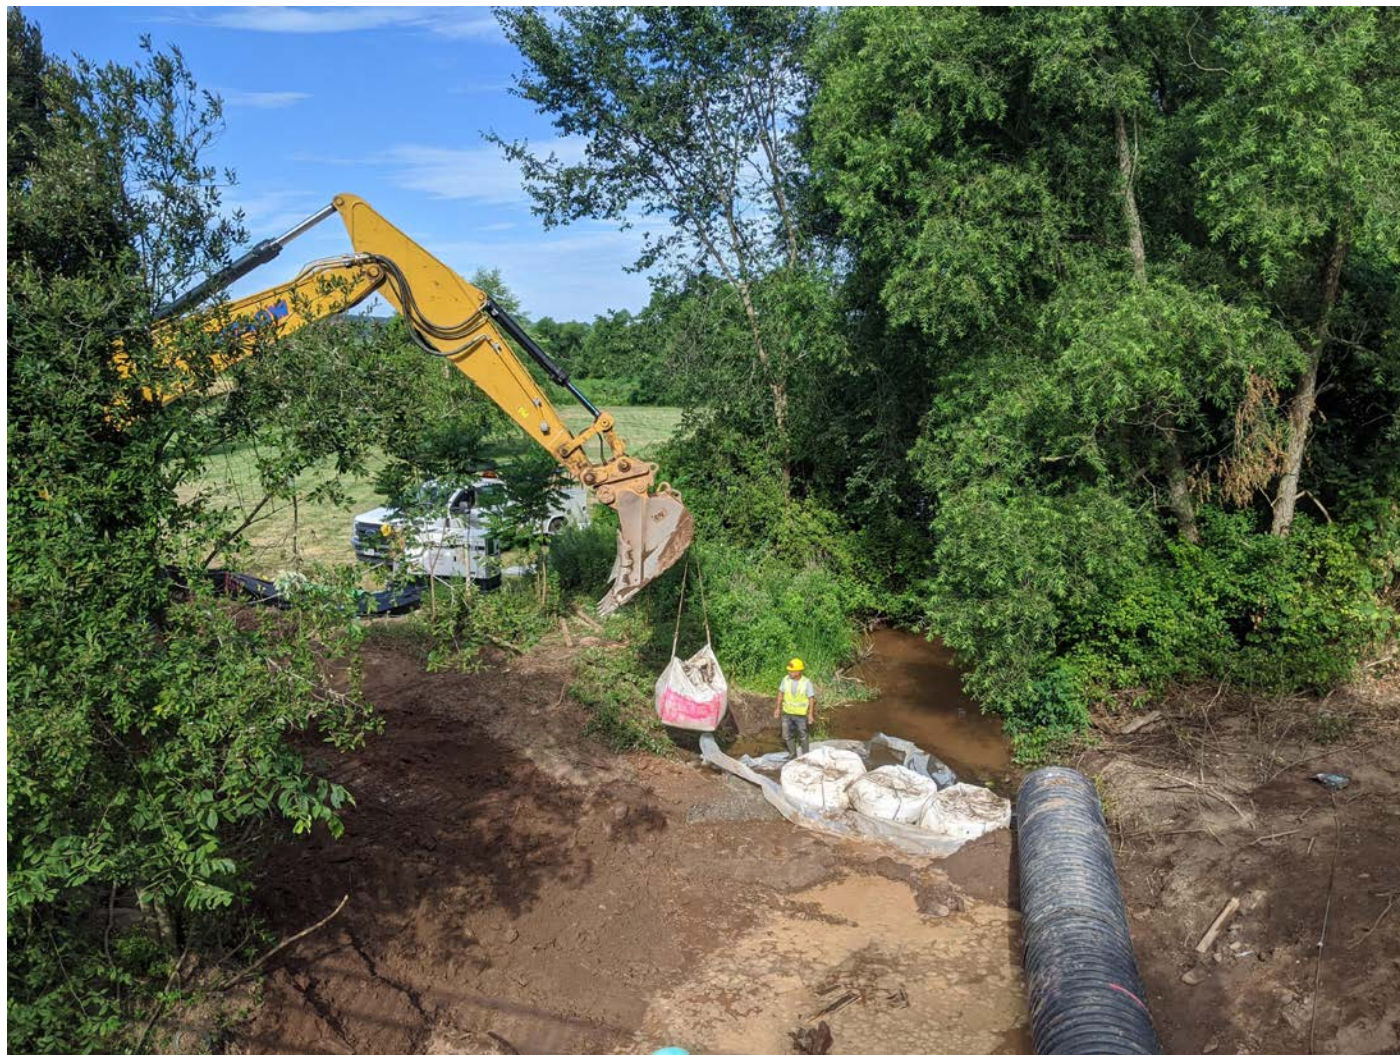
0857: Ludlow backfilled the excavation area and is beginning to remove the sandbags from the stream bed.

Picture 2: Ludlow construction removing sandbags from the stream bed, Maple Avenue, Station 905 + 00. View to the west.

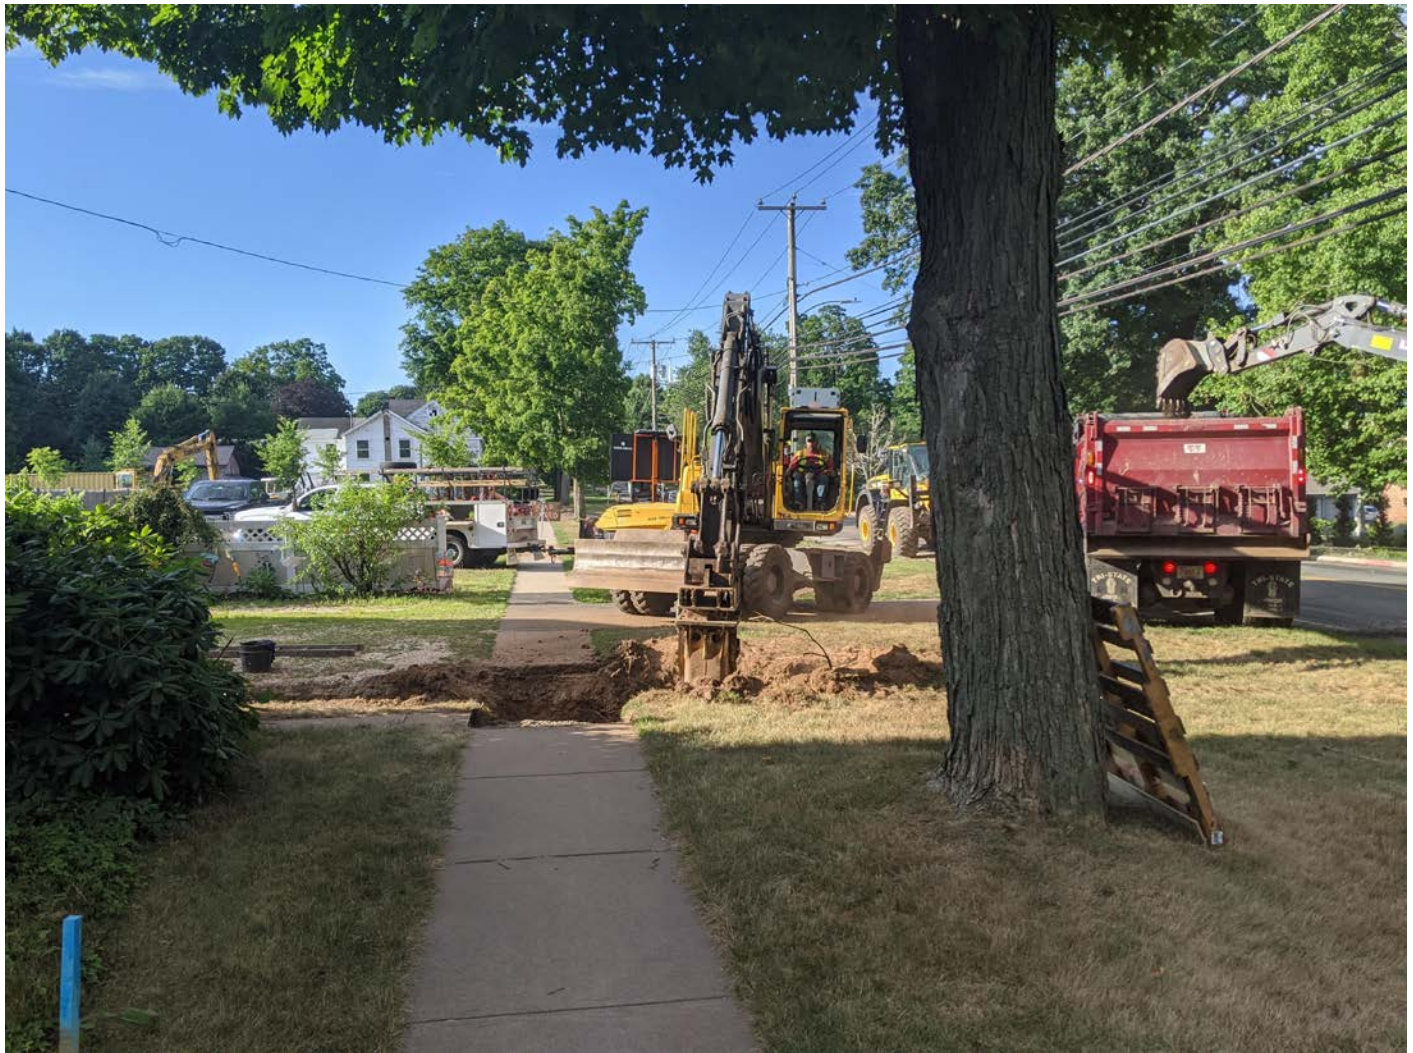
0745: Ludlow is beginning to dig a trench line at station 182+50. This area is located at outside of 289 Main Street. Ludlow is utilizing a rock hammer due to ledge. A piece of the sidewalk was removed due to ledge.

Picture 3: Ludlow construction hammering ledge in trench line at station 182+50 on Main Street, Main Street, Station 182+50. View to the south.

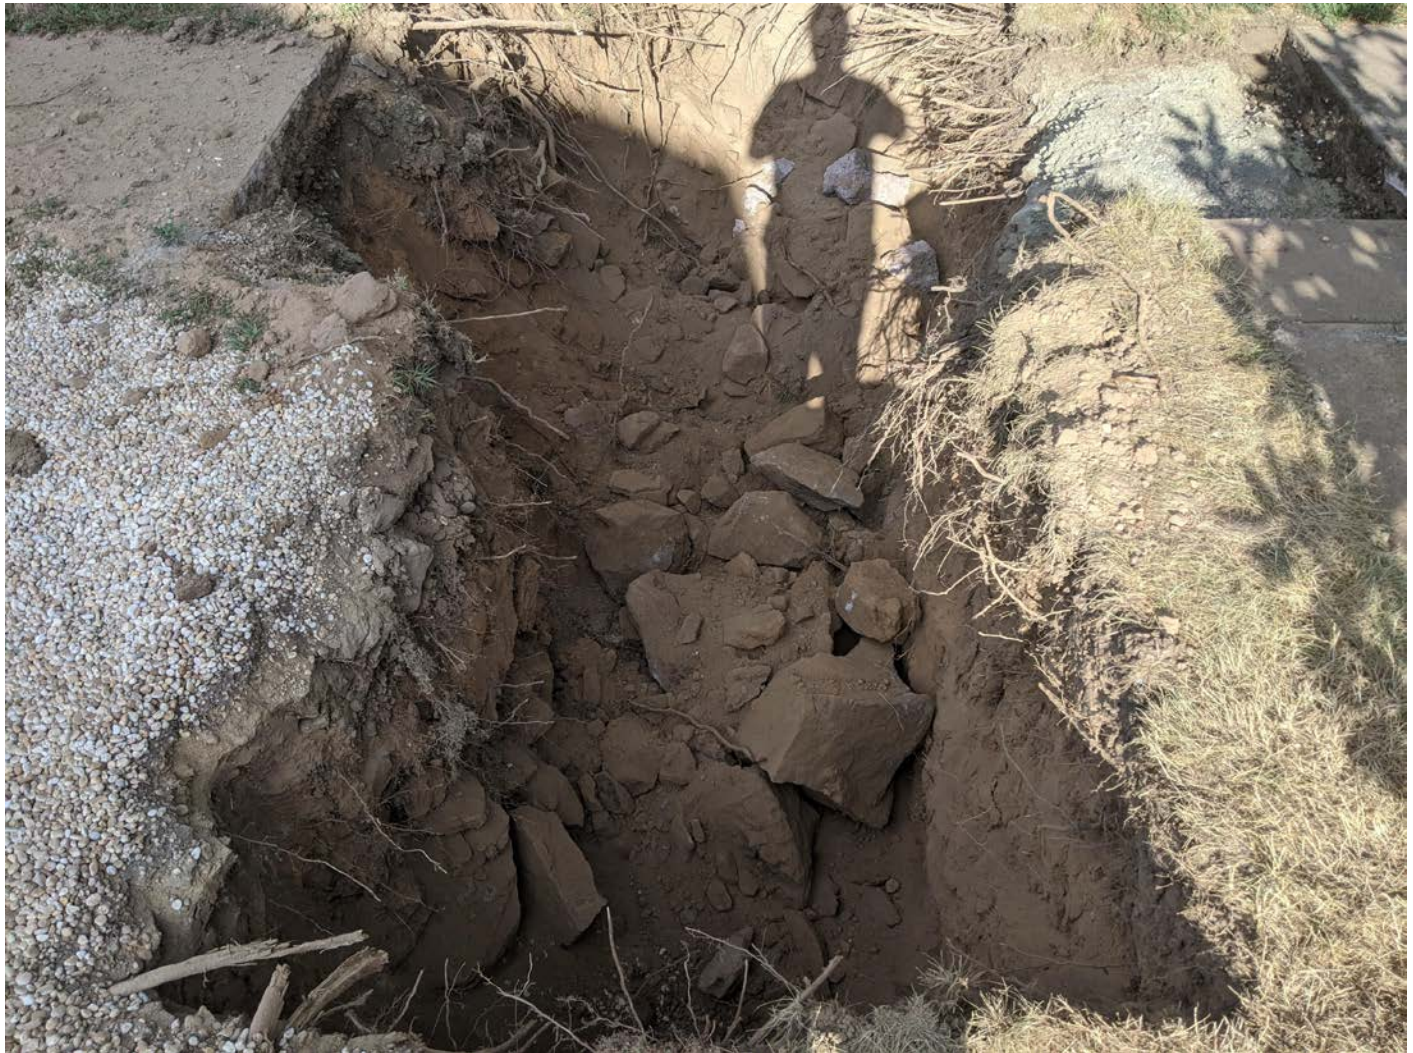
0925: Ludlow is continuing to hammer the ledge at the 289 Main Street location.

Picture 4: View of the ledge encountered in the trench line at station 182+50 on Main Street, Main Street, Stations 182+50. View to the west.

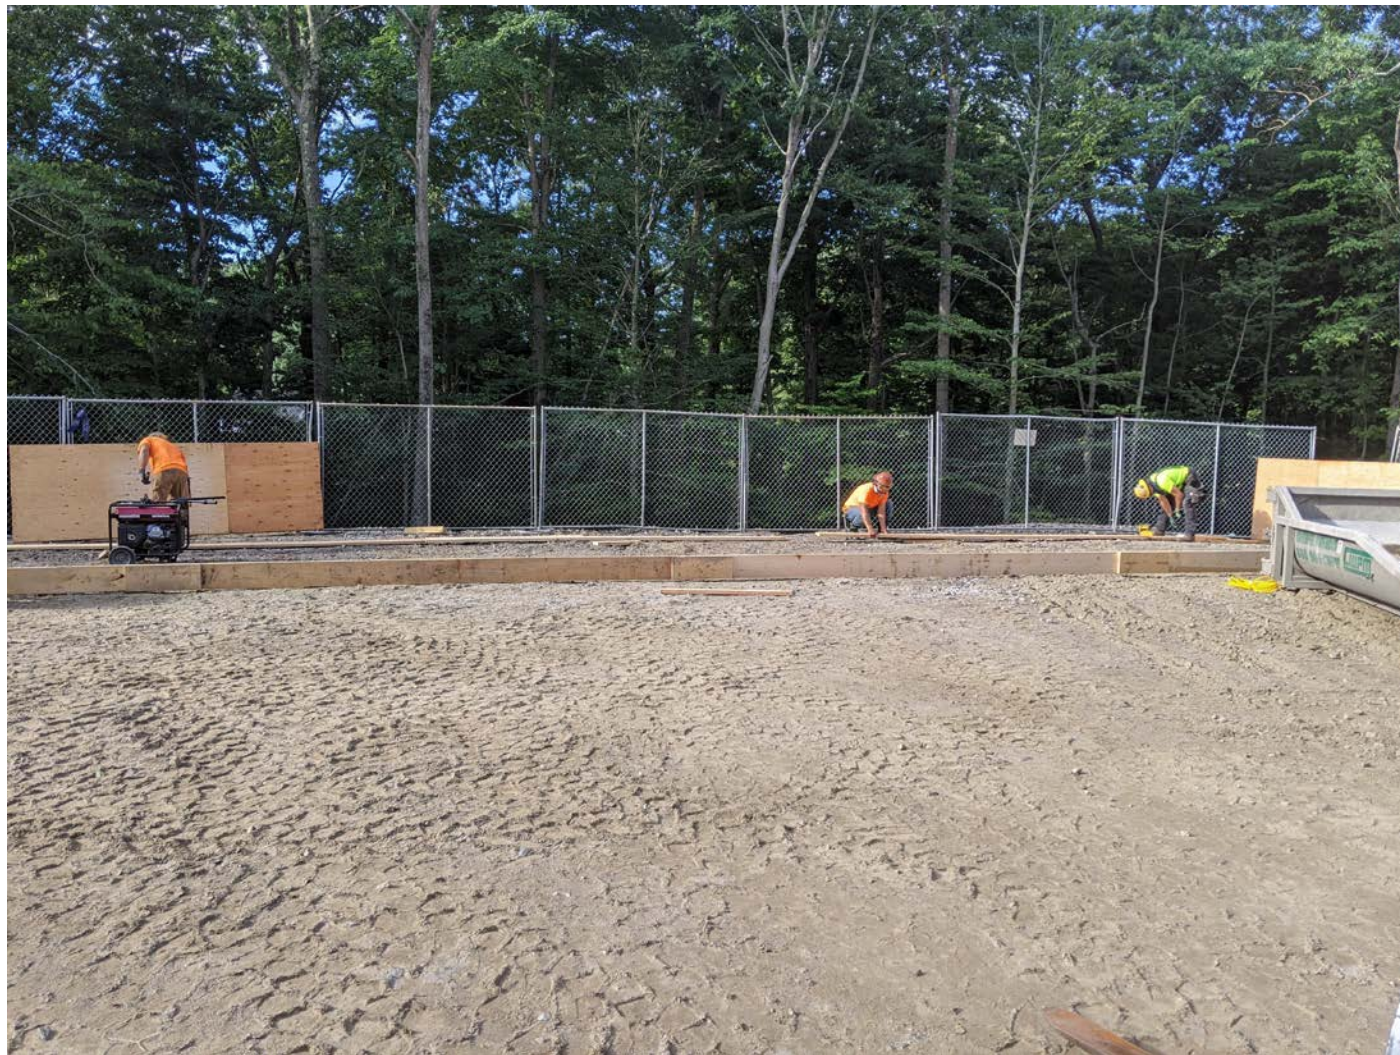
Picture 5: DN tanks working on the concrete forms for the water tank, Shared Access Driveway. View to the east.

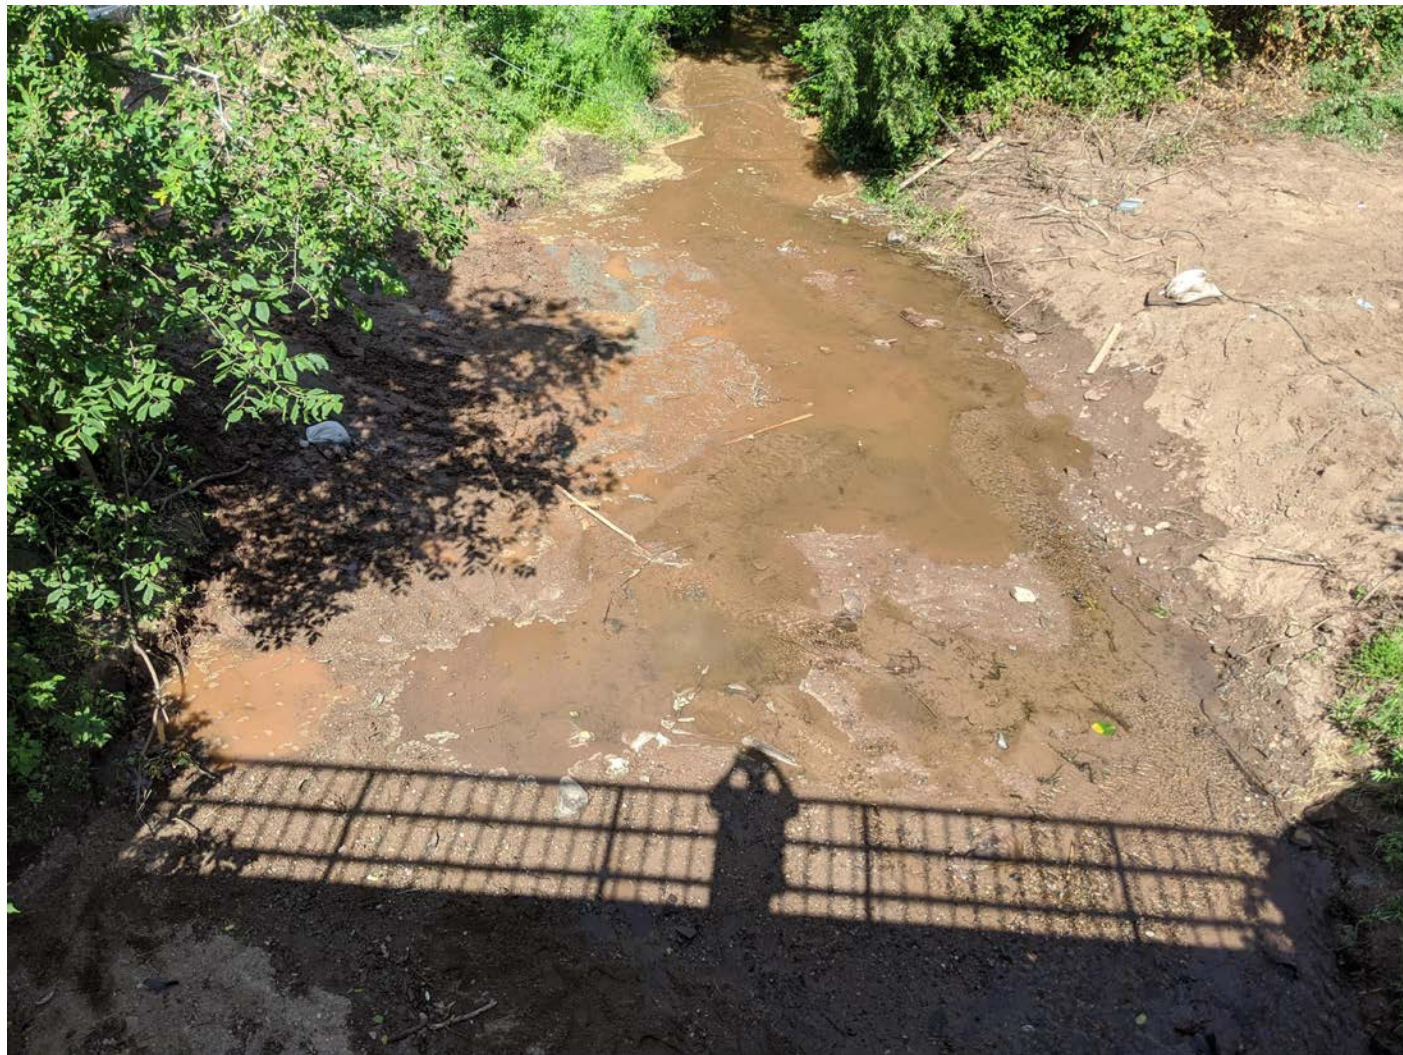
1018: Ludlow removed all the sandbags and piping from the stream bed.

Picture 6: View of Allyn Brook with all the stream crossing materials removed, Maple Avenue, Stations 905+00. View to the west.

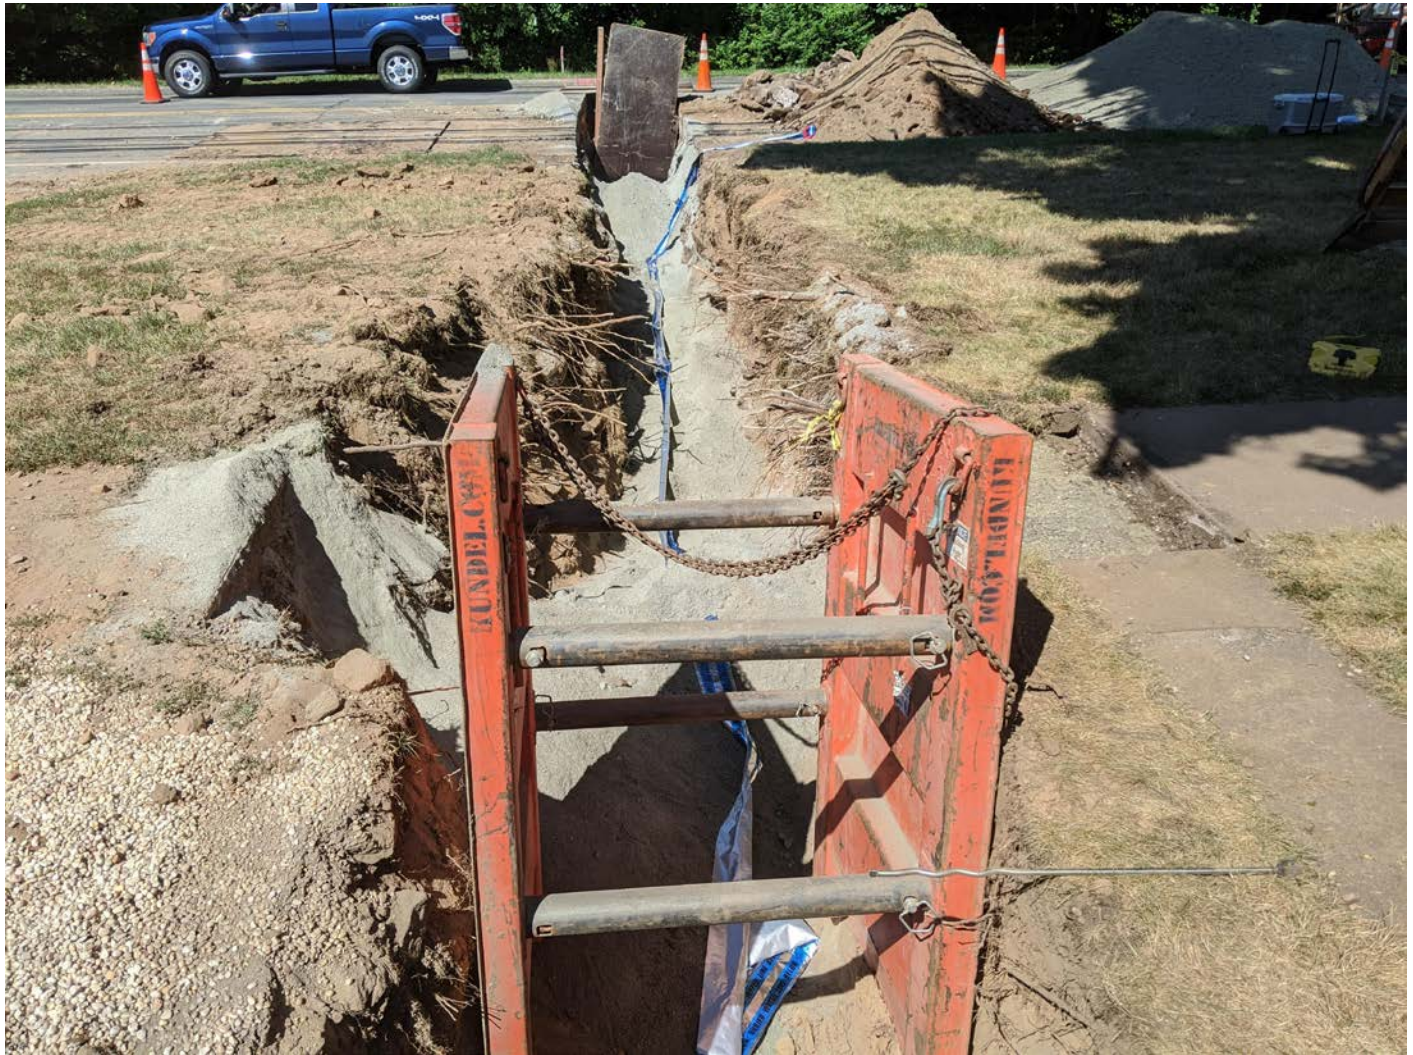
1130: Ludlow is working on the new tap for the service line at station 182+50. The curb stop is located 41' from the edge of the road. Ludlow is now beginning to backfill the trench line at 182+50 with soil and pea gravel.

Picture 7: Trench line at station 182+50 backfilled with pea gravel and lined with caution tape, Main Street, Station 182+50. View to the west.

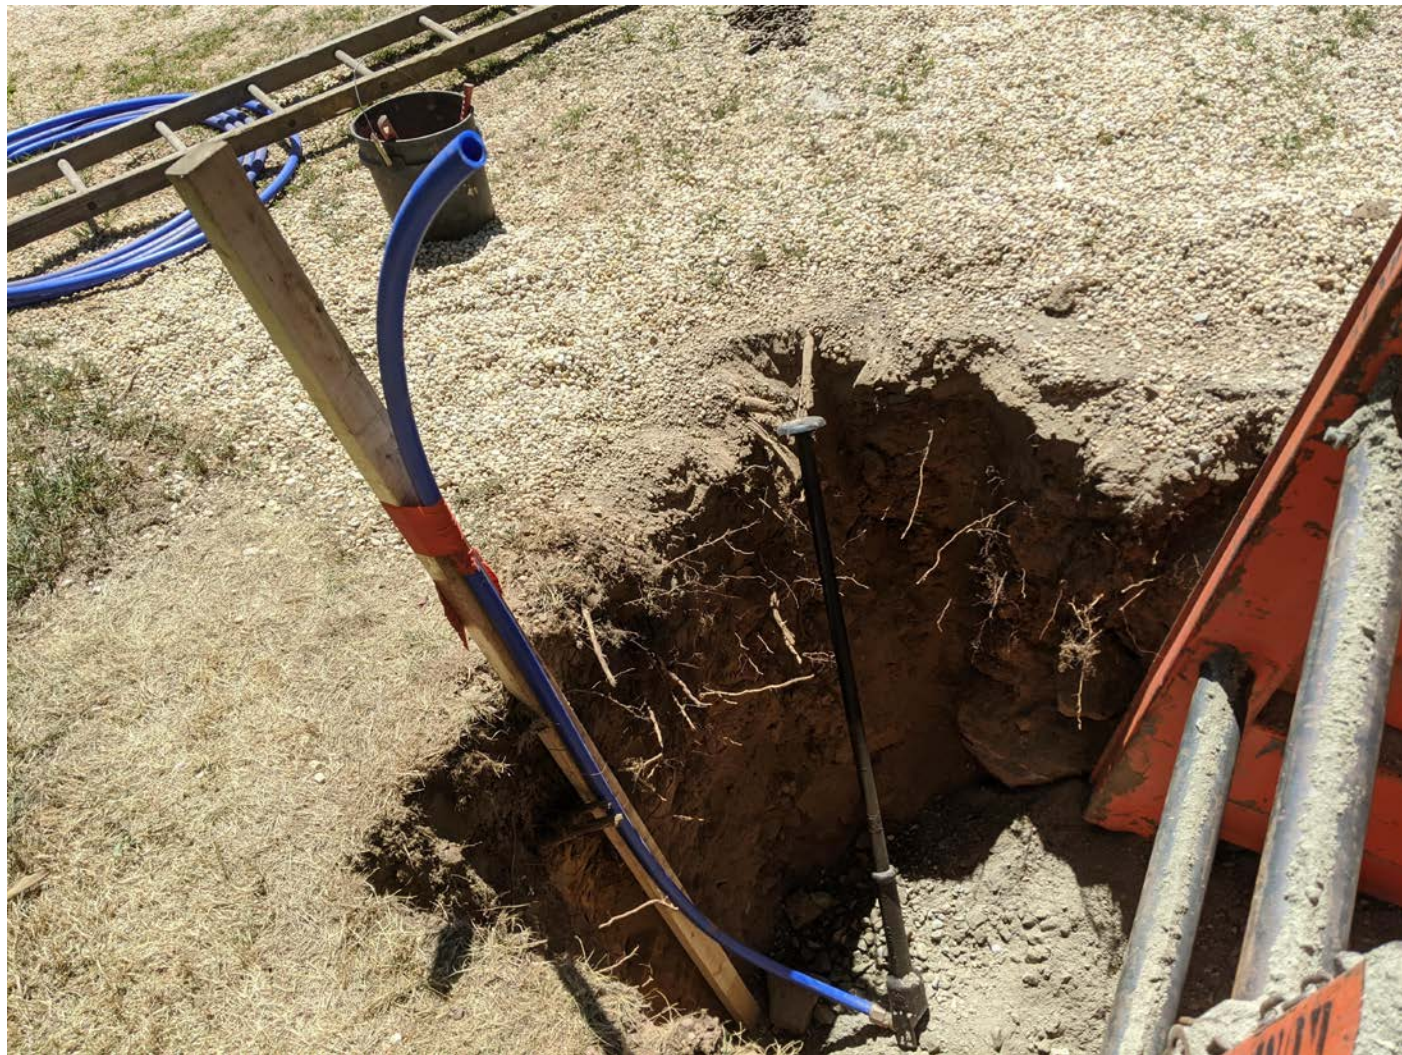
1030: Ludlow has installed the curb stop at station 182+50. Ludlow is taking their lunch break.

Picture 8: Curb stop installed at the station 182+50 located at 289 Main Street, Main Street, Station 182 + 50. View to the south.

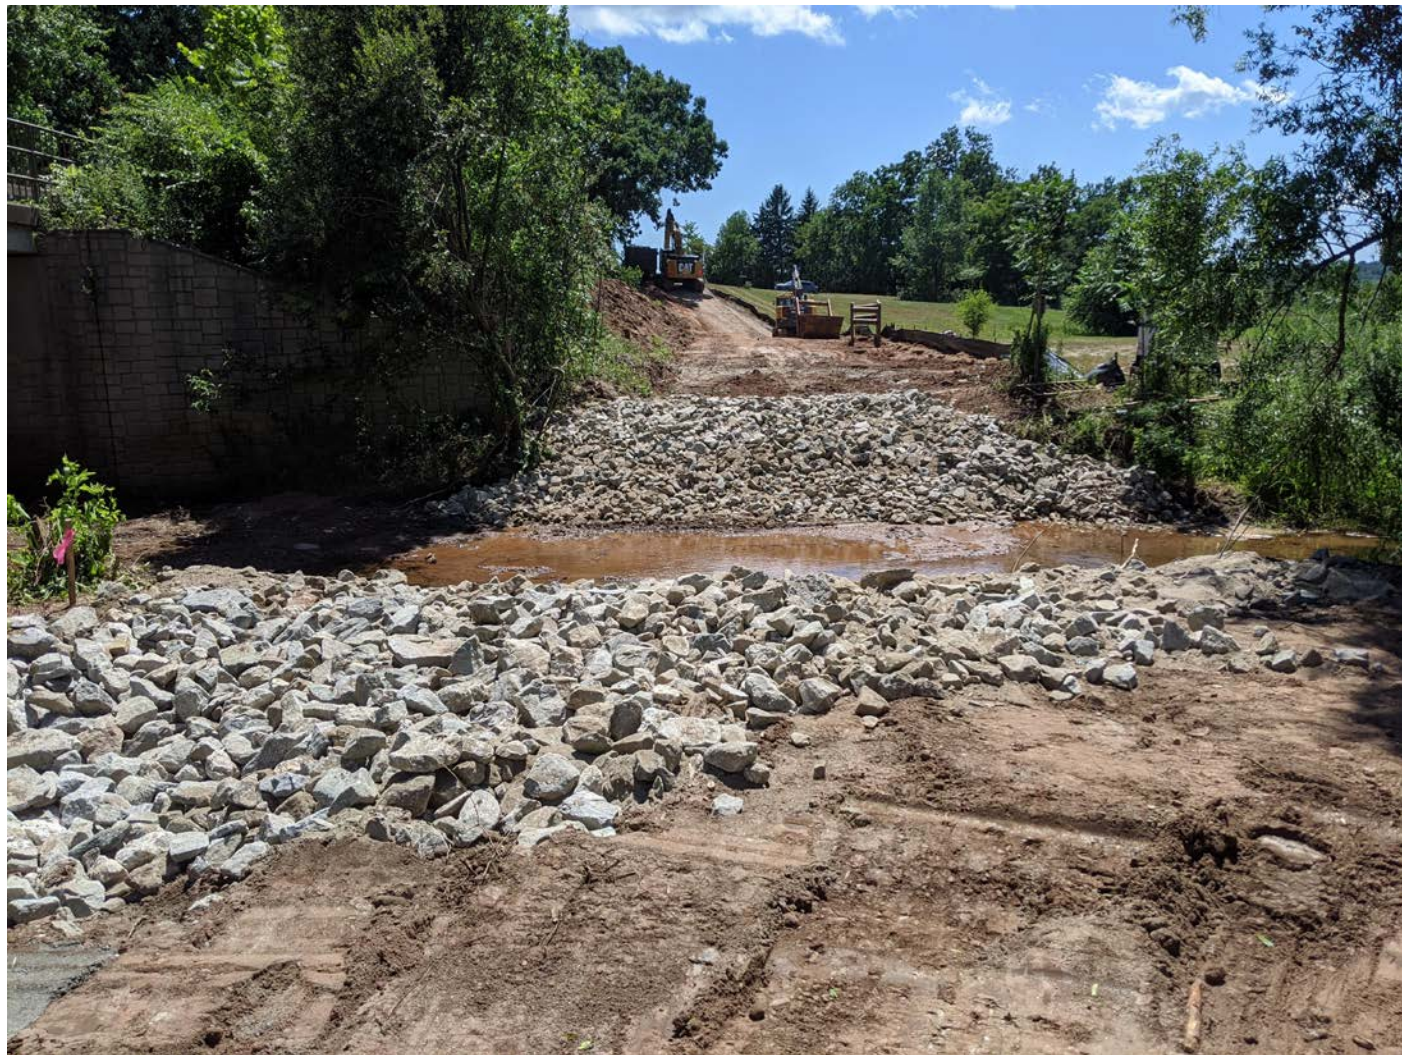
1115: Ludlow is placing cobbles on the banks of the stream.

Picture 9: Rip rap placed on the banks of Allyn Brooke, Maple Avenue, Station 905 + 00. View to the south.
