## Daily Report

<b>Project:</b>	Durham Meadows Pipeline Installation	<b>Date:</b>	August 4, 2020
<b>Location:</b>	Maple Avenue, Main Street, and the Shared Access Driveway	<b>Day of Week:</b>	Tuesday
<b>Project #:</b>	AECOM: 6061487	<b>Report No:</b>	133
<b>Contractor:</b>	Ludlow Construction	<b>Page:</b>	<b>1 of 10</b>

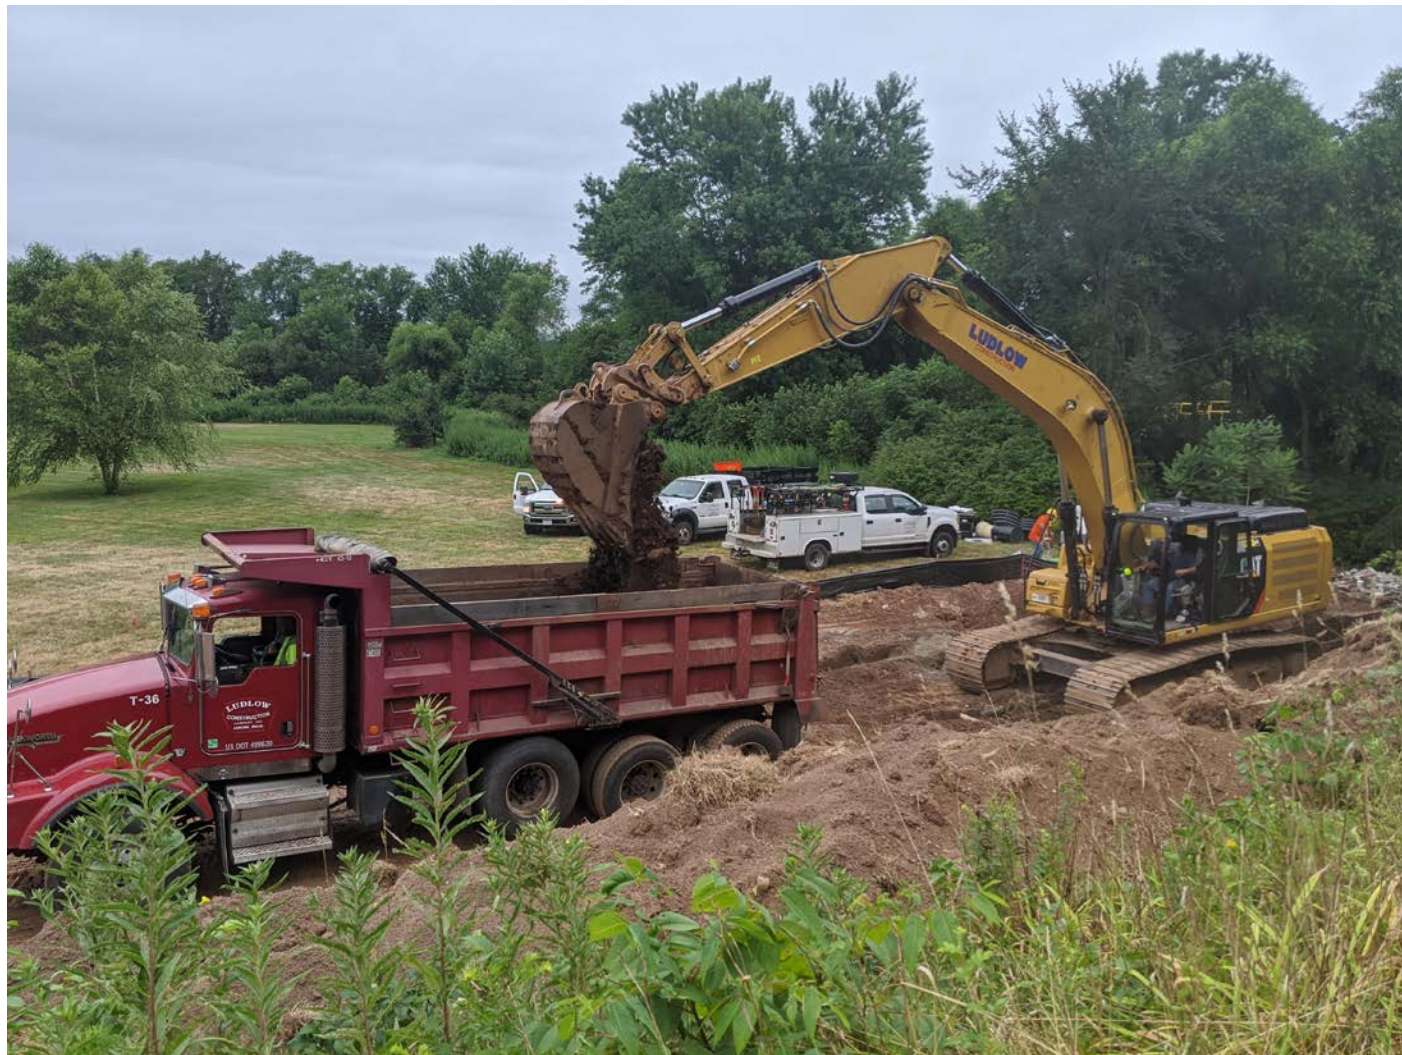
**Picture 1: Ludlow construction digging trench lines to the south of the stream crossing, Maple Avenue, Stations 904+50 to 902+03.5. View to the west.**

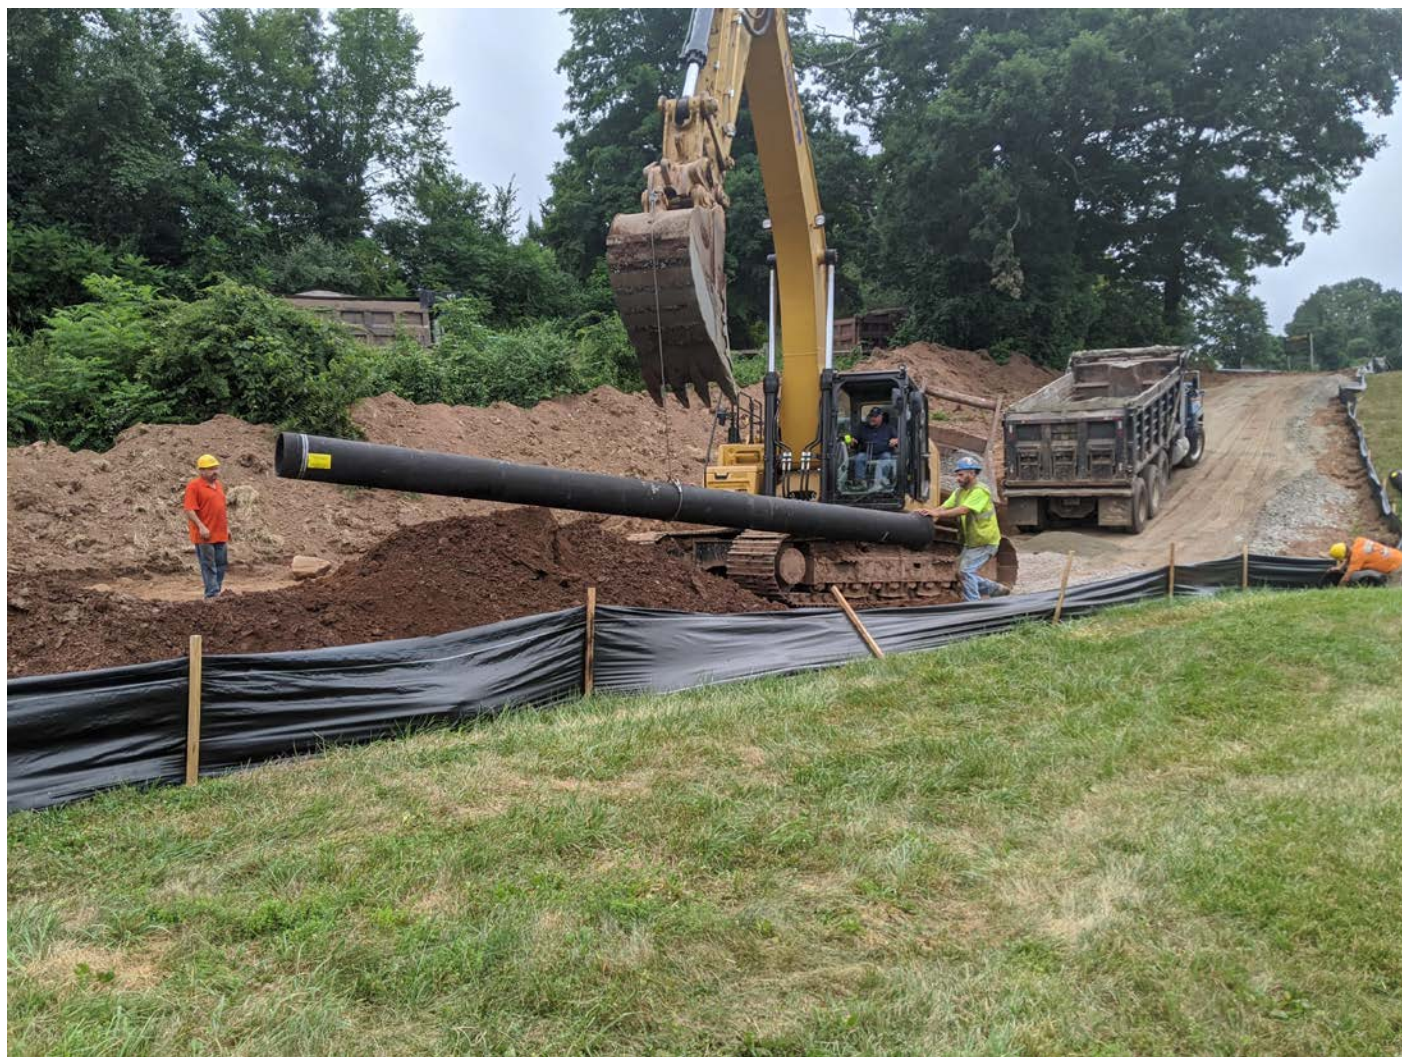
**Picture 2: Ludlow construction installing a 20' section of DIP south of the stream crossing, Maple Avenue, Station 904+50 to 902+03.5. View to the east.**

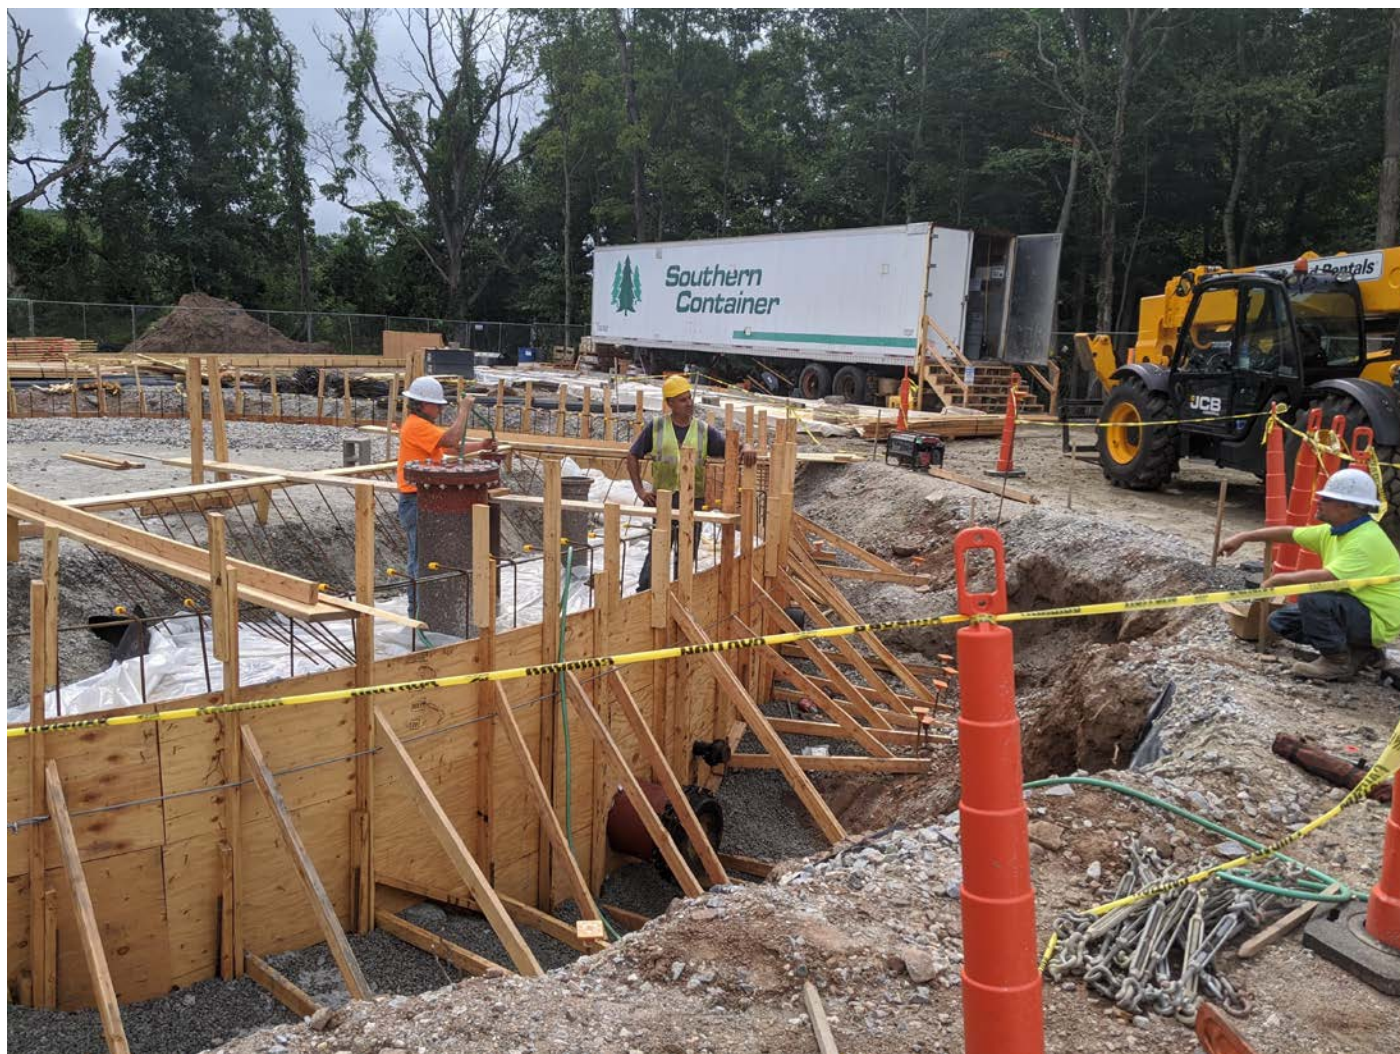
**Picture 3: Ludlow Construction and DN Tanks preparing for the pressure testing of the water tank piping, Shared Access Driveway, View to the southeast.**

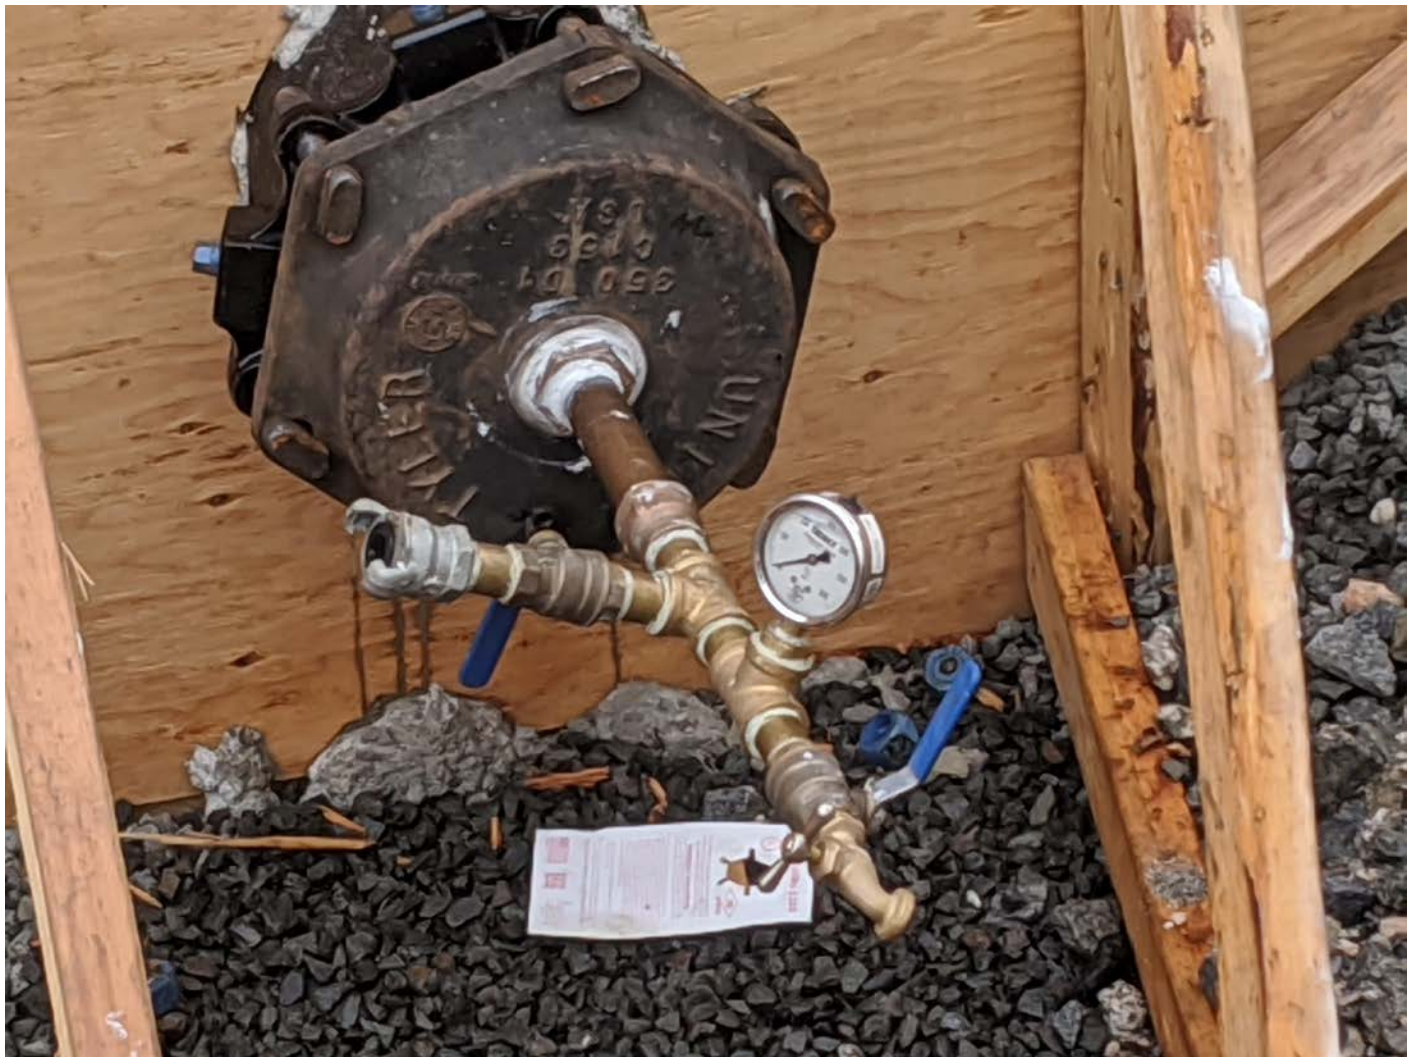
Picture 4: Pressure gauge attached to the water tank piping, Shared Access Driveway. View to the north.

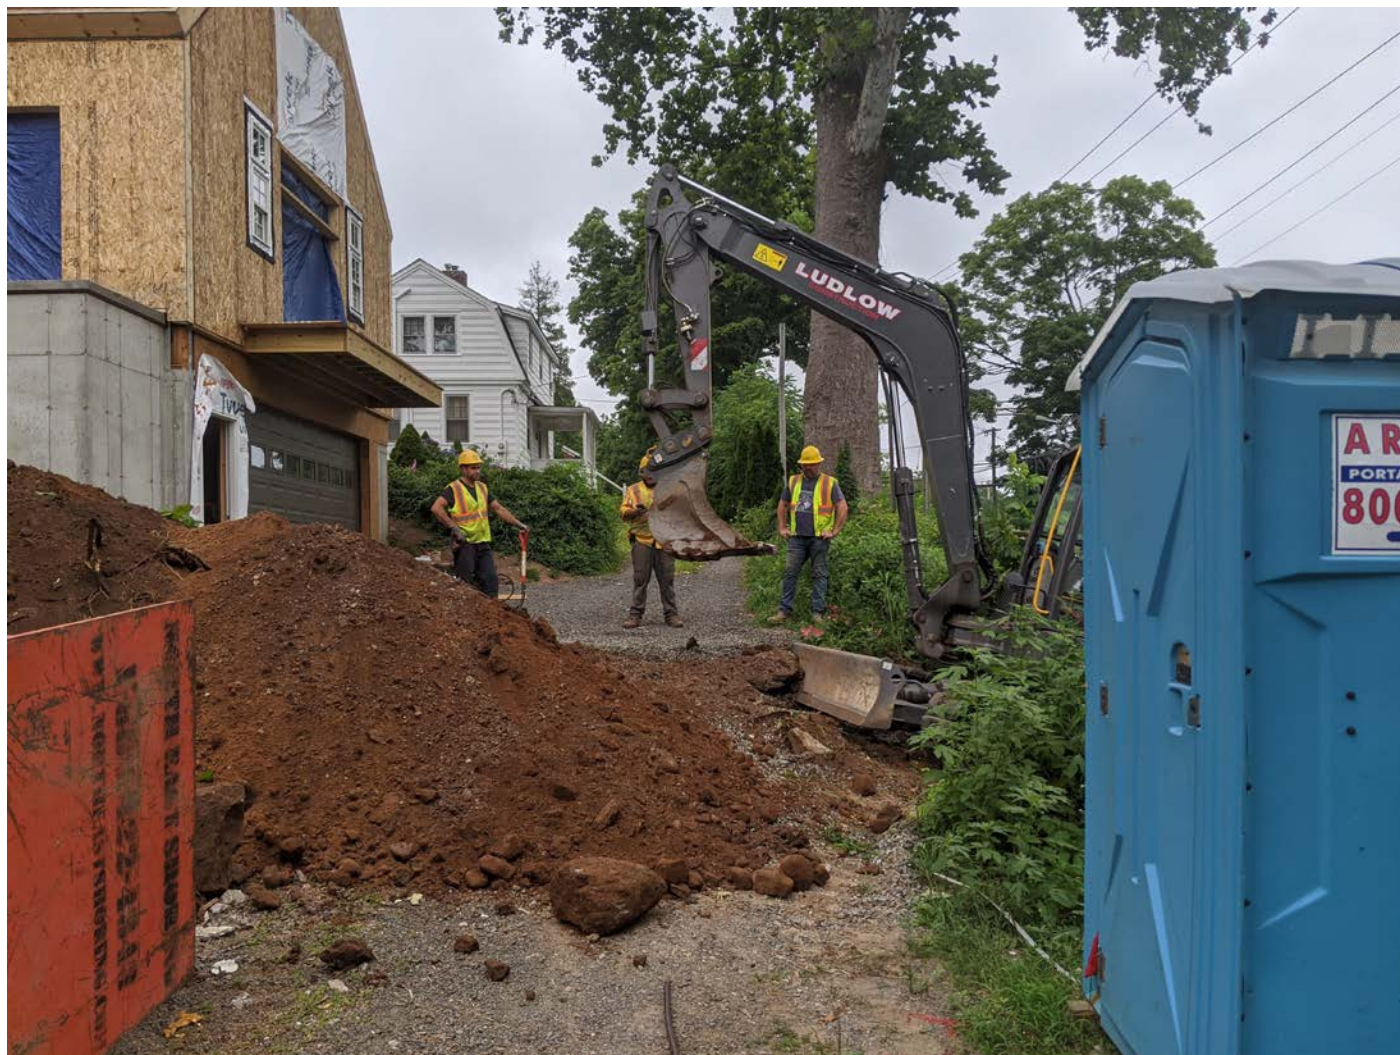
Picture 5: Ludlow digging a trench line up on the hill at station 205+50, Main Street (#174), Station 205+50. View to the north.

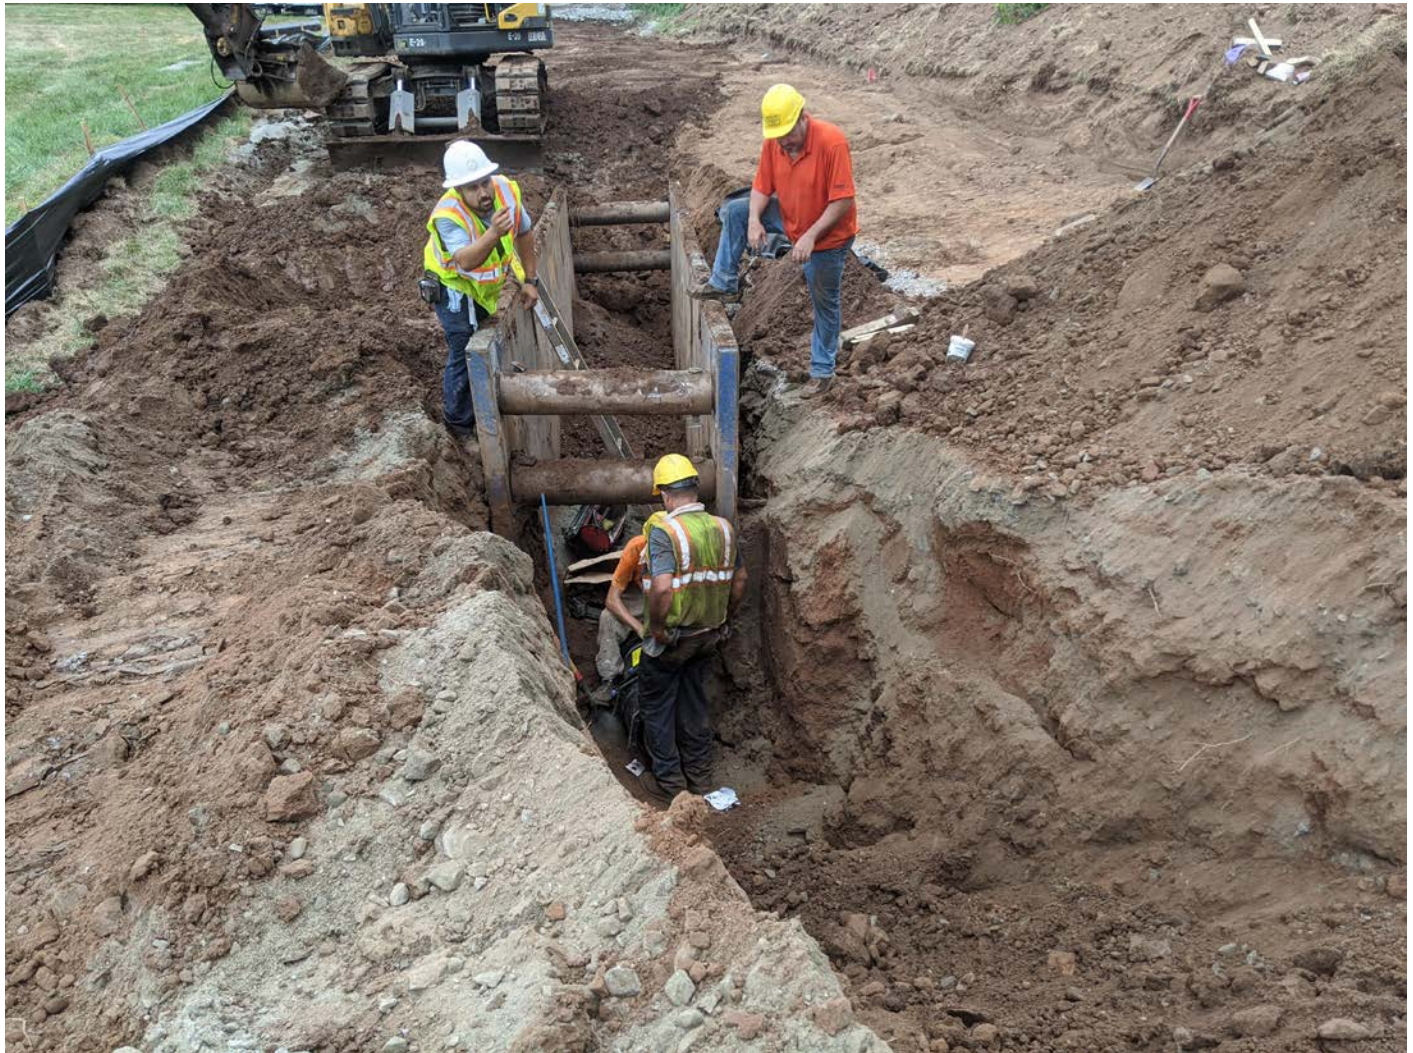
**Picture 6: Ludlow Construction working on joining a 20' section of 12" DIP south of the stream crossing, Maple Avenue, Stations 904+50 to 902+03.5. View to the north.**

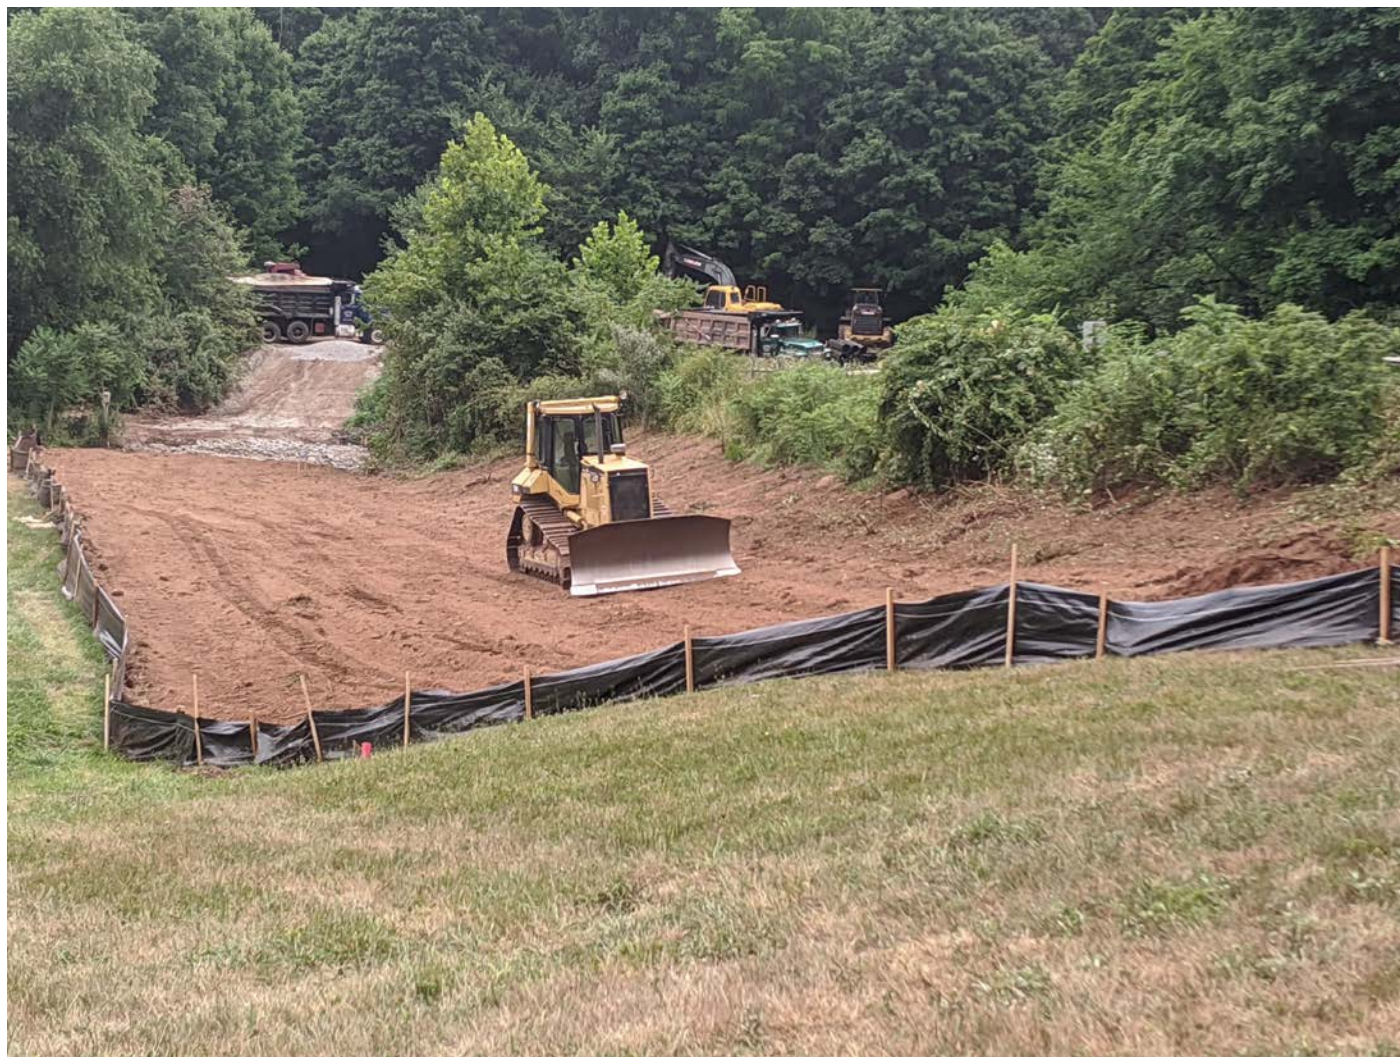
Picture 7: Ludlow grading the area where the DIP was laid south of the stream crossing, Maple Avenue, Stations 904+50 to 902+03.5. View to the north.
