## Daily Report

<b>Project:</b>	Durham Meadows Pipeline Installation	<b>Date:</b>	September 2, 2020
<b>Location:</b>	Maple Avenue and Main Street, Durham, the Shared Access Driveway, Middletown	<b>Day of Week:</b>	Wednesday
<b>Project #:</b>	AECOM: 6061487	<b>Report No:</b>	151
<b>Contractor:</b>	Ludlow Construction	<b>Page:</b>	1 of 13

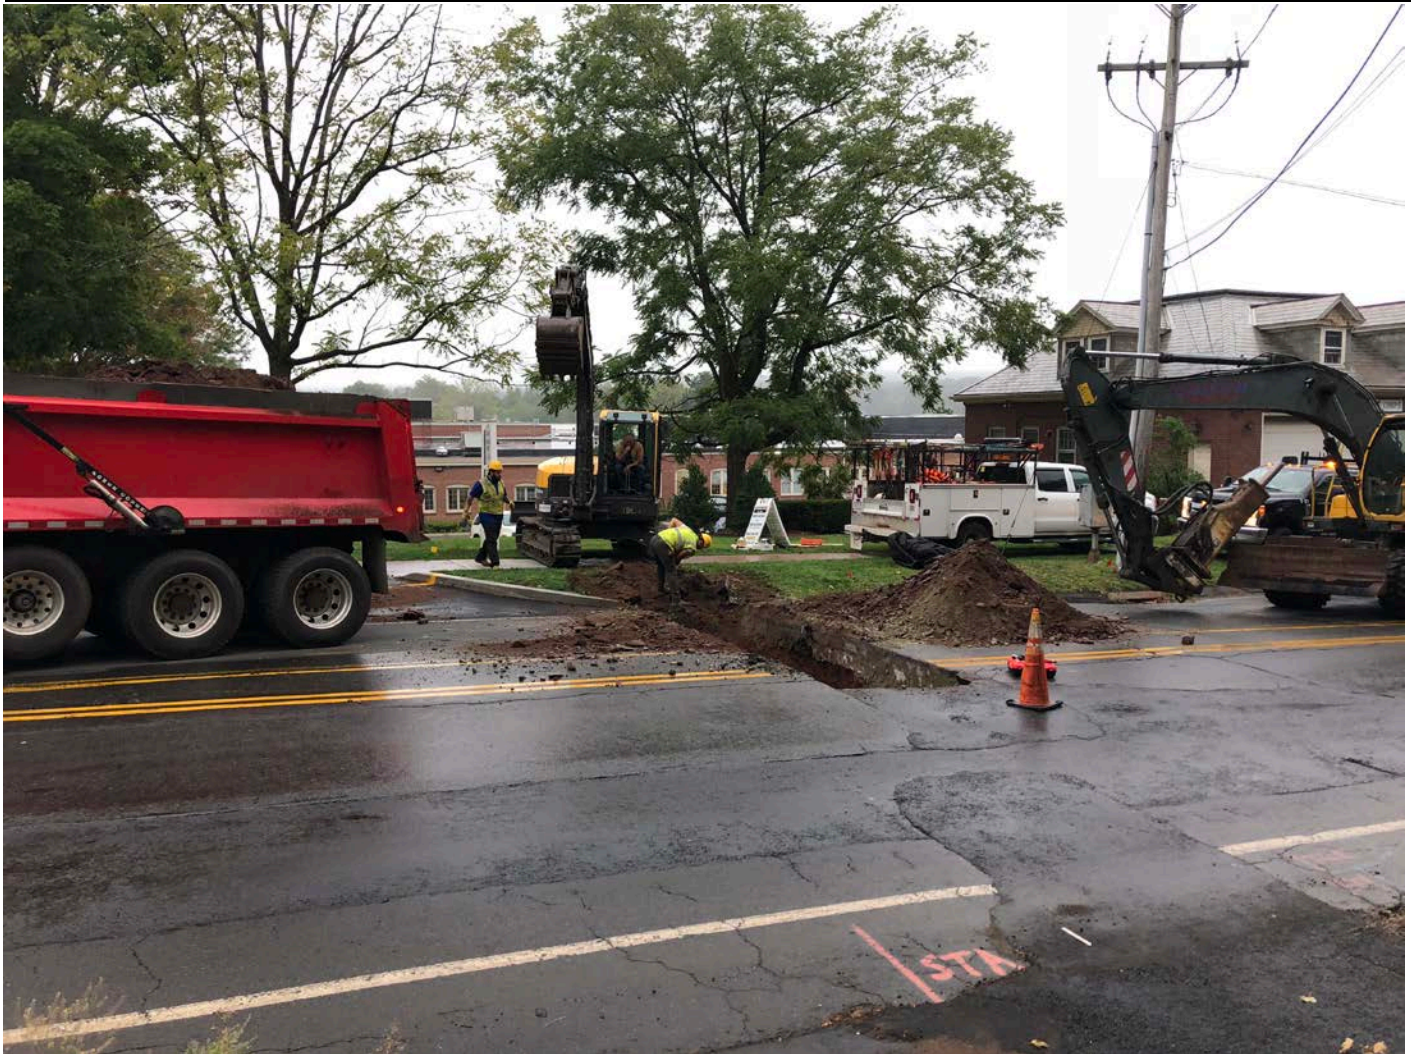
1107: Ludlow has finished the installation of 4" DIP at Station 198+10 and is currently backfilling and compacting the trench. Ludlow is using a Broce Broom to clean up the work zone. The east end of the installed 4" DIP is 19' from the edge of pavement. JTC is on site and is about to collect soil compaction data.

Picture 1: Ludlow installing 4" DIP at Station 198+10, Main Street, Durham. View to the east.

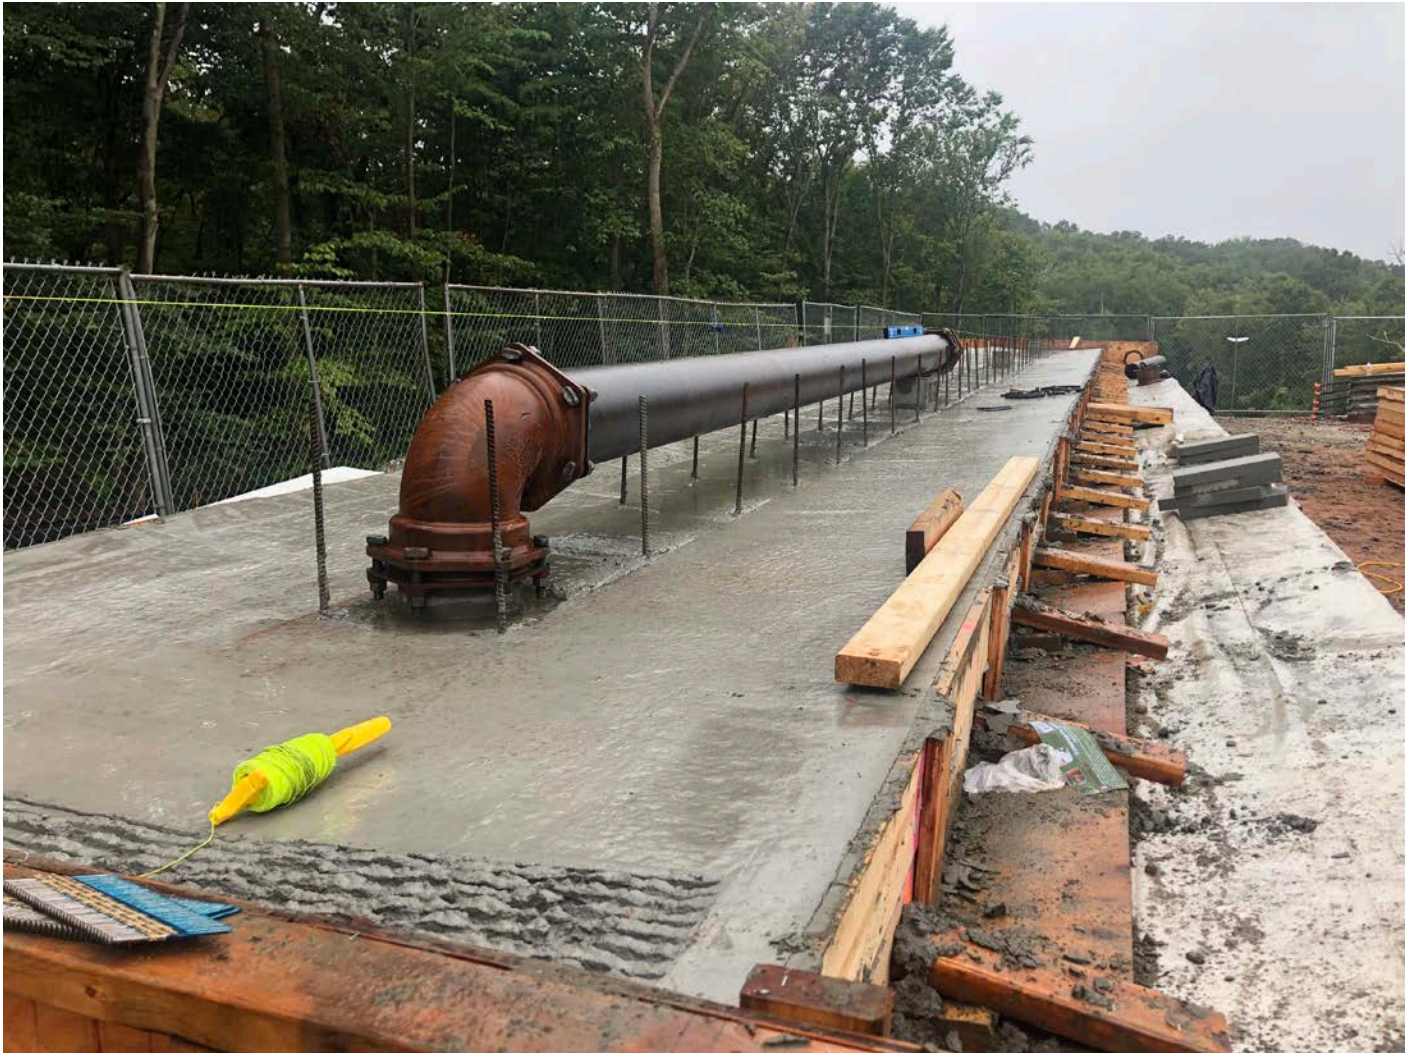
1205: DN Tanks has resumed the placement of 8" DIP on the narrow side panel for the water tank. DN Tanks is also continuing to remove the wooden formwork from the wide panel concrete forms.

Picture 2: 8" DIP installed on one of the narrow water tank side panels. Water tank work zone, east of the Shared Access Road, Middletown. View to the west.

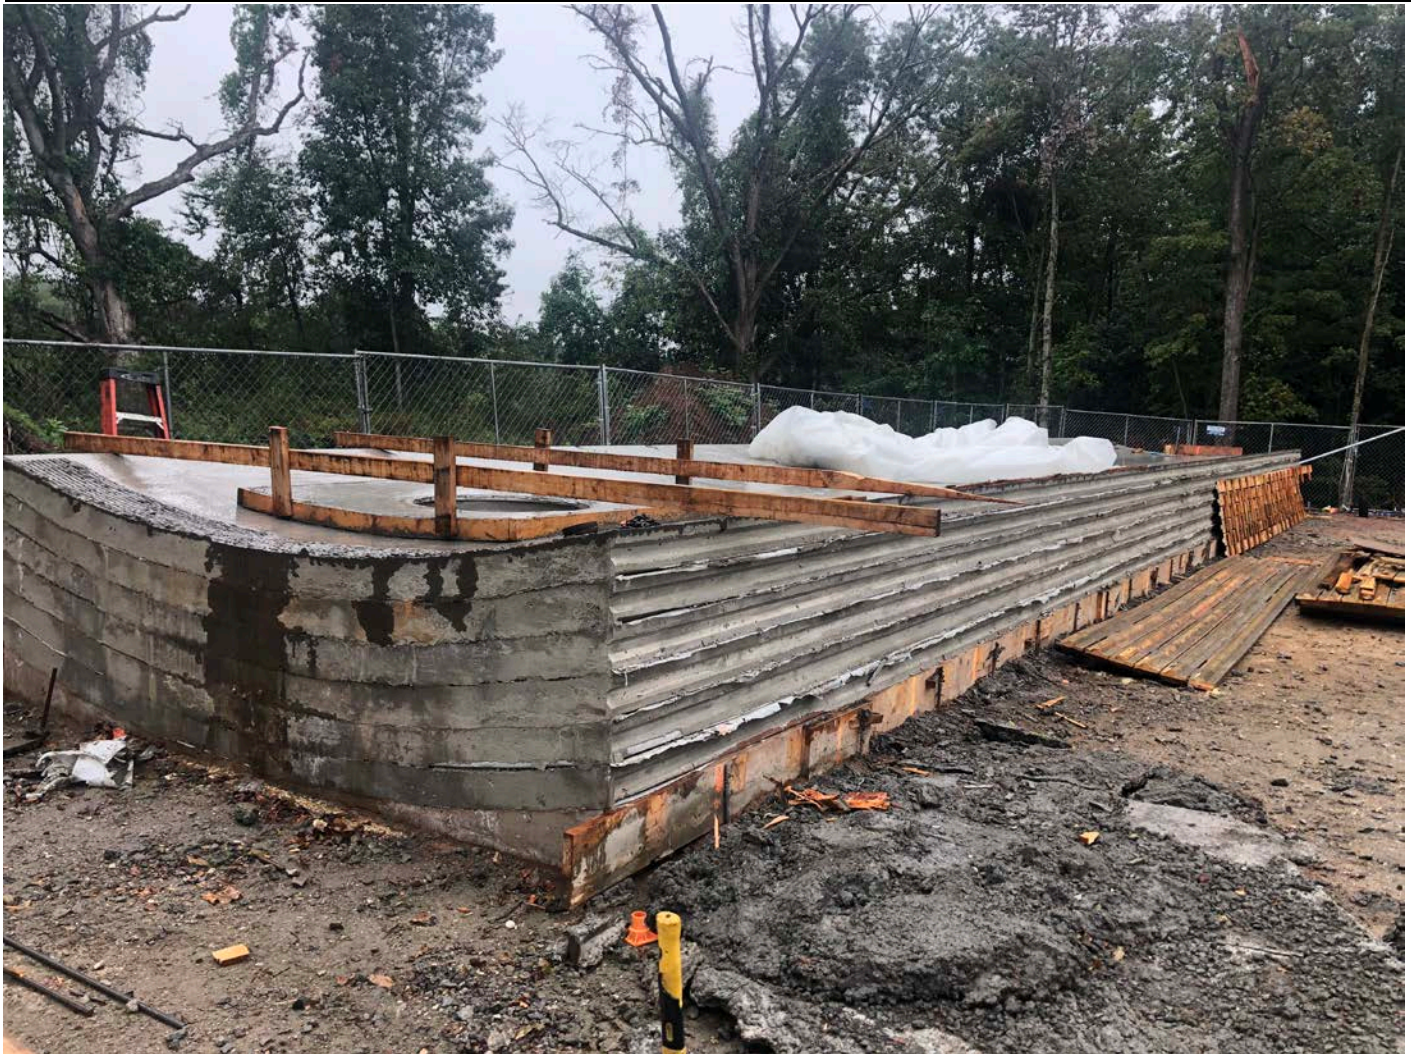
0848: DN Tanks is currently not working as steady rain is falling. They have started to place a section of 8" DIP on the interior side of one of the narrow side panels. DN Tanks has also begun to remove the wooden concrete form from the sides of the water tank wide panel form.

Picture 3: Wide water tank side panels with the wooden forms partially removed. Water tank work zone, east of the Shared Access Road, Middletown. View to the south.

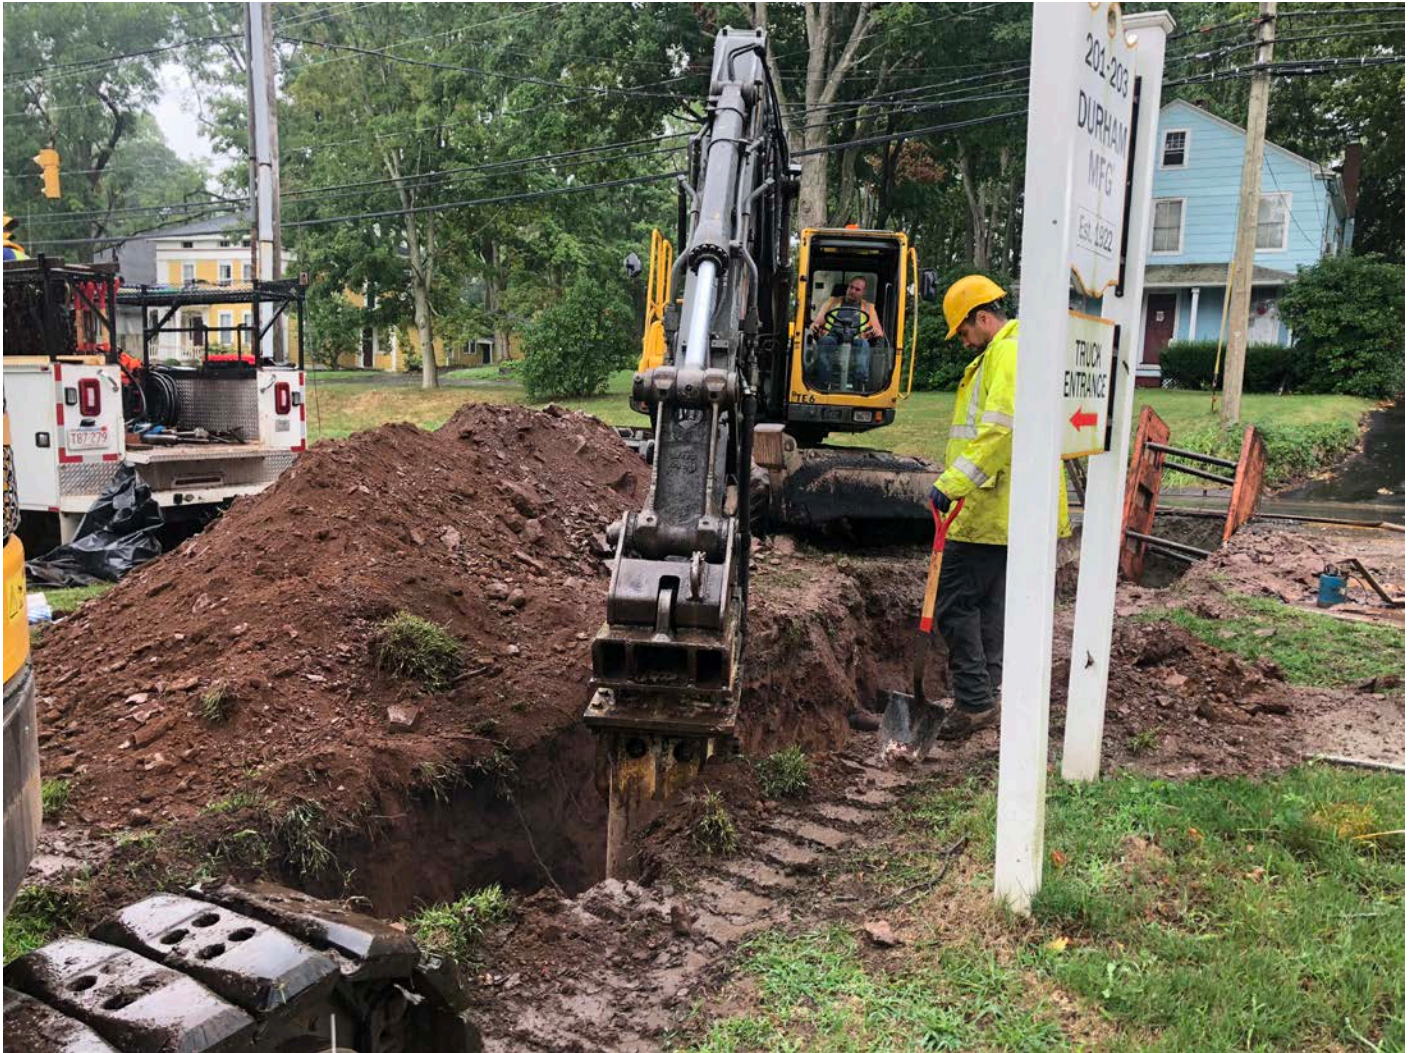
0752: Ludlow is excavating a trench on the northbound lane of Main Street, Durham at Station 198+10 to install a 4" DIP line that will be connected to the 16" main water line running under Main Street. Ludlow has had to hammer rock to excavate the trench.

Picture 4: Ludlow hammering rock as they excavate a trench for the installation of 4" DIP at Station 198+10. 201-203 Main Street, Durham. View to the west.

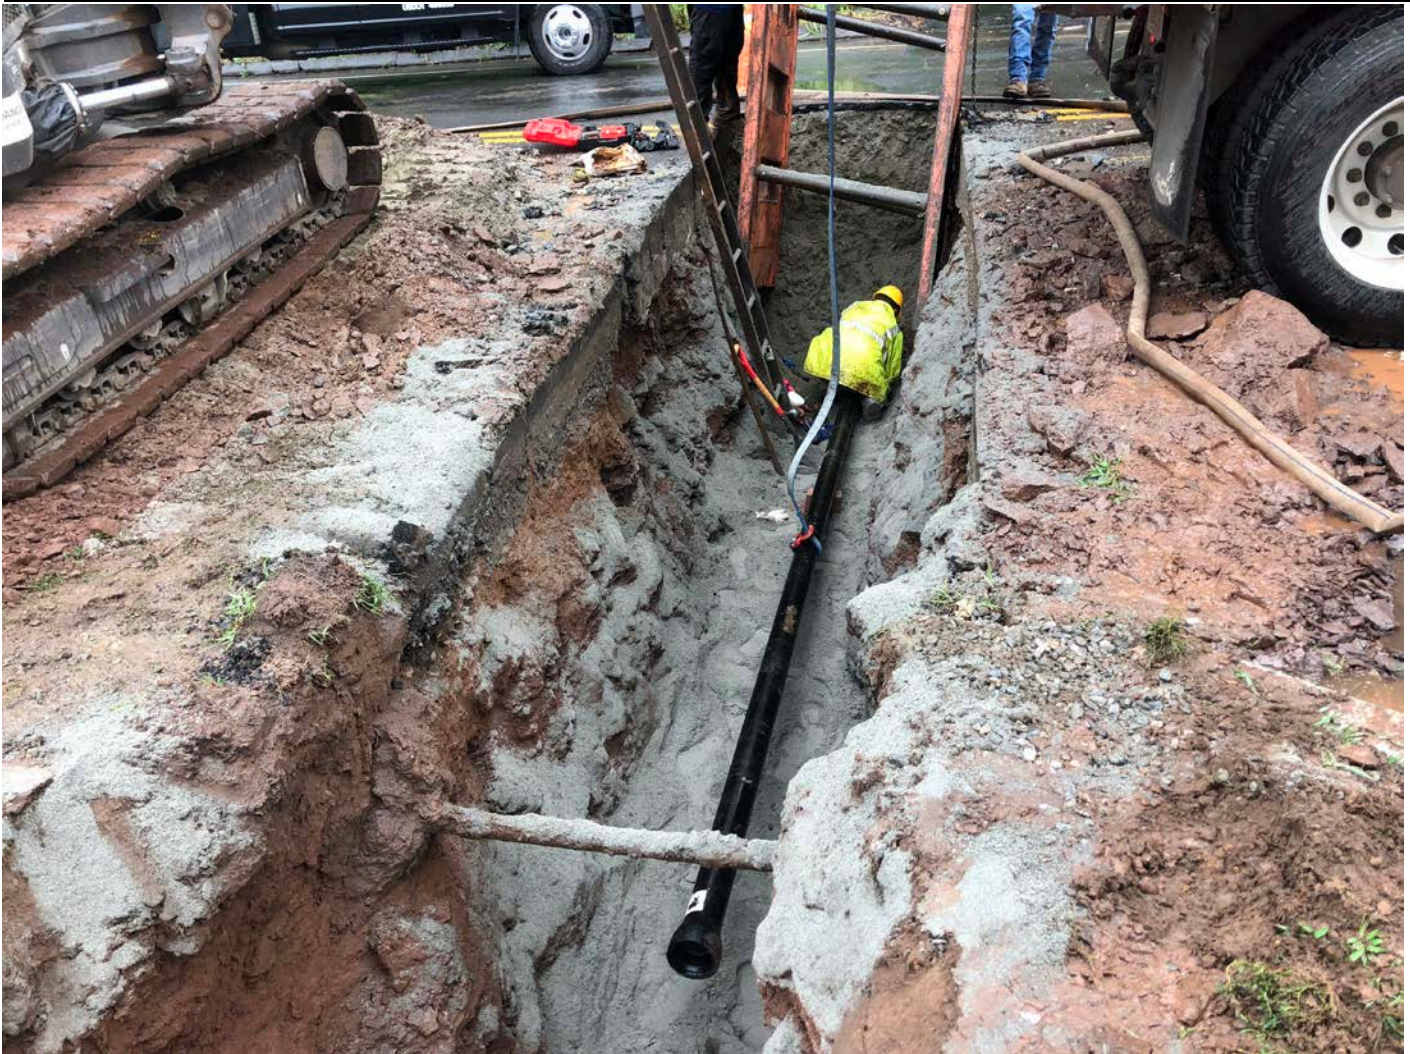
1000: Ludlow begins to install the first 20 foot section of 4" DIP at station 198+10.

Picture 5: Ludlow installing 4" DIP at Station 198+10. 201-203 Main Street, Durham. View to the west.

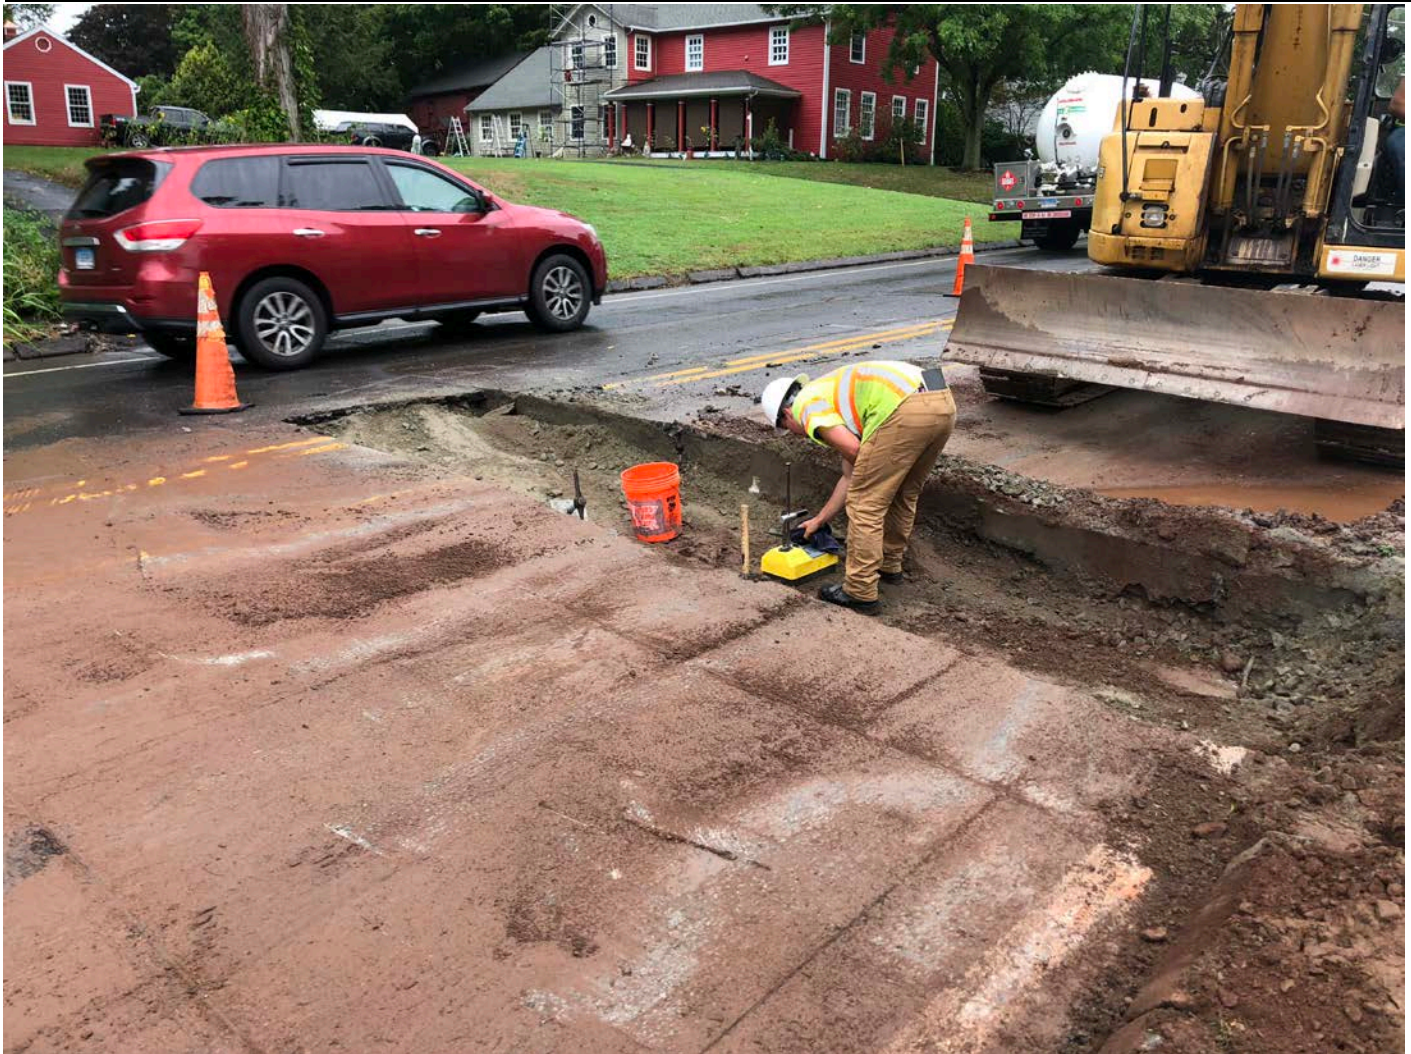
Picture 6: JTC collecting soil compaction data at Station 198+10, Main Street, Durham. View to the northwest.

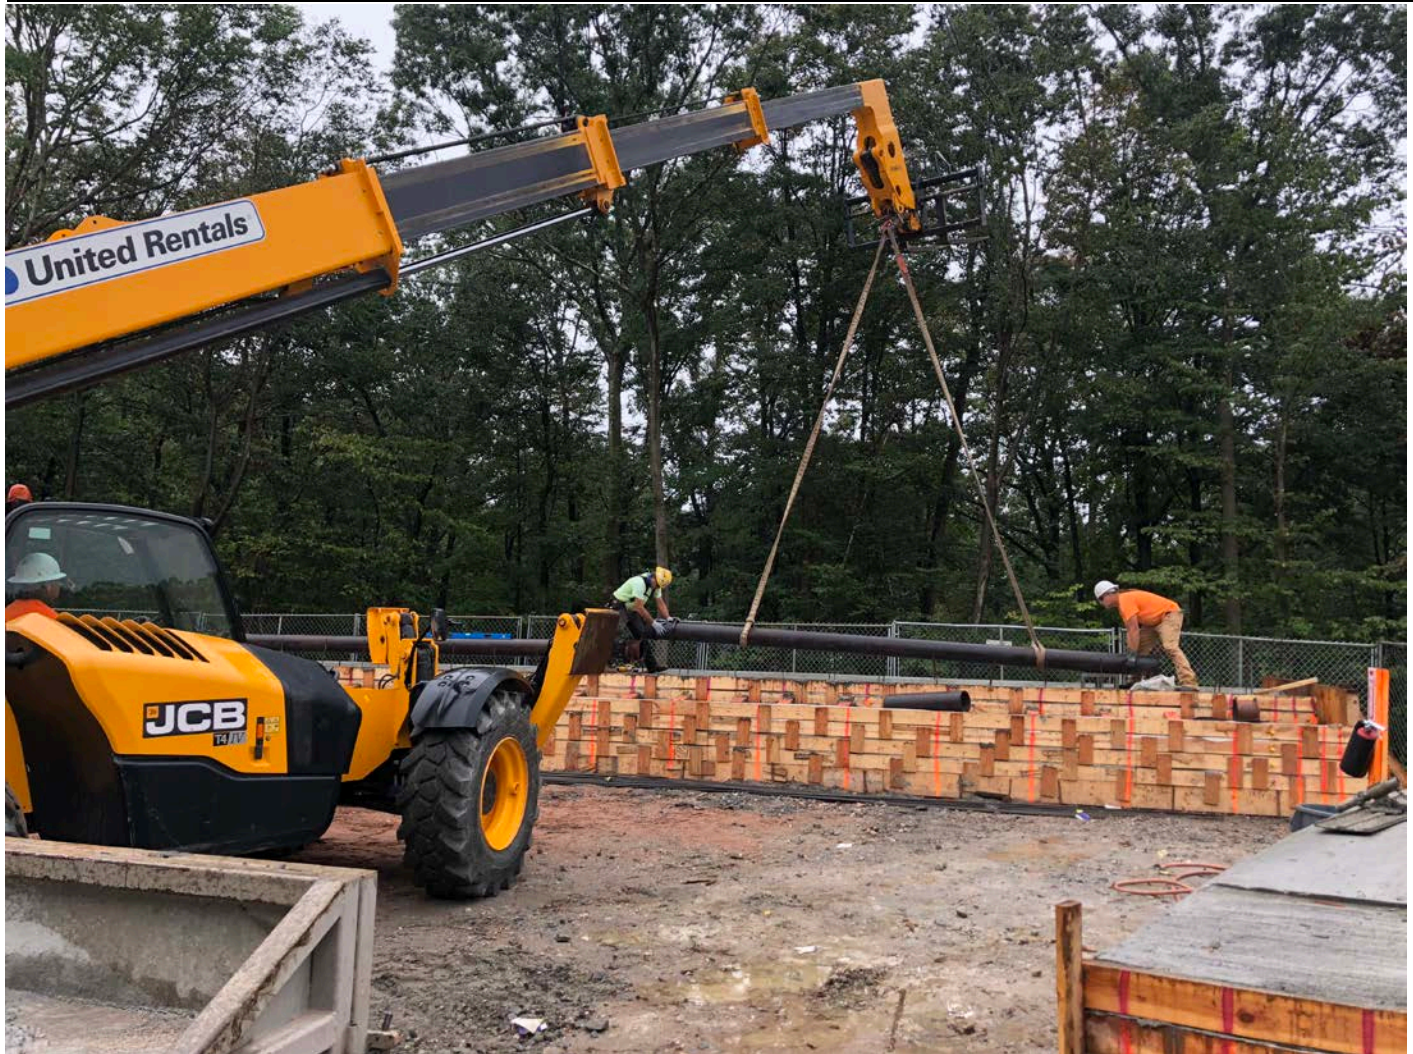
Picture 7: DN Tanks placing 8" DIP on one of the narrow water tank side panels. Water tank work zone, east of the Shared Access Driveway, Middletown. View to the south.

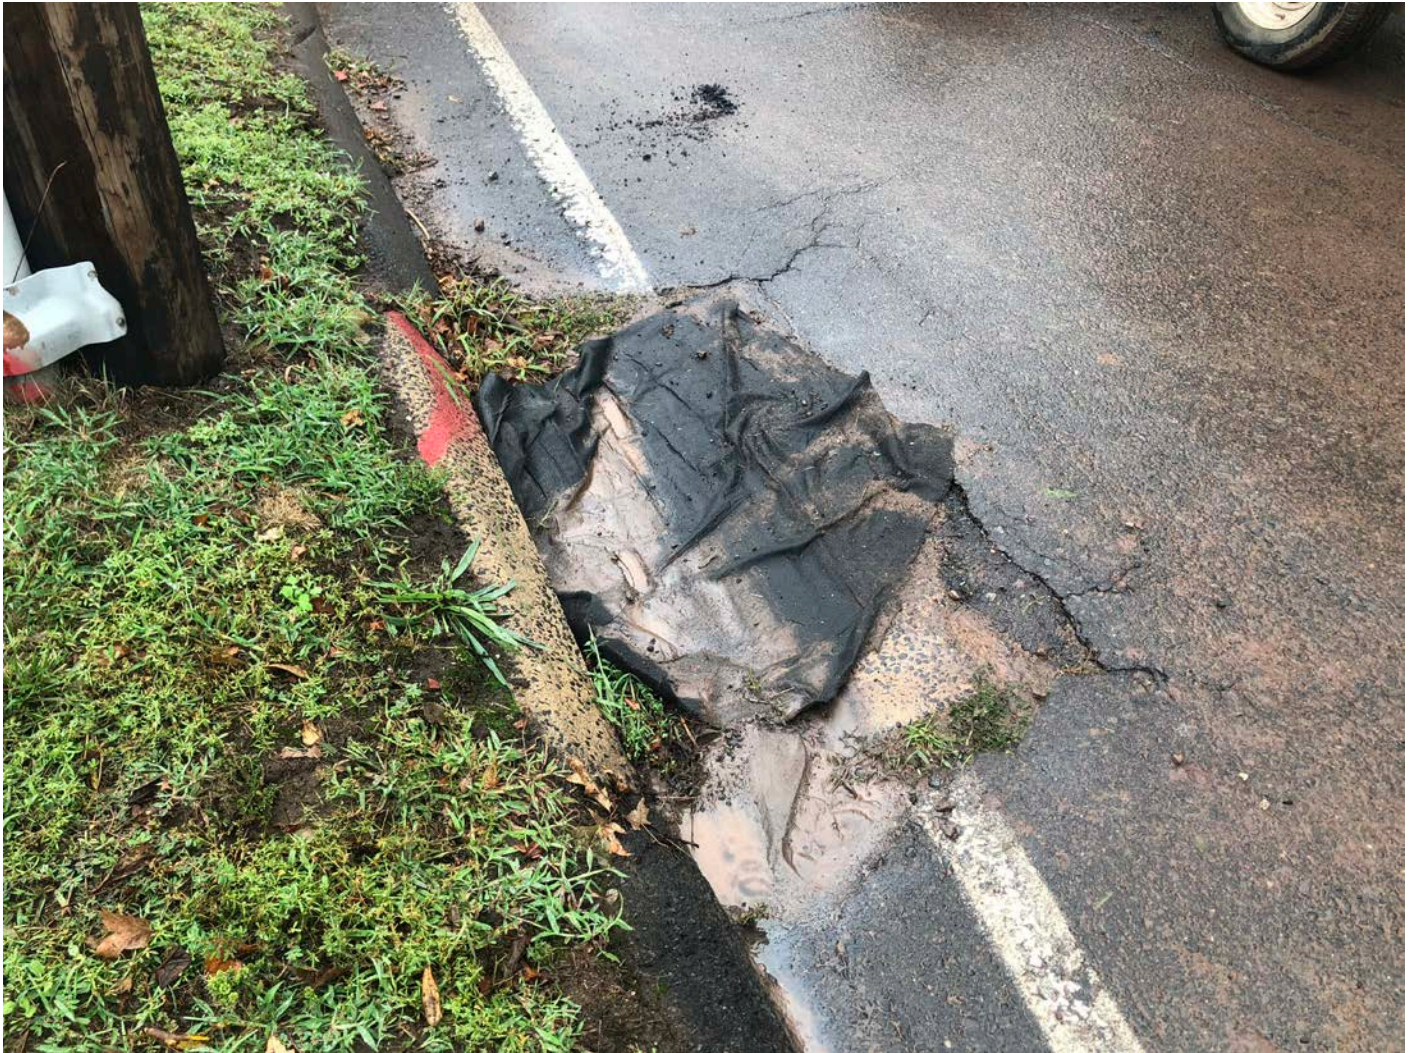
**Picture 8: Filter fabric placed over storm drain on Main Street downgradient of the excavation at Station 198+10. Main Street, Durham.**

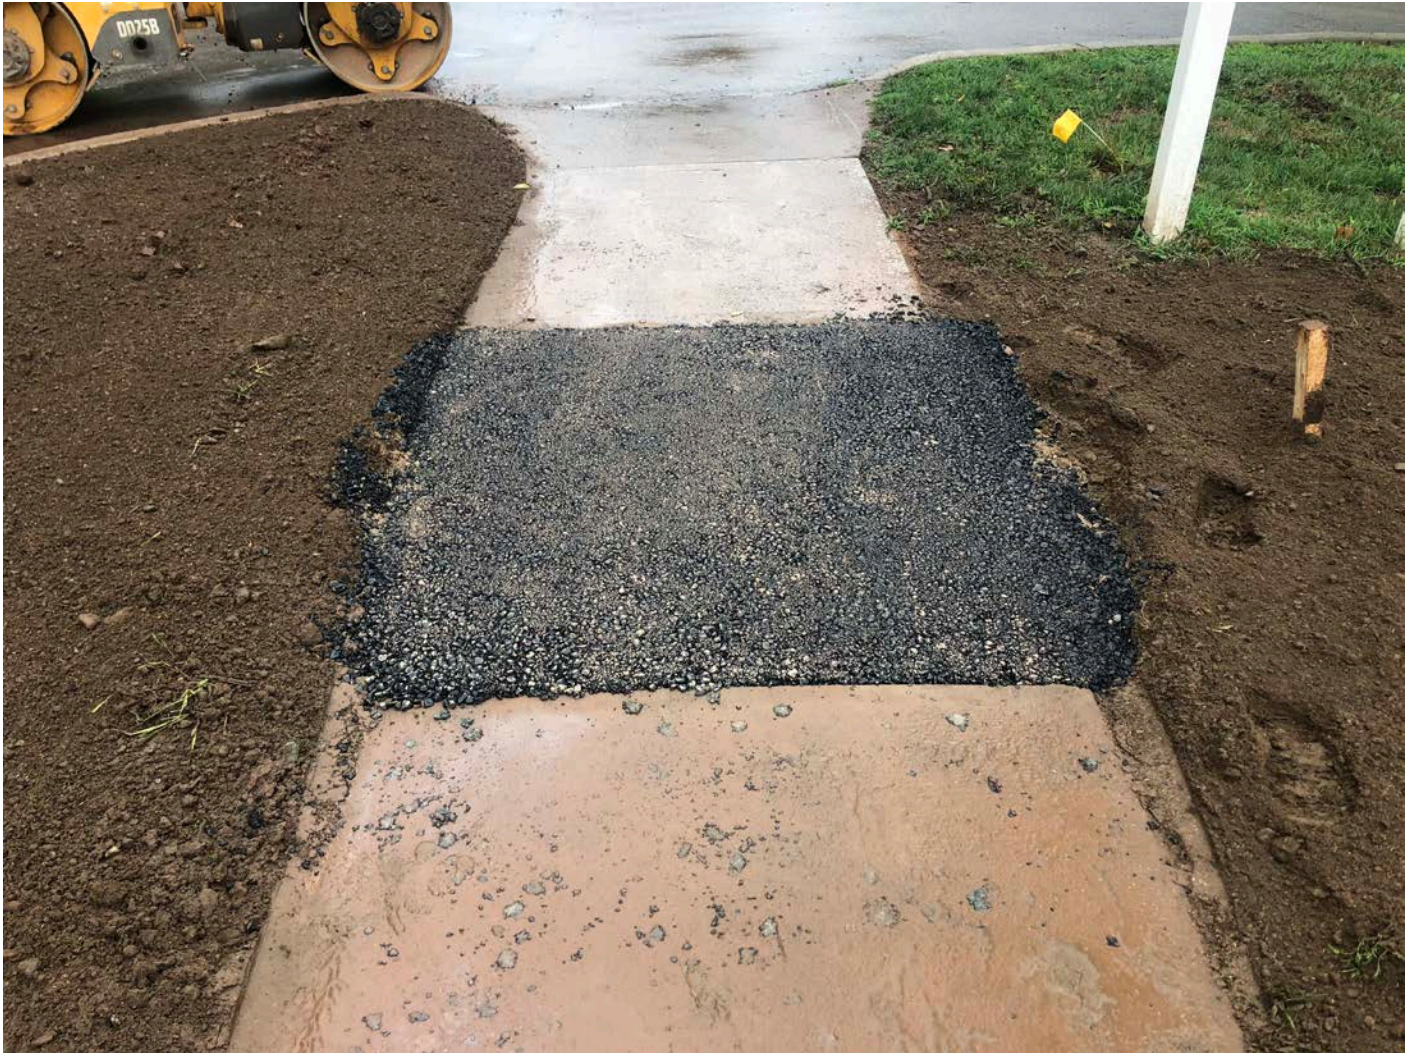
Picture 9: Sidewalk at Station 198+10 temporarily repaired with hot patch. Main Street, Durham. View to the south.

1240: Ludlow has completely backfilled the trench at Station 198+10. All disturbed areas have been loamed and seeded. Ludlow used hot patch to repair the one panel of the concrete sidewalk that was broken in the process of installing the pipe.

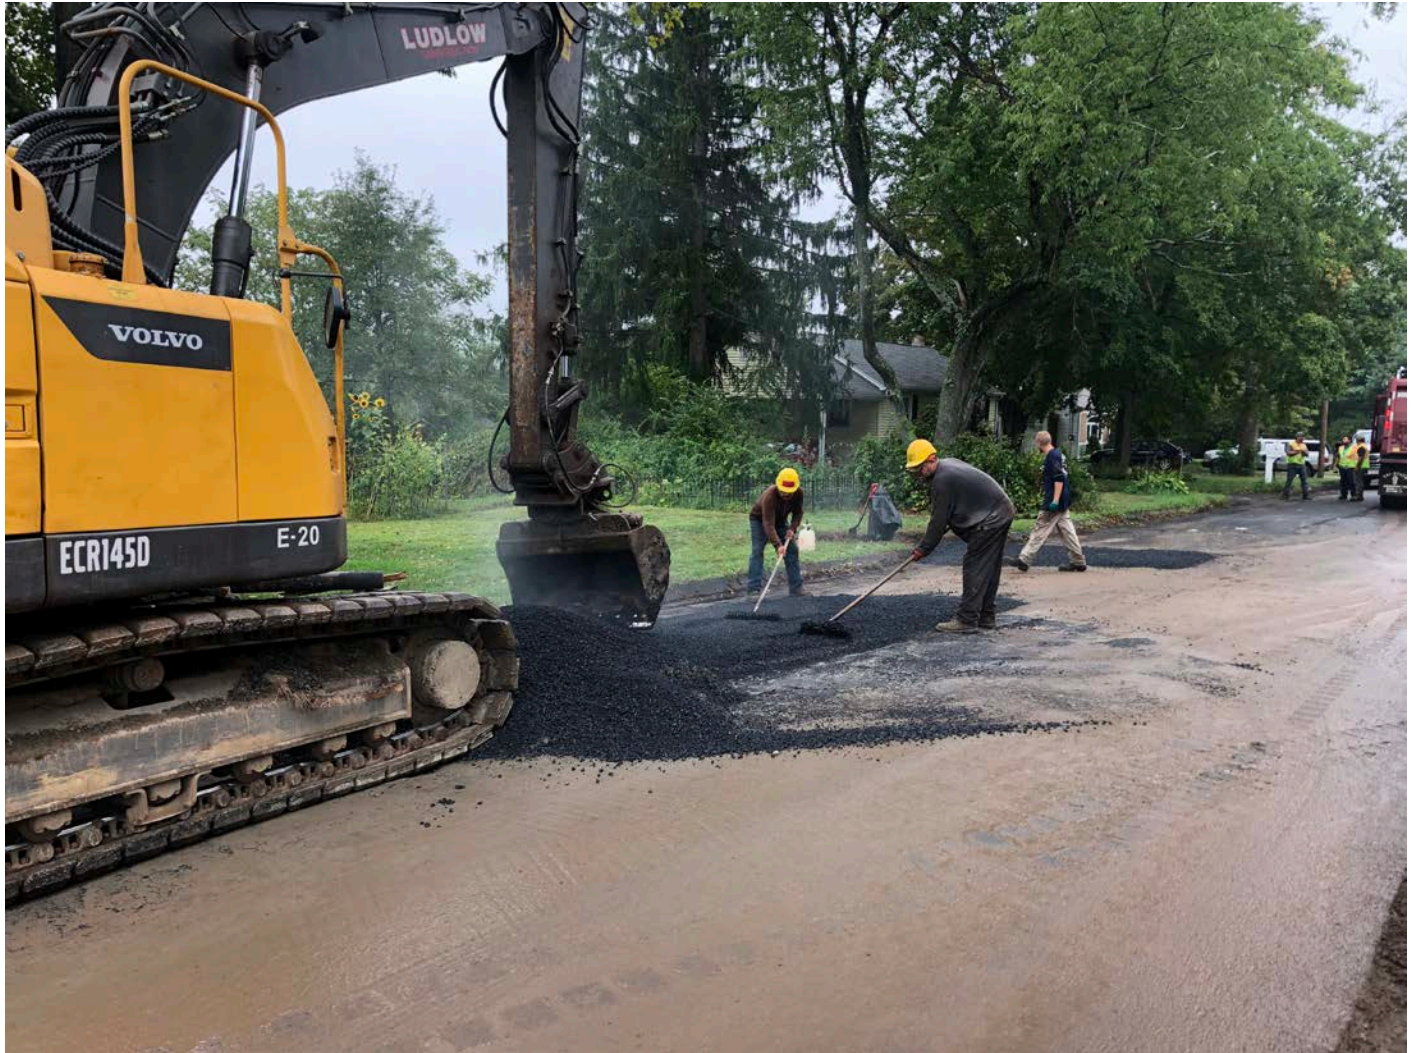
1326: Ludlow is placing hot patch on the trench that was opened today on Maple Avenue for the installation of 8" DIP.

**Picture 10: Ludlow placing hot patch on the trench that was excavated today for the installation of 8" DIP. Maple Avenue, Durham. View to the southwest.**
