Daily R	Rep	or	t			
Project:	Durham Meadow	vs Pipeline Installation					Date: Octobe	er 15, 2020
Location:							Day of Week:	Thursday
		ham; Shared Access Driveway	, Mi	ddl	etov	vn		
Project #:	AECOM: 606148						Report No:	180
Contractor:	Ludlow Construct	tion					Page:	1 of 13
		Weather C	ondi	tior	nc			
Conditions:	Davlight k	nours: partly sunny. Winds va				nh		
	5 0		IIdui	e u	-0 111	рп	l.	
Temperature (°F):	High	72°F Low 61F		_				
С	ontractors & Sub	contractors Workforce					Equipment in Use	
Trade	# x hrs	Trade	#	Х	hrs		Туре	# x hrs
USACE		Ludlow Construction					Concrete/Asphalt Road Saw	0 x 8
Field Engineer	1 x 8	Superintendent	1	Х	8		Dump truck	0 x 8
		Safety Officer	1	Х	8		Excavator – Large	0 x 8
		Foreman	1	Х	8		Excavator - Mid-Size	0 x 8
		Dump truck Operator	4	Х	8		Excavator - Rubber Wheeled – Rock	0 x 8
		Excavator Operator	1	Х	8		Skid Steer / Bucket Loader	0 x 8
		Skid Steer/Bucket Loader	1	Х	8		Rolling Compactor	0 x 8

Project:	Durham Meadows Pipeline Installation	Date:	October 15, 2020
Location:		Day of Week:	Thursday
LUCATION.	Main Street, Durham; Shared Access Driveway, Middletown		
Project #:	AECOM: 6061487	Report No:	180
Contractor:	Ludlow Construction	Page:

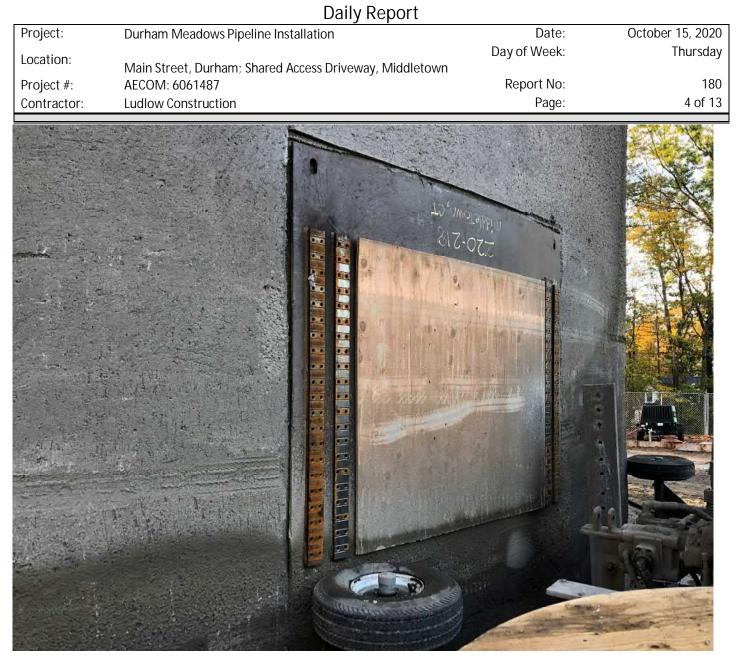
Picture 1: Stress plate that DN Tanks installed on the manways located on the west side of the water tank. Water tank work zone located east of the Shared Access Driveway, Middletown. View to the southeast.

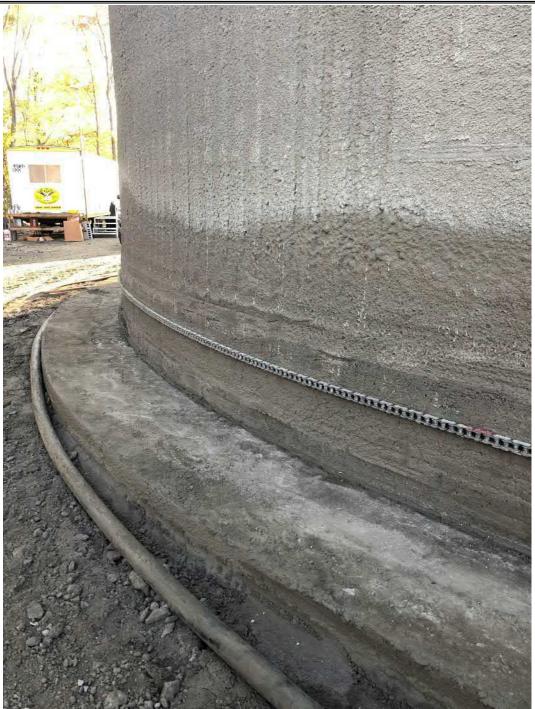
Picture 2: The base of the water tank after shotcrete was applied to it yesterday. Water tank work zone located east of the Shared Access Driveway, Middletown. View to the east.

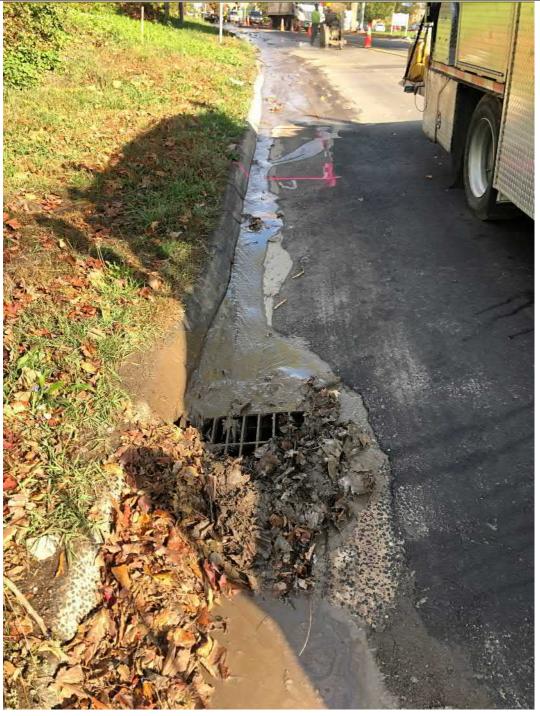
0946: Veilleux is saw cutting pavement on the southbound lane of Main Street, Durham at Station 206+00. Two private flaggers are providing traffic detail. The catch basin located downgradient of the work zone at Station 206+20 does not have a silt sock installed in it. Ludlow indicated that the grate to the drain was stuck in place. AECOM requested that filter fabric be placed over the catch basin grate, which Ludlow quickly addressed.

Picture 3: Water and silt from saw cutting operations on the southbound lane of Main Street, Durham entering the catch basin located at Station 206+20. View to the north.

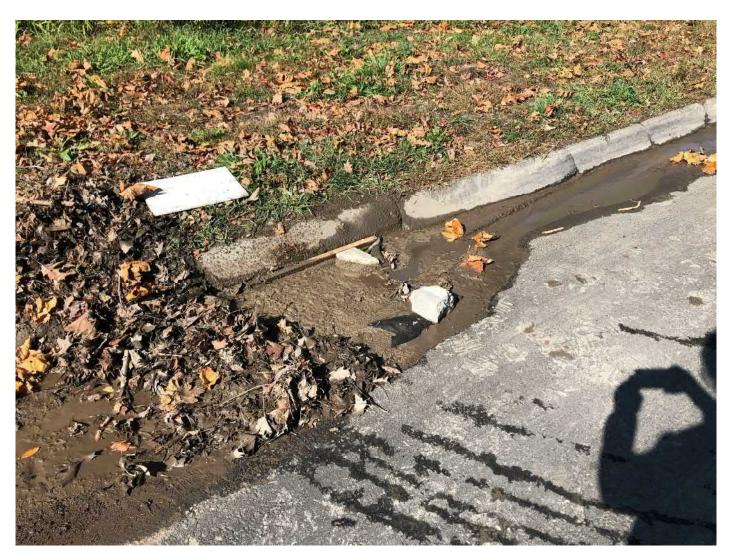
Picture 4: Silt fabric placed over the catch basin located at Station 206+20, which is located downgradient of pavement saw cutting activities. Main Street, Durham; view to the northwest.

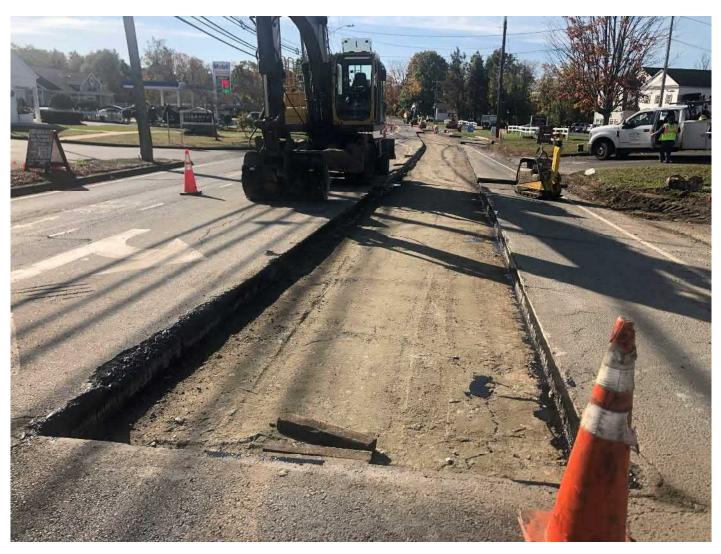
Picture 6: Asphalt stripped away from trench overcuts paving work zone located on the southbound lane of Main Street, Durham, between Stations 167+30 and 171+00.

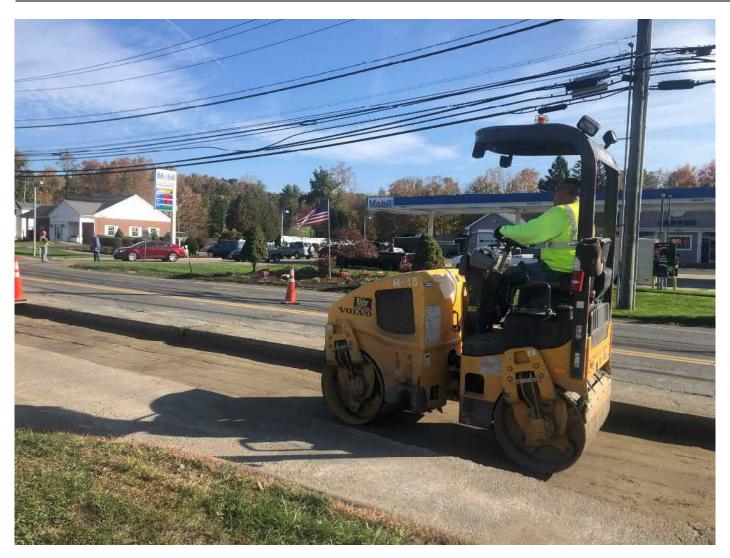
Picture 7: Ludlow compacting 1.5" processed gravel as part of trench overcut paving activities on the southbound lane of Main Street, Durham, between Stations 167+30 and 171+00.

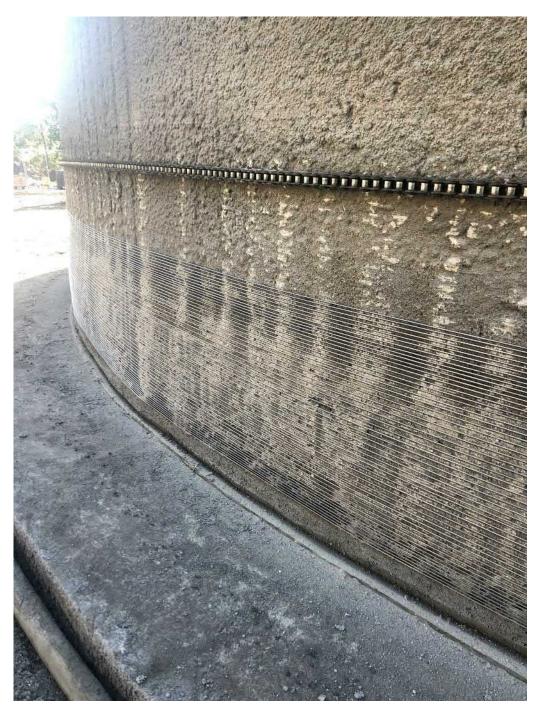
Picture 8: DN Tanks started to place a second layer of prestressed wire on the base of the water tank after shotcrete was applied to it yesterday. Water tank work zone located east of the Shared Access Driveway, Middletown. View to the east.

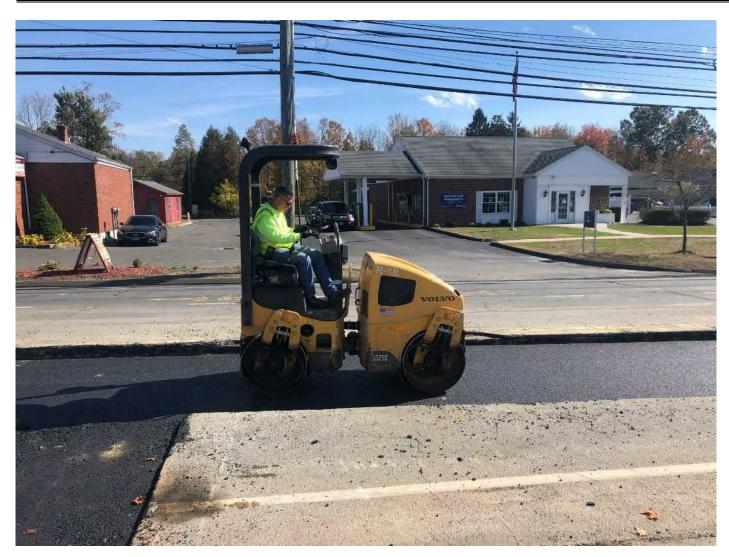
Picture 9: Ludlow compacting first 3" lift of asphalt as part of trench overcut paving activities on the southbound lane of Main Street, Durham, between Stations 167+30 and 171+00. View to the east.

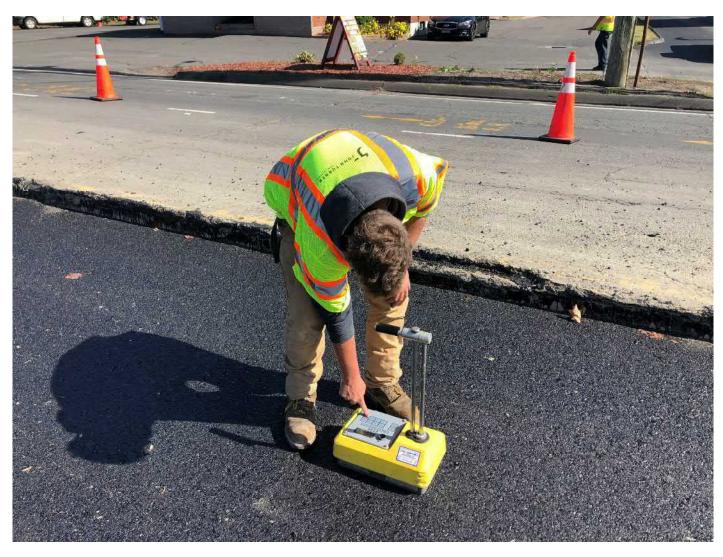
Picture 10: JTC collecting compaction data from the first 3" lift of asphalt as part of trench overcut paving activities on the southbound lane of Main Street, Durham, between Stations 167+30 and 171+00. View to the northeast.
