Daily Report

| Project: | Durham Meadows Pipeline Installation | Date: | October 28, 2020 |
| Project #: | AECOM: 6061487 | Report No: | 189 |
| Contractor: | Ludlow Construction | Page: | 1 of 10 |

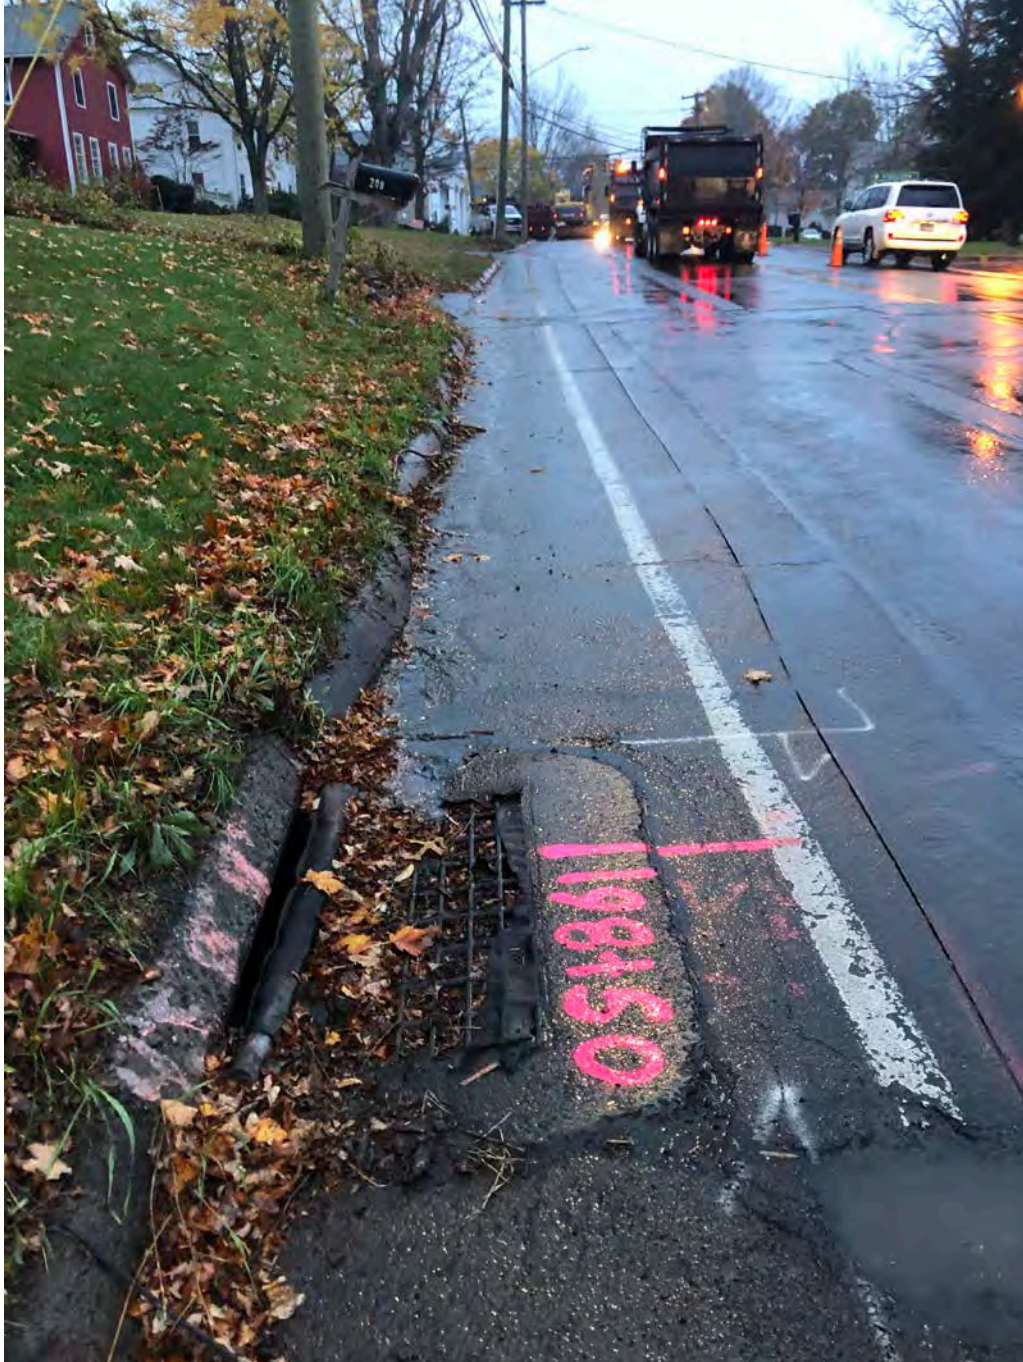
0731: Ludlow continues to excavate asphalt from trench overcuts in a southern direction on the southbound lane of Main Street just south of Route 68 as part of permanent paving activities. The catch basin located immediately downgradient of where Ludlow is working at Station 198+50 has a silt sock installed in it.

Picture 1: Catch basin with installed silt sock located at Station 198+50 located downstream and south of where Ludlow is placing permanent paving between Stations 195+30 to 195+85 on the southbound lane of Main Street, Durham. View to the north.

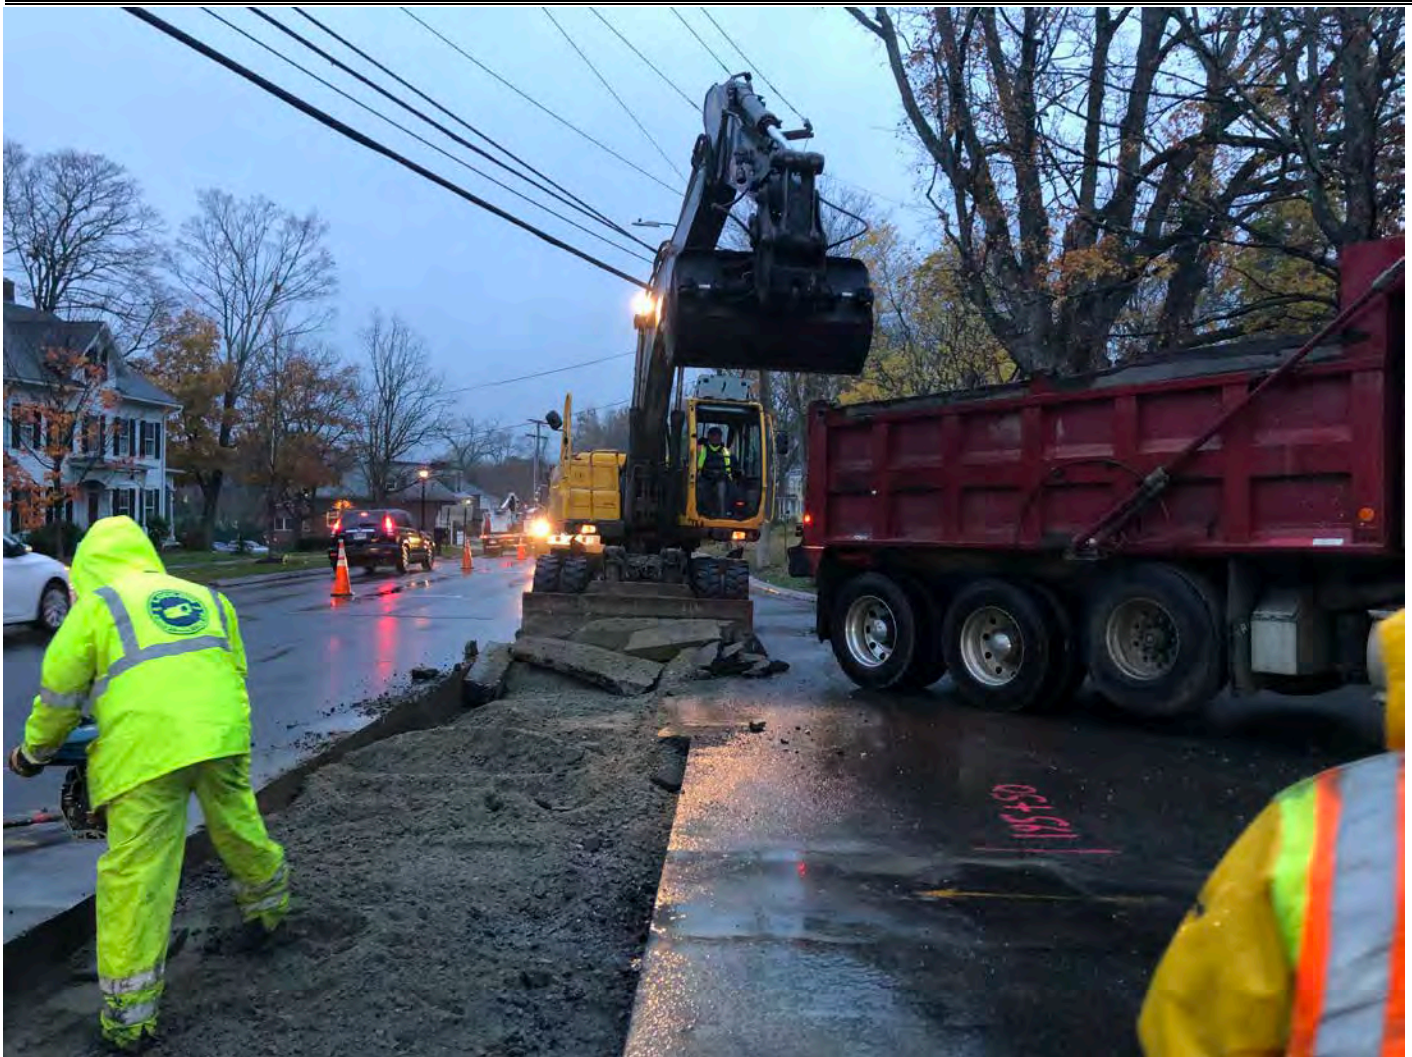
0817: Ludlow has excavated pavement from trench overcuts from Station 195+30 to 195+85 a curb stop overcut at Station 195+85.

Picture 2: Ludlow stripping pavement away from trench overcuts between Stations 195+30 to 195+85 on the southbound lane of Main Street, Durham, as part of permanent paving activities. View to the south.

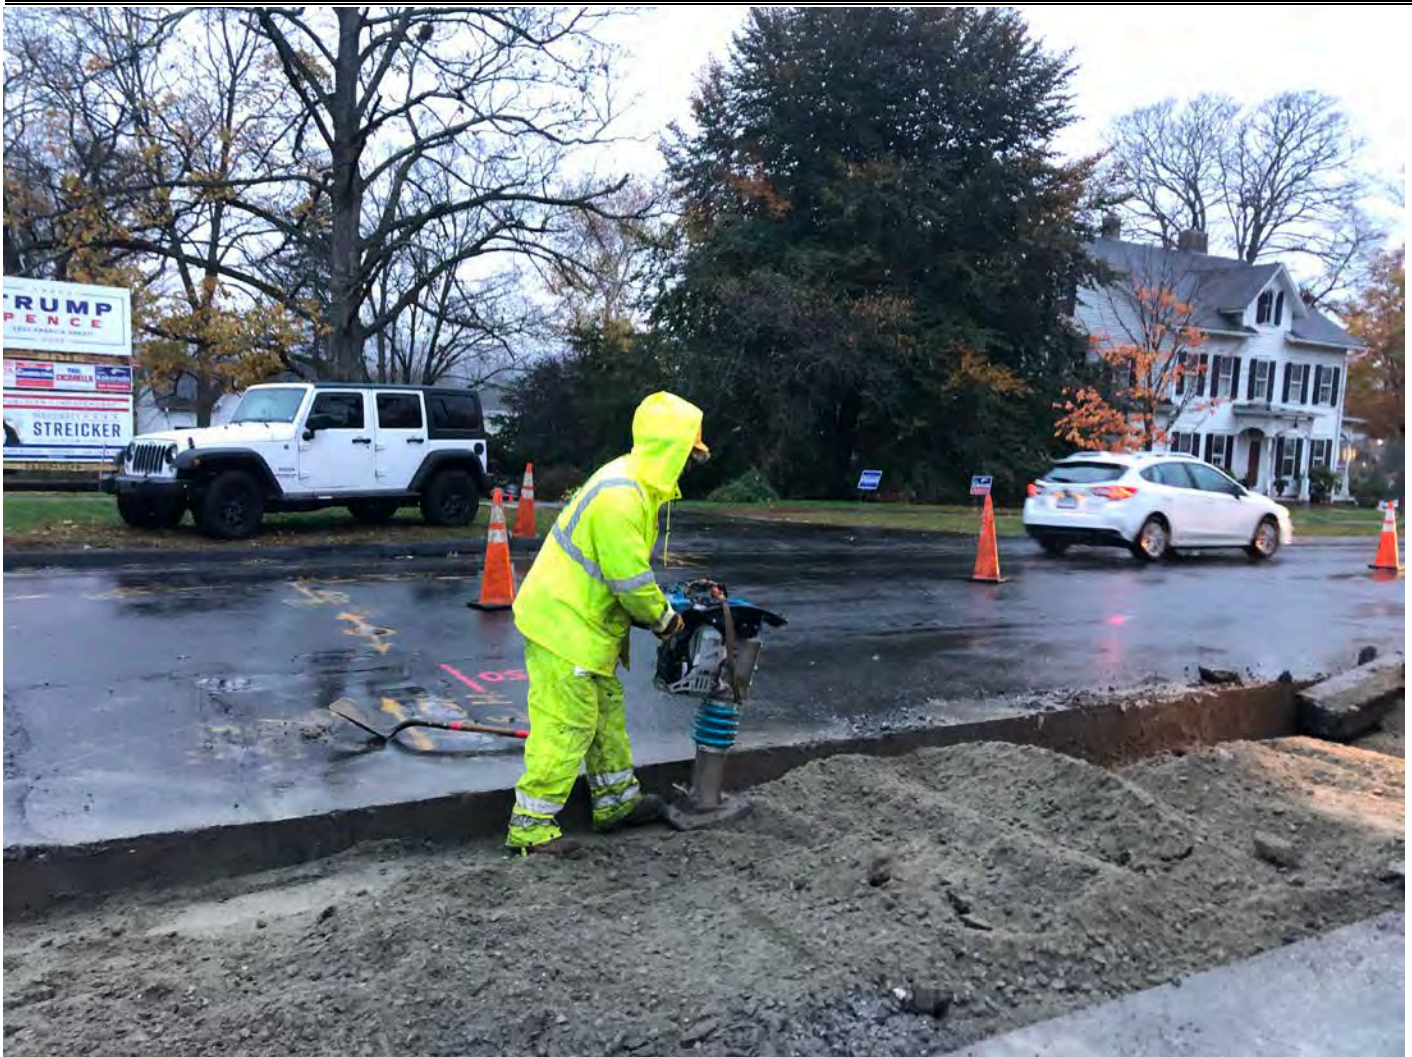
Picture 3: Ludlow compacting 1.5" processed gravel between Stations 195+30 to 195+85 as part of permanent paving activities on the southbound lane of Main Street, Durham. View to the southeast.

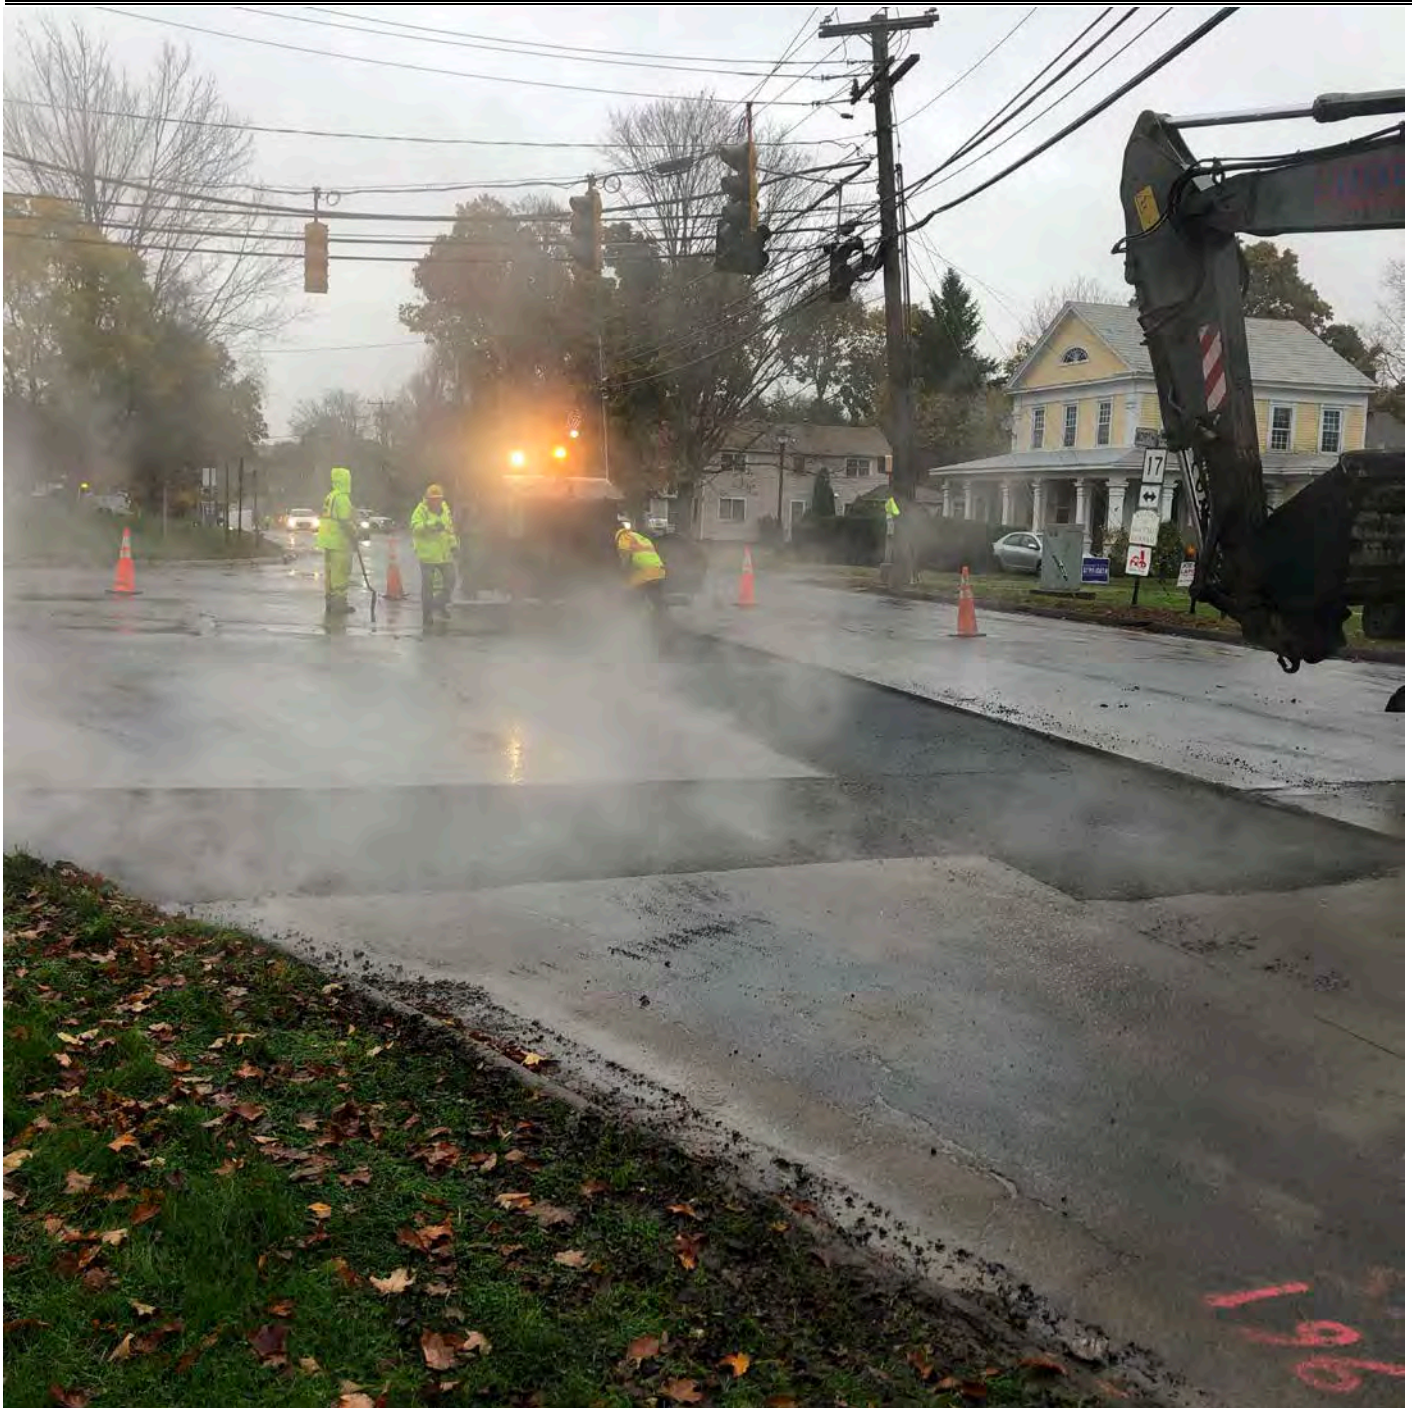
Picture 4: Ludlow placing asphalt on trench overcut between Stations 195+30 to 195+85 on the southbound lane of Main Street, Durham, as part of permanent paving activities. View to the north.

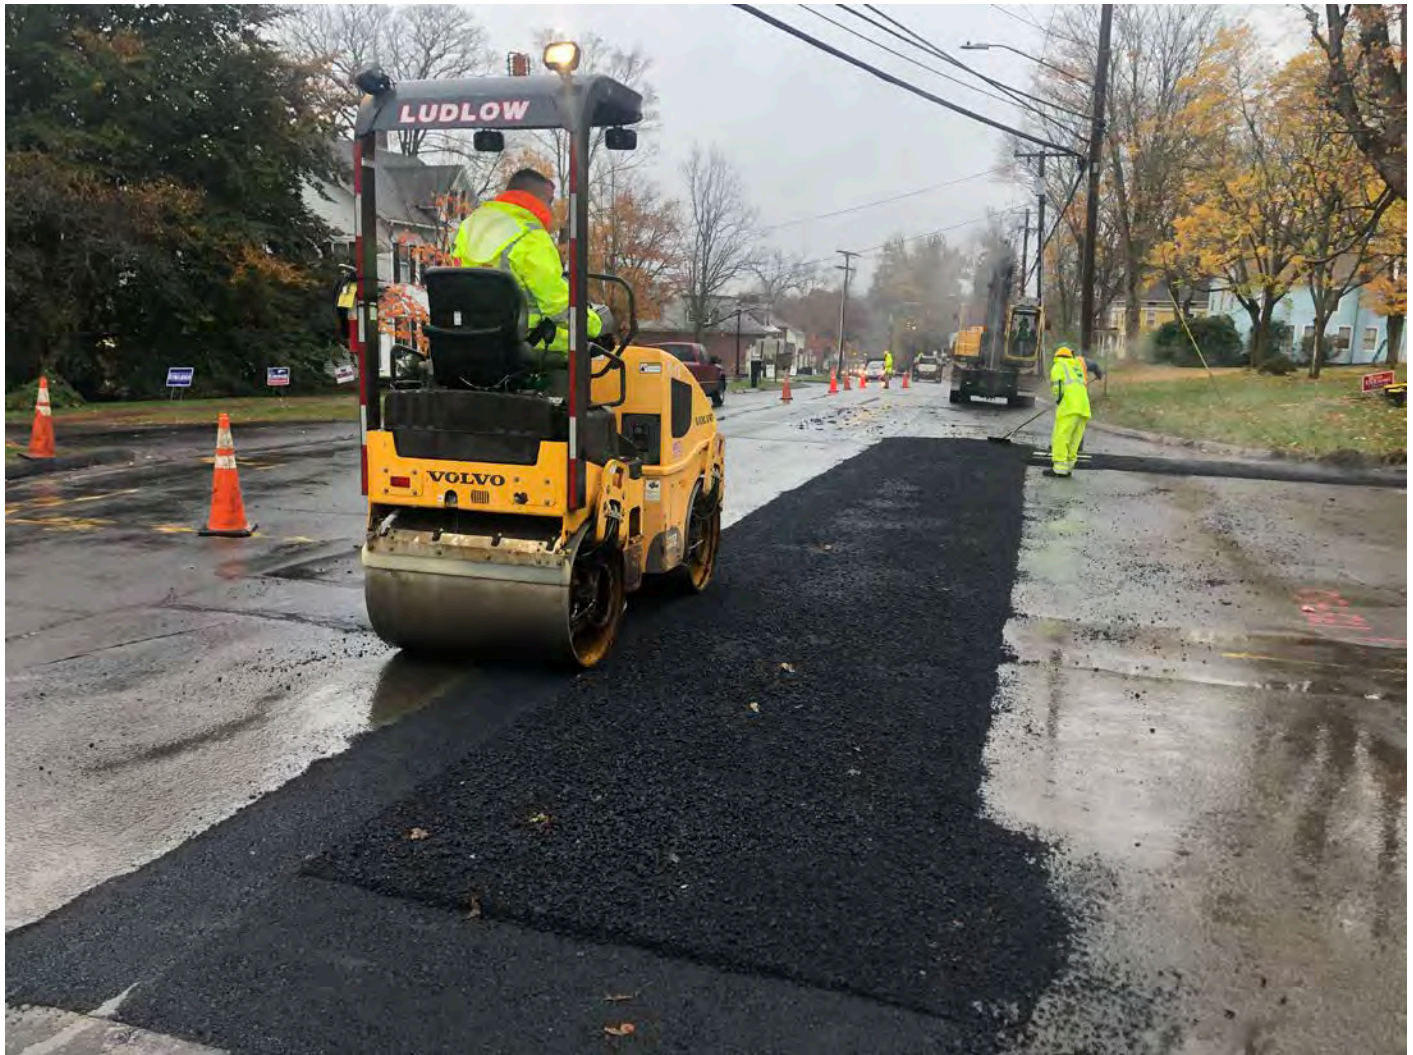
0945: Ludlow continues to place a third 3" lift of asphalt on trench overcuts as part of permanent paving on the southbound lane of Main Street, Durham. Compaction testing was not performed on any of the lifts of asphalt that Ludlow placed today.

Picture 5: Ludlow compacting the third of three 3" lifts of asphalt between Stations 195+30 to 195+85 as part of permanent paving activities on the southbound lane of Main Street, Durham. View to the south.

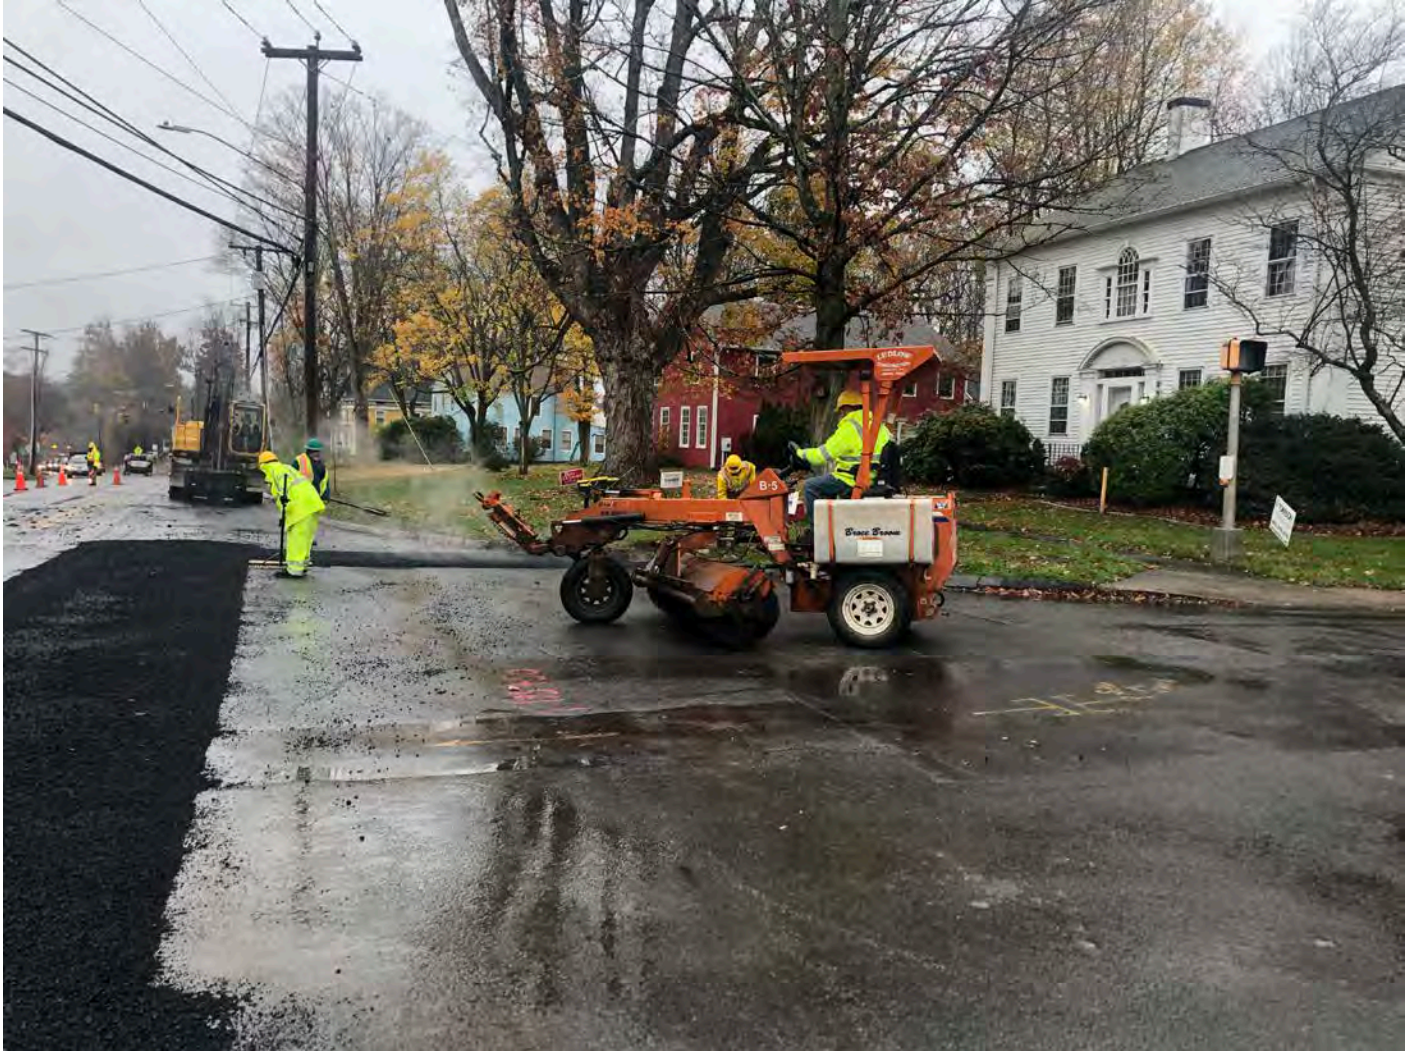
1033: Ludlow is demobilizing from the intersection of Main Street and Route 68 in Durham. Ludlow is also using a Bocce Broom to clean up the work zone.

Picture 6: Ludlow cleaning up work zone between Stations 195+30 to 195+85 as part of permanent paving activities on the southbound lane of Main Street, Durham. View to the south.

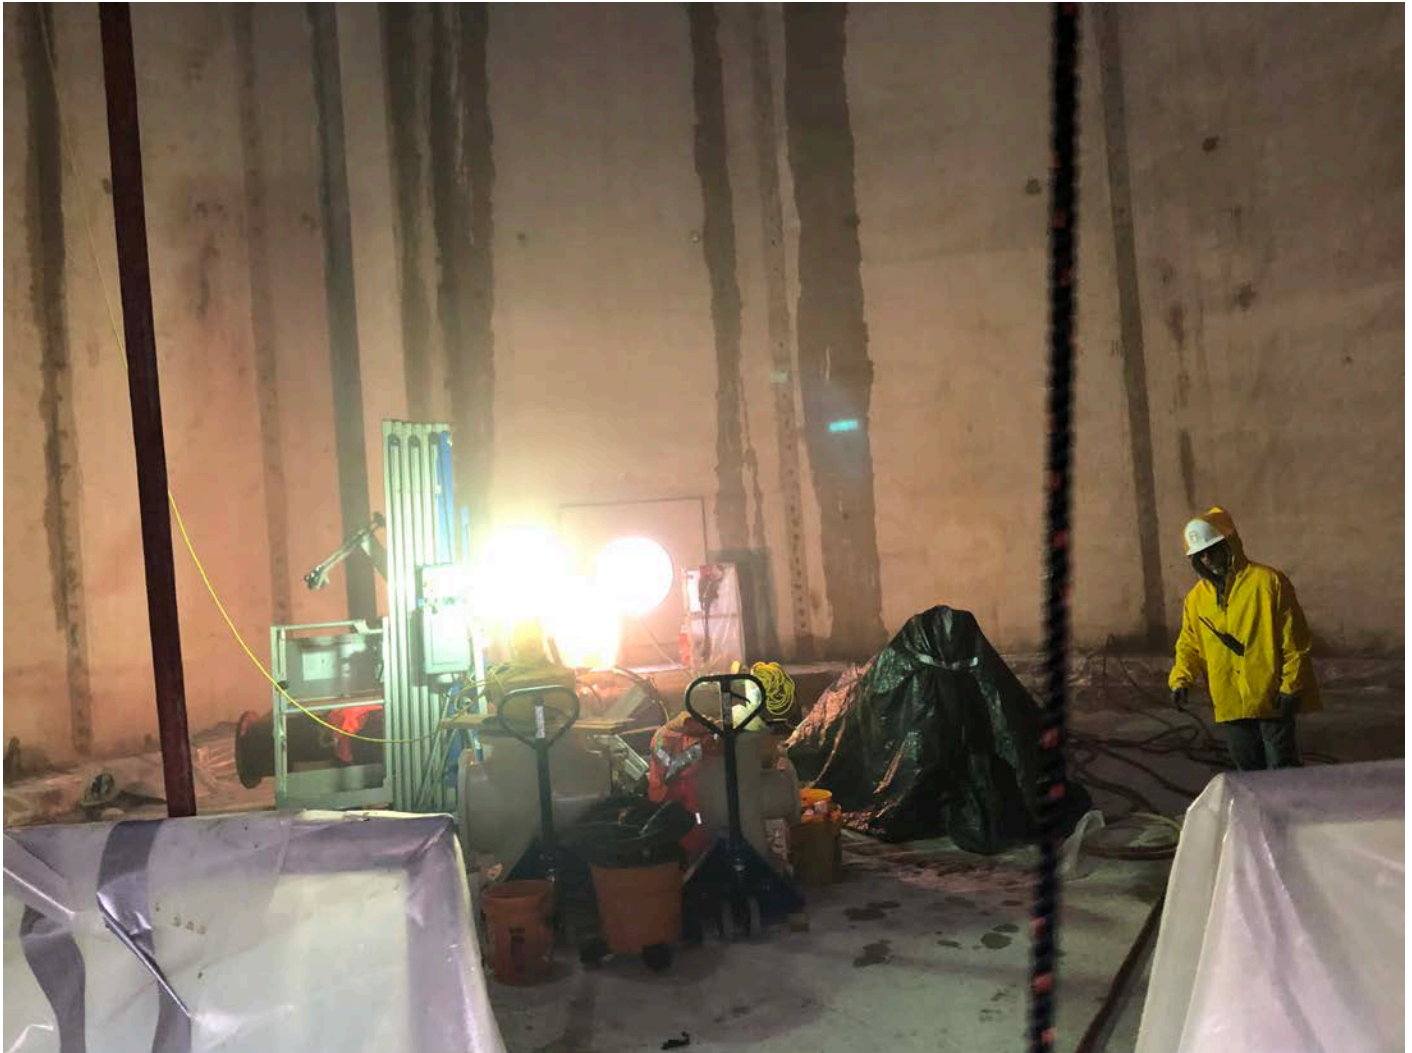
0755: DN Tanks is working inside of the water tank this morning, cleaning it out and preparing to pressure wash the interior of the water tank as they prepare to place the CIM activator coating.

Picture 7: Current view of water tank interior. Water tank work zone located to the east of the Shared Access Driveway, Middletown.
