## Daily Report

<b>Project:</b>	Durham Meadows Pipeline Installation	<b>Date:</b>	November 17, 2020
<b>Location:</b>	Maple Avenue, Durham; Shared Access Driveway, Middletown	<b>Day of Week:</b>	Tuesday
<b>Project #:</b>	AECOM: 6061487	<b>Report No:</b>	202
<b>Contractor:</b>	Ludlow Construction	<b>Page:</b>	1 of 10

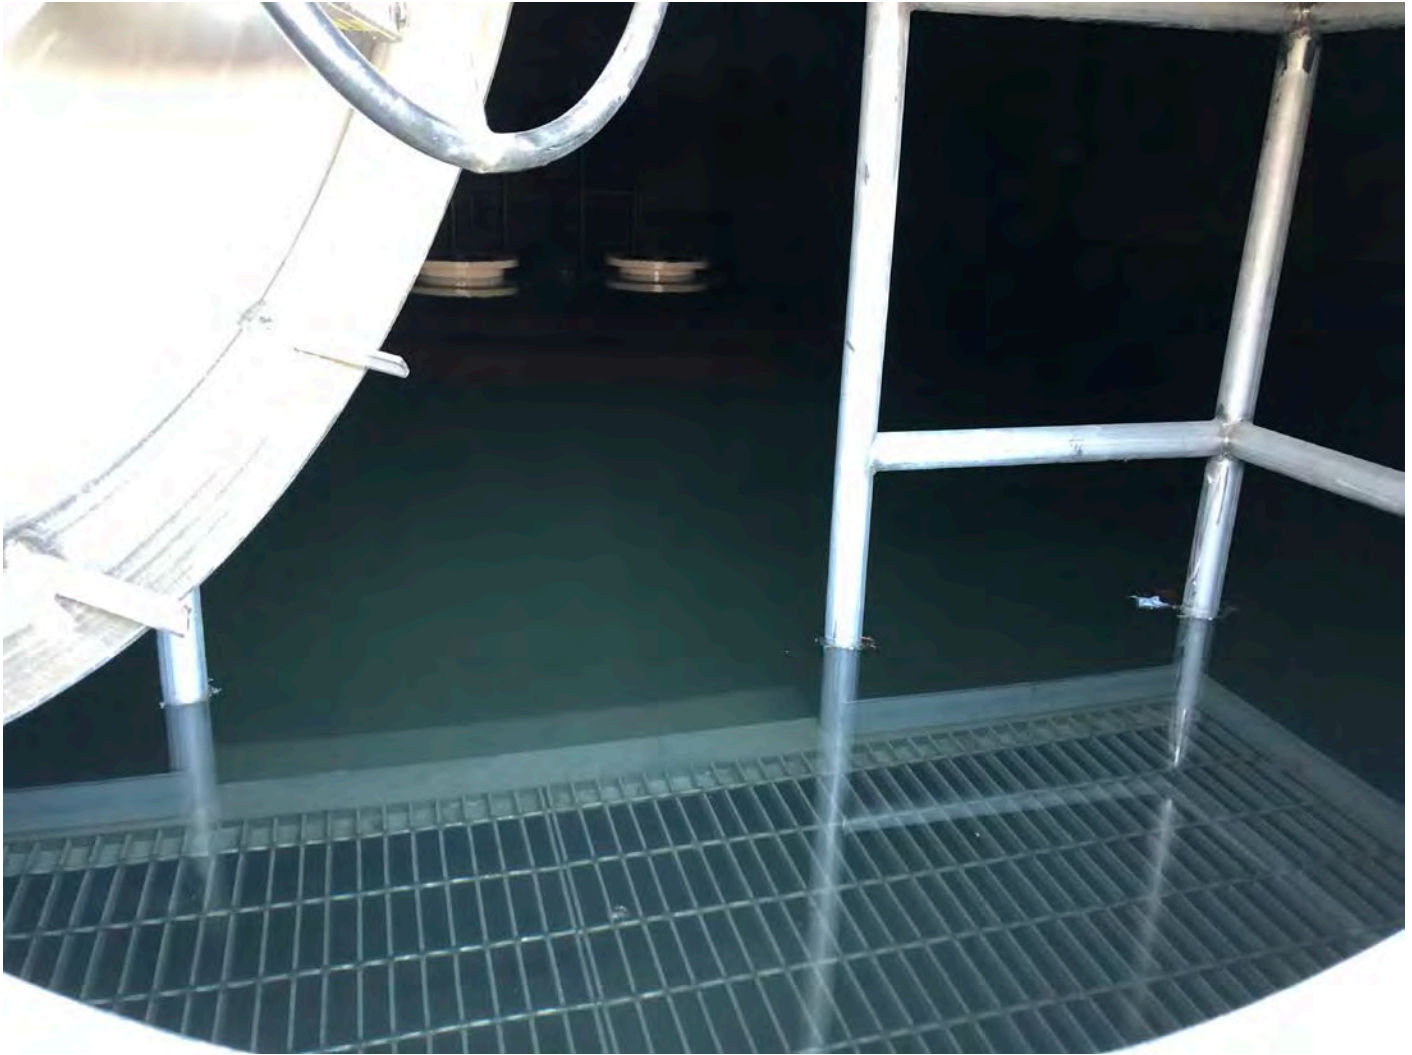
0740: Ludlow is present at the water tank zone located to the east of the Shared Access Driveway, Middletown preparing to add water to the water tank. The tank will be filled to just below the manway hatch on the west side of the water tank.

0955: Ludlow has stopped filling the water tank, as the water level rose to the bottom of the manway on the west side of the water tank. DN Tanks has one representative on site who is performing light housekeeping around the water tank work zone.

**Picture 1: Water level in the water tank located to the east of the Shared Access Driveway, Middletown at 0746 hours this morning, prior to Ludlow adding additional water.**

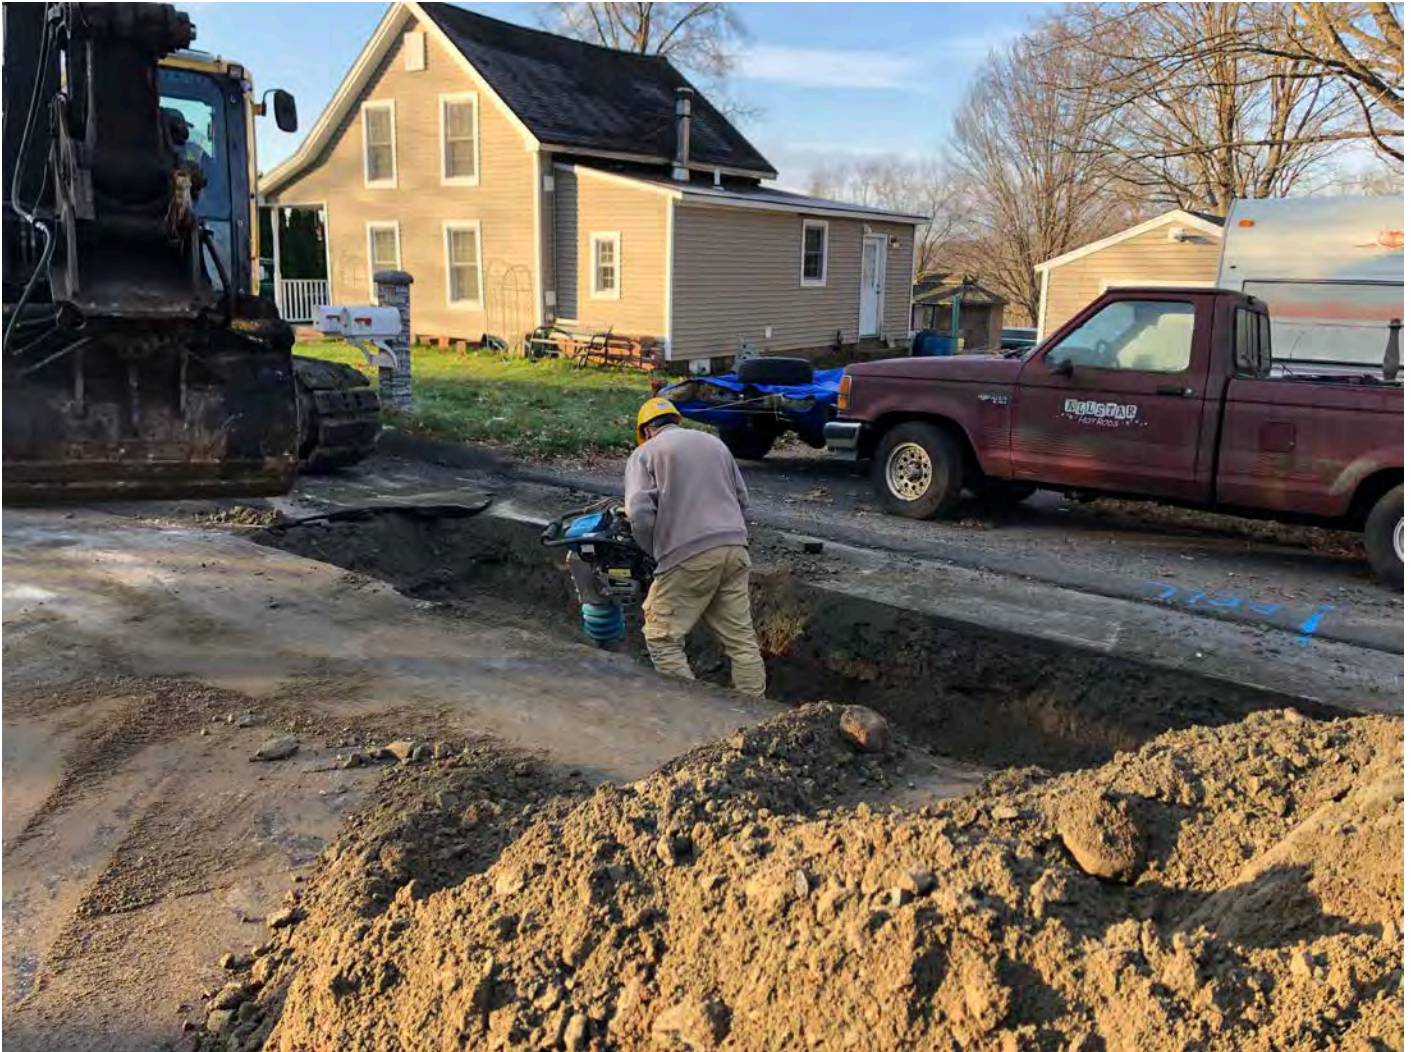
0808: Ludlow is in the process of backfilling a test pit that they excavated on the southbound lane of Maple Avenue, Durham at Station 924+70 as they continue to look for the source of the leak on the 8" DIP water line they installed earlier in the year.

**Picture 2: Ludlow compacting soil in test pit they excavated at Station 924+70 as the searched for the source of a leak on the 8" DIP water line on Maple Avenue, Durham. View to the southwest.**

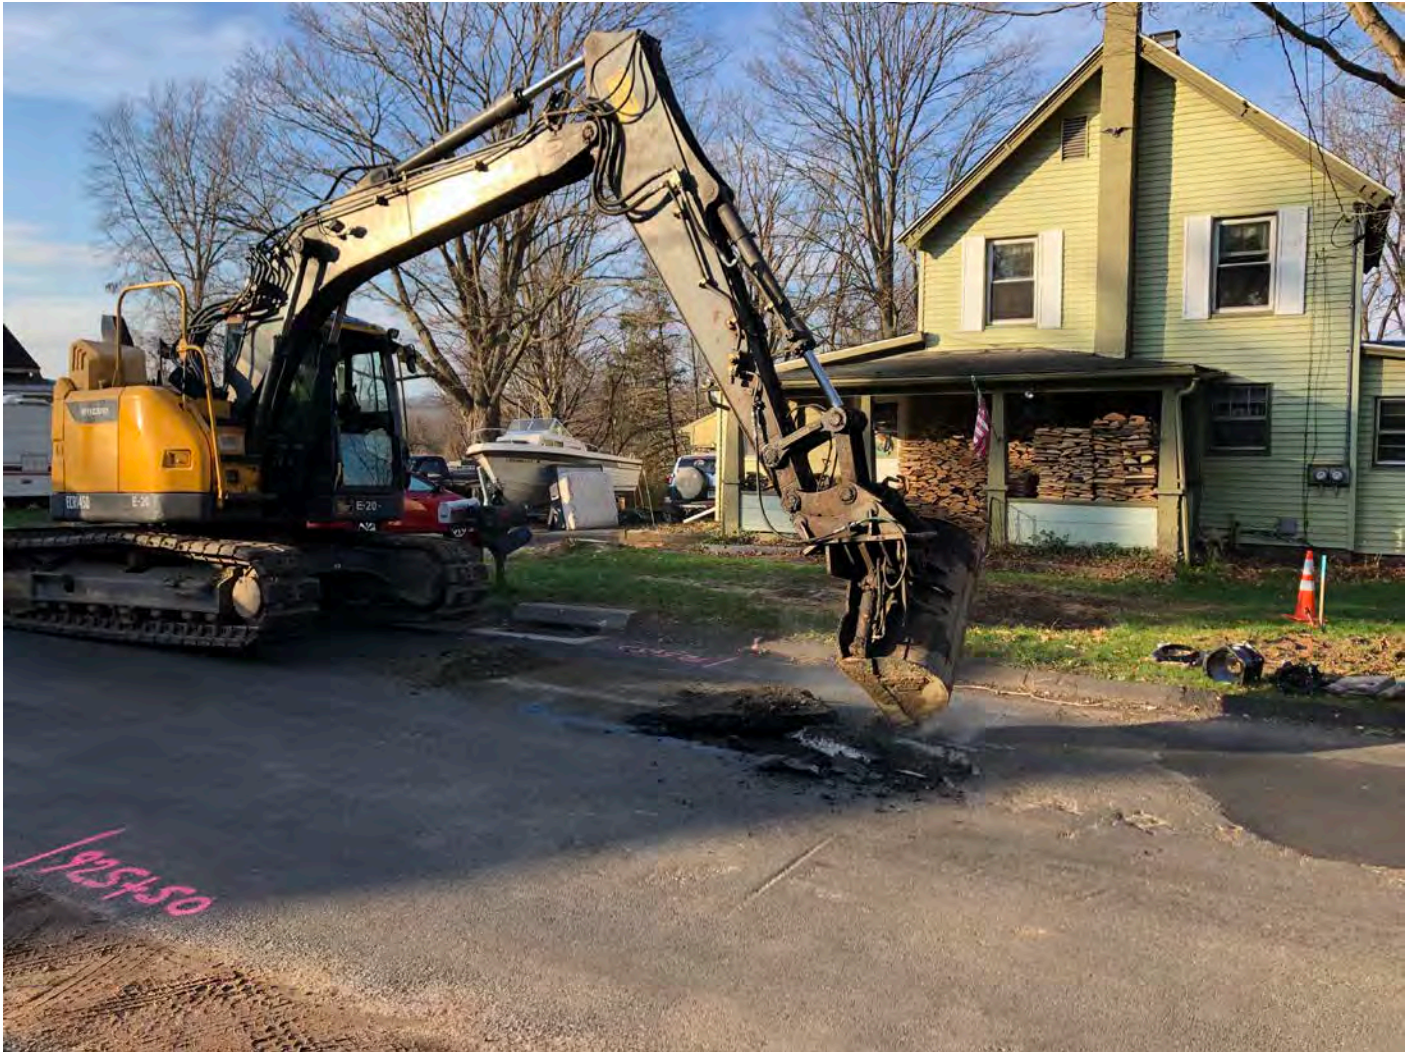
0820: Ludlow is excavating on the southbound lane of Maple Avenue, Durham at Station 925+55 to install a gate valve that they hope will help isolate a leak in the 8" DIP water line they installed earlier in the year.

Picture 3: Ludlow beginning to excavate on the southbound lane of Maple Avenue, Durham at Station 925+55 to install a gate valve to help isolate a leak in the 8" DIP water line they installed earlier in the year. View to the west.

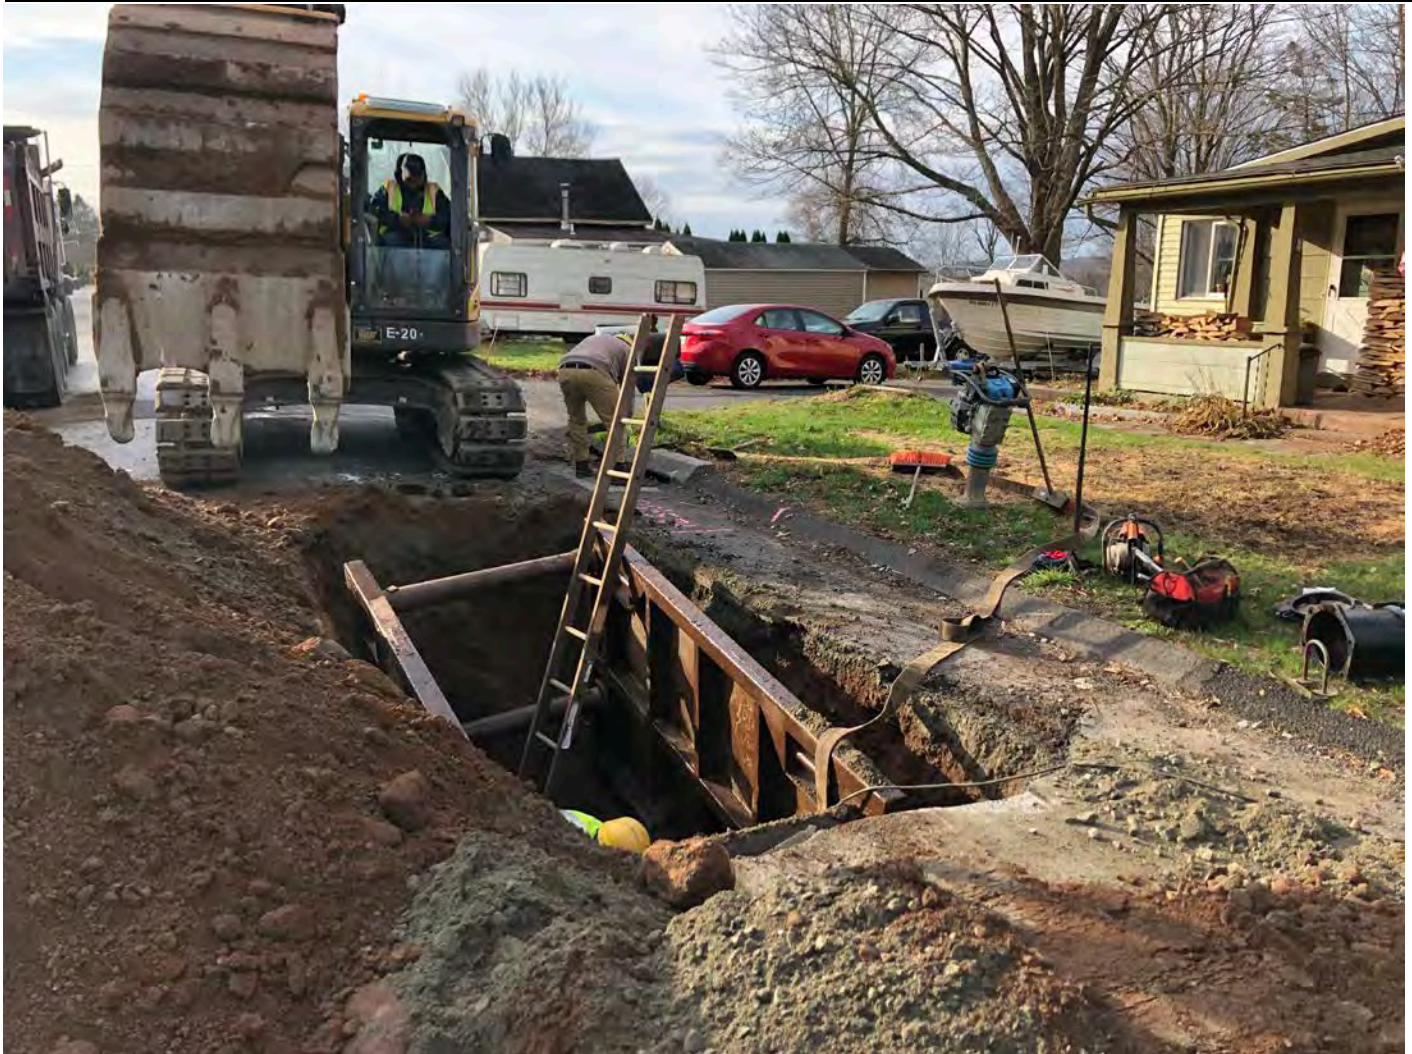
**Picture 4: Ludlow in the process of installing a gate valve on the southbound lane of Maple Avenue, Durham at Station 925+55. View to the southwest.**

1014: Ludlow has finished installing a gate valve at Station 925+55 on north end of the cut waterline on the southbound lane of Maple Avenue, Durham. Ludlow is currently attaching a MJ solid sleeve onto the south end of the cut waterline. Ludlow will place a 3' section of 8" DIP between the gate valve and a M.J. solid sleeve in order to connect each end of the water line to each other.

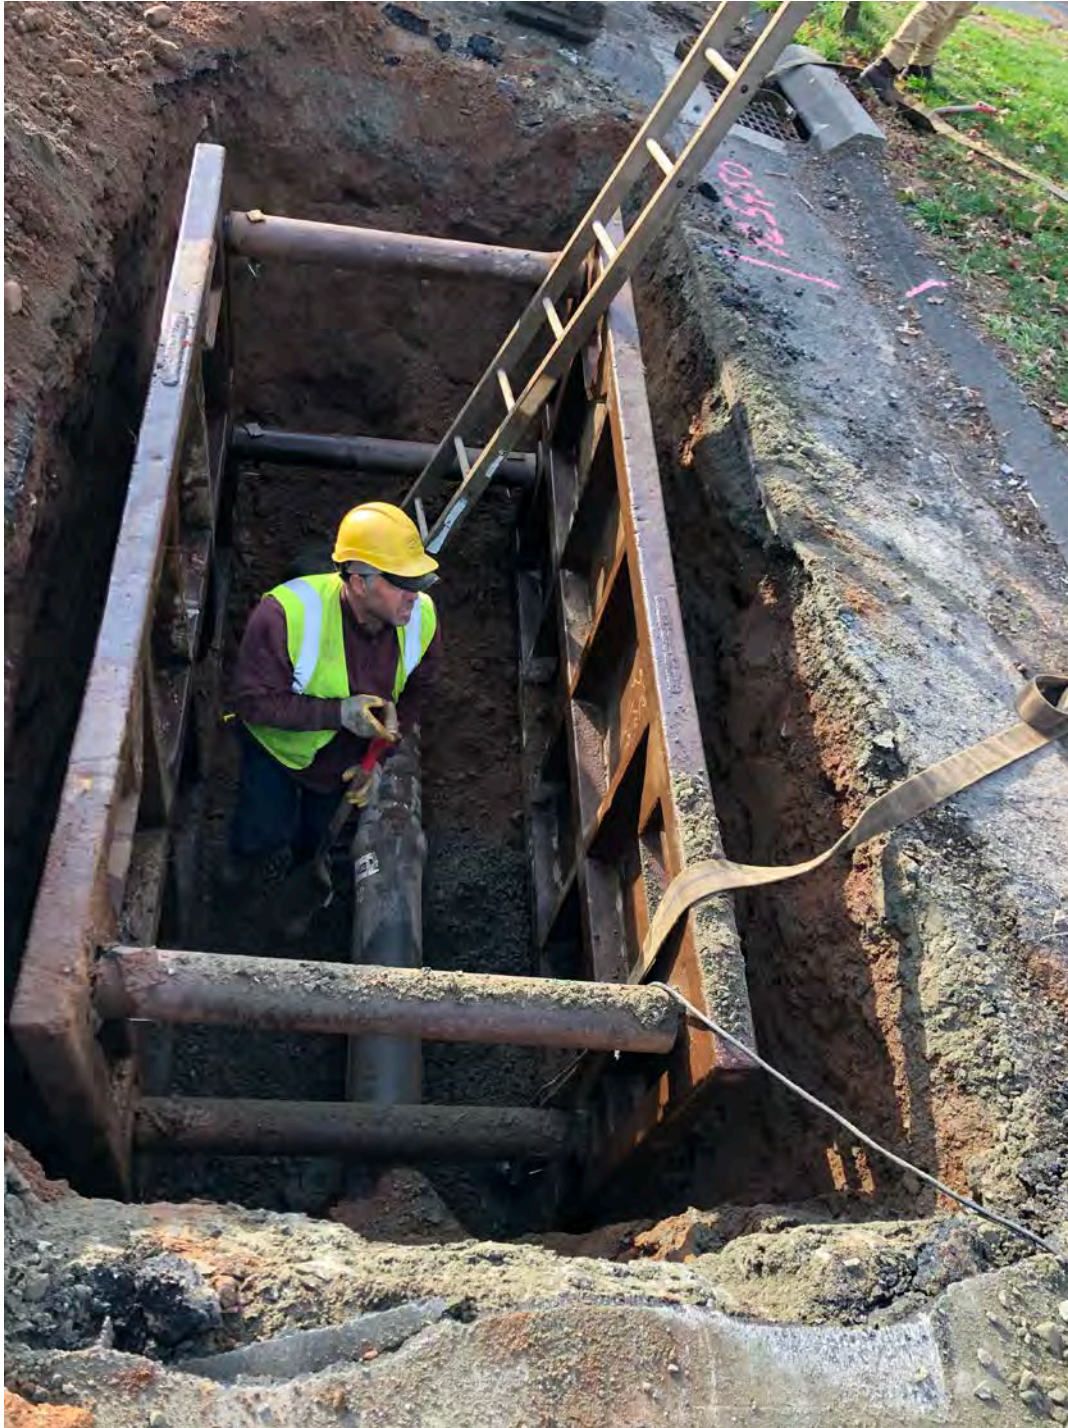
Picture 5: Ludlow in the process of installing a gate valve on the southbound lane of Maple Avenue, Durham at Station 925+55. View to the south.

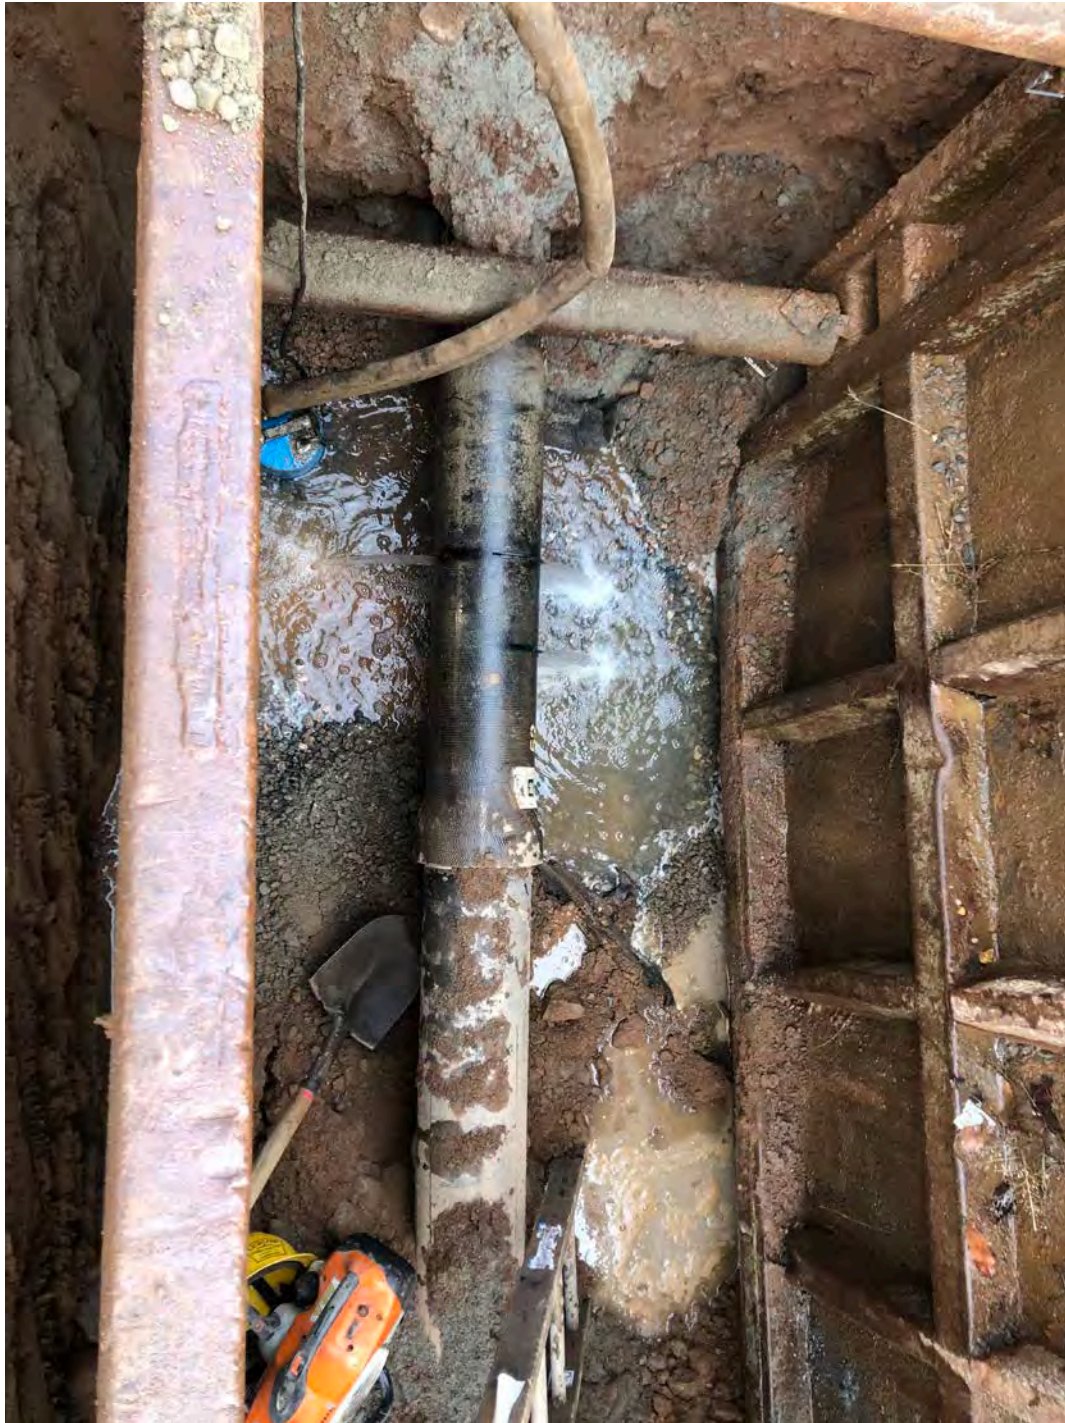
0917: Ludlow has cut several slits into the 8" DIP water line at Station 925+55 on the southbound lane of Maple Avenue, Durham. Water is draining from the cuts and is being pumped into an adjacent catch basin.

**Picture 6: Water exiting the 8”DIP water line on the southbound lane of Maple Avenue, Durham at Station 925+55 where Ludlow cut slits in the pipe.**

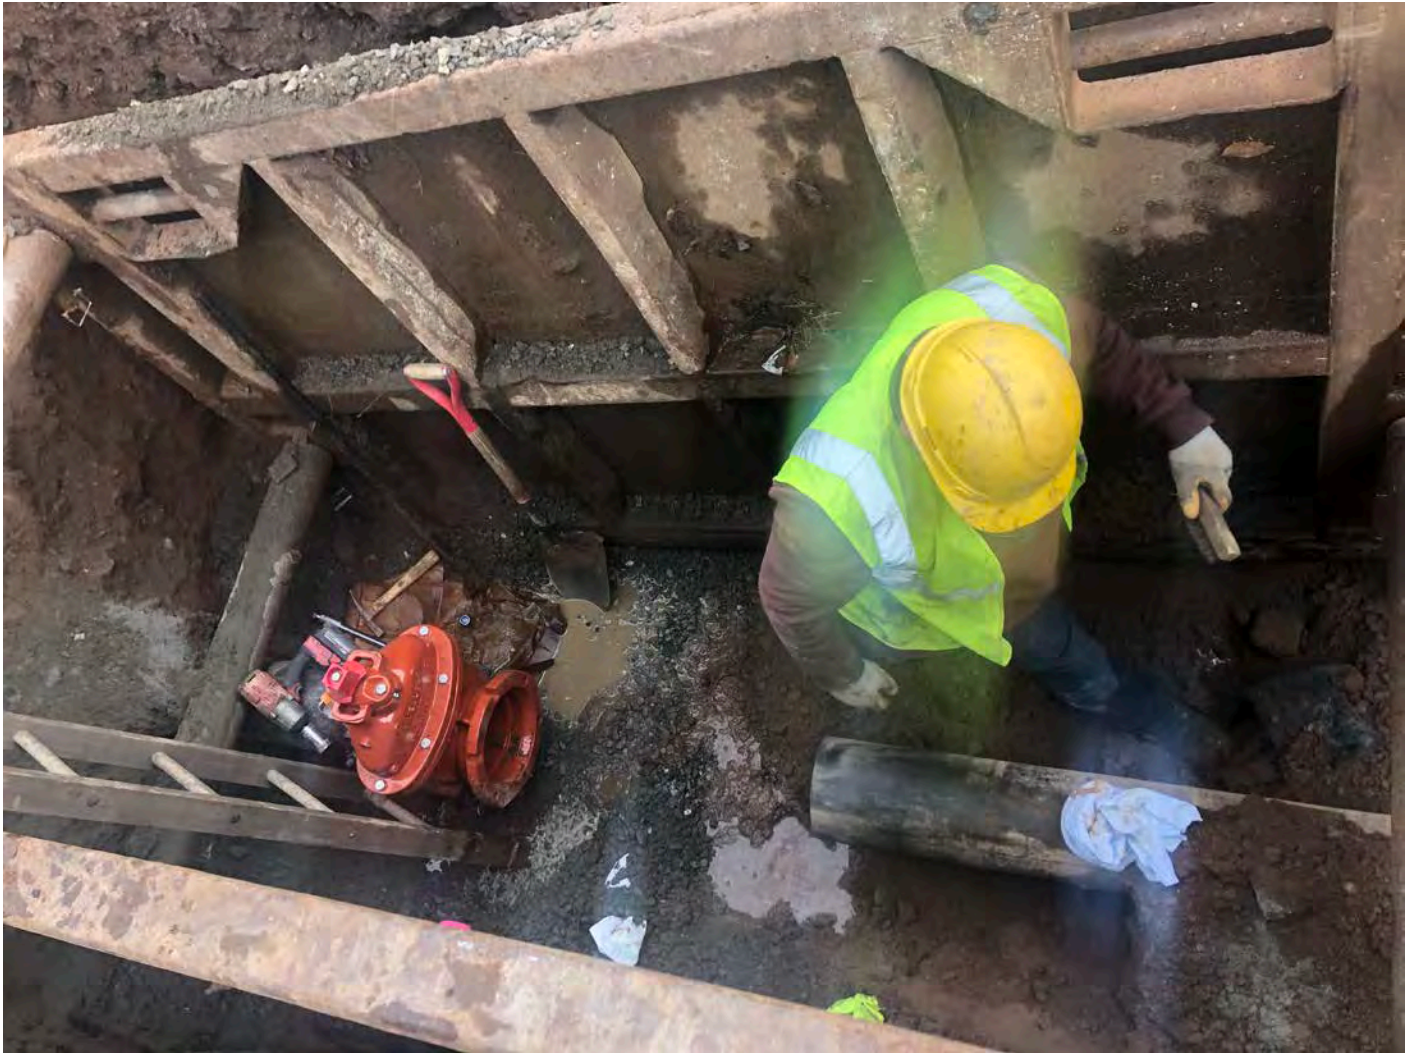
Picture 7: Ludlow in the process of installing a gate valve on the southbound lane of Maple Avenue, Durham at Station 925+55. View to the east.
