#### **Daily Report**

| Project: | <b>Durham Meadows Pipeline Installation</b> | Date: | December 07, 2020 |
| Project #: | AECOM: 6061487 | Report No: | 213 |

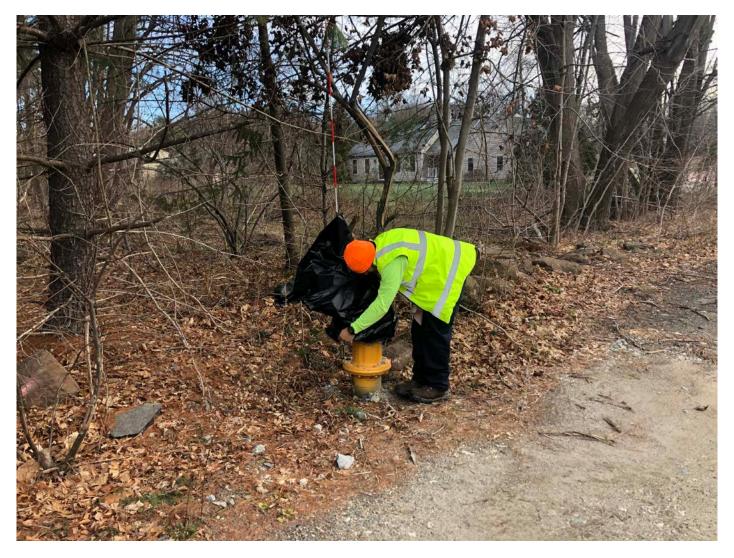
Picture 1: Ludlow placing a garbage bag over an off-line hydrant located on Packinghouse Hill Road next to where it intersects with Main Street, Durham. View to the northeast.

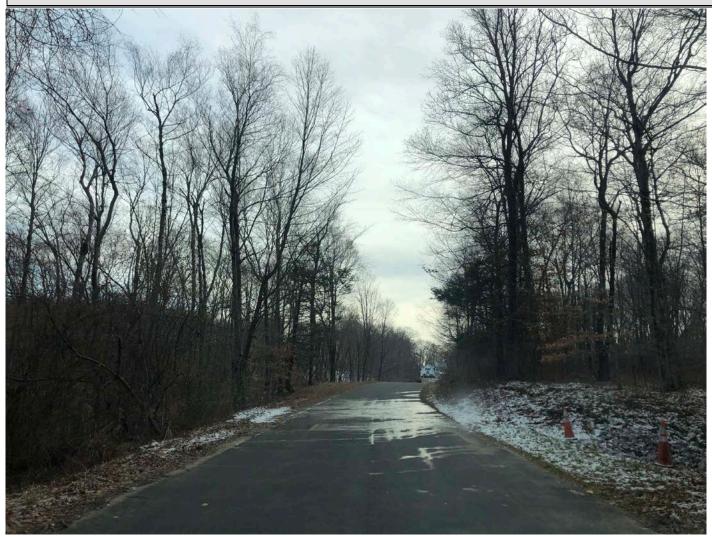
0810: A complaint about ice on the Shared Access Driveway has been relayed to the USACE representative.

0939: AECOM and the USACE inspect an area on the Shared Access Road at ~Station 19+50 where water has moved from south to north across the road and froze in place (just east of the plunge bowl located on the south side of the road at ~Station 19+80).

Picture 2: Area on the Shared Access Driveway at ~Station 19+50 where water has moved from south to north across the road and froze in place (just east of the plunge bowl located on the south side of the road at ~Station 19+80). View to the southeast.

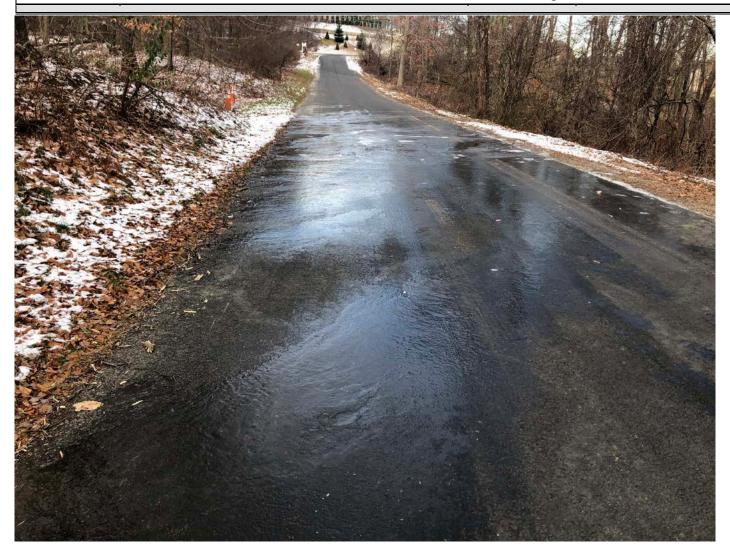
Picture 3: Area on the Shared Access Driveway at ~Station 19+50 where water has moved from south to north across the road and froze in place (just east of the plunge bowl located on the south side of the road at ~Station 19+80; visible just past the traffic cone on the rear left of the photograph). View to the northwest.

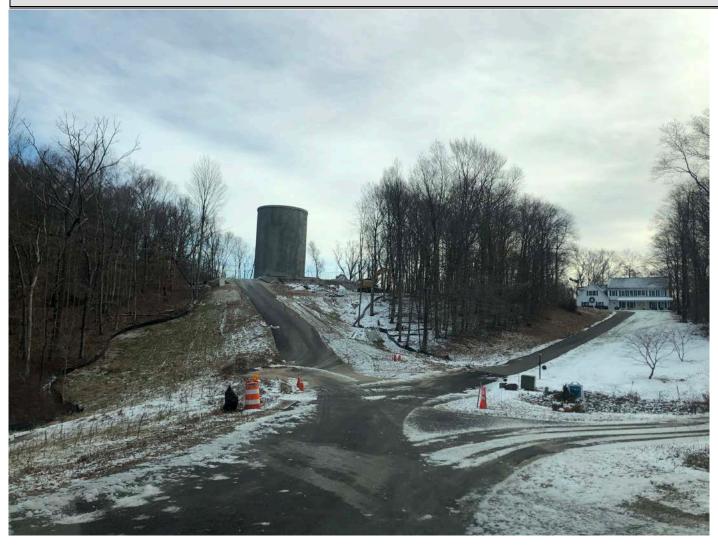
Picture 4: Overview of the water tank and adjacent portion of the Shared Access Driveway, Middletown. View to the east.
