#### **Daily Report**

Project:Durham Meadows Pipeline InstallationDate:April 16, 2021Location:Shared Access Driveway, MiddletownDay of Week:FridayProject #:AECOM: 6061487Report No:223

**Contractor:** Ludlow Construction

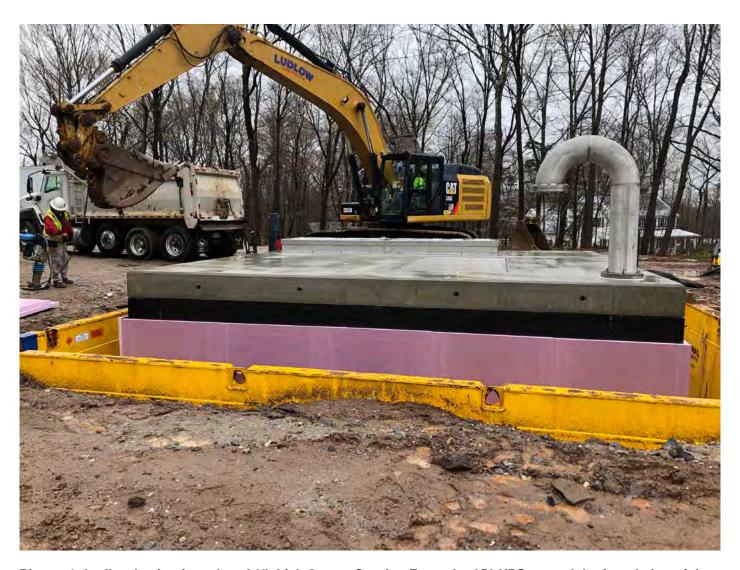
Picture 1: Ludlow having just placed 2" thick Owens Corning Foamular 250 XPS around the foundation of the altitude vault east of the Shared Access Driveway in Middletown. View to the south.

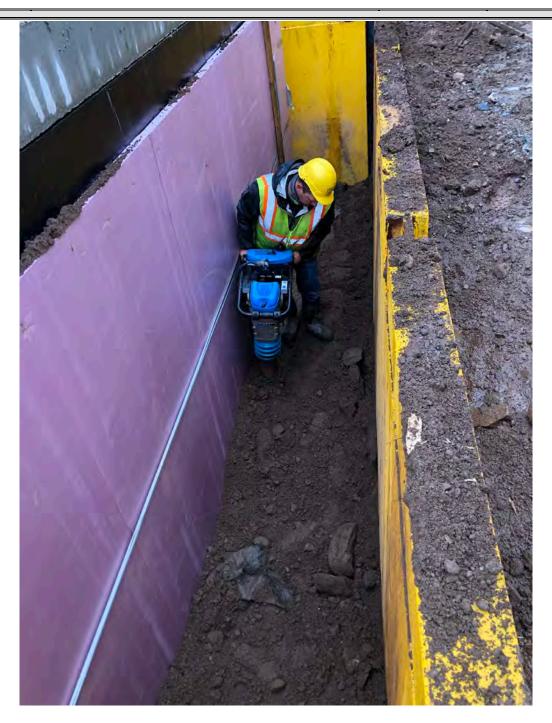
Picture 2: Ludlow compacting -3.5" gravel fill that was placed around the outside of the altitude valve vault located east of the Shared Access Driveway in Middletown.

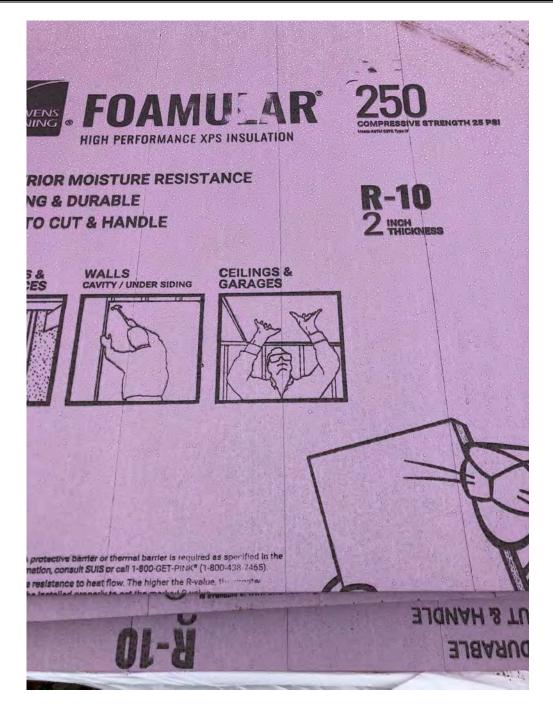
Picture 4: The 2" thick Owens Corning Foamular 250 XPS insulation board that Ludlow placed around the exterior of the altitude valve vault prior to backfilling.

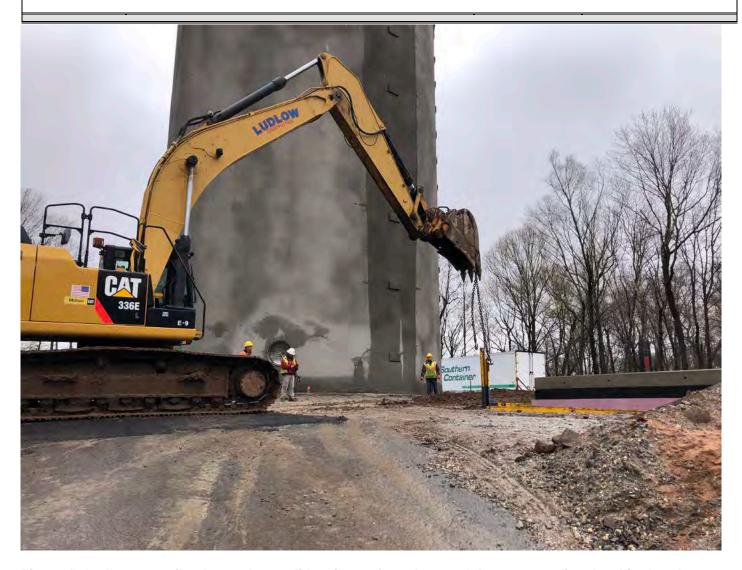
Picture 5: Ludlow removing the northeast slide rail post from the trench box surrounding the altitude valve vault as they backfill around east of the Shared Access Driveway in Middletown; view to the southeast.

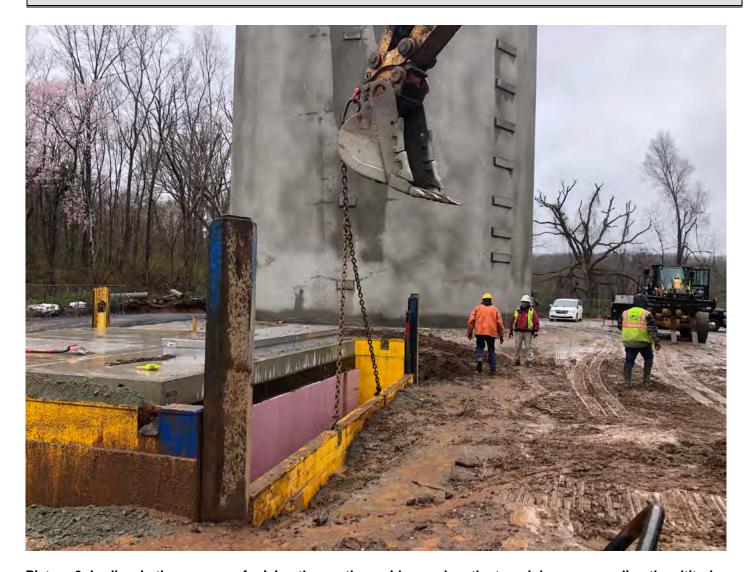
Picture 6: Ludlow in the process of raising the southern side panel on the trench box surrounding the altitude valve vault as they place and compact -3.5" gravel around the exterior of the vault. East of the Shared Access Driveway, Middletown. View to the east.

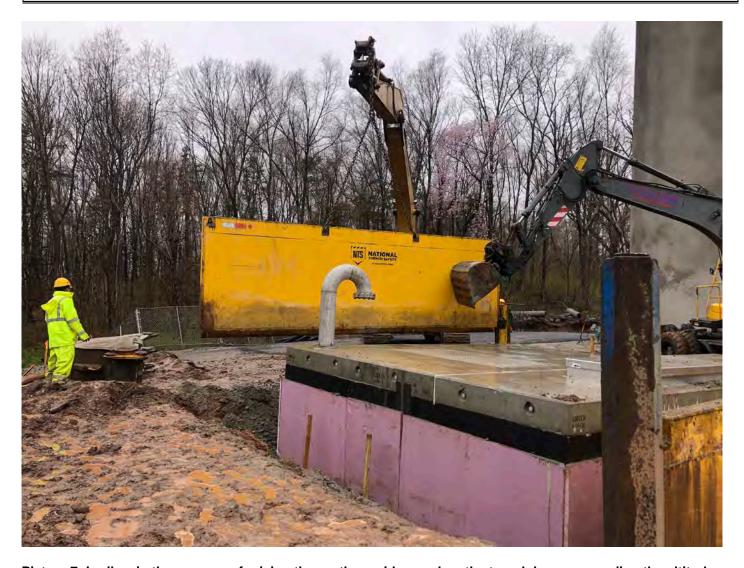
Picture 7: Ludlow in the process of raising the northern side panel on the trench box surrounding the altitude valve vault as they place and compact -3.5" gravel around the exterior of the vault. East of the Shared Access Driveway, Middletown. View to the north.

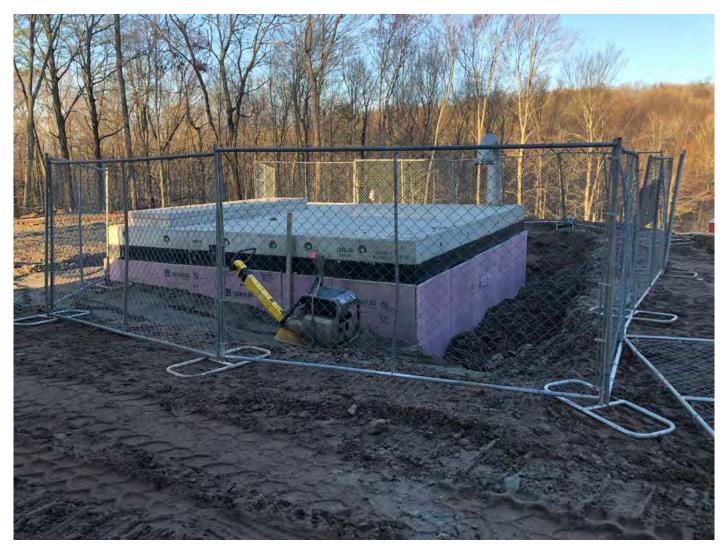
Picture 8: Altitude valve vault after Ludlow placed and compacted fill around the vault exterior. Ludlow secured the vault at the end of the day with temporary fencing. East of the Shared Access Driveway, Middletown. View to the southwest.
