Daily Report

Project:Durham Meadows Pipeline InstallationDate:April 19, 2021Shared Access Driveway, Middletown and Wallingford Road,Day of Week:Monday

Project #: AECOM: 6061487 **Report No:** 224

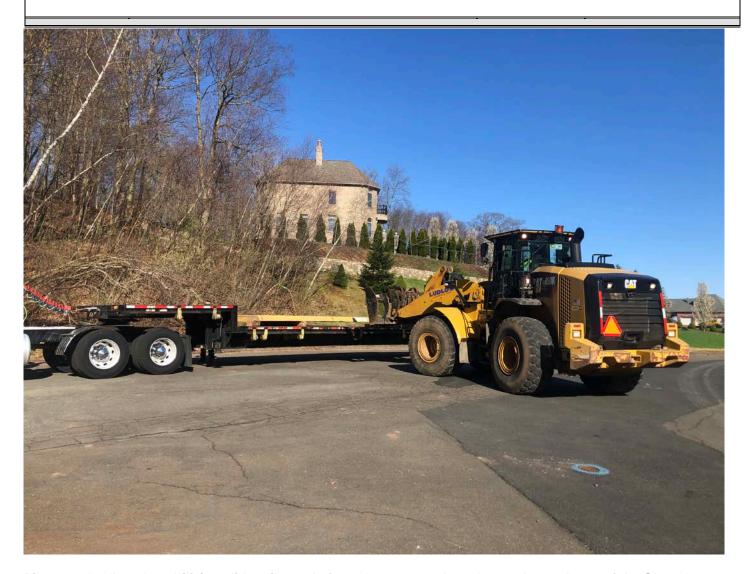
0739: Ludlow demobilizing slide rail panels from the water tank work zone located east of the Shared Access Driveway in Middletown.

Picture 1: Ludlow demobilizing slide rail panels from the water tank work zone located east of the Shared Access Driveway in Middletown.

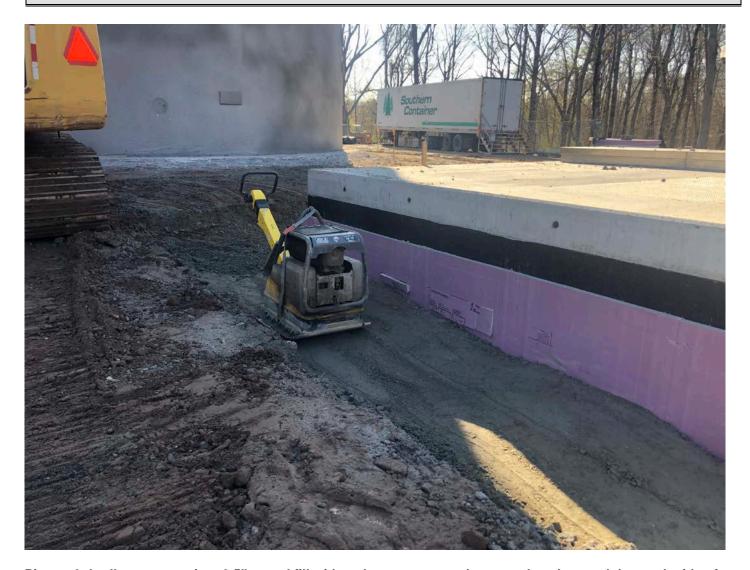
0805: Ludlow is working at the water tank work zone located east of the Shared Access Driveway in Middletown. They are currently removing temporary fencing from around the altitude valve vault and are placing and compacting additional -3.5" gravel around the sides of the vault. Compaction is being performed with a plate compactor.

Picture 2: Ludlow compacting -3.5" gravel fill with a plate compactor that was placed around the north side of the altitude valve vault located east of the Shared Access Driveway in Middletown.

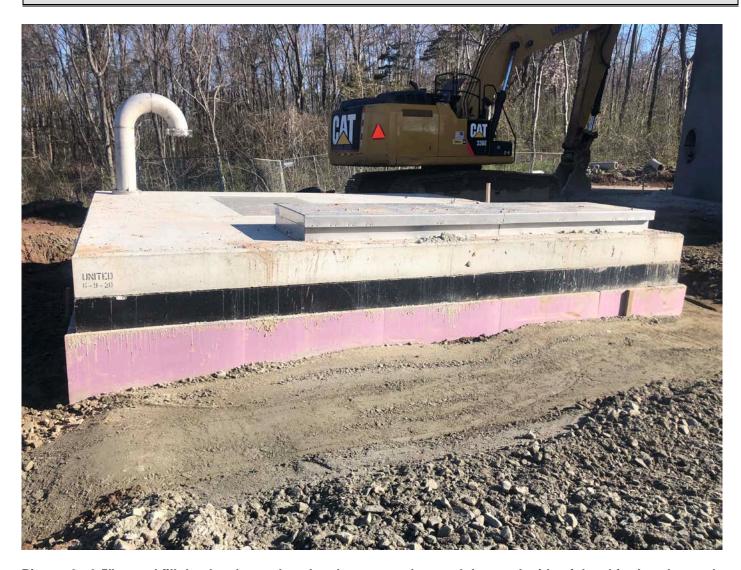
Picture 3: 3.5" gravel fill that has been placed and compacted around the south side of the altitude valve vault located east of the Shared Access Driveway in Middletown. View to the north.

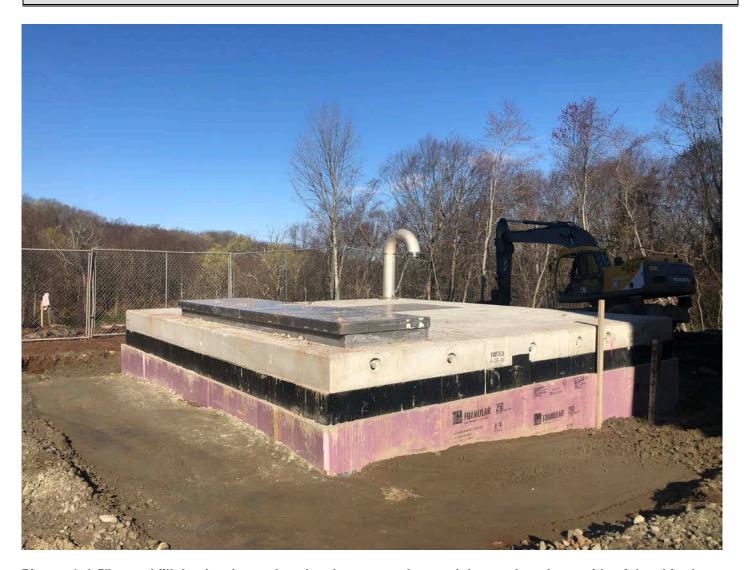
Picture 4: 3.5" gravel fill that has been placed and compacted around the south and east side of the altitude valve vault located east of the Shared Access Driveway in Middletown. View to the northwest.

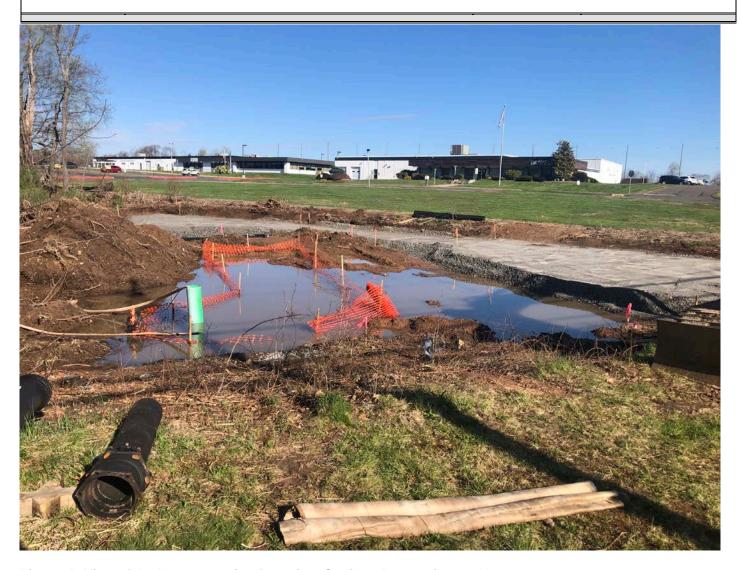
Picture 5: View of the booster station footprint. Station 750+63; view to the west.

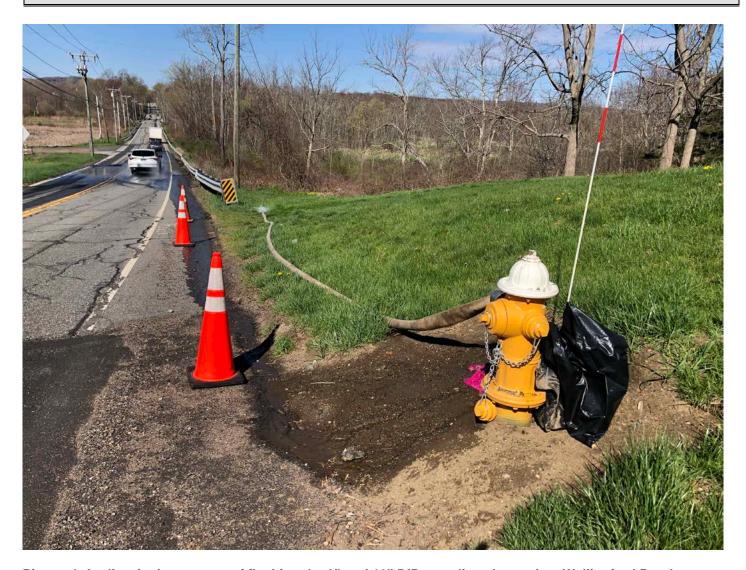
0917: Ludlow is flushing the 8" and 12" DIP waterlines that runs down Wallingford Road (Route 68) from the intersection of Main Street to 47 Wallingford Road, Durham. The water is being flushed from a hydrant and is being directed into a grassy area adjacent to the hydrant.

Picture 6: Ludlow in the process of flushing the 8" and 12" DIP waterlines located on Wallingford Road, Durham. Hydrant is located at Station 609+46. View to the west.

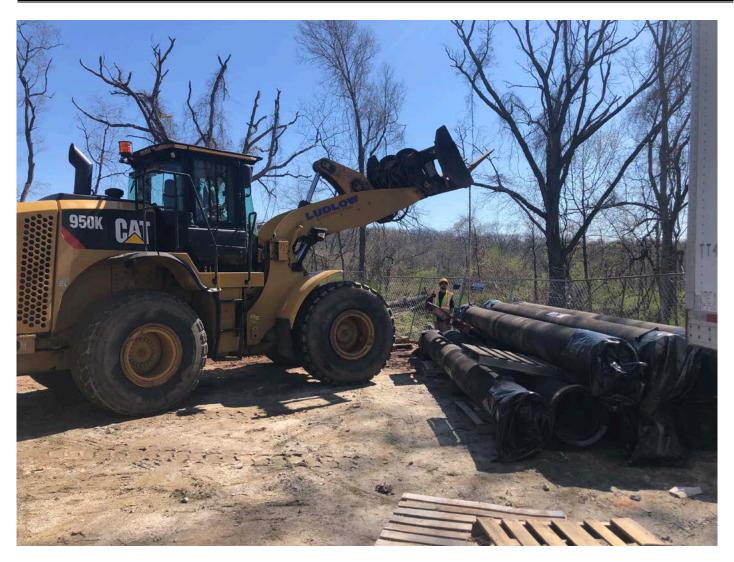
1035: Ludlow is staging 16" DIP (moved from the site trailer yard at 289 Main Street) on the southeast corner of the water tank work zone located east of the Shared Access Driveway in Middletown.

Picture 7: Ludlow staging 16" DIP at the southeast corner of the water tank work zone located east of the Shared Access Driveway in Middletown.

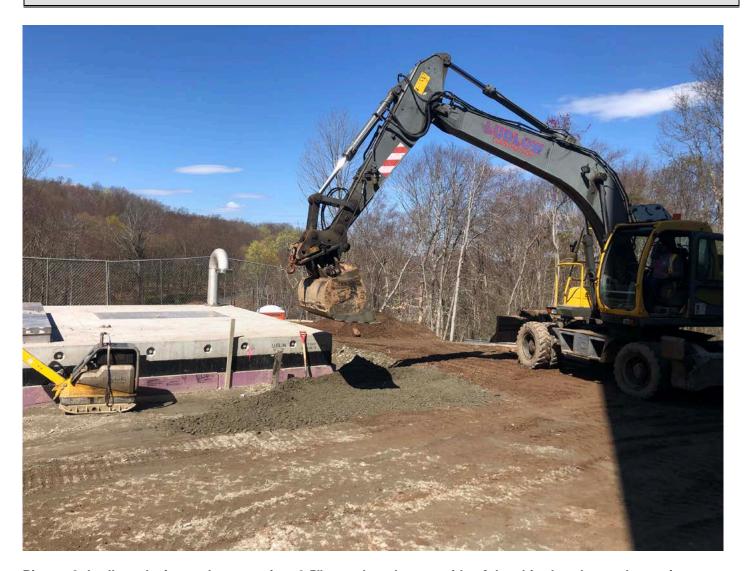
1020: Ludlow is placing additional -3.5 inch gravel on the north and east sides of the altitude valve vault located east of the Shared Access Driveway in Middletown.

Picture 8: Ludlow placing and compacting -3.5" gravel on the east side of the altitude valve vault exterior. View to the northwest.
