Daily Report

Project:	Durham Meadows Pipeline Installation	Date:	May 6, 2021
Location:	S. Main Street and the Shared Access Driveway, Middletown	Day of Week:	Thursday
Project #:	AECOM: 6061487	Report No:	237
Contractor:	Ludlow Construction	Page:	2 of 10

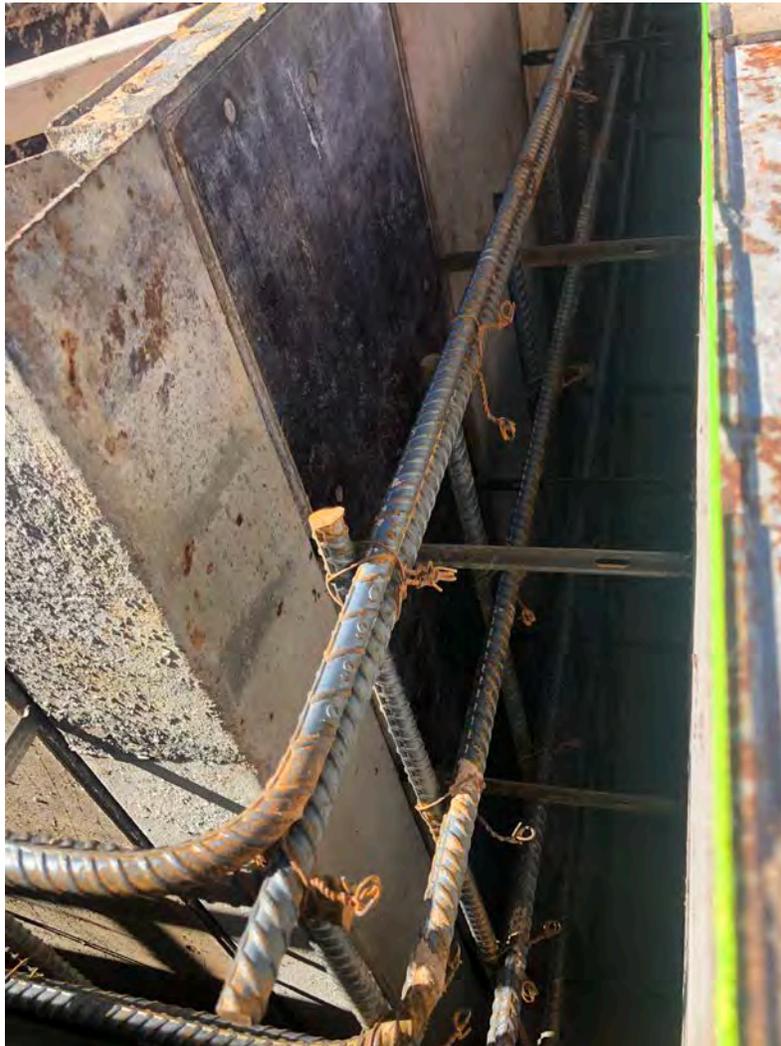
1224: Ludlow is continuing to install braces on the exterior and interior of the frost wall concrete forms at the booster station footprint located at Station 750+63 South Main Street in Middletown. The USACE field representative checks to confirm that the frost wall forms are square, that the width of the frost wall is correct, that the spacing on the frost wall rebar is correct, that the overlap on horizontal sections of rebar on the corners is adequate, and that the form walls are straight.

Picture 1: Overlapping rebar on a corner of the concrete form for the booster station frost wall located at Station 750+63 in Middletown. The corner overlaps meet or exceed the minimum overlap required.

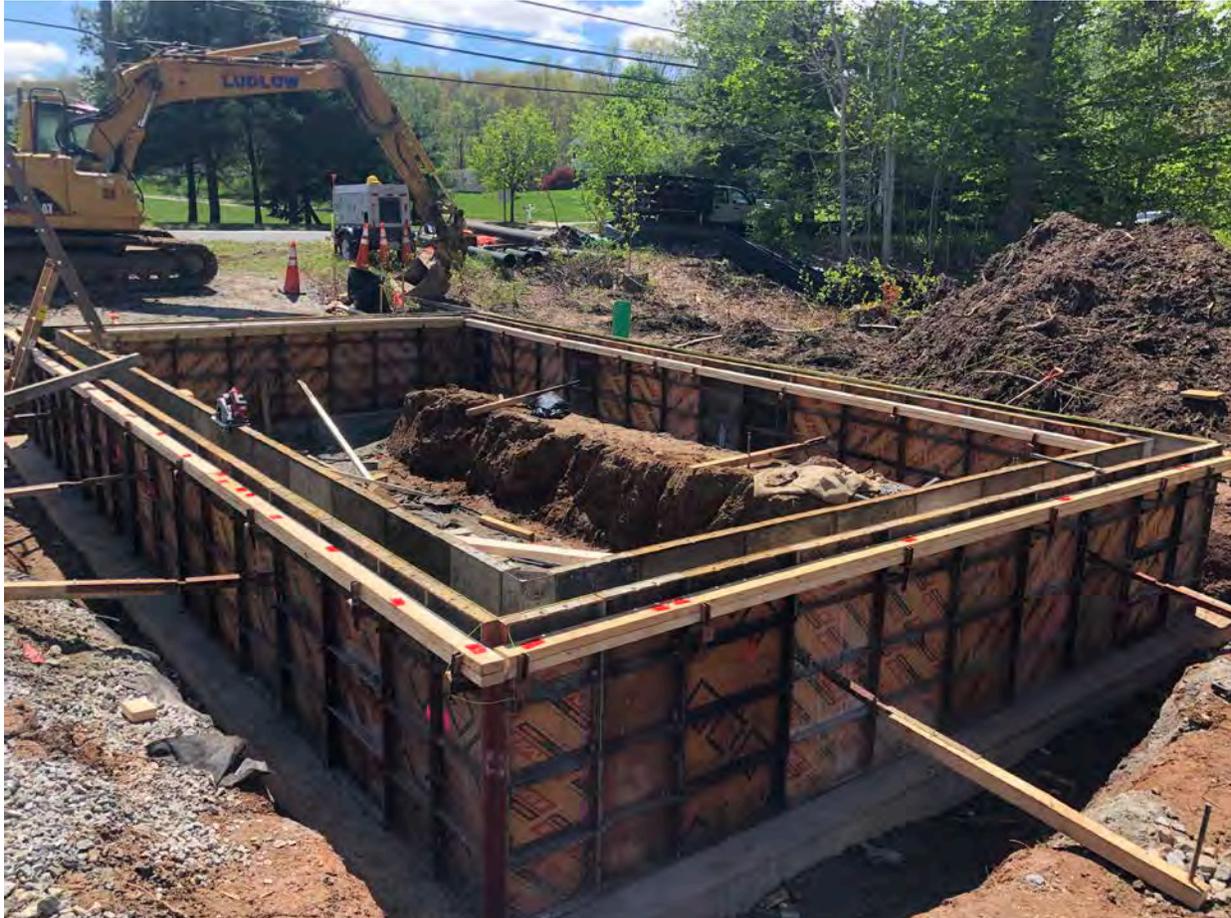
Picture 2: Bracing that Ludlow has placed on the exterior of the north and west side of the concrete forms and the interior of the east and south wall of the concrete form for the booster station frost wall. Station 750+63 South Main Street, Middletown. View to the southeast.

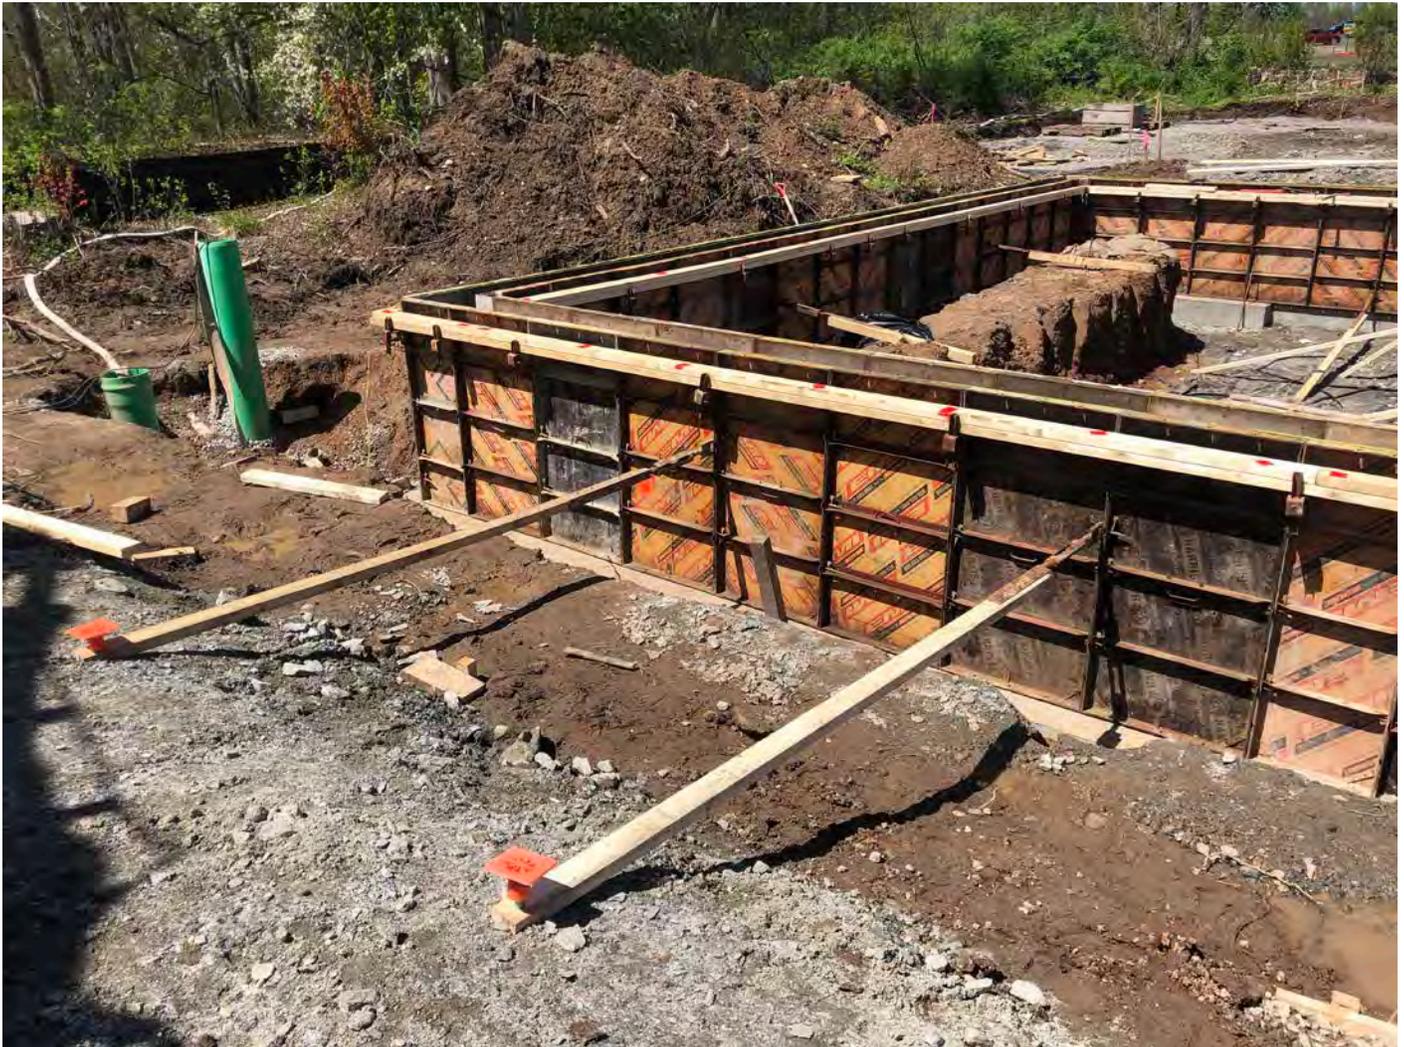
Picture 3: Bracing that Ludlow has placed on the exterior of the east side of the concrete form for the booster station frost wall. Station 750+63 South Main Street in Middletown. View to the southwest.

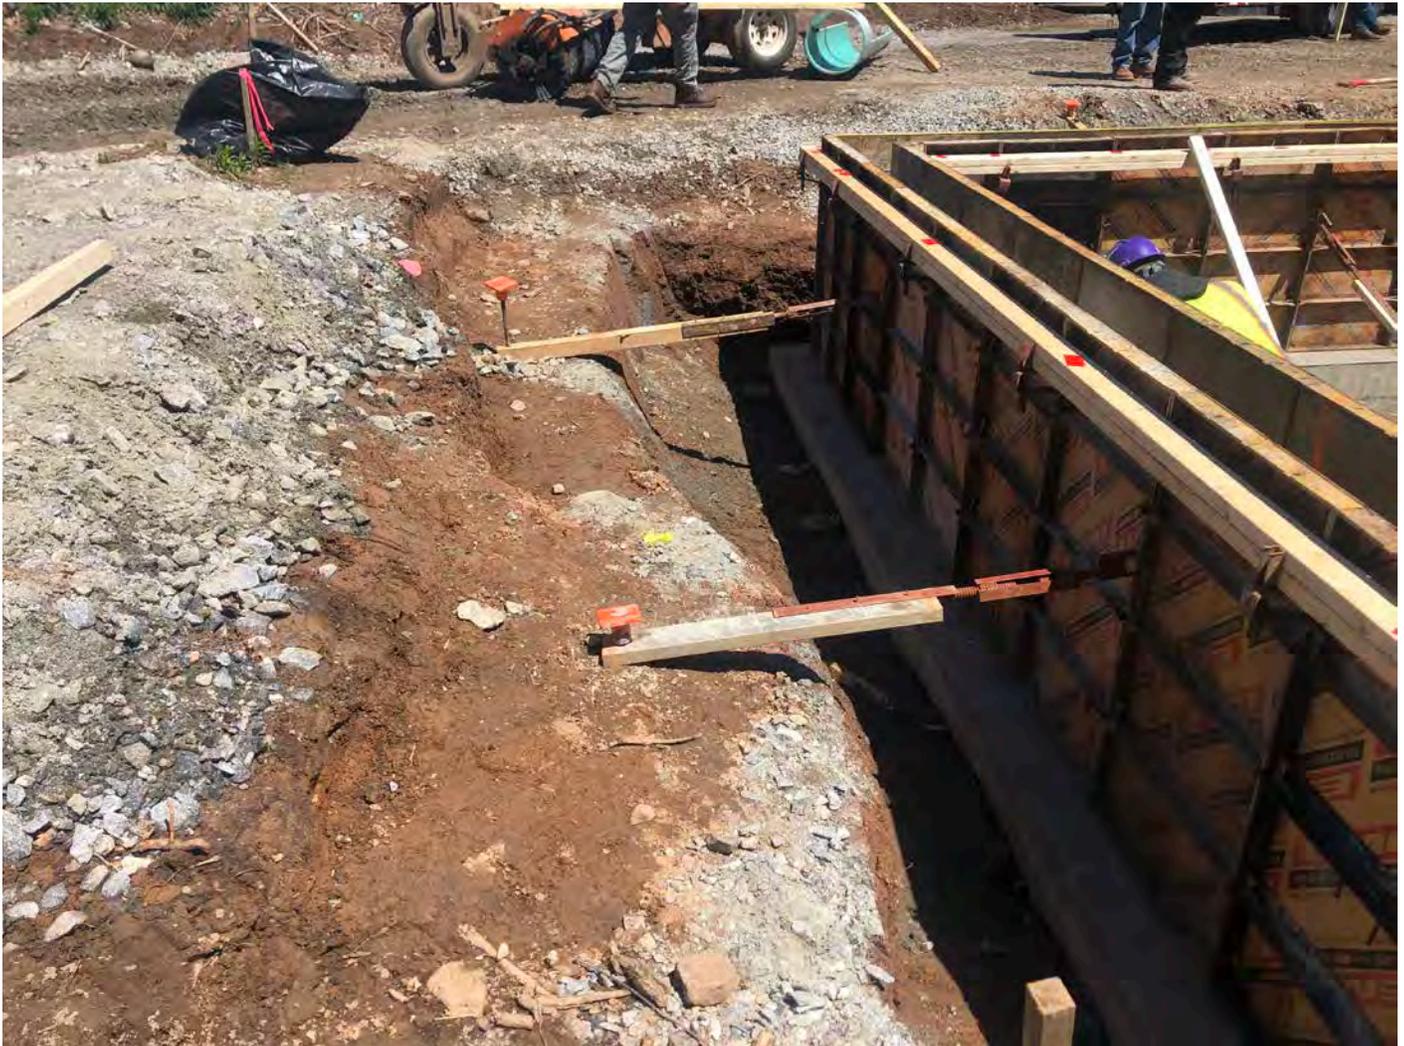
Picture 4: Bracing that Ludlow has placed on the exterior of the west side of the concrete form for the booster station frost wall. Station 750+63, South Main Street in Middletown. View to the north.

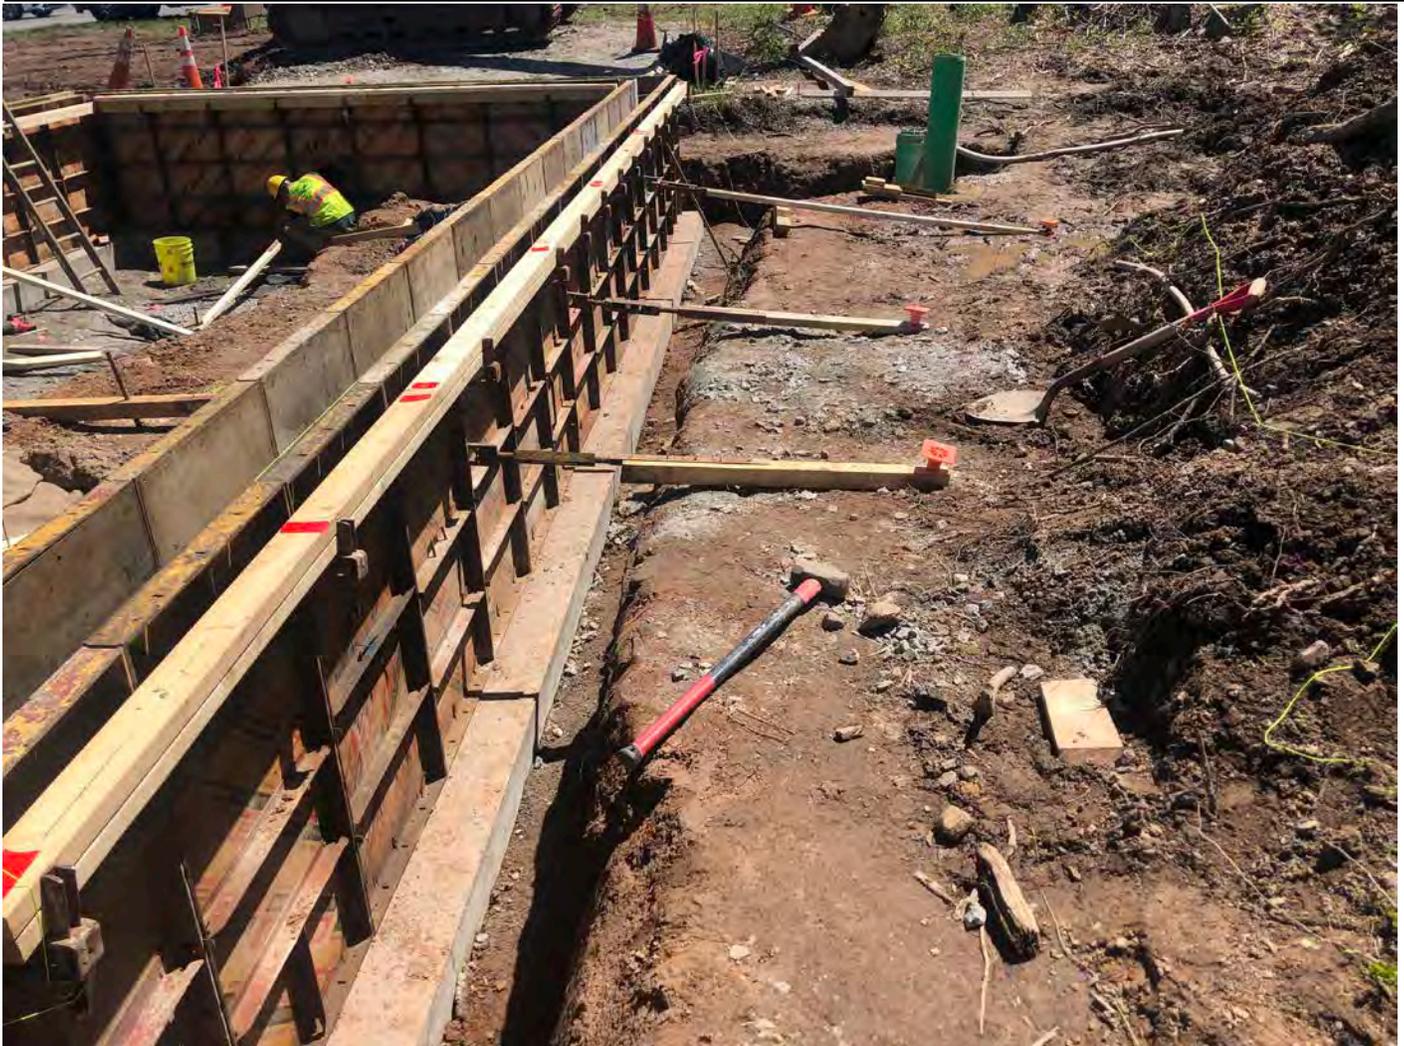
Picture 5: Bracing that Ludlow has placed on the exterior of the north side of the concrete form for the booster station frost wall. Station 750+63, South Main Street in Middletown. View to the east.

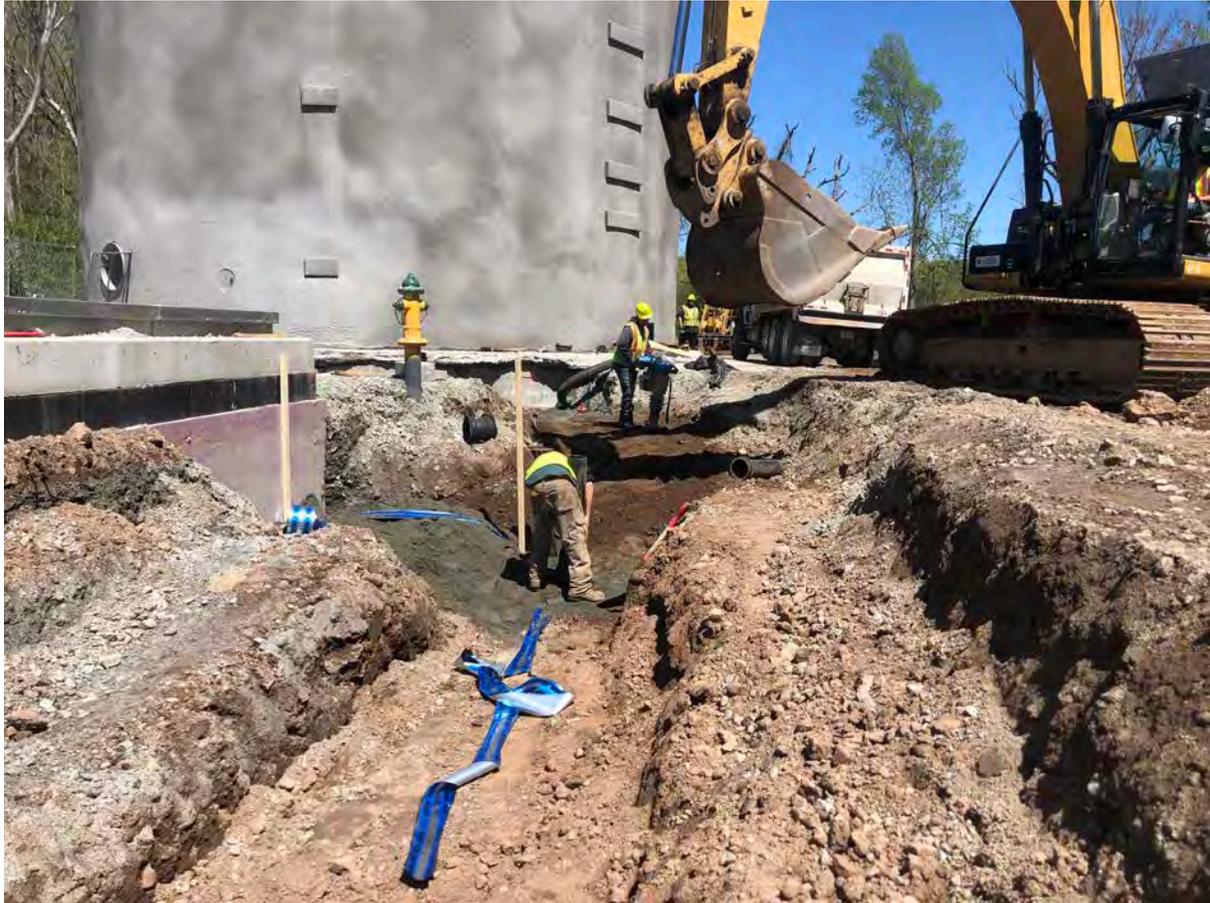
Picture 6: Ludlow placing backfill over the 8" DIP drain line that runs from the southwest side of the water tank towards a headwall located at Station 11+70. Water tank work zone located east of the Shared Access Driveway in Middletown. View to the east.

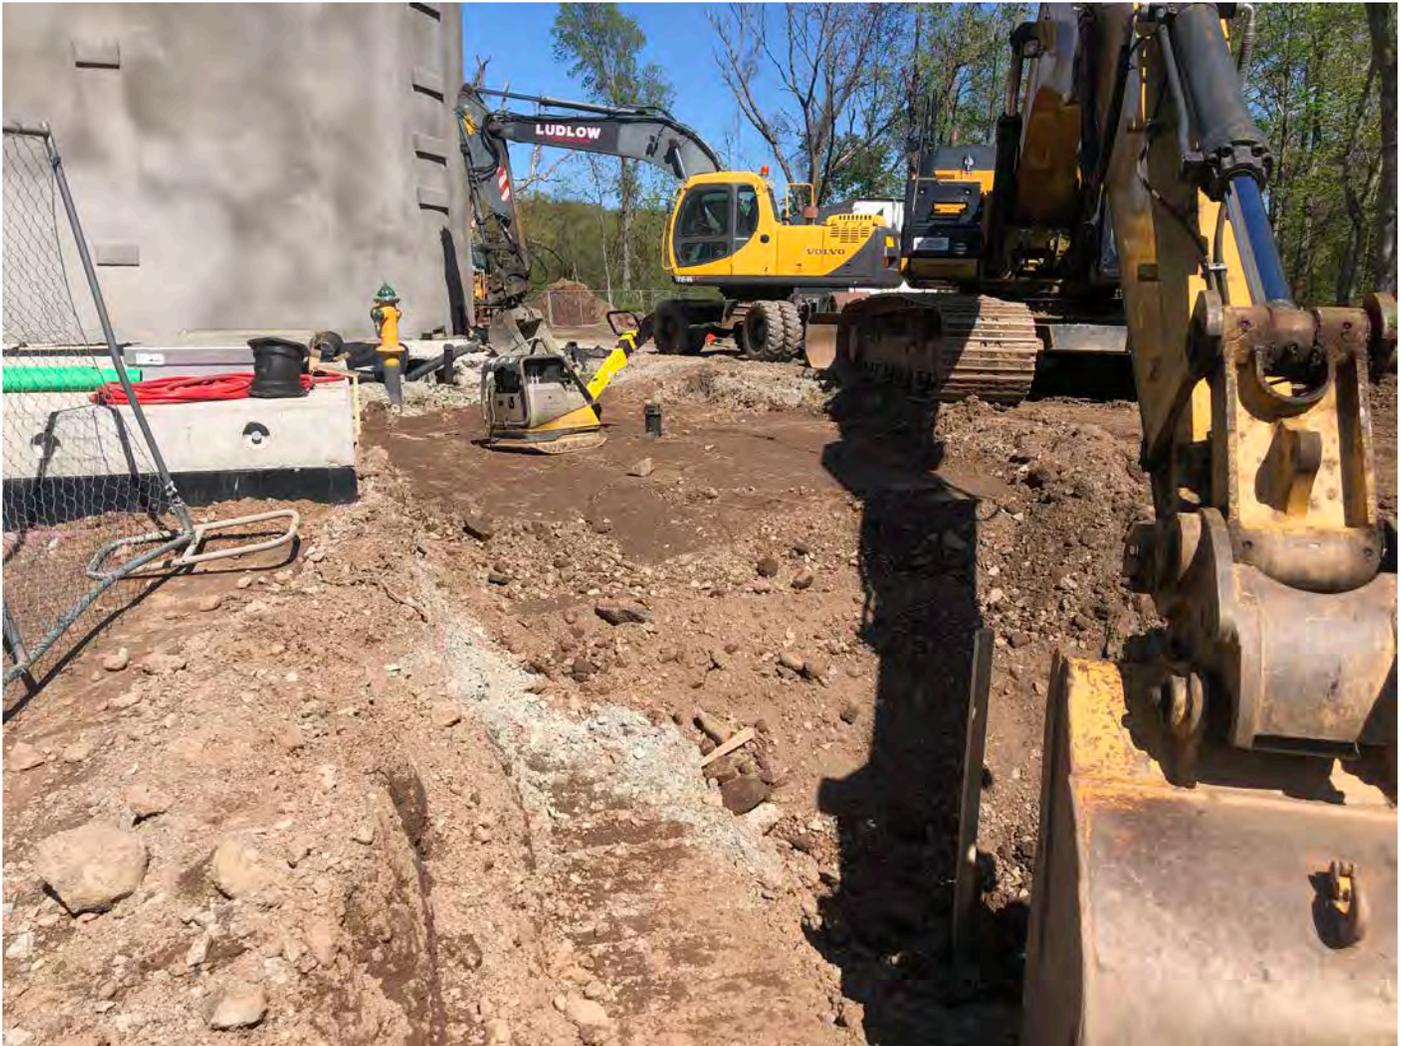
Picture 7: Final progress of placement of backfill over the 8" DIP drain line that runs from the southwest side of the water tank towards a headwall located at Station 11+70. Water tank work zone located east of the Shared Access Driveway in Middletown. View to the east.

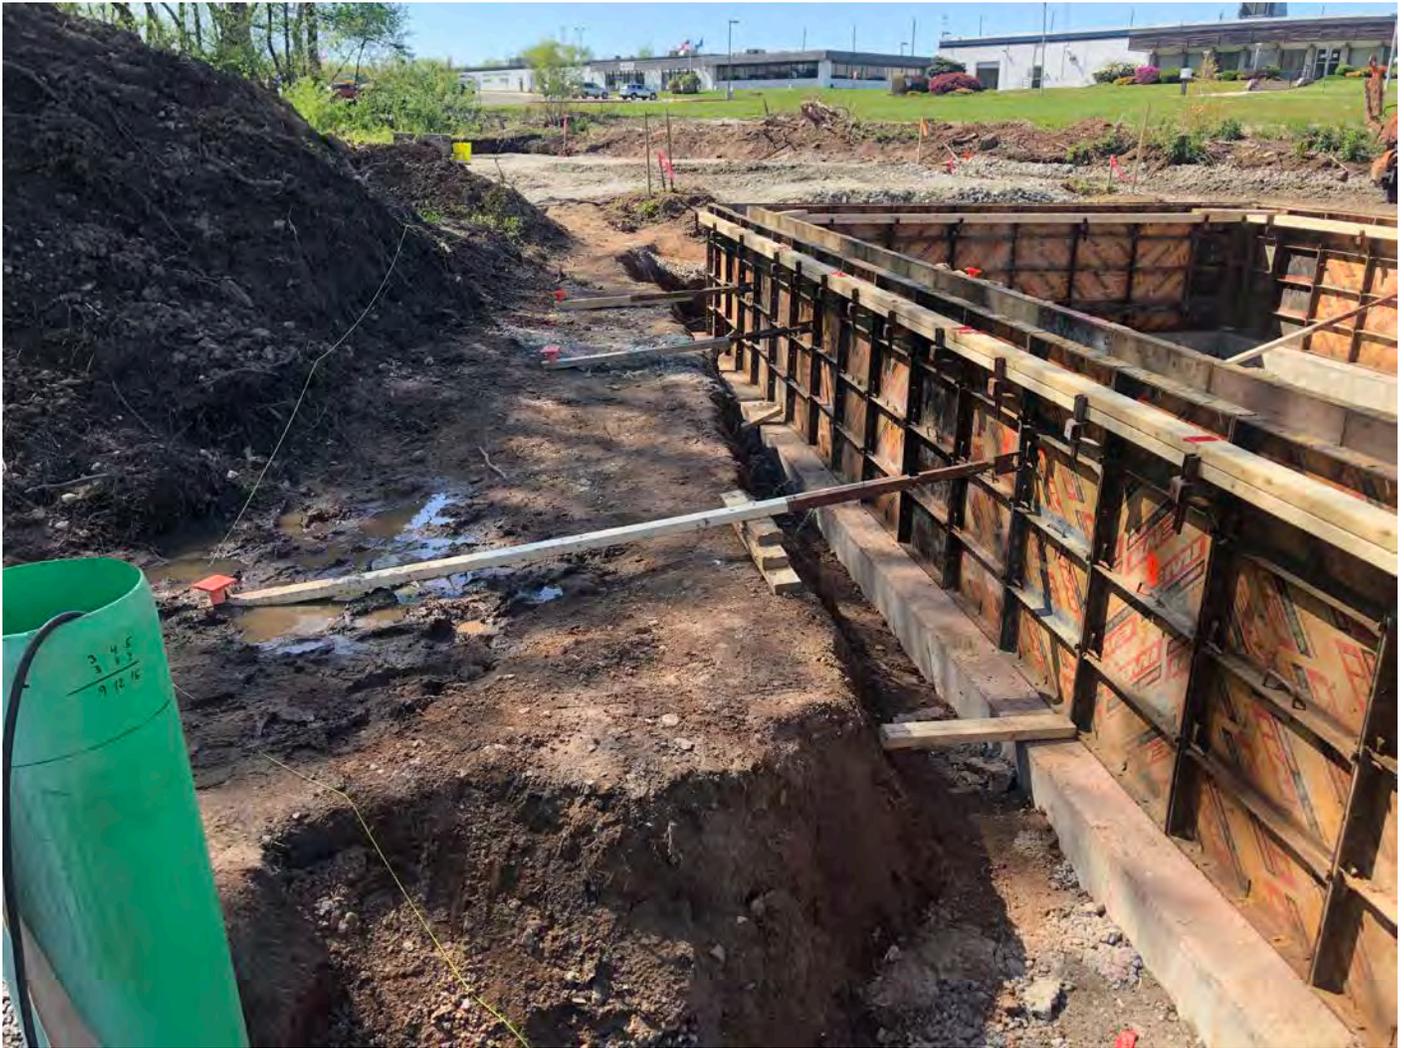
Picture 8: Bracing that Ludlow has placed on the exterior of the southern side of the concrete forms for the booster station frost wall. Station 750+63, South Main Street, Middletown. View to the east.
