Daily Report

Project:	Durham Meadows Pipeline Installation	Date:	May 12, 2021
Location:	Main Street, Durham and the Booster Station Site, South Main Street, Middletown	Day of Week:	Wednesday
Project #:	AECOM: 6061487	Report No:	241
Contractor:	Ludlow Construction	Page:	2 of 12

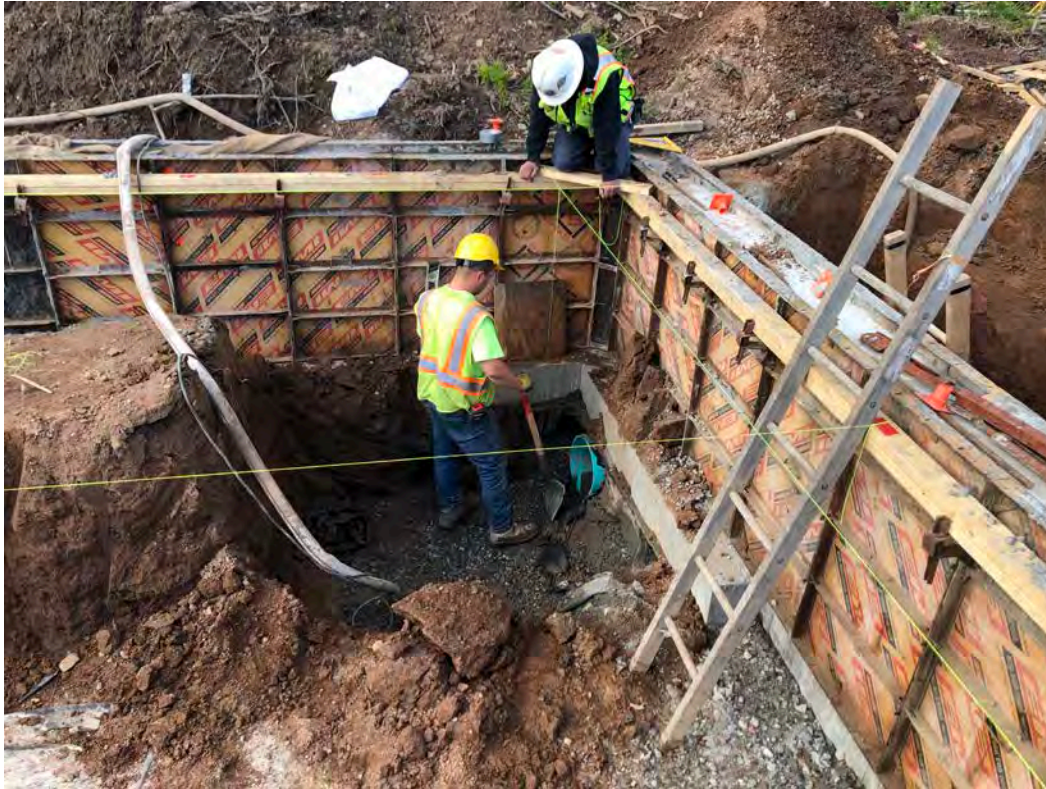
Picture 1: View of the southwest interior corner of the booster station footprint that was excavated to daylight the previously-installed PVC conduit for the installation of 8" DI booster station suction pipe. View to the southwest.

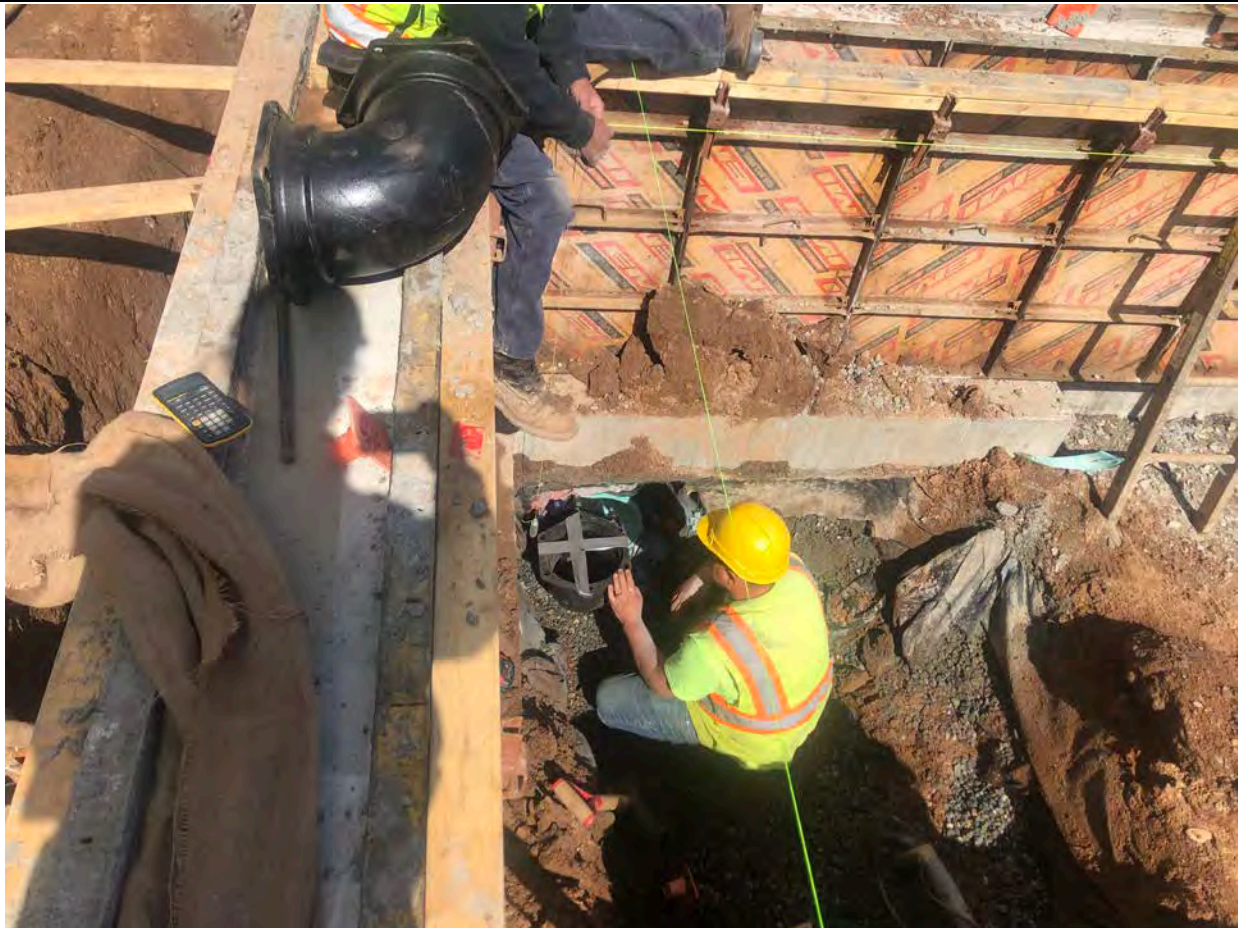
1034: Ludlow has installed 8" DIP through the 16" PVC conduit located on the southwest corner of the booster station footprint. Ludlow has installed an 8" DIP 90° bend onto the 8" DIP they placed through the PVC conduit; the bend is pointing upwards on the inside of the booster station footprint. In addition, Ludlow has installed an 8" DIP 90° bend to the same piece of 8" DIP on the exterior of the booster station footprint. The DIP bend points north on the exterior of the footprint.

Picture 2: View of the southwest interior corner of the booster station footprint, where Ludlow has installed 8" DIP through the 16" PVC conduit that runs beneath the western footing of the booster station. Also visible is the 90° bend that Ludlow attached to the east side of the 8" DIP (the bend is facing upwards in the photograph). Booster station work zone located at Station 750+63 South Main St. Middletown. View to the west.

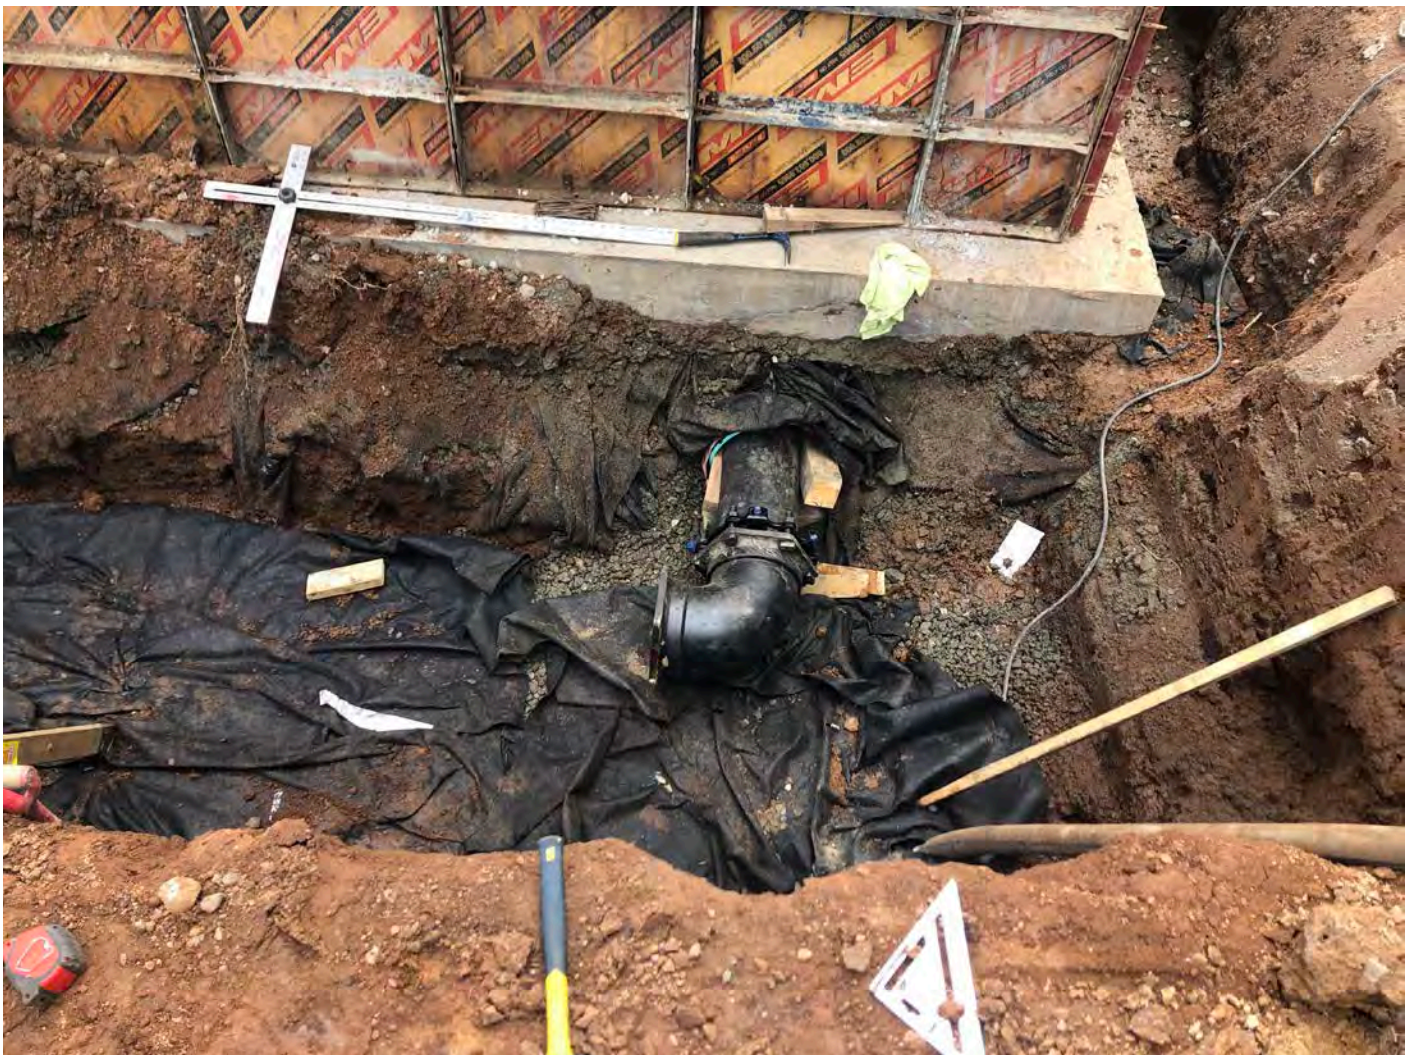
Picture 3: View of 8" DIP installation beneath the western footing of the booster station, with an 8" DIP 90° bend attached to it. View to the east; booster station work zone located at Station 750+63 South Main Street in Middletown.

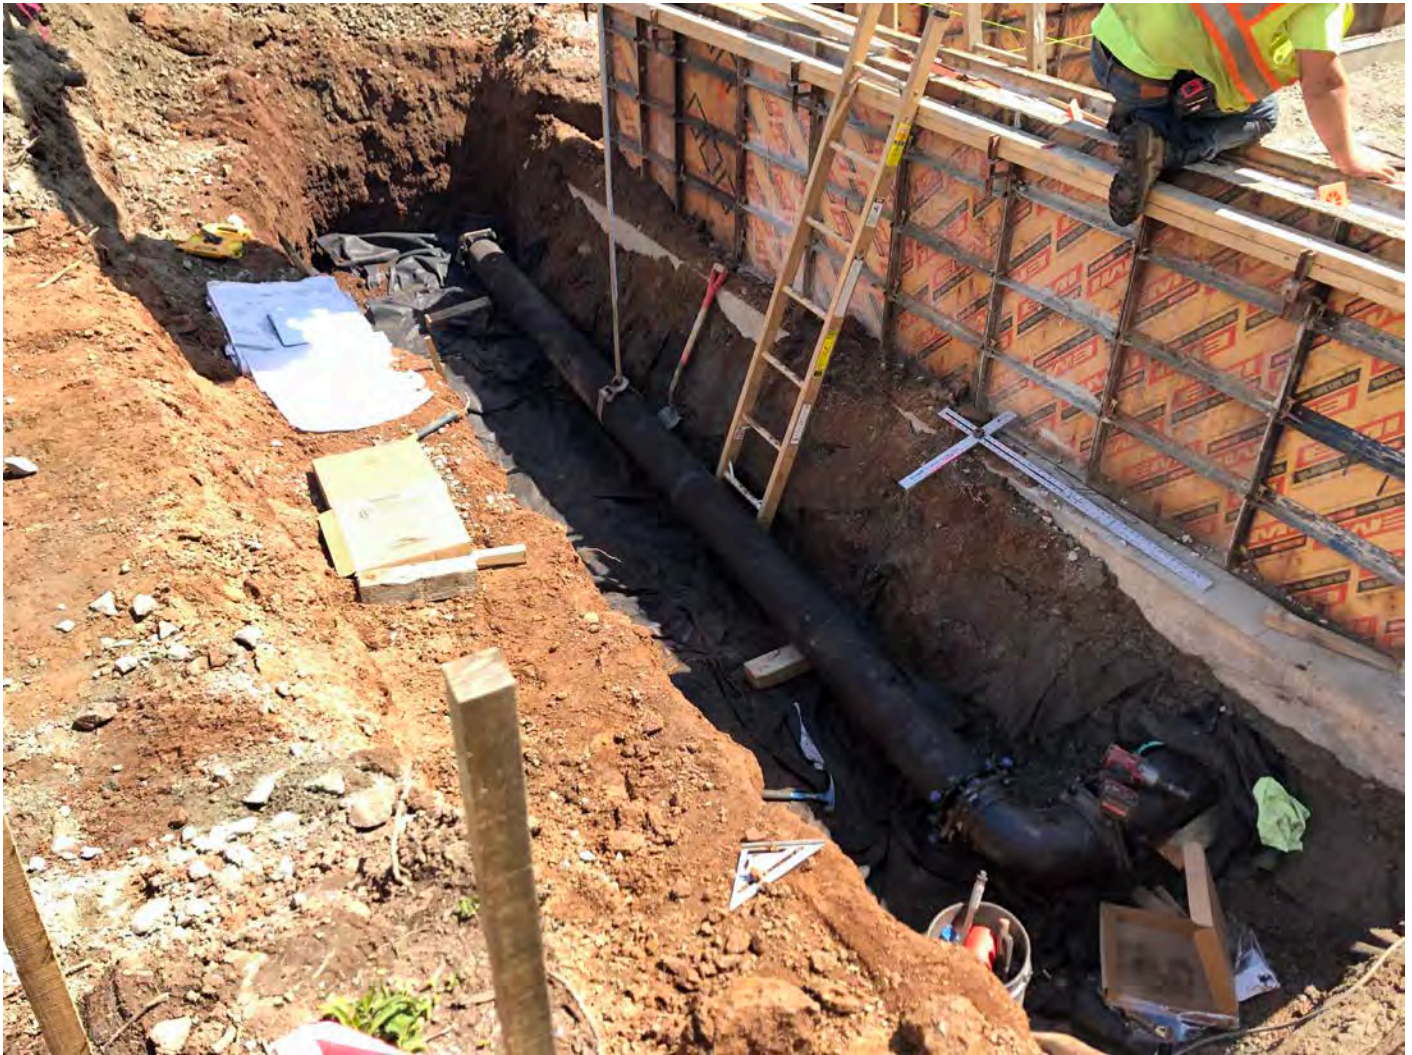
1055: Ludlow is in the process of placing a section of 8" DIP coming off the 90° bend at the exterior of south west corner of the booster station footprint and extending to the north towards the northwest corner of the footprint. Ludlow has installed an 8" DIP 45° bend at the north end of the section of 8" DIP they just installed on the west side of the booster station footprint.

Picture 4: Ludlow in the process of installing a section of 8" DIP to the 8" DIP 90° bend that they just installed at the southwest exterior corner of the booster station footprint. View to the northeast; booster station work zone located at Station 750+59 South Main Street in Middletown.

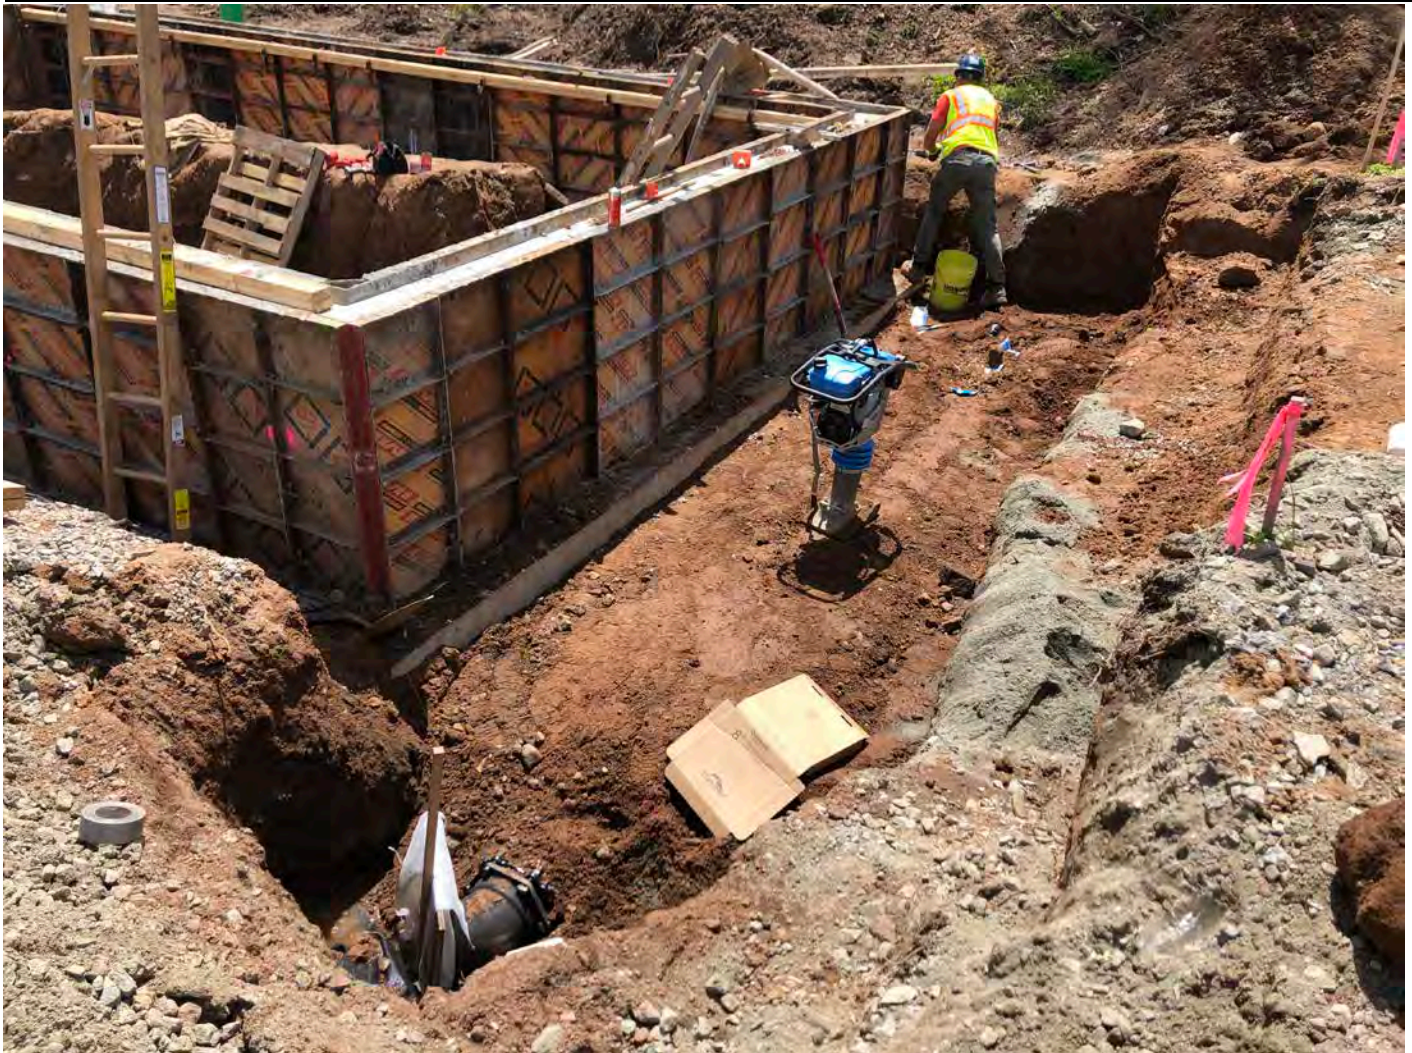
1246: Ludlow has covered the 8" DIP they just installed with native fill (-5" gravel) and compacted it with a jumping jack. Ludlow is currently removing the concrete forms from the sides of the booster station frost wall.

Picture 5: Ludlow used a jumping jack to compact fill that was placed over the 8" DIP that they just installed to the west of the booster station footprint. View to the southeast; booster station work zone located at Station 750+59 in Middletown.

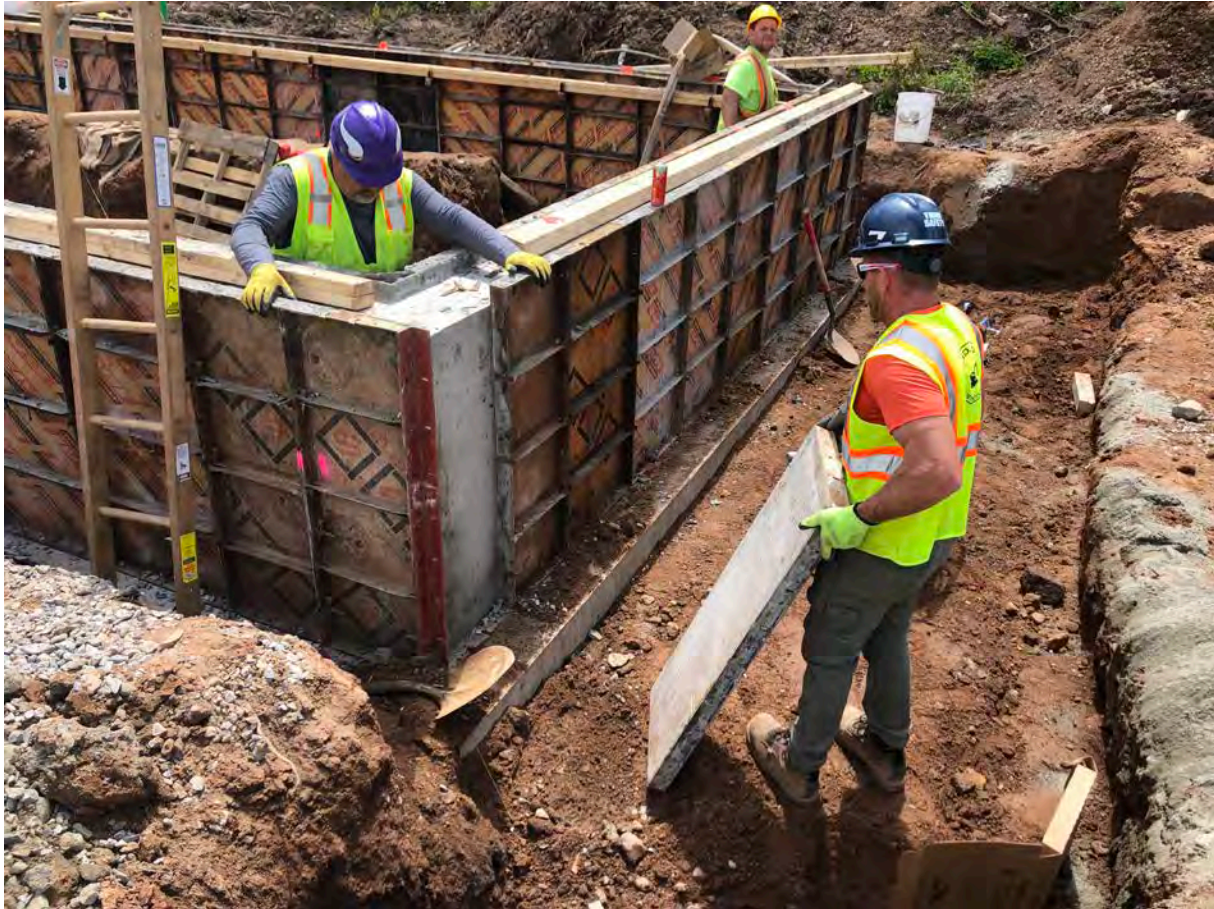
Picture 6: Ludlow beginning to remove concrete forms from the northwest corner of the booster station frost wall. View to the southeast.

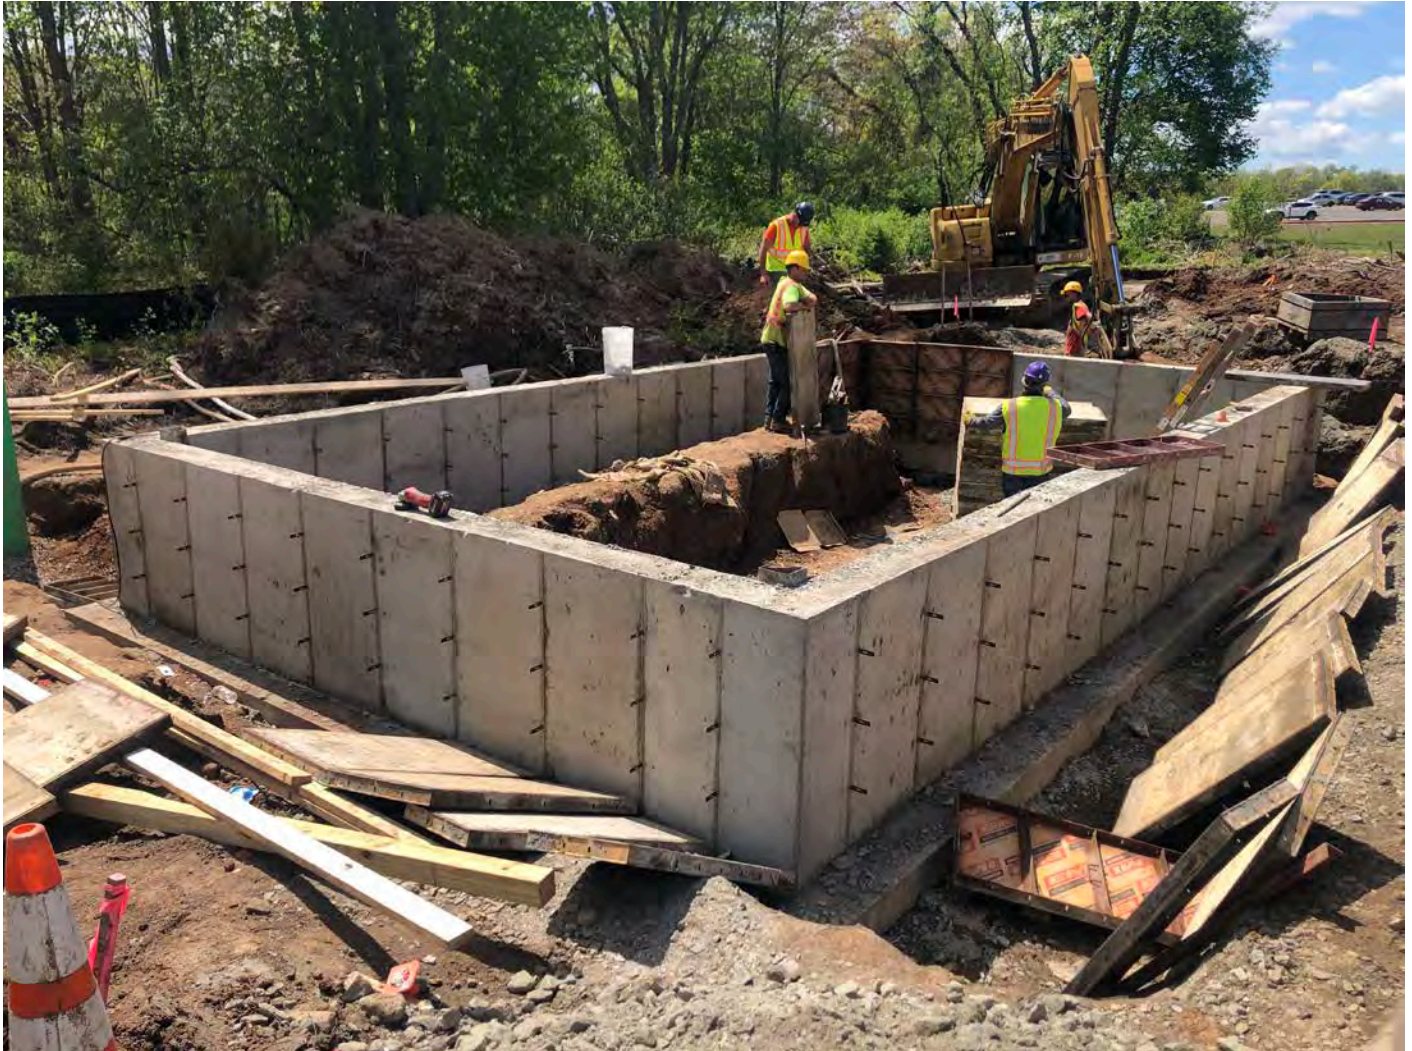
1407: Ludlow has removed approximately ¾ of the concrete forms from the sides of the booster station frost wall.

Picture 7: View of booster station frost wall with most of the concrete forms removed. View to the southwest.

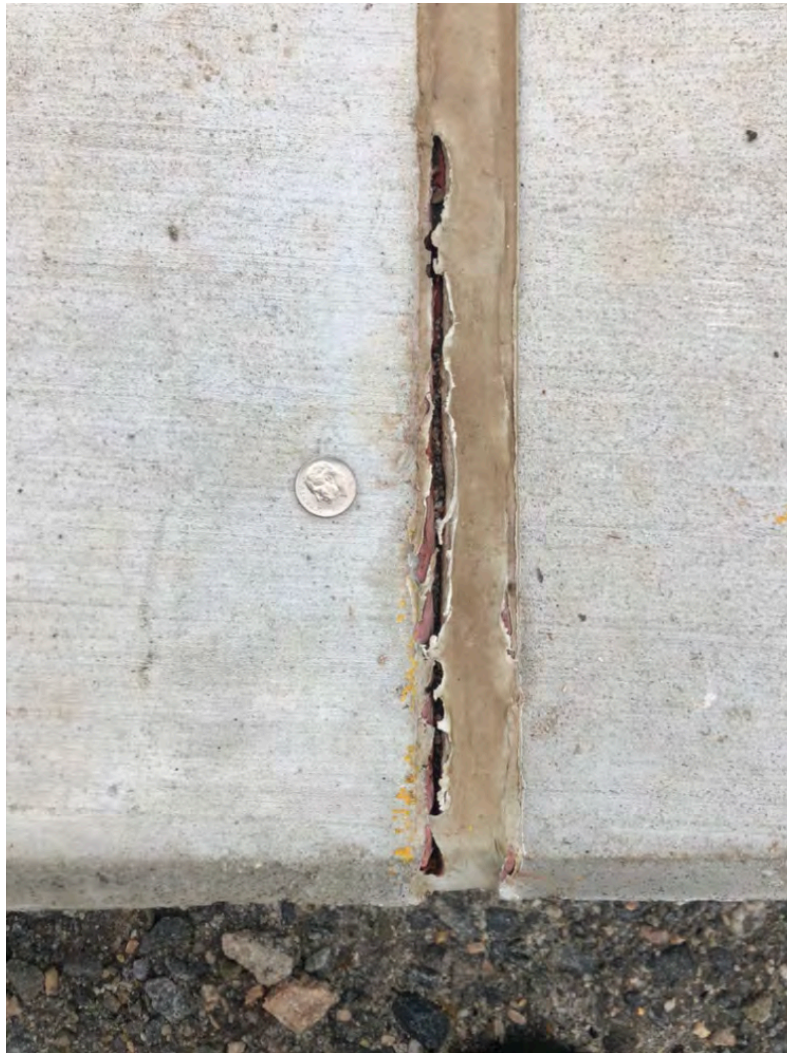
United Concrete worked on removing damaged caulking between the two pieces of the pressure reducing valve vault roof located at ~Station 161+40 Main Street in Durham.

Picture 8: Caulking on the seam between the two sections of the pressure reducing valve vault located at ~Station 161+40 Main Street Durham.

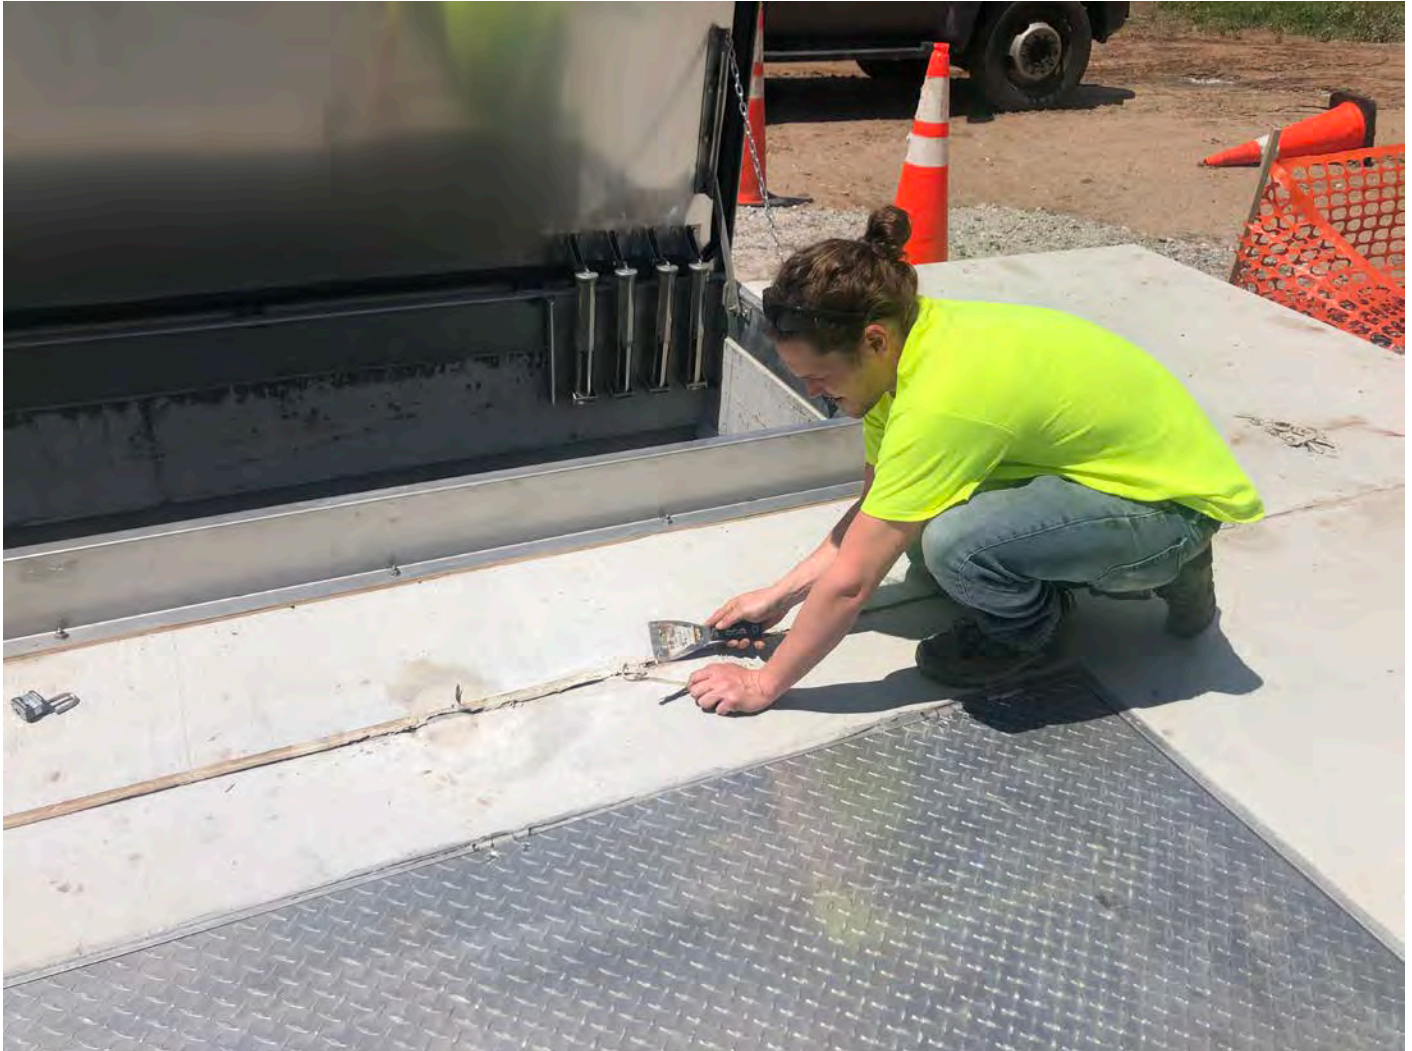
1233: Two personnel from United Concrete are working at the pressure reducing valve vault, removing caulking from the seam located between the two halves of the vault roof.

1310: United Concrete continues to remove damaged caulking from the pressure reducing valve vault located at ~Station 161+40. United Concrete indicated that they would come back some time in the future to remove additional caulking. United Concrete stated that they had to pump approximately 5" of standing water from the vault this morning. There are concerns about the vault components being affected by the humidity in the vault: the USACE representative spoke to Ludlow about getting a dehumidifier working inside of the vault.

Picture 9: United Concrete removing damaged caulking from the seam between the two sections of the pressure reducing valve vault located at ~Station 161+40 Main Street Durham. View to the west.

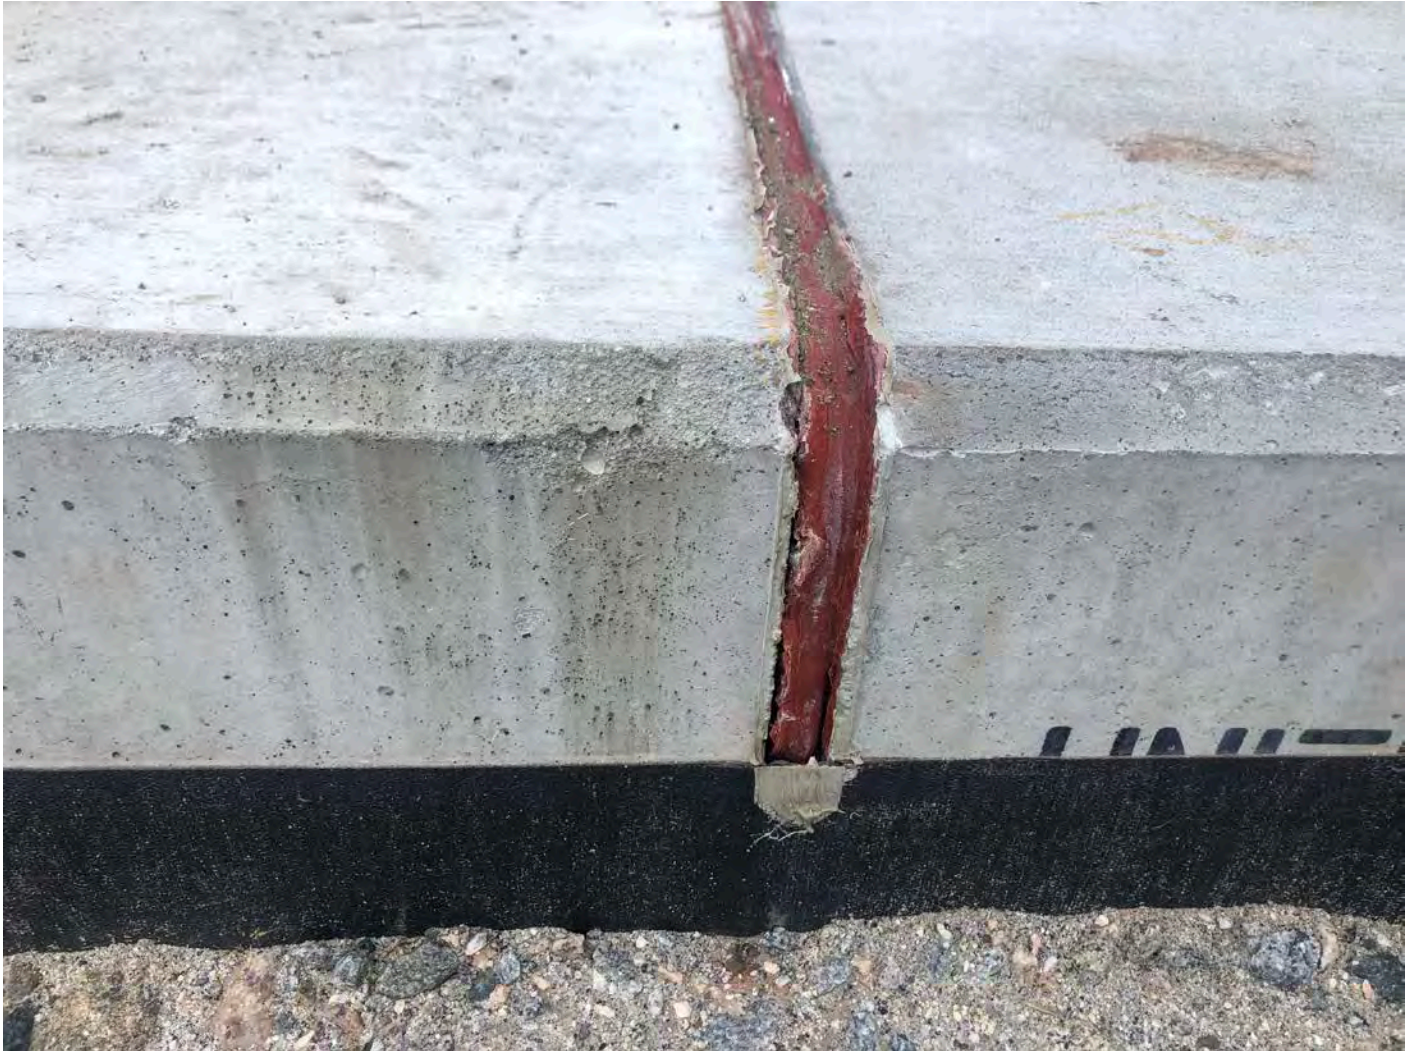
Picture 10: View of the seam located between the two sections of the pressure reducing vault located at ~Station 161+40 with some of the caulking removed.
