Daily Report

Project: June 24, 2021 **Durham Meadows Pipeline Installation** Date:

Report No: 271 Project #: AECOM: 6061487

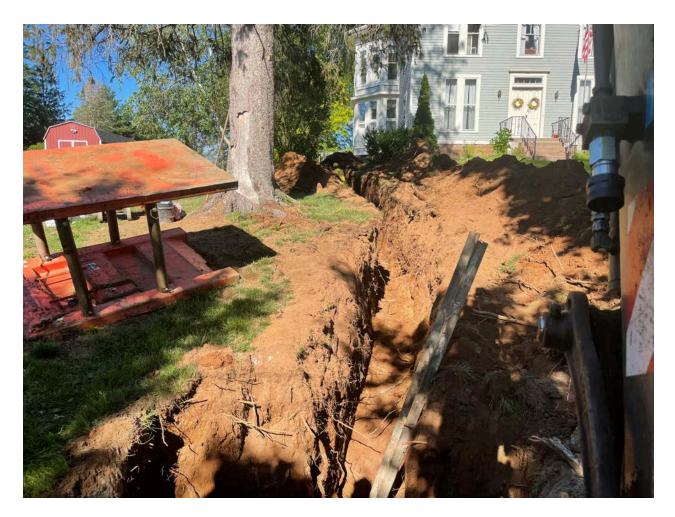
0842: Ludlow continues to work on installing a 1" copper water service line at the 188 Main Street residence in Durham. They have excavated a trench from the house to the curb stop located approximately 80' east of the house. Ludlow is currently laying

Picture 1: Trench excavated for the Installation of a 1" copper water service line at the 188 Main Street residence. View to the west.

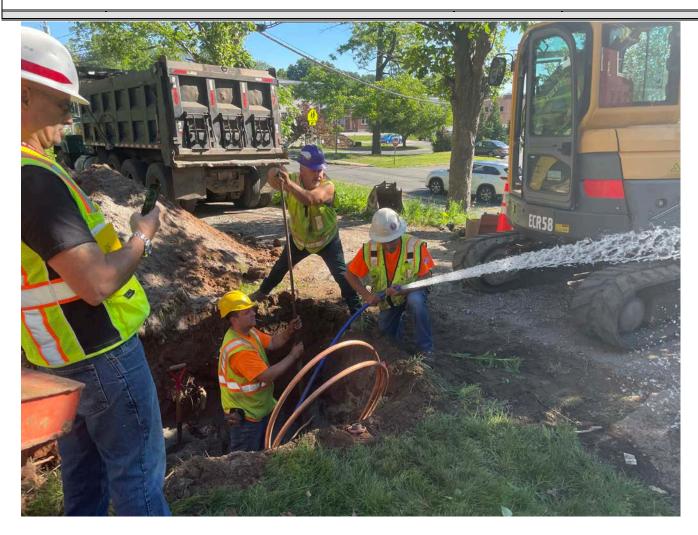
Picture 2: Ludlow purging the curb stop at 188 Main Street, Durham, before attaching a 1" copper water service line to it. View to the northeast.

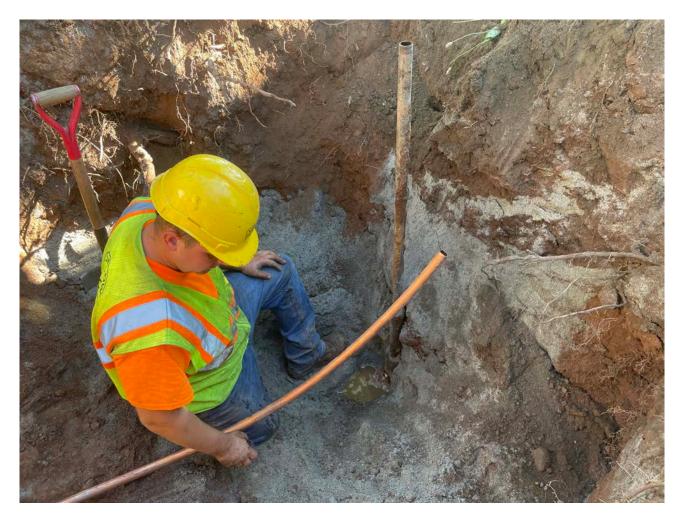
Picture 3: Ludlow preparing to connect 1" copper water service line to the curb stop for 188 Main Street, Durham. View to the northeast.

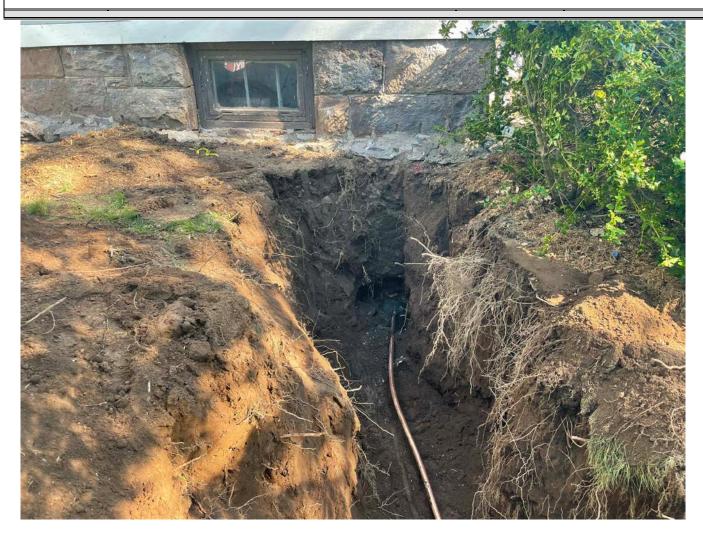
Picture 4: 1" copper water service line that has penetrated the south side of the foundation of the residence at 188 Main Street in Durham. View to the north.

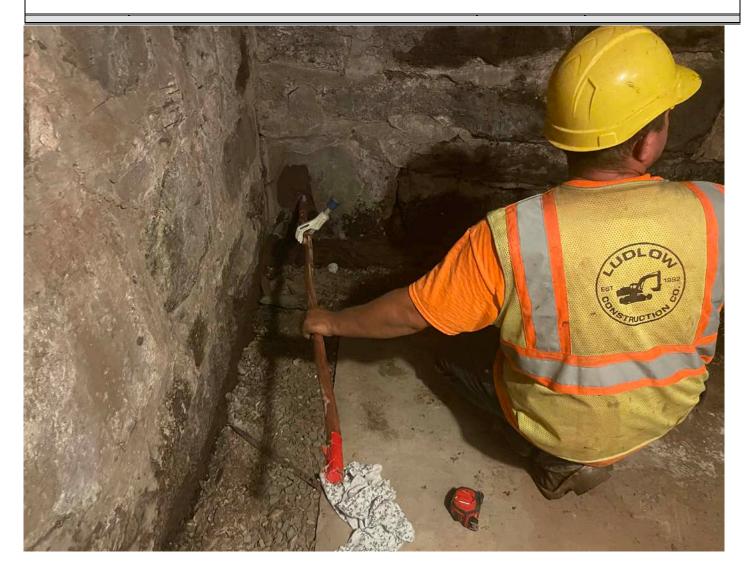
1317: Ludlow has just penetrated the north side of the foundation of 199 Main Street next to the northwest corner. The foundation is comprised of fieldstone.

Picture 5: Ludlow pulling 1" copper water service line through the penetration that was made through the foundation of the 199 Main Street building on the north side (next to the northwest corner of the foundation). View to the north.

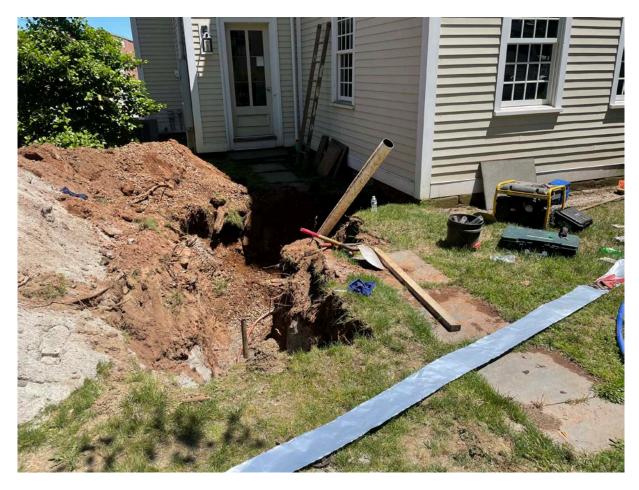
Picture 6: View of the installation of a 1" copper water service line for the building at 199 Main Street, Durham. View to the southeast.

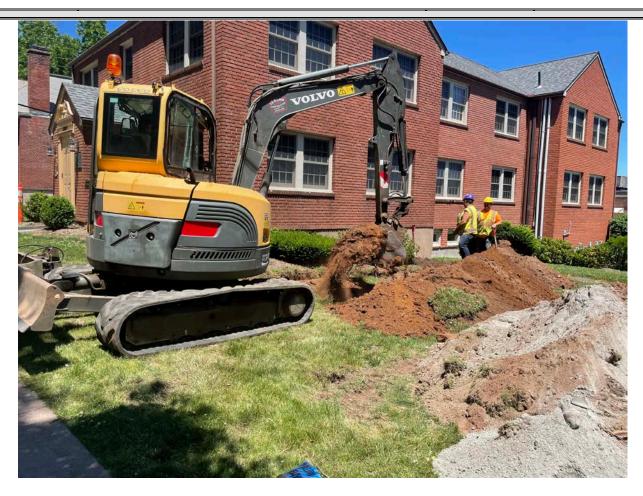
1302: Ludlow starts to excavate a trench for the installation of a 1" copper water service line at the 201 Main Street building. Ludlow is excavating on the south side of the building to make an entry point into the south side of the concrete foundation.

Picture 7: Ludlow excavating for the installation of a 1" copper water service line on the south side of the 201 Main Street building. View to the northeast.

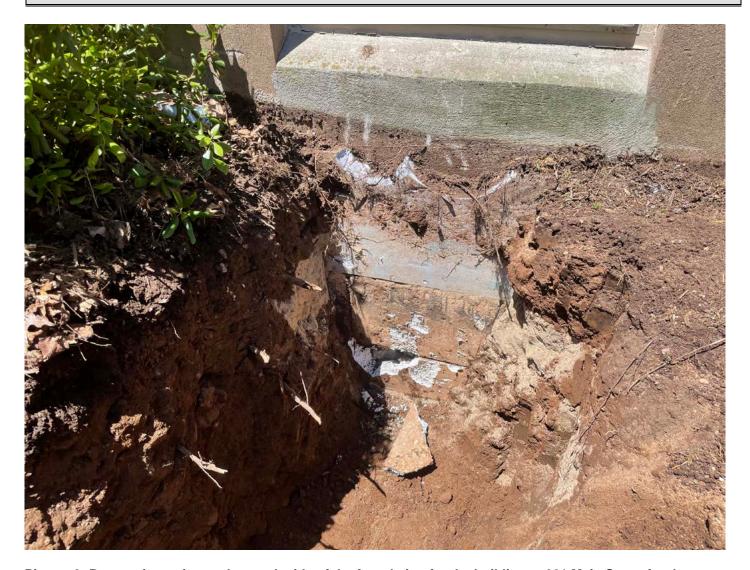
1359: The penetration point on the south side of the foundation for 201 Main Street is 17' 5" from the southwest corner of the building. Ludlow is currently backfilling the trench after having connected a 1" copper water service line from the curb stop to the insertion point on the south side of the foundation. Ludlow places 1' of sand over the copper line before backfilling with the soil they excavated from the trench.

Picture 8: Penetration point on the south side of the foundation for the building at 201 Main Street for the installation of a 1" copper water service line. View to the north.

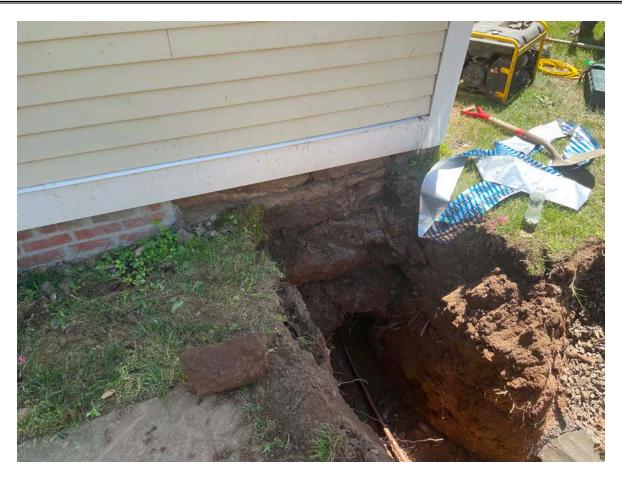
Picture 9: North-facing foundation of the building at 199 Main Street, Durham where Ludlow inserted a 1" copper water service line. View to the southwest.

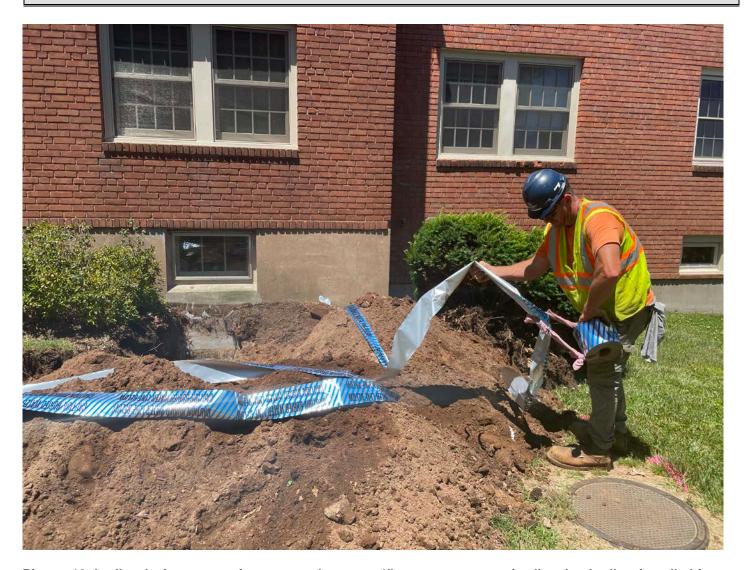
Picture 10: Ludlow laying out caution tape to place over 1" copper water service line that Ludlow installed for the building at 201 Main Street, Durham. View to the north.

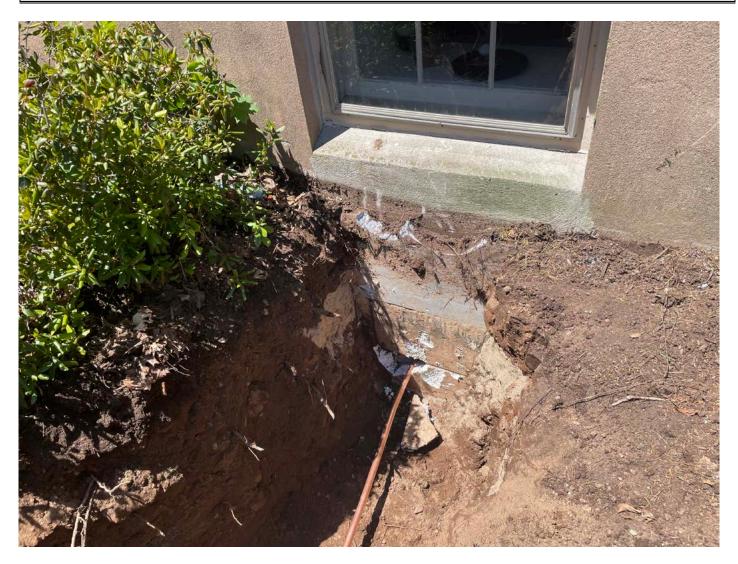
Picture 11: 1" copper water service line that has been fed through the penetration that was made on the south wall of the foundation for the 201 Main Street. View to the north.
