## Daily Report

<b>Project:</b>	Durham Meadows Pipeline Installation	<b>Date:</b>	August 02, 2021
<b>Location:</b>	Main Street and Maple Avenue, Durham; Shared Access Driveway, Middletown	<b>Day of Week:</b>	Monday
<b>Project #:</b>	AECOM: 6061487	<b>Report No:</b>	293
<b>Contractor:</b>	Ludlow Construction	<b>Page:</b>	1 of 11

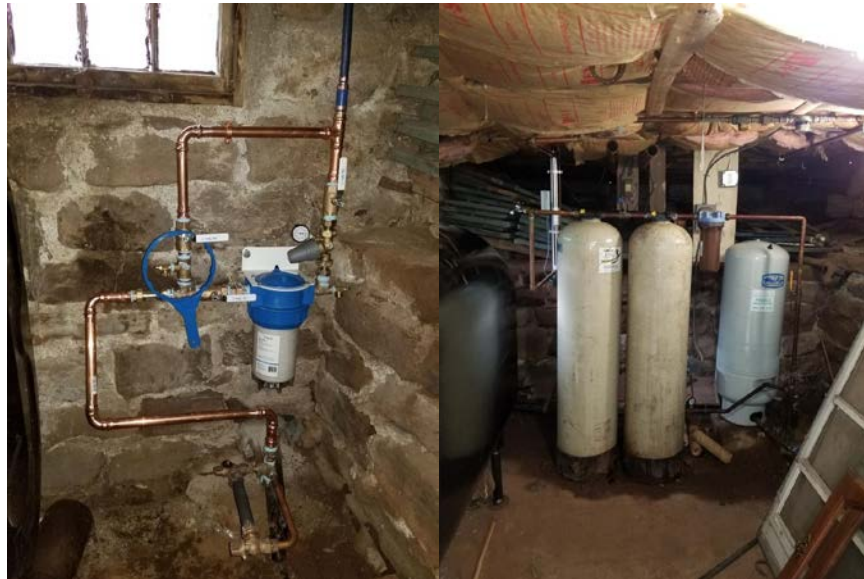
Picture 1: Fazzino installation at 239 Main Street. Completed on south wall of building.

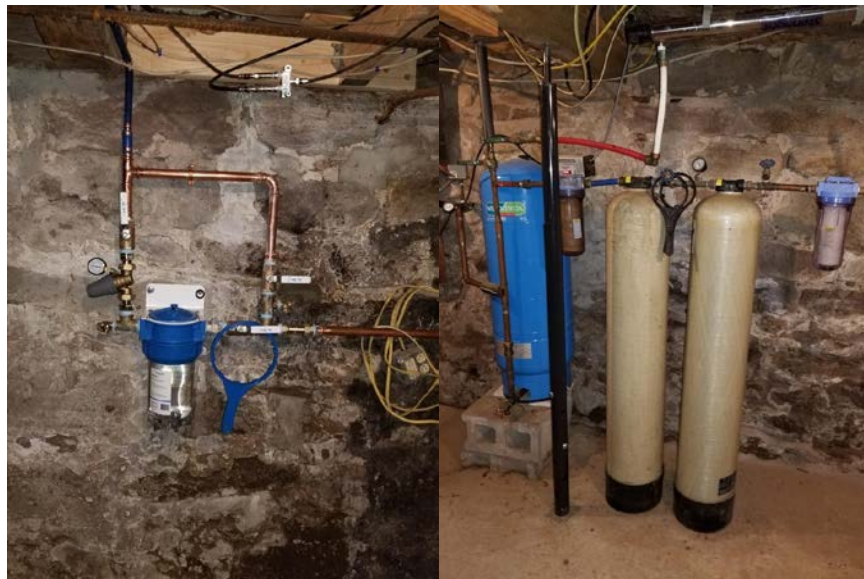
Picture 2: Fazzino installation at 242 Main Street. Installation is on the east wall of the home.

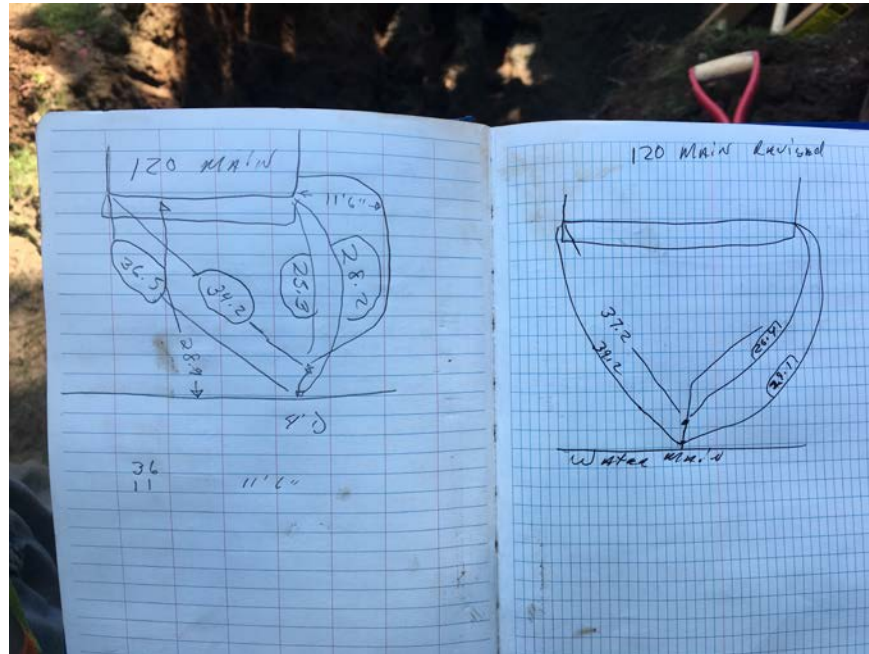
Picture 3: Ludlow tie-offs for 120 Main Street. On the left were the original tie-offs and on the right are the tie-offs for the location of the relocated corporation connection and curb stop. Note that the water main here is plastic not ductile iron.

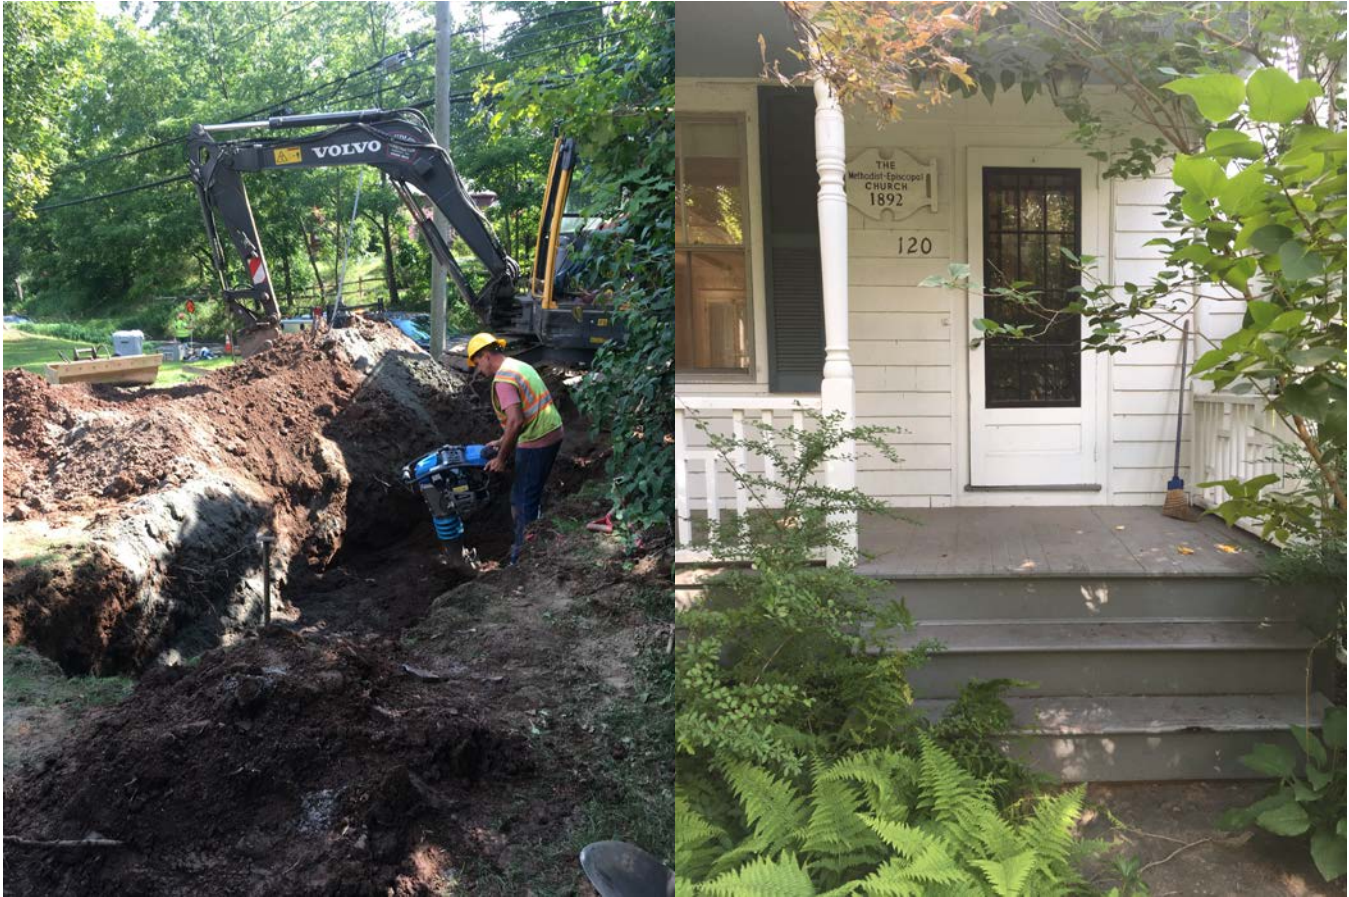
0730: Ludlow begins work at 120 Main Street. The installation was a second attempt at repair at this location. The plumbers determined, during their installation inside the house, that there was pressure but no flow. Having addressed all the piping and other options, Ludlow determined that the saddle/Corp that was previously installed by others was not properly set. Rather than locating and shutting down the main, Ludlow closed and abandoned the original corporation stop and installed a new corporation stop and a couple feet new line. While they were performing the work, they plugged an old drainage line that had been abandoned during the initial water main installation. New tie-offs are included in this report.

Picture 5: Facing northeast – 120 Main St. Backfilling new line and corporation connection. Replaced improperly installed corporation stop that prevented water flow to building. The water main is approximately 24 feet from the top step of the porch.

Ludlow installed a new corporation stop and 2 feet of water line to 120 Main Street after the plumber reported that the house had pressure but no flow. In the process they plugged an old foundation drain they encountered that was cut through when the water main was installed (not by Ludlow) roughly 8 years ago. The need to go back to 120 delayed work at 280 Main Street; although running the line to the Notre Dame Church would be a 1.5-2 day job anyway given the complexity of bringing the water line into the building. Ludlow managed to install 79.2 feet of 1.5" copper line from the curb stop to the meter vault, and then to a point just south of the southeast corner of the building. They will complete the rest of the line, which is set to enter the southwest corner of the building, later in the week due to scheduling at other locations. Tuesday at Durham Family Eyecare and Durham Market and Wednesday at 227 Main Street, where the installation will go through the existing water line foundation for final hook up by Fazzino.

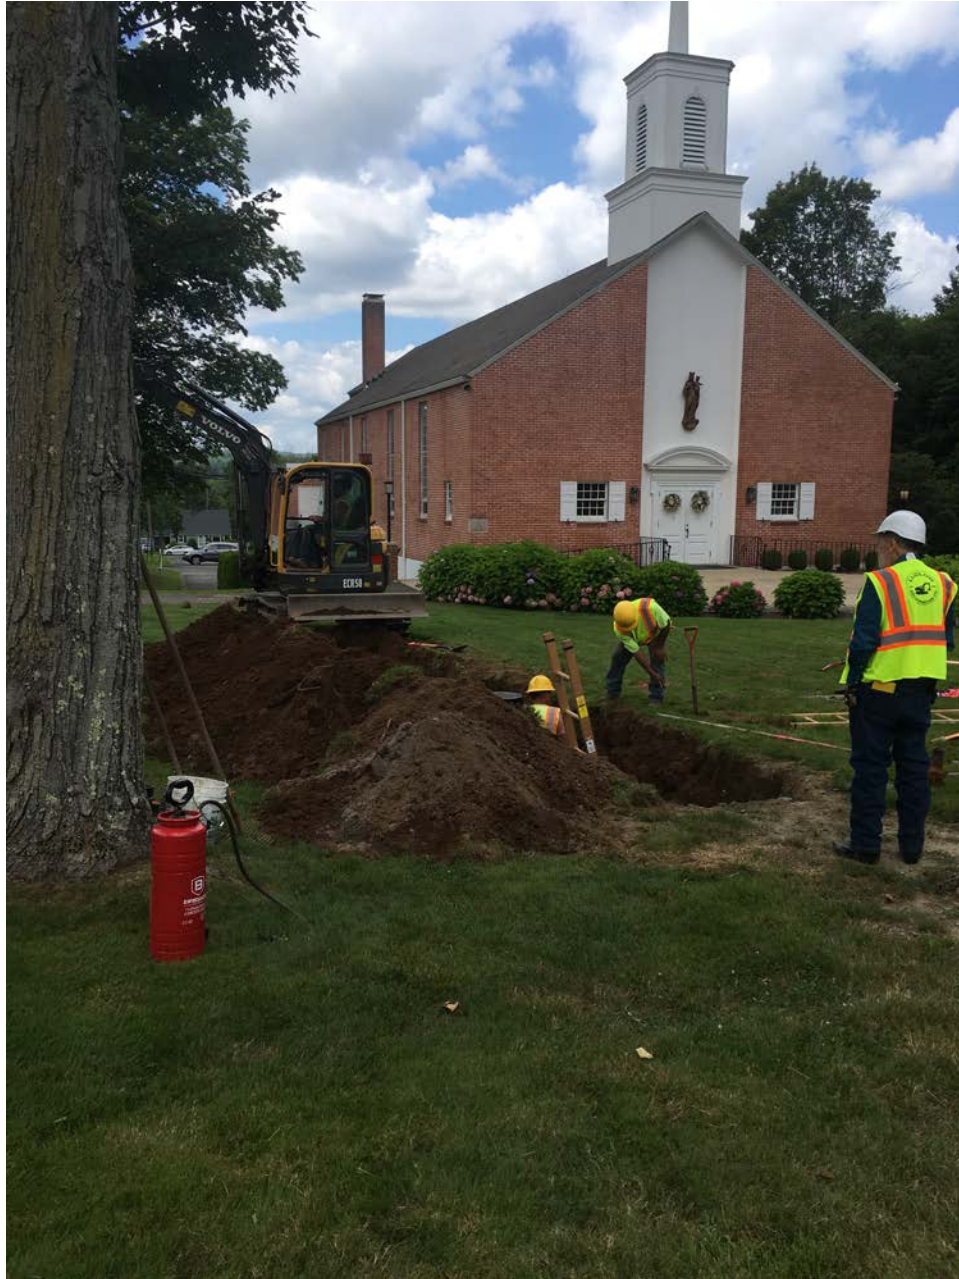
1100: Ludlow has excavated and installed 1.5" copper water line from the curb stop (located 48 feet west from the water main) to the meter pit, which was installed another 10 feet west of the curb stop.

**Picture 6: Facing west. 280 Main Street (Notre Dame Church) Installation. Curb stop 48 feet from water main in Route 17. Line will run down south side (left) of the building to the back corner.**

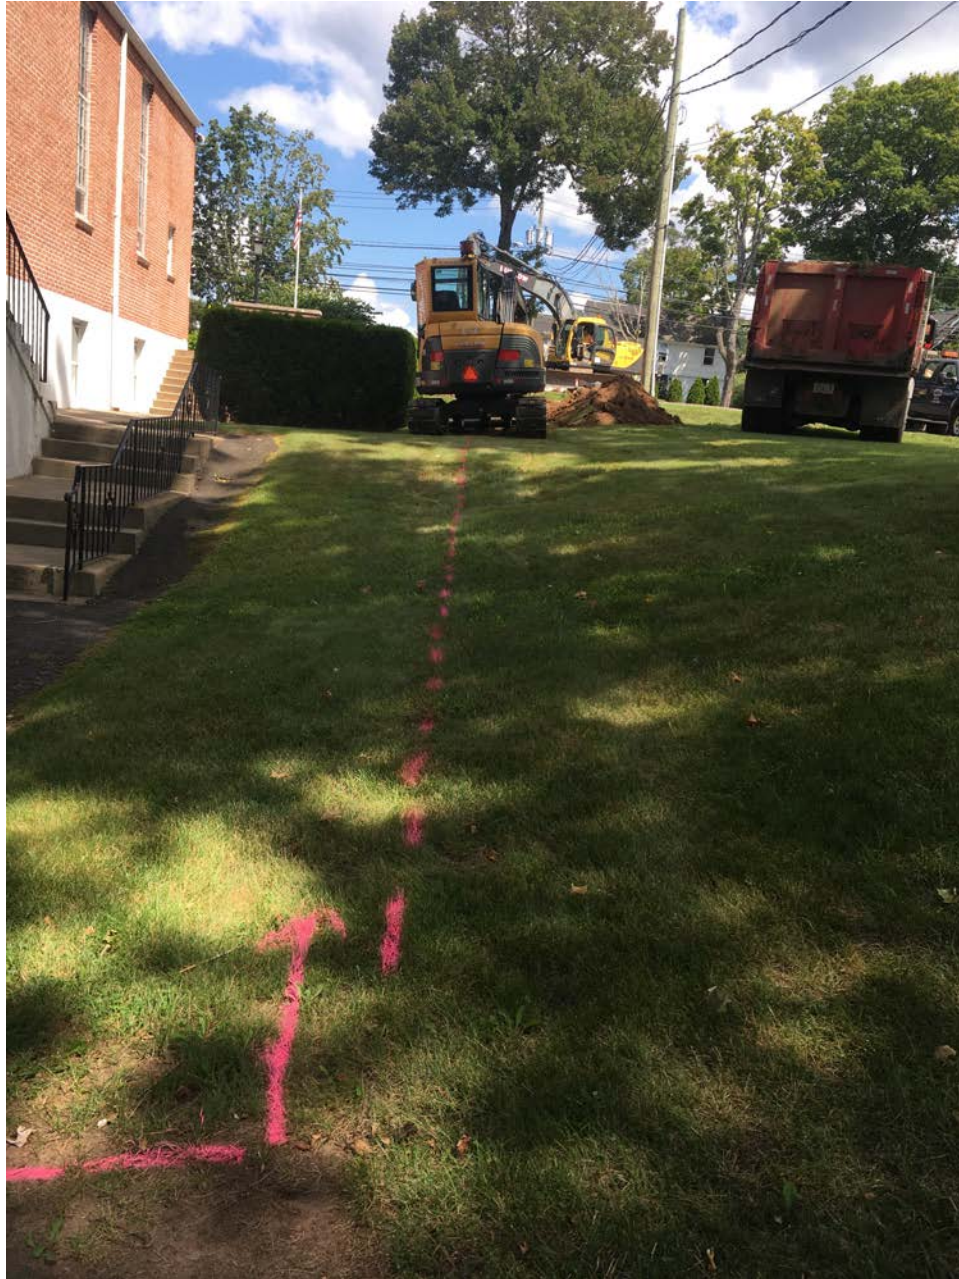
Picture 7: Facing east. View from back of 280 Main Street, where water line will go into the building.

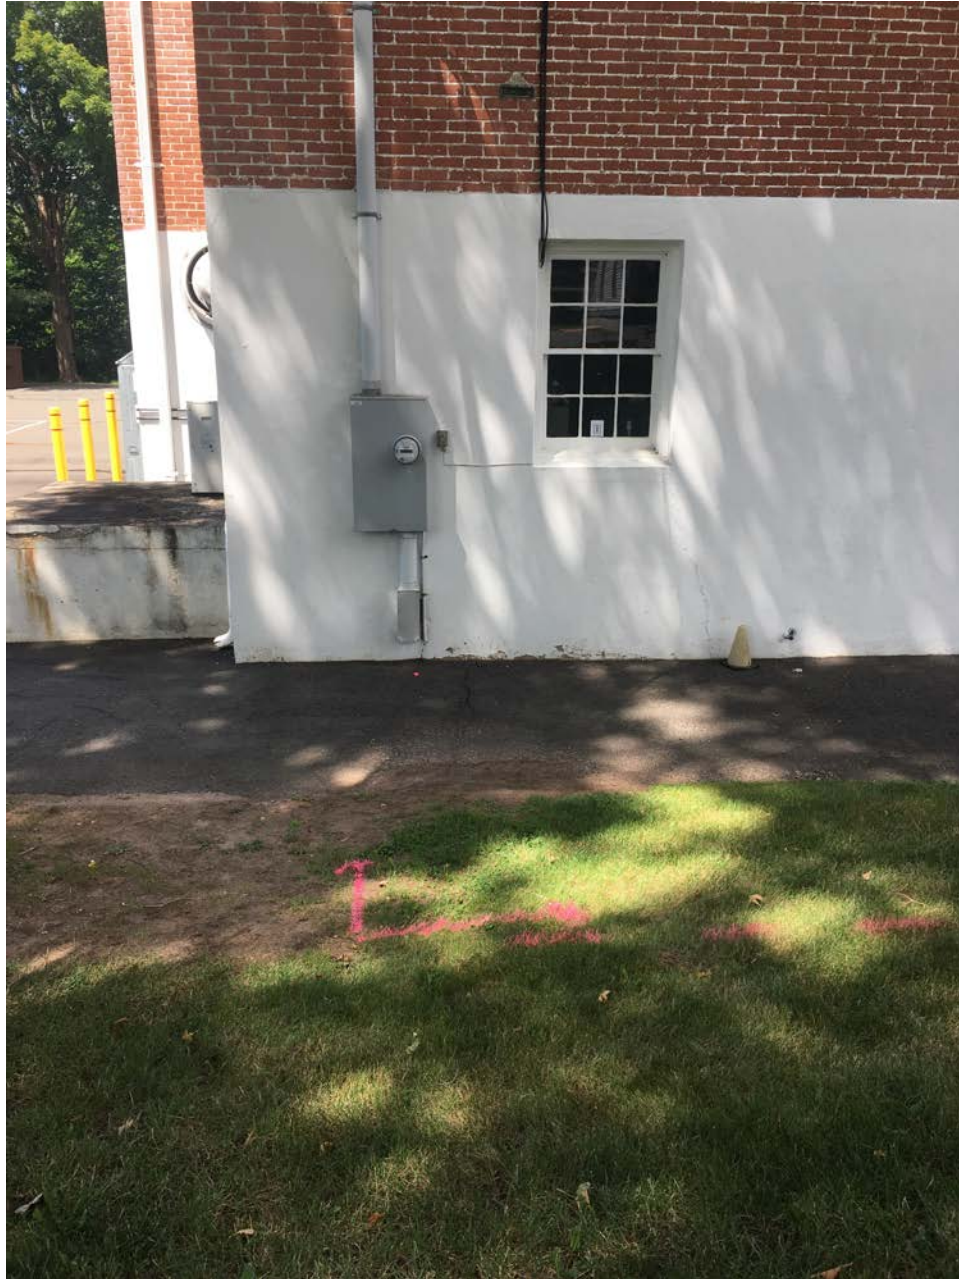
**Picture 8: Facing north. Ludlow will have to go under the floor of the building and then come up to install the water line at 280 Main Street. This will likely be completed later this week.**

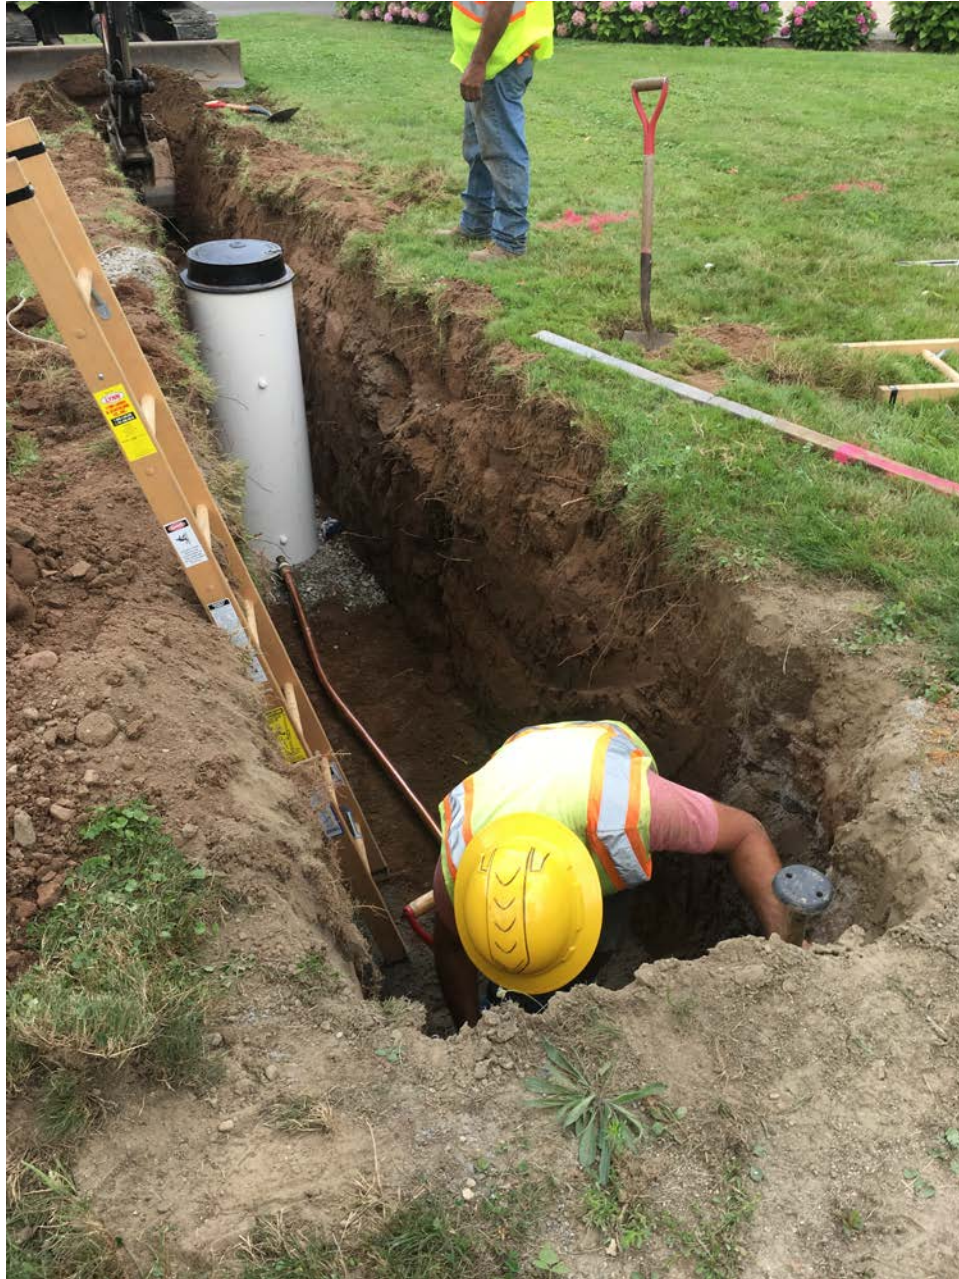
Picture 9: Facing east. 280 Main Street curb stop and meter vault set 10 feet apart. 1.5-inch copper line in trench. Ludlow installed 79.2 feet of line today.

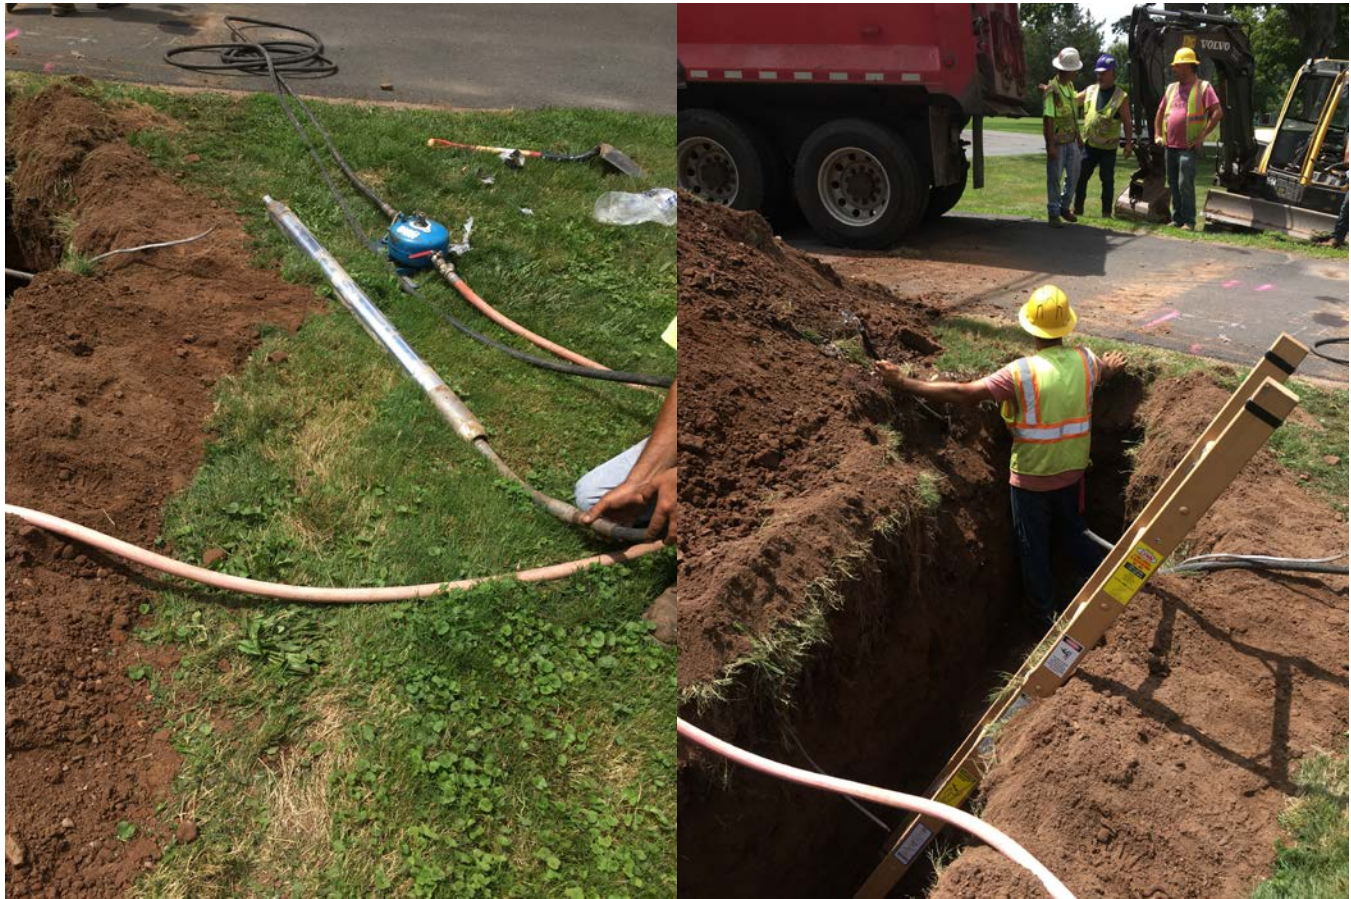
1230: Ludlow is simultaneously trying to excavate the irrigation lines that they had repaired previously. Apparently there is a problem with the system that causes it to run. However, they broke another line by the church and the search for the leak will have to be suspended, not only to fix the water line, but also until after the municipal water line is hooked up to avoid drying out the well which is still serving the rectory. Many unmarked water lines and electrical lines were encountered today. Three unmarked Romex electrical lines were also broken during trenching.

Picture 10: Facing southerly. Picture on left is the mole used to pull water line under the pavement area at 280 Main Street to avoid excavating asphalt walkway. On the right behind the ladder is an example of one of the three Romex electric lines buried about 6 inches deep that were breached and later splice back together. In the Ludlow workers hand is and irrigation line, also about 6 inches deep, that was splice back together. There is still a leak in the line, not in any of the dug-up parts that were repaired, but – Ludlow thinks – likely a connection that was pulled out. Leak will be trouble shot after connection of municipal water so as not to dry out the well in the search.

1330: Ludlow has installed 79.2 feet of 1.5-inch copper water line to a point near the southeast corner of the church. They used an air driven tunneling device to avoid digging up church paved areas. They are currently fixing the irrigation line and 2 out of 3 electrical breaks. The last break requires some additional line to be able to reconnect. As for the irrigation line, Ludlow is certain of their connections and therefore thinks that the line may have disconnected elsewhere, where they haven't dug. The plan is to run the system after the municipal supply is connected to determine where the leak is occurring.
