Daily Report

Project:Durham Meadows Pipeline InstallationDate:August 04, 2021

Project #: AECOM: 6061487 **Report No:** 295

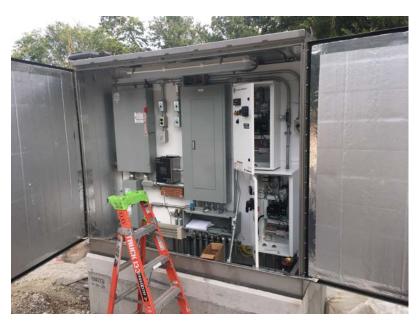
Picture 1: United Concrete electrician working on Control Box up at the Tank. Reconfigured box with new control panels. Electrician will return Friday 8/6 to complete conduits and wiring.

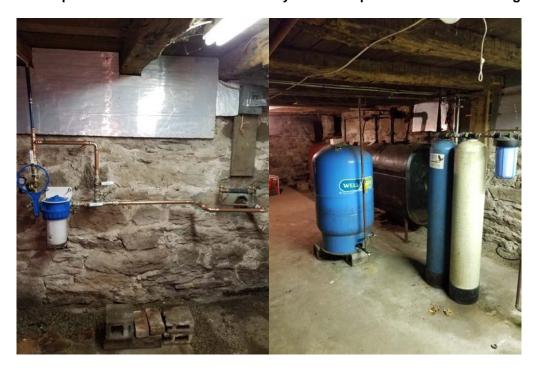
Picture 2: Fazzino installation on south wall of 227 Main Street on left. On right items removed.

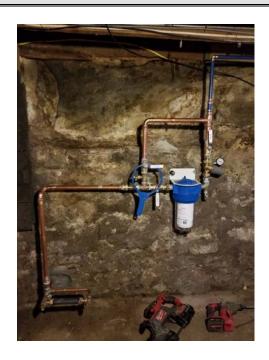
Picture 3: Fazzino 246 Main Street installation on the east wall, water line enters on the east wall.

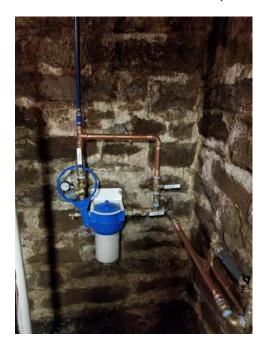
Picture 4: Fazzino 243 Main Street installation on the south wall, water line enters on the west wall.

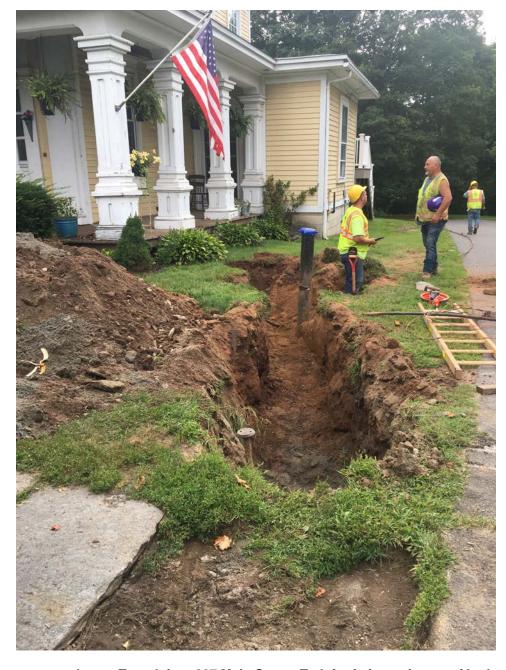
0845: Ludlow is having trouble getting the copper line through the conduit because there is a turn in the conduit that is preventing the 1" copper line from being pulled through. They have extended the trench up to the edge of the porch and remove the conduit up to the elbow, creating a straight shot into the house. The conduit/water line enters the house 26" from the southwest corner of the house (not porch) at approximately 3 feet below grade along the south side. Inside, the pipe comes through the wall at 4.5 feet below the sill.

Picture 5: Facing east-northeast. Trench into 227 Main Street. To left of picture is row of hedges and sidewalk. In foreground is the curb stop and mid distance the well. Due to a bend in the conduit (not visible) this trench will need to be extended.

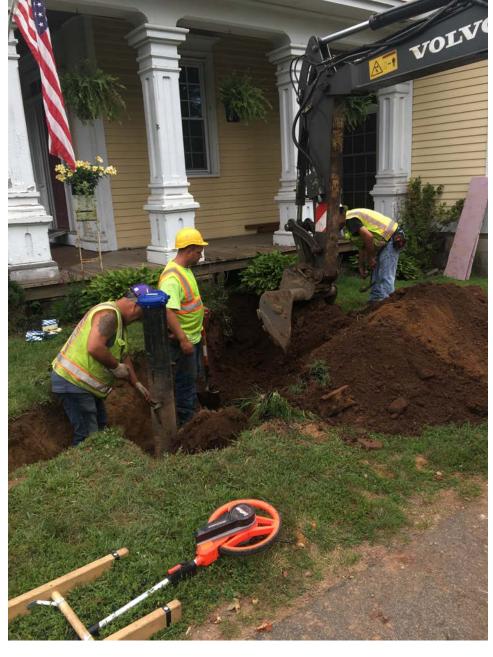
Picture 6: Facing northeast. Extension of the trench at 227 Main Street up to the porch edge in order to remove the elbow in the line. The 1' copper line was not flexible enough to make the turn.

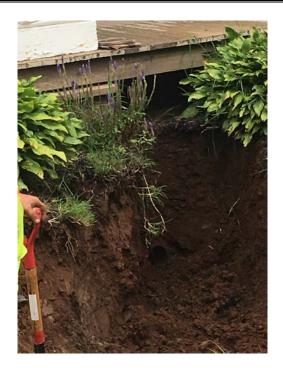
Picture 7: Conduit under porch for 1" copper water line into 227 Main St. Depth is approximately 3 feet.

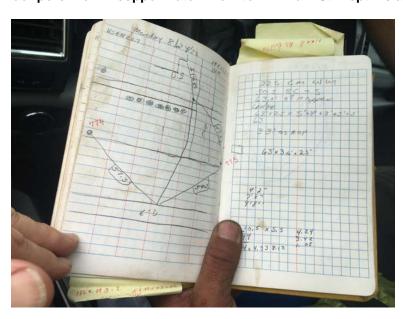
Picture 8: Tie-offs for 227 Main Street, recorded last year. Show tie off to corp and to curb stop..

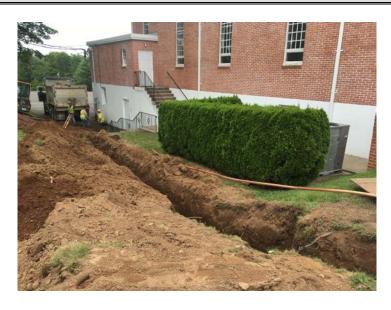
Picture 9: Facing westerly. 280 Main Street Notre Dame Church continuation from Monday.

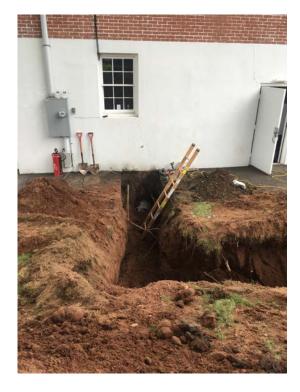
1300: Ludlow has completed the trench down to the back of the church building at 280 Main Street. Working on the penetration into the building. The line is entering 10 feet east of the southwest corner of the church at a depth of 3 feet below the asphalt. This places the pipe right above the footing of the building. Inside the 1.5" copper line comes in 32" below the floor of the building. A hole was hammered through the floor to access and bring the line up into the utility room of the church.

Picture 10: Facing north, Trench turns into south side of Church at 290 Main St..

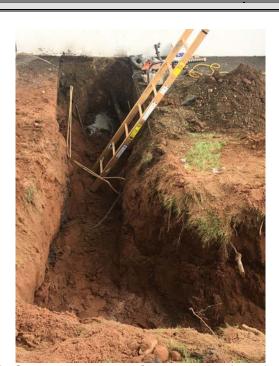
Picture 11: Facing North. 280 Main Street. Notre Dame Church collection of abandoned pipes and wires. Wires were not energized. On the left are the small copper lines and on the left is 1.5 inch line seen just behind the ladder.

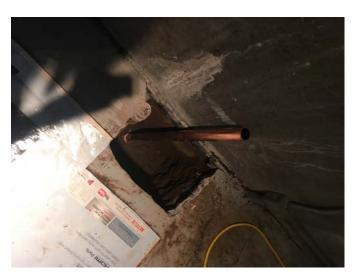
Picture 12: Inside picture of 280 Main Street. Behind copper pipe is the same wall as can be seen from outside. Picture is facing south and down. Note in the hole created for the 1.5' copper line to the left of the new service is the same pipe seen behind the ladder in the previous picture and that pipe has been plugged.

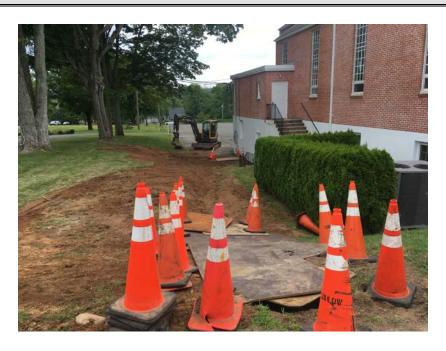
Picture 13: Facing west. End of day at 280 Main Street. Some final grading yet to be completed.

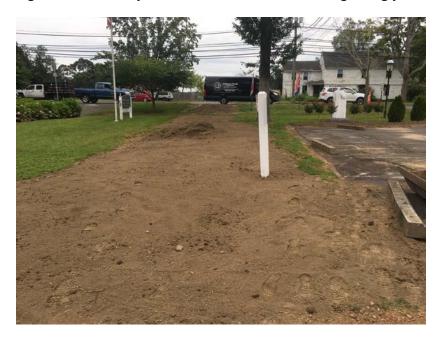
Picture 14: Facing east, End of day at 280 Main Street. This section was completed on Monday and final loam cover was raked out today. Minor cleaning up including returning parking bocks to their original positions.

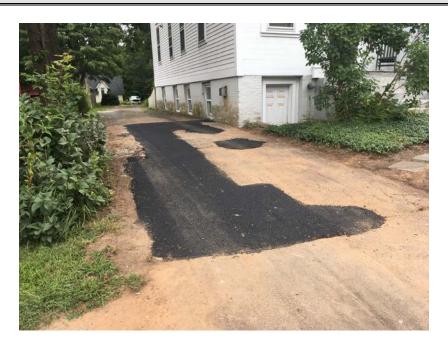
Picture 15: Facing east. Durham Academy drive. Patched last night.

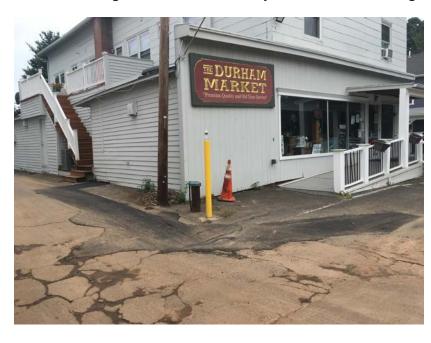
Picture 16: Facing northwest. Durham Market. Patched last night.
