### **Daily Report**

Project:Durham Meadows Pipeline InstallationDate:August 05, 2021

**Project #:** AECOM: 6061487 **Report No:** 296

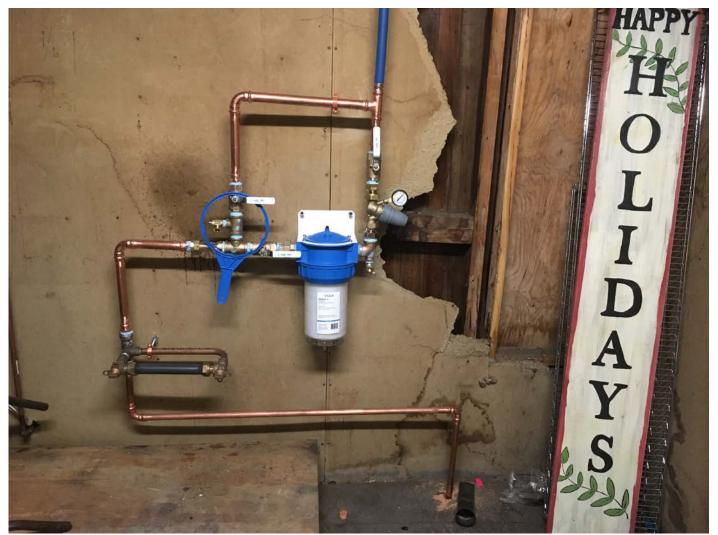
1530: Fazzino completes Durham Market. Installation is on the south wall near the southeast corner of the building. The submeters for the apartments are still backordered so will have to be installed later.

Picture 1: Fazzino completed Durham Market installation. Photo faces south, the installation is on the south wall above where the line comes into. Durham Market. Submeters for the apartments will likely be installed to the upper left. The water service enters on the southeast corner of the building.

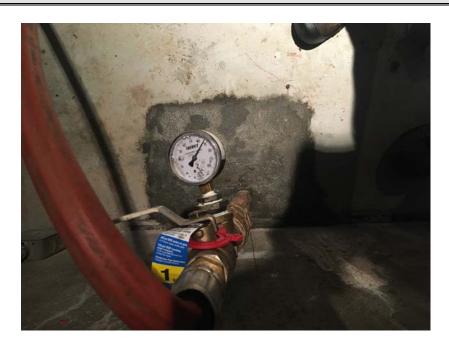
0810: Ludlow re-locates the curb stop, which was accidently buried by loam and installs a bypass in the meter pit so that they can pressurize test the system at 280 Main Street. System checked out, no leaks. Now just pending interior installation by the plumber.

Picture 2: Facing down. Water line in through the floor at the back of 280 Main Street (Notre Dame Church)

Pressure test of the system to insure no leaks. Note cemented floor restoration.

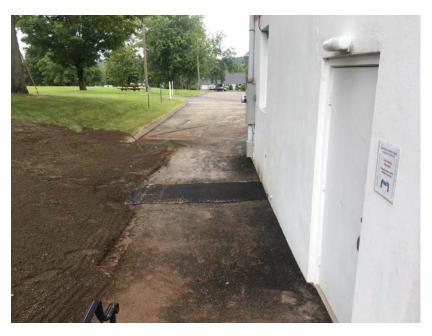
Picture 3: Facing west. Hot patched walkway where 1.5" copper enters 280 Main St. on southwest corner.

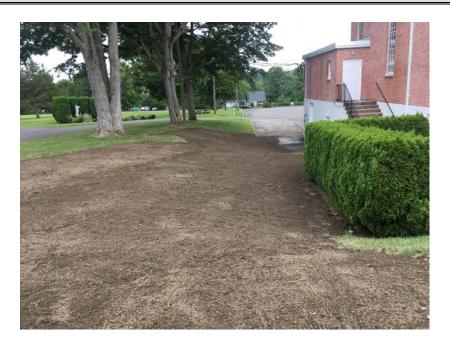
Picture 4: Facing west. Final grading 280 Main Street from roughly mid-point.

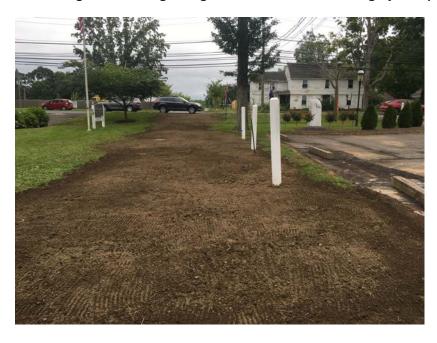
Picture 5: Facing east. Final grading 280 Main Street from roughly mid-point.

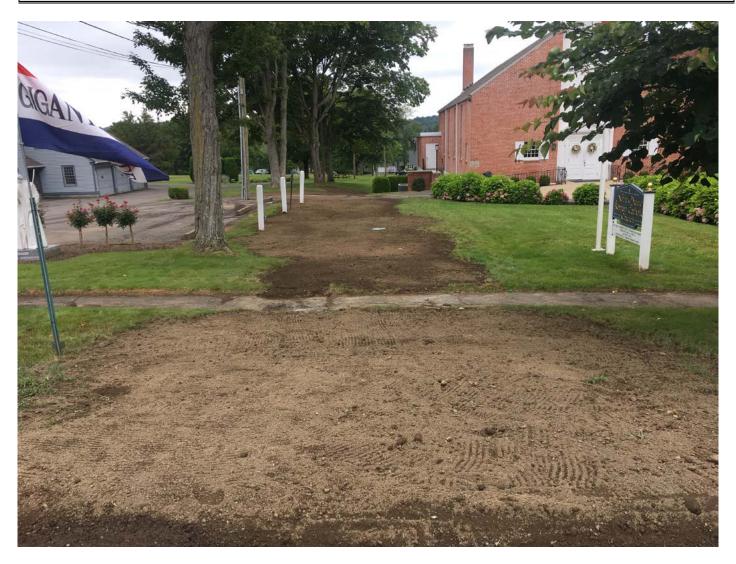
Picture 6: Facing west. Overview of the entire run from Route 17 up the south side of Notre Dame Church, 280 Main Street.

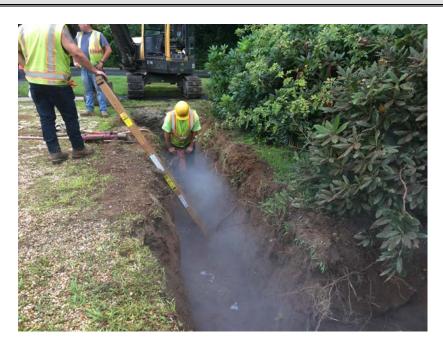
1100: Ludlow has dug the trench from the curb stop to the house at 289 Main Street, hitting bedrock in two places.

Picture 9: Facing west. Jack hammering one of two bedrock highs. The other was near the foundation wall.

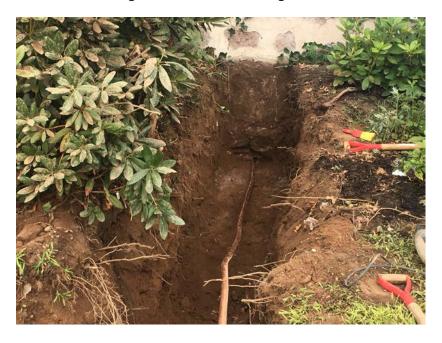
Picture 10: Facing north, 1" copper service into 289 Main Street.

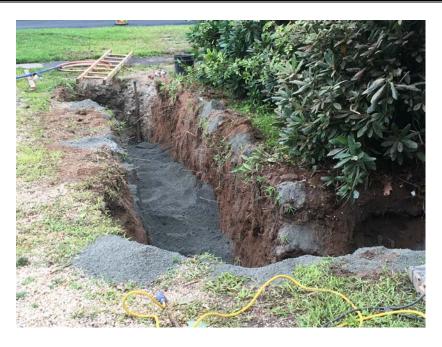
Picture 11: Facing west. 289 Main Street. Sand layer over the water line. Curb stop at top of picture by the ladder. Tie-offs were not yet completed and will be included in Fridays report.

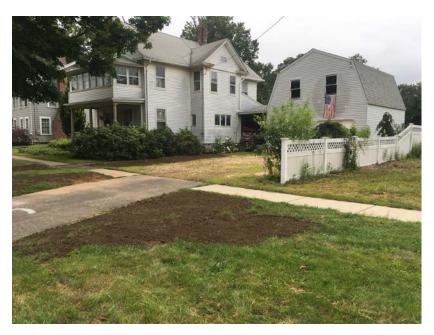
Picture 12: Facing northeast. Overview of completed installation at 289 Main Street.

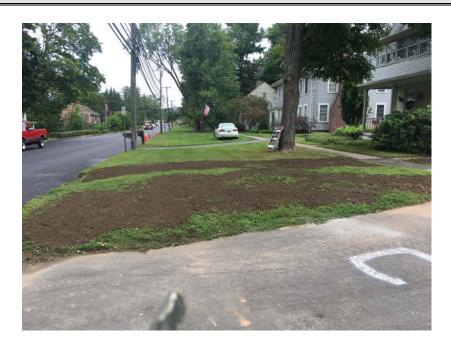
Picture 13: Facing north. Front lawn 289 Main Street. Driveway "C" is for 289 Main St. Final grading.

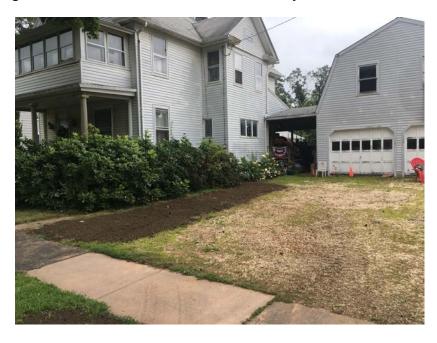
Picture 14: Facing northeast. Trench from curb stop to house and driveway of 289 Main St. Final grading..

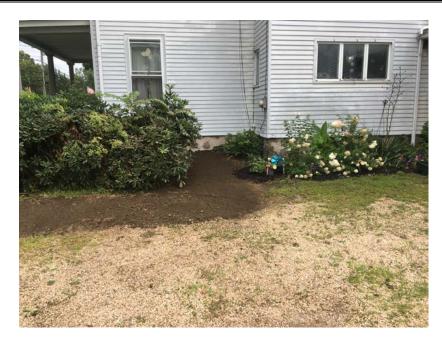
Picture 15: Facing north. Final grading 289 Main St. driveway and trench into house. 1" copper line enters 8 feet from southeast building corner (not porch corner).

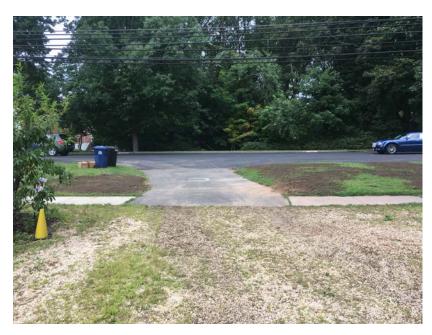
Picture 16: Facing west. Final grading at 289 Main St. View is from garage facing Route 17. House is to the right of the photo.
