Daily Report

Project:	Durham Meadows Pipeline Installation	Date:	August 06, 2021
Location:	Main Street and Maple Avenue, Durham; Shared Access Driveway, Middletown	Day of Week:	Friday
Project #:	AECOM: 6061487	Report No:	297
Contractor:	Ludlow Construction	Page:	1 of 11

Daily Activities – Installation of water lines, Main Street, Durham

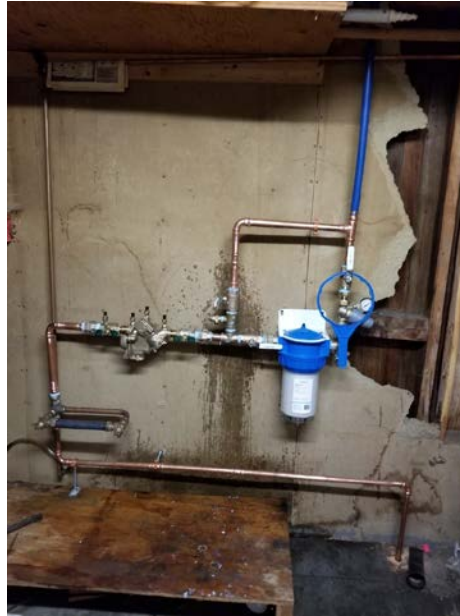
Picture 1: Fazzino returned to Durham Market to install an updated backflow preventer.

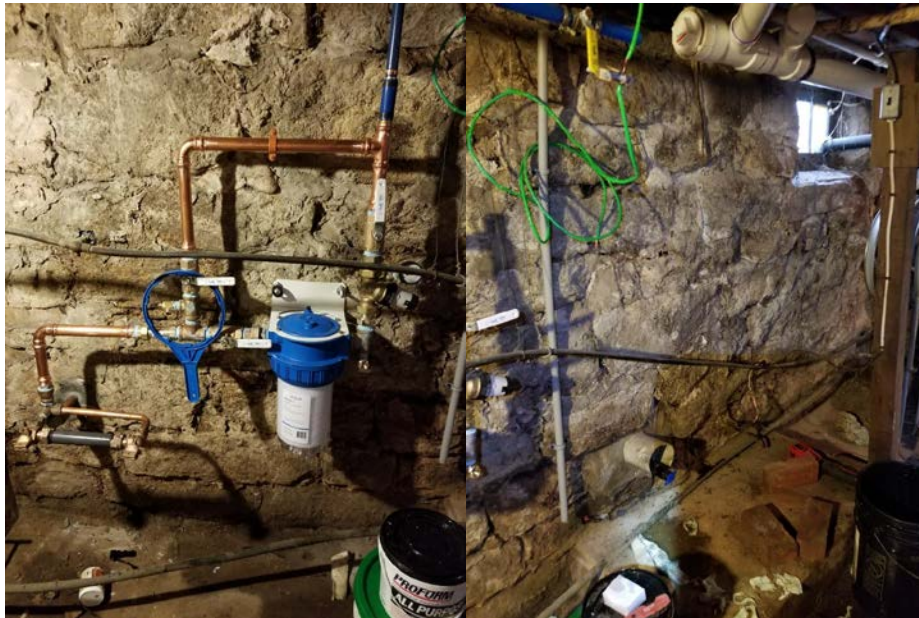
Picture 2: Fazzino installation at 257 Main Street. Left picture is the north wall installation. Right shows inlet.

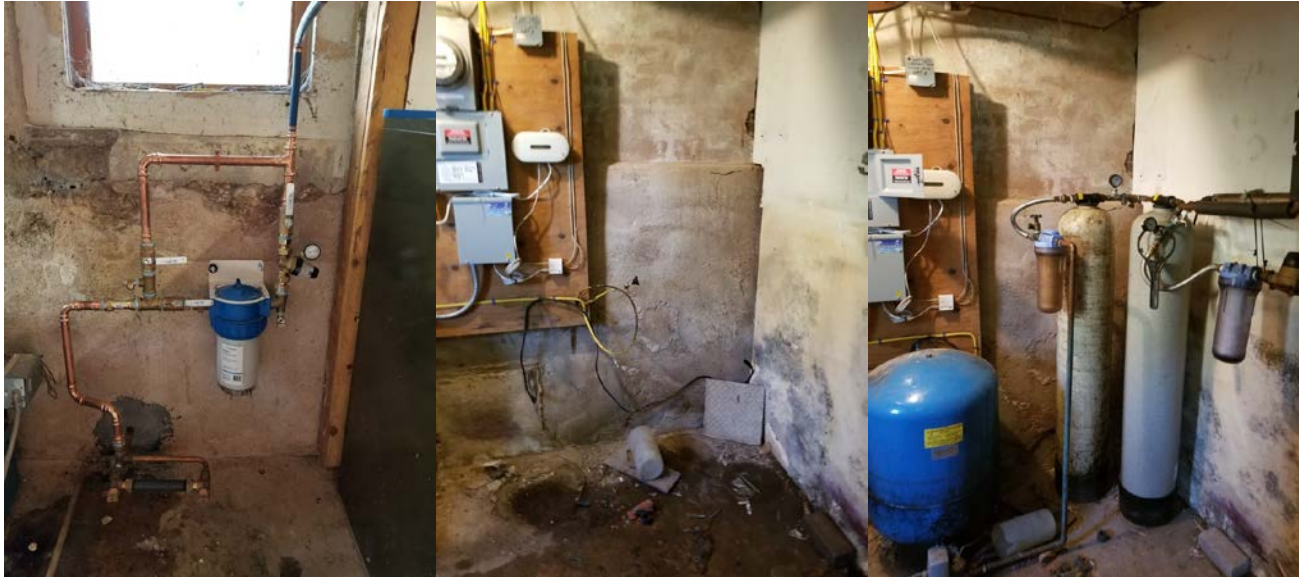
Picture 3: Fazzino installation at 253 Main Street. Left picture is the north wall installation. Center and right are pre-installation.

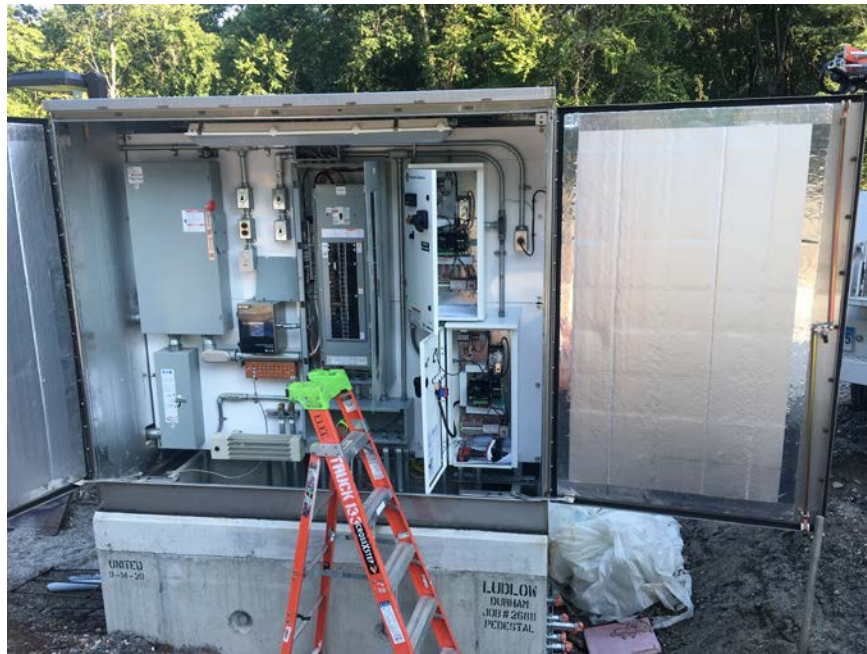
United Concrete completed the control panel work that was started at the beginning of the week. The connections outside the control panel will be done next week once Ludlow gets up to the tank to dig the conduit trenches.

Picture 4: Facing north. Completed control panel up at the Tank. Electrical just needs to run conduits and wire.

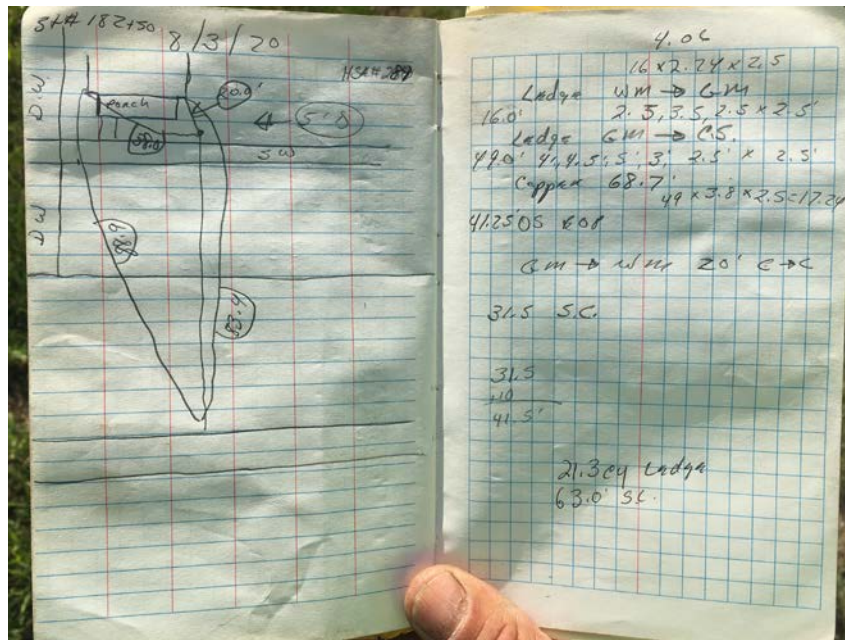
Picture 5: 289 Main Street Tie-offs. Installation was yesterday 8/5/21.

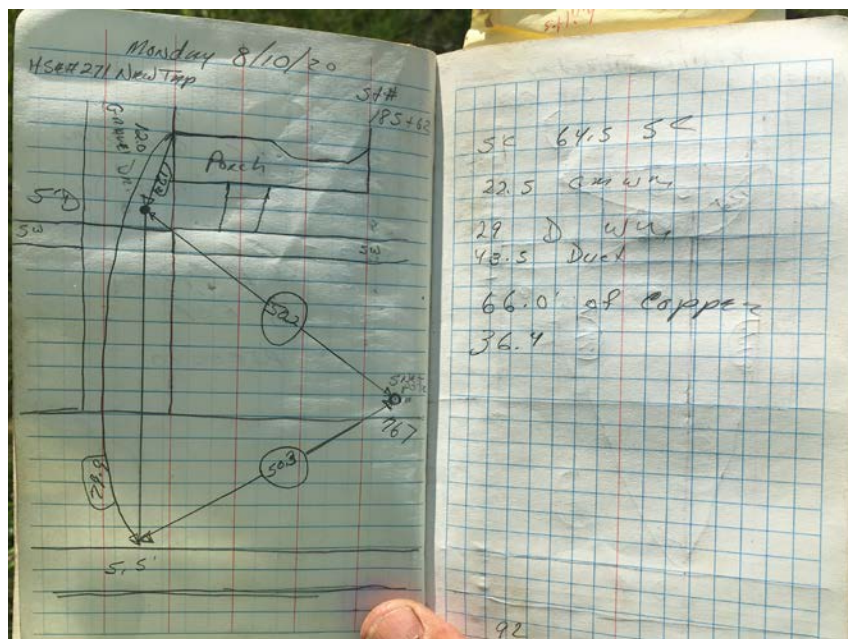
Picture 6: 271 Main Street Tie-Offs.

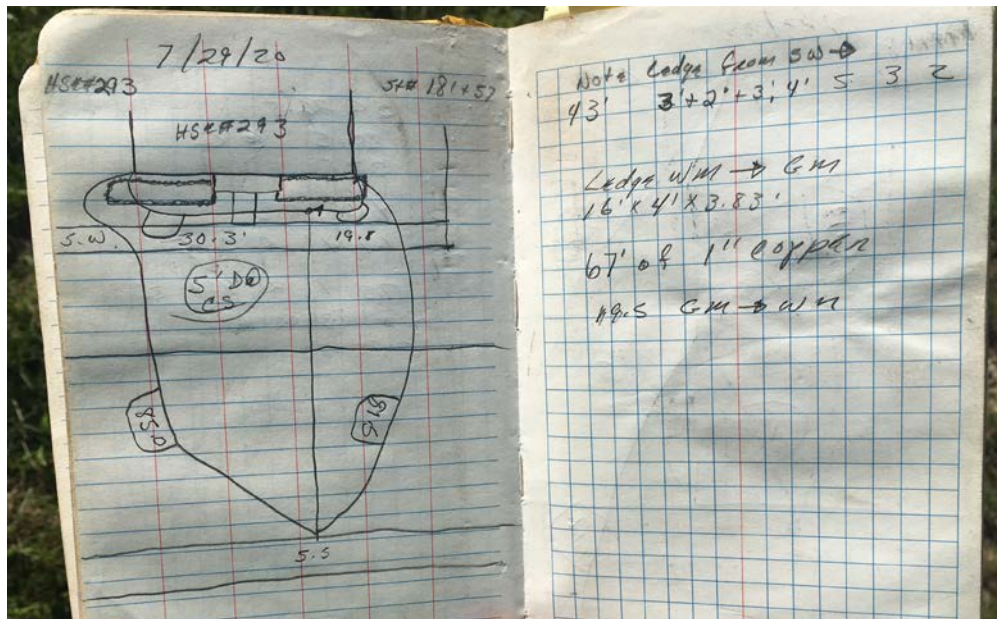
Picture 7: 293 Main Street tie-offs.

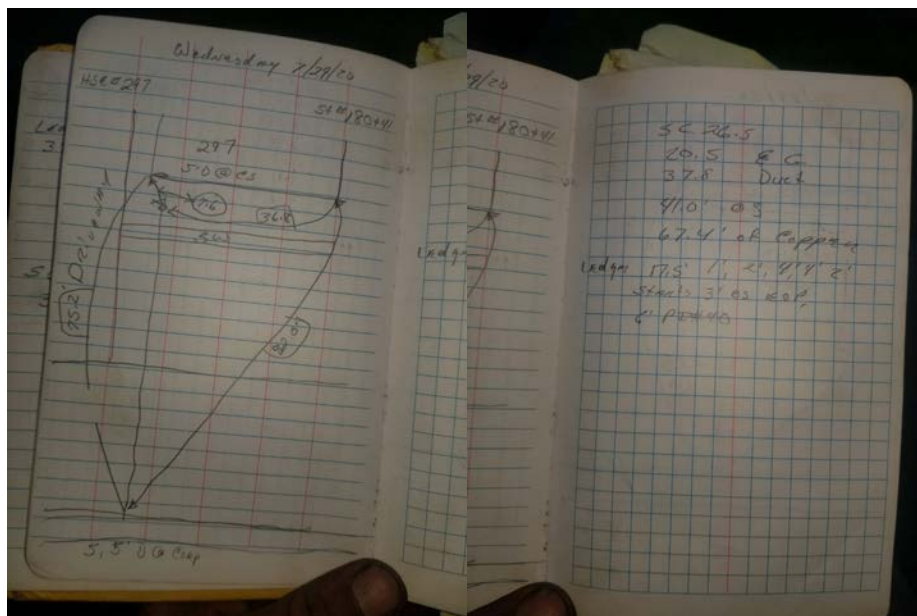
Picture 8: 297 Main Street tie-offs.

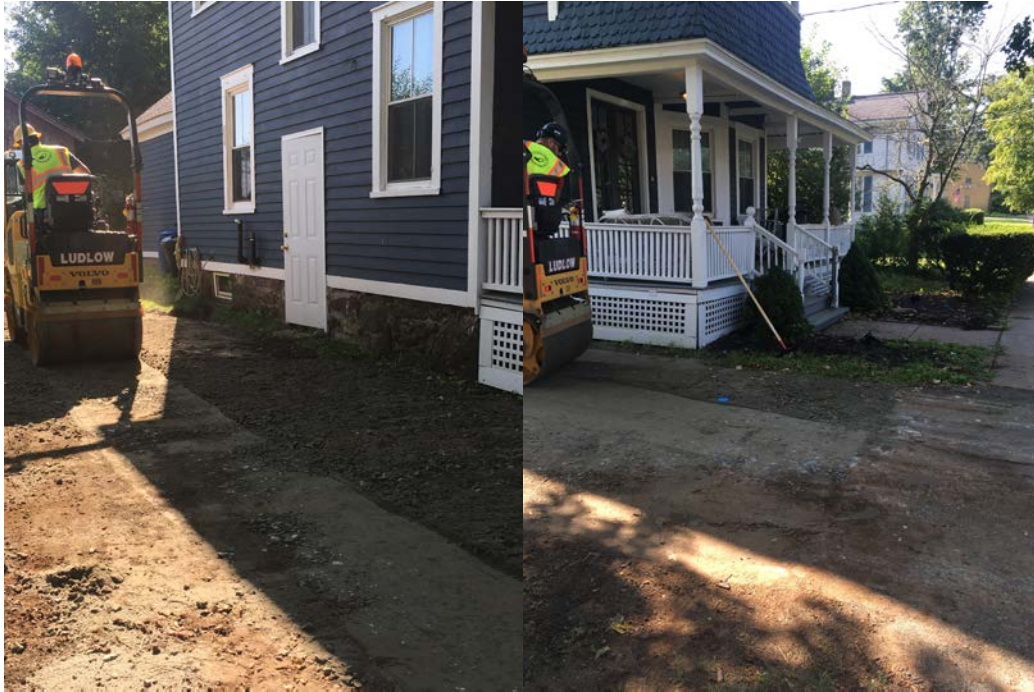
Picture 9: Facing west (L) and south (R). Left is compacting gravel drive, 1" copper enters just base basement window. Right the blue dot is the curb stop.

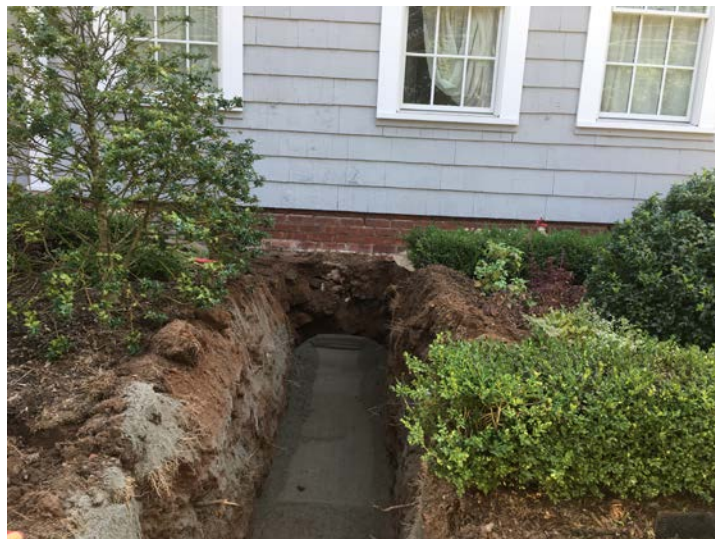
Picture 10: Facing east, 293 Main Street. Resident helped with removing and replacing shrubs. Sanded in 1" copper line.

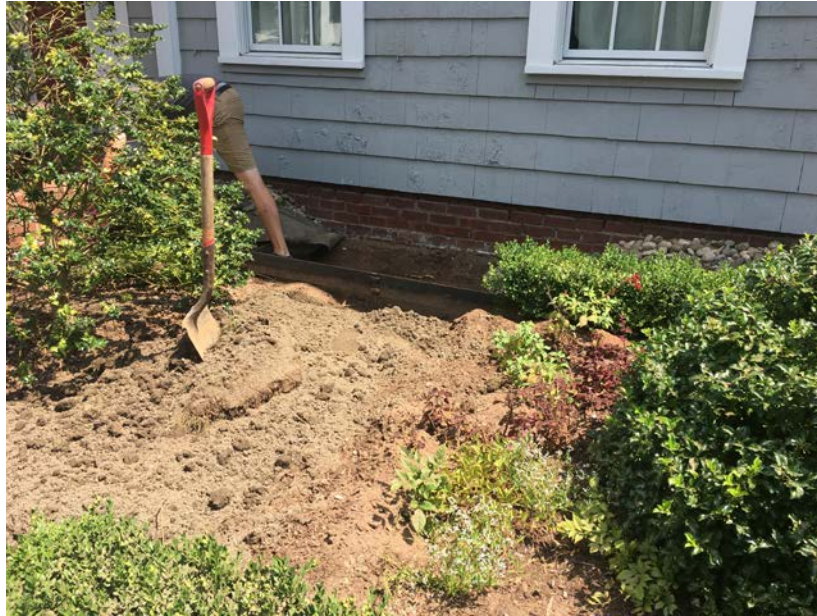
Picture 11: Facing easterly. Finish grade at 293 Main Street.

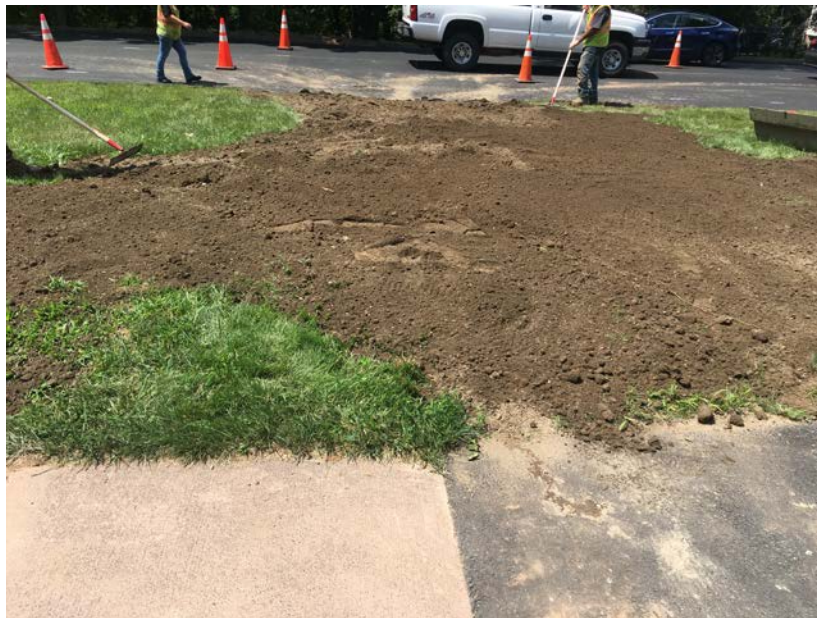
Picture 12: Facing west. Entrance re-grading/seeding at 293 Main Street.

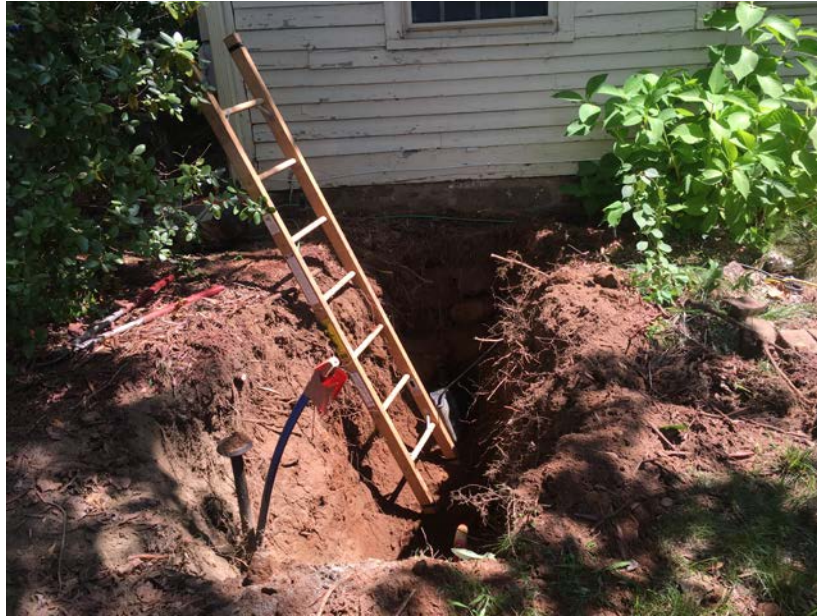
1300: The foundation wall at 297 Main St. is slightly thicker than usual, needed a little extra help getting through the wall. Ludlow installed two rose bushes and cut one rhododendron branch at 289 Main Street per owners/EPA request. The wall issue at 257 Main Street appears to have been resolved. Ludlow rebuilt the stone wall properly.

1420: Ludlow cleaning up and seeding 297 Main St. Billy (Ludlow) said that he asked Kathy to move this one up in the schedule due to the well going dry. Said it is likely because of a leak in the house. He noted it to the new owner. Unclear if plumber is aware.

Picture 13: Facing east, 297 Main Street curb stop and trench. Foundation thicker than most other homes. Possible leaking in house causing well to run dry. Location put on priority list.

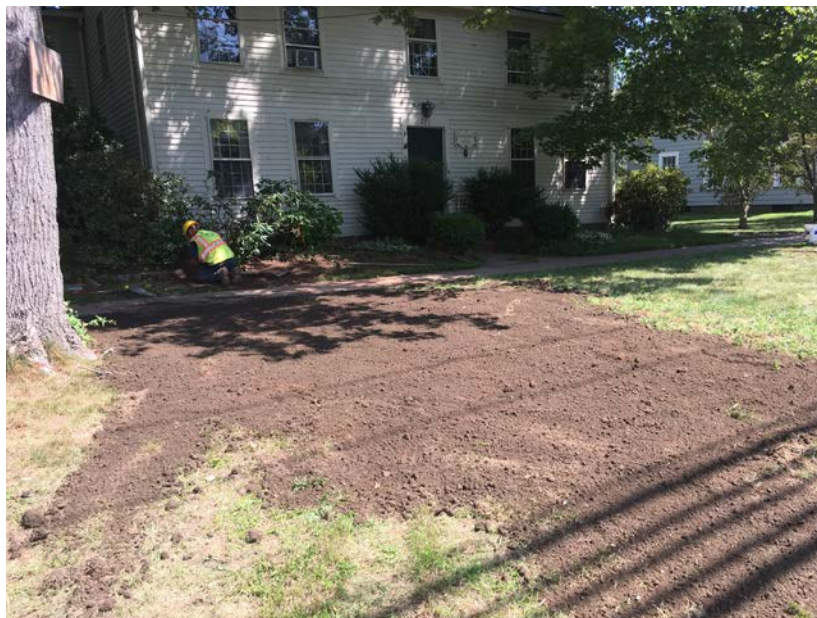
Picture 14: Facing southeasterly at 297 Main Street. Final grading and replacing brick trim.

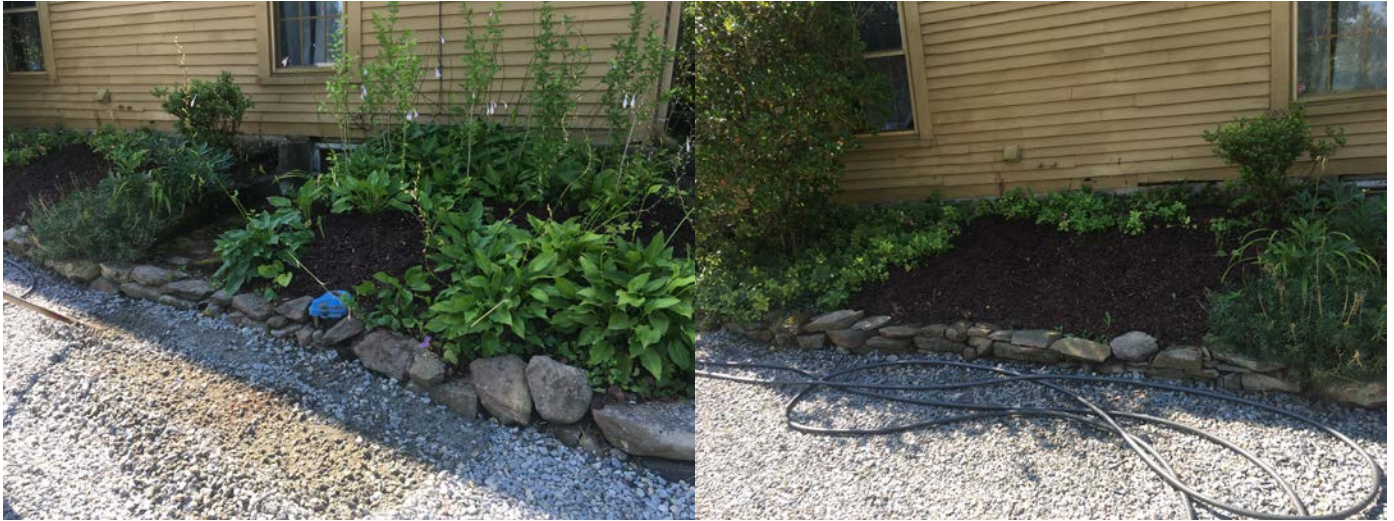
0950: Ludlow is responding to a complaint from 257 Main Street that the flag stone wall was not properly rebuilt. They are rebuilding the wall.

Picture 15: Facing southerly, before shots of stone wall at 257 Main Street, subject of complaint about replacement of wall.

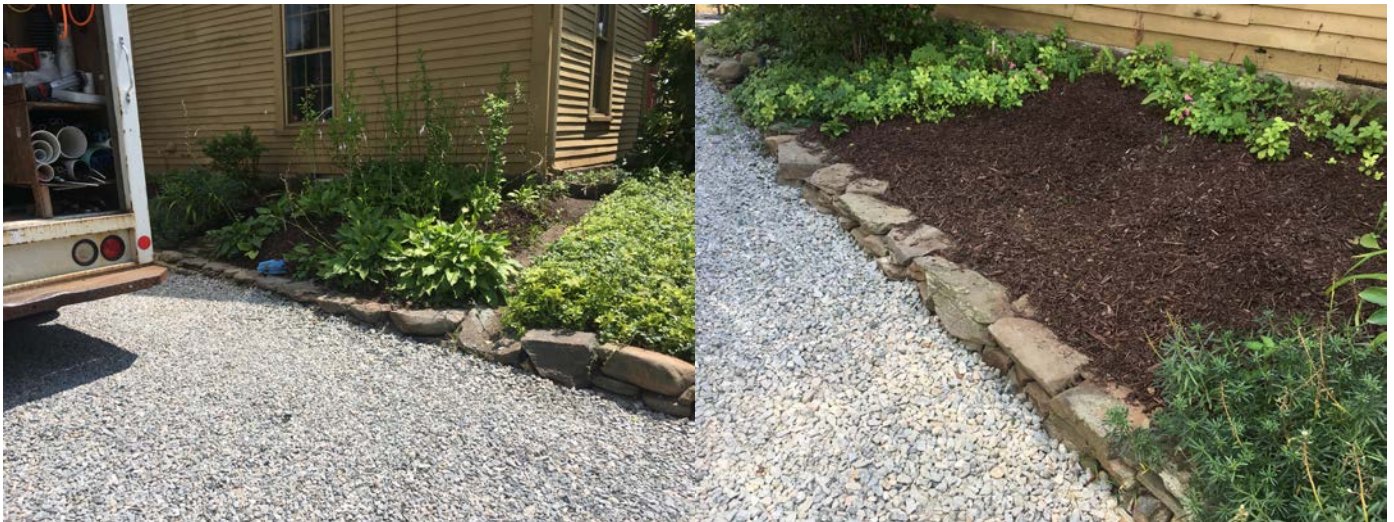
Picture 16: Facing southerly, after shots of stone wall at 257 Main Street after Ludlow made effort to repair. Homeowner seemed pleased with the effort.
