Daily Report

| Project: | Durham Meadows Pipeline Installation | Date: | August 17, 2021 |
| Project #: | AECOM: 6061487 | Report No: | 304 |

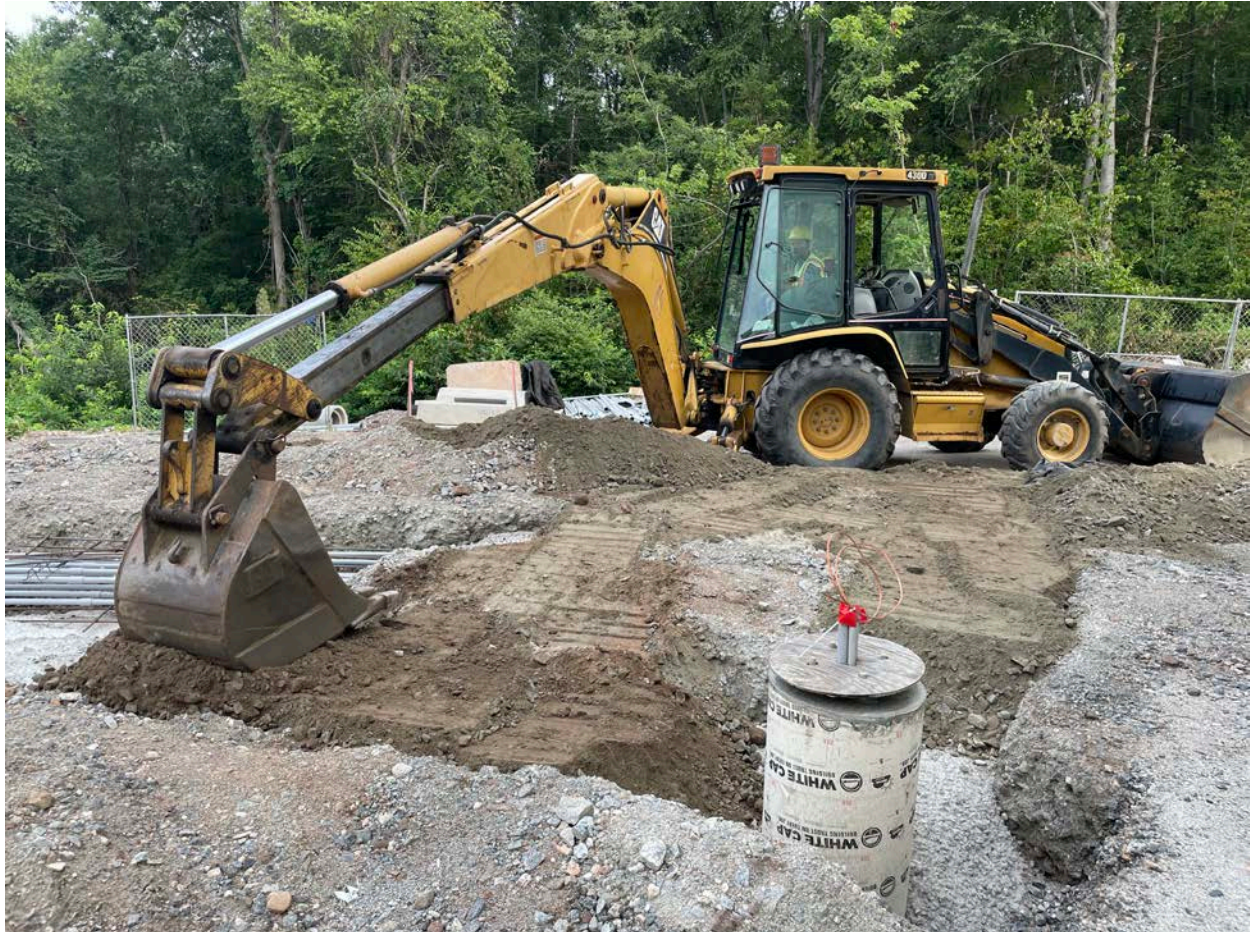
0749: Ludlow is backfilling soil over the concrete that was poured over the utility duck banks last week at the water tank work zone located east of the Shared Access Driveway in Middletown.

Picture 1: Ludlow backfilling over portions of the utility duct banks located west and north of the water tank located east of the Shared Access Driveway in Middletown. View to the north.

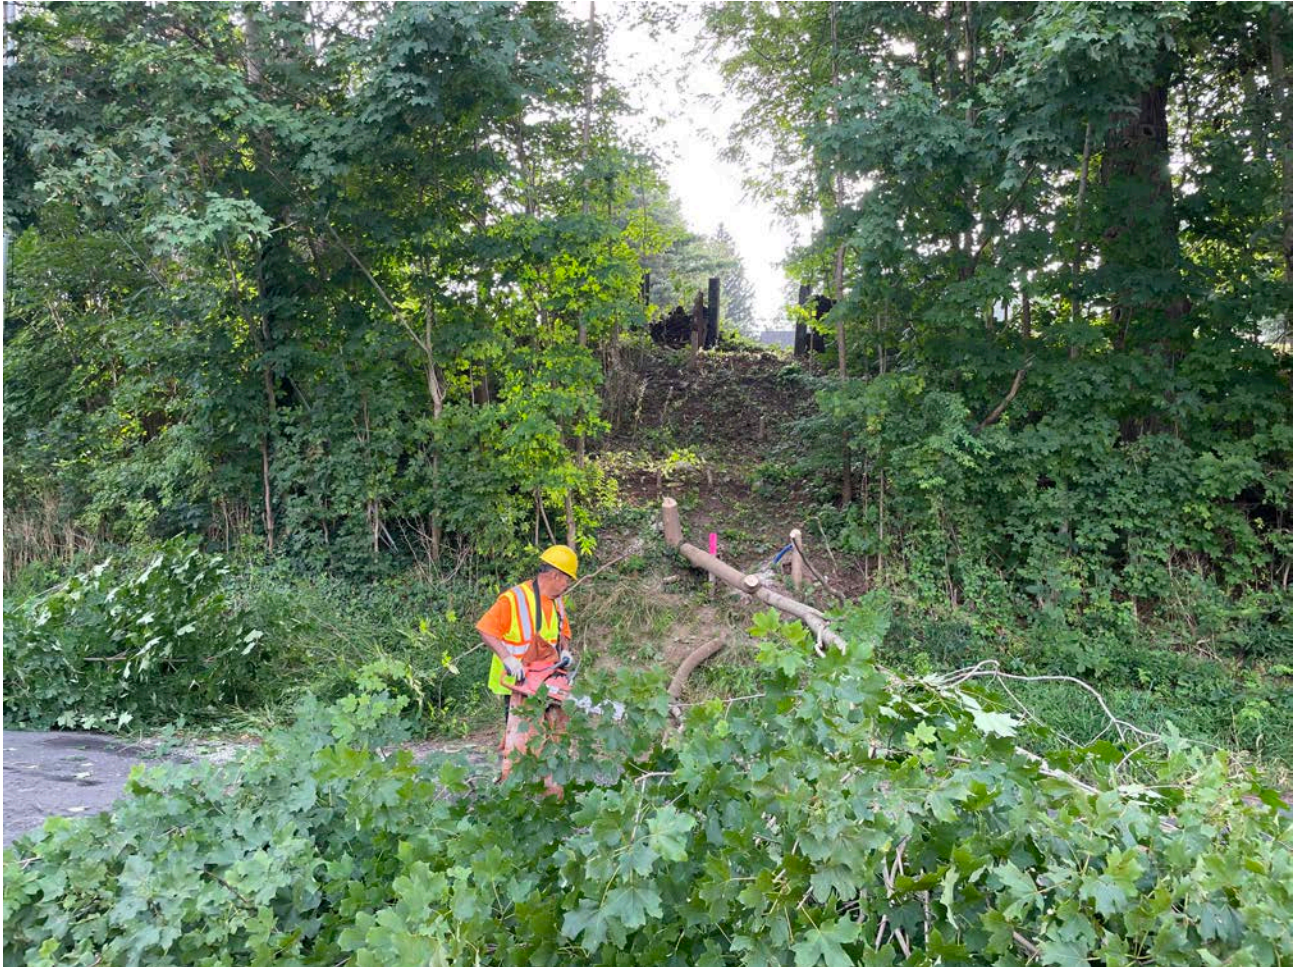
0818: Ludlow begins to cut trees on the sloping portion of the 97 Maple Avenue property next to Maple Avenue as they prepare to install a 1.5" copper water service line.

Picture 2: Ludlow removing trees at the 97 Maple Avenue property to install a 1.5" copper water service line to the residence. View to the east.

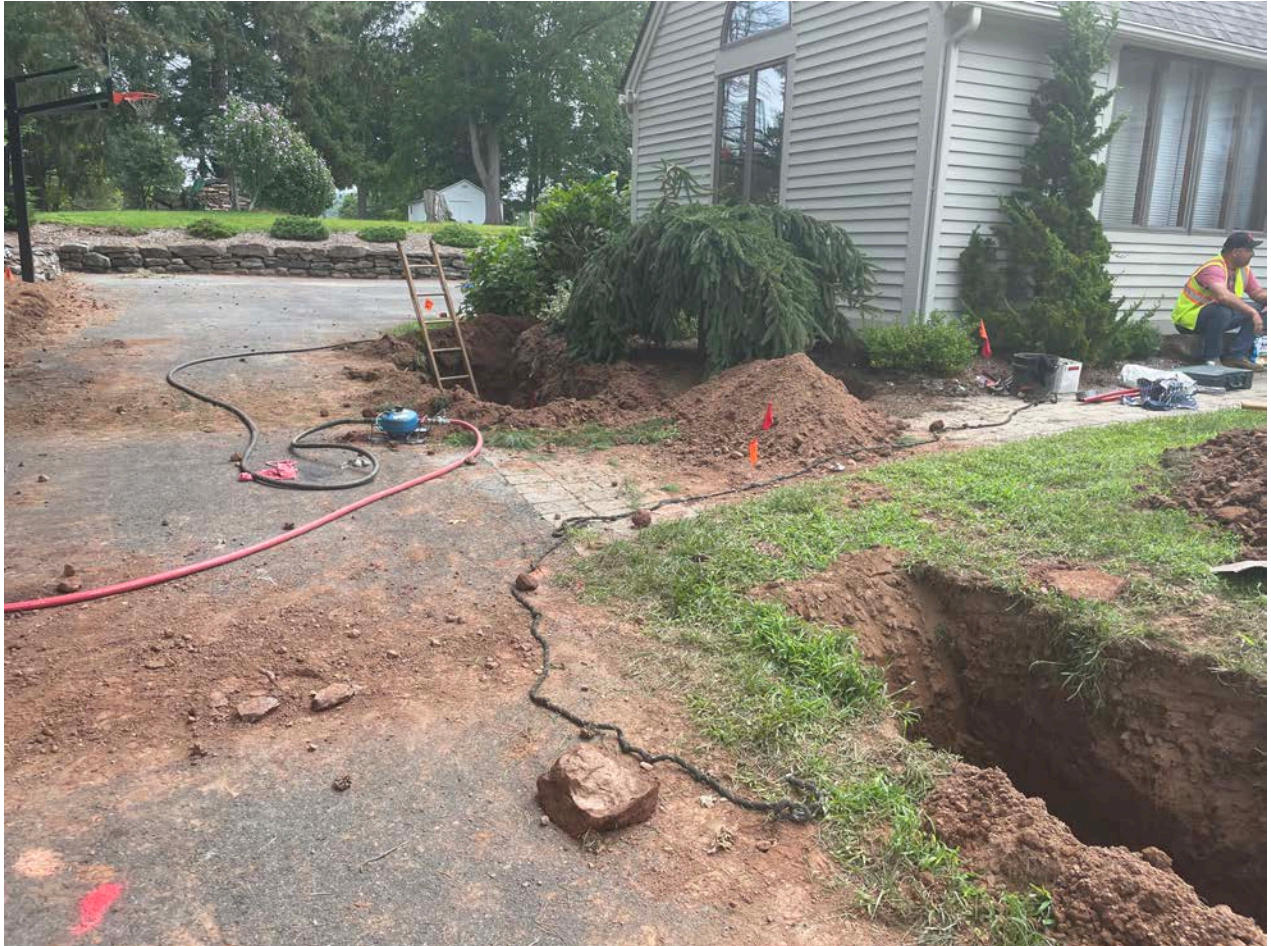
Picture 3: View of the excavation that Ludlow has made at the 97 Maple Avenue property for the installation of a 1.5" copper water service line. Ludlow used a pneumatic mole to punch a hole under the brick sidewalk for the copper pipe to be placed. View to the southeast.

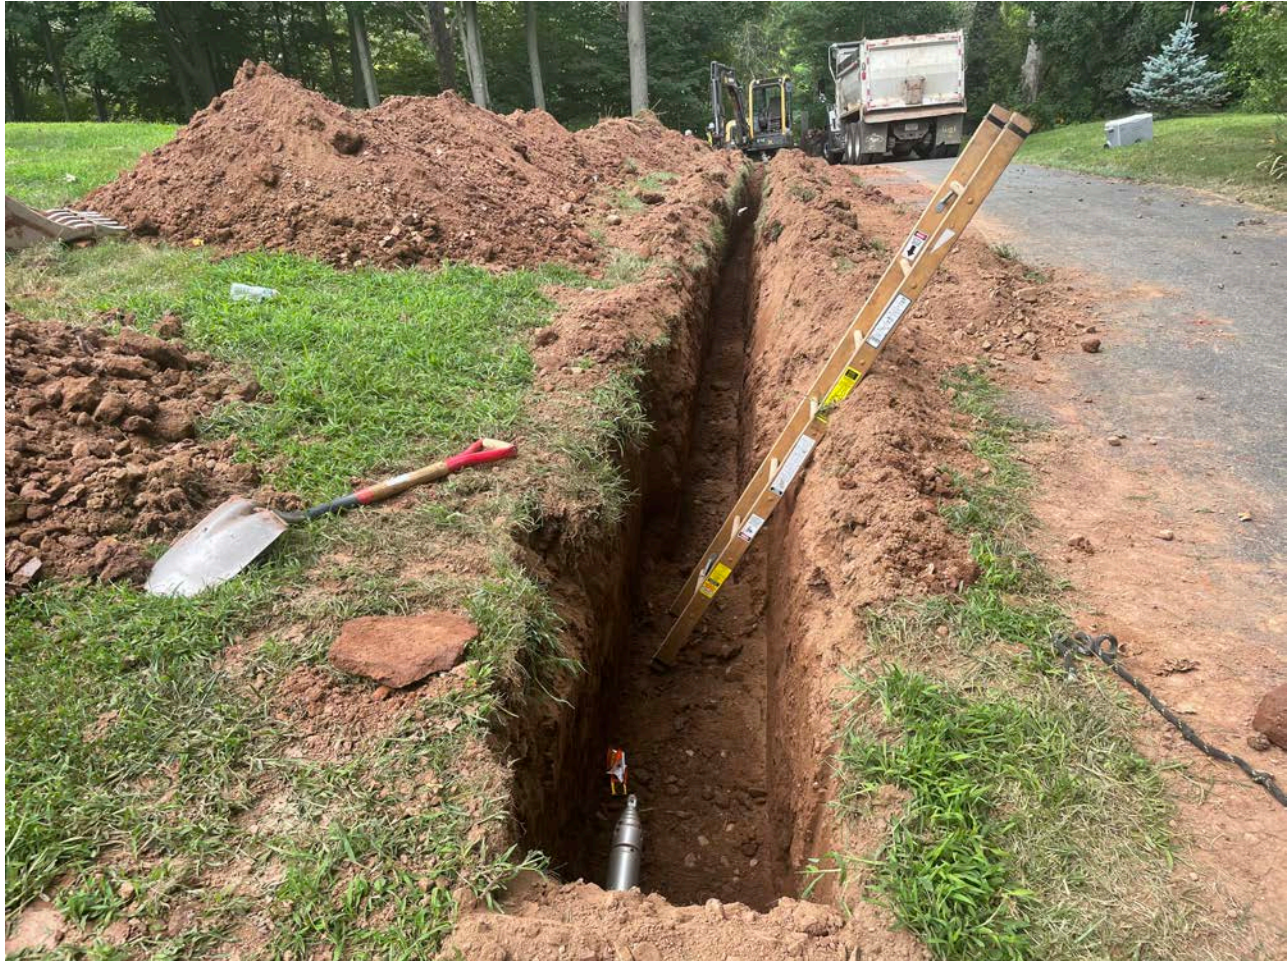
Picture 4: Ludlow excavating on the 97 Maple Avenue property. Note pneumatic mole in trench. View to the west.

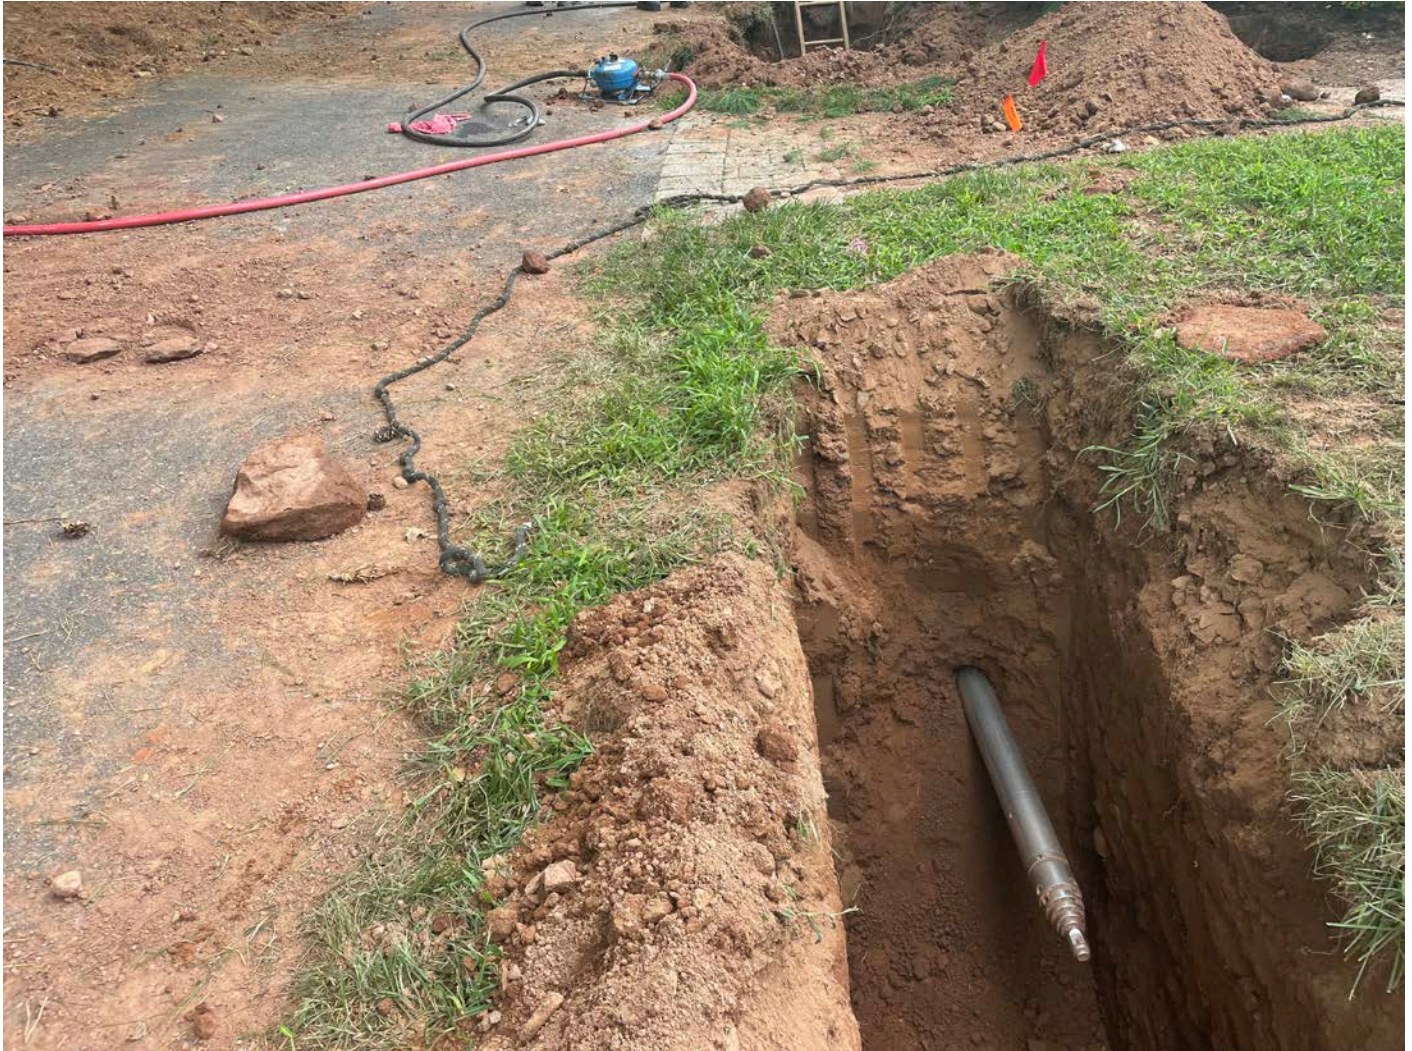
Picture 5: Ludlow using a pneumatic mole to create a hole beneath a brick walkway for the placement of 1.5” copper line. View to the east.

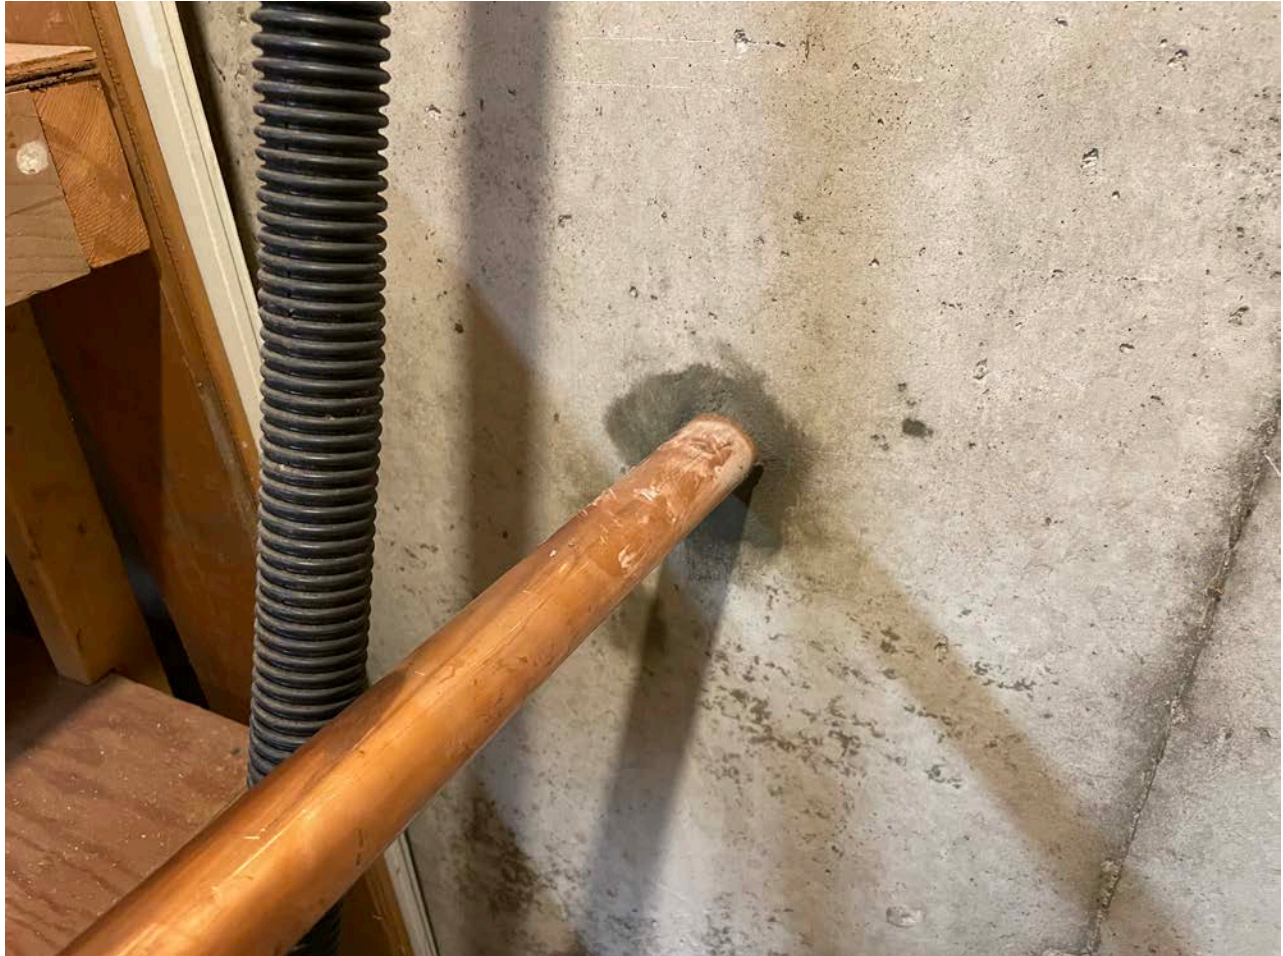
1241: Ludlow is setting up to run a pneumatic mole underneath the driveway of the 97 Maple Avenue residence for the installation of a 1.5" copper water service line. Ludlow has drilled through the north side of the home's foundation with a rotary hammer and has inserted the 1.5 copper" waterline into the home's basement. The penetration point is 4'7" west of the home's northeast corner.

Picture 6: 1.5" copper pipe that was inserted through the northern foundation of the 97 Maple Avenue residence and secured in place with non-shrink grout. View to the northwest.

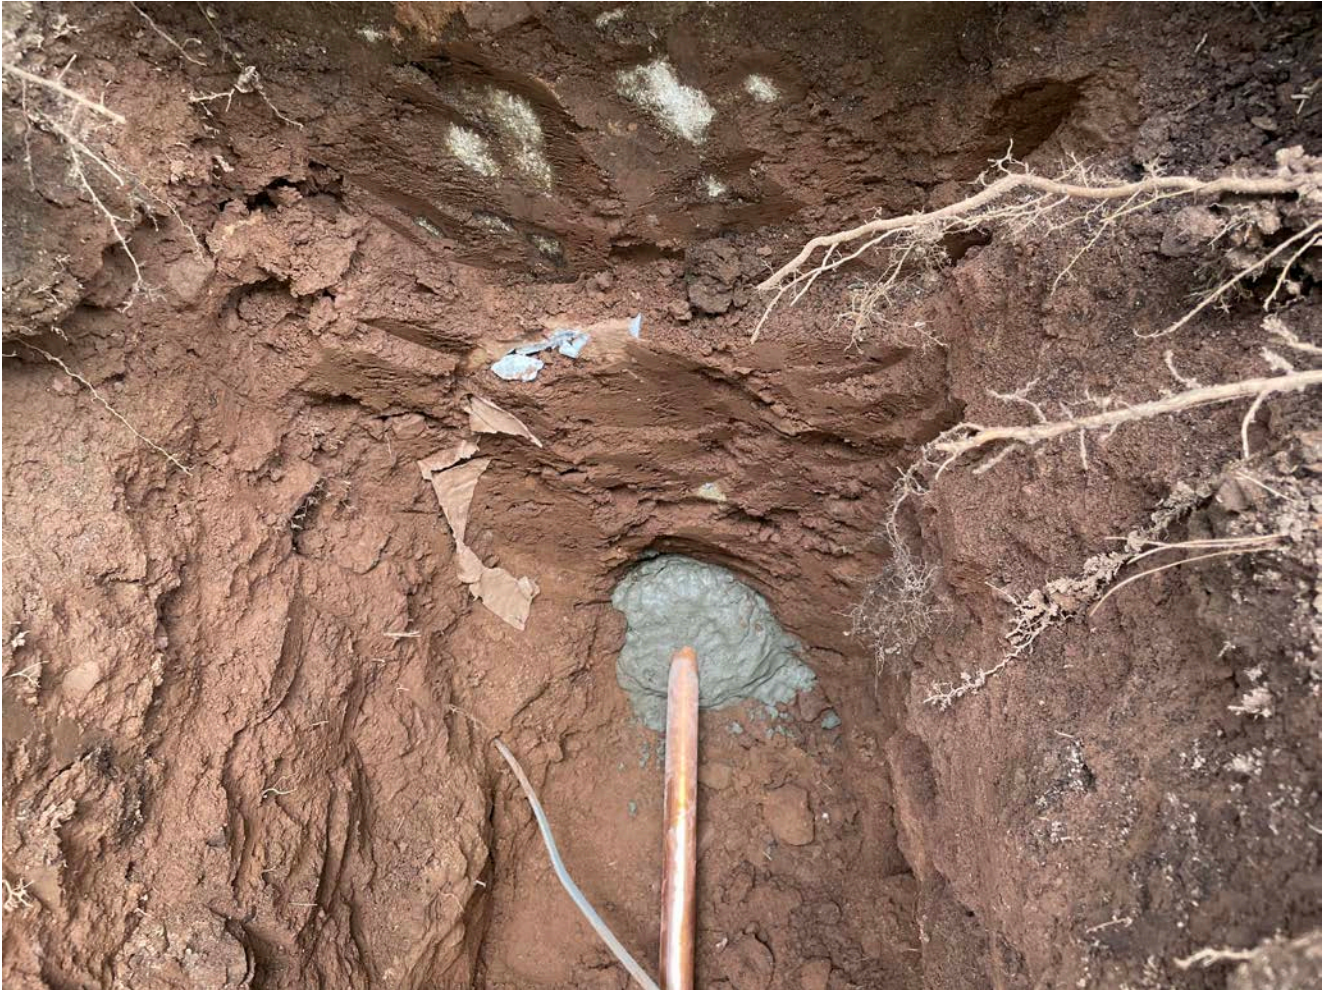
Picture 7: 1.5" copper pipe that was inserted through the northern foundation of the 97 Maple Avenue residence and secured in place with non-shrink grout. View to the south.

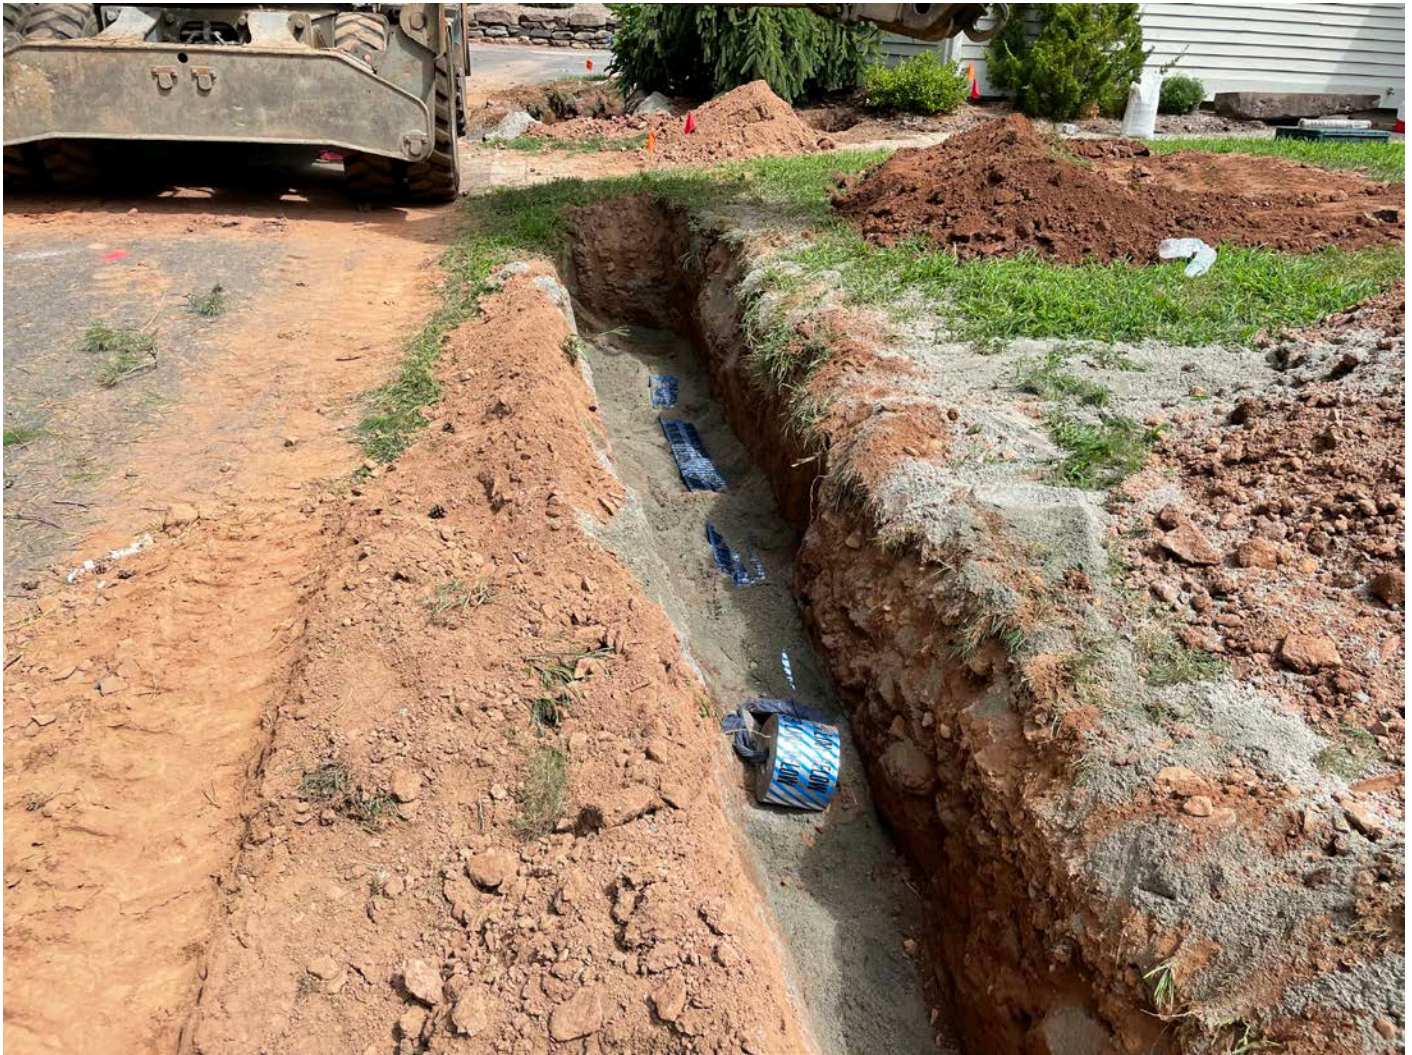
1410: Ludlow is backfilling over installed 1.5" copper water service pipe next to the northern side of the 97 Maple Avenue residence. Ludlow has placed sand and caution tape over approximately 70' placed pipe so far.

Picture 8: Ludlow in the process of placing sand followed by caution tape over installed 1.5" copper water service line at the 97 Maple Avenue property. View to the east.

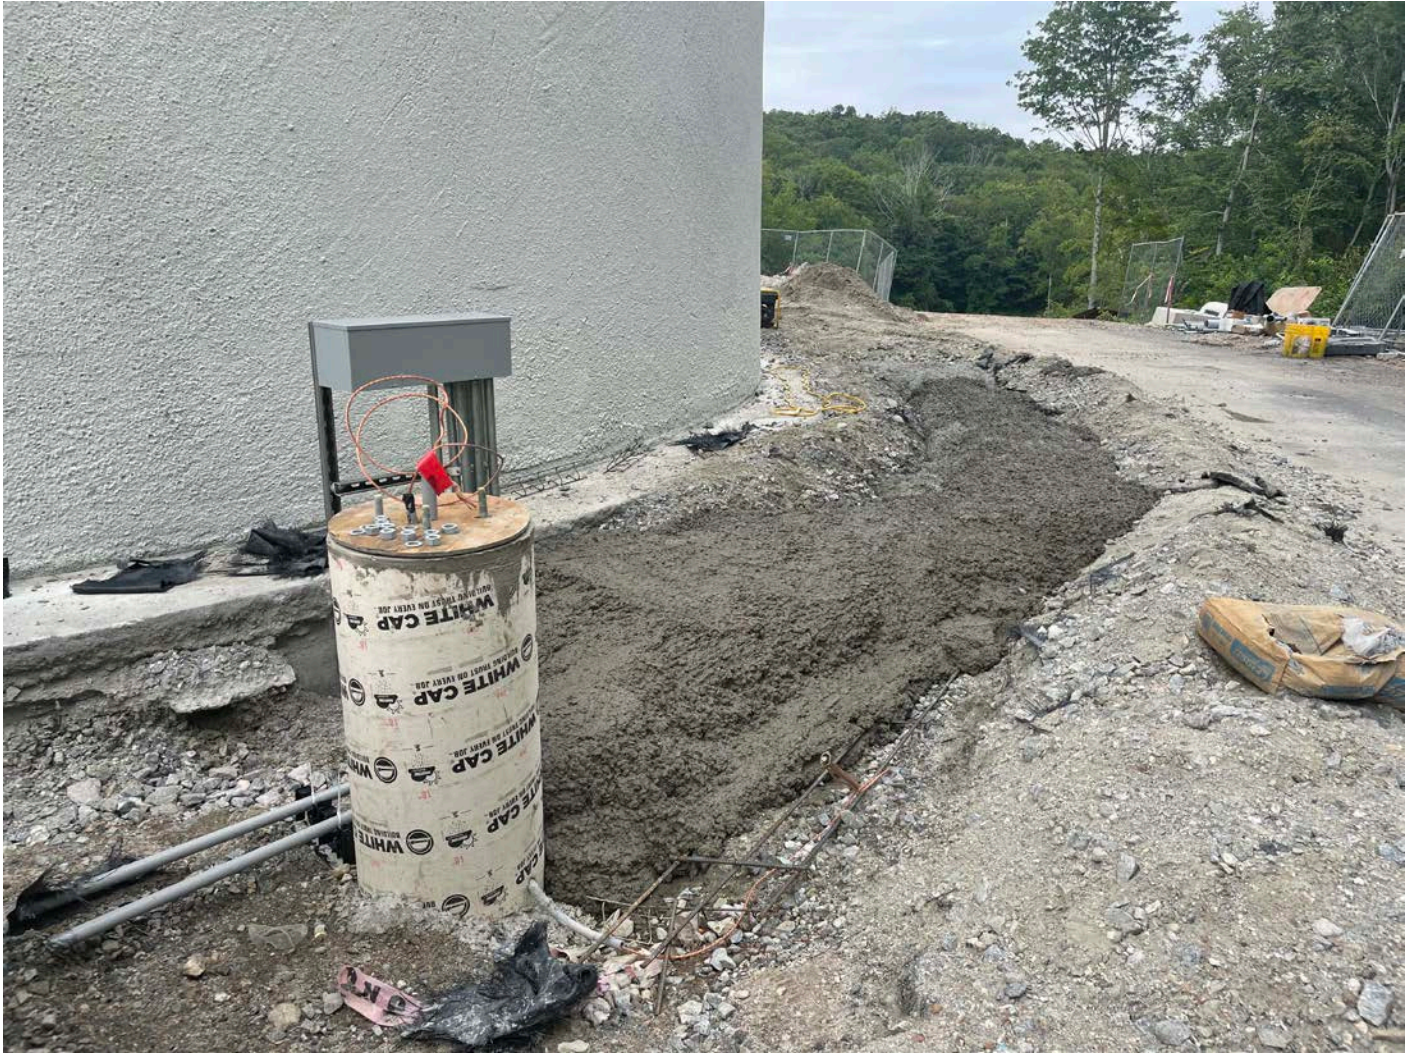
- Air Entrainment: 4.0%
- Slump: 7.25"
- Temperature: 80°F

Picture 9: 4000 PSI concrete that was placed over a section of the utility duct bank on the north side of the water tank located east of the Shared Access Driveway in Middletown. View to the west.

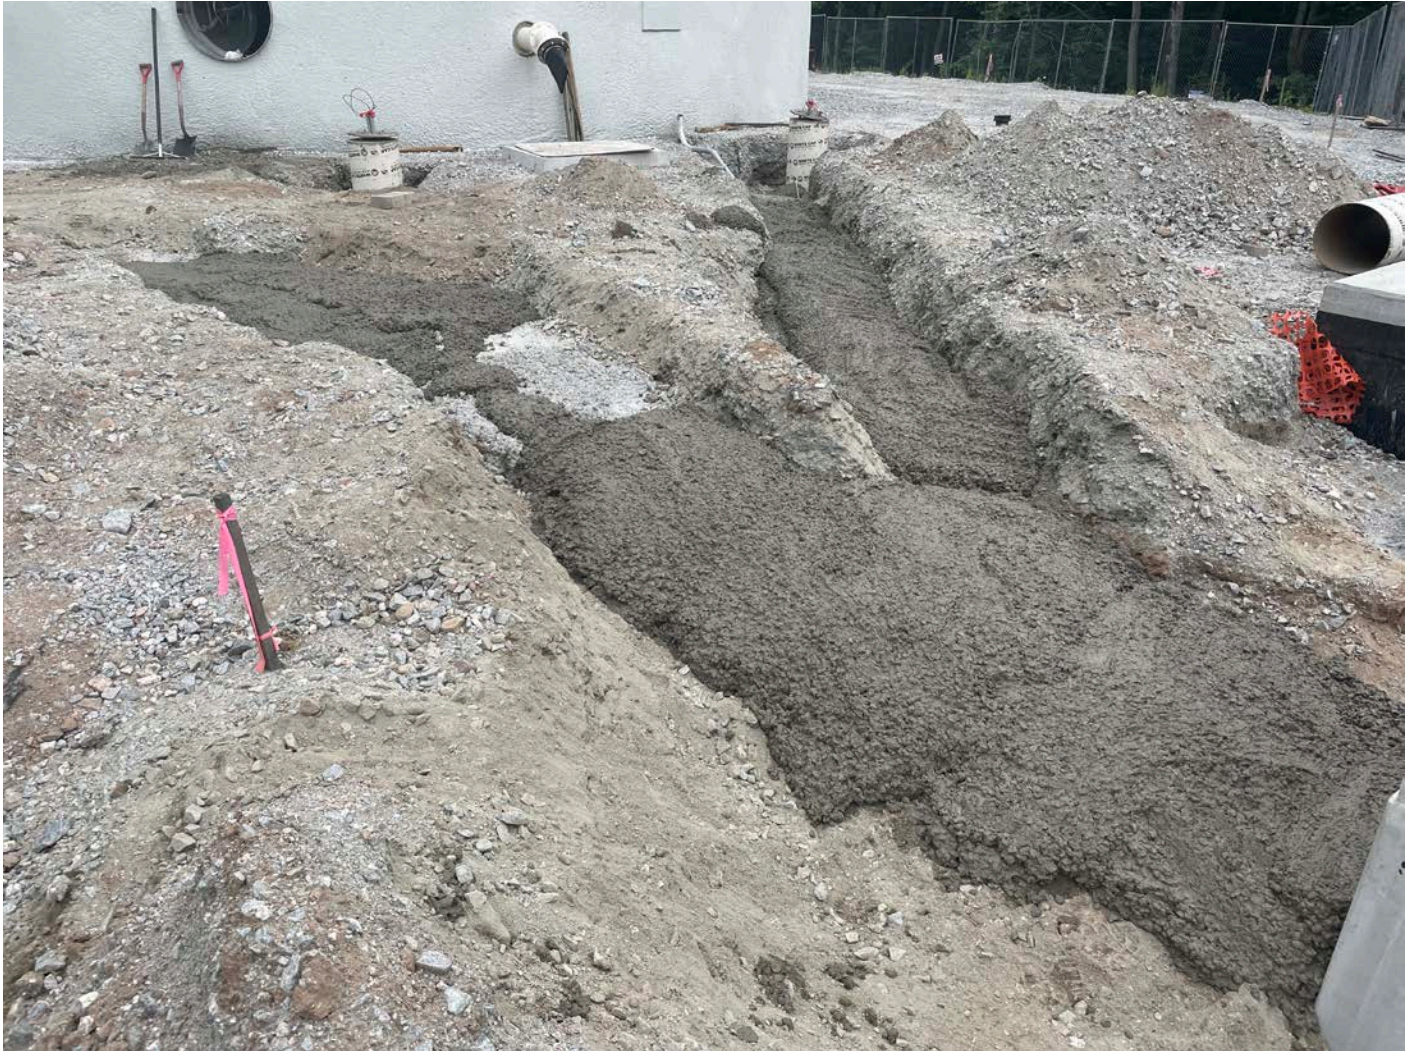
Picture 10: 4000 PSI concrete that was placed over a section of the utility duct bank on the west side of the water tank located east of the Shared Access Driveway in Middletown. View to the southeast.

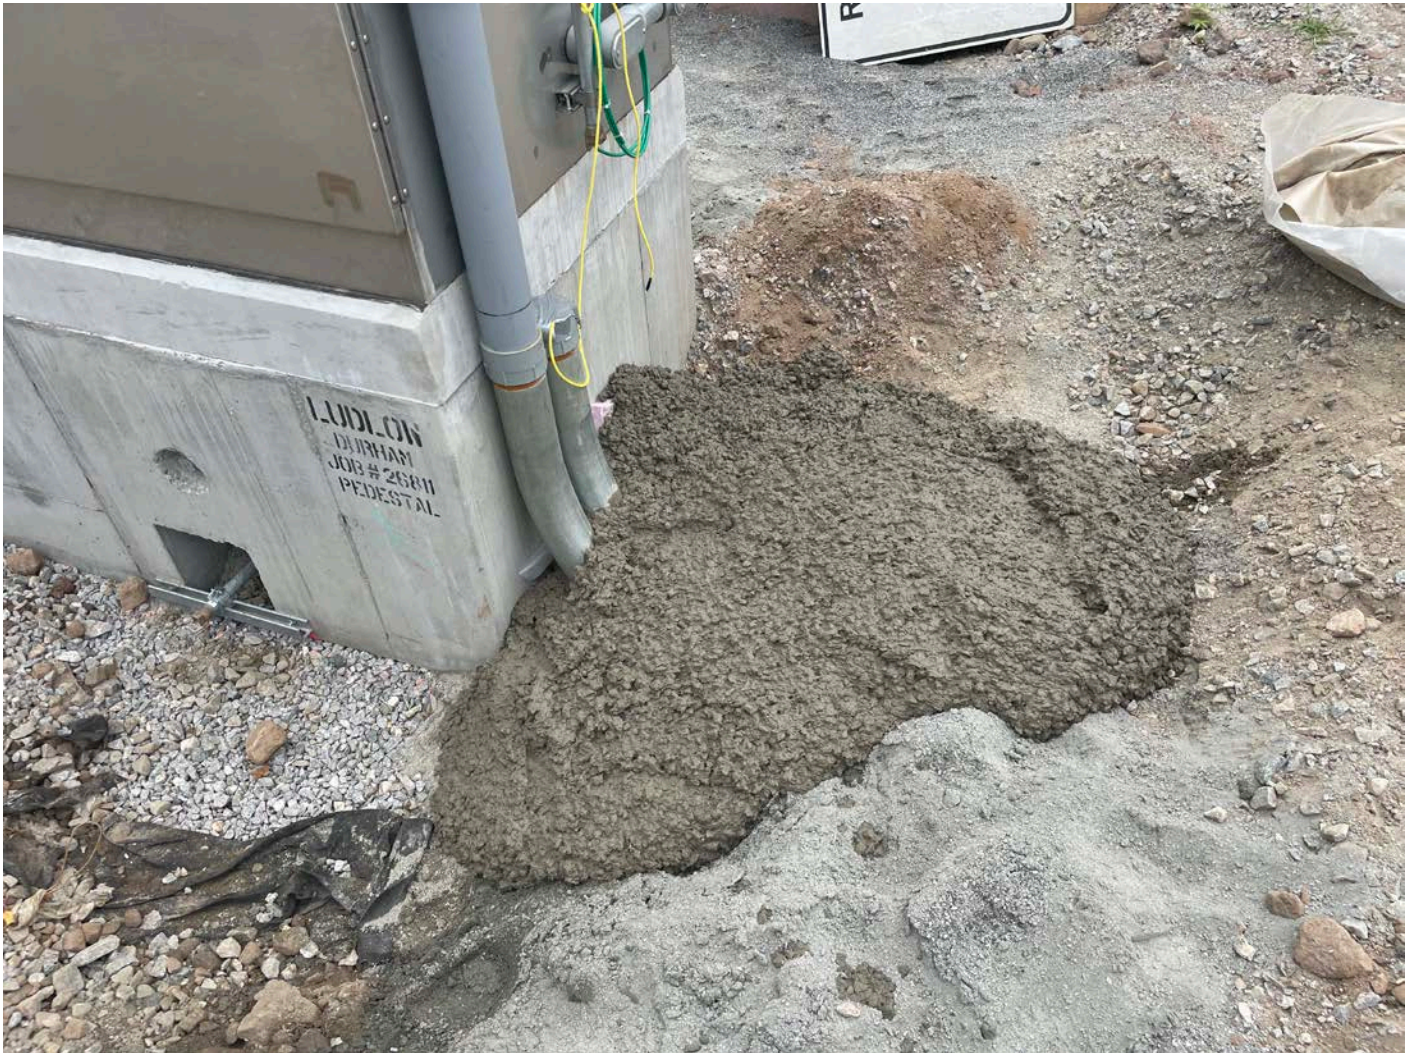
Picture 11: 4000 PSI concrete that was placed over a section of the utility conduits on the west side of the electrical enclosure located north of the altitude valve vault at the water tank work zone in Middletown. View to the southeast.

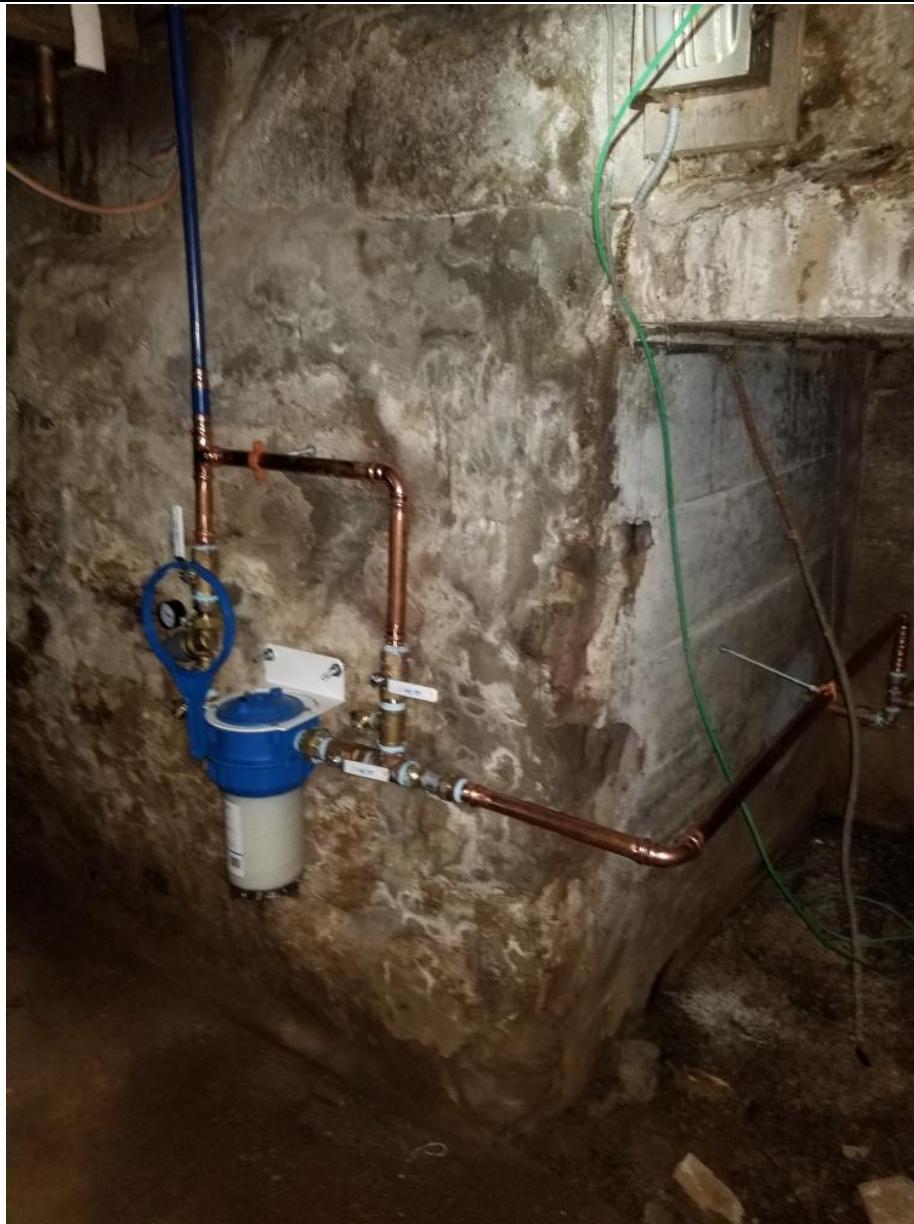
Picture 12: Final water service components that Fazzino Plumbing installed today at the residence located at 252 Main Street, Durham. View to the south.

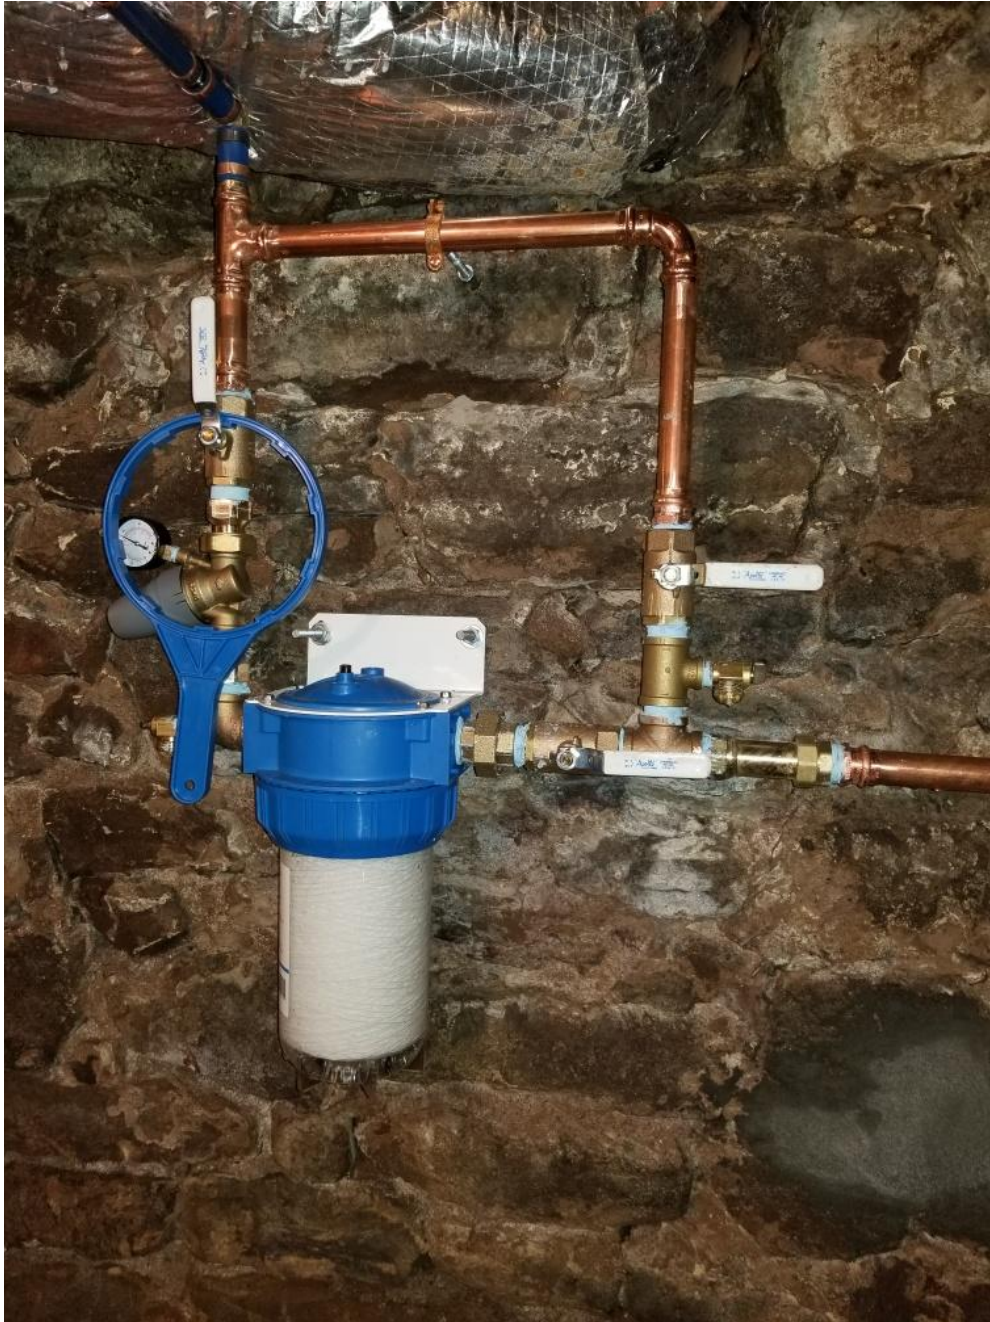
Picture 13: Final water service components that Fazzino Plumbing installed today at the residence located at 262 Main Street, Durham. View to the south.
