Daily Report

Project:Durham Meadows Pipeline InstallationDate:August 24, 2021Location:Maple Avenue, Durham; Long Hill Road, MiddletownDay of Week:Tuesday

Project #:
 AECOM: 6061487
 Report No:
 309

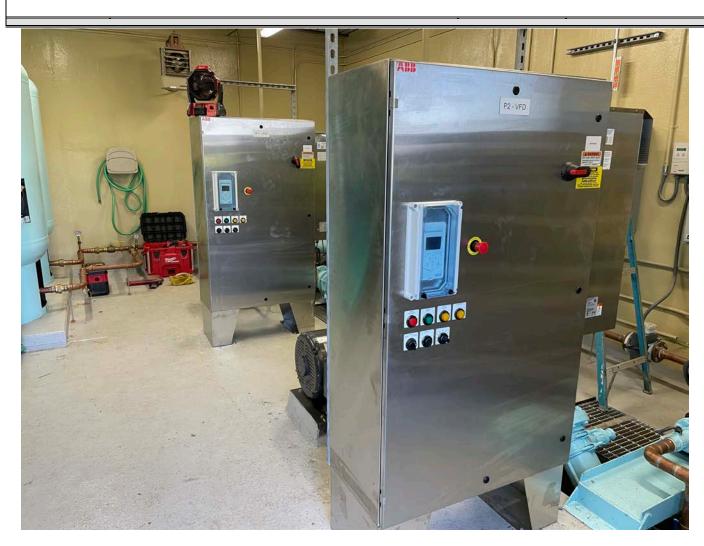
Picture 1: Long Hill pump station where A&R Electrical has installed two VFD cabinets. View to the south.

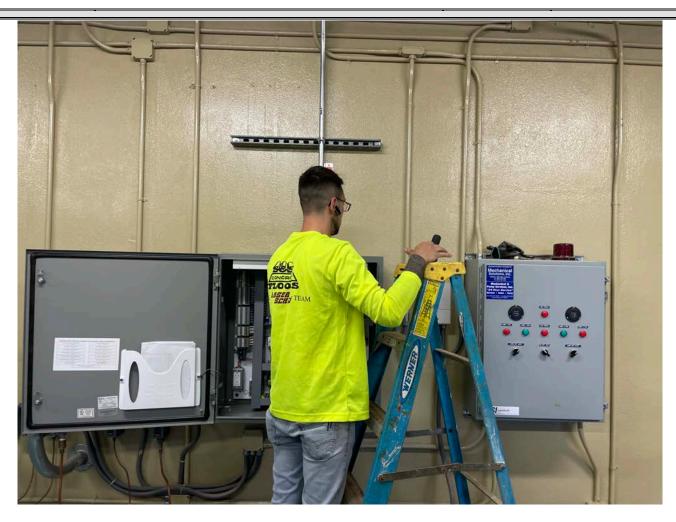
Picture 2: -A&R Electrical working on an instrumentation panel at the Long Hill pump station. View to the west.

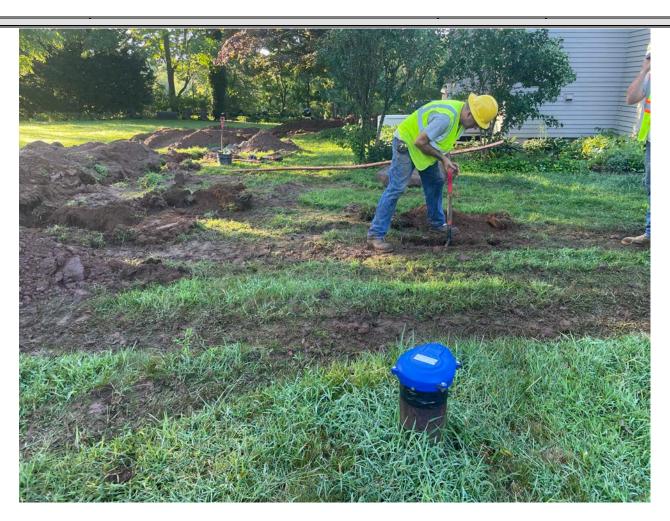
0755: Ludlow is hand digging between the 95R Maple Avenue residence and its drinking water well as they attempt to locate the well feedline into the house before continuing to excavate a trench for the installation a 2" copper water service line.

Picture 3: Ludlow hand digging to locate the water line between the 95R Maple Avenue residence and it's drinking well. View to the south.

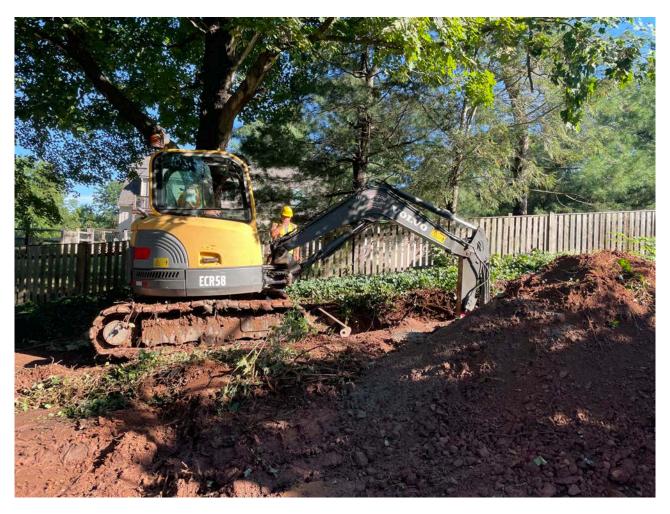
0914: Ludlow has completed excavating a trench for the installation of a 2" copper water service line at the 95R Maple Avenue residence. Ludlow is currently installing final sections of 2" copper water line.

Picture 4: Ludlow excavating for the installation of a 2" copper water line at the 95R Maple Avenue residence. View to the north.

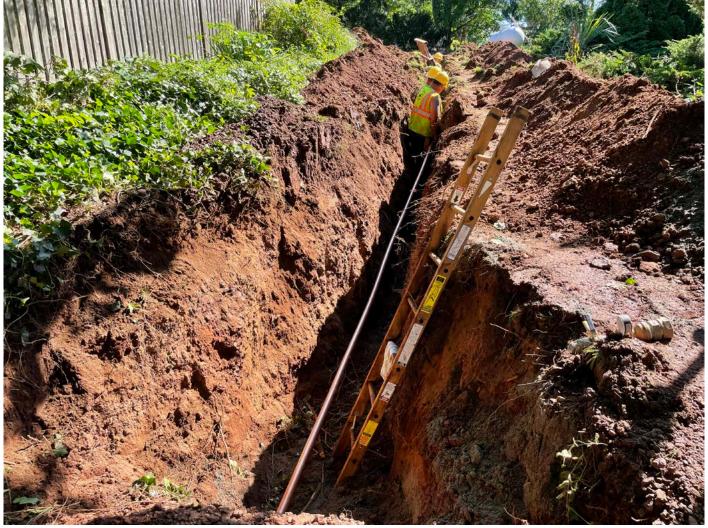
Picture 5: Ludlow placing 2" copper water service line at the 95R Maple Avenue property. View to the east.

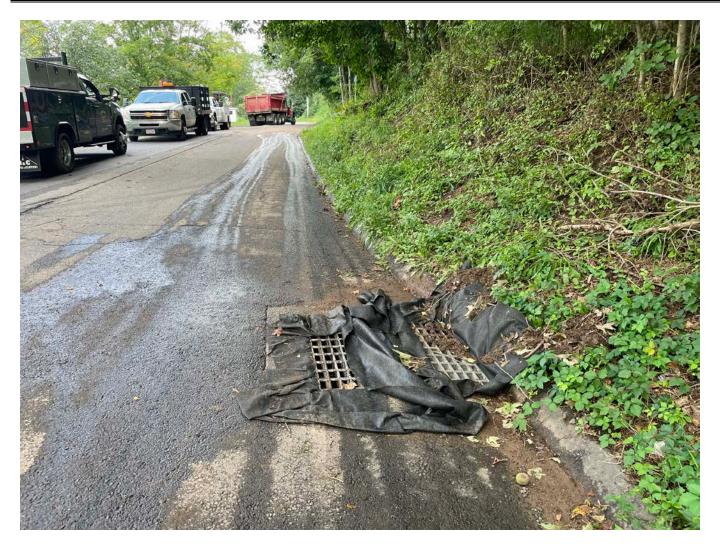
Picture 6: Filter fabric placed at a catch basin on the east side of Maple Avenue; south and downgradient of 95R Maple Avenue. View to the north.

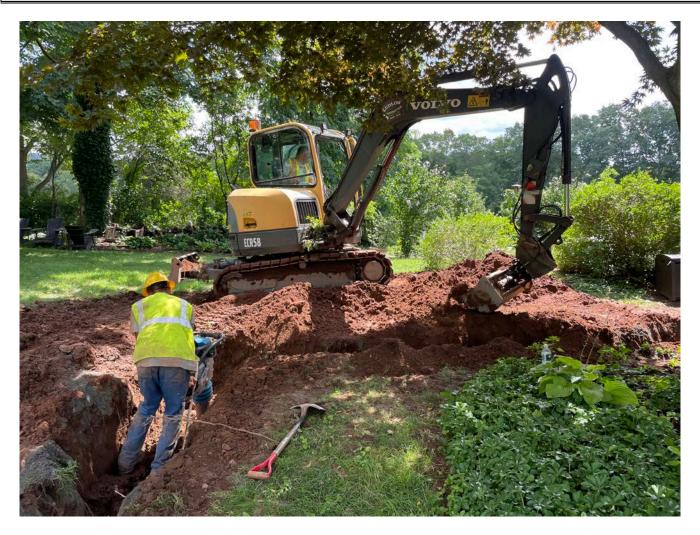
1115: Ludlow has backfilled over approximately 30 feet of 2" copper water service line at the 95R Maple Avenue residence. Backfill sequence over the copper pipe is sand followed by caution tape followed by native fill that is being placed in 1' lifts. Ludlow is compacting the fill with a jumping Jack.

Picture 7: Ludlow placing sand over placed 2" copper water service on the east side of the 95R Maple Avenue residence. View to south.

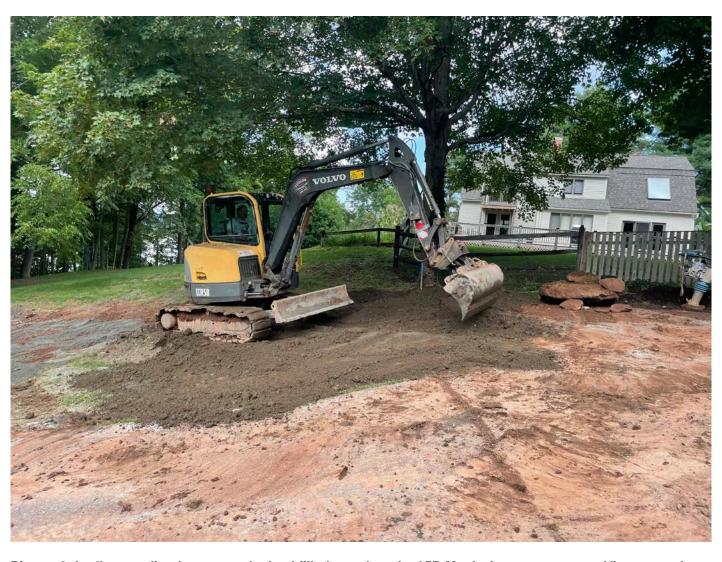
1358: Ludlow has completely backfilled the water line installation trench at the 95R Maple Avenue property. Ludlow is currently spreading loam over portions of the property's yard that were disturbed during the water line installation.

Picture 8: Ludlow grading loam over the backfilled trench at the 95R Maple Avenue property. View to north.

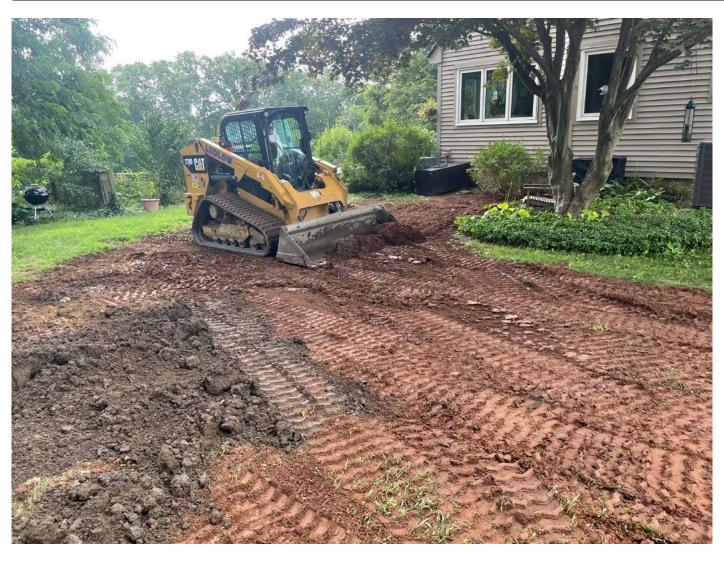
Picture 9: Ludlow grading loam over the backfilled trench at the 95R Maple Avenue property. View to southwest.
